HUGHES TOOL COMPANY · AIRCRAFT DAVISION: Culver City, California

BEST AVAILABLE COPY Report No. HTC-AD 64-10

#### Final Report

#### 20MM MARK 4 GUN POD 250,000 ROUND RELIABILITY IMPROVEMENT PROGRAM

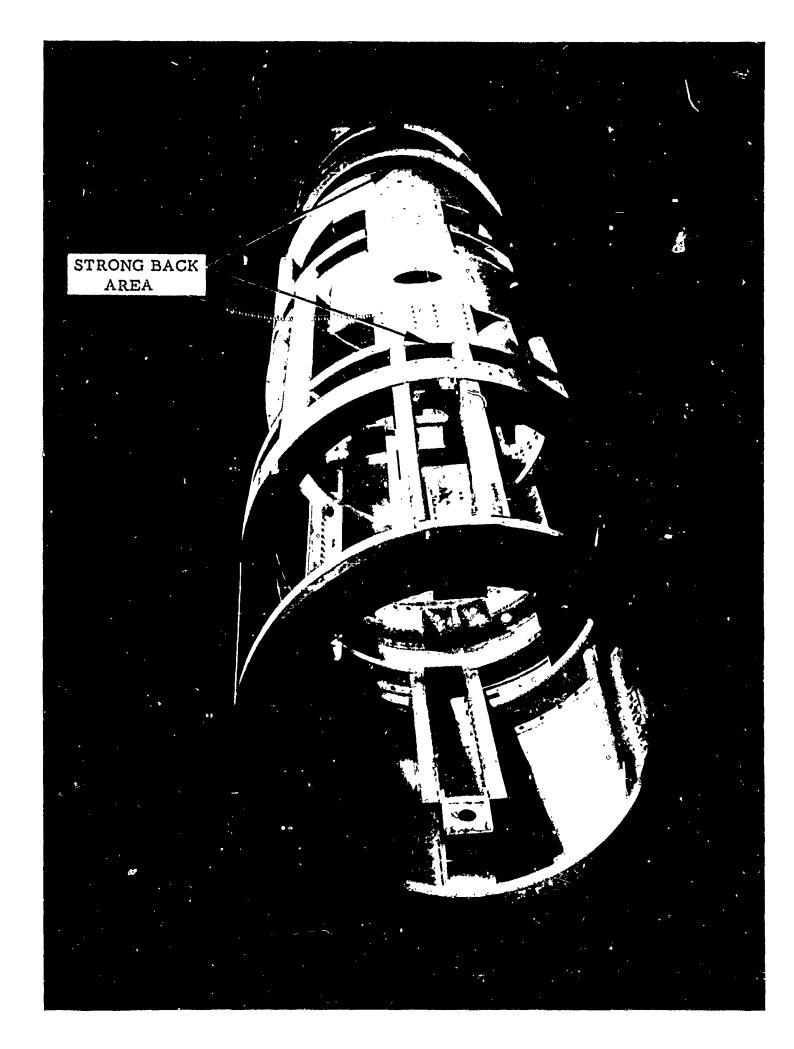
Figure 8. Strongback for F100

A number of improvements were made in the Mk 4 Mod 0 Gun Pod over the EX-1 Gun Pod used in the previous 300,000 round reliability test. The pod structure was strengthened by changing the forward strongback to stainless steel and beefing up the sway brace areas as shown in Figure 8. This made the pod capable of being flown at speeds up to Mach 1.2 on wing pylons. In addition the fore and aft loads were taken out in the forward lug as opposed to the aft lug on the EX-1, and the rear lug was provided with azimuth adjustment or  $\pm 1^{\circ}$ . The adjustable rear mount is shown in Figure 9. The bulkhead at Station 108 was changed to cast aluminum with a stronger stainless steel channel in order to take the fore and aft magazine loads out at this station rather than at the aft end of the magazine as was done in the EX-1 gun pod. This allowed the aft magazine support to be lighter and less complex, and also helped to control the tolerance buildup in the magazine drive gear. The location of the cast bulkhead is shown in Figure 10.

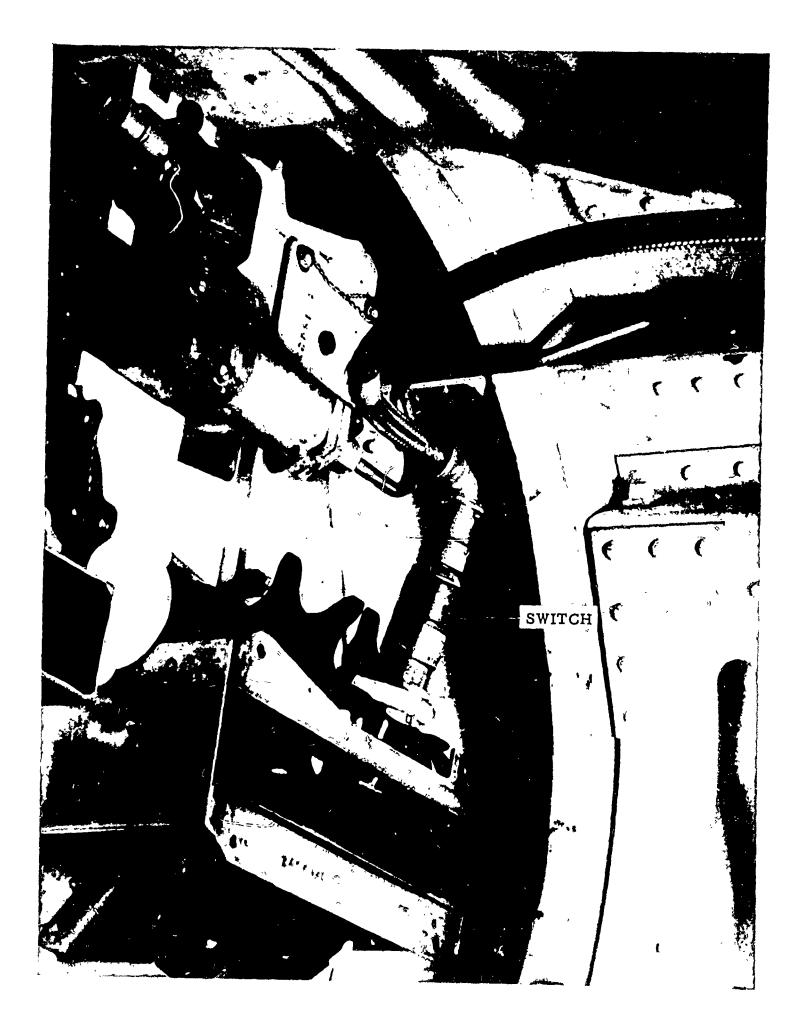
Figure 13. Last Round Switch

A switch was mounted on the ammunition drive sprocket to shut off the air motor. This switch opened when the last round in the magazine passed through, thus cutting the current to the air motor solenoid. Without this switch, the air motor would reach high rotational velocities and cause unnecessary wear. The last round switch is shown mounted in Figure 13. This switch may also be used to open the automatic charge circuit so that continuous charging would not take place after a fireout with a multiple pod installation. No problems were encountered using this switch, and the wear on the air motor was not noticeable at an inspection at 82,000 rounds of firing.

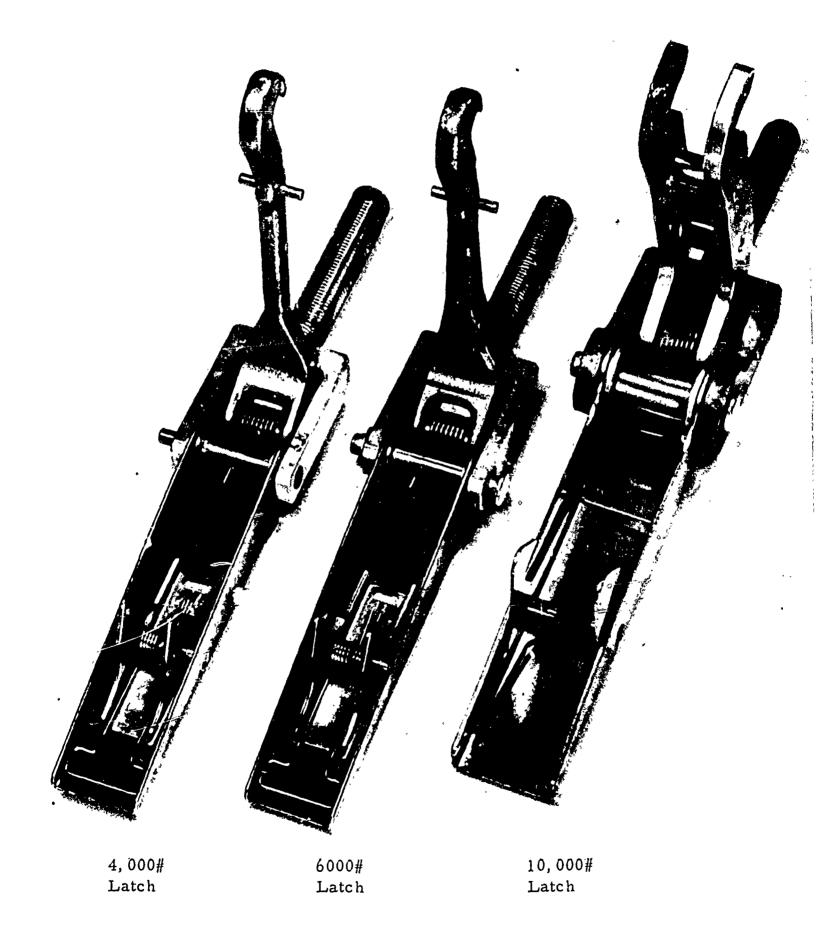
Figure 16. 10,000 lb. Nose Latches

Several changes were made in the pod nose. The safety pads for the trunnion latches were made more rugged, so the nose could not be put on the pod unless the trunnions were locked. A stronger nose latch was found to be necessary due to the increased forward loads of the blast suppressor. A 6000 lb. latch was first used, since it was interchangeable with the original 4000 lb.

latch. This latch did not have the desired safety factor, however, and a 10,000 lb. latch was installed. There have been no latch failures with the 10,000 lb. latch installation. The blast suppressor was cast of 17-4PH corrosion resistant steel. The nose changes are shown in Figures 15, 16, 17, and 18.

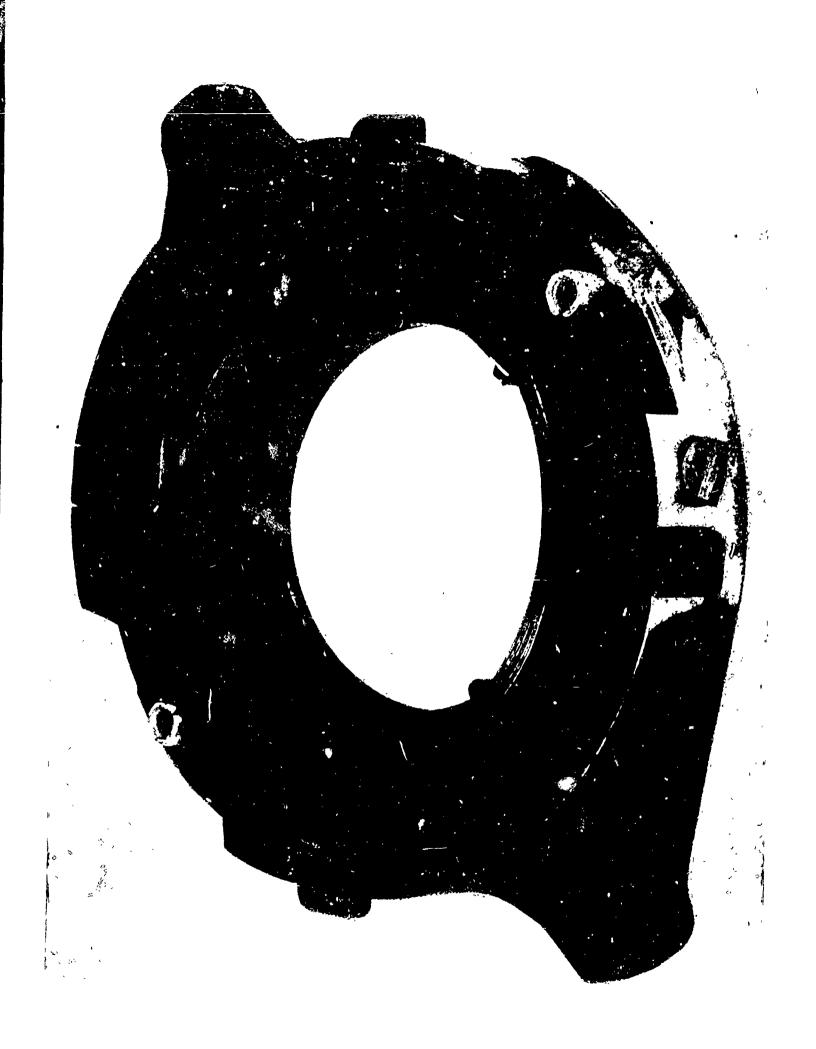
Figure 25. Round Positioner Assembly

The gun junction box housing was changed from a welded-up structure to an aluminum casting as shown in Figure 24. A stiffer ring spring round positioner was added to the Mk 11 Mod 5 Gun, and this increased the force on the latches and detents to 50 lbs. in order to eliminate pre-ejection. Figure 25 shows the new ring spring round positioner.

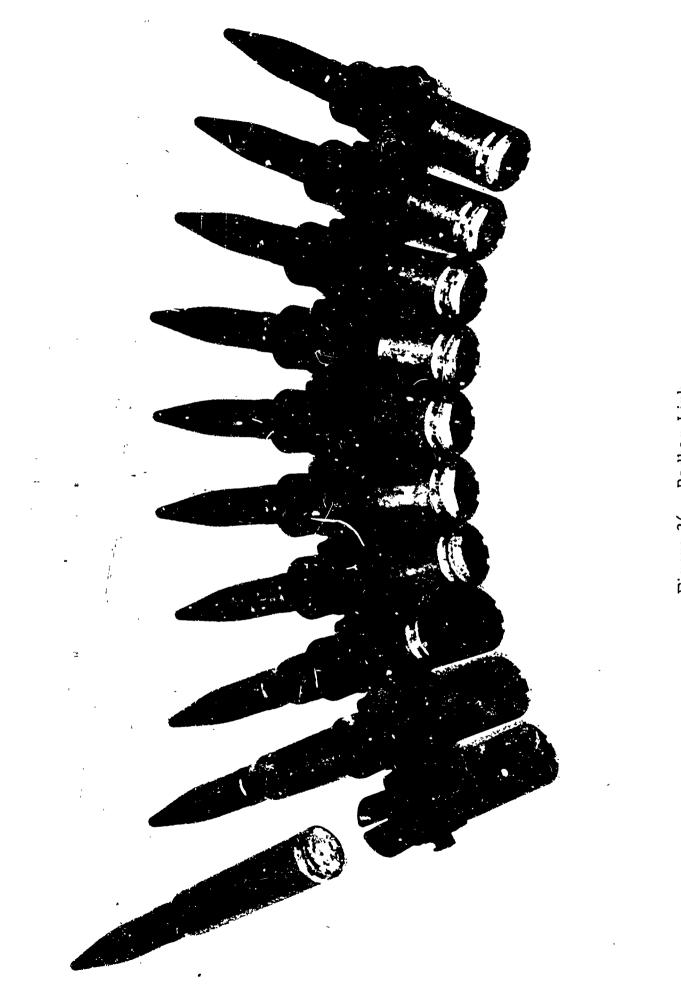
Figure 26. Radhaz Link

The new Mk 6 Mod 4 link with the radhaz protective cap was used for the entire reliability program, with good results. In addition to protecting the round from radhaz, the cap increased the ejection strength of the link by a factor

of 2, thus making it possible to eject empty cases at higher velocities without passing through the link. Figure 26 shows the new Mk 6 Mod 4 link. Firing Range

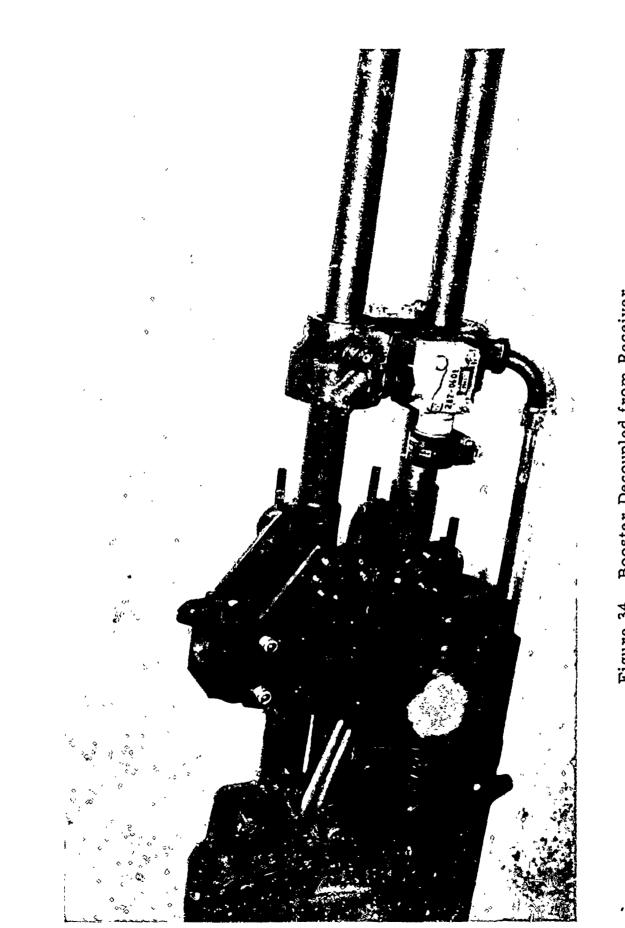
Figure 34. Booster Decoupled from Receiver

An experimental quick disconnect booster block was built in October, and approximately 13,000 rounds have been fired with this part with good results. The booster block attaches to the receiver with four quick disconnects. By rotating the quick disconnects 180 degrees, the booster is locked in place. The booster block also locks the barrels in place by preventing barrel rotation. To remove the barrels the booster block is removed from the gun and the barrels are then rotated to decouple them from the interrupted threads in the breech. Figure 34 shows the booster block decoupled from the receiver. In the final design of the booster housing, it is anticipated using three quick disconnects instead of four in

order to make the part simpler, and reduce the tolerances involved with the four quick disconnect system.

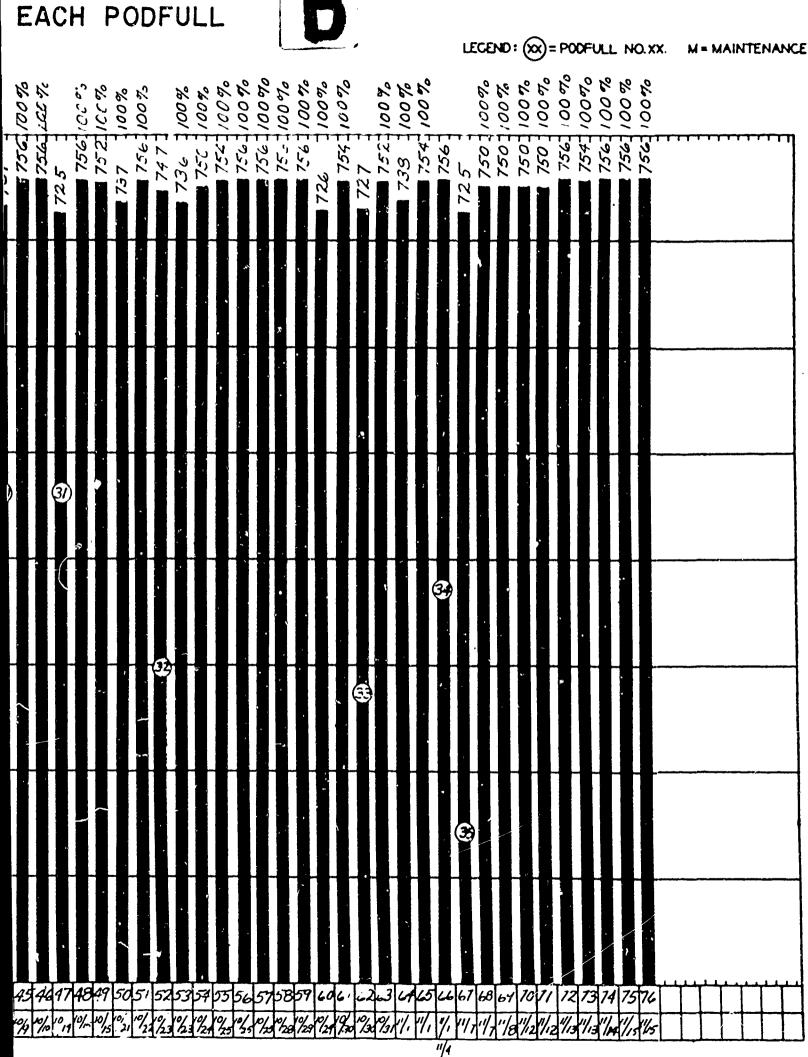
and the second	-	FOR POD NO. 10	
fuit	pago	Rounds Since Stoppsge	Stoppess	Gan A Ldr. No.
	The second secon		100% Fireout.	
Š.	1	803	Loader. R & D Poppet shattered "lex 49). Heat treat too high.	
3.		a frighting and as by days by a	100% Fireout.	
			100% Fireout.	
64		2461	Gun. * Insufficient clearance at Breech.	
		<b>B1</b> 5	Manufacturing Error. Mislocated gas port in old barrel. causing low ram pressure.	
			Loader. (Fail to resear) Sear link latch spring Jammed in rammer housing.	
		644	Manufacturing Error. Improper huck bolt and collar failed at aject chute attachment.	
			Gun. 24 Barrel Insert failed (heavy two-piece obturating eleeves installed at time).	
		<b>67</b>	Gun. * Insufficient clearance at Breech.	
14.	8	9952	Gun. ** Barrel insert (F/F) failed.	
			100% Fircout.	
12.			100% Fireout.

fall	pago	Rounds Sinco Stoppage	. Stoppago	Gan & Lêr No.
23.	9	. 2002	Gun. ** Barrel insert (F/F) failed.	ć
	10	481	Manufacturing Error. Mislocated port in old barrel, causing low ram pressure.	7 -
14.			100% Fireout.	
15.	11	1932	Gun. ** Barrol insert (F/F) failed.	2
16.	13	358	Louder. Sear link pin failed (L/F). (16, 671 rounds)	
17.	13	900	Gun. ** Barrel insert failed.	
18.	14	364	Loader. Ram failed. (4489 rounds)	
19.			100% Fireout.	
				-
			* Remachined Breech for more clearance after Stoppage #7.	
			*** Ring seals installed at end of month (August).	
				Ş

Million Sylar	Contraction of the second s	LOR FOD NO. 10	
f init	Stop- Page No.	Rounds Since Stoppige	Stoppago	Gun & Ldr. No.
20,			100% Fireout.	9.
21.	i i g v		100% Fixeout.	
	15 15	2759 2759	Loader. Check valve function faulty: (15,448	
	*** **	717	Manufacturing Error. Oscillating guide not to print: causing link squeeze which caused ram failure.	
24.0	17	952	Ammunition. Grounded primer.	
25.	15	696	Manufactúring Error. Improper huck bolt at Bleet chute attachment.	
	12	388	Londer. Rom Lailed. (6806 rounds)	
26.	20	694	Londer. Sear link failed. (7278 rounds)	
27.			100% Fireout.	
28. »,	27	3 308	Ammunition. Soft case.	). <u></u>
29.	22	579	Manufacturing Error. Improper huck bolt at eject chute attachment.	-
30.	ده ۲ <b>3</b> %	218	Manufacturing Error. Fail to ram. Same as Stoppage #16, but cause not determined until later.	
.31°.			100% Fireout.

Pod <sup>2</sup> full No.	pago	Rounde Since Stoppage	Stoppego	Gun & Ldr. No.
32.		алан салан сал Салан салан сал	100% Fireout.	
33.			100% Fireout.	
34.	24	3399	Lozder, Piston ring failed.	
35.	25	677	Loader. Broken ram, L/F. (7215 rounds)	
36.		р <u>анца формация</u> ния 	100% Fireout.	
37,			100% Fireout.	
38.			100% Fireout.	
39.			100% Fireout.	
× 40.			100% Fireout.	
41,	Ç.	÷	100% Fireout.	
42.		-	100% Fireout.	
43.			190% Fireout.	
44.	26	6805	Manufacturing Error. Same as #16 - Oscillating guide not to print, causing ram failure.

Ped- fall No.	page	Pounds Since Stoppage	Stoppage	Gun & Ldr. No.
45.	28	704	Manufacturing Error. Rammer housing out of tolorance. Fail to resear.	
1~	29	3	Manufacturing Error. Oscillating guide not to print; link jam.	-
46.	2) 		100% Fireout.	
47.	- - - -		100% Fireout.	
<b>18.</b>	30	1968	Ammunition. Soft case; fail to cject.	
5	31	7	Manufacturing Error. Oscillating guide not to print: link squeeze causing ram failure.	
			100% Fireout.	
50.	\$ \$ } ;		100% Fireout.	, , , , , , , , , , , , , , , , , , ,
51.	<sup>2</sup> 32	1958	Ammunition. Soft case; fail to eject.	
52.	33	701	Loader. Rex 49 Poppet nut improperly heat treated.	
53. <sup>°</sup>	34	723	Gun. Damper rod failed. (48, 995 rounds)	
54. *	20		100% Fircout.	
55.			100% Fireout.	9.

ده ۲۰ ۲۰ ۲۰	+ + 2 - 		POR FOD NO. 10	,
182	Da PO	Rounds Sinco Sinco	Stoppage	Gan & Ldr No.
55. 3	1	<sup>\$</sup> 80¥*```	Gun. Feko failed. (51, 031 rounds)	
	36	<sup>9</sup> B <sup>2</sup> 0	Gun. Firing pin jam; L/F barrel.	
	\$7 \$7	7	Manufacturing Error. Some as Stoppage #31; cause not found until later.	
÷8. €8.	, , ,	4	100% Fireout.	
<u>57.</u>	0 6		The Freedom Antonia	
<u>ко.</u>	Î. Î.		100% Firecut.	
61.	38°	2897	Gun. Broken spring pin in round positioner.	i sin internet
62.			100% Fireout.	
63.	\$ \$ .		160% Fireout.	
<b>64</b> . °	<b>o</b>		109% Fireout.	
65.	39	3018	Leader. Poppet failed to check; one cycle.	,
	^ <b>4</b> 0	424	Gun. Firing pin holder; open circuit (Y). (2705 rounds)	
645. t	**************************************		100% Fireout.

51.		- Q°	Roff Fireast.	
		44	2085	Lorder. Rev 49 Popper shattered, improper heat	
La La Martin Martin		\$ 			
		8		and no final fin An final fi	
سورية فلاخت فيستحدث فيناكل					
The state of the second se				den triden yn wither in feinigen yn de stêre fer preder wei gerstyws yn wei gerstywer fyr û wei op oans mer wei gerstywer yn wei op oans wei op o	
Share on the structure of			₩₩₩₩₩₩₩₩₩₩₩₩₩₩₩₩₩₩₩₩₩₩₩₩₩₩₩₩₩₩₩₩₩₩₩₩₩	national general and free free free free free free free fre	
a france of the second second					
A statistic to be a state of the state of th					The second second
				ALLER ALLE LANDER ALLE LANDER ALLER ALL	
	o i i	15 <sup>1</sup> (1) (2)		nen ann an hardel feil e highlichte grunde san an a	- <del> </del>
		1 3 1 1 3 1 3 1 3 1 3 1 3 1 3 1 3 1 3 1		a the second	το <del>Αντάνολοποίου ζότ</del> η Τι - -

## POD NO. 10

full	1	Rounds Since Stoppage	Stoppage	Cini 1 Lar No.
83.	45	856	Link - Spotweld feiled in Radhaz cap.	
84.		*****	100% -	
85.	46	1663	<u>Gun</u> - Gas transport tube broken. (73, 238 rounds)	
86.	47	723	Mfg. Error - Cylinder chamber finish 100 micro- inches should be 16.	
87.	48	655	Mfg. Error - Cylinder chamber finish 100 micro- inches should be 16,	
88.	WP Trop	*****	100%	
89.		and an ay ay	100%	
70.	and a second	Late for jun, -no.	100%	
91 <b>.</b>	** **	Nu - Nu - Xu - Nu	100%	
92,	49	3775	Mfg. Error - Cylinder chamber finish 100 micro- inches should be 16.	
93.		en dei na da	100%	
94,	20- 1- 20- 20-	an ang ang ang ang ang ang ang ang ang a	100%	
95.		an a	100%
