Hexcel Research
Reference: 6065

August 26, 1964

Subject: Contract No. DA-04-200-AMC-477 (A)
Development and Evaluation of a Lightweight Aluminum Honeycomb Case
Monthly Progress Report #7

REPORT OF PROGRESS
JULY 1964

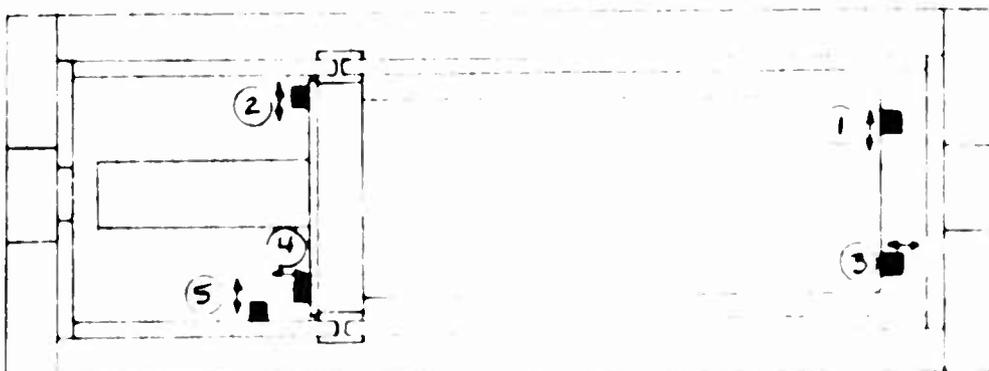
**Accelerometers for Case HXL-5-477 were located as shown below. The arrows indicate the direction along which each accelerometer measured g values. See Progress Report #6 for accelerometer locations for Case HXL-4-477.
