# Operation TEAPOT

Projects 36.1 and 36.2

EXPOSURE OF MOBILE HOMES AND EMERGENCY  
VEHICLES TO NUCLEAR EXPLOSIONS

**EXPOSURE OF MOBILE HOMES  
AND EMERGENCY VEHICLES  
TO NUCLEAR EXPLOSIONS**

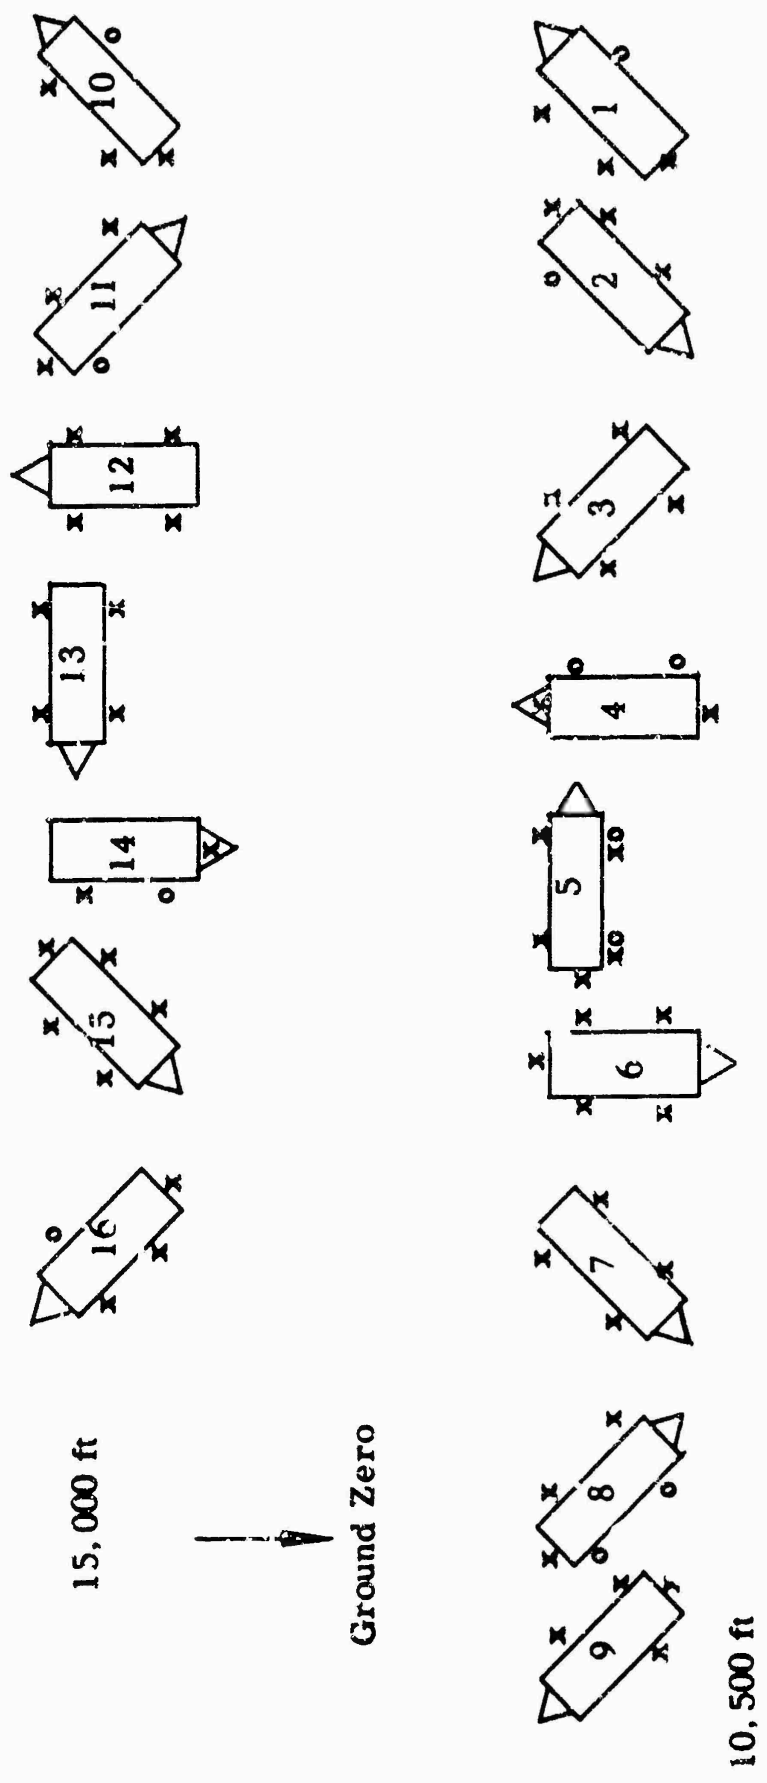
Fig. 2.1—Trailer positions and orientation. x, window(s) open. o, door open.

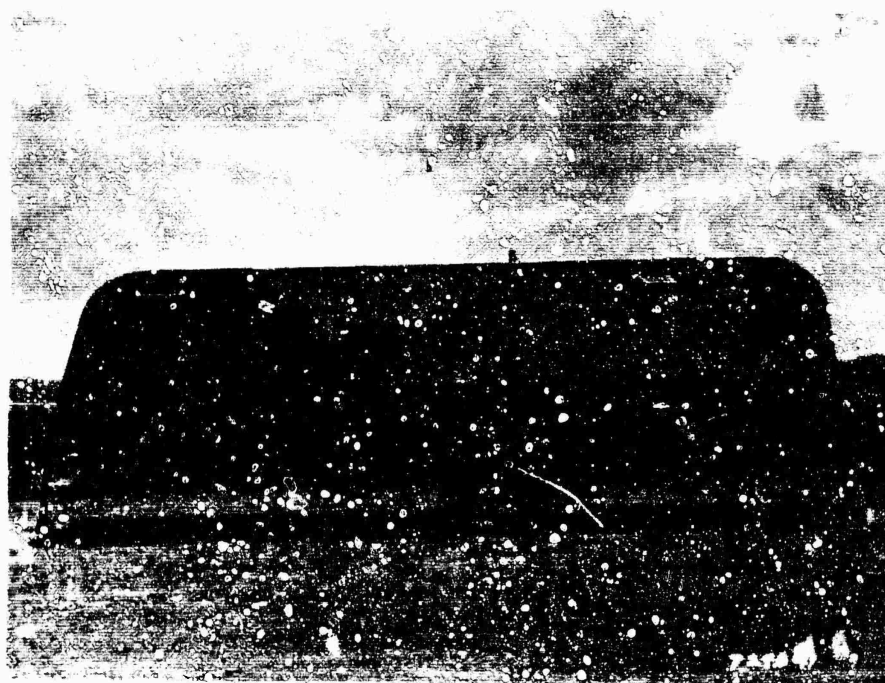
Exterior: Slight distortion on left side. (See Fig. 2.13.)

Fig. 2.13—Exterior of Columbia trailer at 15,000 ft after the blast.

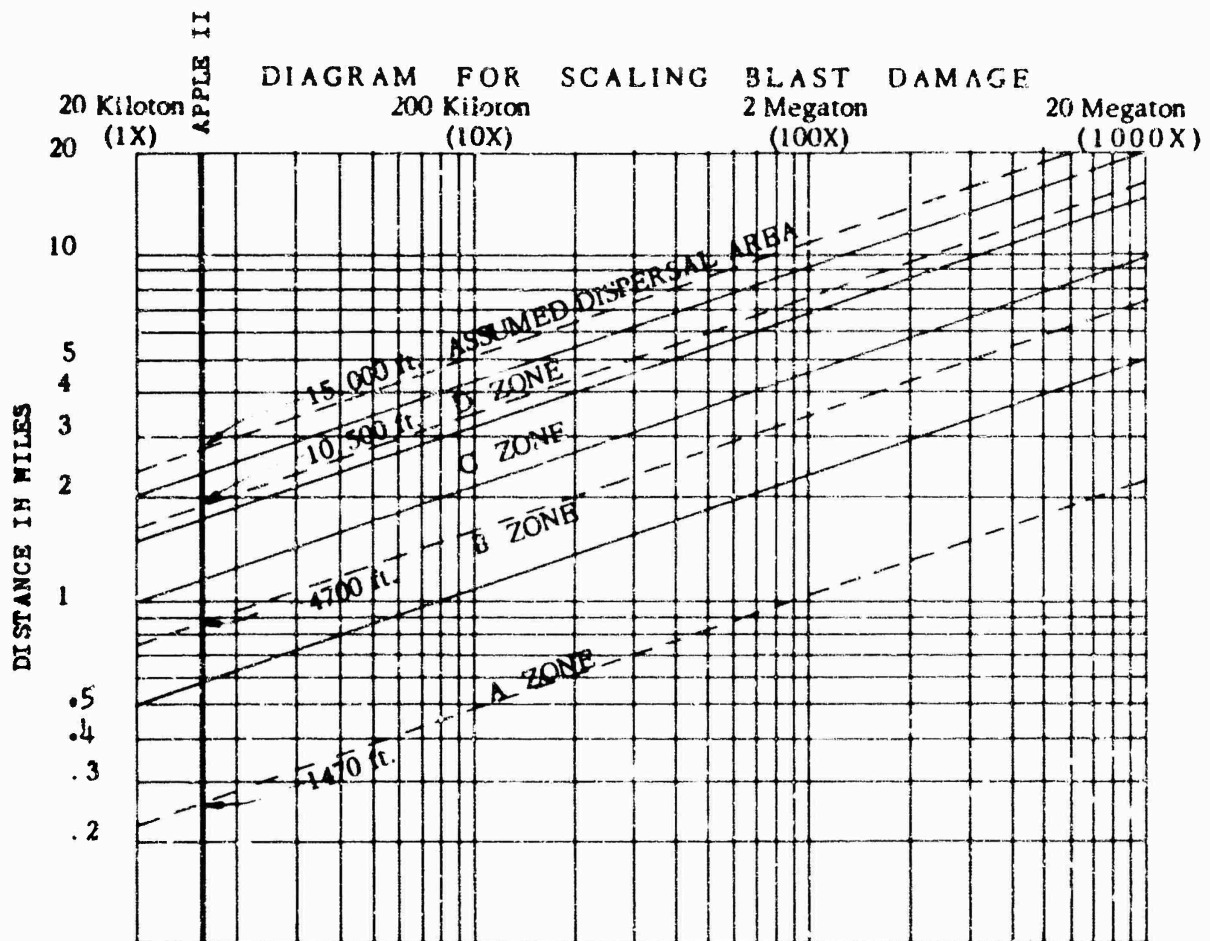
Fig. 4.1 — Range of damage as a function of bomb yield.

Chicago has an area of 207.5 square miles. This area would be included in a circle of 8.1 miles radius. By assuming that a bomb used on Chicago would cause C damage to 8.1 miles from Ground Zero, the bomb size from the curve of Fig. 4.1 is seen to be approximately 3.1 megatons (Mt). Under this condition the damage occurring at the various distances from Ground Zero in Apple II shot would occur as shown in Table 4.1. By this procedure the comparable-
