**USATRECOM TECHNICAL REPORT 65-6**

**CRASHWORTHINESS EVALUATION OF AN  
ENERGY-ABSORPTION EXPERIMENTAL  
TROOP SEAT CONCEPT**

**Langston W. T. Weinberg**

February 1965

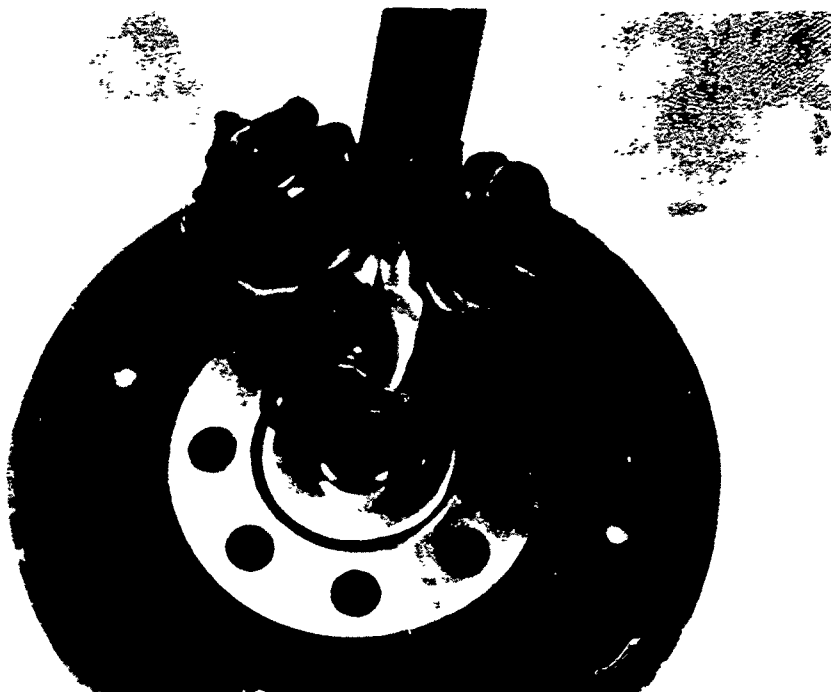
The energy-absorbing strut depressed, as designed, through 7 of its 12 inches of travel. Figure 17 is a closeup view of the strut.

Figure 17. Postcrash View of Energy-Absorbing Strut.

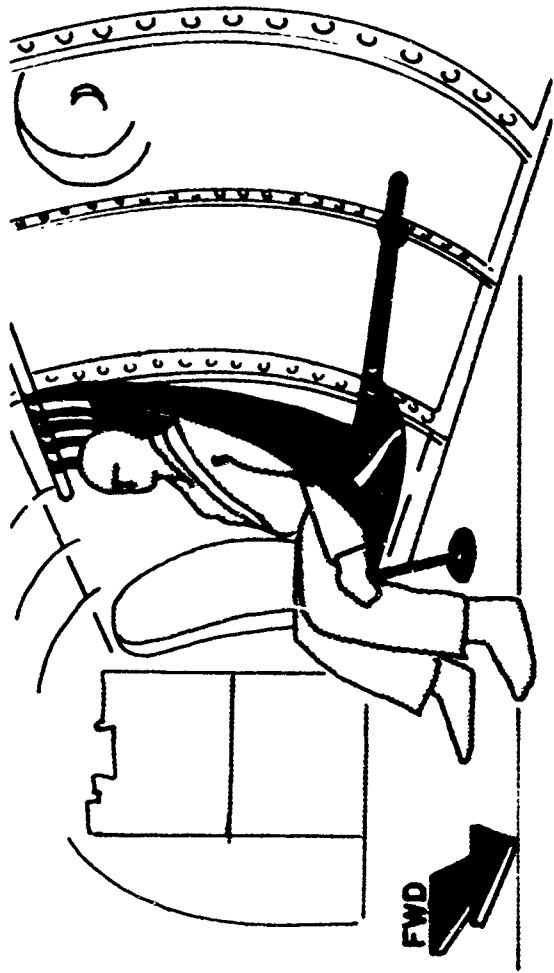
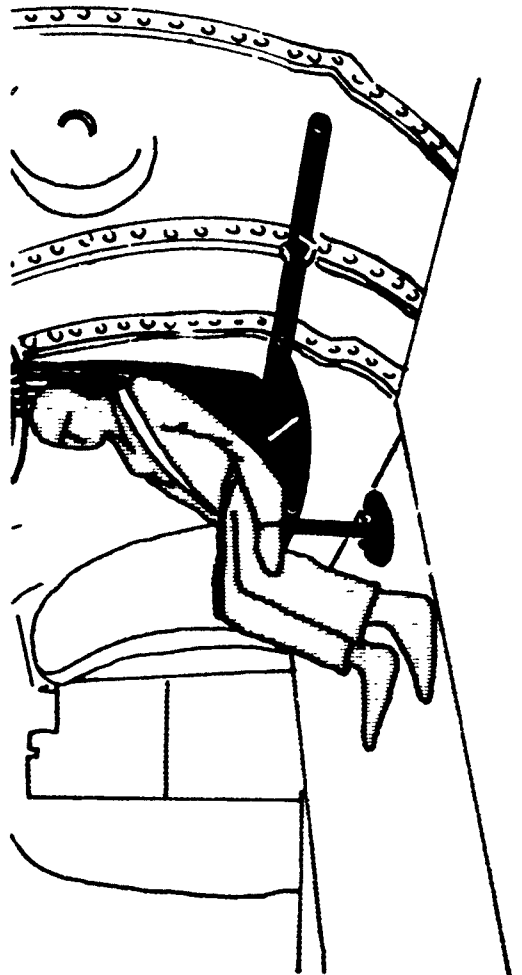
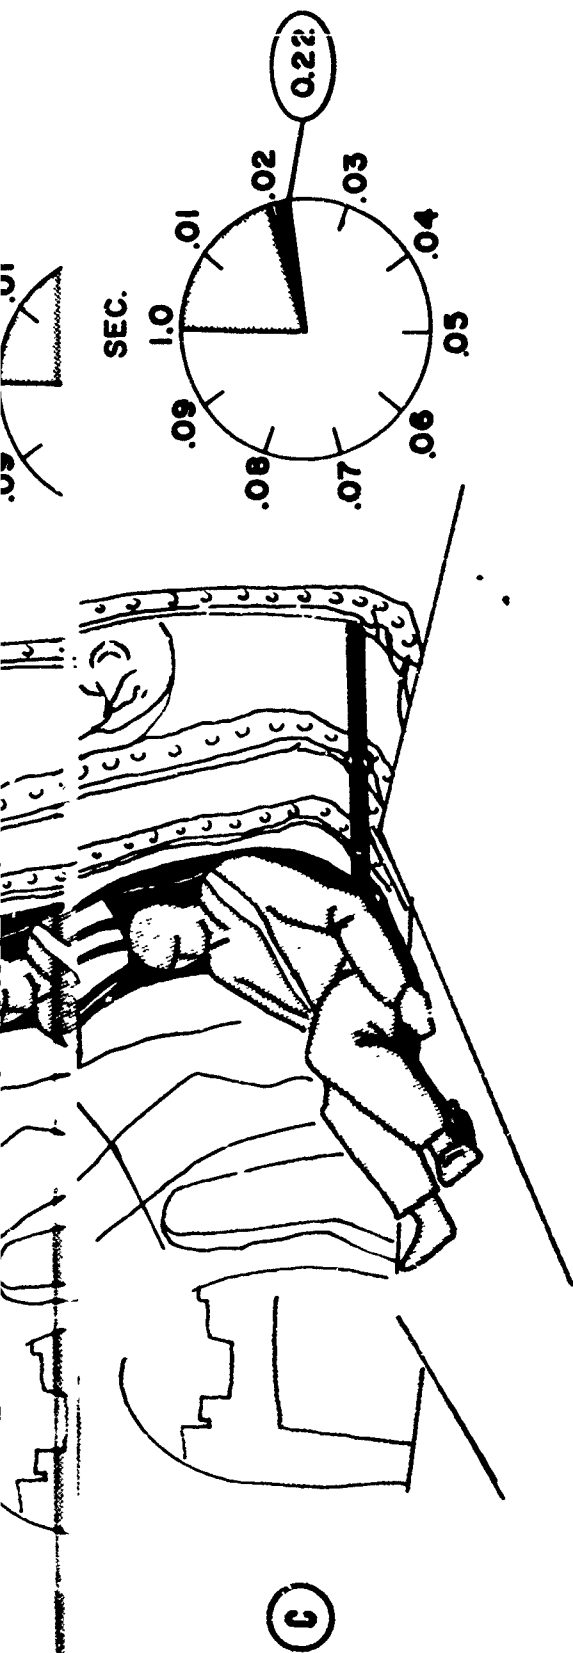
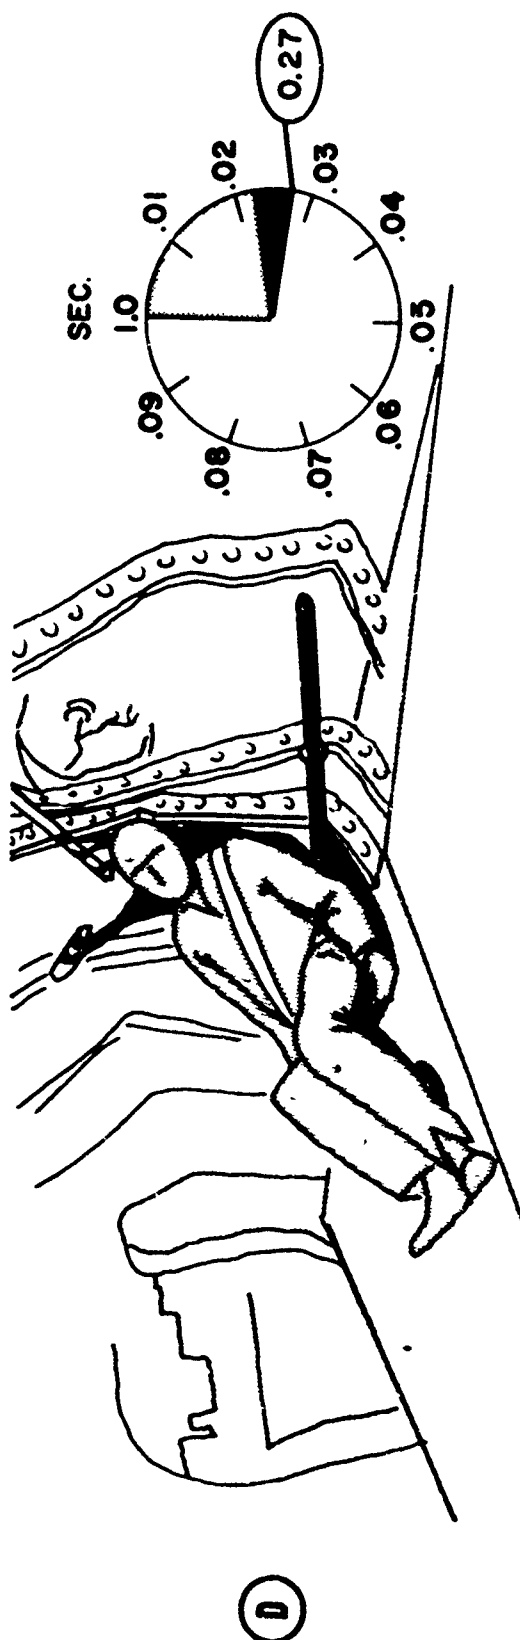
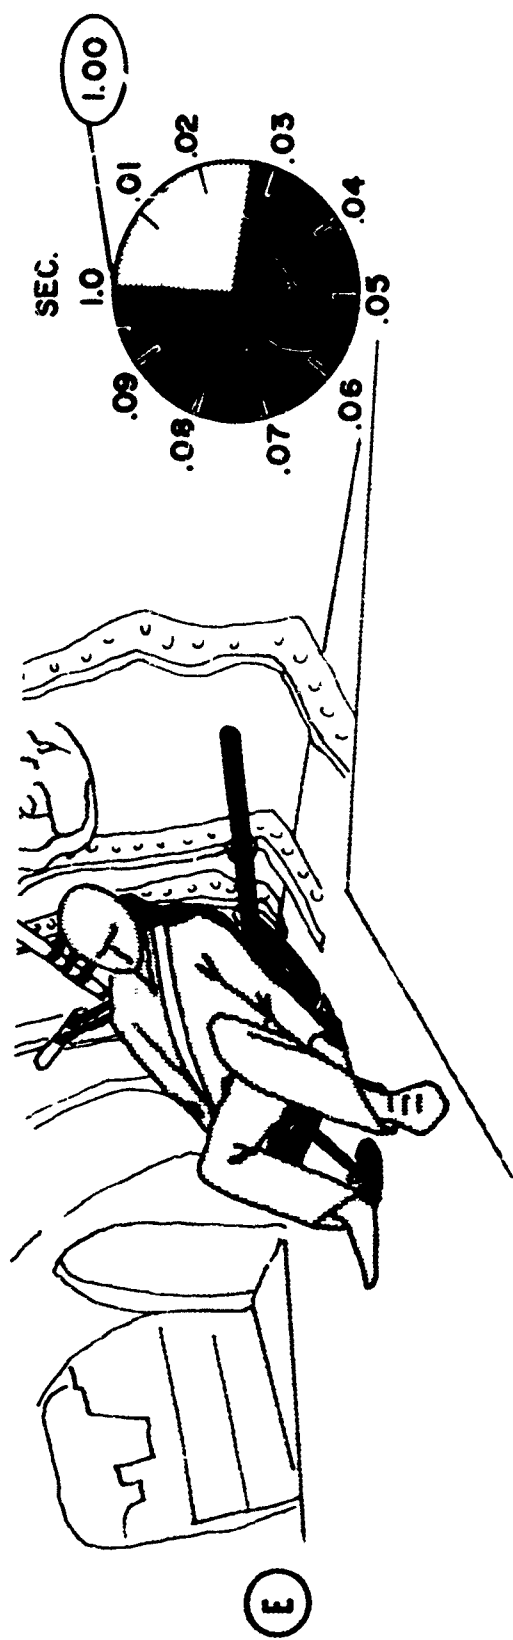
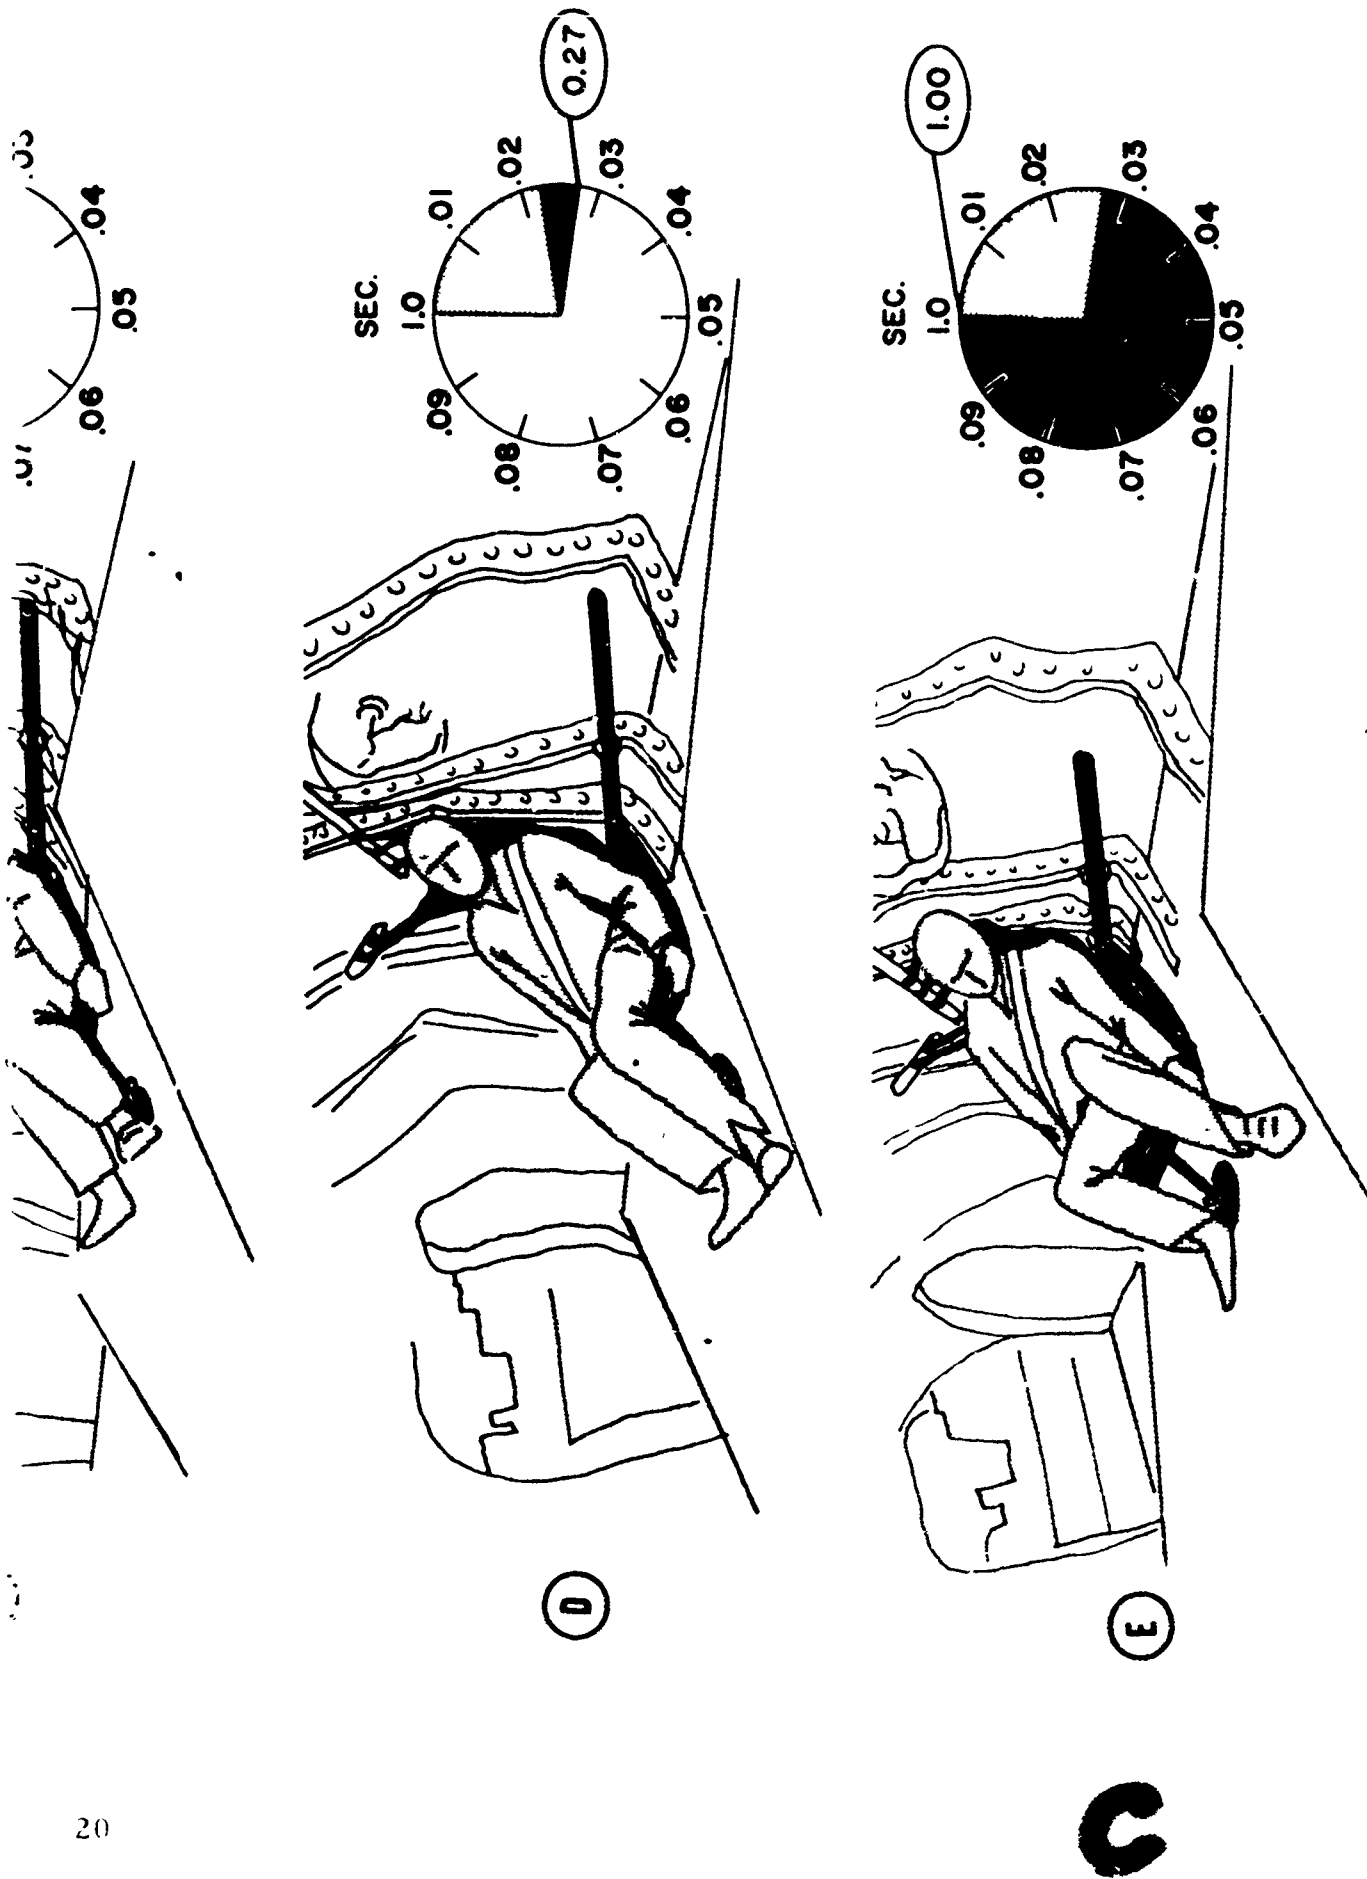
Figure 18. Kinematic Sketch of Seat 1 and Dummy During Crash Impact Sequence, T-7.

Figure 18 is a kinematic sequence of the action of the seat and dummy during the crash. The positions of the dummy and the chain of events that occurred concerning the seat and airframe are based on high-speed film analysis. The times shown with each picture are related to time of impact and show each significant event in the crash sequence.

1. Figure 18A shows the seat after the helicopter has made ground contact but before significant forces have been sensed by the dummy.
2. Figure 18B shows the seat beginning to function while the support structure is still intact. The energy-absorbing strut is peeling. The bulkheads are beginning to collapse, and the upper support tube is bowing, since the casting has sheared from the wall.
3. Figure 18C shows that the upper support tube has failed and that the bulkhead has collapsed sufficiently to allow the seat to contact the floor.
4. Figure 18D shows that the dummy has fallen to the left sufficiently to allow head contact with the fuselage frame.
5. Figure 18E shows the seat and dummy in the final position.

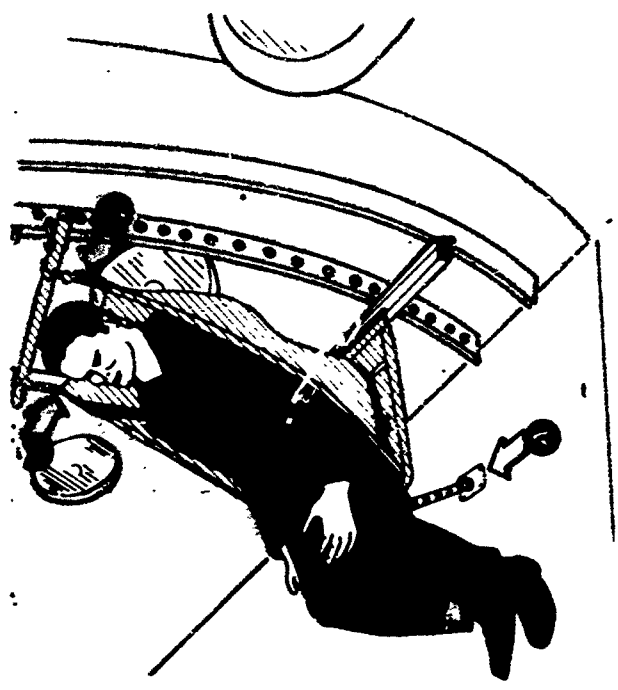
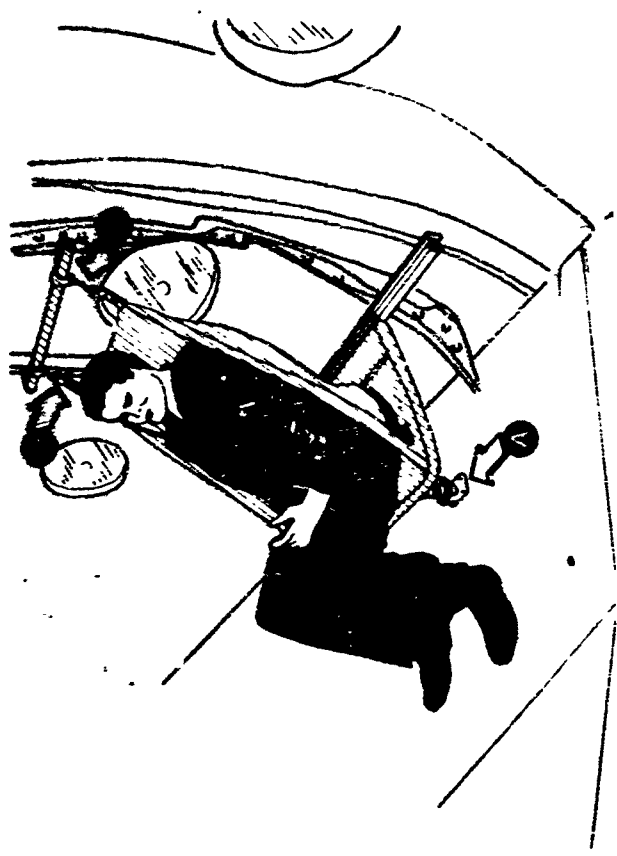
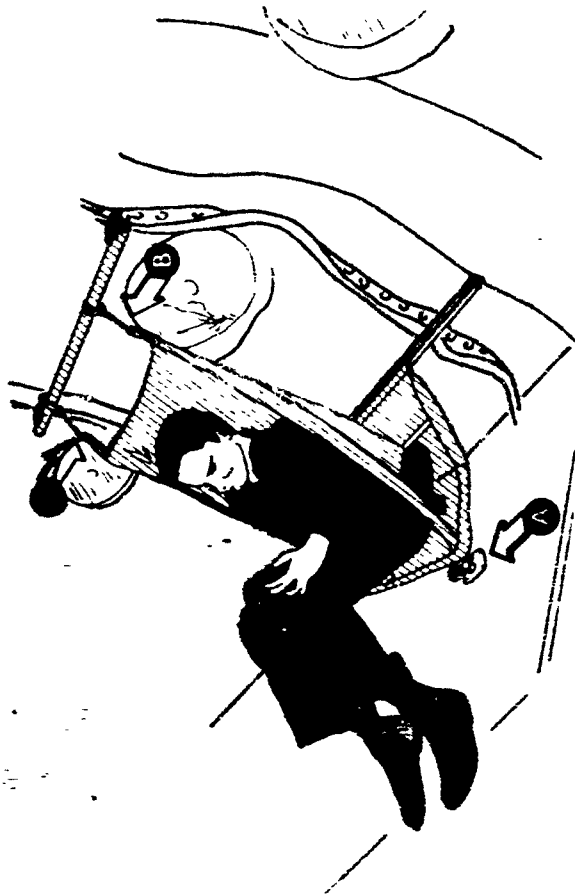
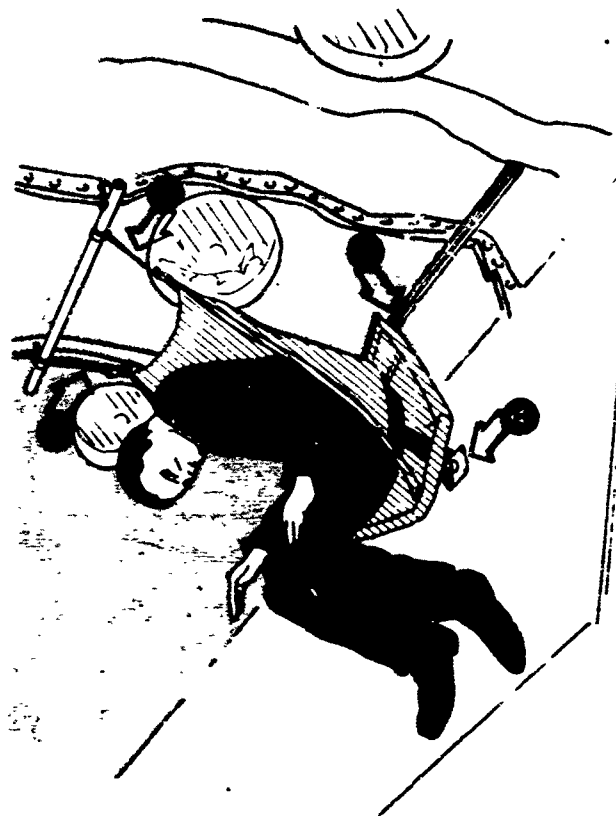
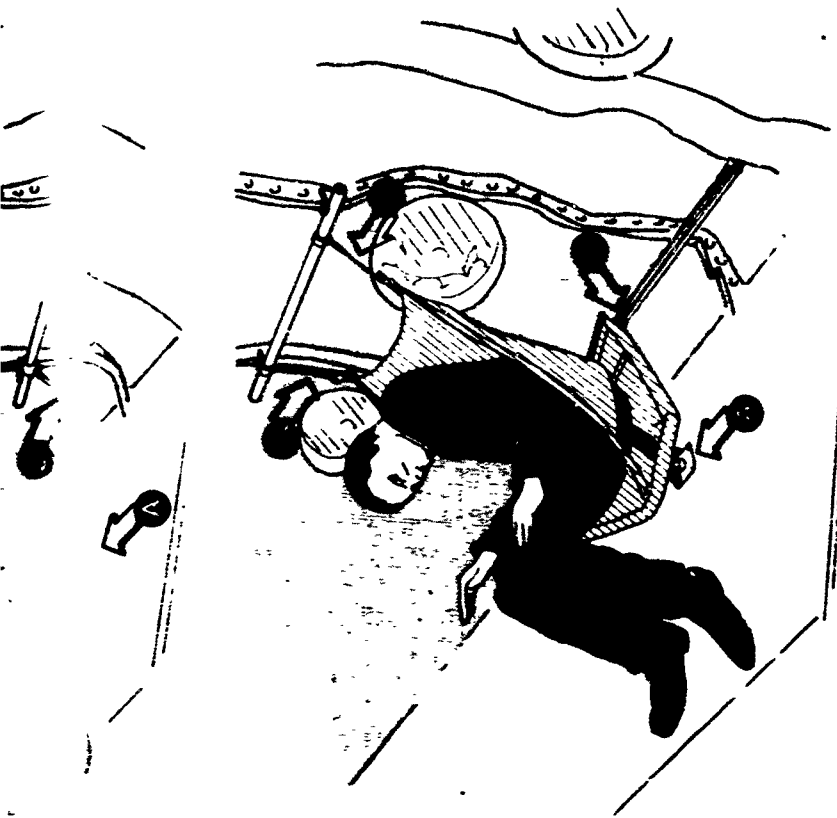
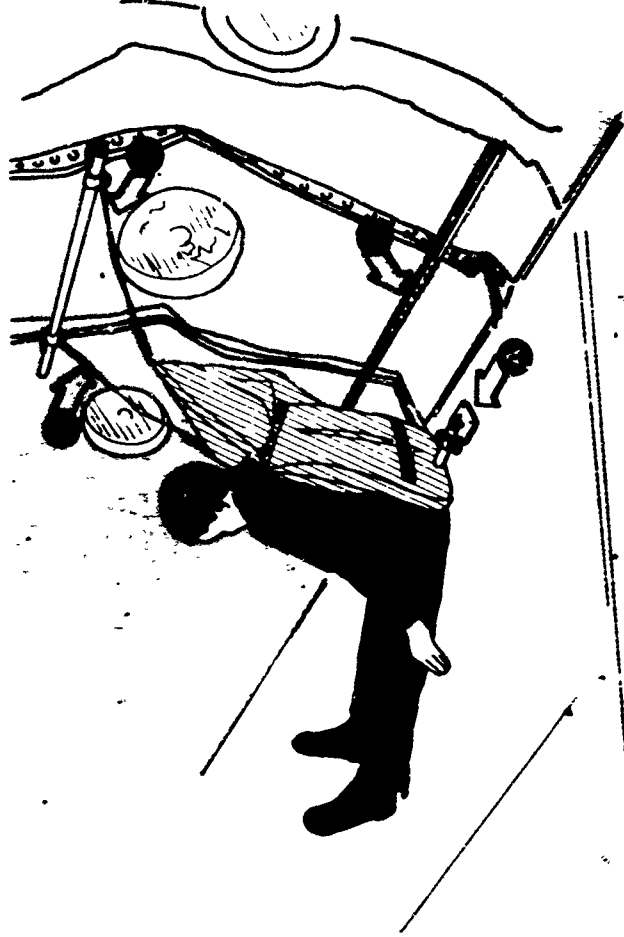
A kinematic sketch of the impact showing the behavior of the seat and dummy is presented as Figure 41. Significant occurrences during the crash sequence are shown along with the times at which these events occurred from initial impact. The times shown are also related to the accelerometer-time and force-time histories included and discussed later in this chapter.

The seat belt force built up almost linearly to a maximum of 500 pounds from  $t = 0.13$  second to  $t = 0.19$  second as the depressing of the energy-absorbing strut allowed the dummy to shift toward the front of the seat. The seat-belt load remained at 400 to 500 pounds until the dummy contacted the floor after the seat hinge sheared from the wall. The seat-

Figure 41. Kinematic Sketch of Seat 2 and Dummy During Crash Impact Sequence, T-9. Arrows A show the kinematics of the energy-absorbing strut; Arrows B show the kinematics of the energy-absorbing device in the upper supports; Arrows C show the sheared seat mounting hinge.

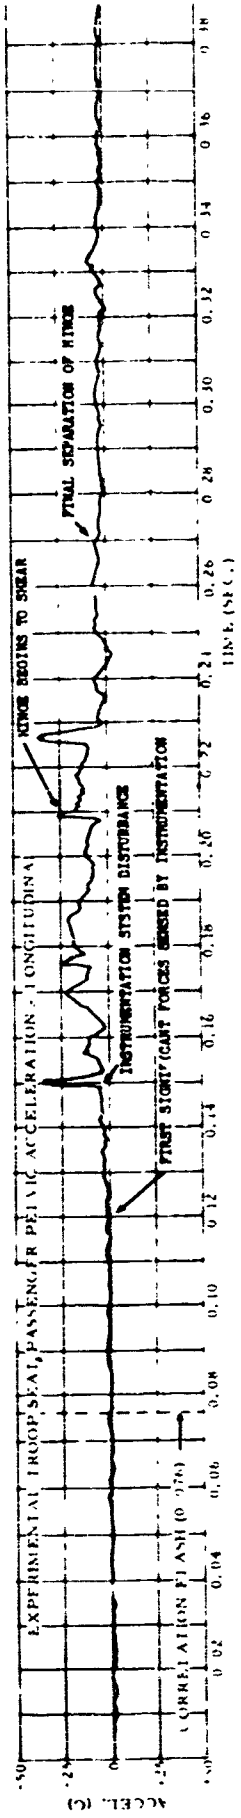
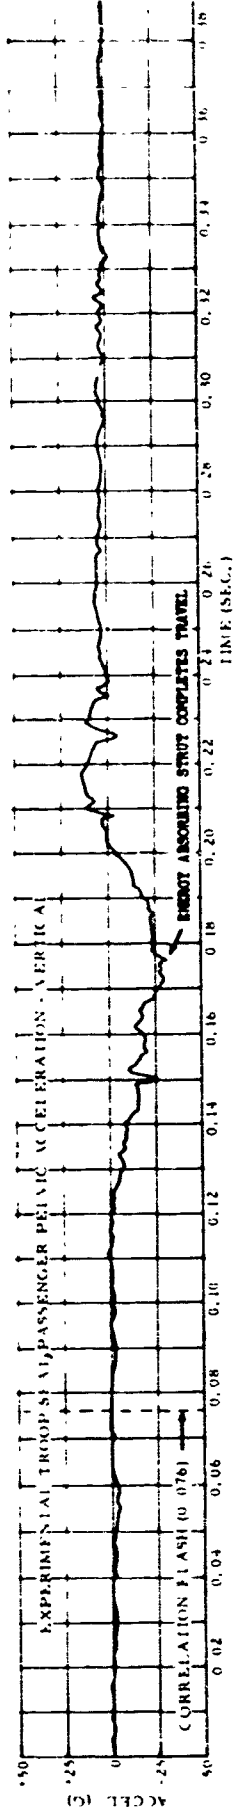
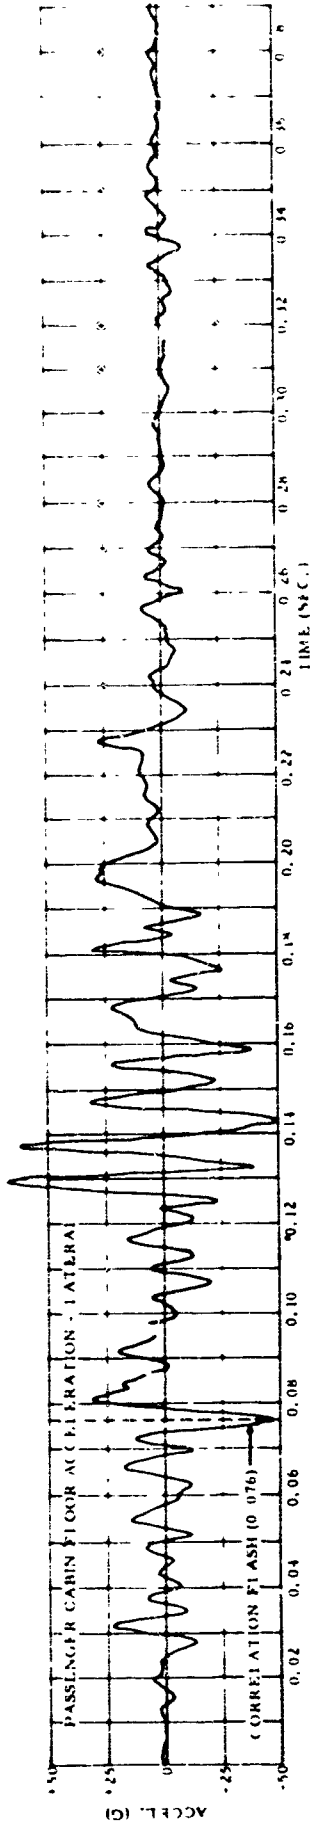
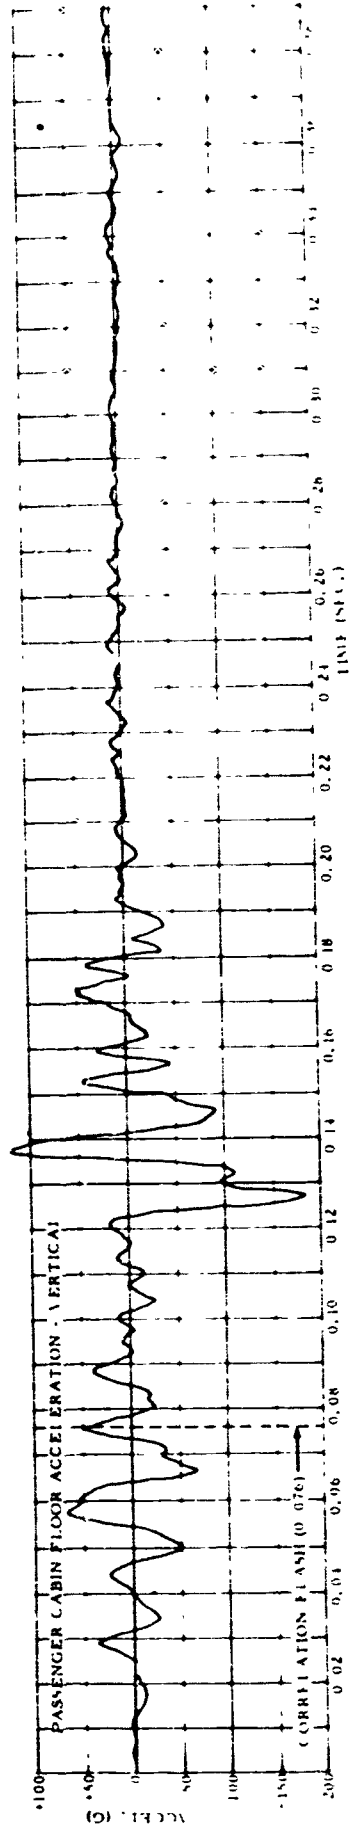
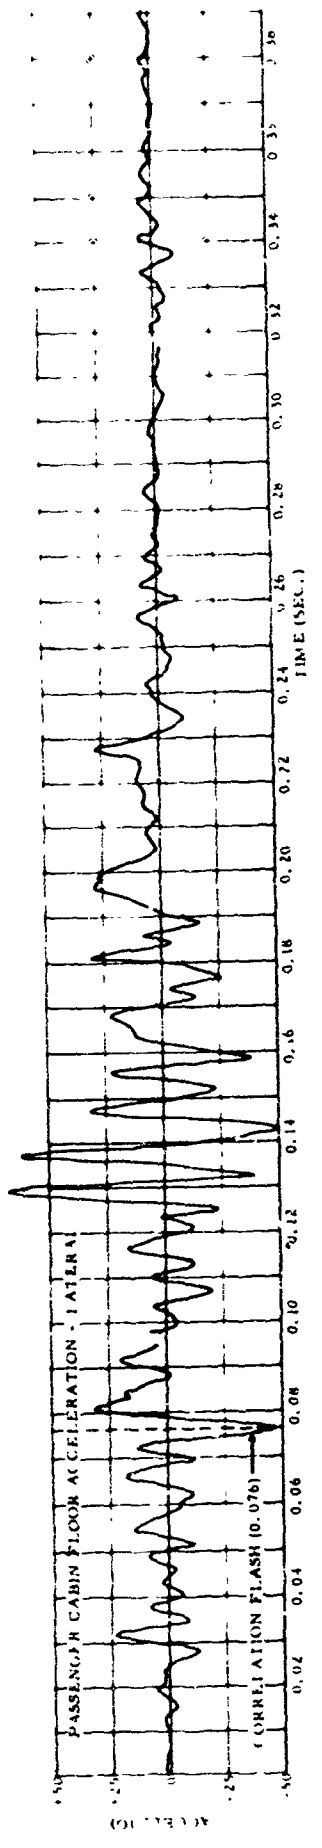
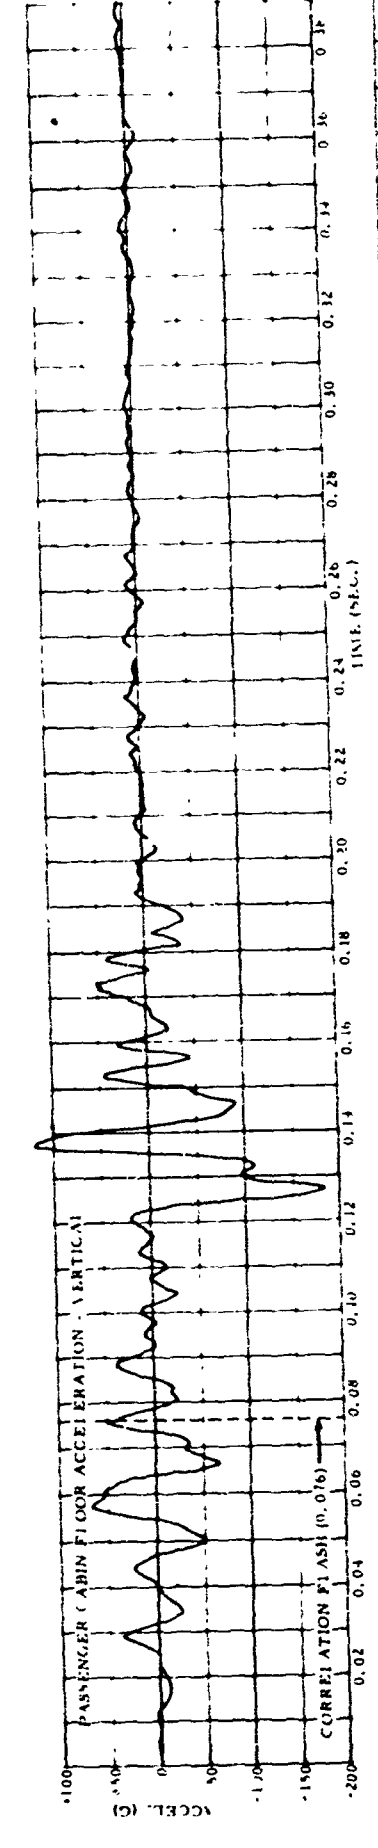
The accelerometer-time and force-time records obtained during the crash are presented in Figure 42. The observations presented here may be followed through reference to the kinematic drawing and the oscillograph traces.

The significant occurrences during the crash sequence, shown graphically on the kinematic sketch, Figure 41, are indicated by arrows on the accelerometer-time and force-time histories, Figure 42.

Figure 42. Accelerometer-Time and Force-Time Histories, Seat 2, During CH-21 Helicopter Crash Test T-9.

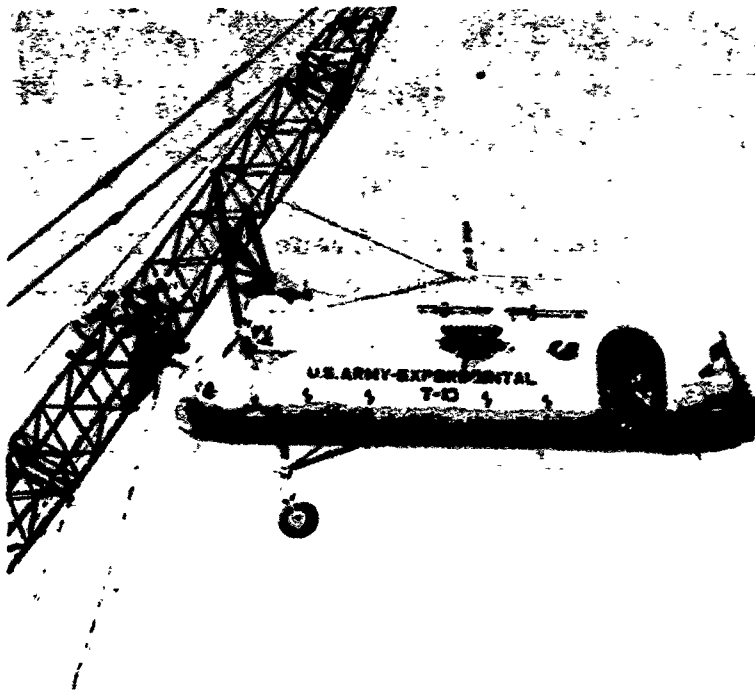
This, the final test of this experimental concept, was conducted in a crane drop of the forward portion of the CH-21 fuselage that was left relatively intact from the previous drone crash. This type of test has produced excellent results in that it is possible to establish exact precrash conditions and to produce a crash environment of controlled magnitude. The test setup, shown in Figure 53, produced the following impact conditions:

Figure 53. Crane Drop Method as Used in Test T-13.
