DEEP-OCEAN BIODETERIORATION  
OF MATERIALS - PART II. SIX  
MONTHS AT 2,340 FEET

August 1965

U. S. NAVAL CIVIL ENGINEERING LABORATORY  
Port Hueneme, California

James S. Muracka

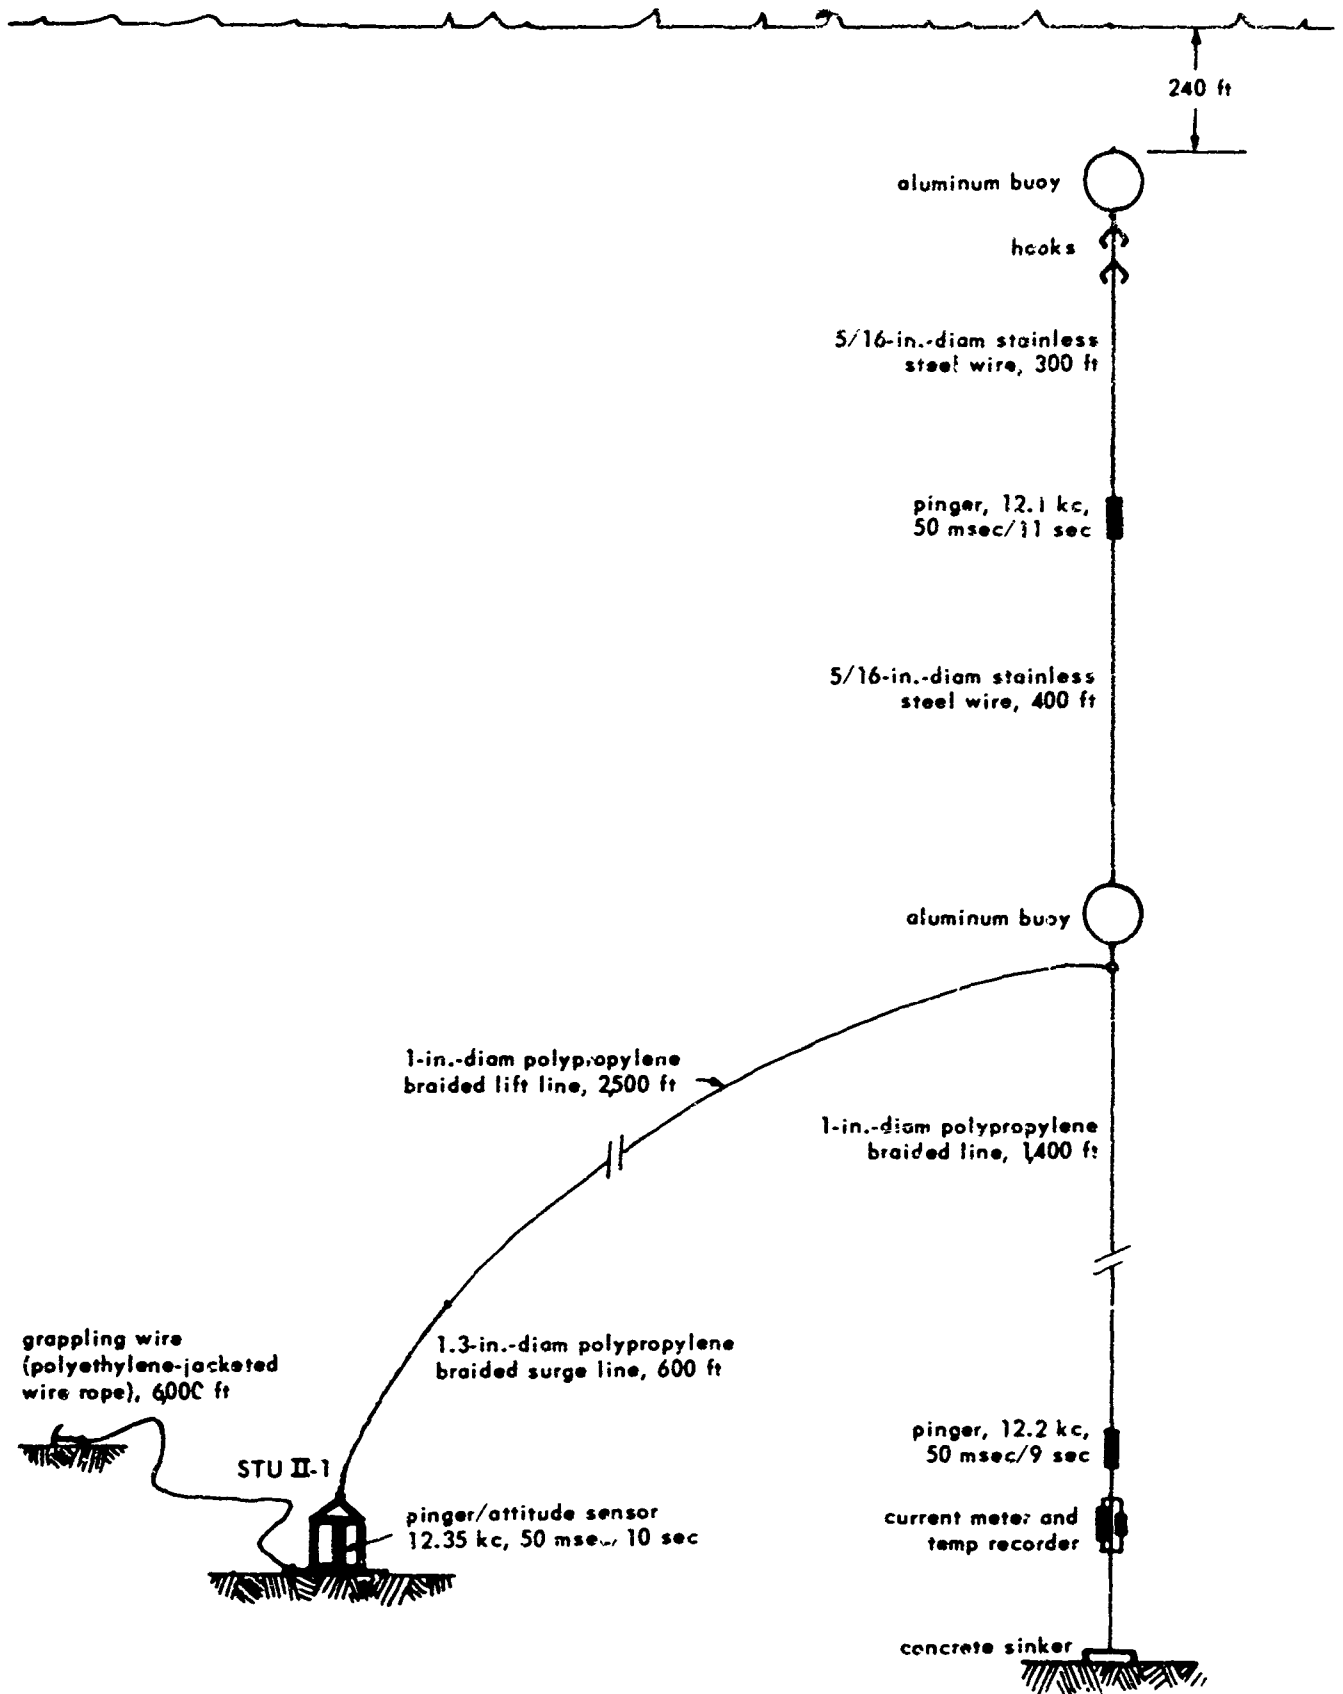
Figure 2. Schematic of STU II-1 on the ocean floor in 2,340 feet of water.

The upper buoy of the vertical riser line was submerged approximately 240 feet below the surface of the water, the lower buoy approximately 940 feet below the surface (Figure 2). A fairly dense attachment of hydroid growth over the upper half section of each of the two aluminum buoys was observed when they were recovered (Figure B-1 in Appendix B). A 2-inch-long pink-colored coelenterate (possibly a sea anemone) was also securely attached to a buoy (Figure B-2).

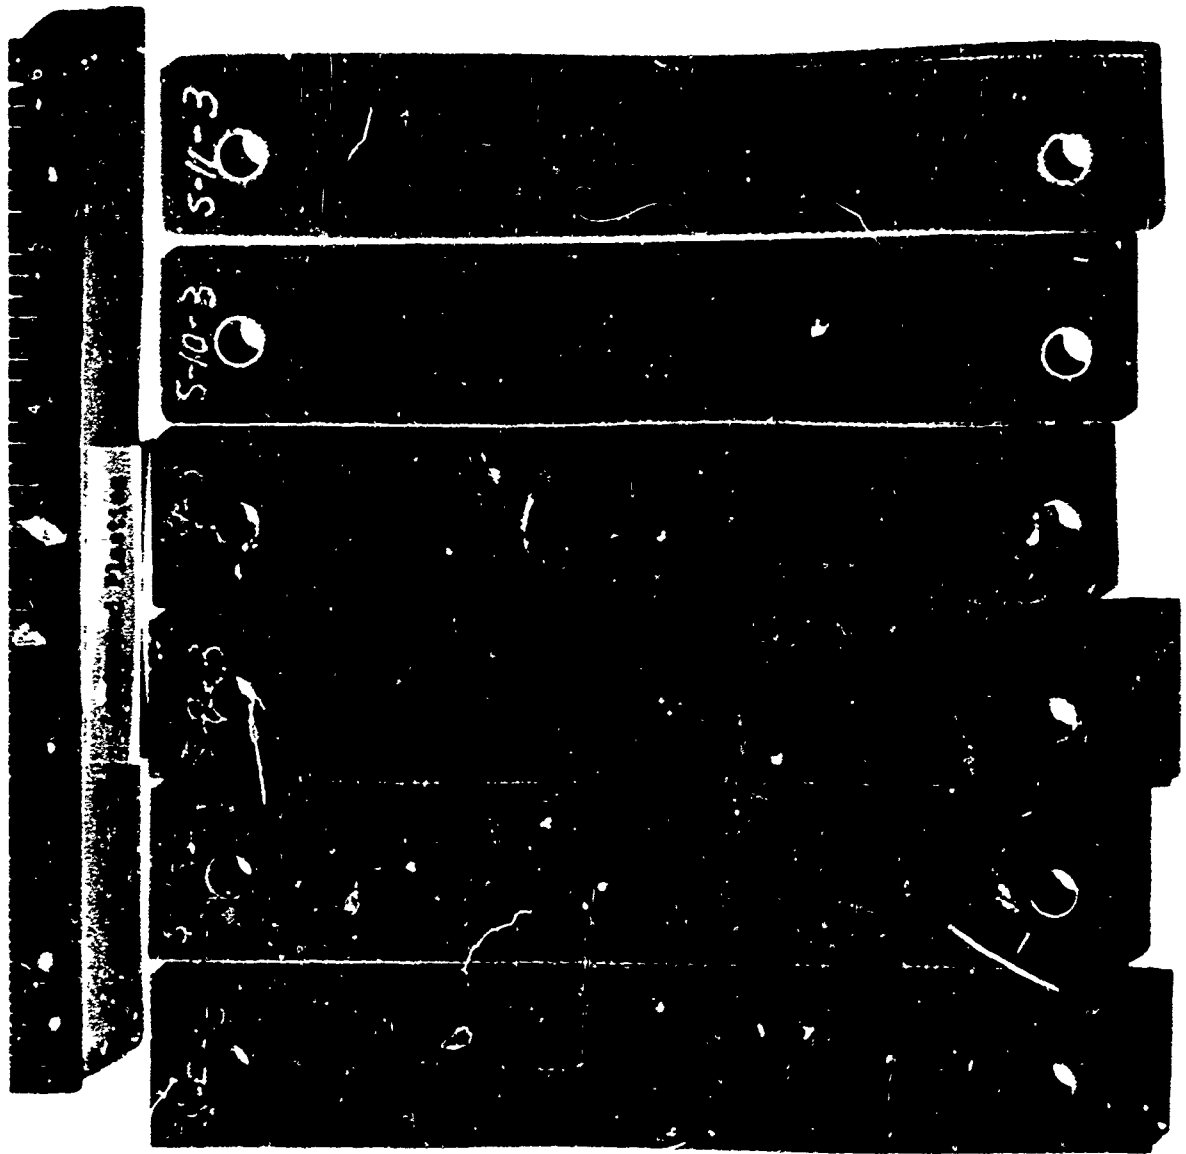
Figure B-27. Laminated plastic test specimens after 6 months on the ocean floor.
