USAAVLABS TECHNICAL REPORT 65-64

TEST PROGRAM FOR AUTOMATIC LIGHT AIRCRAFT READINESS MONITOR

(Project ALARM)
FINAL REPORT

August 1965

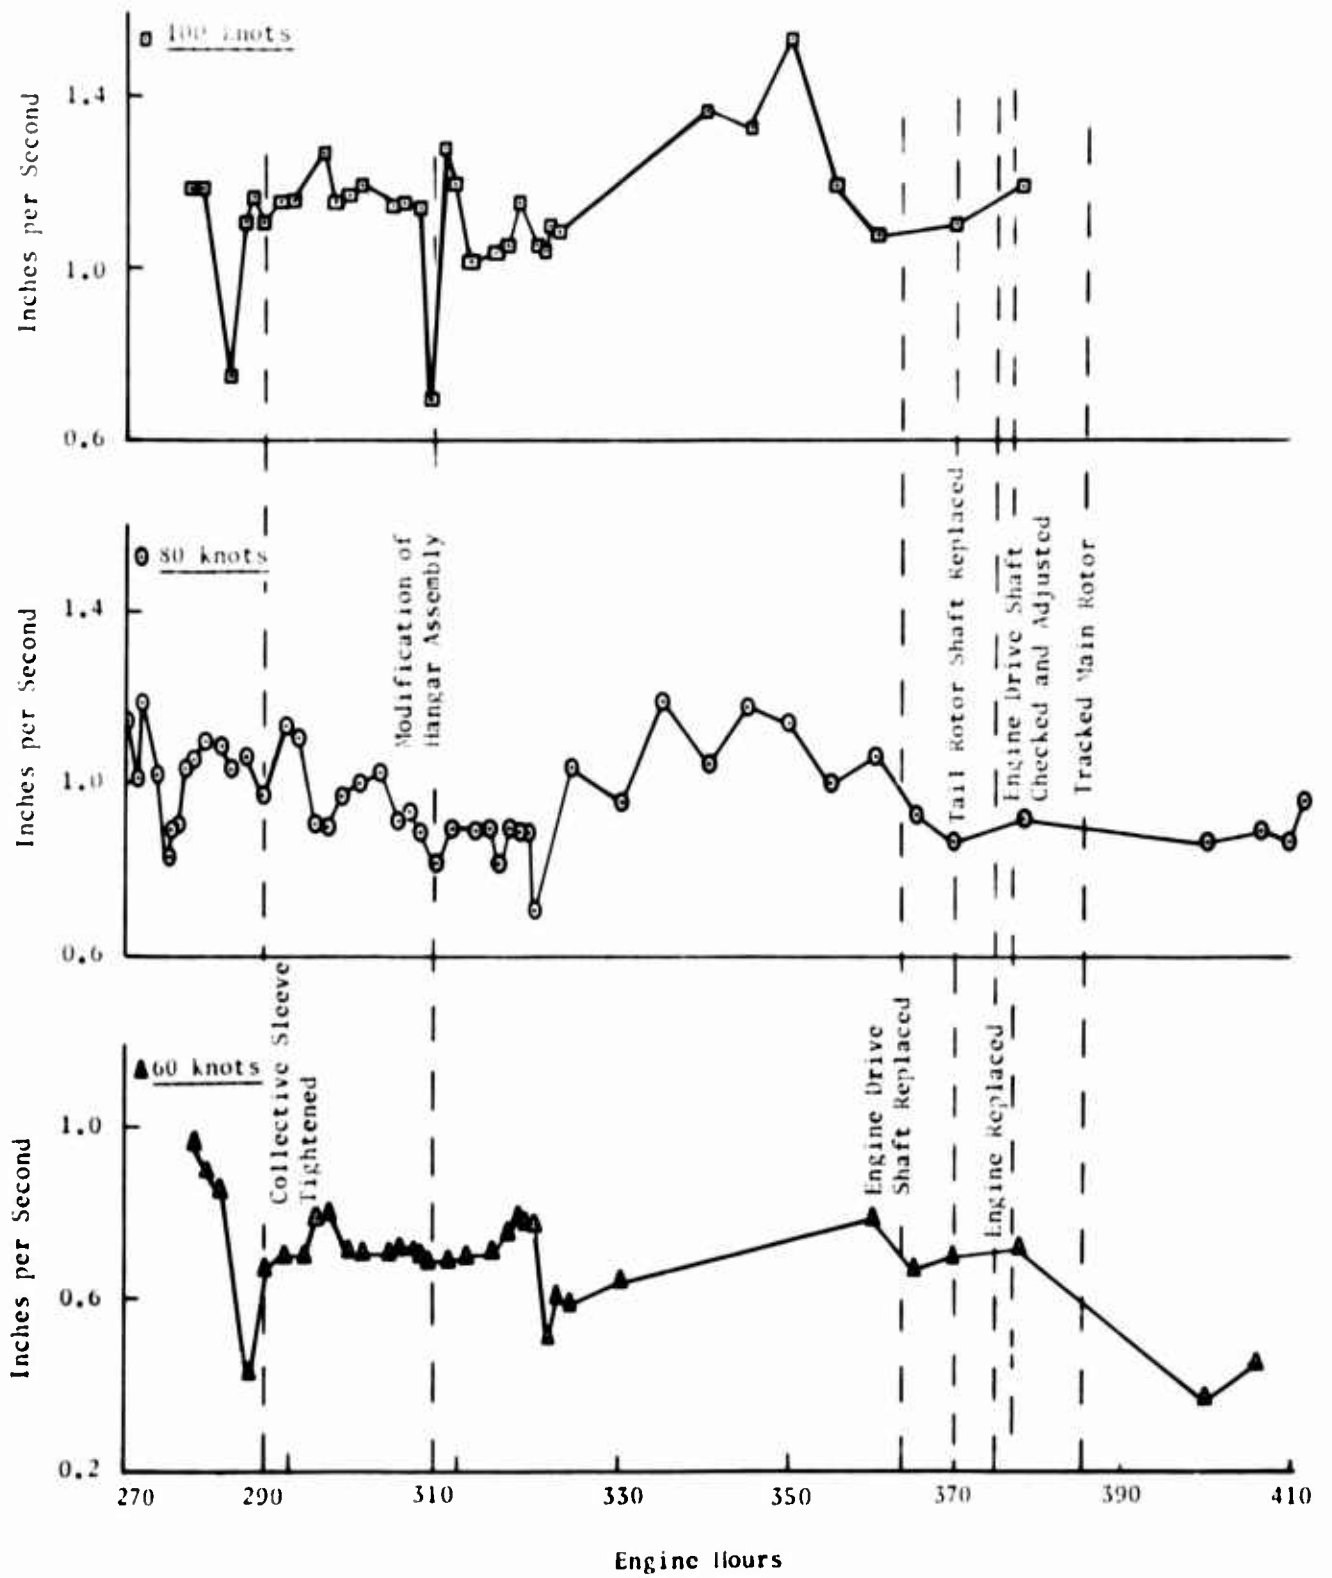
Figure 8. Aft Engine Vibration (20 to 2,000 cps).

Figures 5 through 9 display the vibration levels of various components of the aircraft versus engine hours. Superimposed on each of these graphs are descriptions of the major repairs performed on the aircraft during the test period. Each of the vibration levels recorded was taken through a frequency band wide enough to include all significant vibrations of the respective component. Most noteworthy of the vibration plots is that of the tail vibration, Figure 5, which displays a climb in the vibration level beginning at 330 engine hours. The climb continued to the 370-engine-hour reading; then, a bent tail rotor shaft and three cracks in the tail boom were repaired and the engine was replaced. The vibration level took a substantial drop immediately following these repairs; however, it did not drop to the normal operating level until the engine drive shaft was adjusted at 377 engine hours and the main rotor was tracked at 385 engine hours.

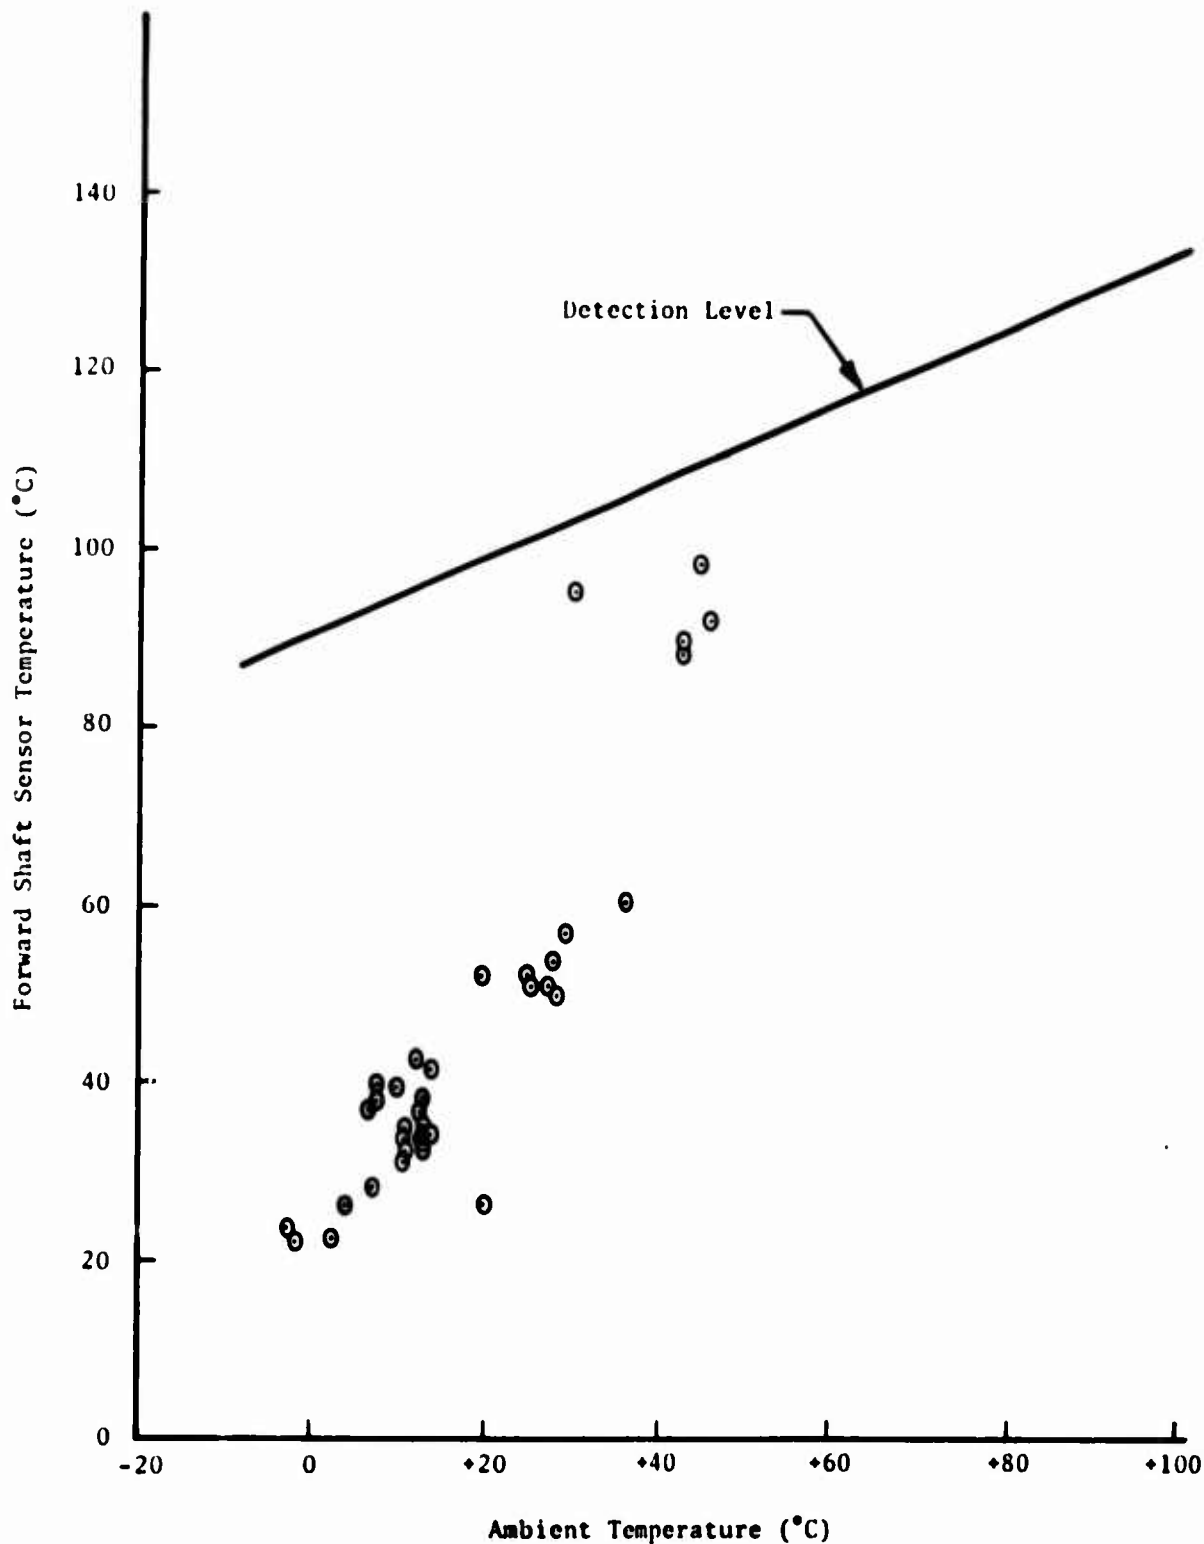
Figure 10. Forward Shaft Bearing Sensor Temperature Versus Ambient Temperature.

The no-go indicators for these channels were constantly monitored, and the actual voltage readings of each of the sensors were recorded during dynamic and flight tests. The temperatures of the sensors were calculated and plotted versus the ambient temperature, as determined from the ambient generator channel readings. These plots can be found in Figures 10 through 16. The detection levels for each of the temperature channels are superimposed on the respective graphs. The temperature detection levels were designed to adjust automatically 1°C for every 2°C change in ambient temperature.

channels must be redesigned to provide for a detection level that will adjust 1°C for every 1°C change in ambient temperature.
