# USAAVLABS TECHNICAL REPORT 65-43

## SURVIVABILITY SEAT DESIGN DYNAMIC TEST PROGRAM

July 1965

CONTRACT DA 44-177-AMC-191(T)

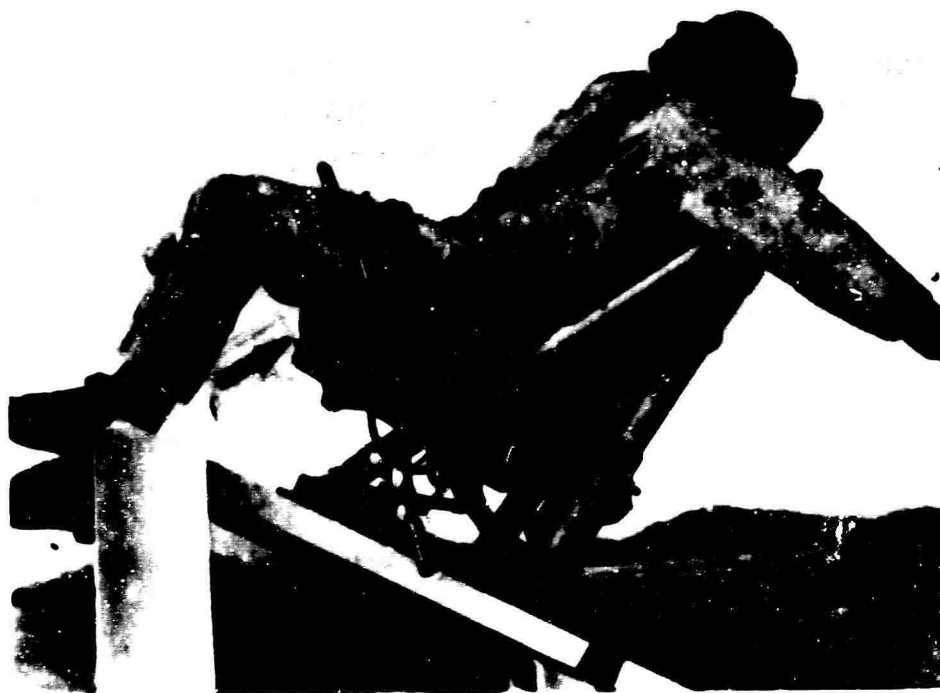
Under this test condition, the seat was oriented 28 degrees from the horizontal, as shown in Figure 14, to give both longitudinal and vertical loading of the seat. As the seat accelerated, the dummy moved downward into the cushion and, at approximately 0.01 second, it began to move forward with respect to the seat. The chest armor plate was also moving forward at this time. At approximately 0.03 second, the chest armor plate had moved forward through its maximum permissible travel distance, failed as designed, and jettisoned clear of the sled. It was also at this point that the dummy began to accelerate with the sled. The sled had traveled approximately 18 inches before the dummy began to accelerate. Figure 15 is a posttest view of the seat and dummy, showing the forward bulge on the front seat pan lip (arrow) caused by the dummy's moving downward and forward during the initial phase of the acceleration. The figure also shows the failure of the chest armor plate support tube. During some part of the test, the left seat belt became disconnected at the latch; however, the remaining restraint harness was sufficient to retain the dummy in the seat. The energy absorbers gave only a slight indication of operating. They should not have operated, of course, to any extent, since the vertical acceleration did not exceed their design load (20G), for any appreciable time.

**Figure 15. Posttest View of Bell Seat - Test Condition No. 1.**

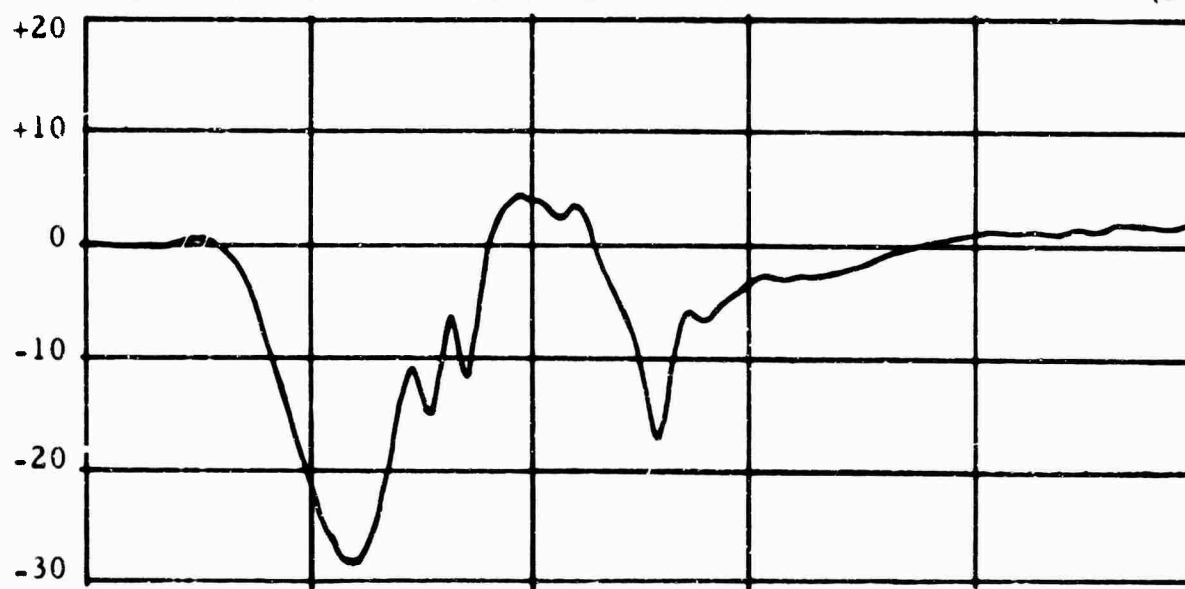
(F)

Figure 17F shows a dynamic amplification of 2.4 (26G  $\div$  11G) for the vertical deceleration for the dummy. This "overshoot" is probably due to cushion deflection coupled with internal deflection in the dummy itself. The dummy longitudinal record was obtained in this test and is presented but not discussed because of an apparent instrument malfunction.

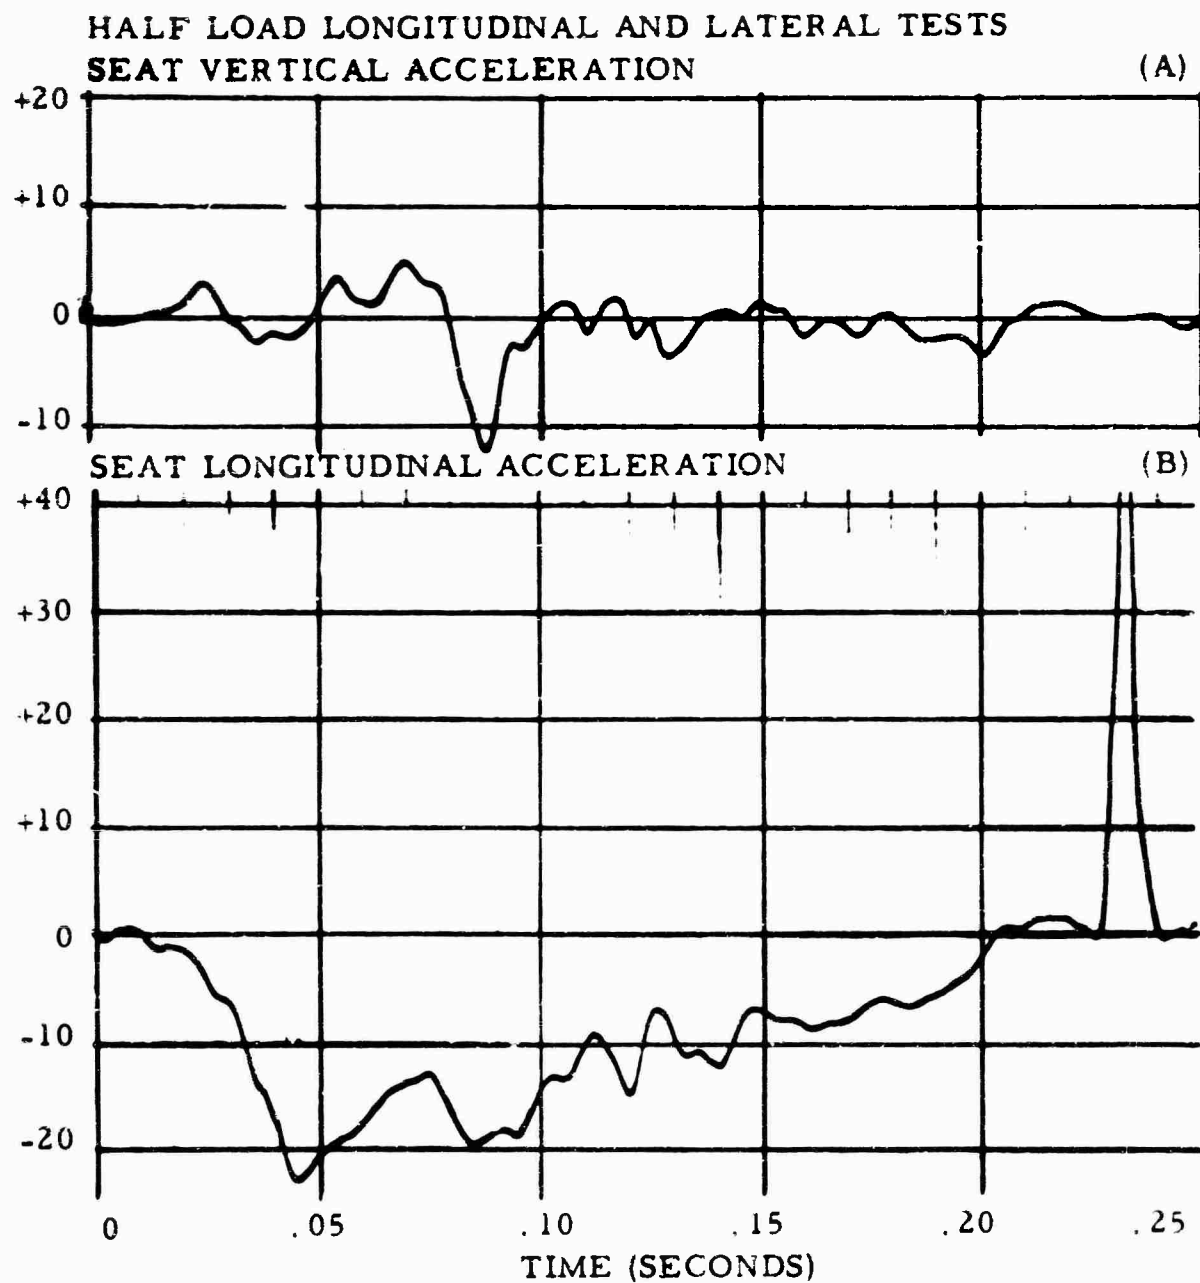
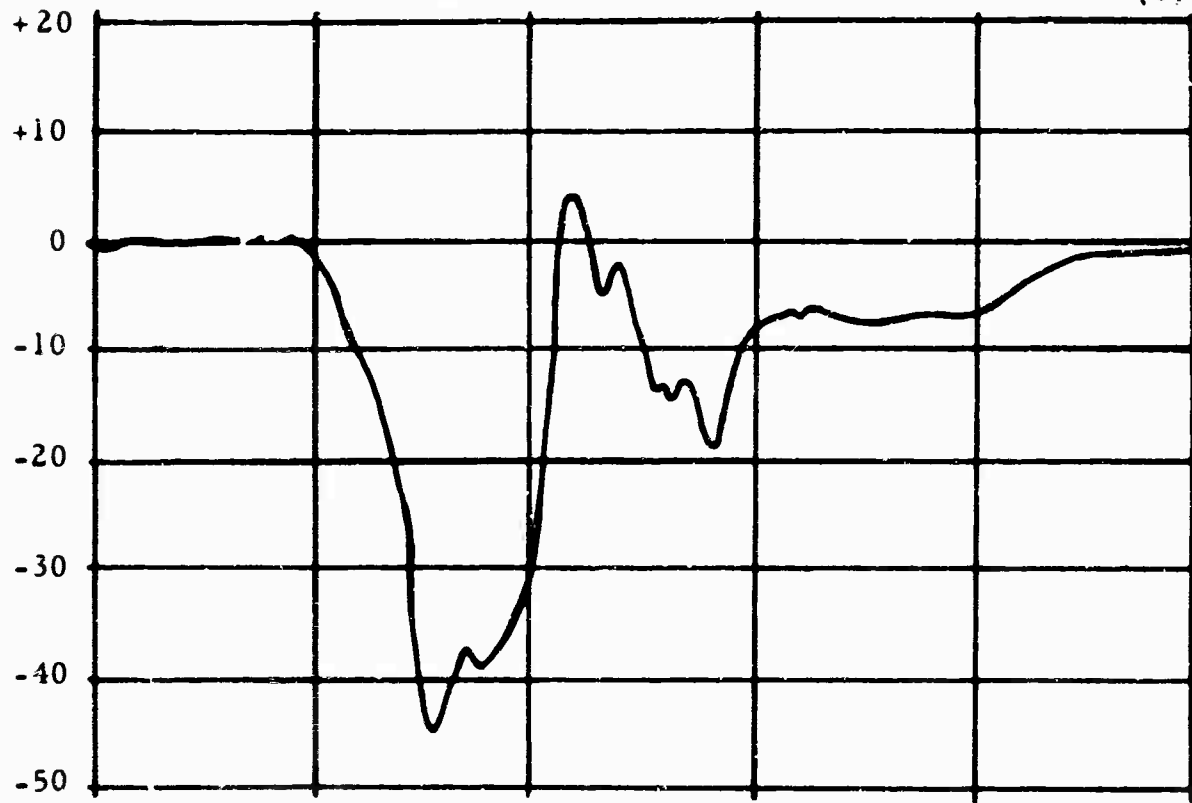
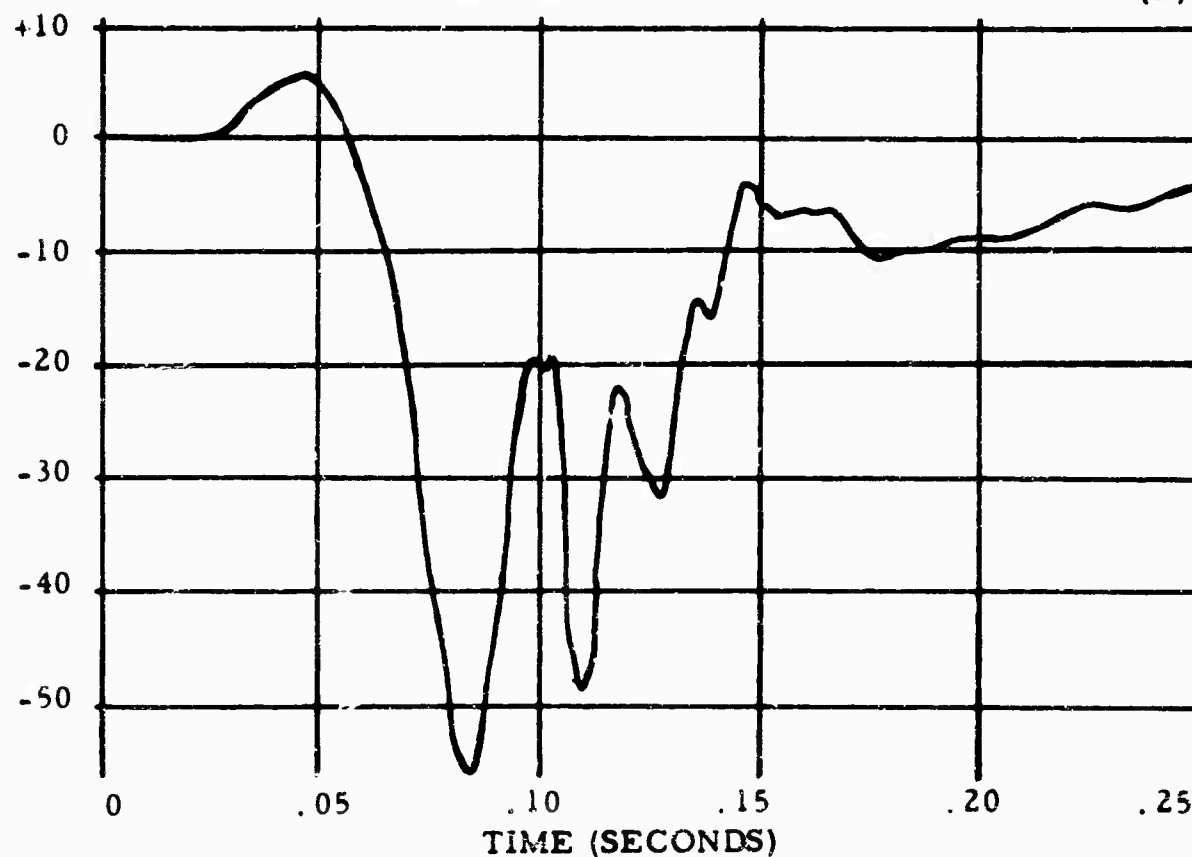
Figure 18. Data Time Histories - Bell Seat -  
Test Condition No. 2.

Figures 18 C and 18D, which give the dummy pelvic lateral and longitudinal accelerations, are of particular importance. Observation of these plots quickly shows that the dummy does not accelerate in phase with the seat

and at the same rate as the sled and seat. As shown by the "average" curve in Figure 18D, the acceleration of the dummy reached a maximum of about 40G, which gives a peak dynamic amplification factor of in excess of 2.5. The response of the dummy, as seen in the high-speed films, bears out this fact. The high G values are caused by the excessive extension of the seat belt and shoulder harness. This allows the dummy to attain a velocity relative to the seat until it is rapidly decelerated by the extended harness.

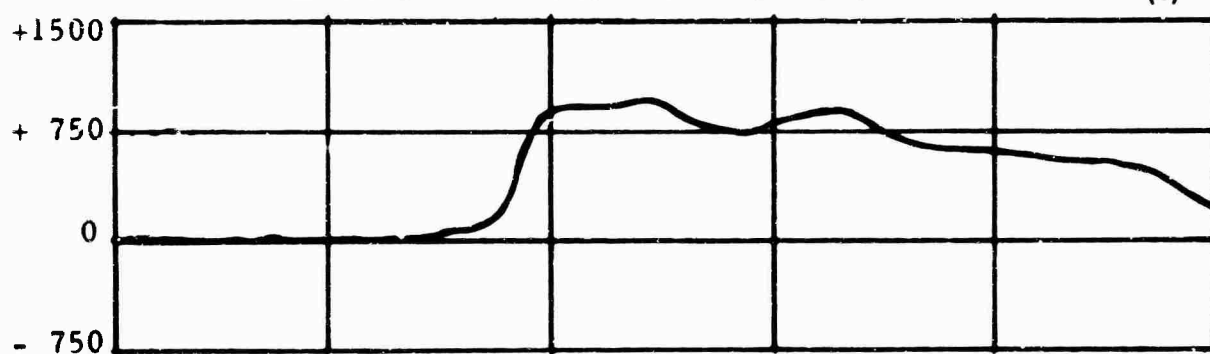
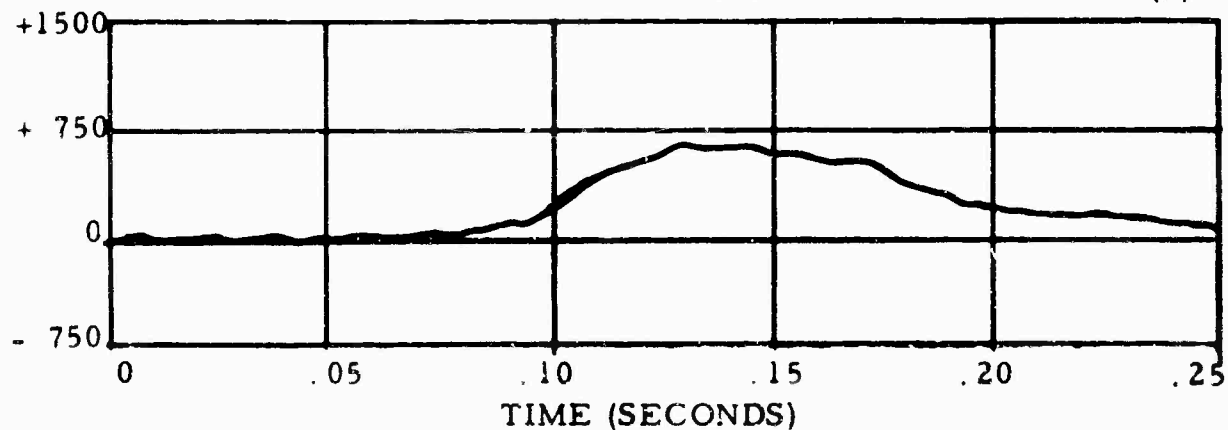
Figures 18I and 18J give the shoulder harness loads which peak at 2000 pounds (left hand) and about 1500 pounds (right hand) in phase with the peak longitudinal accelerations of the dummy. These loads are of the correct order of magnitude to place 40G on the upper torso.

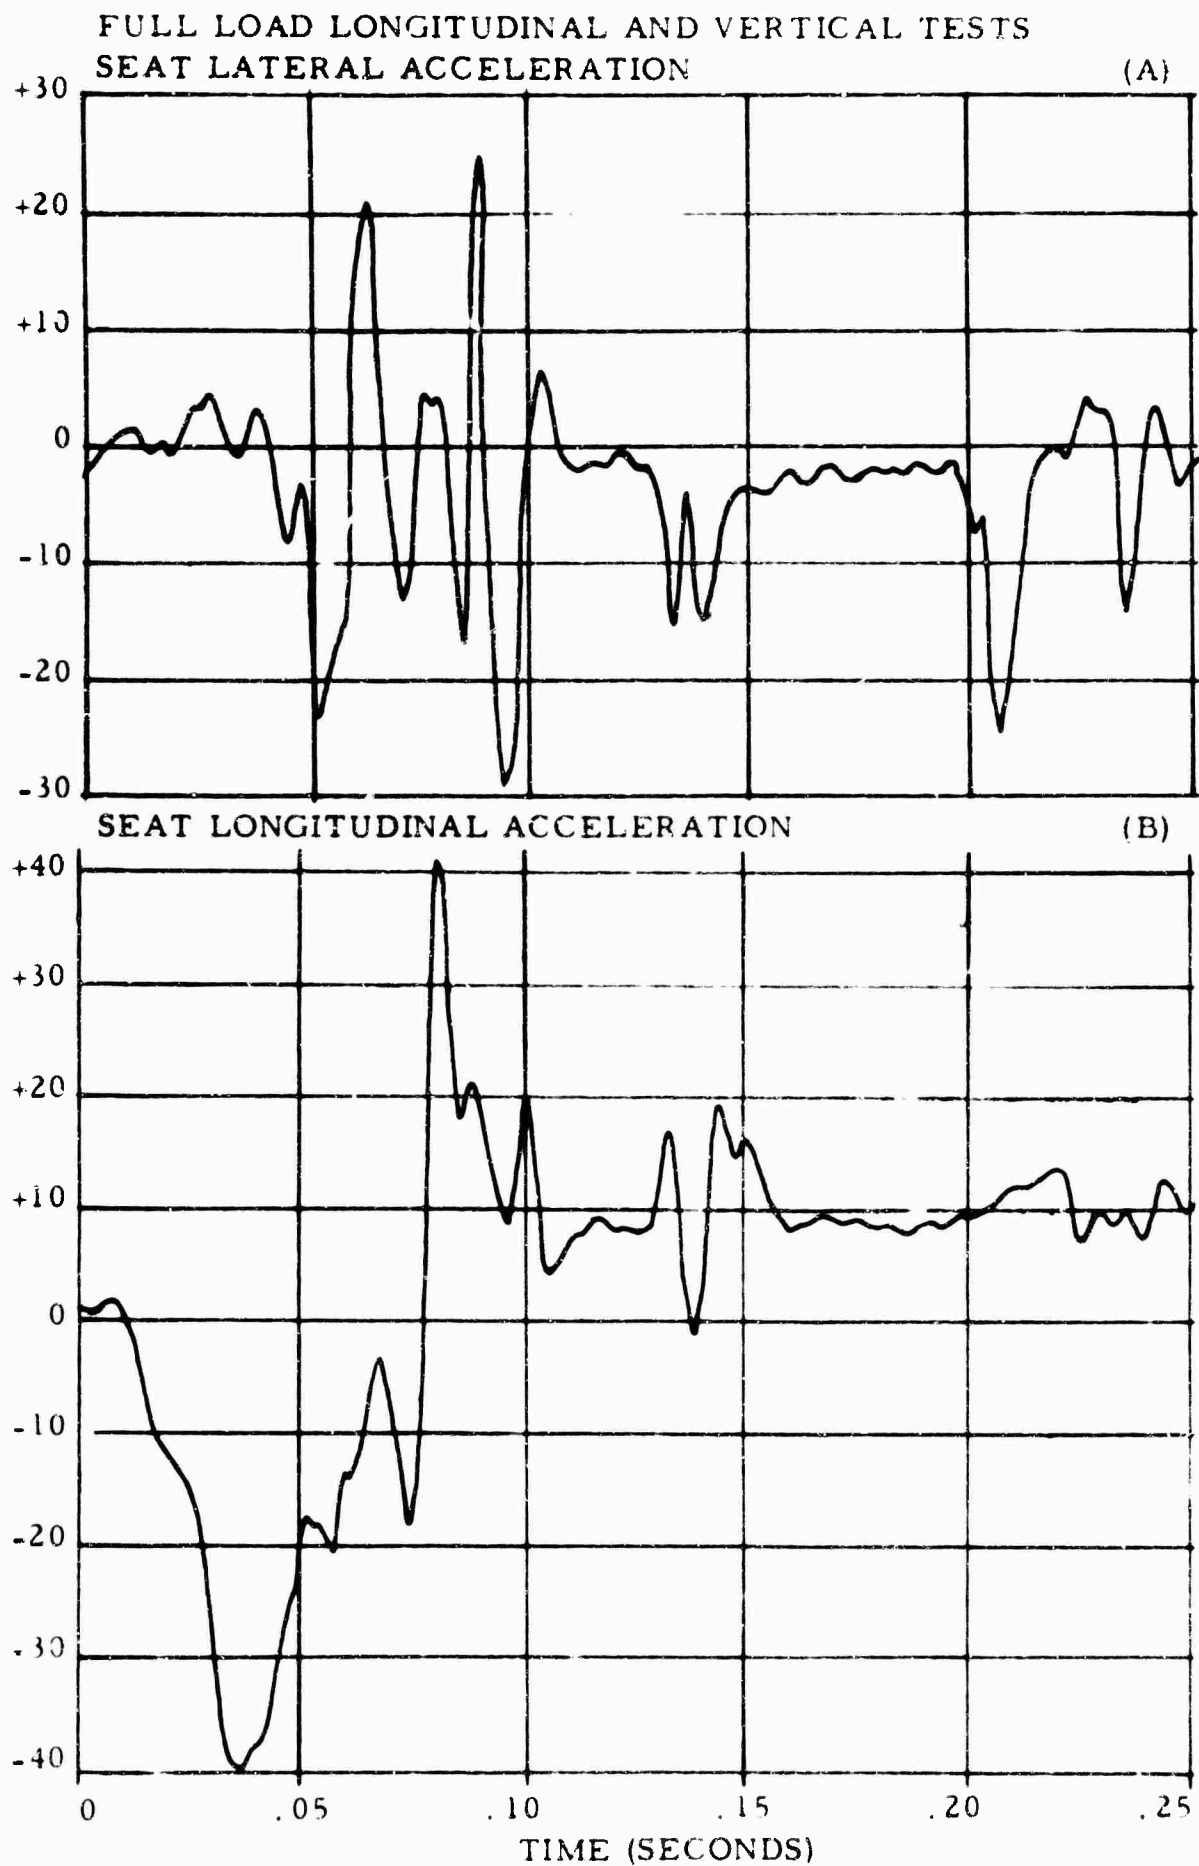
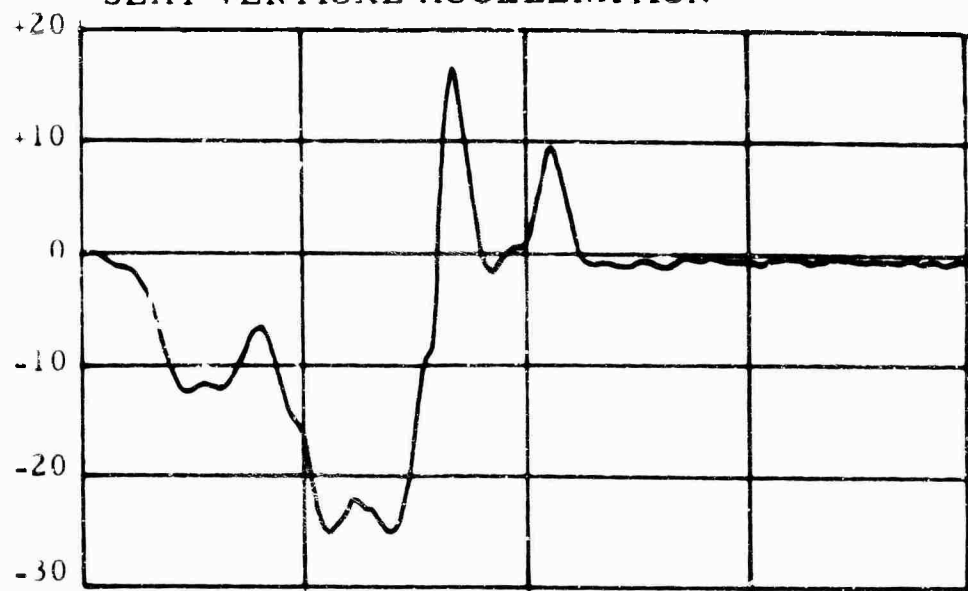
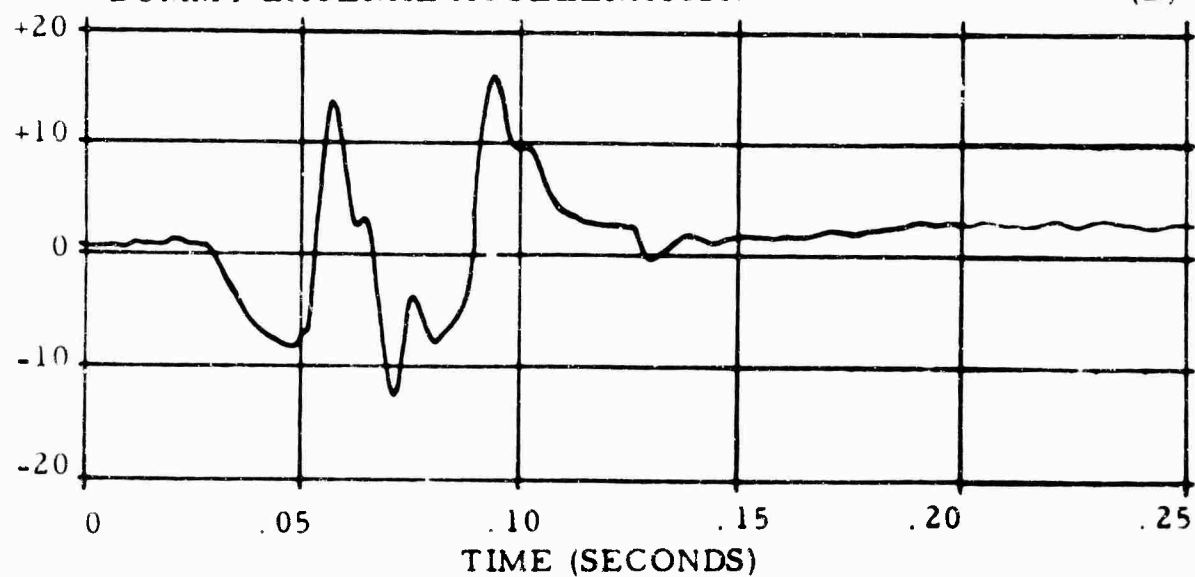
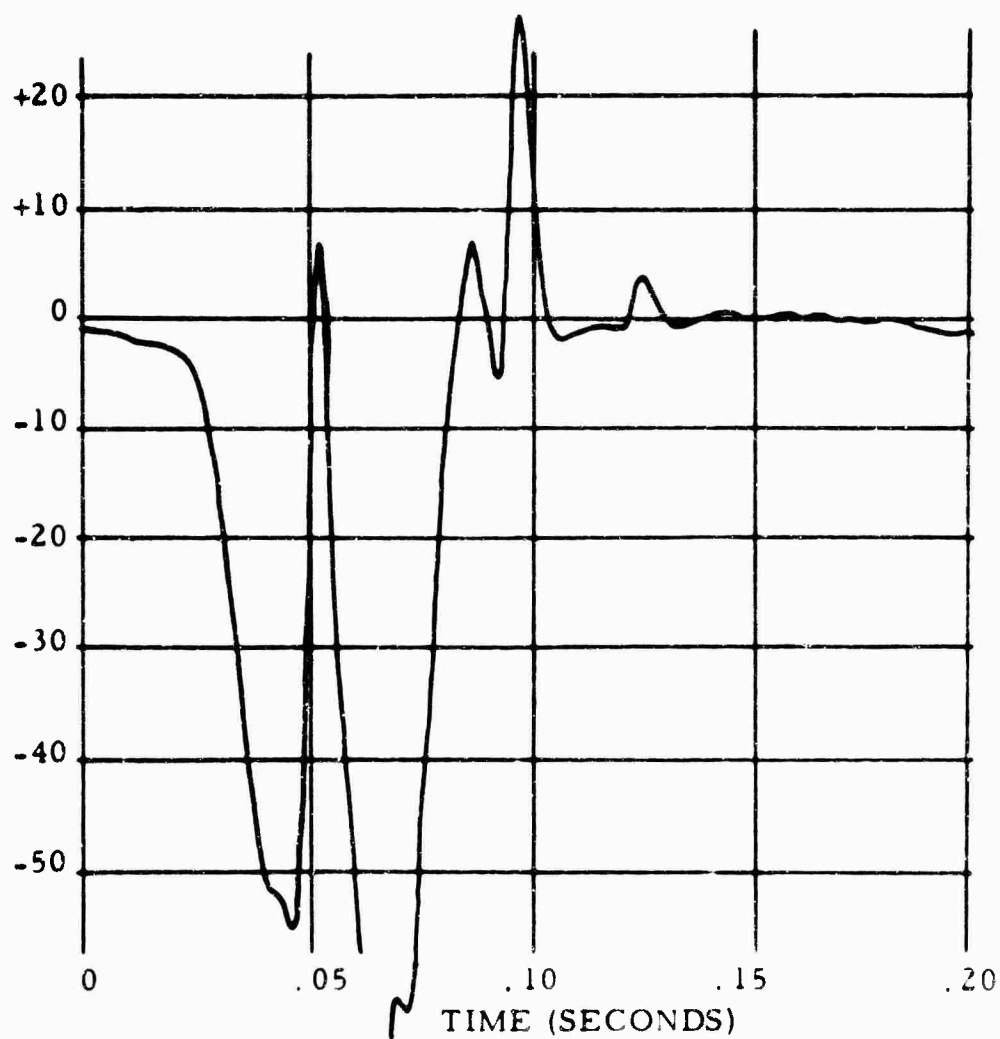
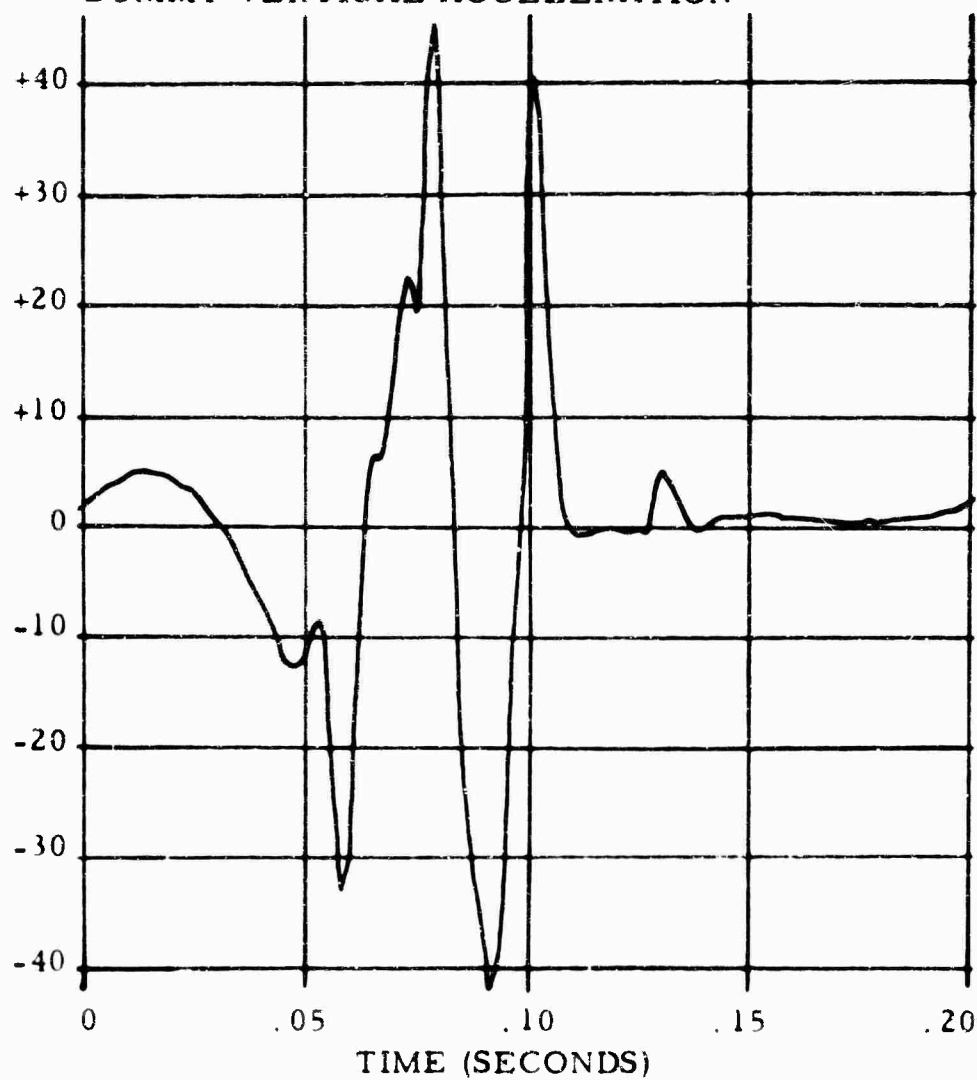
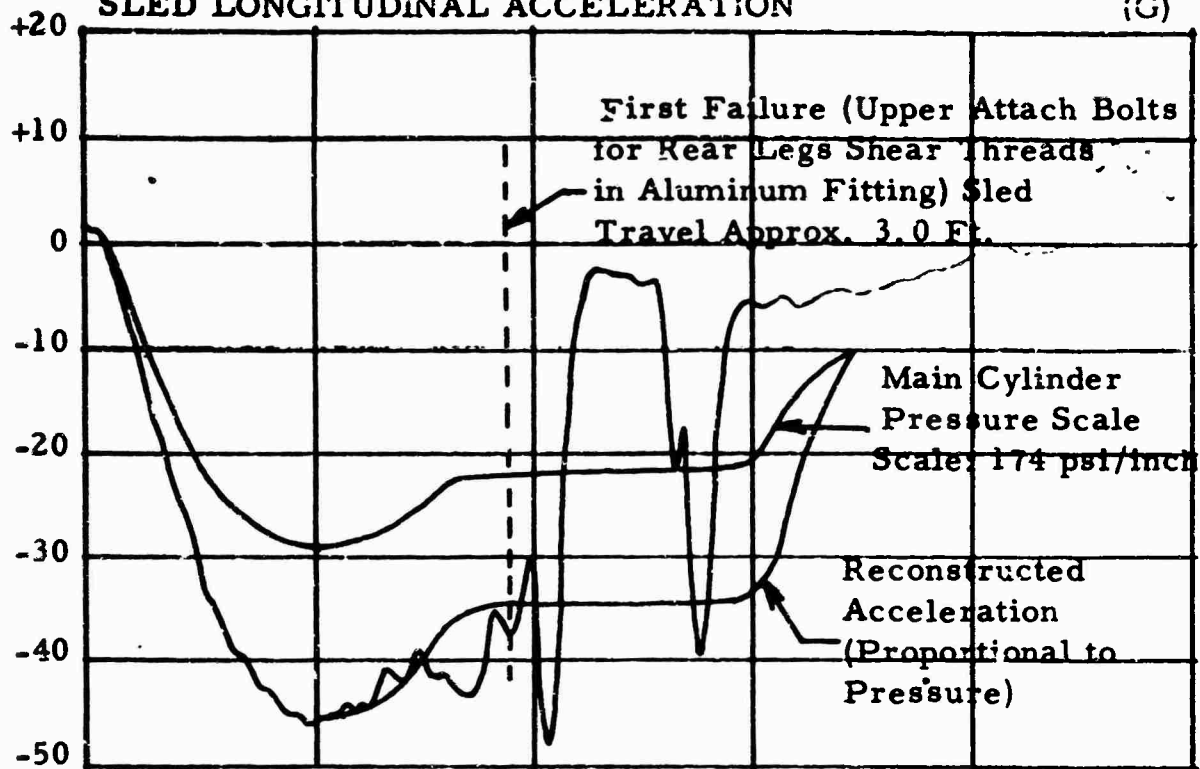
Figure 22. Data Time Histories - Bell Seat -  
Test Condition No. 3.

The sled acceleration pulse for this test is shown in Figure 22G. As noted in the figure, an instrumentation disconnect occurred at approximately 0.09 second. The complete sled acceleration pulse has been reconstructed and plotted in the figure from the main-cylinder steam-pressure curve which was obtained through a separate set of cables,

unaffected by the primary instrumentation disconnect. In all cases where both pressures and sled acceleration curves were obtained, extremely close agreement was evident in the shapes and durations of these curves. This is necessarily true since approximately 95 percent of the load applied to the sled is of the steam pressure against the movable piston; friction and air resistance account for the remainder. For example, in Figure 22, the maximum recorded acceleration ( $t = 0.05$  second) was 41G. The steam pressure recorded was 220 psi at this time. For the 23.5-inch-diameter piston and the sled weight of 2200 pounds, the computed acceleration would be:

The early instrumentation disconnect occurred in all of the full-load tests and, while not intended, did not result in loss of data in the tests of the Bell, Vertol, and Kaman seats, since failure occurred in these systems prior to disconnect. Complete records would have been valuable in the Sikorsky seat test and, in the case of the combination longitudinal-vertical, were nearly obtained.

The disconnect occurred because the forces required to accelerate the umbilical at the full load shots exceeded the strength of the disconnect safety wire. Repeated failures occurred because the disconnect was not noticeable visually. The cable appeared to pay out correctly. When the data was analyzed in detail and the malfunction discovered, the tests had been completed.

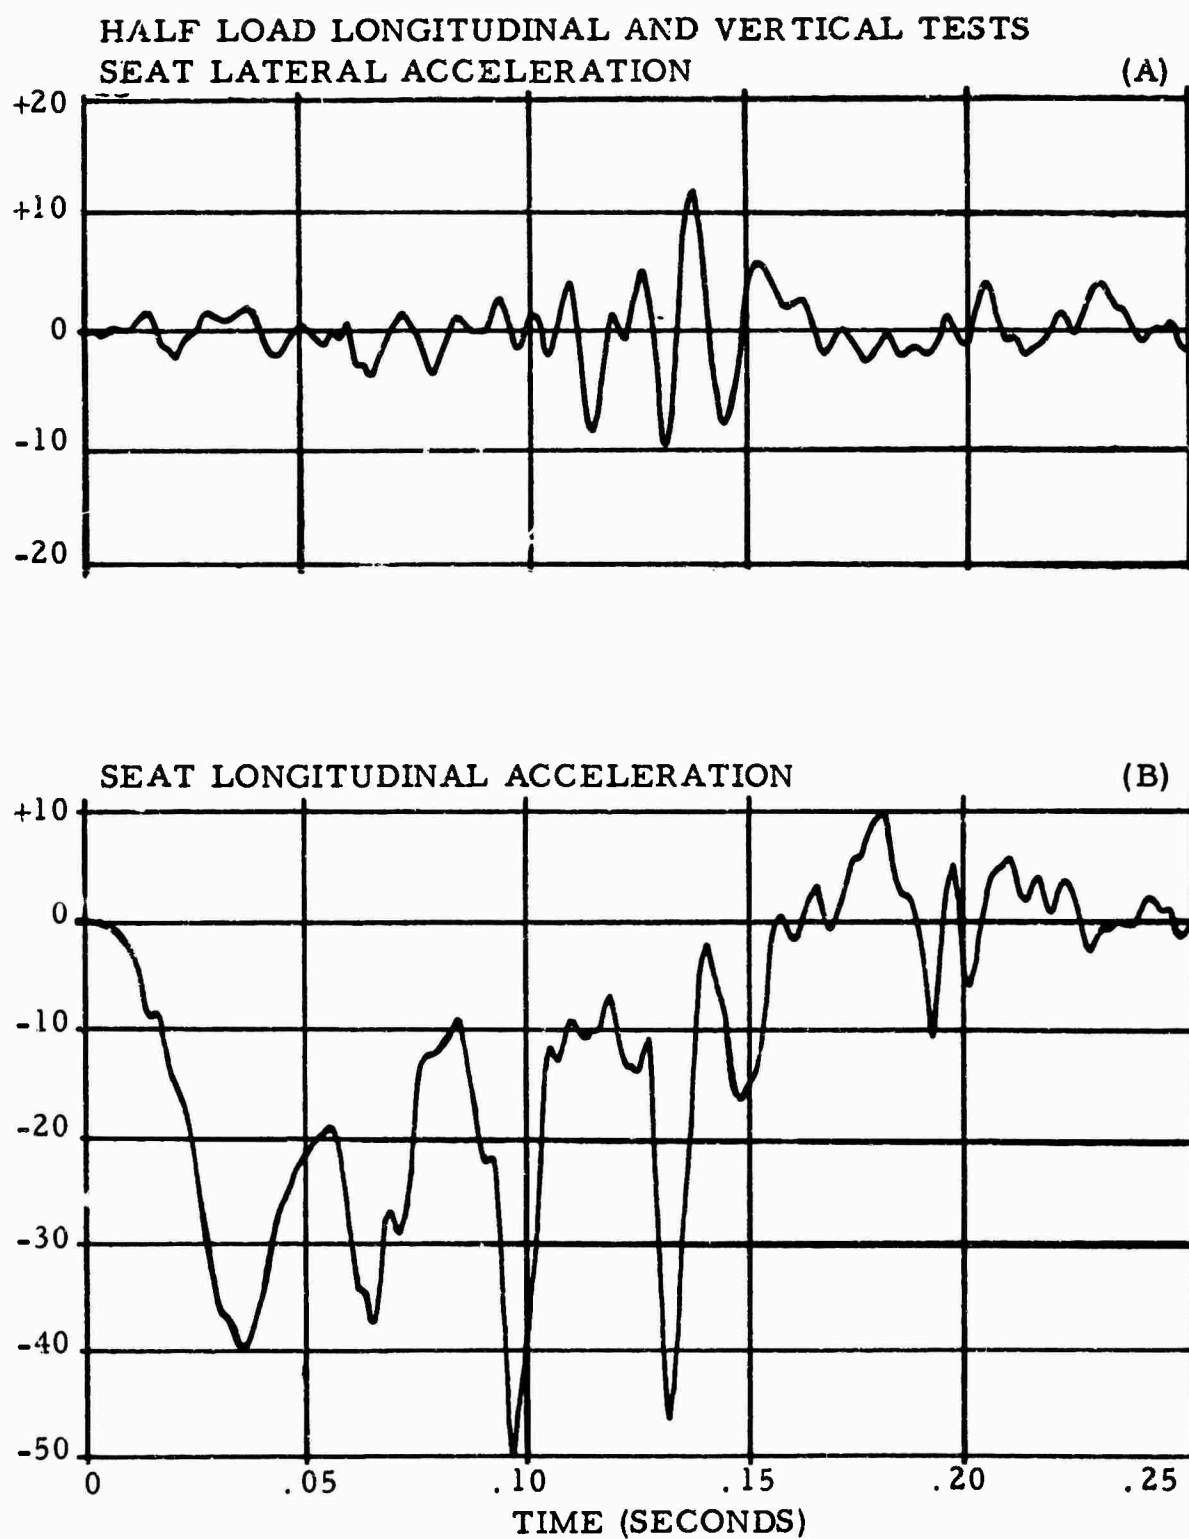
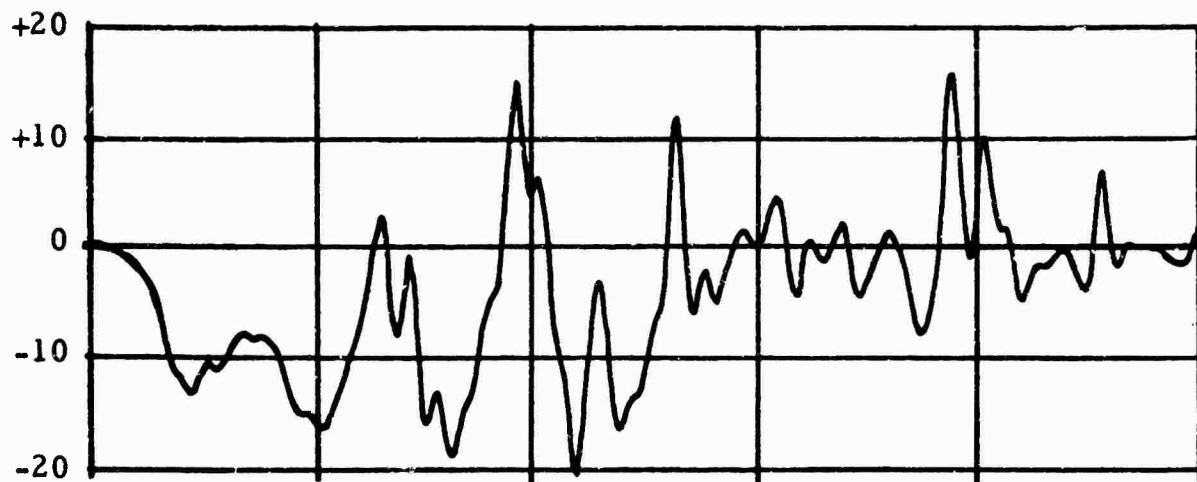
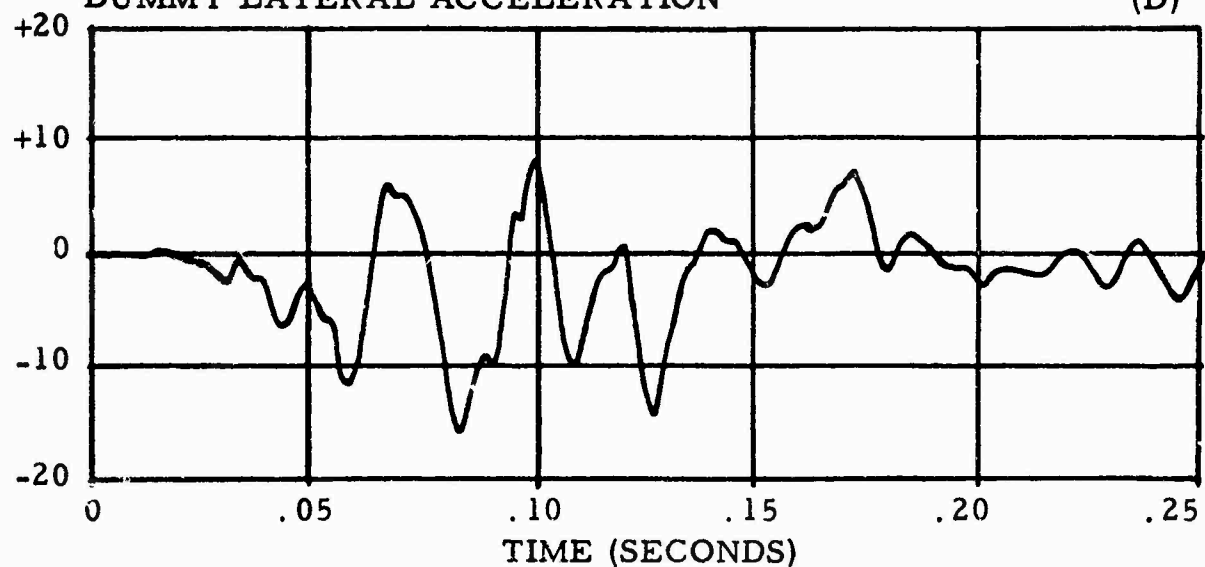
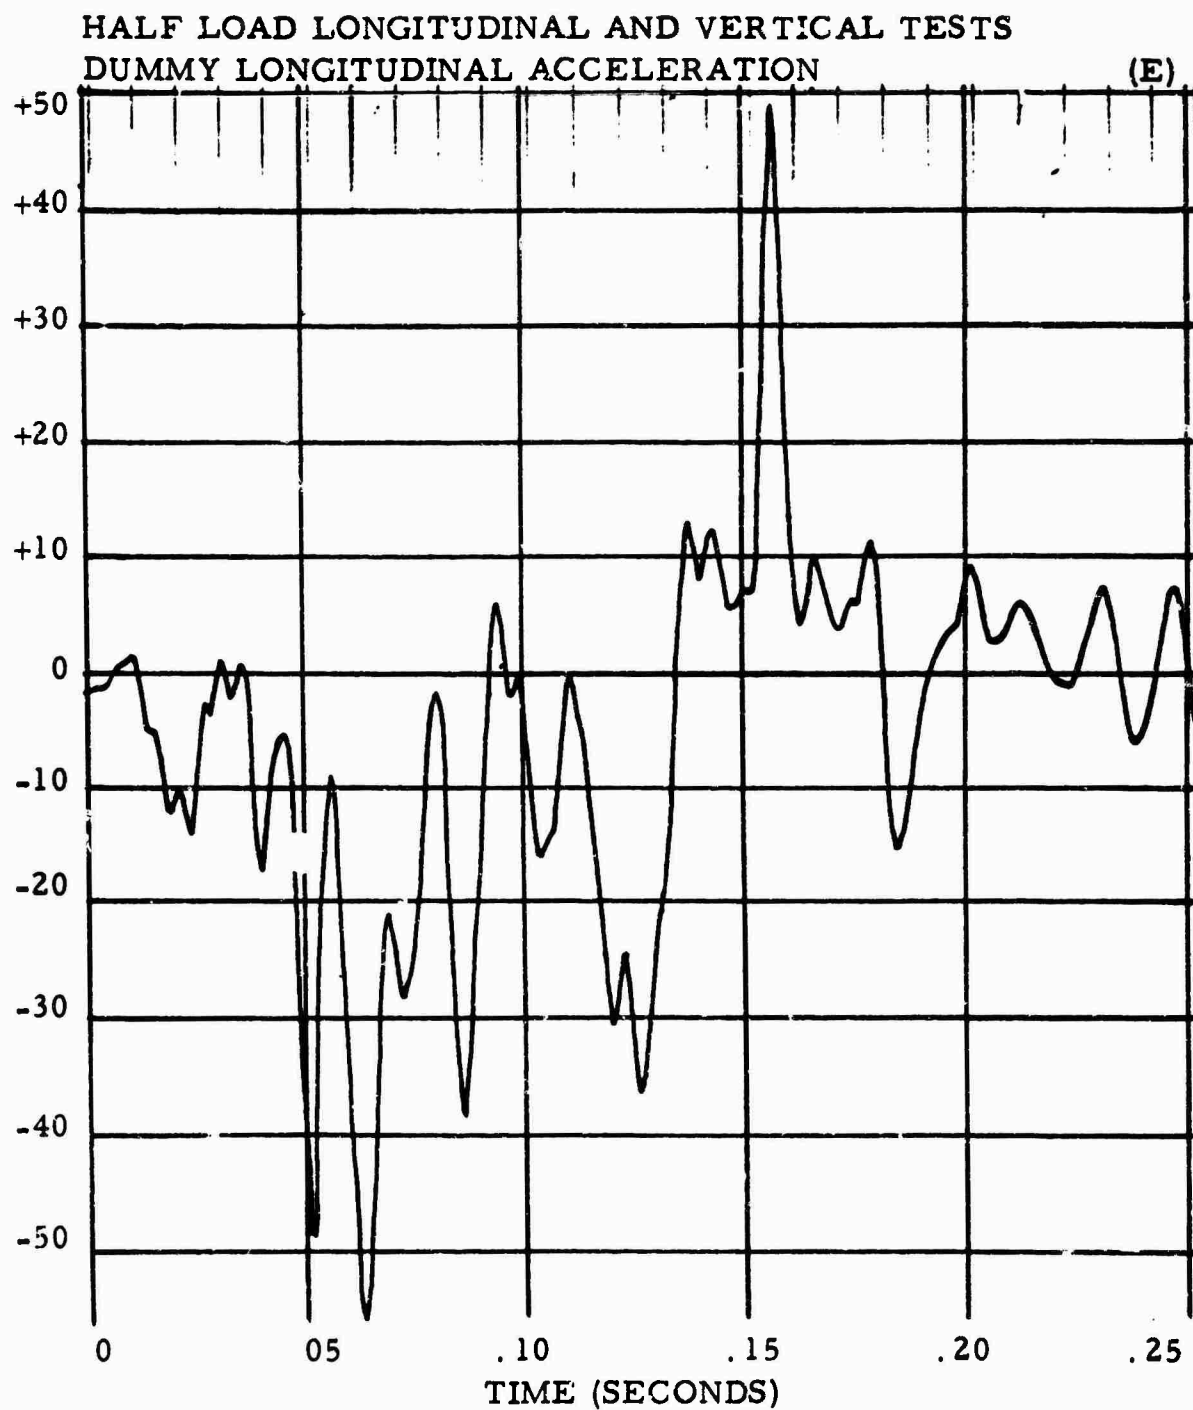
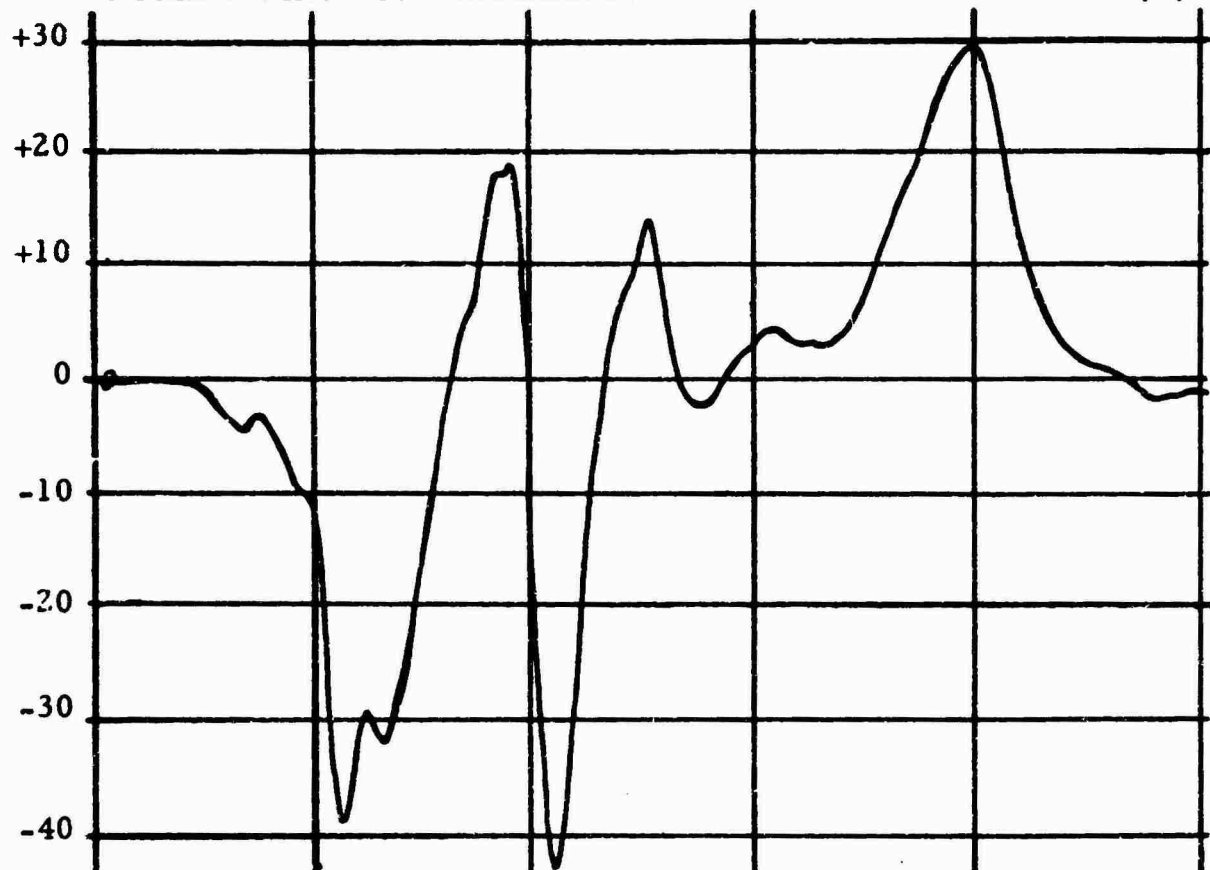
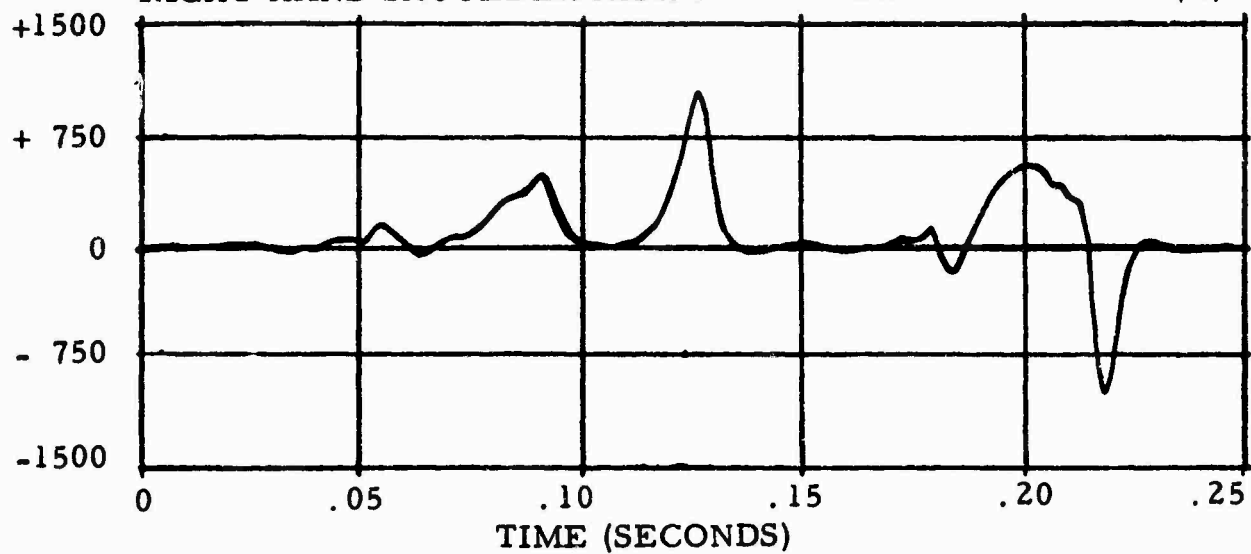
Figure 25. Data Time Histories - Kaman Seat -  
Test Condition No. 1.

The sled acceleration, Figure 25I, and the seat accelerations, Figures 25B and 25C, are in general agreement other than for the higher frequency components. Longitudinal and vertical dummy accelerations, Figures 25E and 25F, were affected by a shift in dummy position.

The seat-belt and shoulder-harness loads, Figures 25G, 25H, and 25J, clearly reflect the failure described above. It is believed that the seat would have carried the loads imposed in this test had the load link not failed. The test was not repeated.
