# USAAVLABS TECHNICAL REPORT 65-43

## SURVIVABILITY SEAT DESIGN DYNAMIC TEST PROGRAM

July 1965

CONTRACT DA 44-177-AMC-191(T)

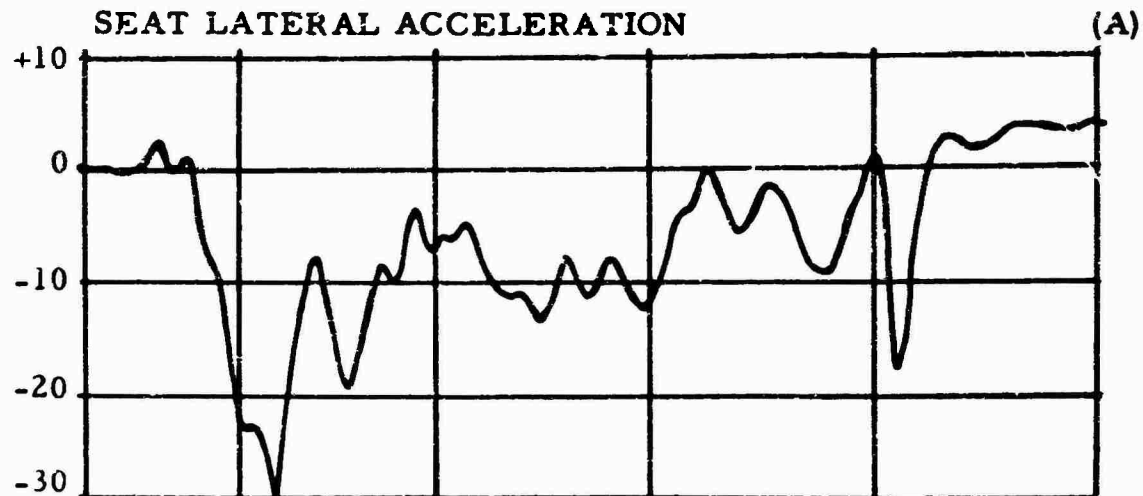
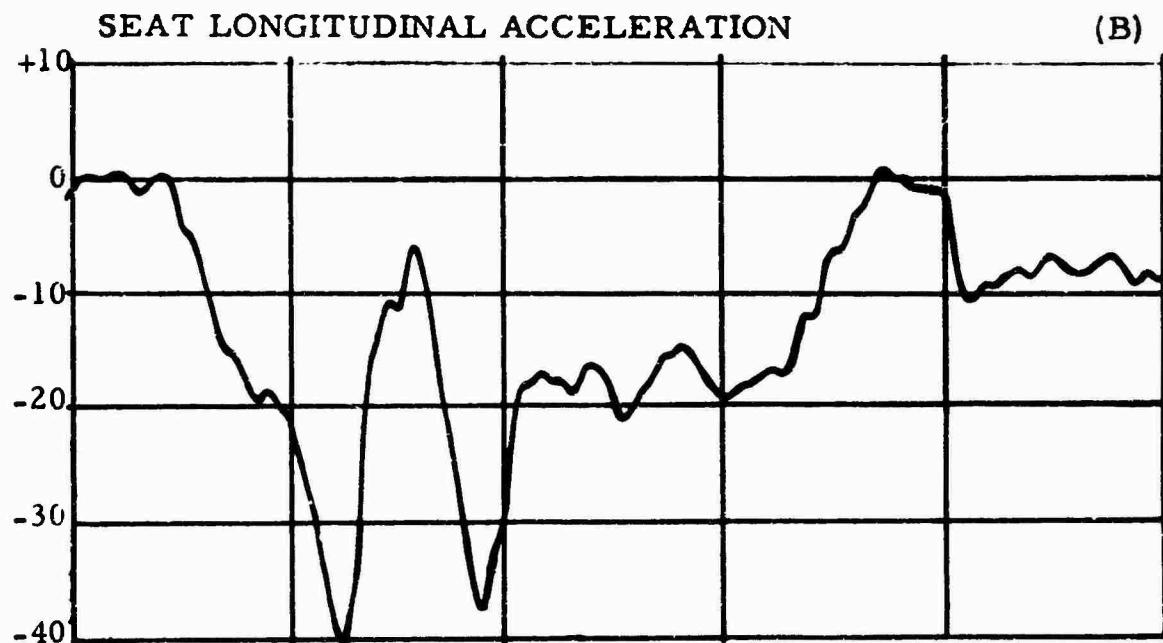
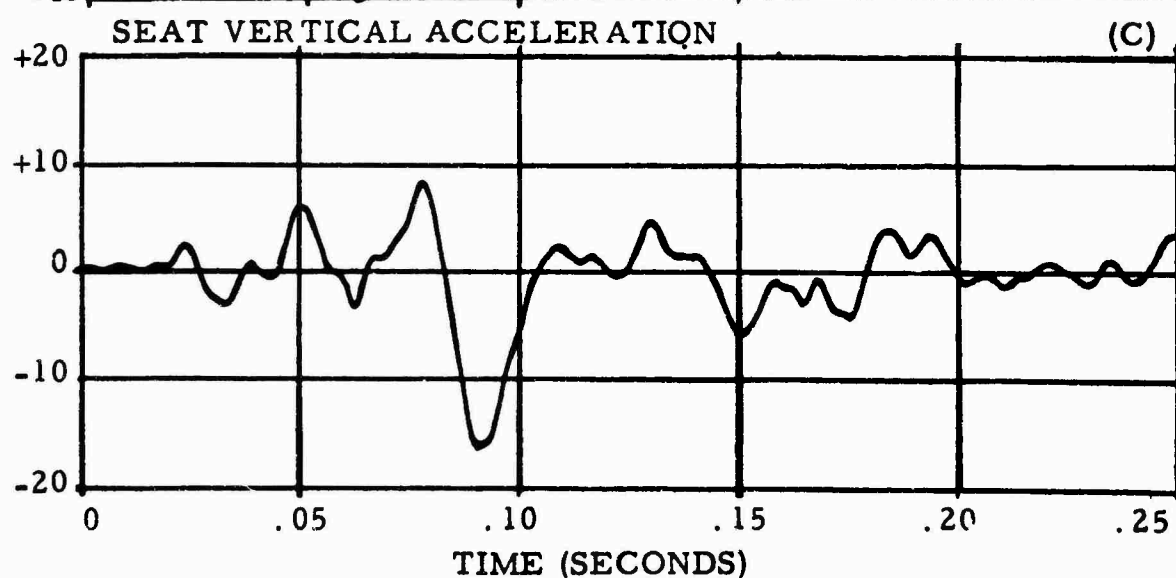
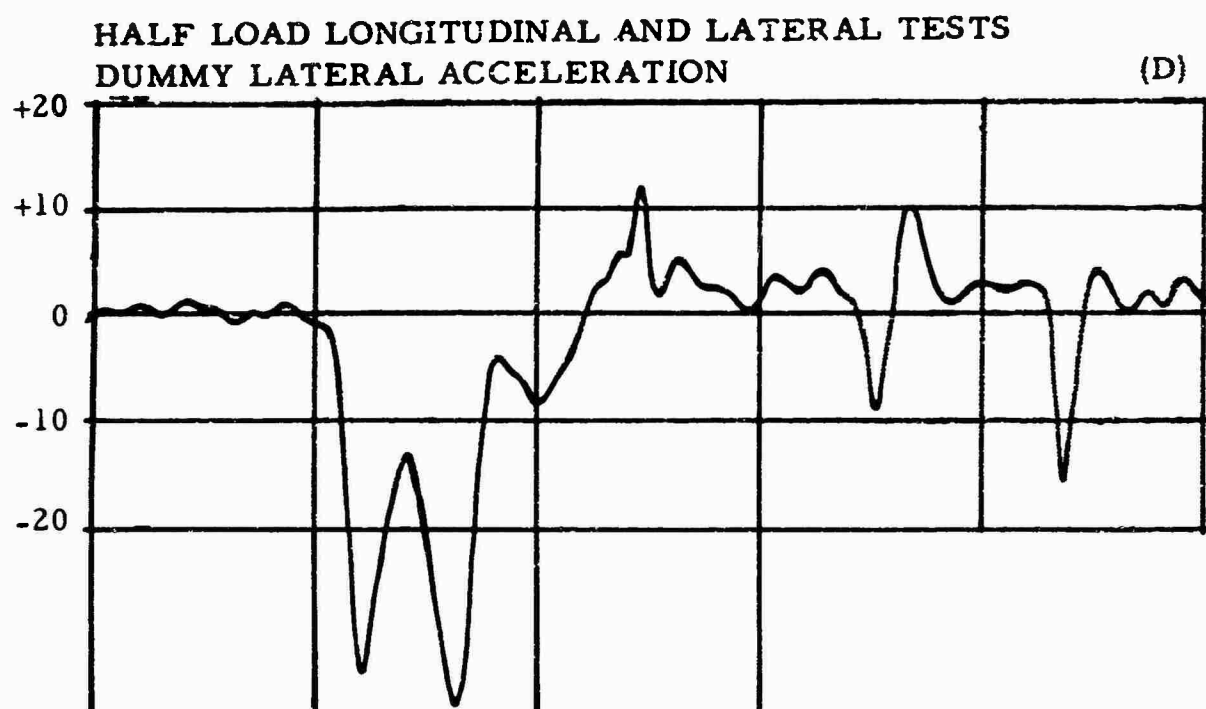
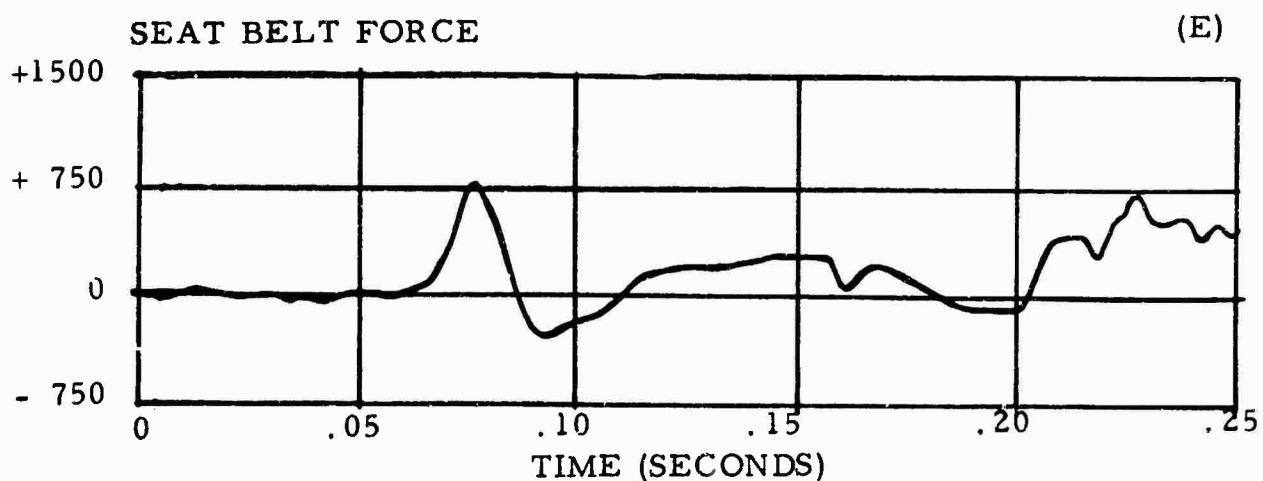
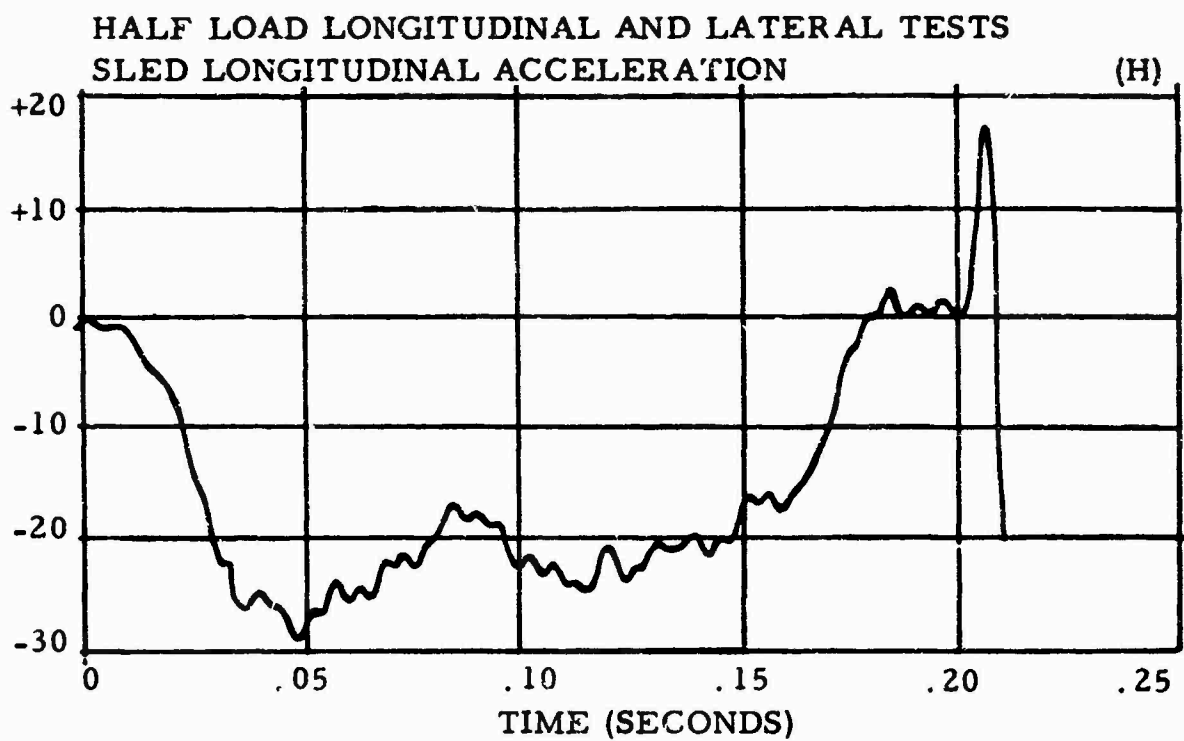
Figure 27. Data Time Histories - Kaman Seat -  
Test Condition No. 2.

The actual test pulse is shown in Figure 27H and averages about 20G. The theoretical seat longitudinal acceleration would be  $20 \cdot \cos(23 \text{ degrees}) = 18.3\text{G}$ , and the lateral acceleration  $20 \cdot \sin(23 \text{ degrees}) = 7.8\text{G}$ . Figures 27A and 27B give the measured seat longitudinal and lateral values; they indicate approximate agreement with the expected result.

The dummy lateral acceleration, Figure 27D, is similar to that obtained in the test of the Bell seat. The seat belt load, Figure 27E, is considerably lower than that recorded for Bell seat test condition No. 2. It is assumed that the strap-on armor used with the Kaman seat carried an appreciable part of the longitudinal load normally carried by the seat belt. The shoulder harness load, Figures 27F and 27G, at 1280 pounds was of slightly lower value than recorded in Bell seat test condition No. 2, and it was not maintained for as long an interval. The "wrap-around" chest armor of the Kaman seat probably contributed to the difference in the measured values.

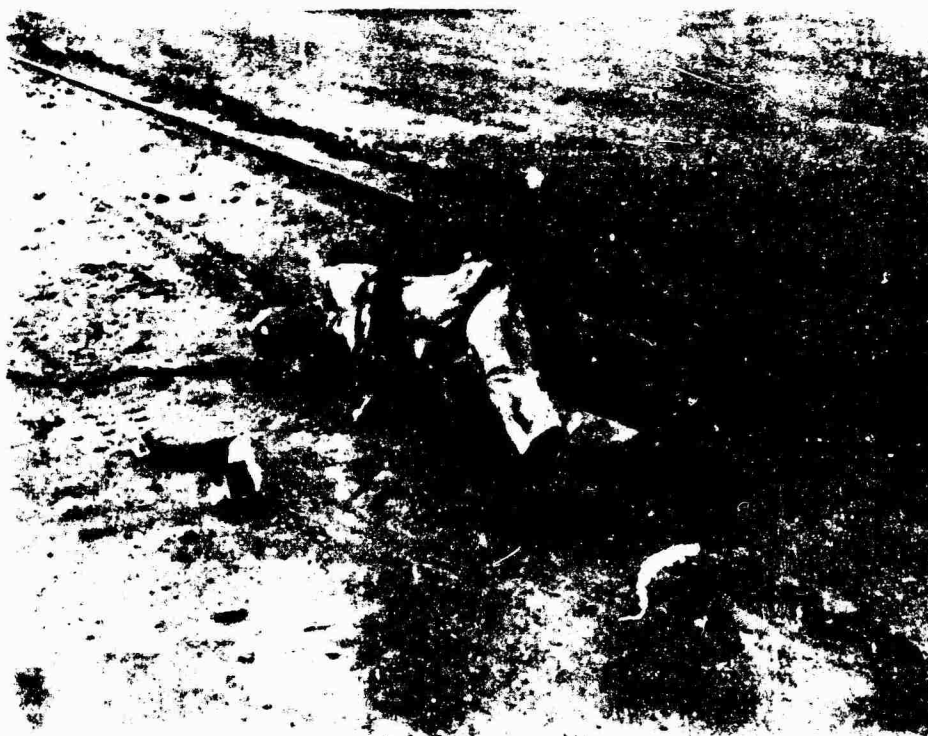
Figure 28. Posttest View of Kaman Seat - Test Condition No. 3.

This test was a full-load test with the seat mounted 28 degrees upward from the horizontal, as shown in Figure 14. Observation of the high-speed films (see sequence photographs taken from this film, Figure 29) shows that the seat moved upward and forward parallel to the floor mounting rails almost immediately after firing. Seat movement was evident by 0.035 second. The safety cable did not retain the seat on the sled. Visual examination of the seat tracks and seat after the test indicates that the pins that hold the seat in place were not fully extended in the holes, although the locking handle was fully depressed. The only damage to the seat was caused by contact with the ground. Figure 28 is a posttest view of the seat and dummy.

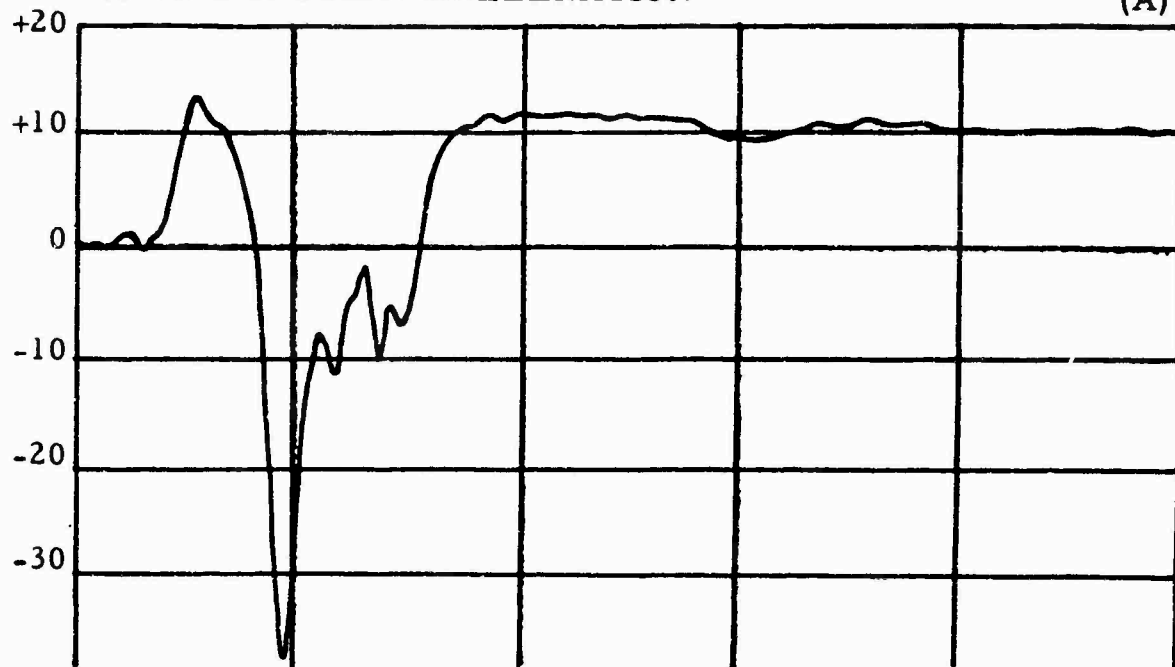
(A)

The data presented in Figures 30A through 30G is not significant after about 0.05 millisecond\* due to the seat failure and the instrumentation disconnect. The sled acceleration, Figure 30G, peaked at 43G at about 0.06 second. The seat longitudinal acceleration, Figure 30B, reached about 30G by 0.035 second, and also indicated that seat restraint was lost at about this time. The dummy longitudinal acceleration, Figure 30E, reached 60G by 0.04 second and would probably have gone to 80+G if no failure had occurred.

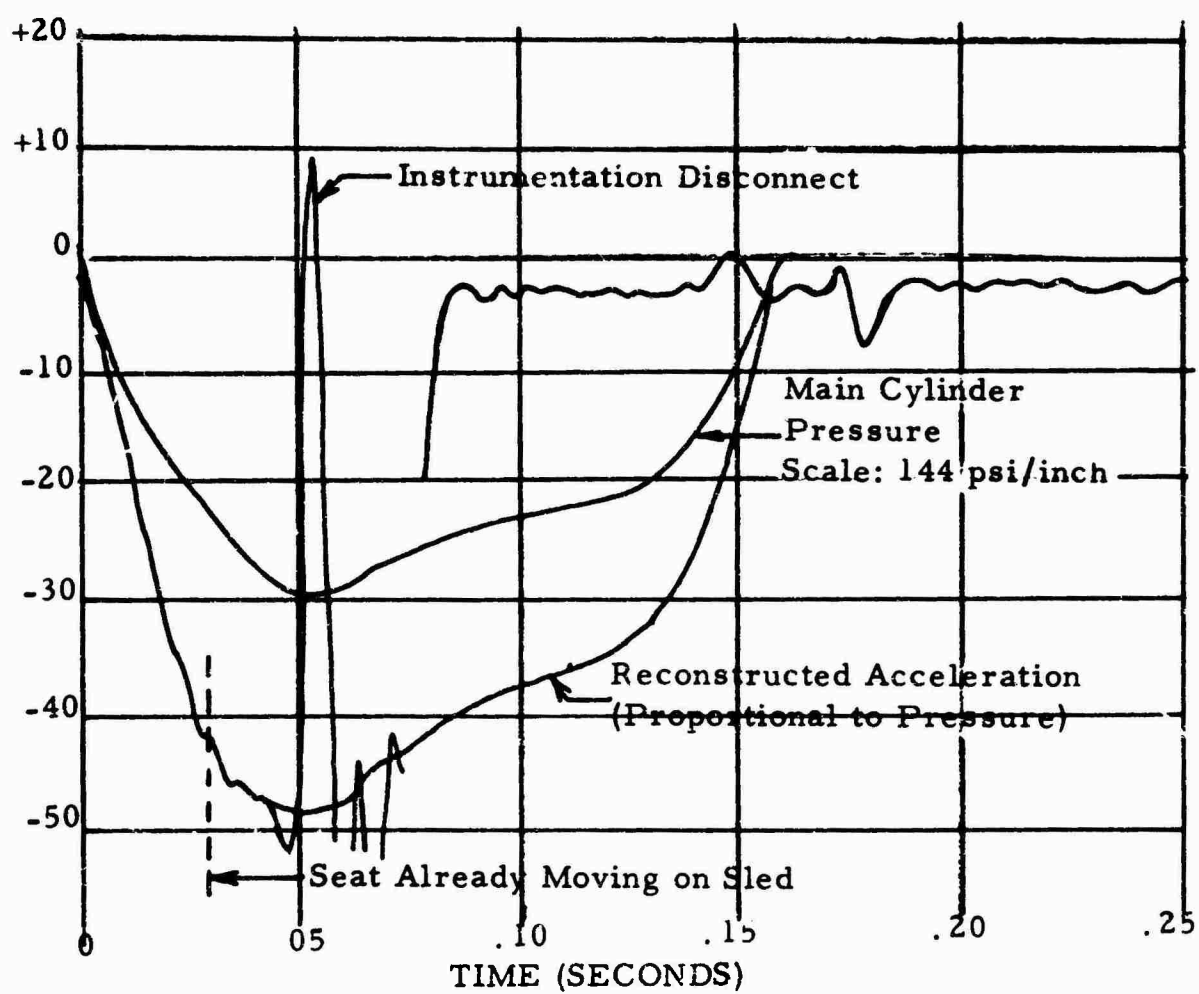
(G)

\* Other than the sled acceleration curve, Figure 30G.

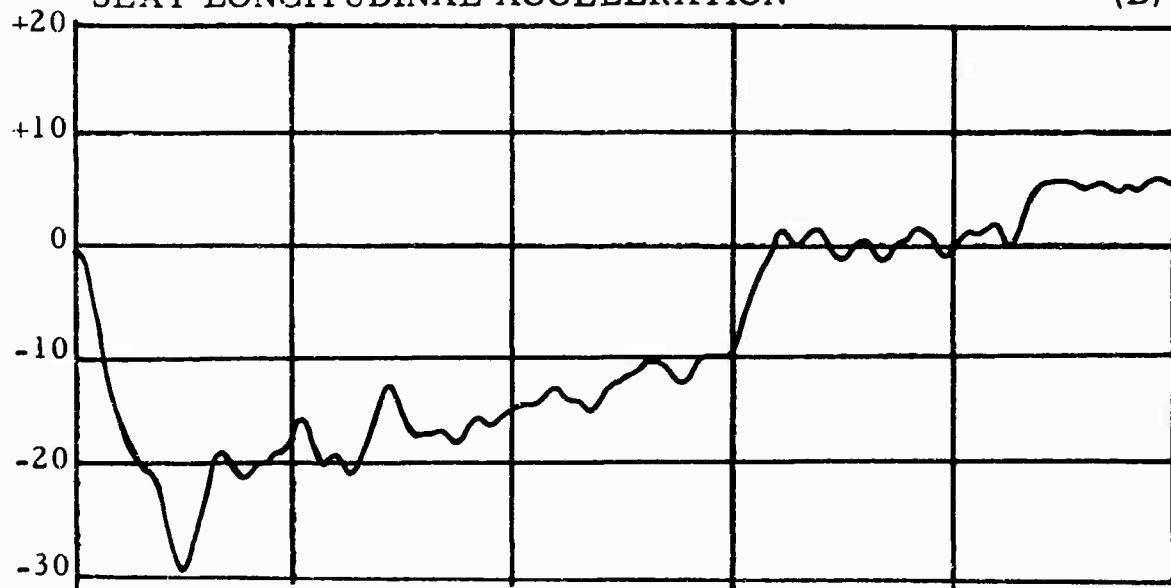
(B)

The sled acceleration on this test approached the desired trapezoidal shape and is shown in Figure 34G. The seat longitudinal and vertical accelerations, as recorded in Figures 34B and 34C, are in excellent agreement with the sled accelerations.

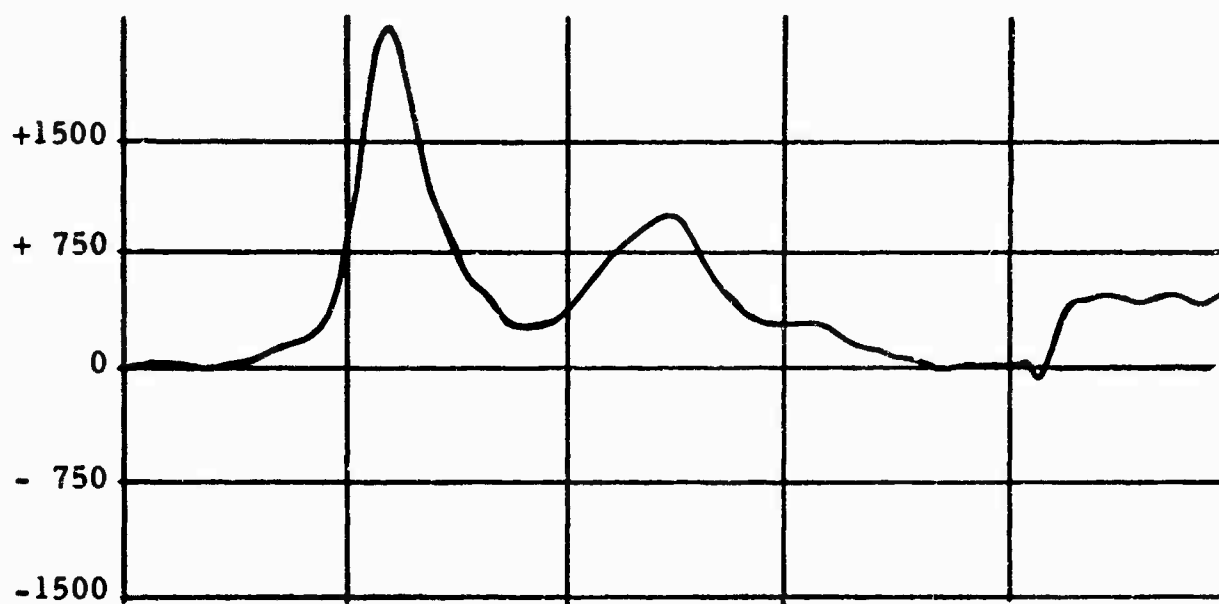
(H)

The seat belt loads, Figure 36I and Figure 36J, are similar in shape to those recorded in the half-load tests, as shown in Figures 34H and 34I. The magnitude of the loads for the full-load tests is on an average about double that for the half-load test.

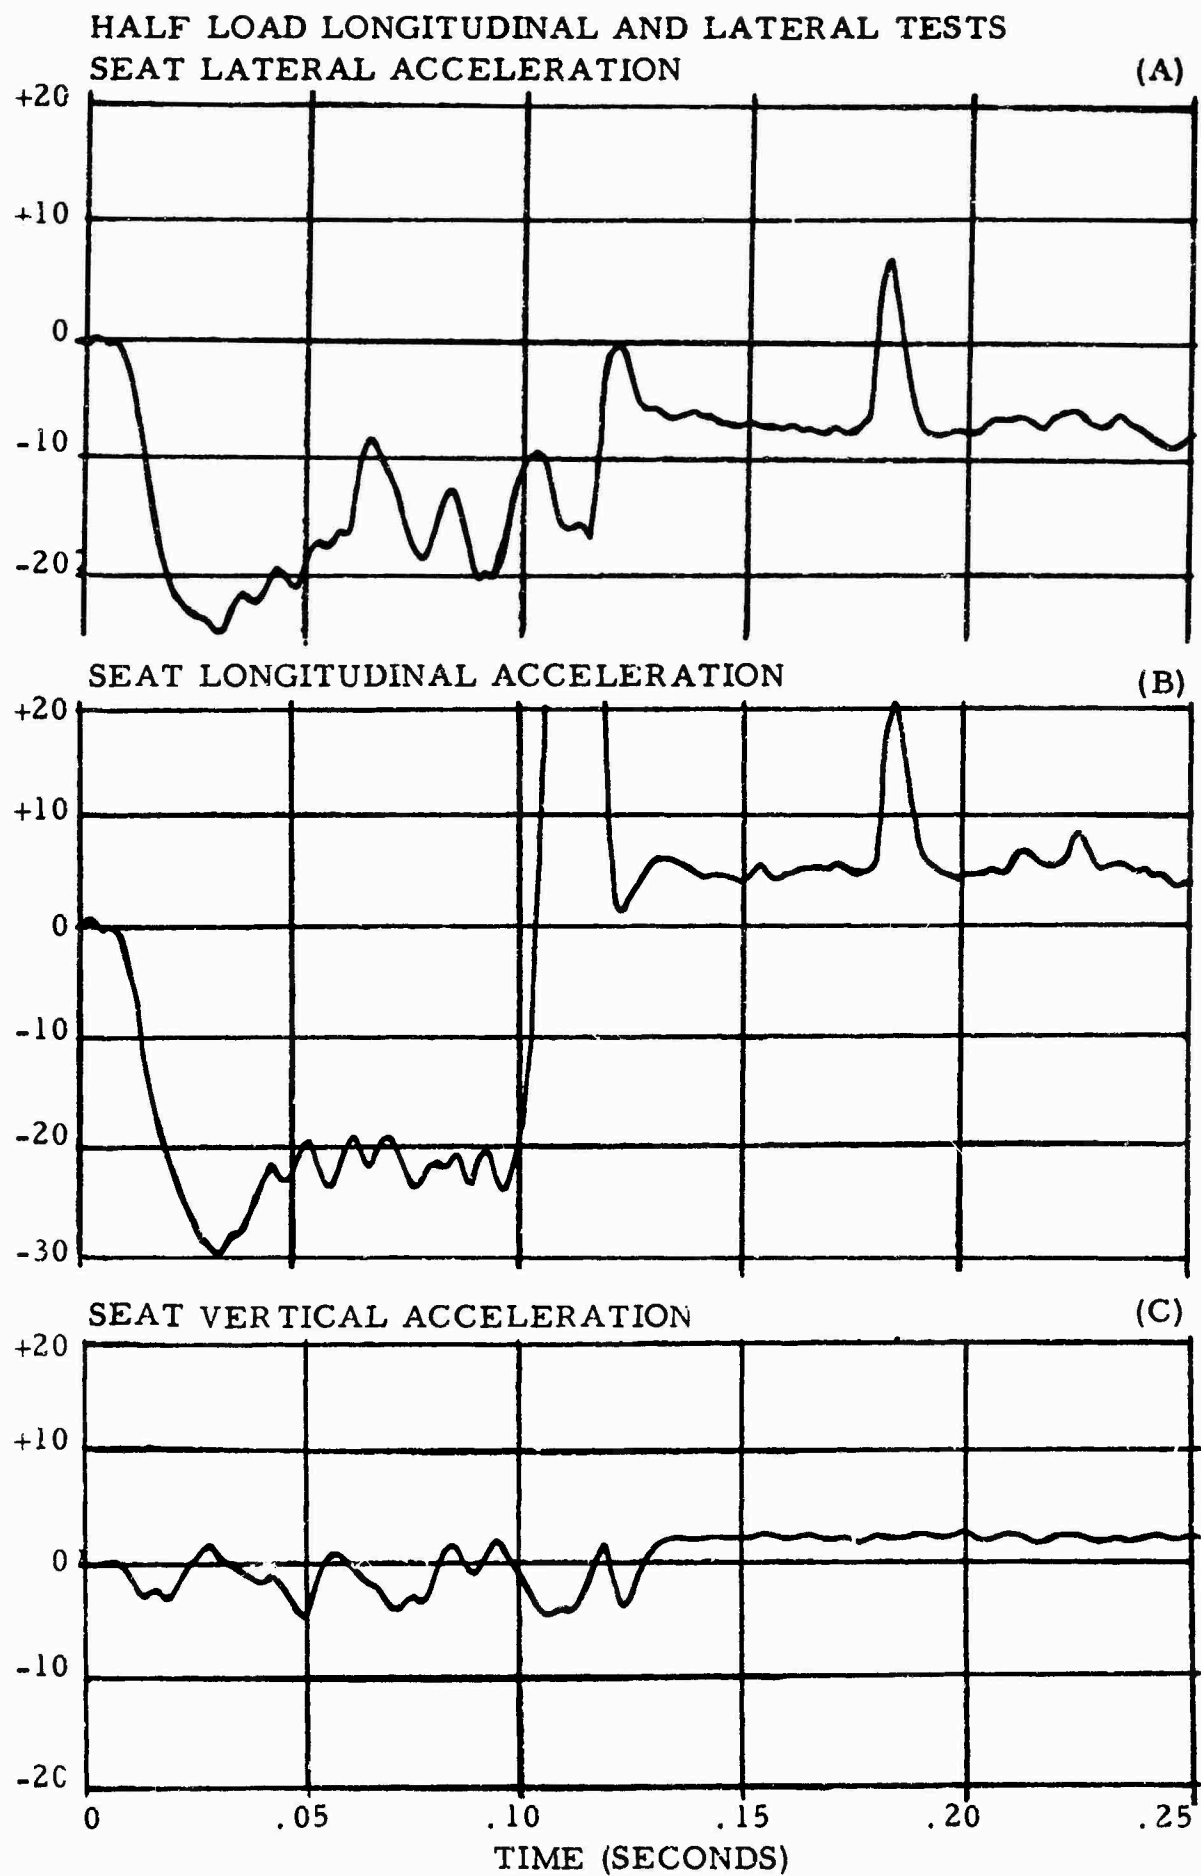
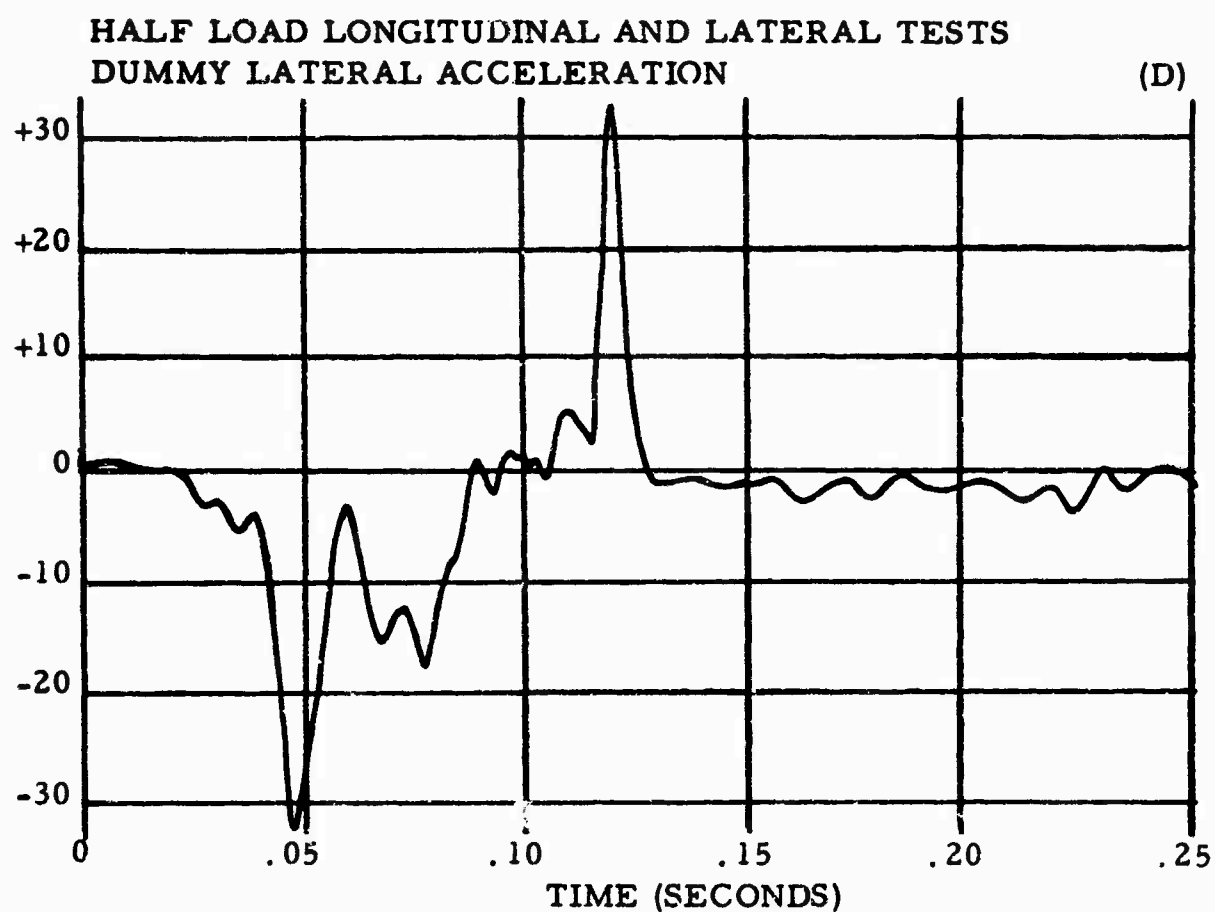
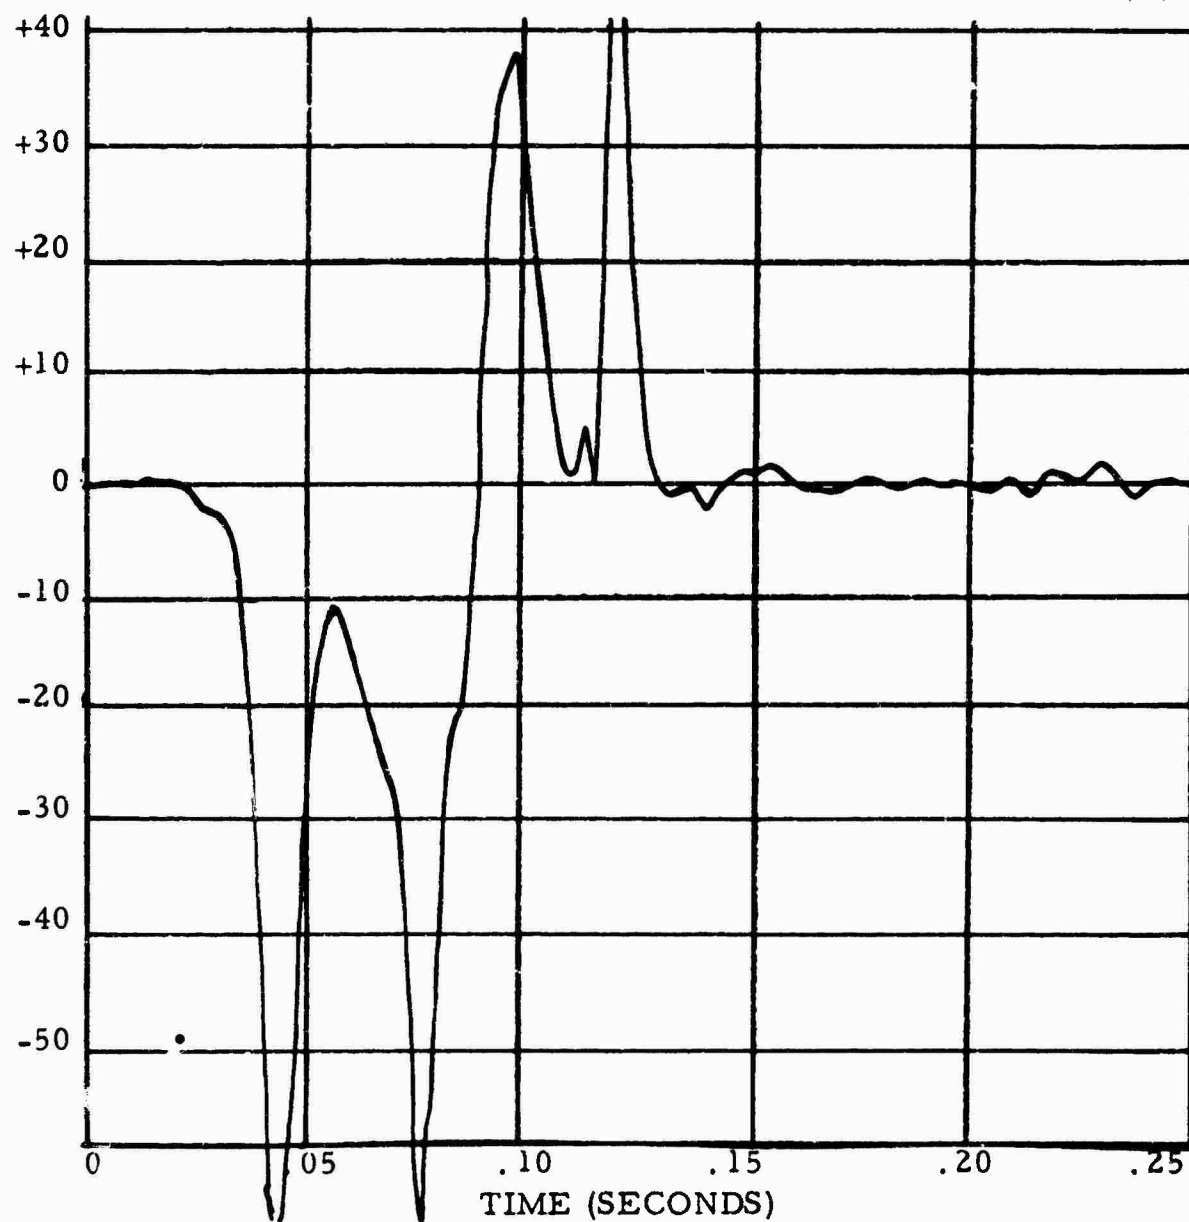
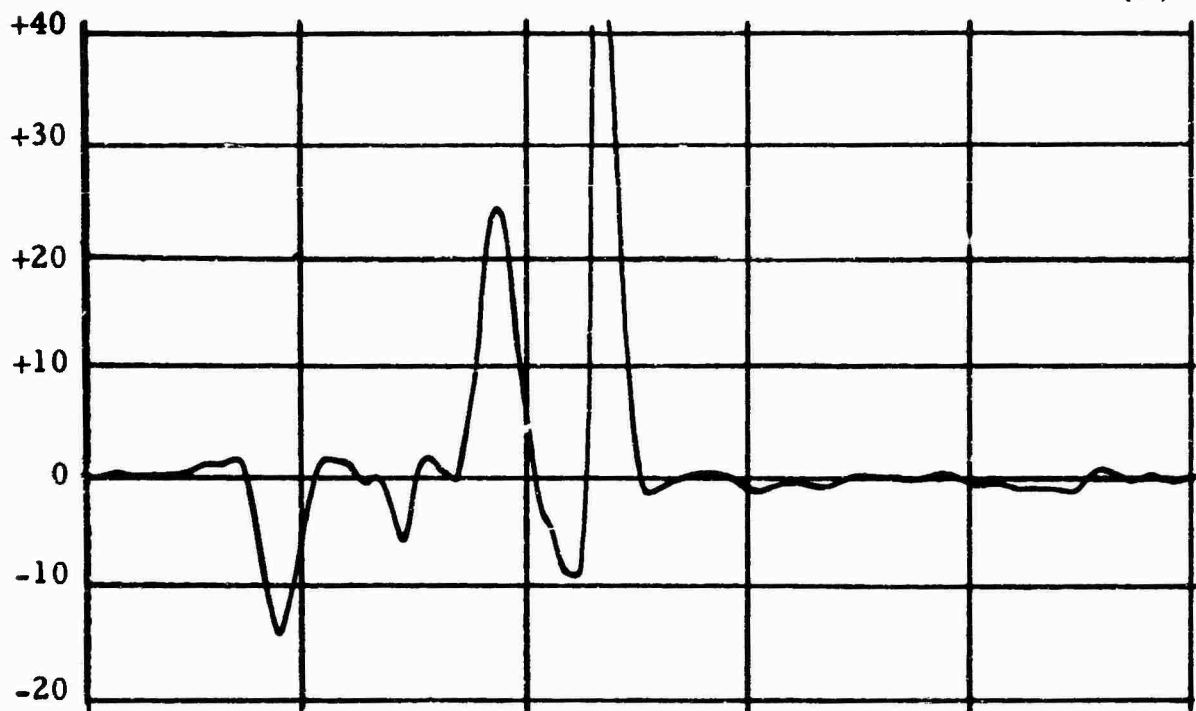
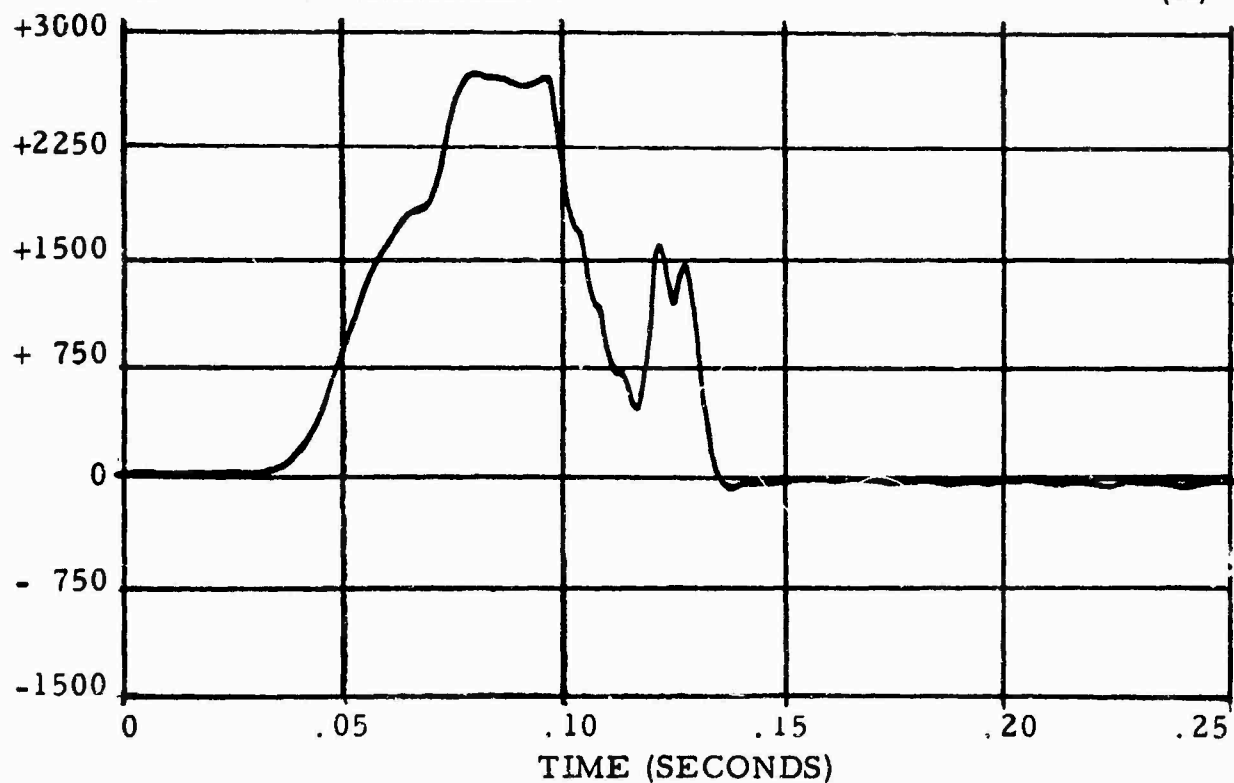
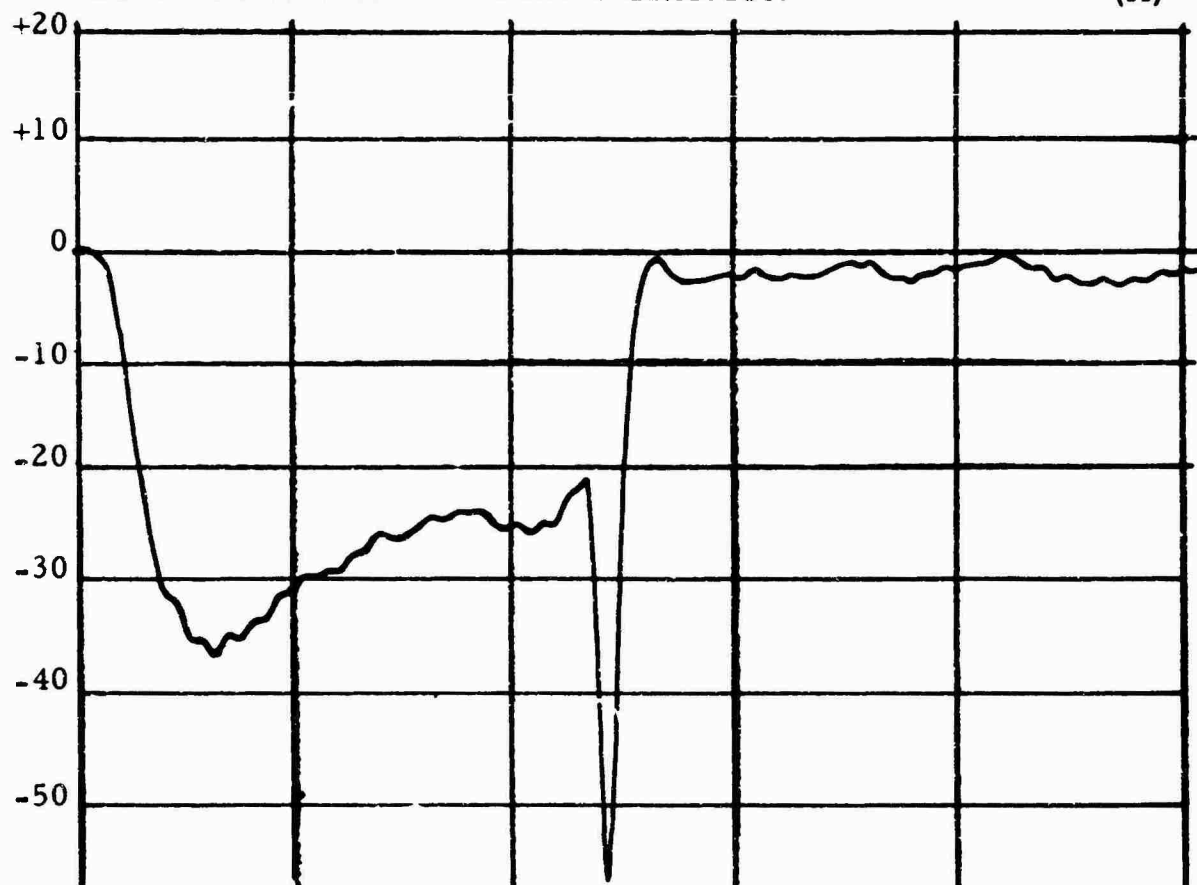
Figure 35. Data Time Histories - Sikorsky Seat -  
Test Condition No. 2.

The Sikorsky seat test condition No. 2 resulted in a failure of the load link attachments in the seat belt at approximately 0.045 second; this resulted in the dummy's being ejected from the seat. Although the data are presented herein in Figure 35, it is not considered significant because of the seat belt failure and is not further discussed. Since a full-load longitudinal-lateral test was successfully made with this seat (condition No. 4), it was not felt necessary to repeat this half-load test.

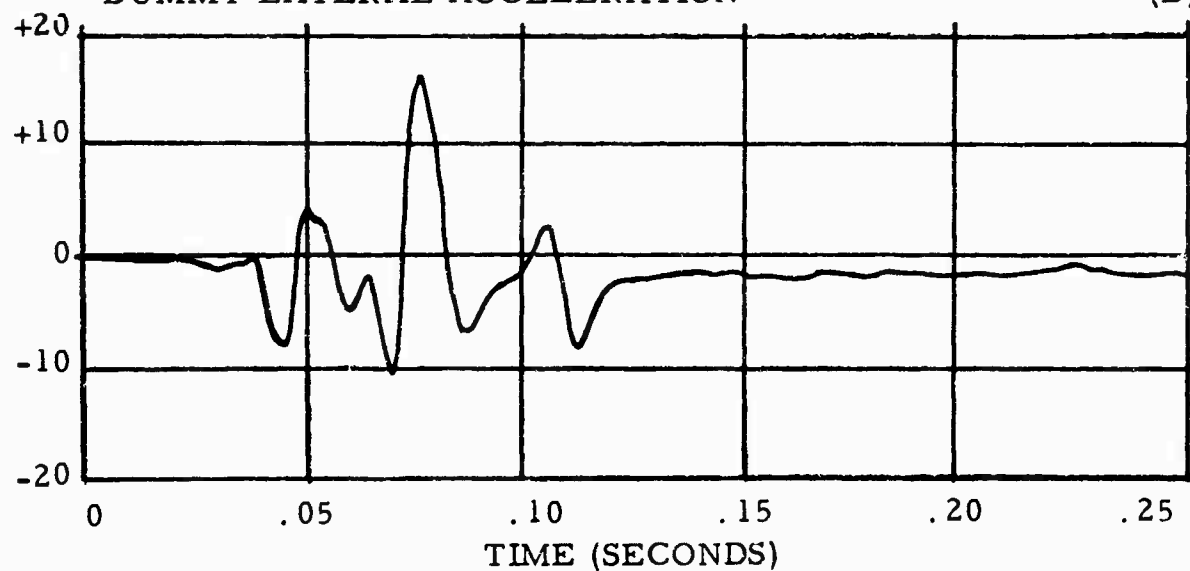
(D)

Figures 36A and 36D show no appreciable lateral seat or pelvic response to the longitudinal-lateral input.

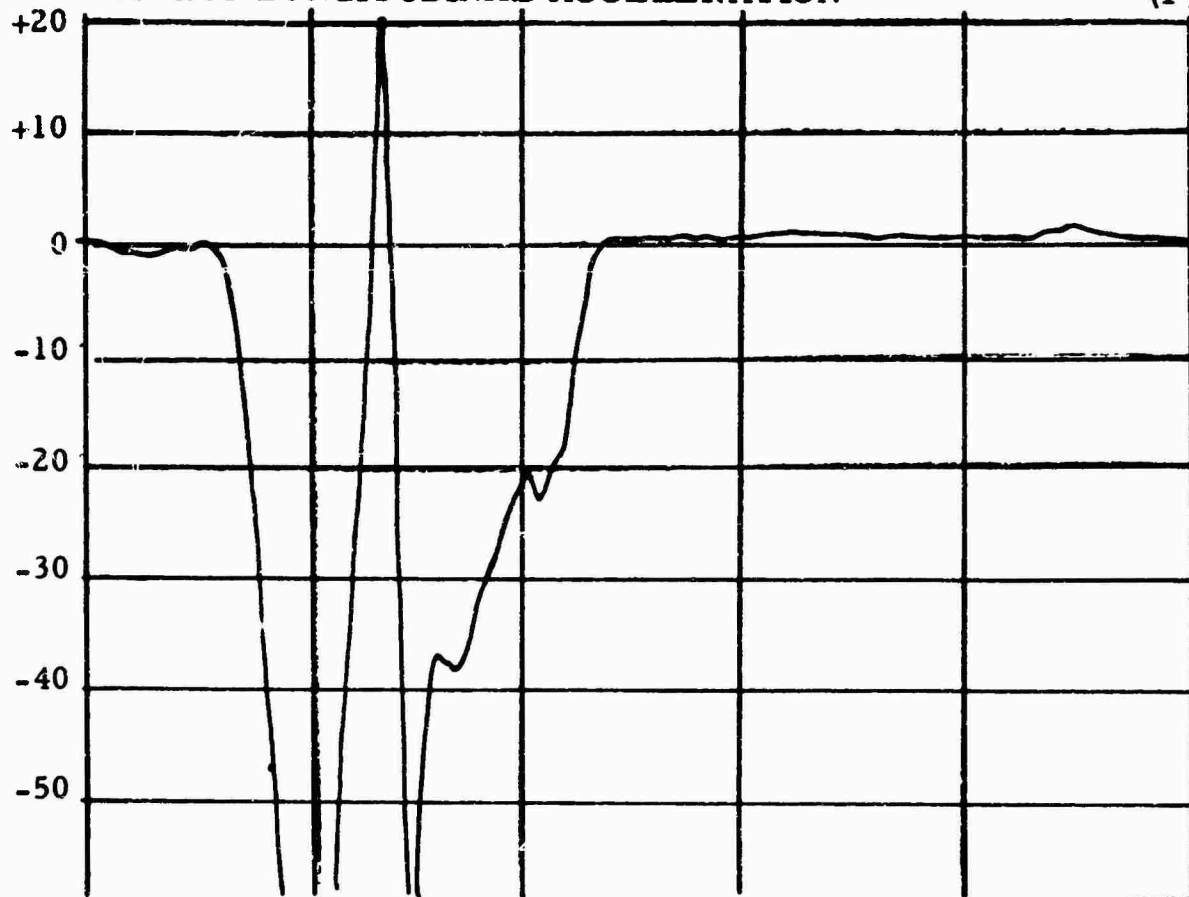
(F)

The dummy longitudinal acceleration, Figure 36F, is characteristic of that recorded in some of the Bell and Vertol half-load tests. The dummy vertical acceleration, Figure 36E, is also similar to the records obtained previously in the Bell and Sikorsky half-load tests. Both the vertical and longitudinal accelerations of Figure 36E and Figure 36F show short-period, high-duration peaks, if the high-frequency components are included in the record. Caution should be exercised in relating these high-frequency components to the anticipated loads on a human seat occupant.

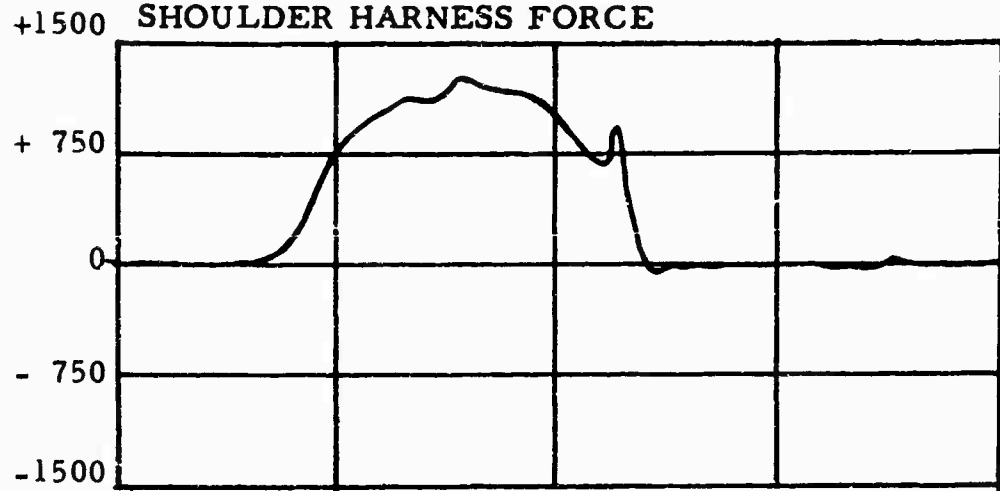
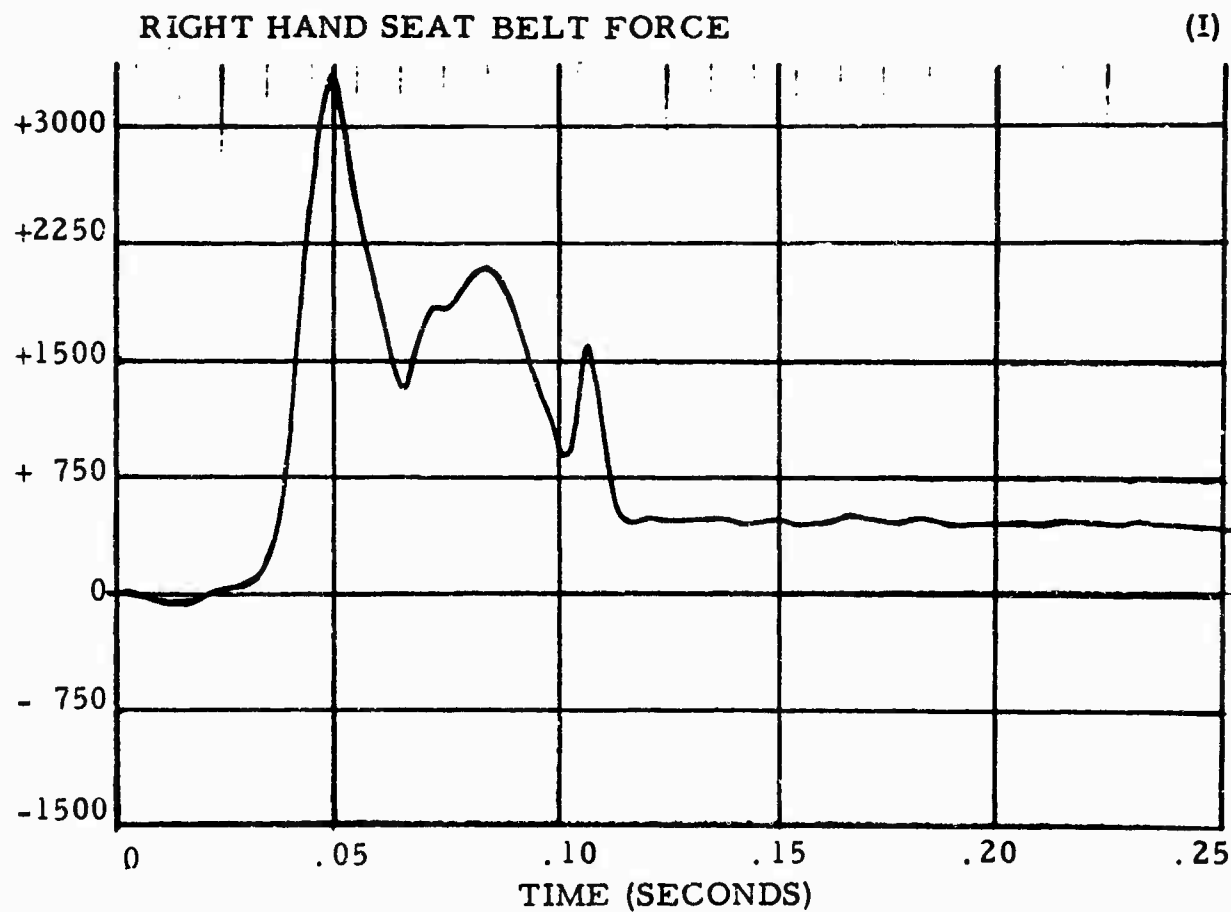
FULL LOAD LONGITUDINAL AND VERTICAL TESTS  
SHOULDER HARNESS FORCE (H)

The shoulder harness load for the full-load test, Figure 36I, is, however, less than the load recorded in the half-load test, Figure 34F. This is not what might be anticipated but is probably due to the vertical accelerations being simultaneously imposed. This same situation has been experienced in past helicopter crash tests in which high vertical accelerations were experienced.
