# USAAVLABS TECHNICAL REPORT 65-43

## SURVIVABILITY SEAT DESIGN DYNAMIC TEST PROGRAM

July 1965

CONTRACT DA 44-177-AMC-191(T)

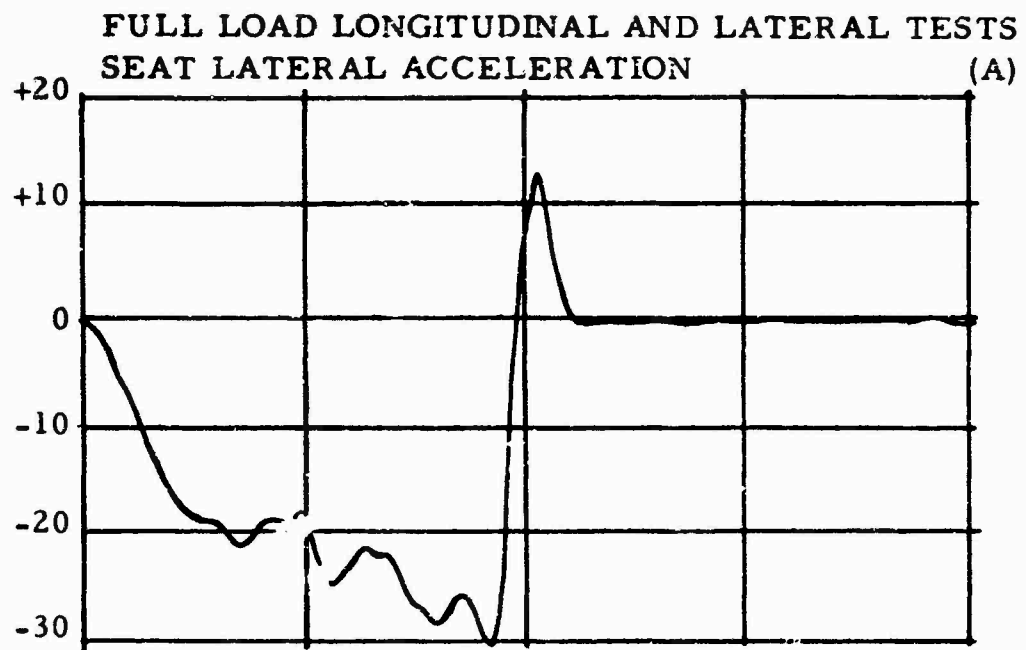
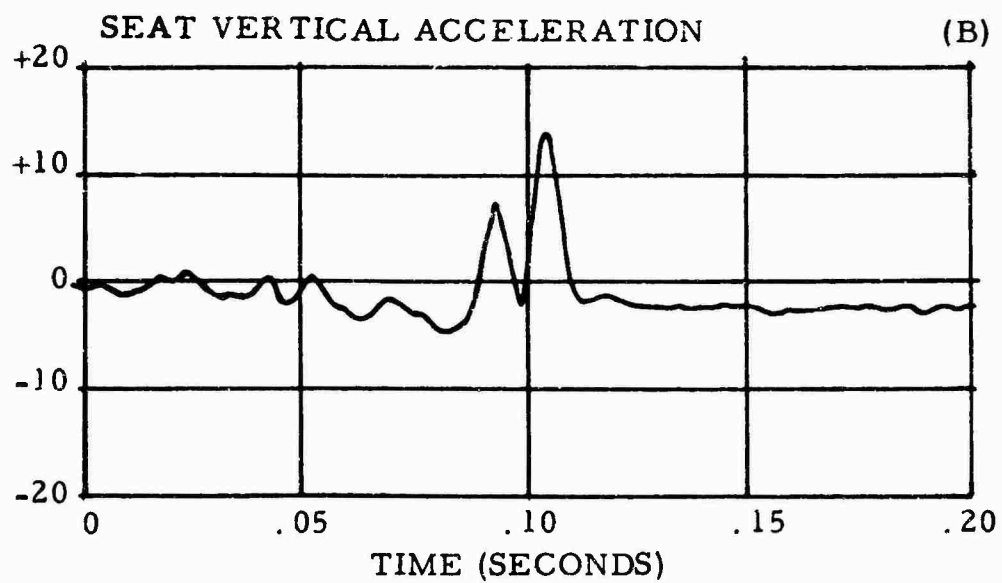
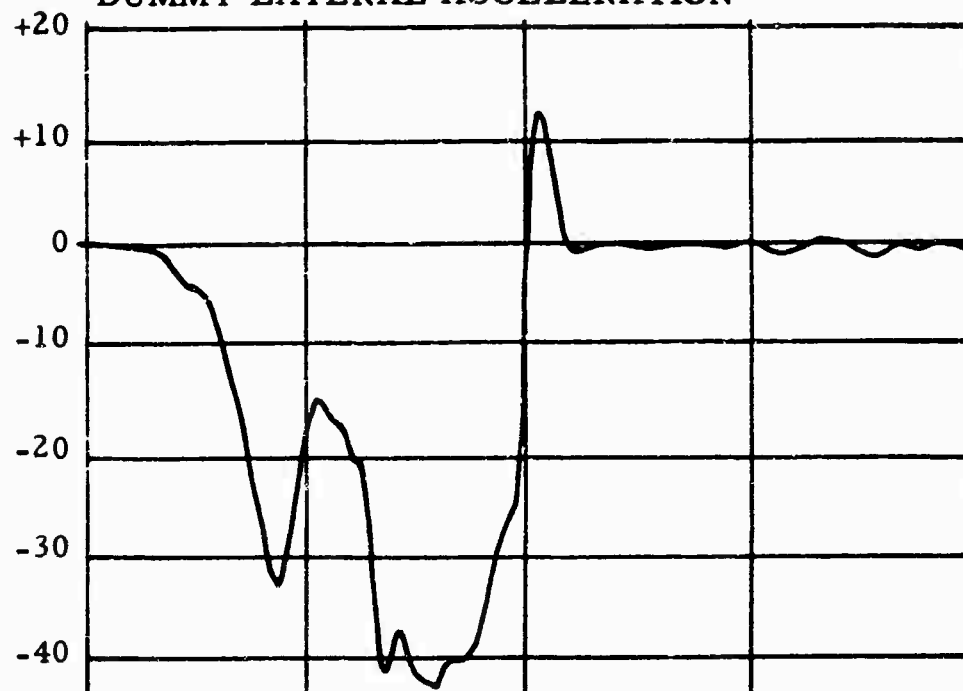
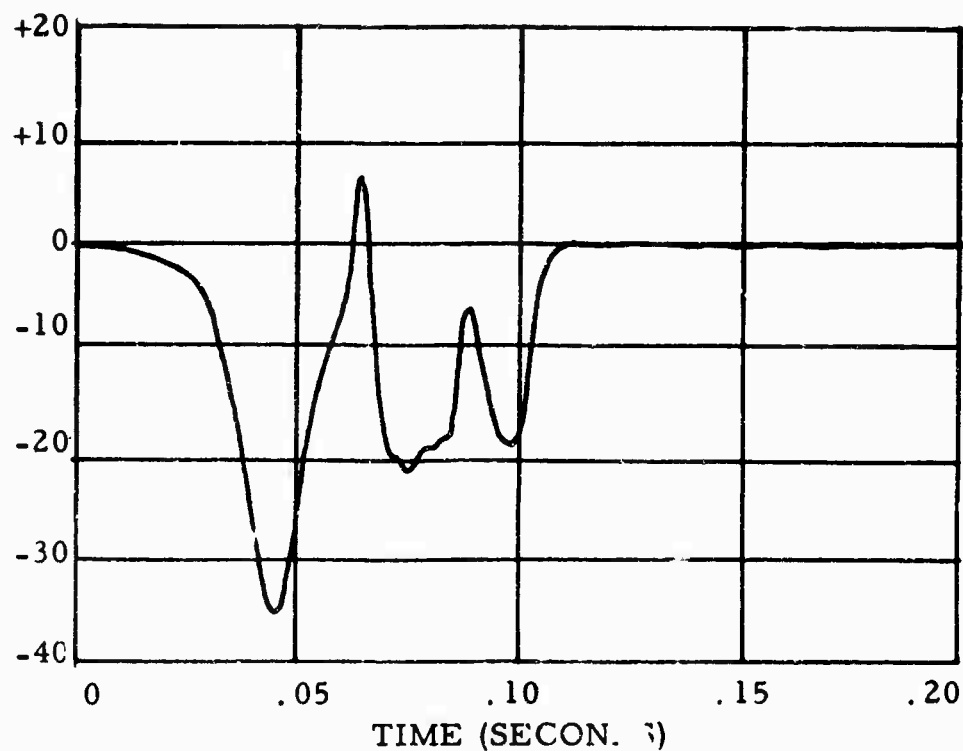
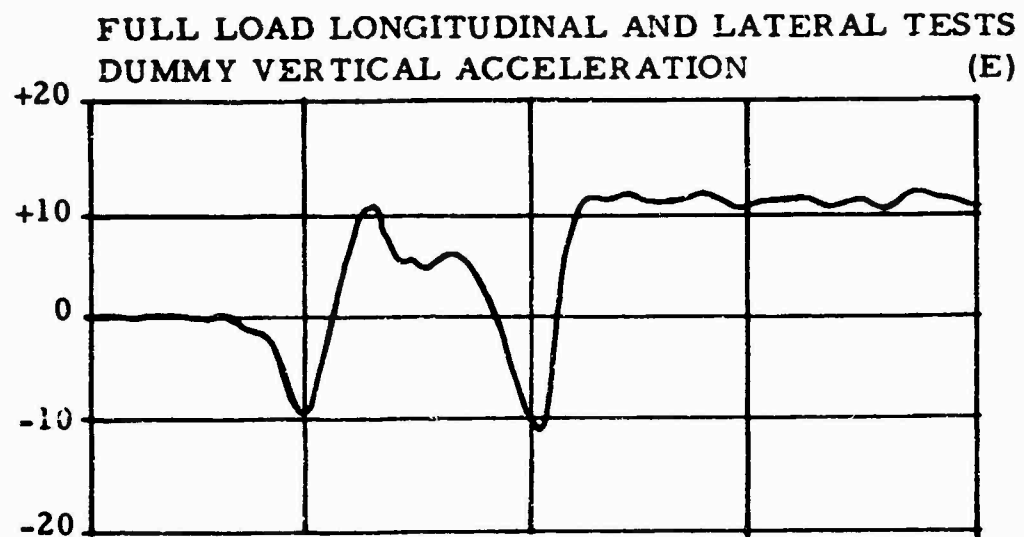
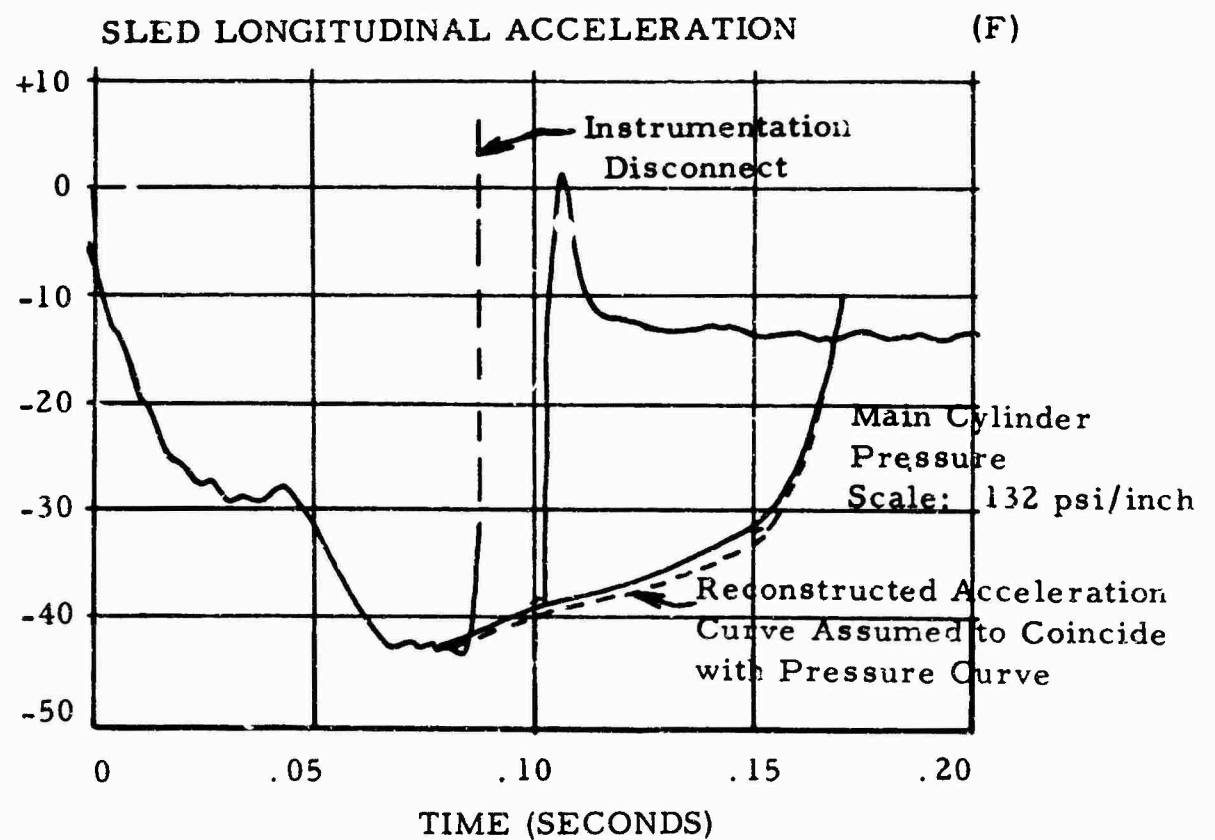
Figure 40. Data Time Histories - Sikorsky Seat -  
Test Condition No. 4.

The acceleration records obtained are presented in Figures 40A through 40F and are valid to  $t = 0.085$  second at which time an instrumentation disconnect occurred.

The agreement between sled acceleration and cylinder pressure up to 0.085 second is very good as seen in Figure 40F. The seat lateral acceleration component, about 26G maximum, Figure 40A, also closely follows sled longitudinal pulse. The dummy longitudinal acceleration is given in Figure 40D and appears to be maintained at about 30G (after a 62G peak at  $t = 0.045$  second) prior to the instrumentation disconnect. This value of 30G longitudinal is very close to the component of the sled acceleration, that is,  $38G \times \cos 45 \text{ degrees} = 27G$ .

The dummy lateral acceleration, Figure 40C, reached about 36G prior to the disconnect, which implies a dynamic amplification factor of about  $36 \div 27 = 1.3$

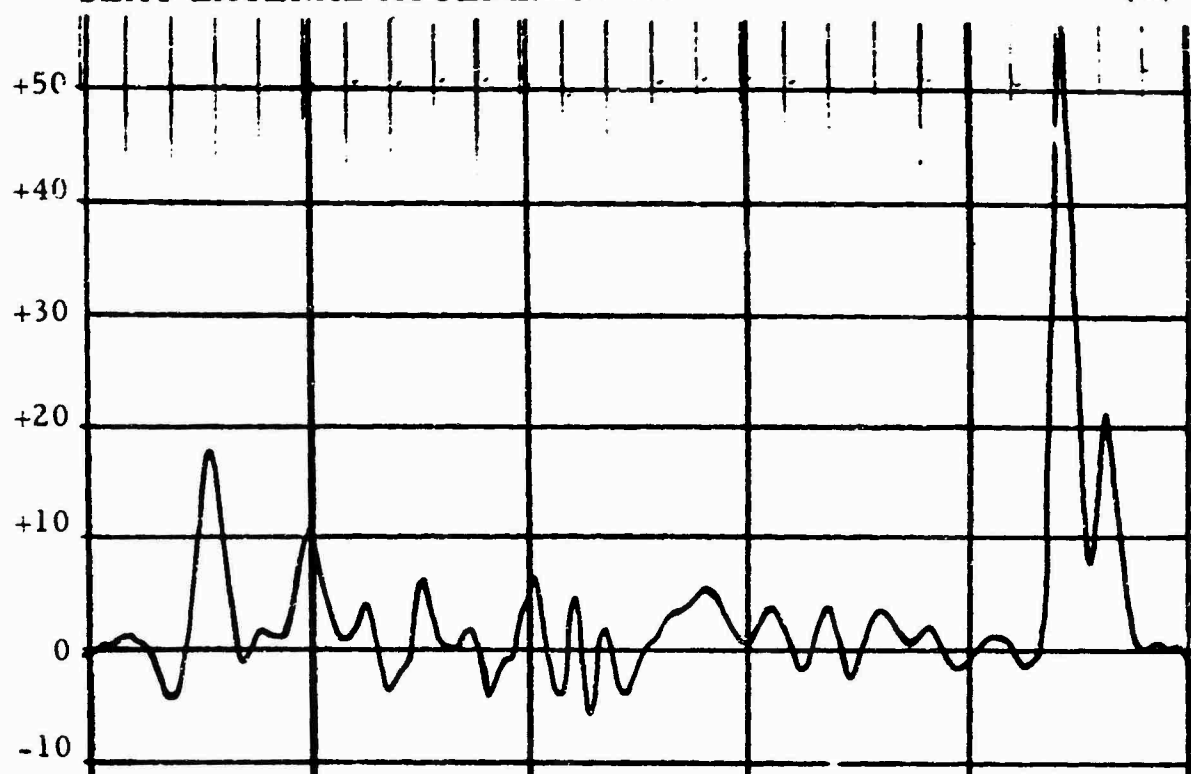
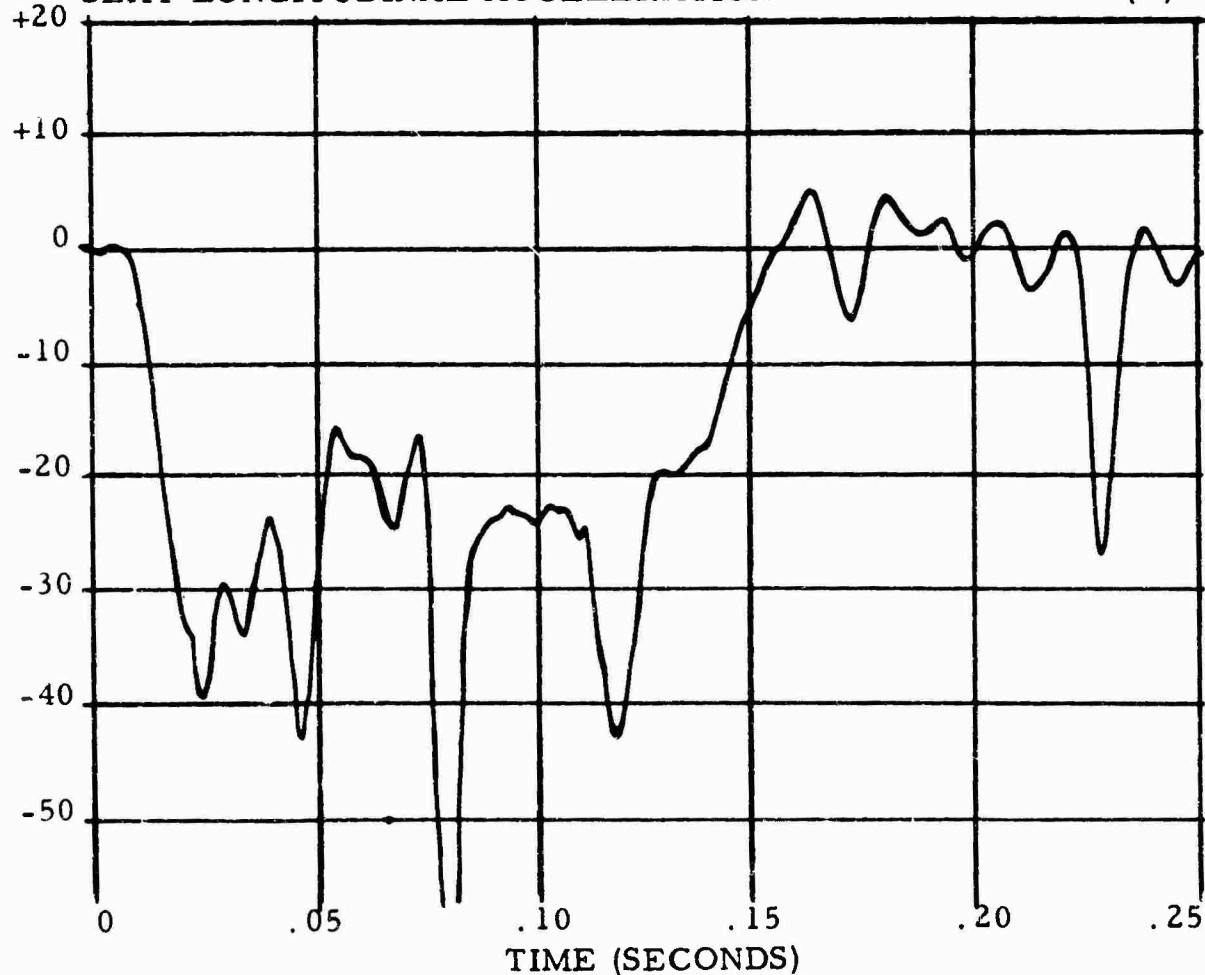
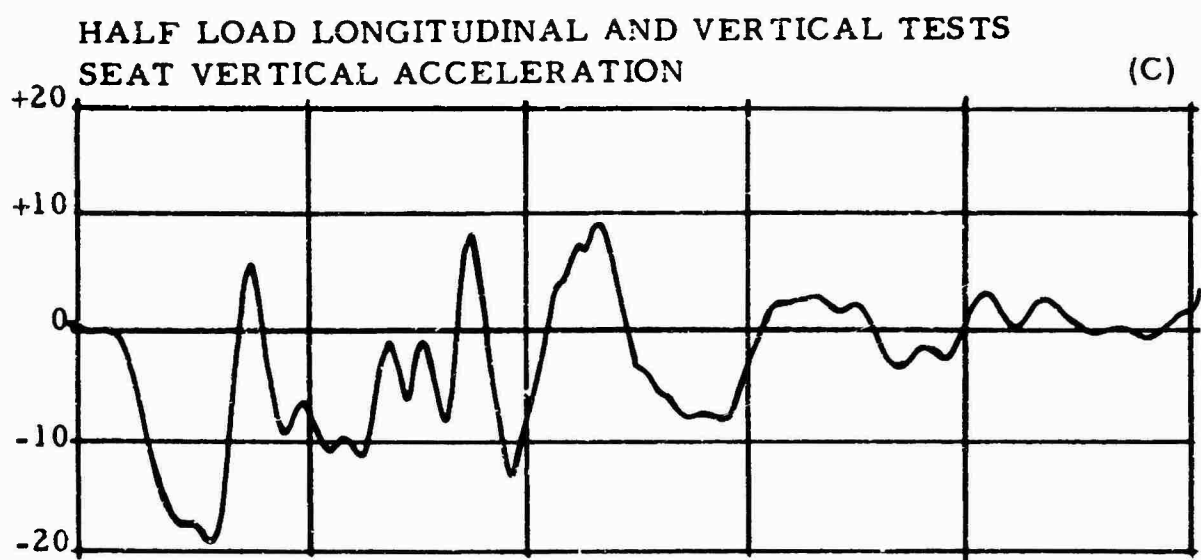
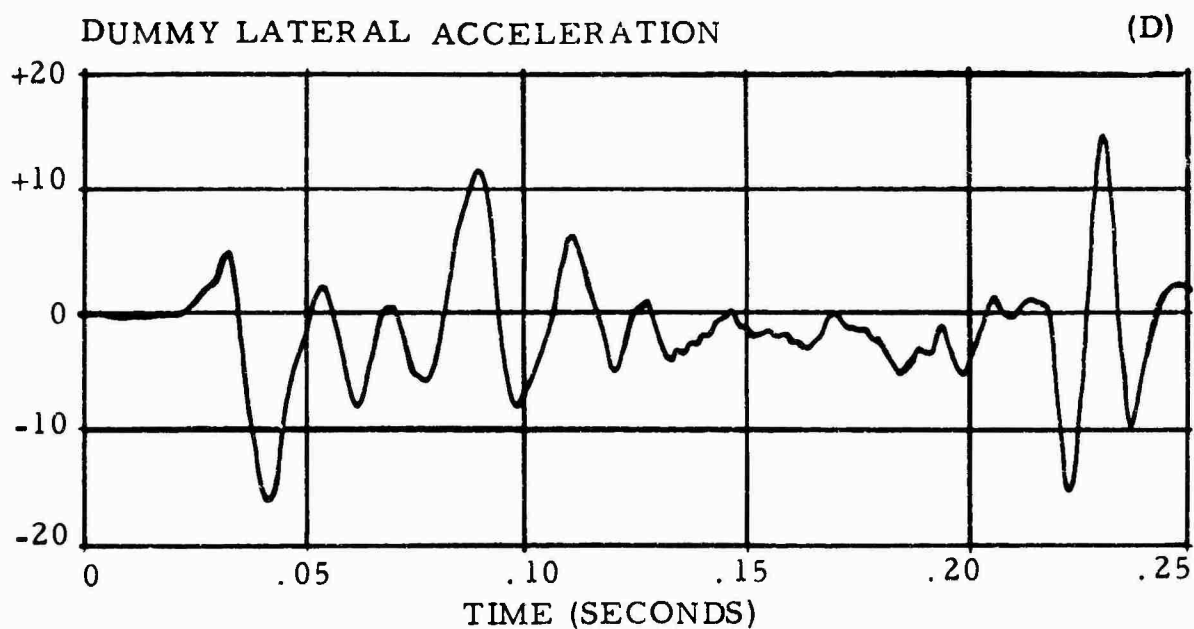
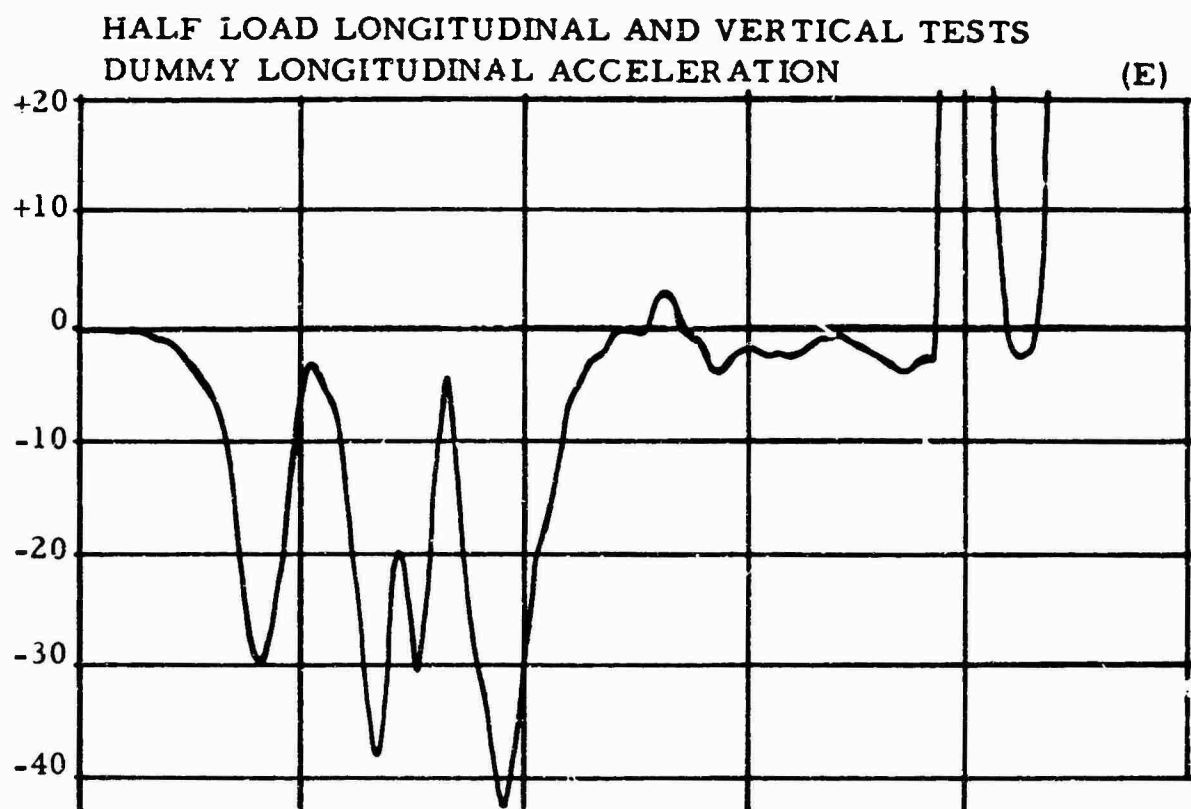
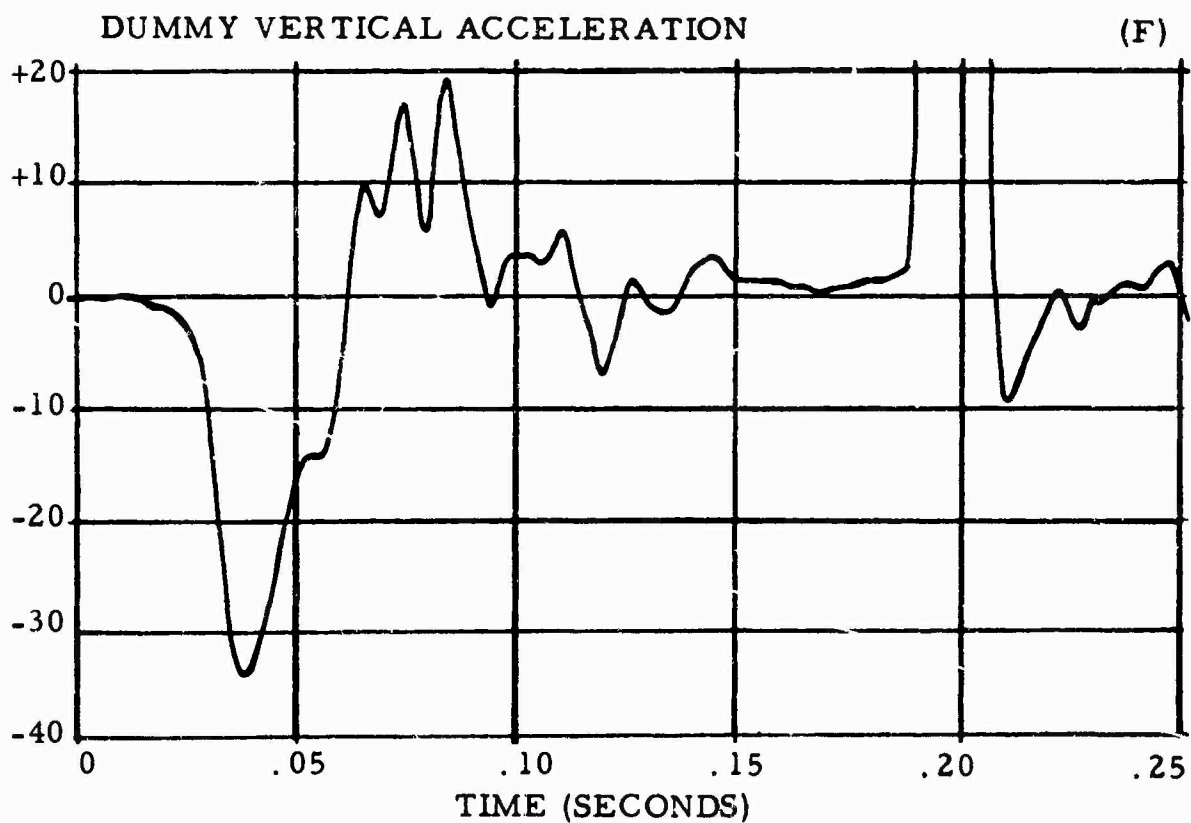
Figure 43. Data Time Histories - Vertol Seat -  
Test Condition No. 1.

The sled acceleration pulse, Figure 43J, shows a 20G trapezoid on which is superimposed a half sine-wave pulse of about 0.030 second. The peak acceleration was approximately 30G. The seat longitudinal acceleration, Figure 43B, is in good agreement with these values. The seat vertical acceleration, Figure 43C, agrees only near the beginning of the pulse; this indicates that appreciable seat deflection must have occurred.

The dummy pelvic accelerations, Figures 43E and 43F, are, of course, affected by the seat belt and shoulder harness failures which occurred between 0.08 and 0.11 second and the subsequent motion of the dummy.

The seat belt loads (one side), as shown in Figure 43G, did not exceed about 1600 pounds prior to failure of seat belt. The shoulder harness loads, Figure 43H, indicate that failure occurred after the seat belt failure. The maximum load reached was 1700 pounds.

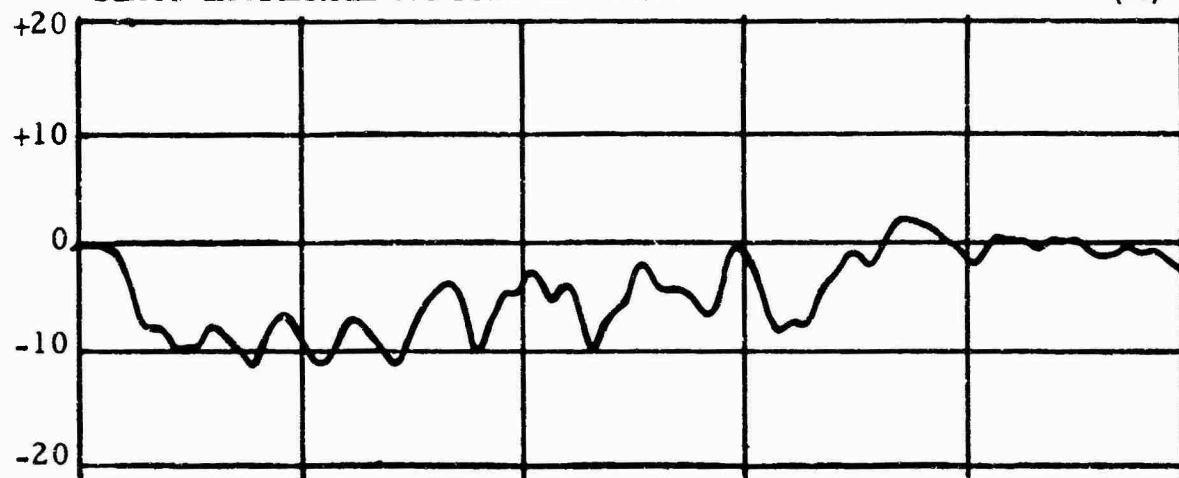
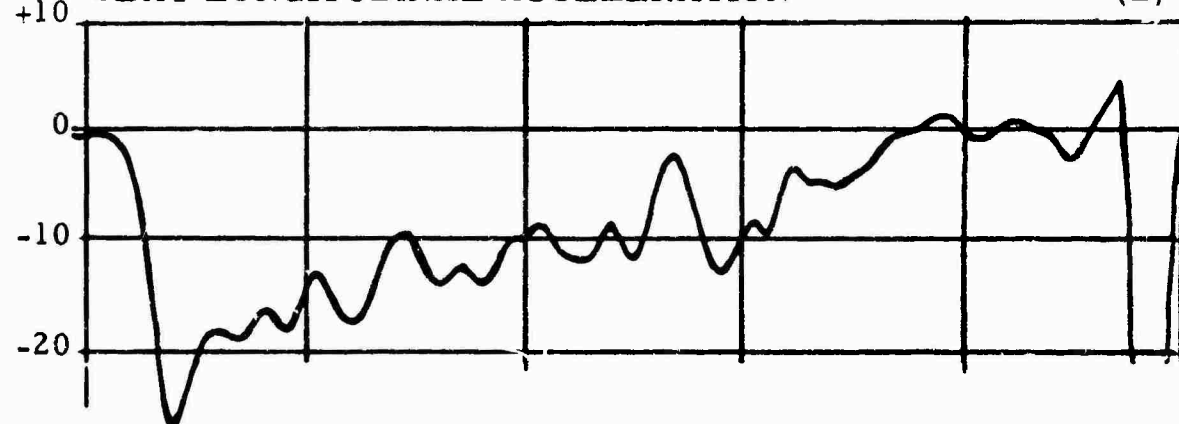
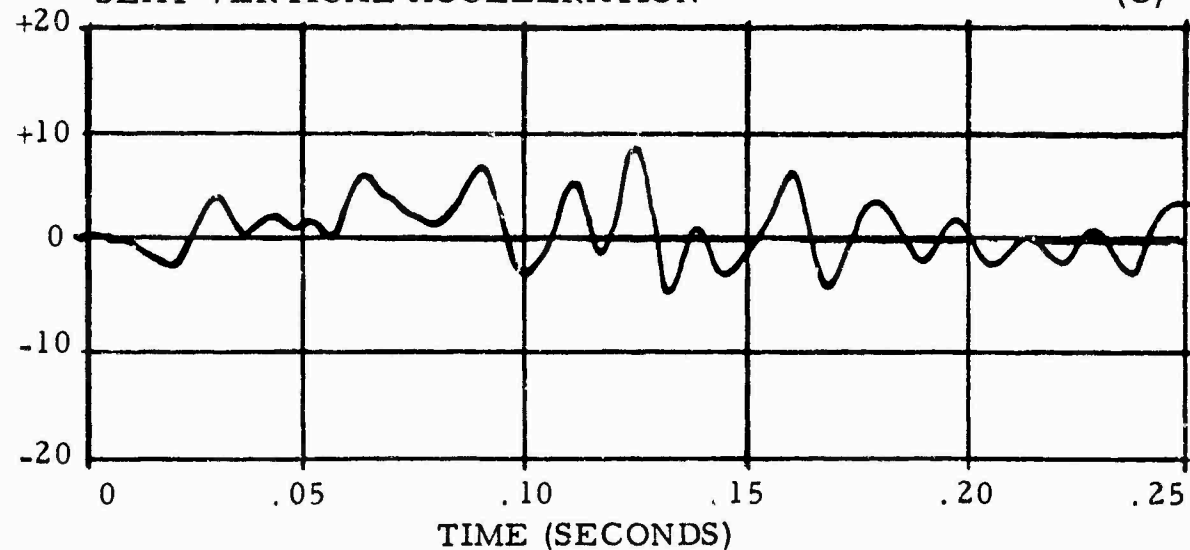
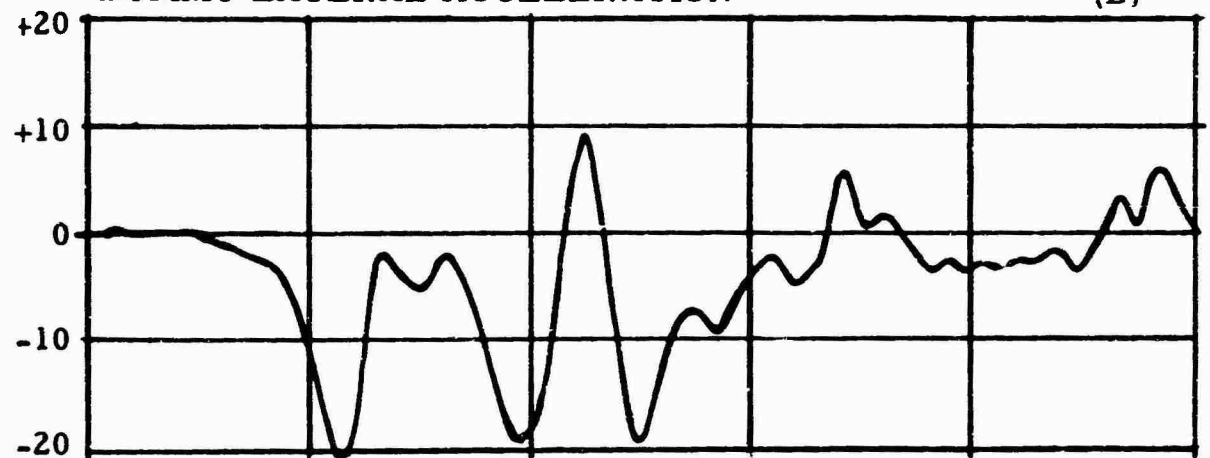
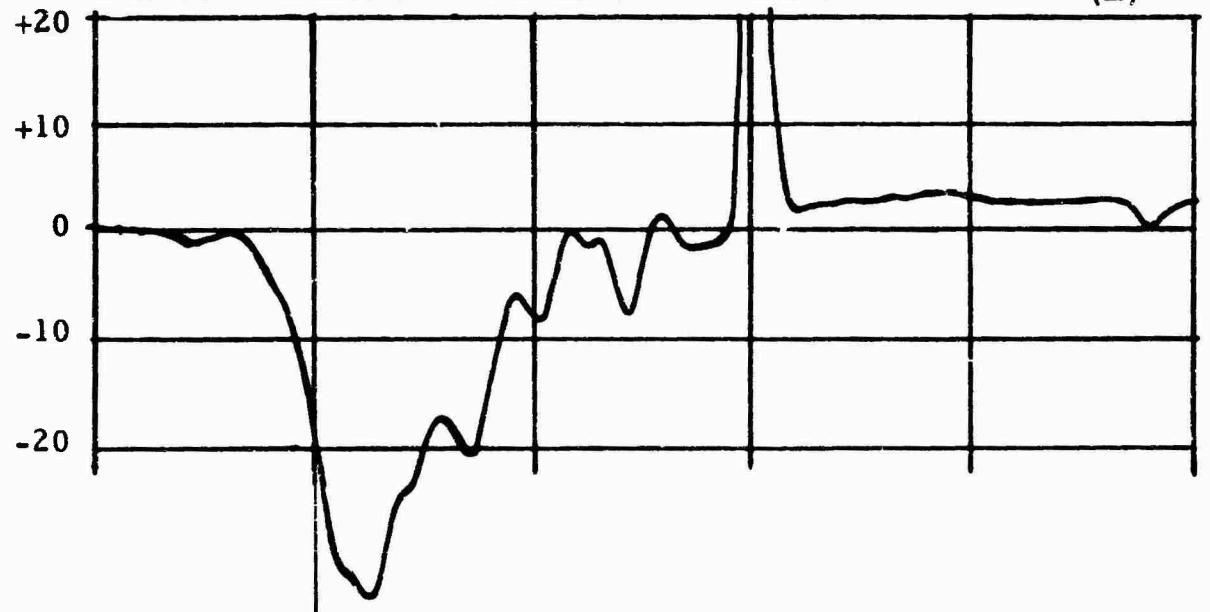
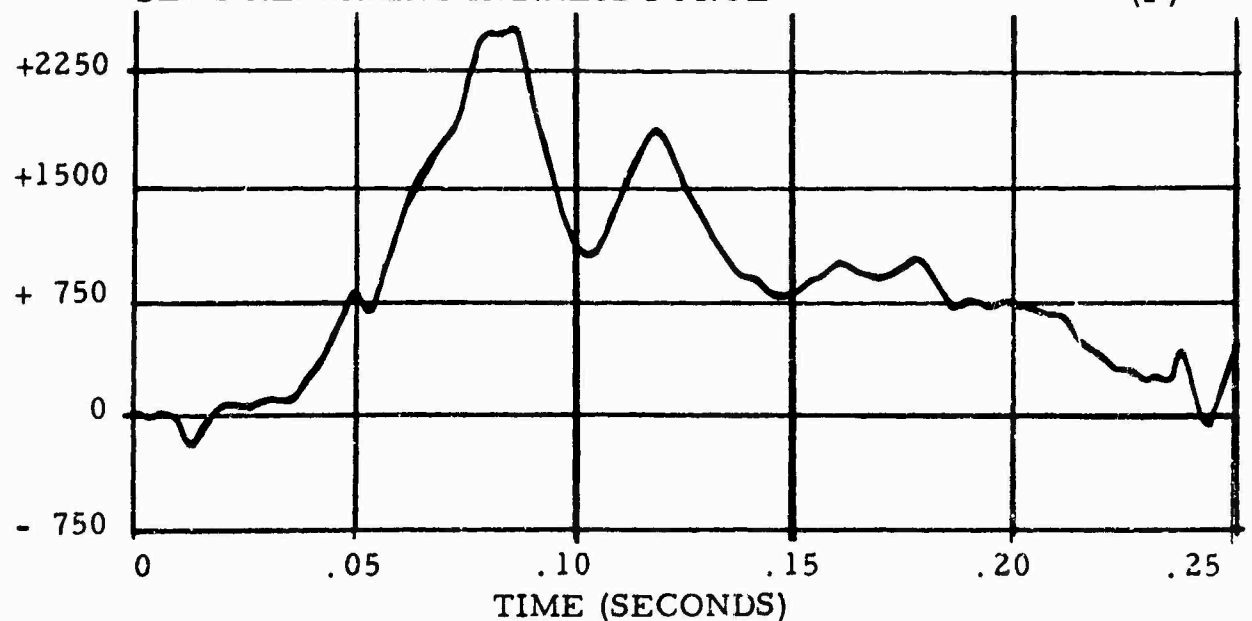
Figure 46. Data Time Histories - Vertol Seat -  
Test Condition No. 2.

Figure 46E shows the dummy longitudinal response. This pulse is of lower amplitude, and the acceleration reduces to zero in about 60 percent of the normally expected time because of the rotation of the accelerometer "axis" with the dummy following the shoulder harness failure. The lateral response, Figure 46D, was also probably affected by the shoulder harness failure. The seat restraint harness load is shown in Figure 46F, and the seat belt load (left-hand side only) is given in Figure 46I. The seat belt itself did not fail.

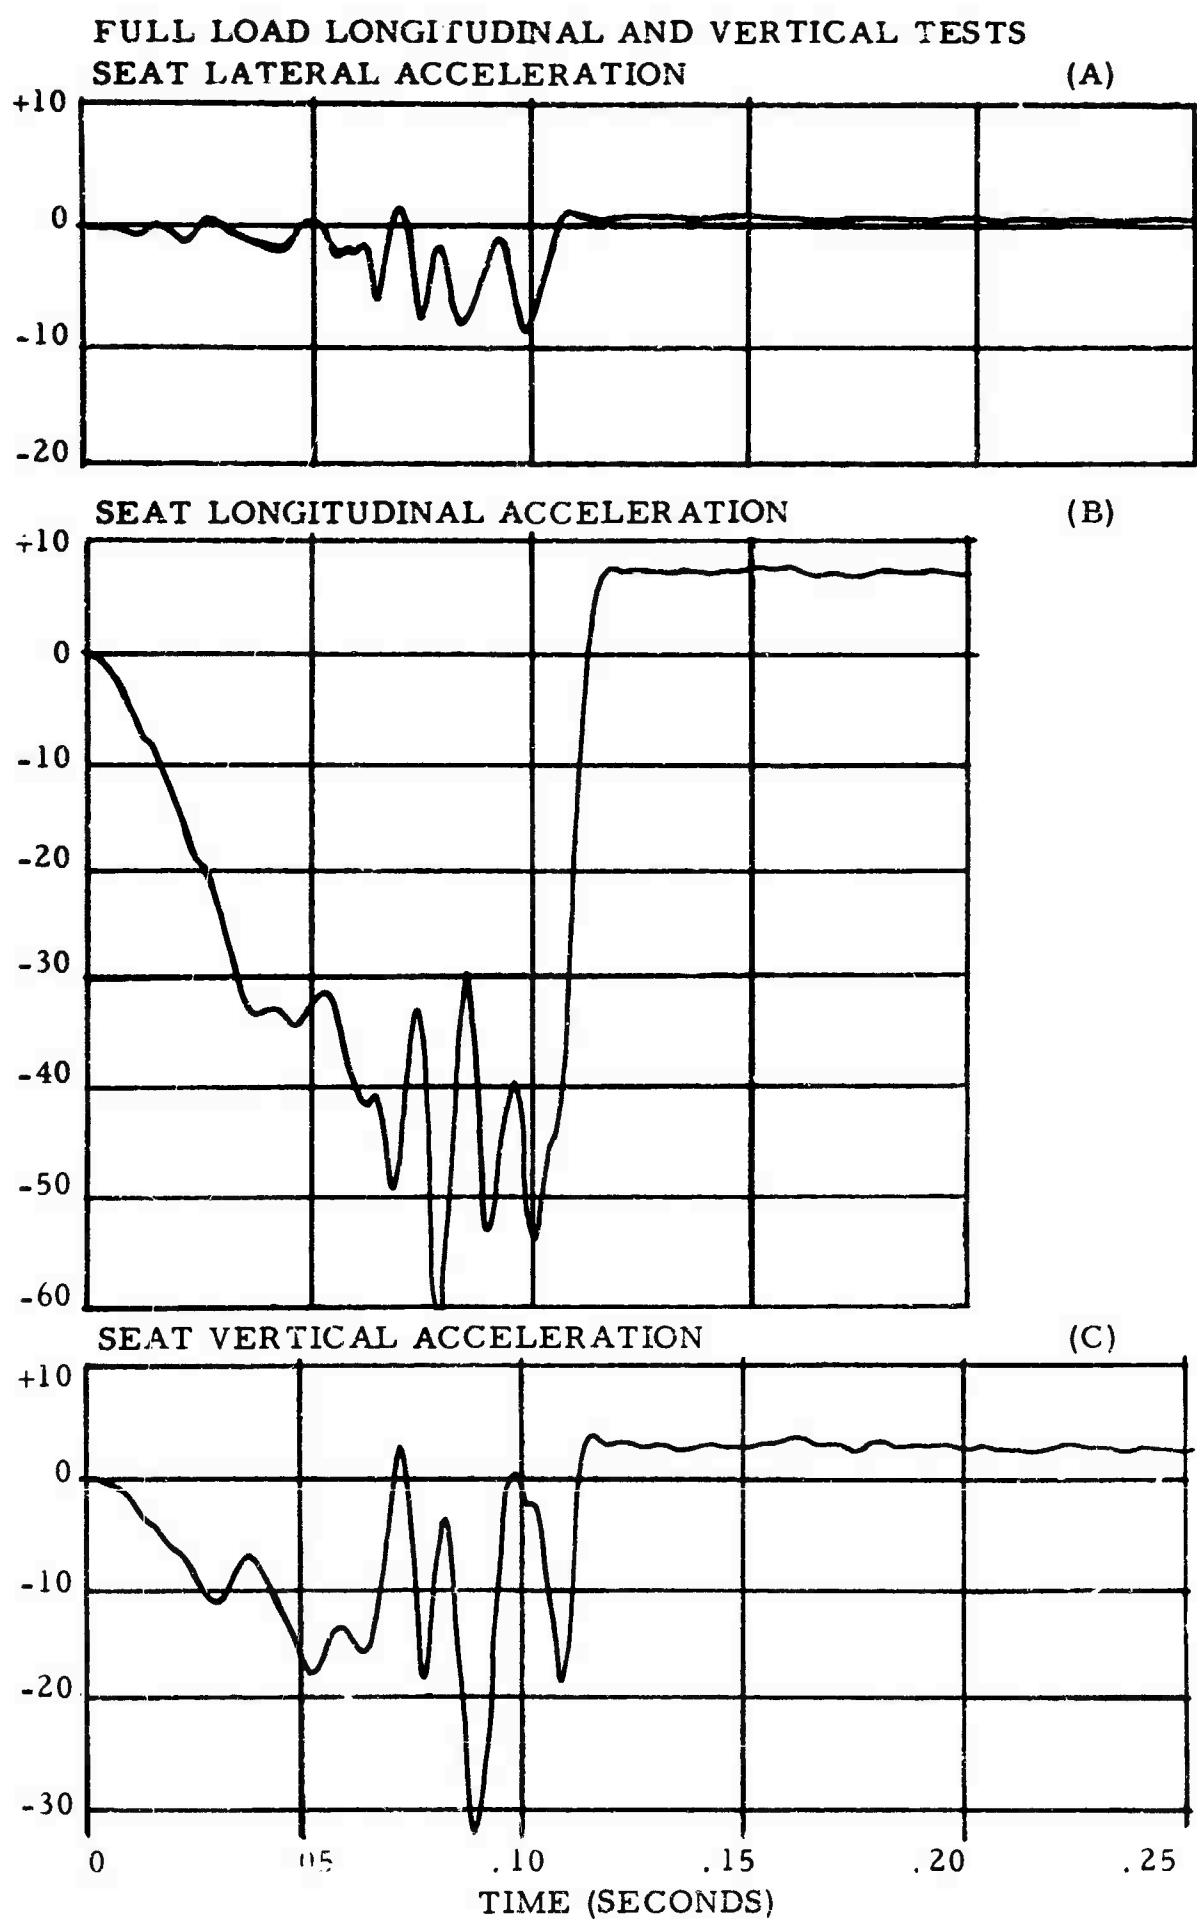
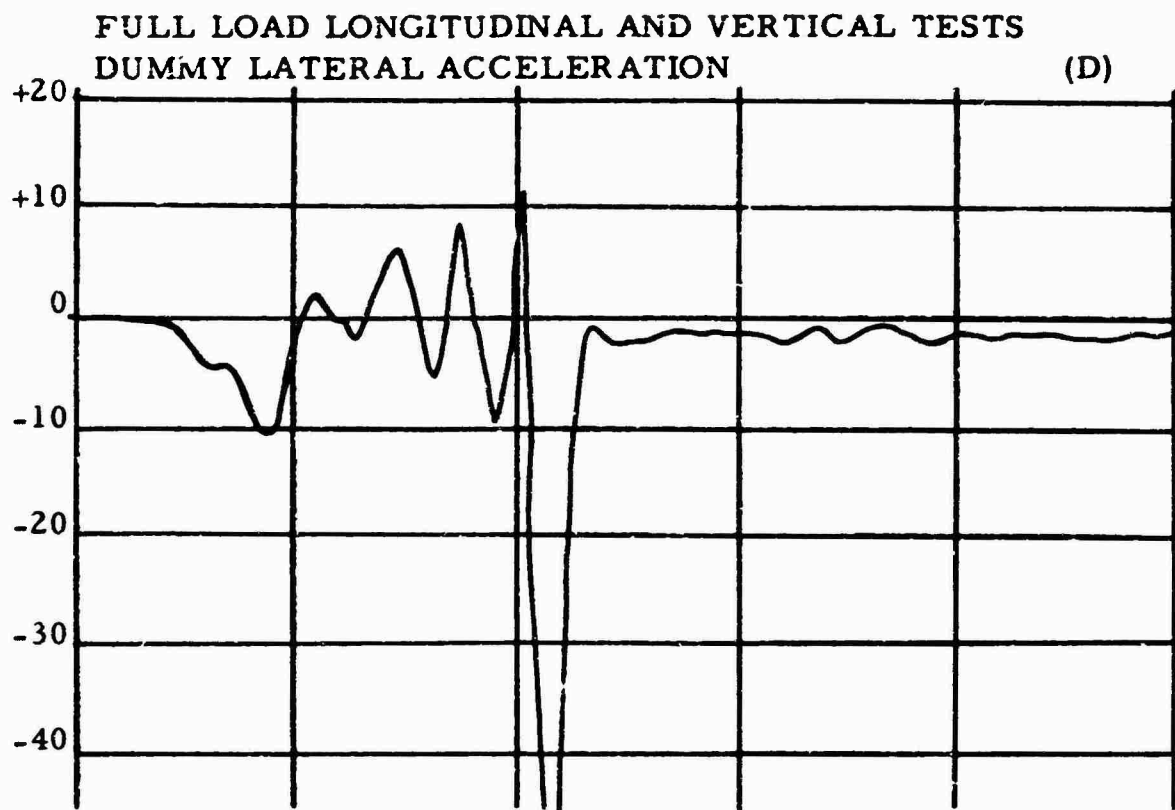
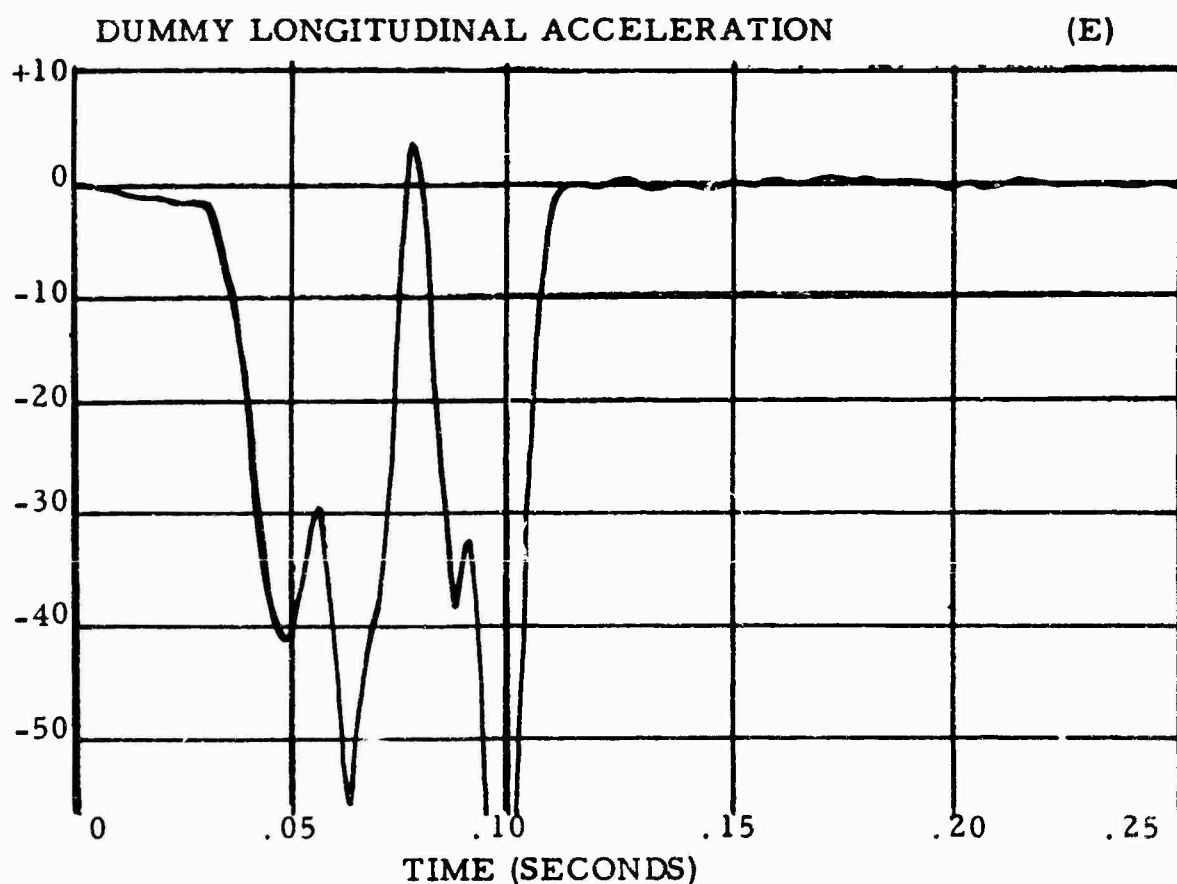
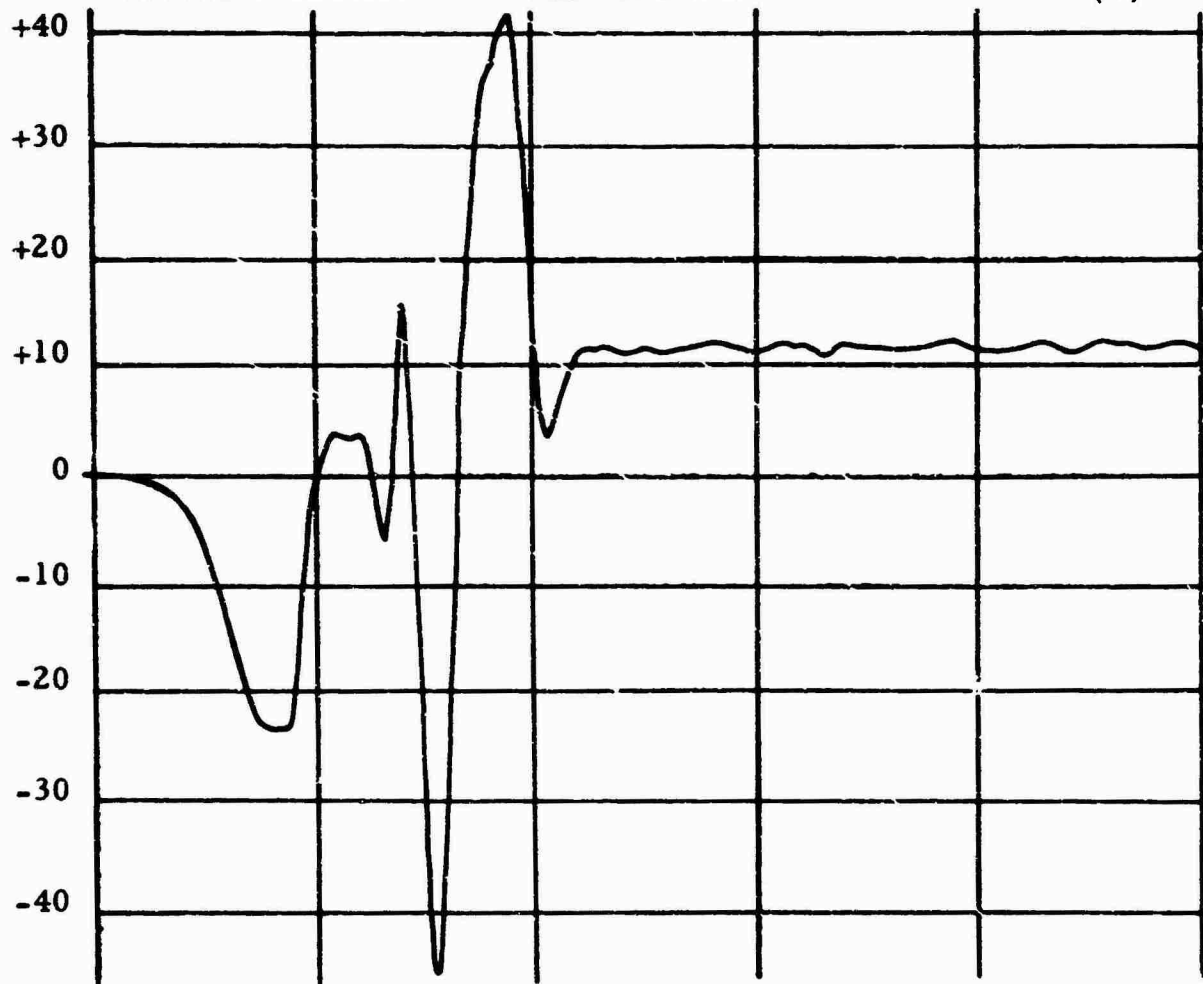
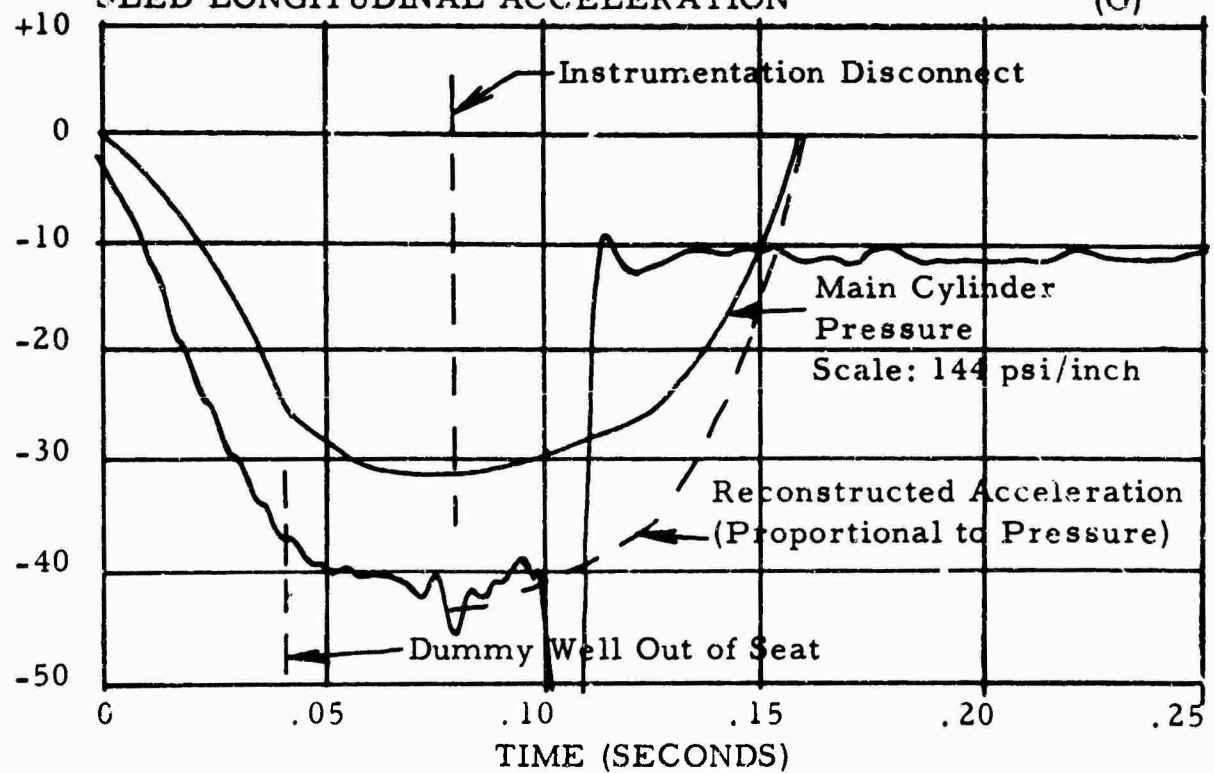
Figure 48. Data Time Histories - Vertol Seat -  
Test Condition No. 3.

This was a full-load test with the seat mounted 28 degrees upward from the horizontal. The input pulse and cylinder pressure curves are shown in Figure 48G.

Recorded data on the seat and dummy would not be significant because the dummy restraint harness system failed almost immediately. The shoulder harness failed, as in the half-load tests, when the dummy stressed the chest armor. Both the seat belt fittings pulled out at the attachment fittings to the seat identically as shown in Figure 44. The dummy hit the safety cable with sufficient force to be severed and ejected from the seat and to fall to the ground a short distance from its original location. Sequence photographs are presented in Figure 47 and a posttest view of the seat is shown in Figure 45.
