انتار (شر) مرز بور X-20 WINDOW TESTS نىيىنى ئىرىدۇر يېچى MURRAY N. ENGLAND T **TECHNICAL REPORT AFFDL-TR-65-211** CLEARINGHOUSE FOR REDERA CONVERTING AND Har weig just queen JANUARY 1966 3.60 \$0.58.39 a Code 1 Distribution of This Document Is Unlimited.

X-20 WINDOW TESTS

MURRAY N. ENGLAND

This report describes two structural integrity tests of the X-20A high temperature side window. One test simulated the air leakage from the window during boost and the second test simulated the thermal cycle experienced during reentry. The outside window panel failed prematurely during the thermal cycle, apparently the result of excessive thermal gradients through the frame and a stress concentration caused by thermistor instrumentation leads passing through the frame and under the window seals.

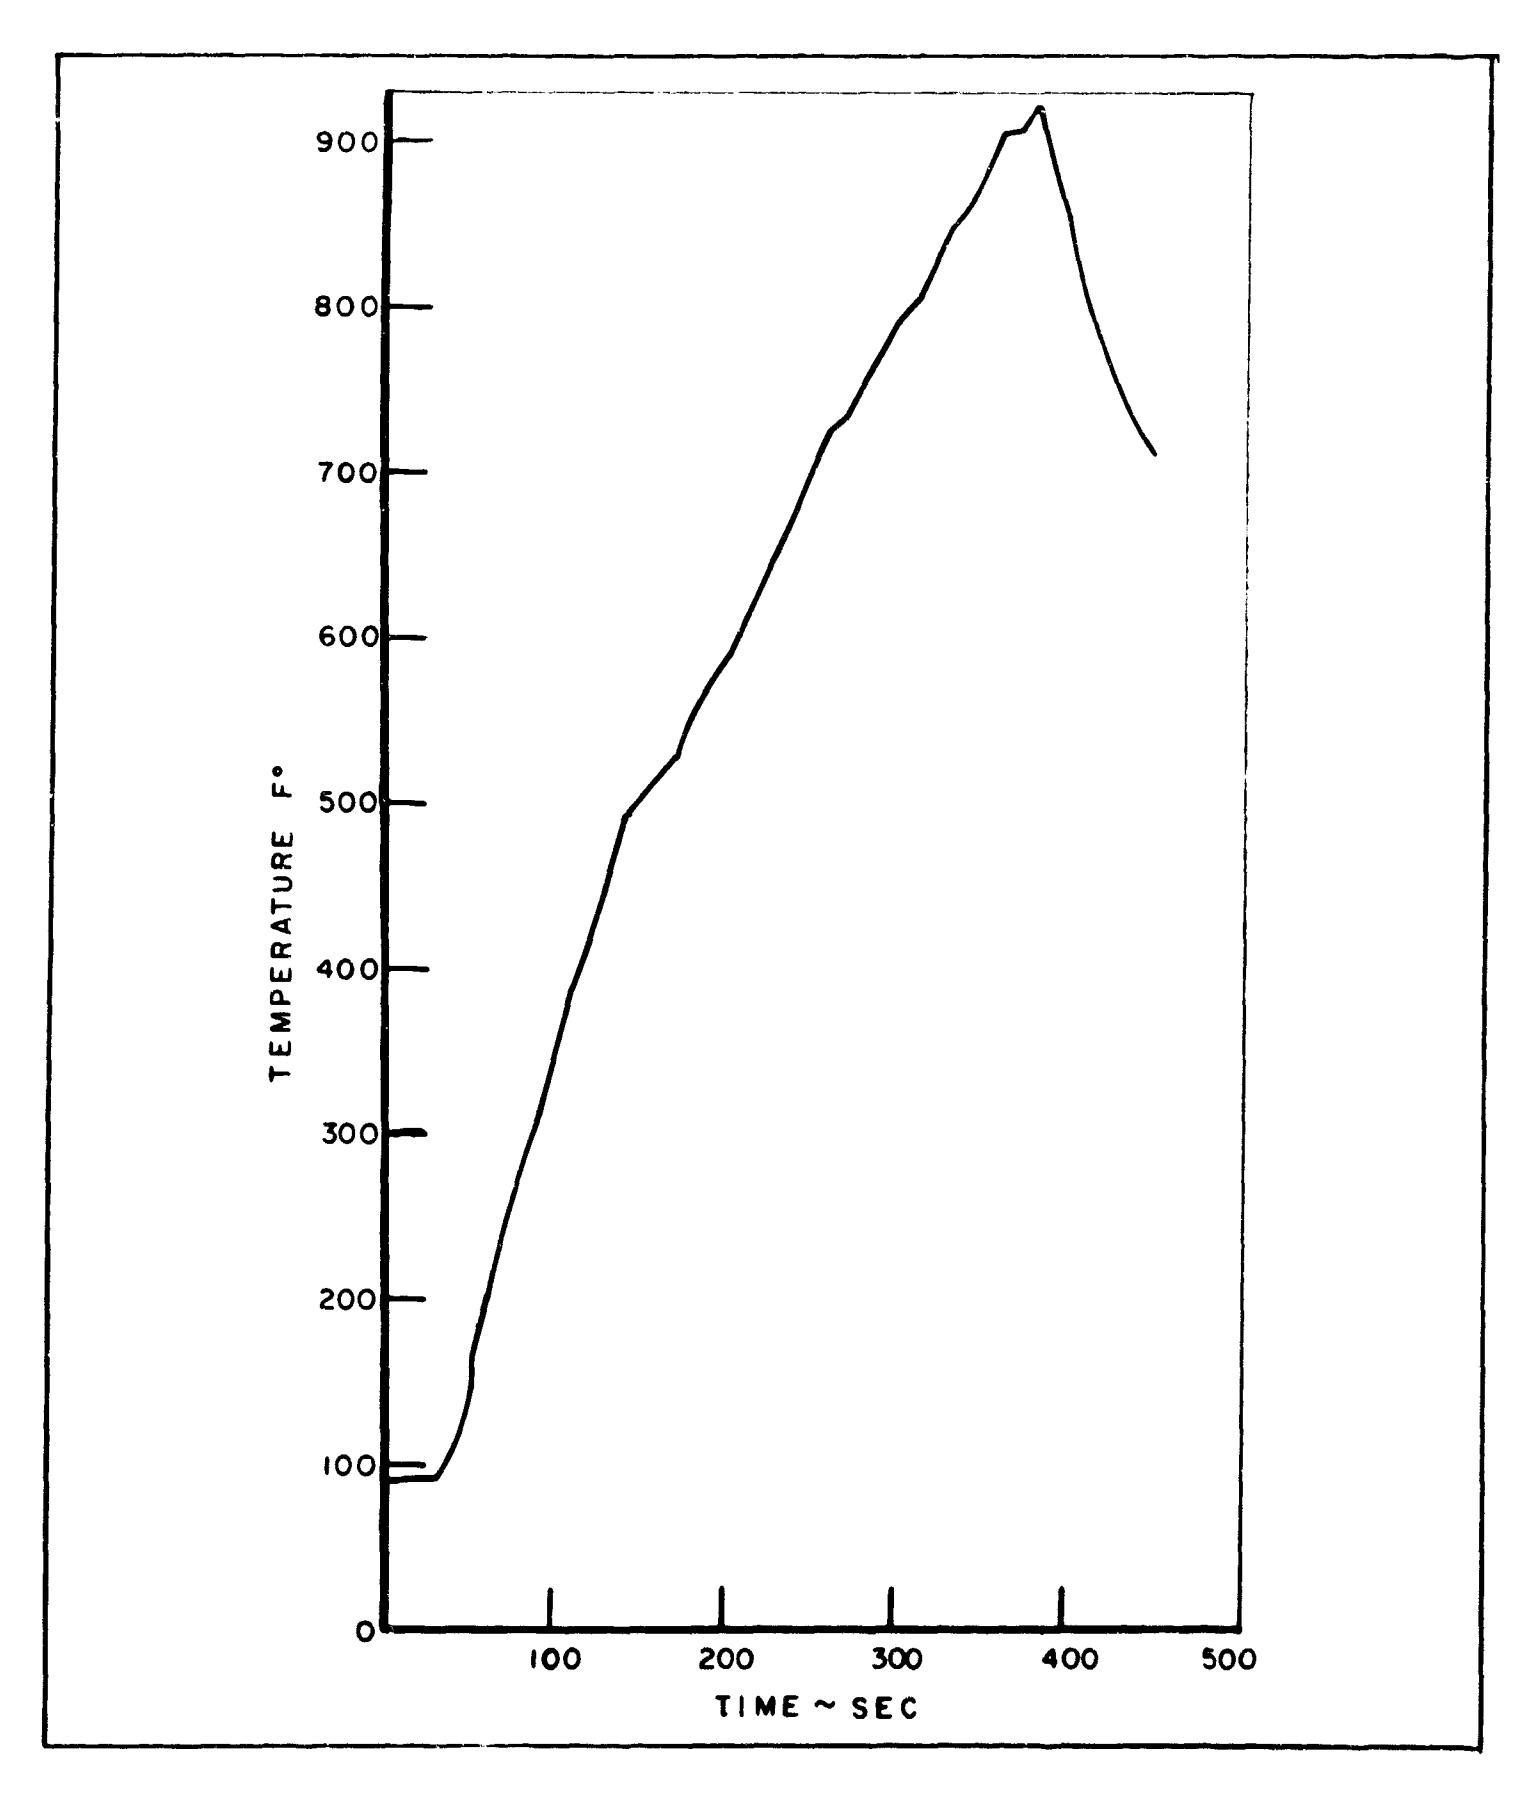
Figure 15. Thermocouple No. T3, Test Condition No. 3

The results of the final test are presented in graphical and tabular form under Serial No. 207 on file at FDTT, AFFDL-TR-65-155 also contains the plotted data for this test condition. Plots of representative temperatures and deflections recorded during Test Condition No. 3 are shown in Figures 15 through 21.
