DEEP-OCEAN BIODETERIORATION
OF MATERIALS — PART III. THREE
YEARS AT 5,300 FEET

U. S. NAVAL CIVIL ENGINEERING LABORATORY
PORT HUENEME, CALIFORNIA

Technical Report R-428

James S. Muraoka

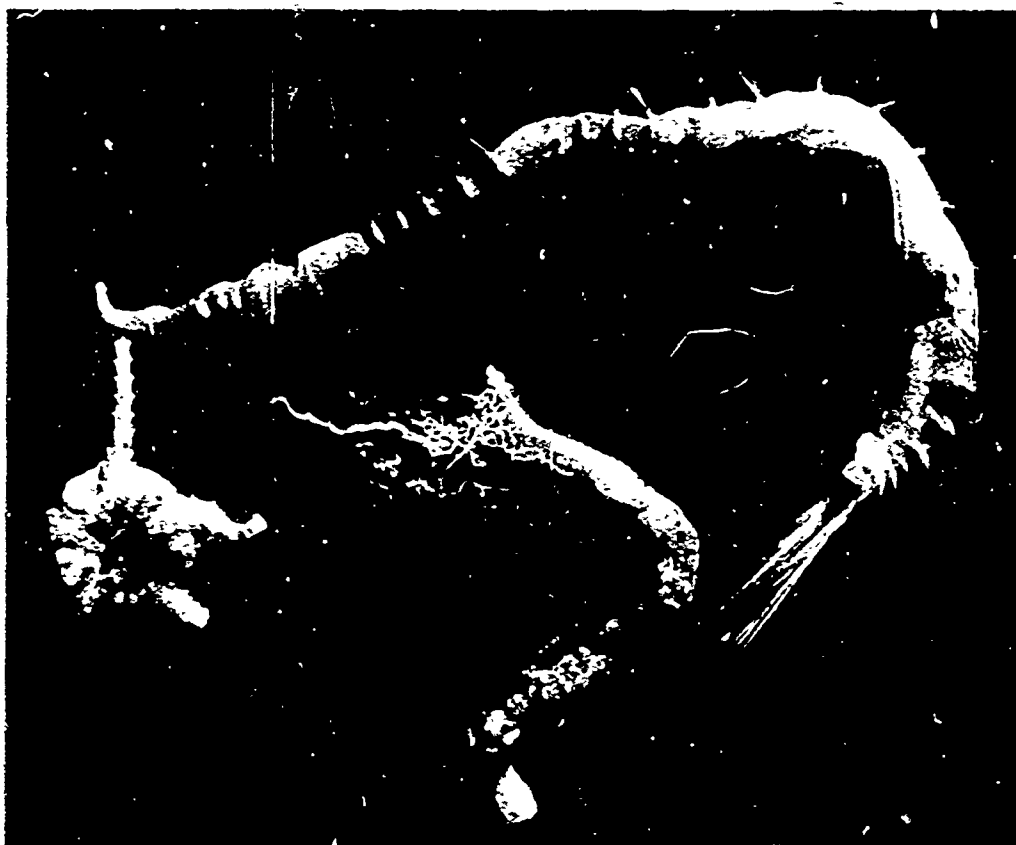
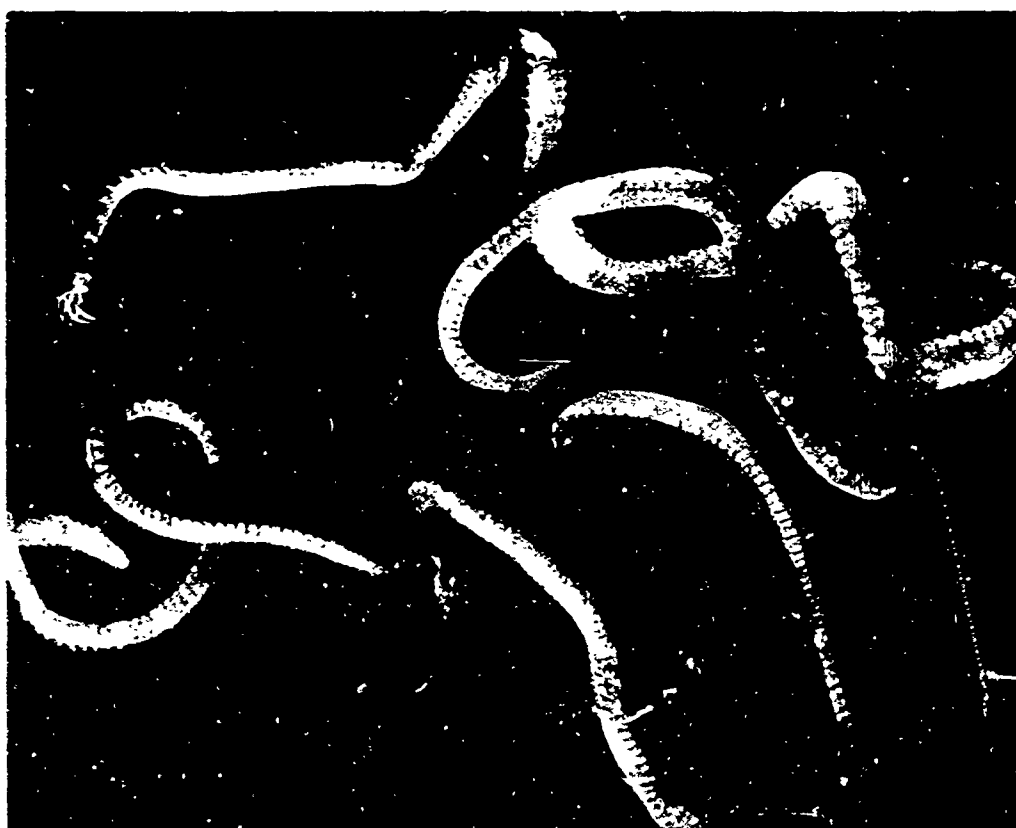
The sediment samples obtained with a scoop sampler were washed through a plastic screen to collect mud-dwelling organisms. The animals were bottled and preserved in a 5-percent glycerol-alcohol solution aboard ship for laboratory analysis. A variety of animals were found in these sediment samples. Annelid worms were the most abundant marine organisms collected in the vicinity of STU I-1 (Figure 6). Other mud dwellers collected were nemertean or round worms, holothurian or sea cucumbers, (Figure 7), molluscs, and Foraminifera tests. The Foraminifera tests found in the sediment samples have been classified and reported in Reference 1.

Figure 6. Annelid worms up to 6 inches in length found in a sediment sample.

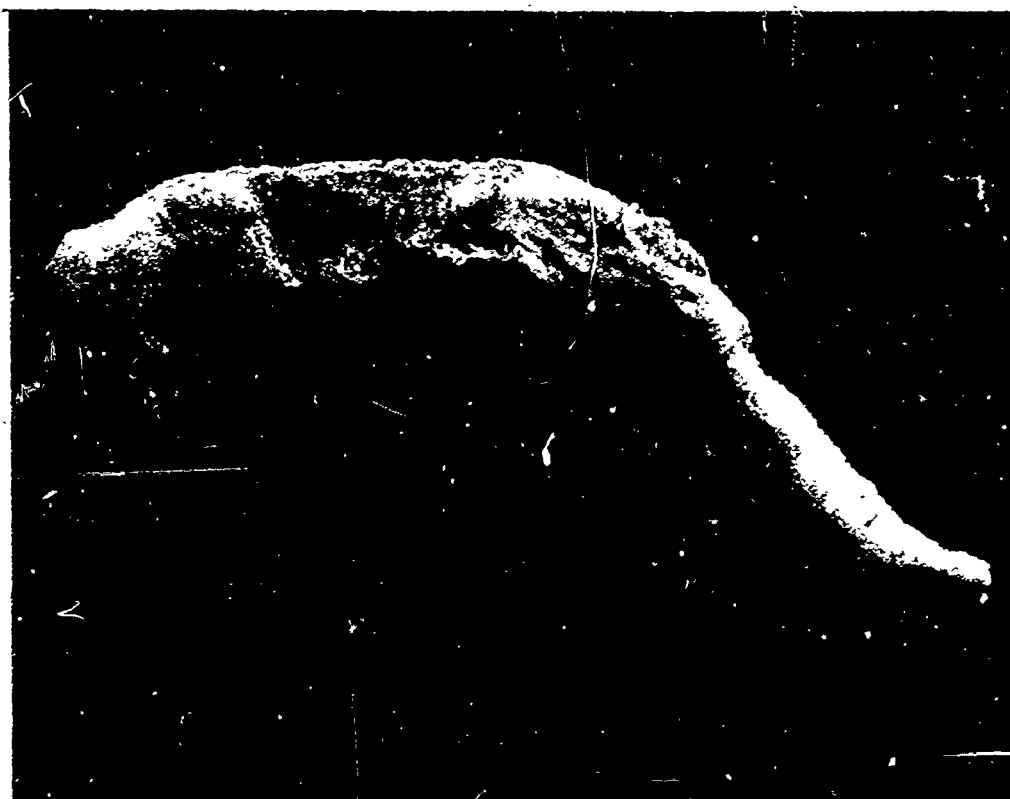
Figure 7. A 1-inch-long holothurian (sea cucumber) found in a sediment sample.
