USAAVLABS TECHNICAL REPORT 66-24

AIRCRAFT FUEL TANK DESIGN CRITERIA

March 1966

U. S. ARMY AVIATION MATERIEL LABORATORIES
 FORT EUSTIS, VIRGINIA
 CONTRACT DA 44-177-AMC-254(T)
 AVIATION SAFETY ENGINEERING AND RESEARCH
 A DIVISION OF
 FLIGHT SAFETY FOUNDATION, INC.
 PHOENIX, ARIZONA

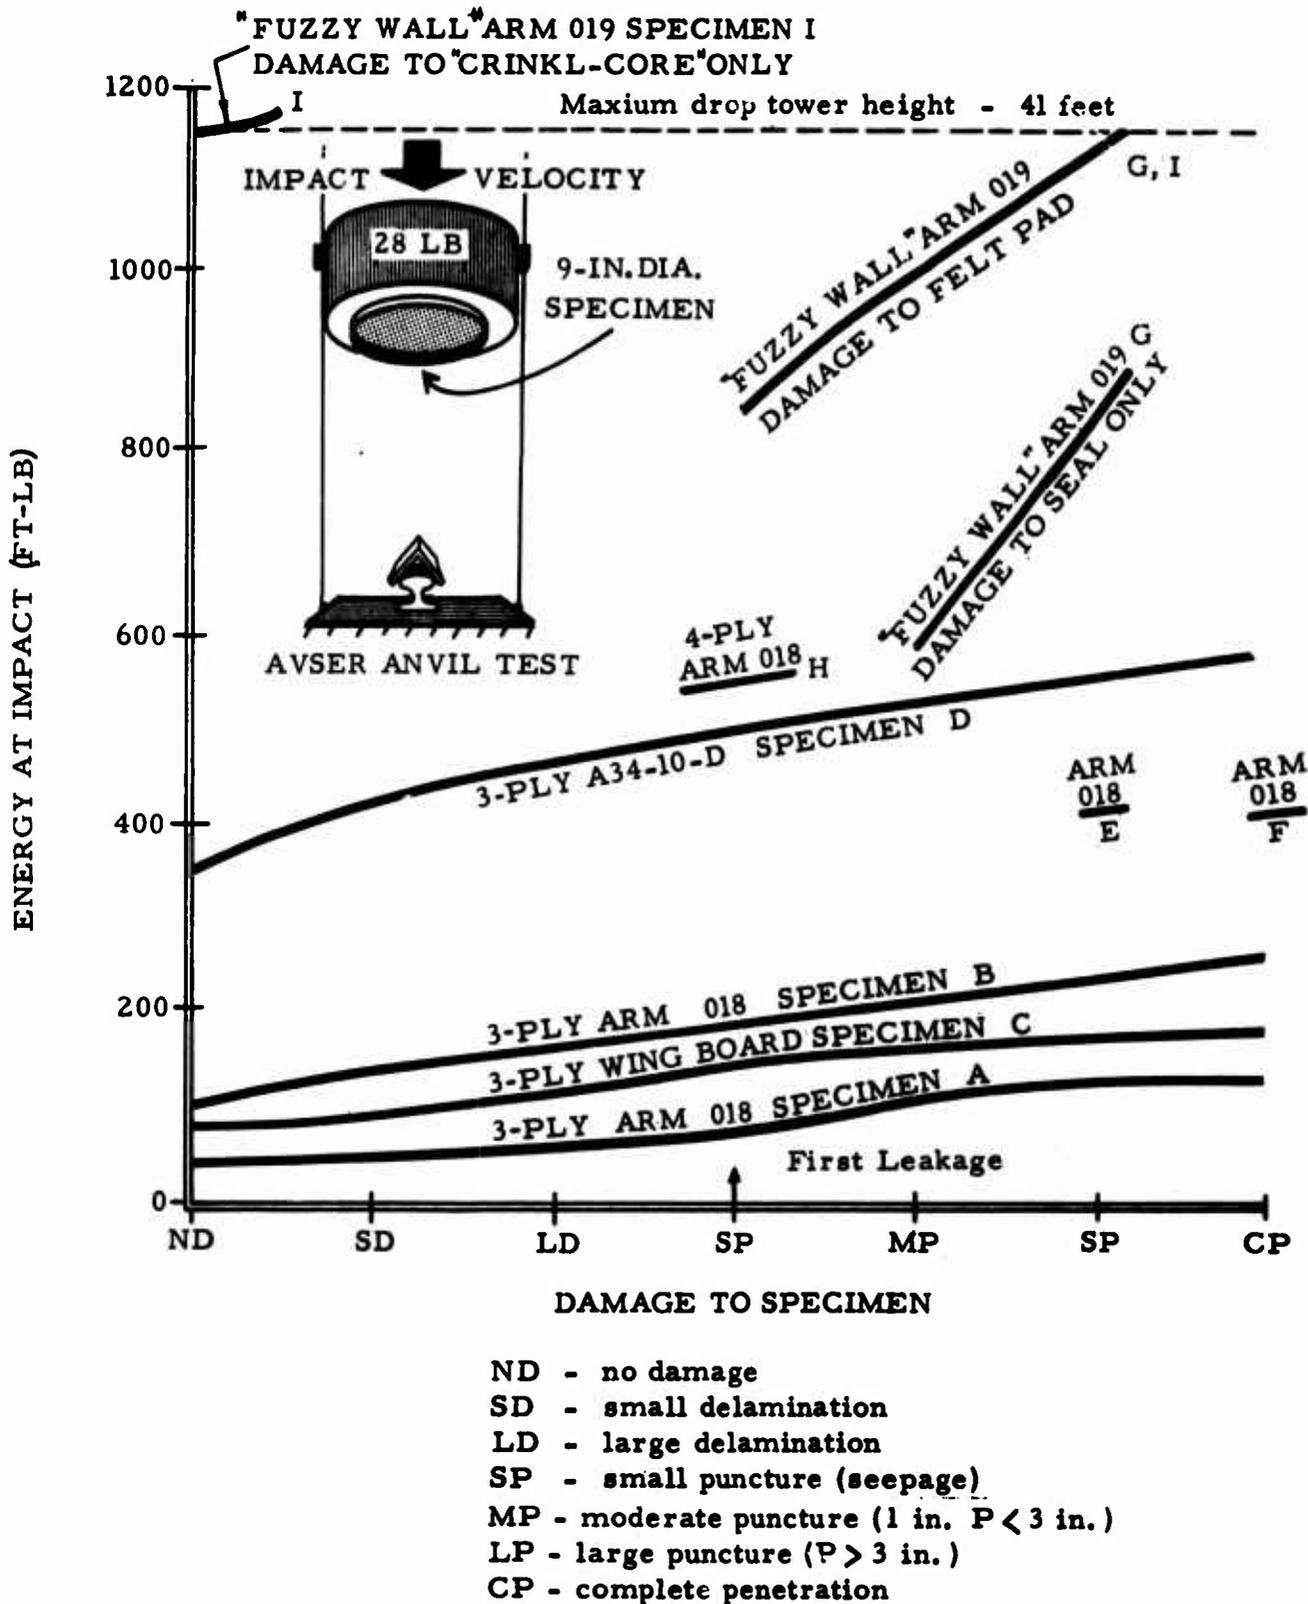
Figure 4. Impact Resistance - Anvil Test. (Damage to 9-inch Diameter Specimen as a Function of Impact Energy. See Table I for Specimen Identity.)

The results from the AvSER test series are given in Figure 4, which shows the correlation between impact energy and degree of damage to the specimen. The results clearly indicate that the "Fuzzy Wall" combinations were capable of sustaining the most energy prior to failure. For example, this material with the Goodyear "Crinkl-Core" sealing layer (Specimen I) took 1140 foot-pounds without leakage occurring.

Failure of the felt pad did occur; however, the sealing layer expanded so as to bridge the opening, as shown in Figure 5. The next best material was the four-ply ARM 018 (Specimen H), which took 575 feet per pound with only a small penetration (equivalent to approximately a 1/8-inch-diameter hole). The three-ply A34-10-D (Specimen D) was almost as good but was 12 percent thicker and 27 percent heavier than the four-ply ARM 018 (see Table I).

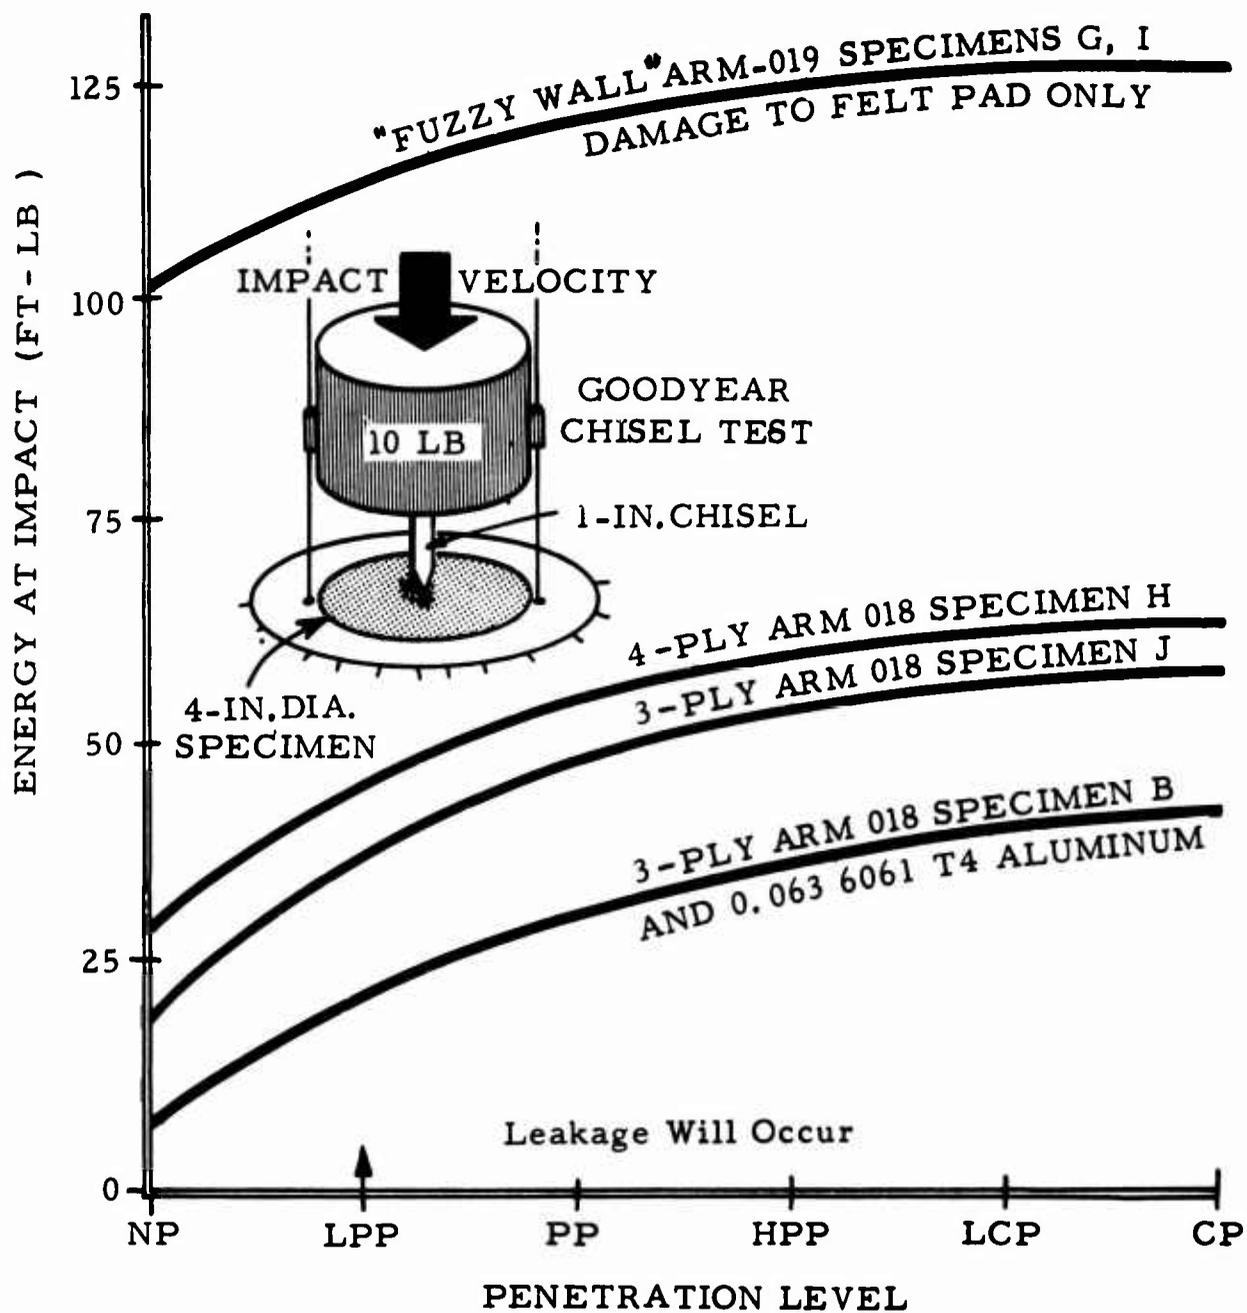
Figure 6. Resistance of Tank Materials to Penetration.

The results of the Goodyear drop tests, using the 1-inch-square, 60-degree chisel, are shown in Figure 6. These data indicate the degree of penetration of the chisel as a function of impact energy. While the AvSER drop test more nearly simulates the impact environment associated with the forcing of small objects (fuel pumps, fittings, etc.) into the tank, the Goodyear test best simulates puncture due to broken stringers, bolts, and other structure. It provides a check on the resistance both to impact (rapid loading) and to penetration. The chisel impact test results of Figure 6 are in good agreement with the AvSER tests; that is, the results for the materials tested show the energy for failure to be in about the same relative ratios for both tests. For example, the "Fuzzy

Wall" material appears to absorb about two times the energy of the next best material ("Tough Wall", four-ply, ARM 018, Specimen H). It is interesting to note, however, that in static tensile load-carrying capacity, the "Fuzzy Wall" is only about one-fifth as strong as the four-ply, ARM 018 (575 pounds per inch versus 3050 pounds per inch).

In Figure 6, it should be noted that the top curve shows the penetration of the chisel into the "Fuzzy Wall" felt pad only. The "Crinkl-Core" was not penetrated even when complete penetration of the pad itself occurred.

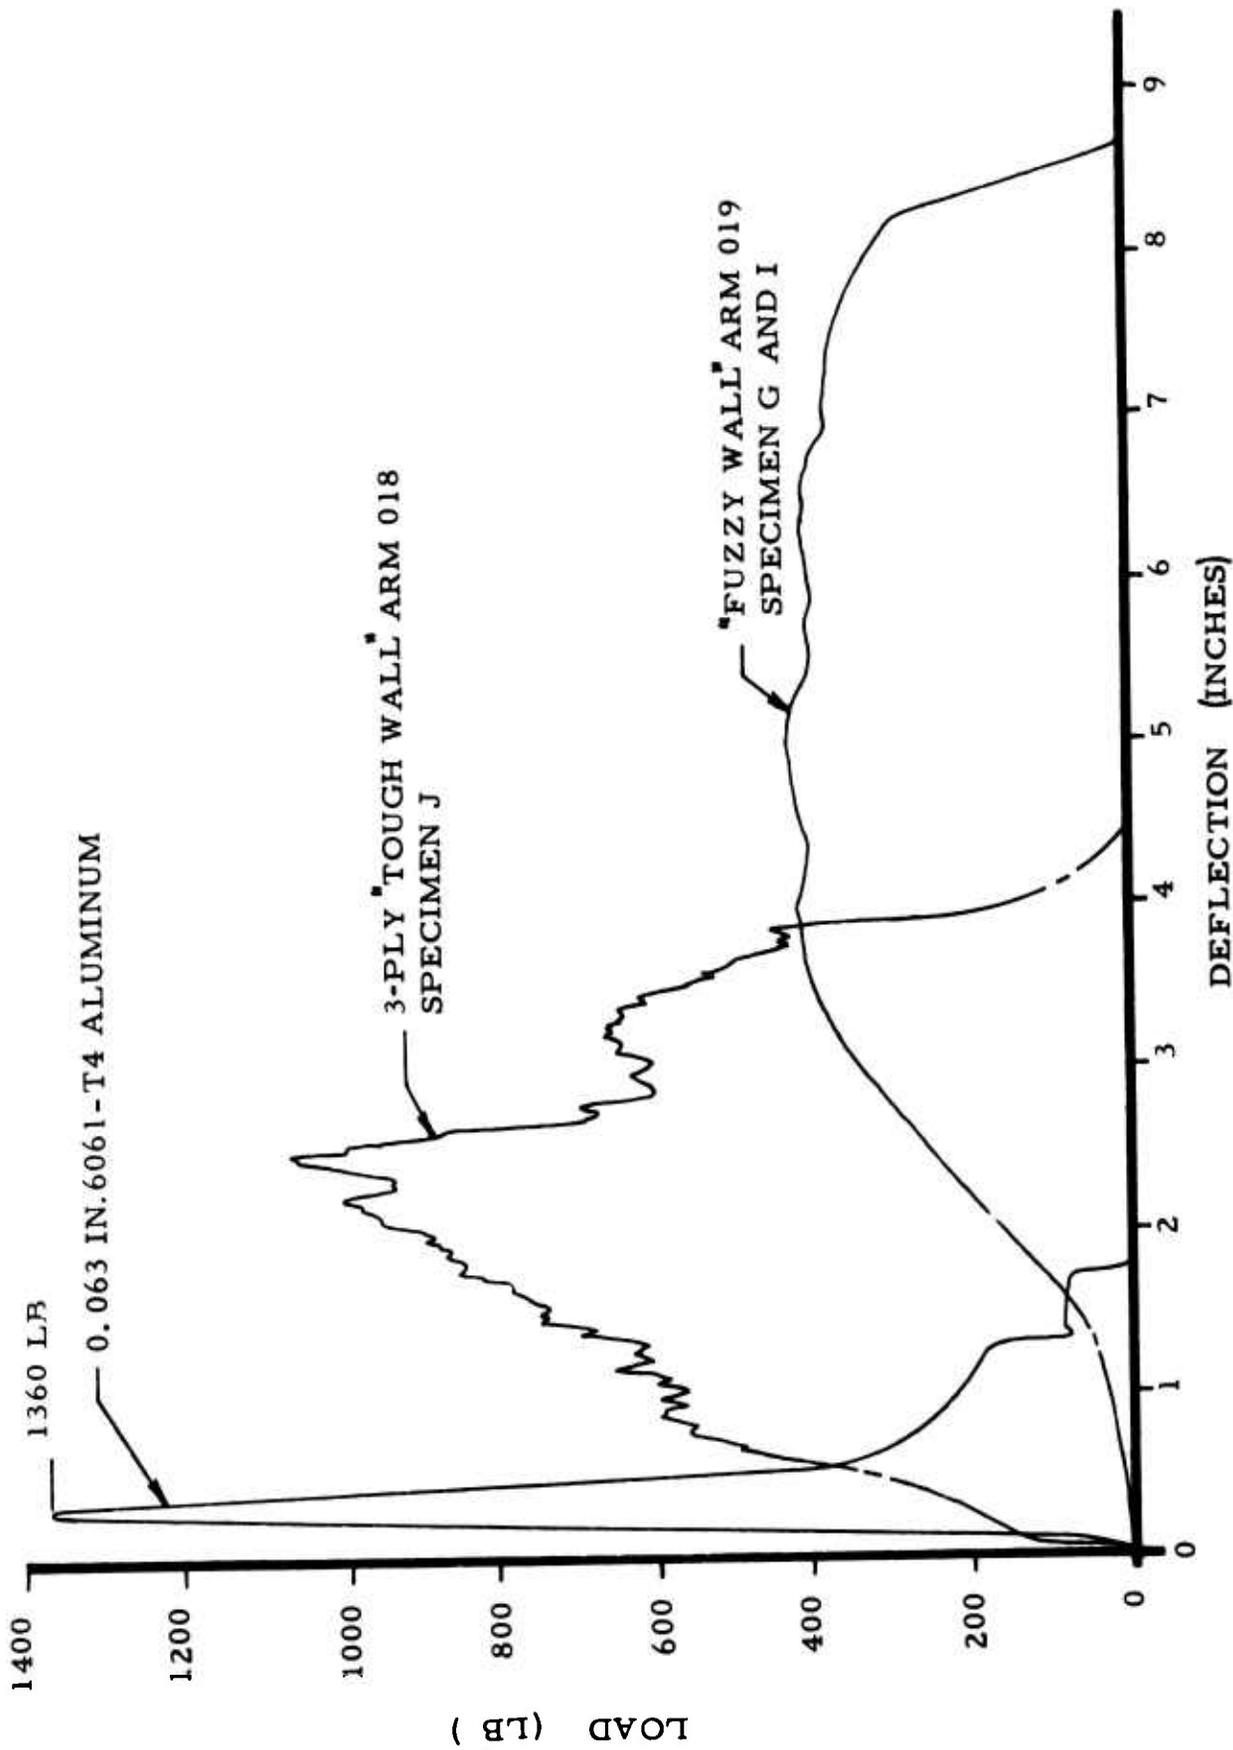
Figure 8. Resistance to Tear for Tank Materials.

The 3- by 7-inch specimens were pulled at 20 inches per minute as illustrated, and load deflection curves were obtained. The results are shown in Figure 8 for "Fuzzy Wall", three-ply ARM 018 "Tough Wall", and 0.063-inch 6061-T4 aluminum.

The area under these curves represents the energy required to fail the specimen completely. The three materials are compared numerically in Table II.

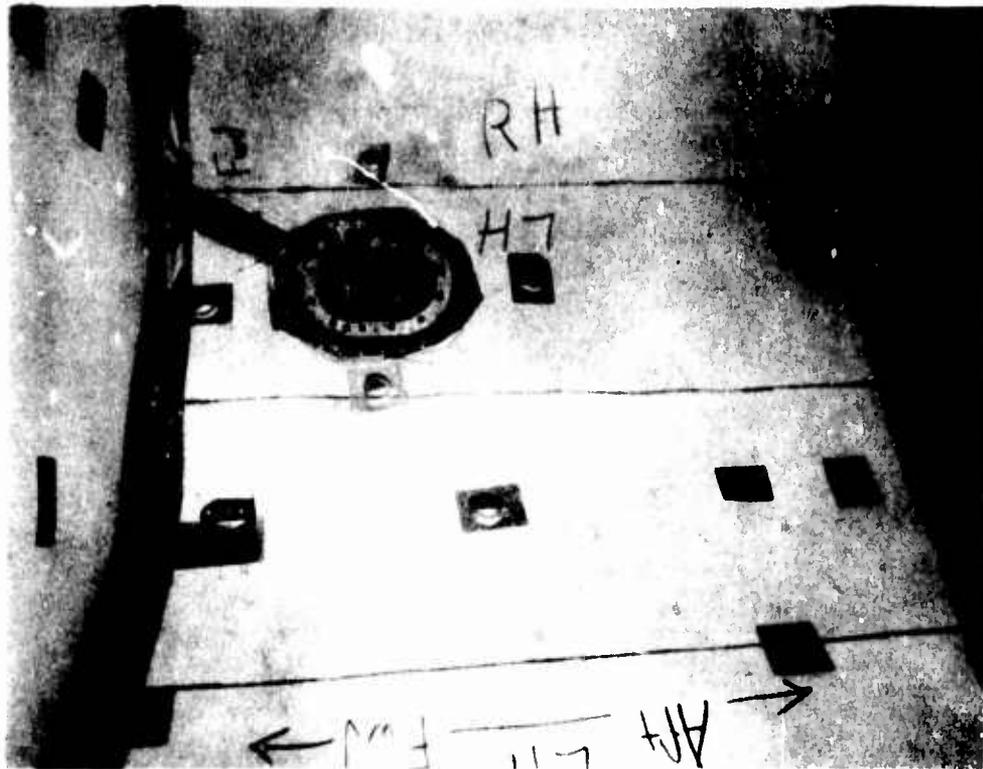
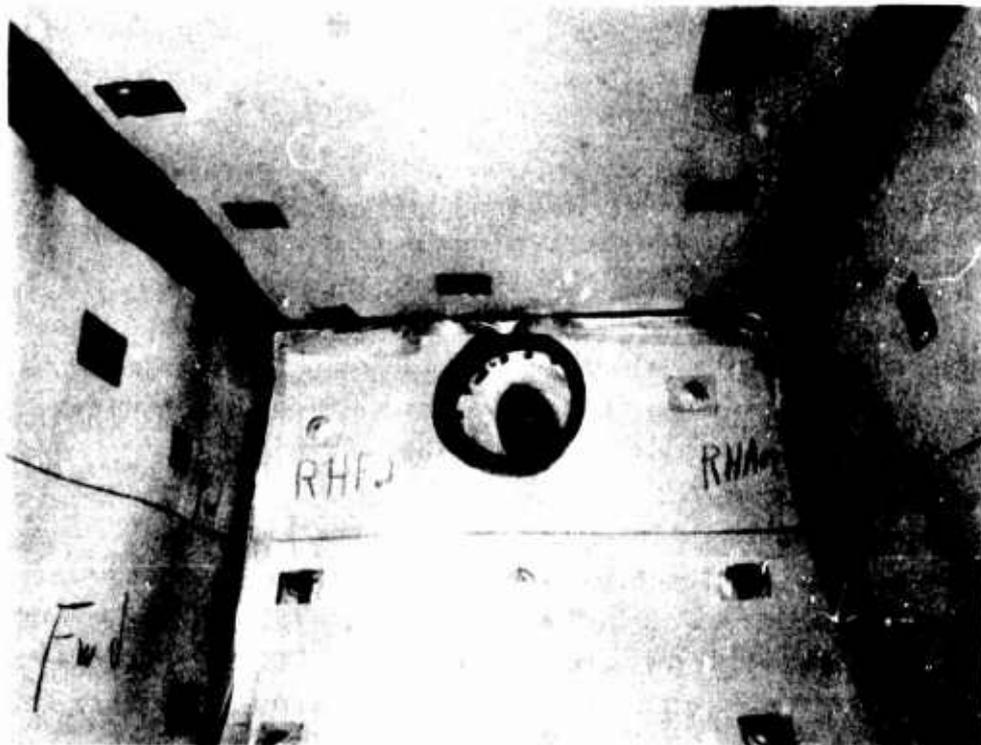
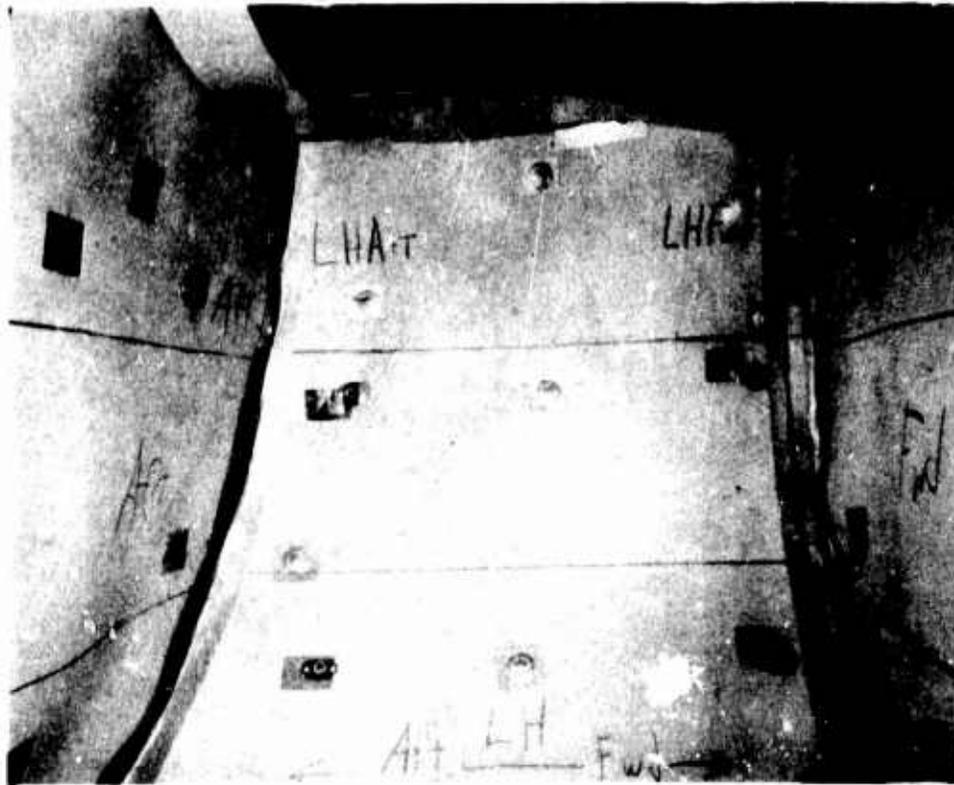
secure the bladder cell to the fuel cell chamber walls. Figures 14, 15, and 16 provide overall views of the liner installation.

The fuel cell was installed after the liner, but structural deformation and the liner installation precluded securing 5 of the 31 fasteners to the chamber top and upper sides.

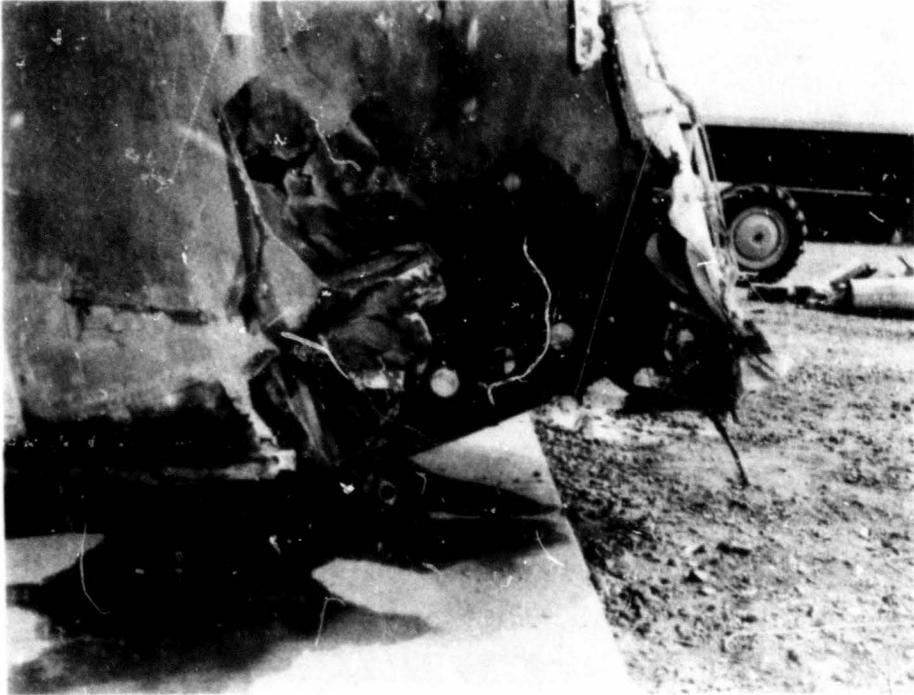
Figure 20. Deformation of Fuel Cell Chamber, Left Side, From T-12.

The fuel cell sustained only two small slit-like perforations, 6 inches apart on the bottom, 1 foot from the instrumentation housing. These are shown in Figures 18 and 19. The perforations measured 1/2 and 1 inch, respectively, and occurred when the longitudinals, shown exposed in Figure 20, sheared upward. Figure 21 depicts the jagged metal that punctured the fuel cell bottom.

As the fuel cell expanded under the decelerative impact force, the metal sides of the cell chamber deformed forward and separated along the seams. This is apparent in Figures 20 and 21. The leakage from the perforations shown in Figures 18 and 19 was sufficient in rate and volume to have resulted in a fire under actual crash conditions.

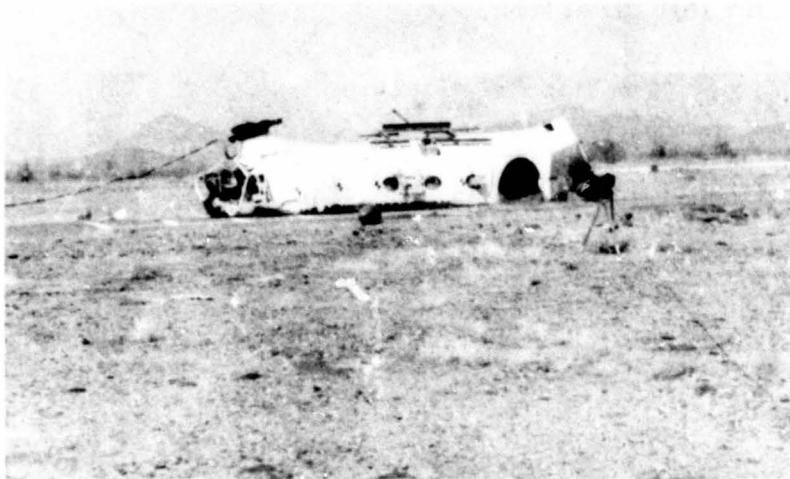
Figure 25. Helicopter Section at Rest After Skid.

Fuel spillage, as seen in Figure 25, subsided to ground level, spread, and soaked the impact area in the pattern shown in Figure 26.

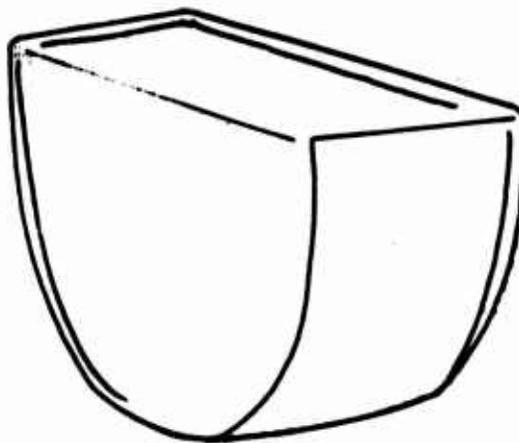
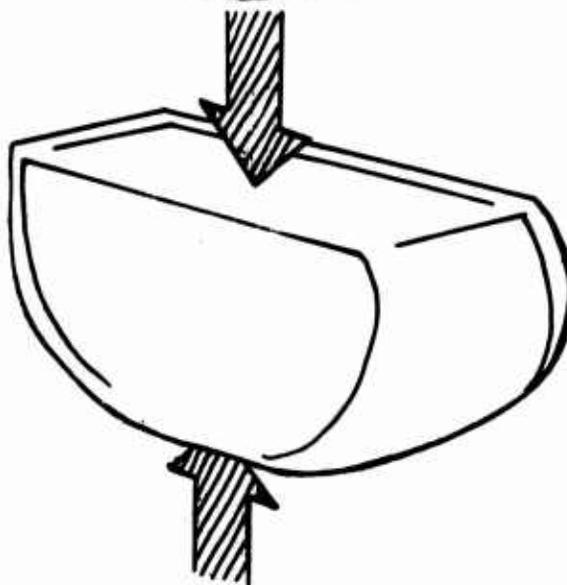
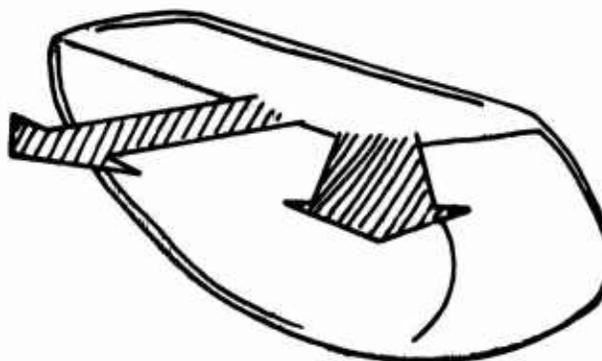
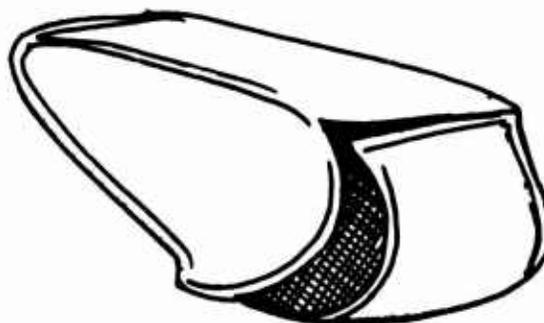
Figure 35. Fuel Cell Rupture Sequence.

Figure 35 is a kinematic sketch that depicts the fuel cell rupture resulting from the impact compression force, primarily in a forward and left direction.

1. The crash resistant bladder cell is considered virtually ineffective as a crash fire deterrent in any crash wherein the supporting structure's failure is severe enough to establish a jagged metal environment.
2. The fuel cell might possibly withstand the impact forces normally encountered during a survivable-type crash if afforded the protection of a flexible seam-bonded liner, such as "wingboard", to enclose it and protect against puncture damage.

3. Airframe structural strength factors surrounding the fuel cell area(s) must be upgraded to prevent:

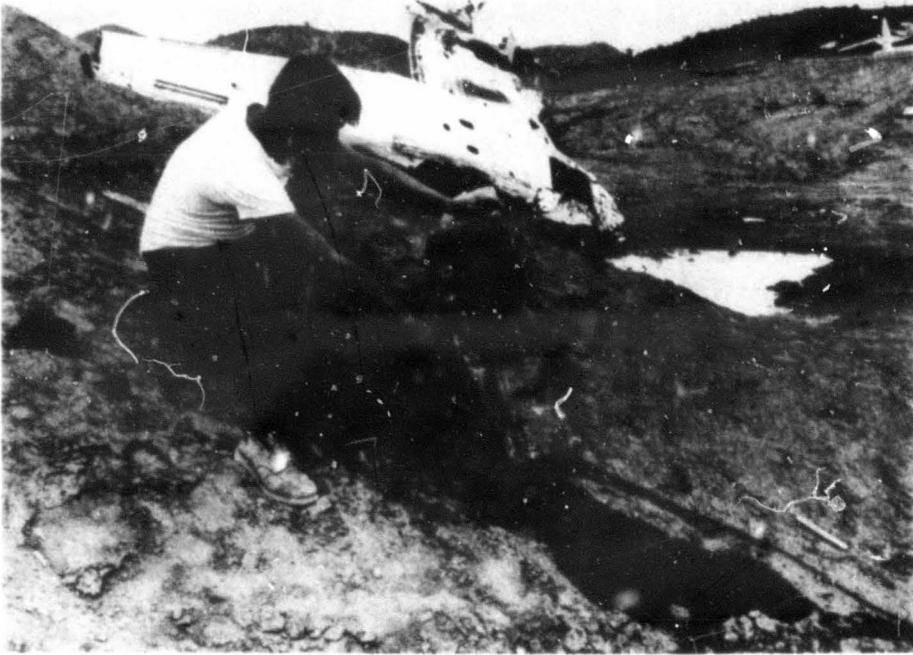
Figure 48. The Right Inboard Fuel Tank, T-19. (Photograph Taken 1 Hour After Impact.)

The right wing was separated from the aircraft just outboard of the engine nacelle as it impacted the telephone poles. The inboard honeycomb-core tank was located at the point where the wing separated from the rest of the aircraft and received a direct blow from the telephone pole. Upon separation of the wing, the tank broke through the opening in the wing structure and traveled a distance of approximately 20 feet from the pole, coming to rest on the side of the hill. The only tank damage experienced was a cut of approximately $3/4$ inch in length in the forward face of the tank. Figure 48 shows this tank in its final resting place.

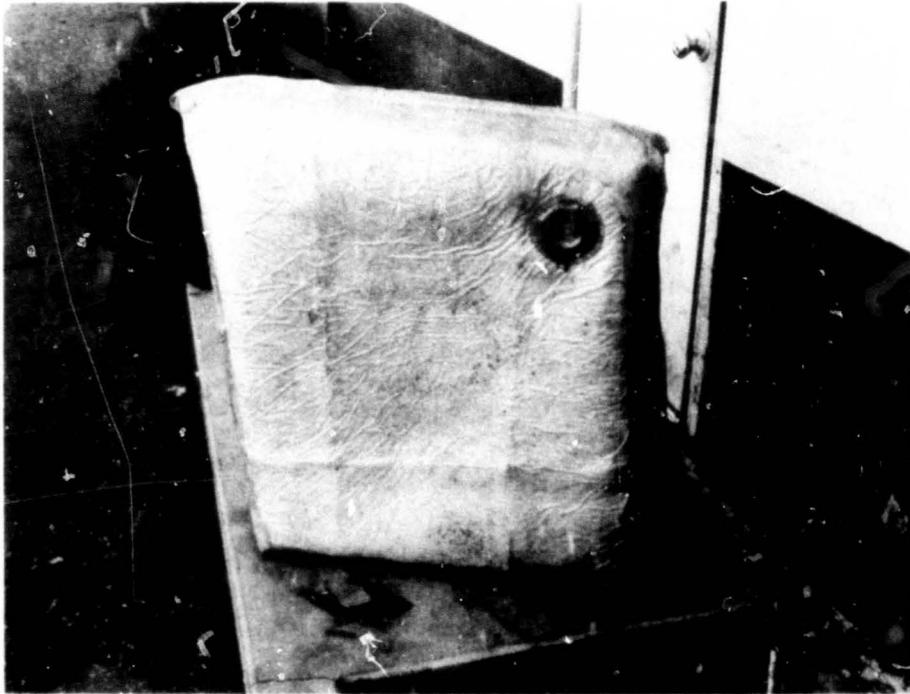
Figure 51. Experimental "Fuzzy Wall", T-24. (The Nylon Felt Tank with the "Crinkl-Core" Interliner Was Covered with a Thin Thermoplastic Film To Prevent the Felt from Functioning as a Wick Should It Become Soaked with Fuel.)

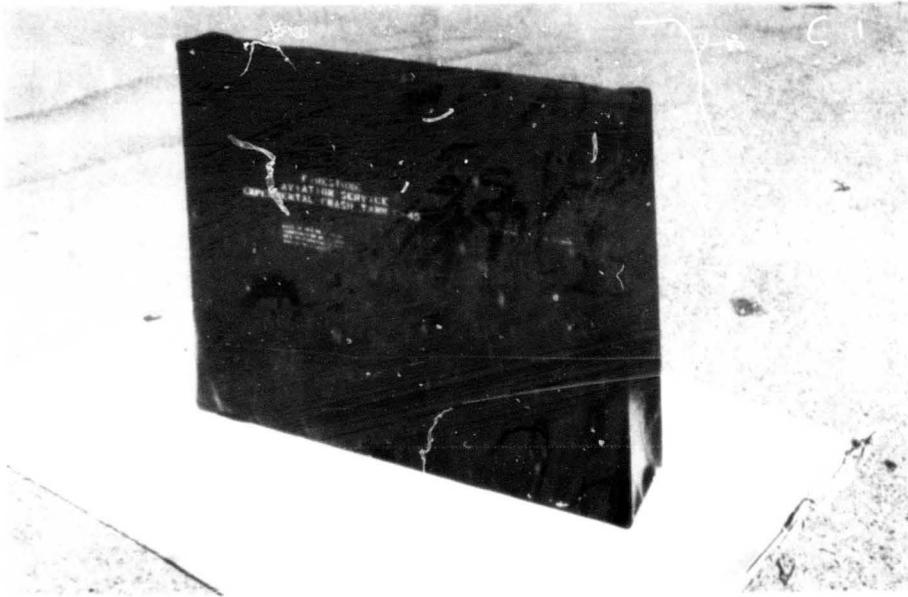
Figure 52. Experimental Sponge-Filled Tank, T-24.
(This Laminated Synthetic Cloth Tank Was Filled with Open-Pore Sponges To Help Dampen Fluid Sloshing and To Retard Fluid Spillage Through a Tank Failure.)

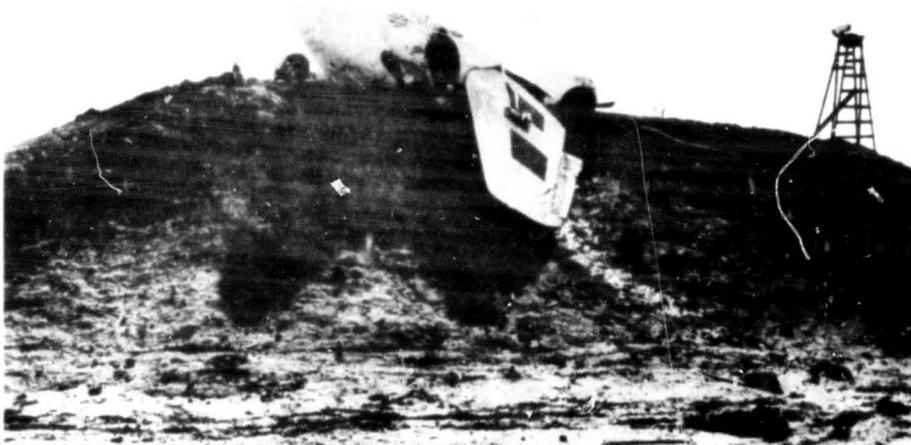
The velocity at the point of impact was approximately 80 mph. At impact with the wing barriers, the right wing was again separated just outboard of the engine nacelle, as shown in Figure 53. The left wing was partially separated just outboard of the engine nacelle and can be seen still attached in Figure 54.

Figure 54. Postcrash View, Left-Hand Side, T-24. (The Left Wing Nearly Separated from the Aircraft at Hill Impact.)

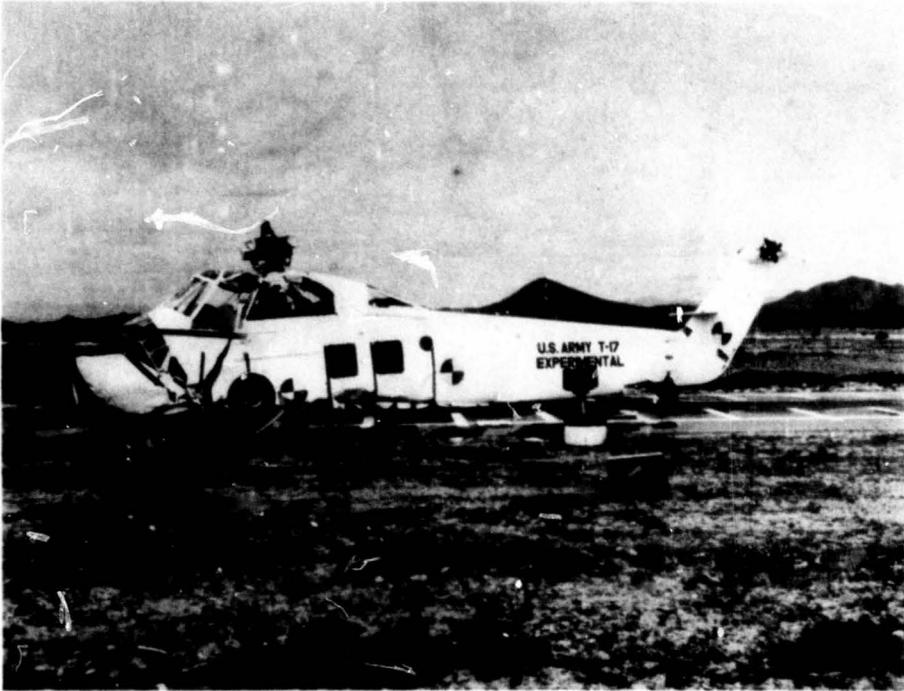
The velocity at impact was 59 feet per second. At impact, the rocks attached to the underside of the fuselage were driven through the aircraft understructure into the tanks, and the underbelly of the aircraft was crushed some 12 to 18 inches, as shown in Figure 61. All except the three "Tough Wall" experimental tanks experienced extensive failure at impact.

Figure 61. Postcrash View, T-17. (During the Impact, the Floor Was Crushed Upward a Distance of 12 to 18 Inches.)

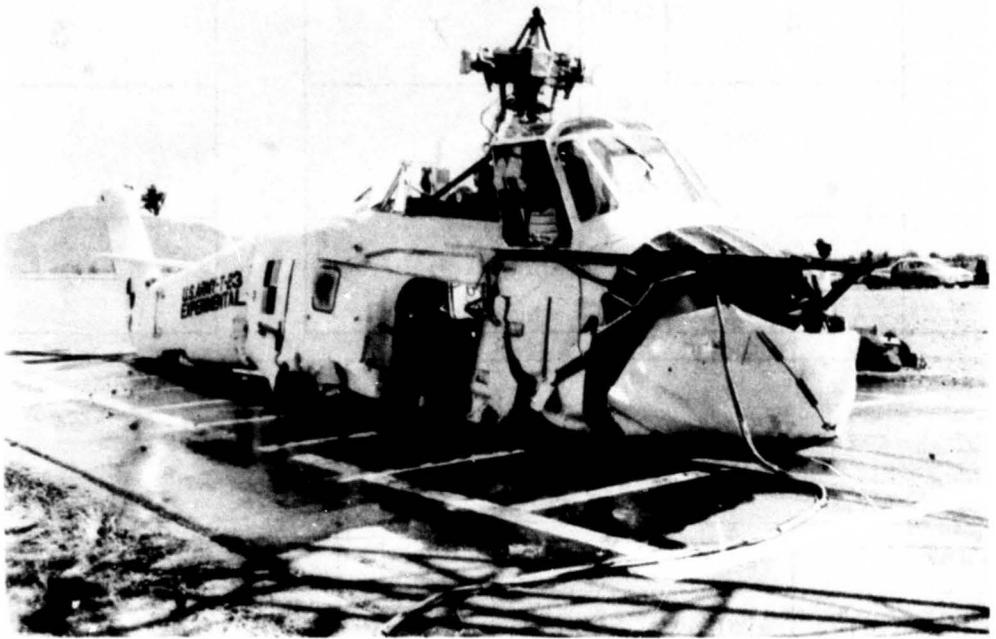
Some damage was experienced with all but one of the tanks installed in the aircraft. Figure 69 shows the aircraft in its final position after the crash. The spillage pattern resulting from the failed tanks is shown in Figure 70. The "Fuzzy Wall" tank was the only tank which did not fail.

Figure 69. Postcrash View, T-23.

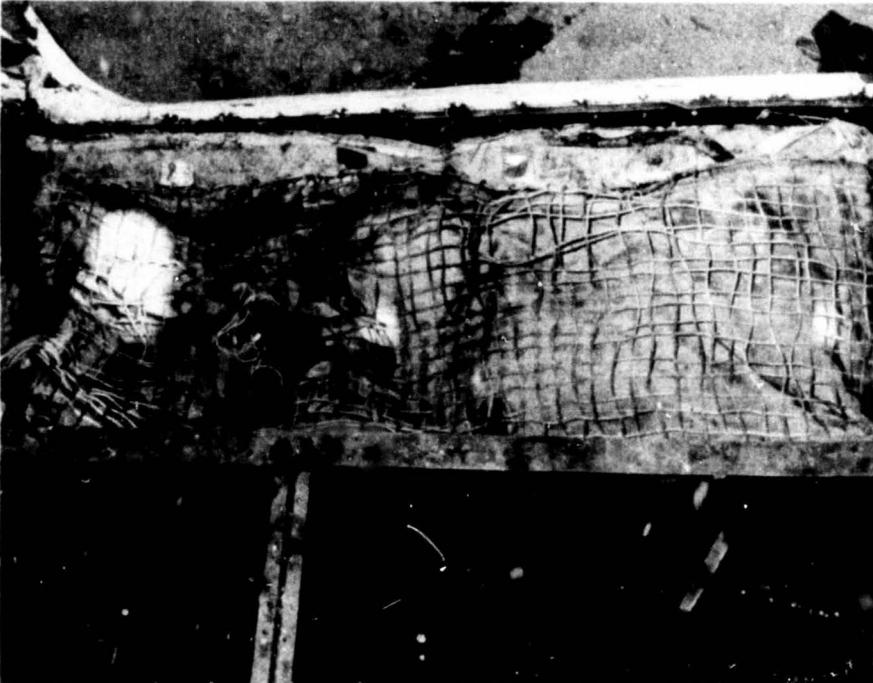
The net tank and the "Tough Wall" honeycomb tank sustained slight damage; however, the leakage was less than 1 gallon per minute. All other tanks sustained massive damage. Figures 71 through 82 show the various tanks before and after the test.

Figure 72. Net Tank - Postcrash, T-23. (View of the Net Tank After the Floor Was Removed.)

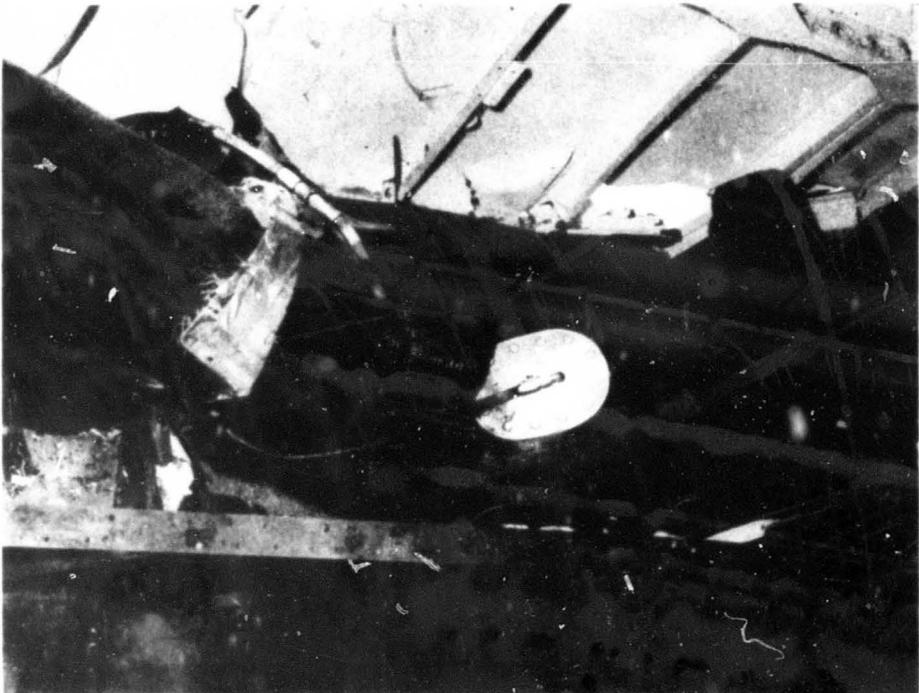
Figure 76. Type A Tank, T-23. (The Sponge-Cored Tank in Location After Floor Removal.)

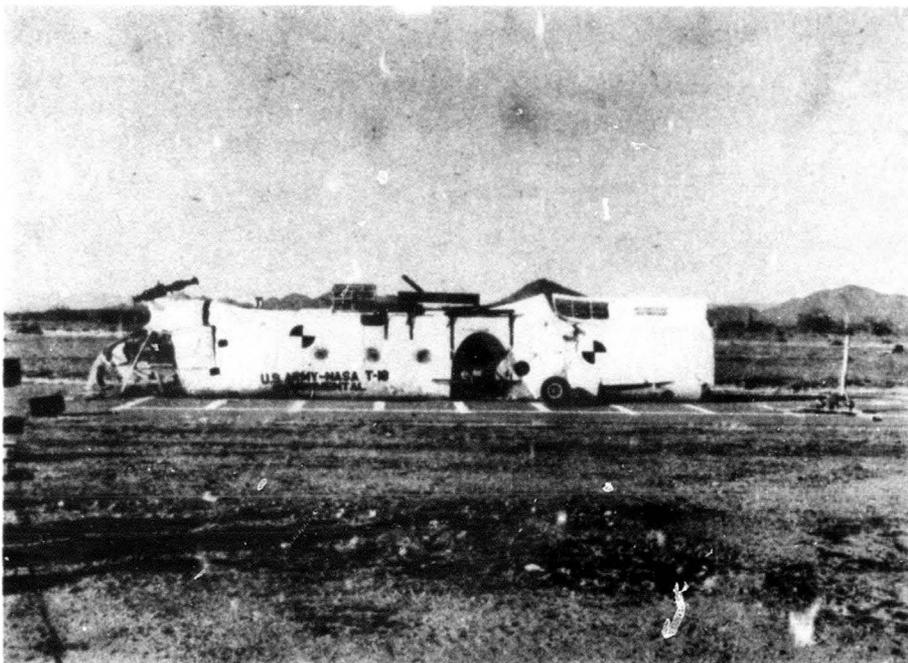
Figure 86. Postcrash View of T-18. (Helicopter Final Resting Position After the 30-Foot Free Fall.)

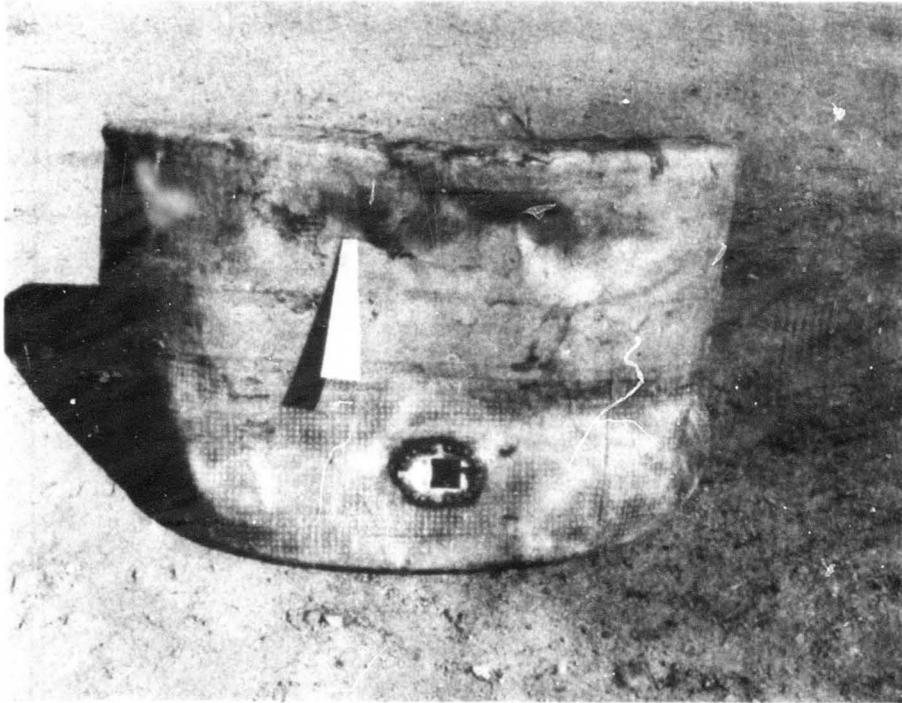
During impact, the tank sustained five small penetrations; three of the penetrations were approximately 1 inch in length, one was approximately 2 inches in length (upper left front corner), and one was approximately 1/8 inch (bottom). The tank is shown in Figure 89 after removal from the aircraft.

Figure 89. CH-21 Tank Cuts. (Pointer Is Inserted into Largest Cut on the Fuel Tank Bottom.)
