The Design
and
Methods of Construction
of
Welded Steel Merchant Vessels

FINAL REPORT OF A BOARD OF INVESTIGATION

To Inquire Into
THE DESIGN
AND METHODS OF CONSTRUCTION
OF WELDED STEEL MERCHANT
VESSELS

15 JULY 1946

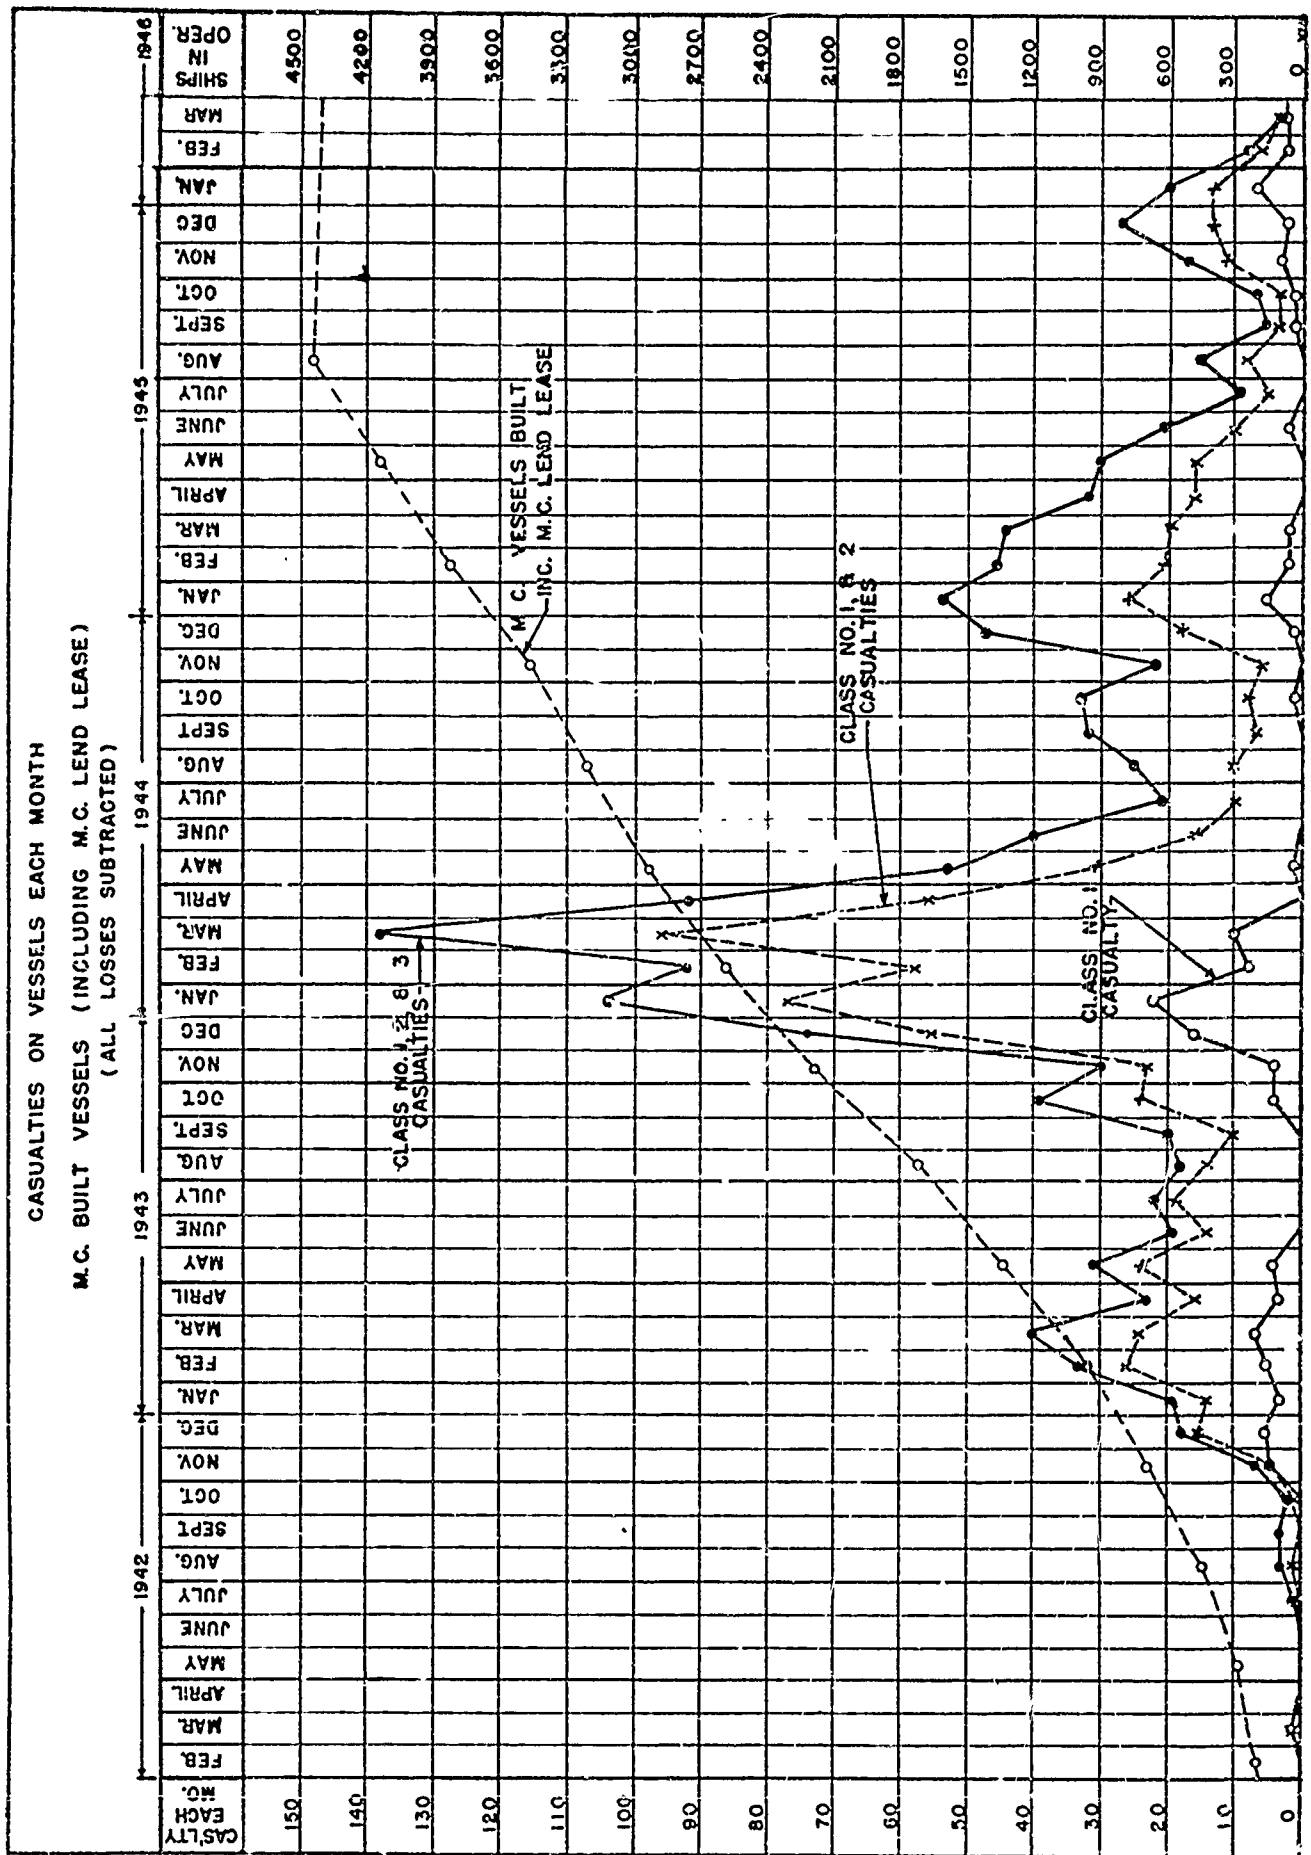
Figure 24.

Figure 24 shows the casualties reported each month and indicates the peaks which occur during the winter months of each year. The dotted line indicates the corresponding number of Maritime Commission-built ships which were afloat and in operation. The steady increase shows the growth of our merchant marine and the slight drop at the end is the result of transferring many ships from the merchant service to permanent military operation. The curves indicate clearly that the measures adopted have been successful in suppressing the serious epidemic of structural failures reflected in the first peak.

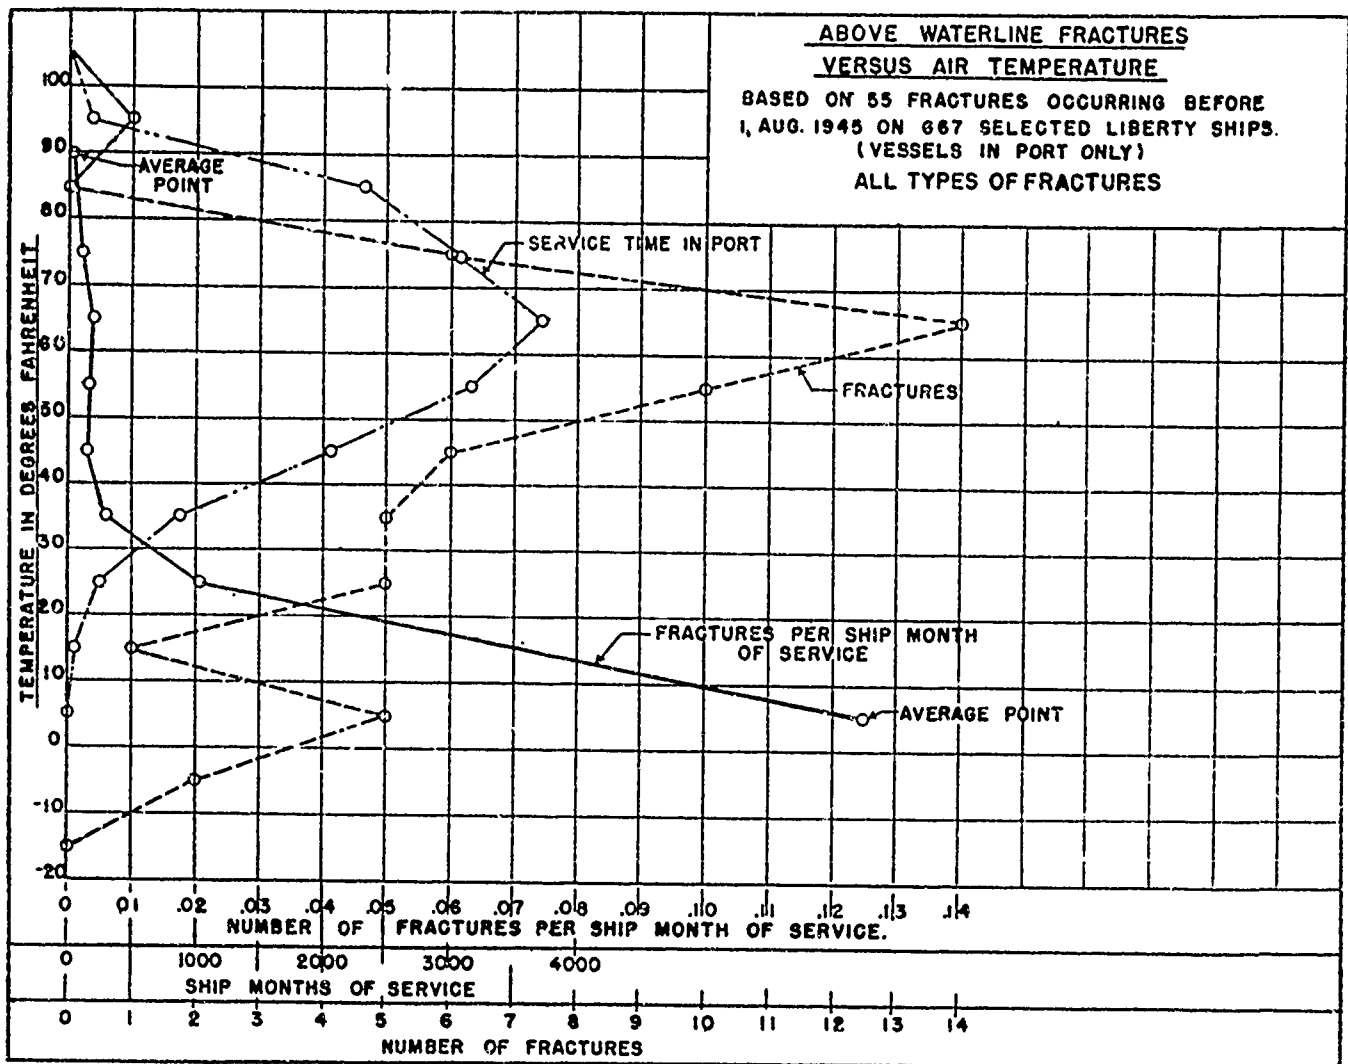
Figure 26.

was made to ascertain the risk of casualty under varying conditions of air temperature and state of the sea. Various plots were made but it was found that the data were not sufficient to establish casualty risks under known combinations of air temperature

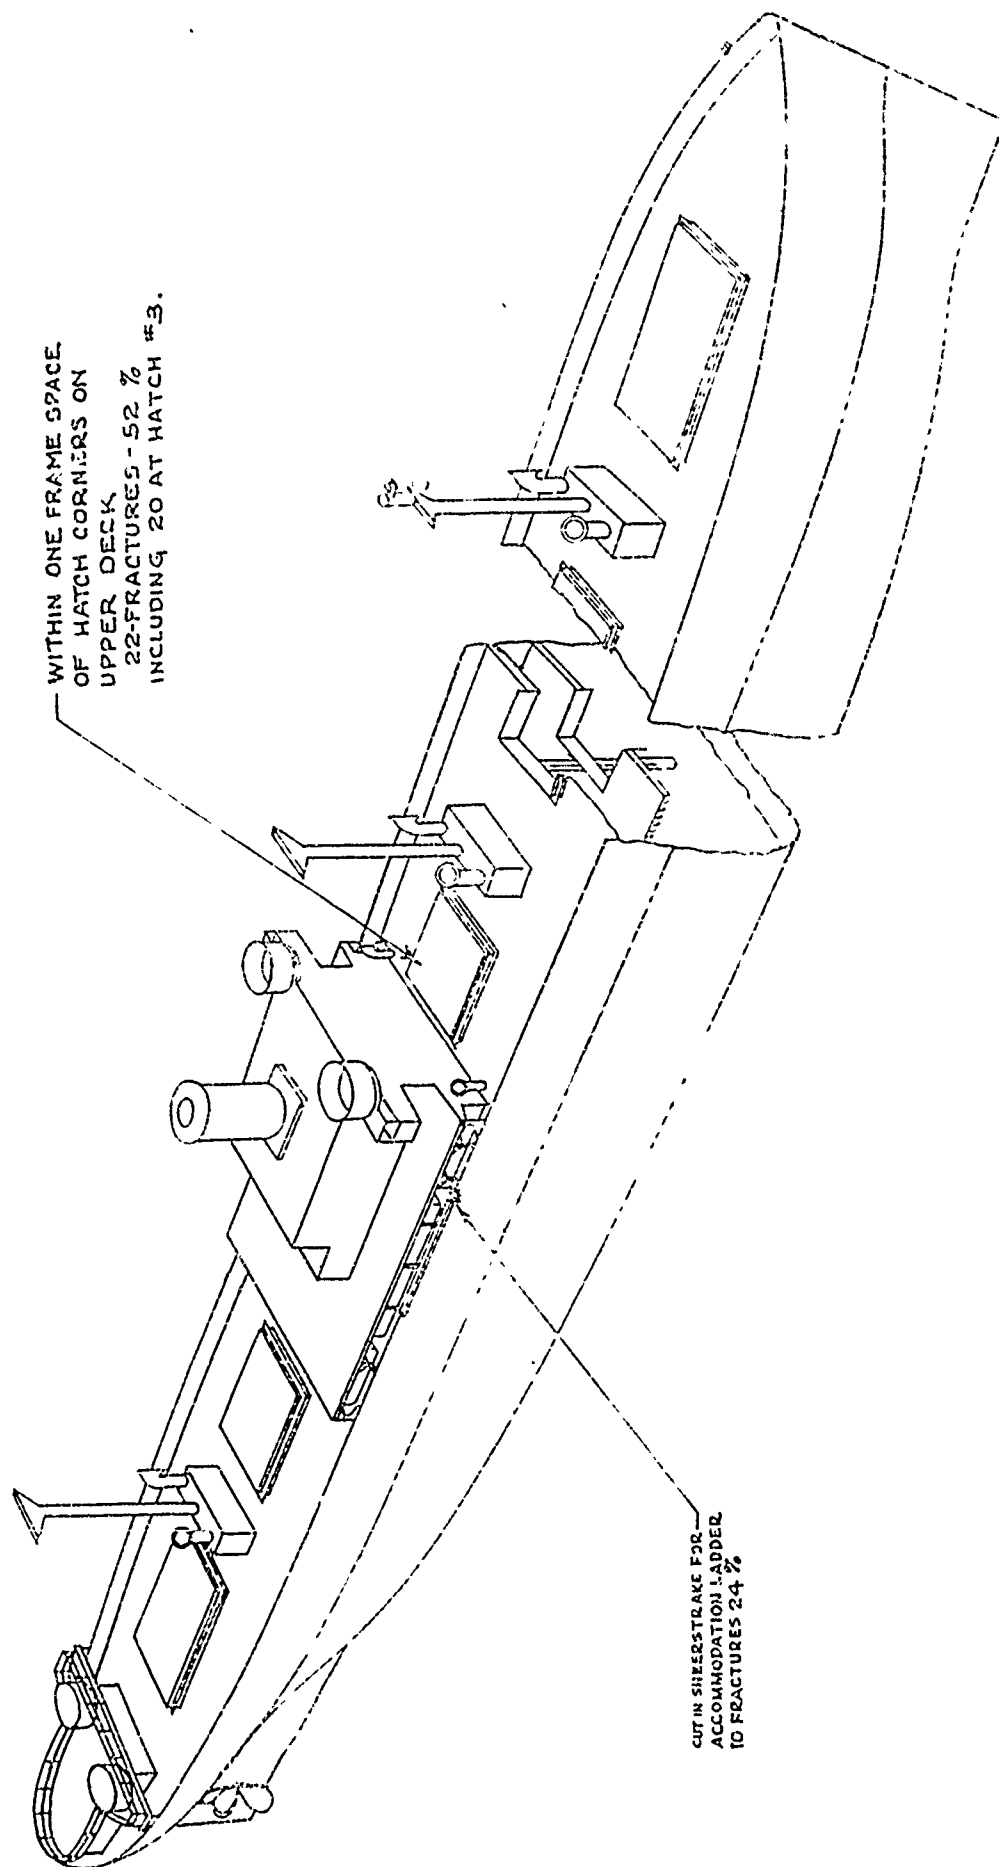
Figure 32

what different, figure 32. In many cases, the damage was so extensive that the starting point was not located. For this reason, it is only possible to identify positively the starting point of 31 casualties involving 42 fractures. Ten of these fractures or 24 percent started in the sheer strake cut for the gangway ladder. 22 or 52 percent started in the hatch corner including 48 percent at No. 3 hatch.

DETAILS WITH ABNORMAL FREQUENCY OF FRACTURES
THESE DATA INCLUDE, 4-2 FRACTURES OF KNOWN
ORIGIN, OCCURRING BEFORE 1 AUG 45, AND WHICH
RESULTED IN CLASS 1 CASUALTIES

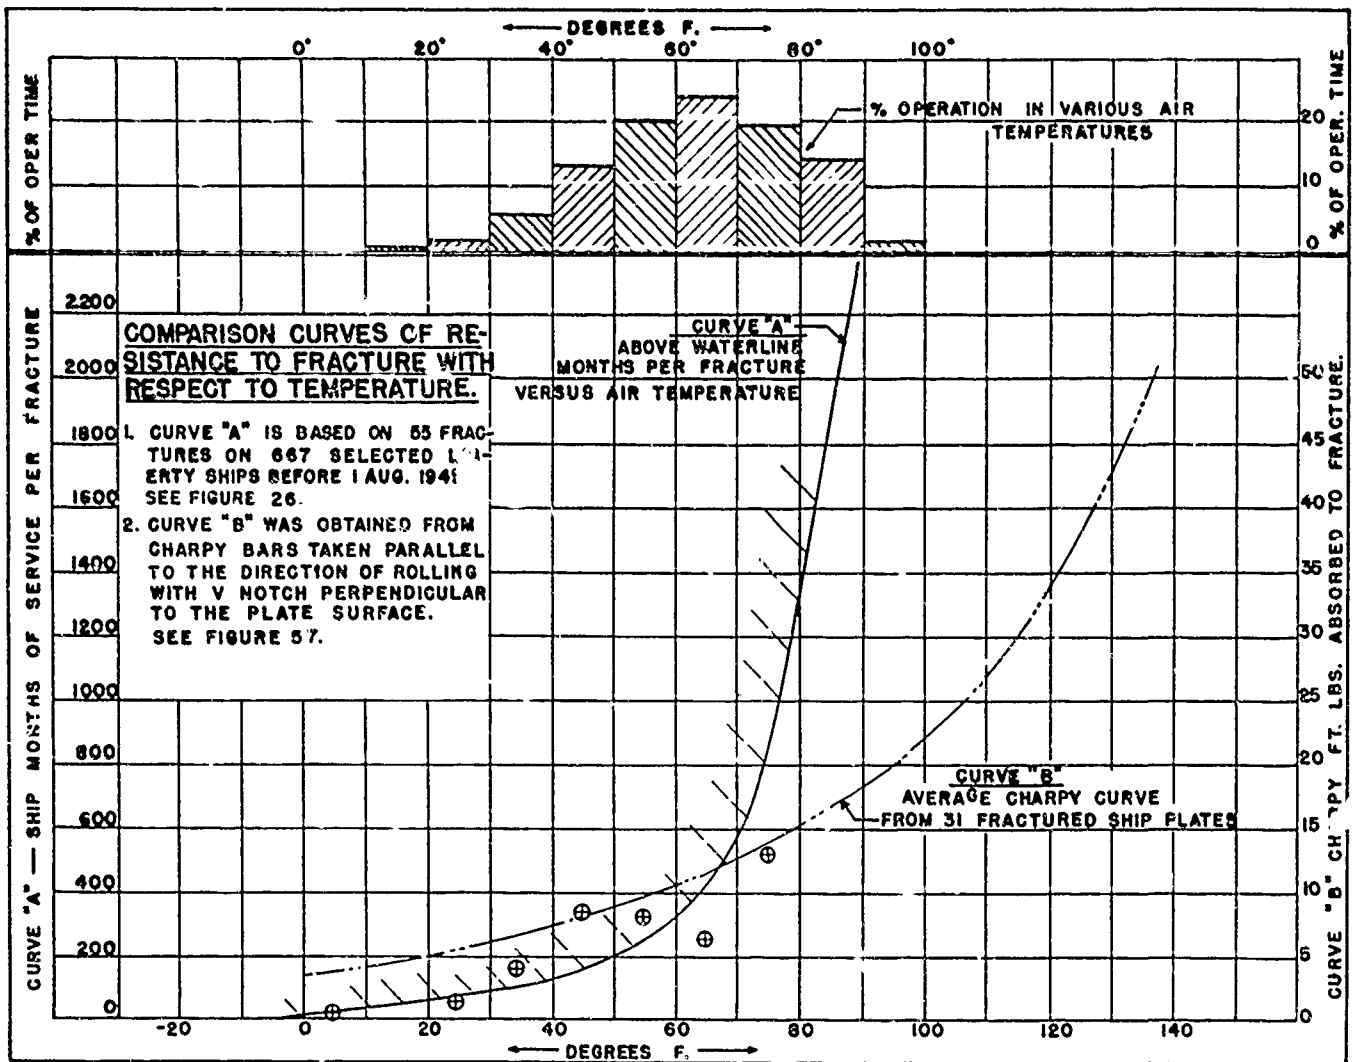
Figure 59.

This similarity is shown in figure 59 where the average curve for Group A from figure 57 is superimposed on another curve drawn from the data on service fractures. This second curve was obtained by plotting ship months per fracture, the simple reciprocal of the quotient "fractures per ship month" in figure 26. When these two curves are brought together, it appears that the ships lose heavily

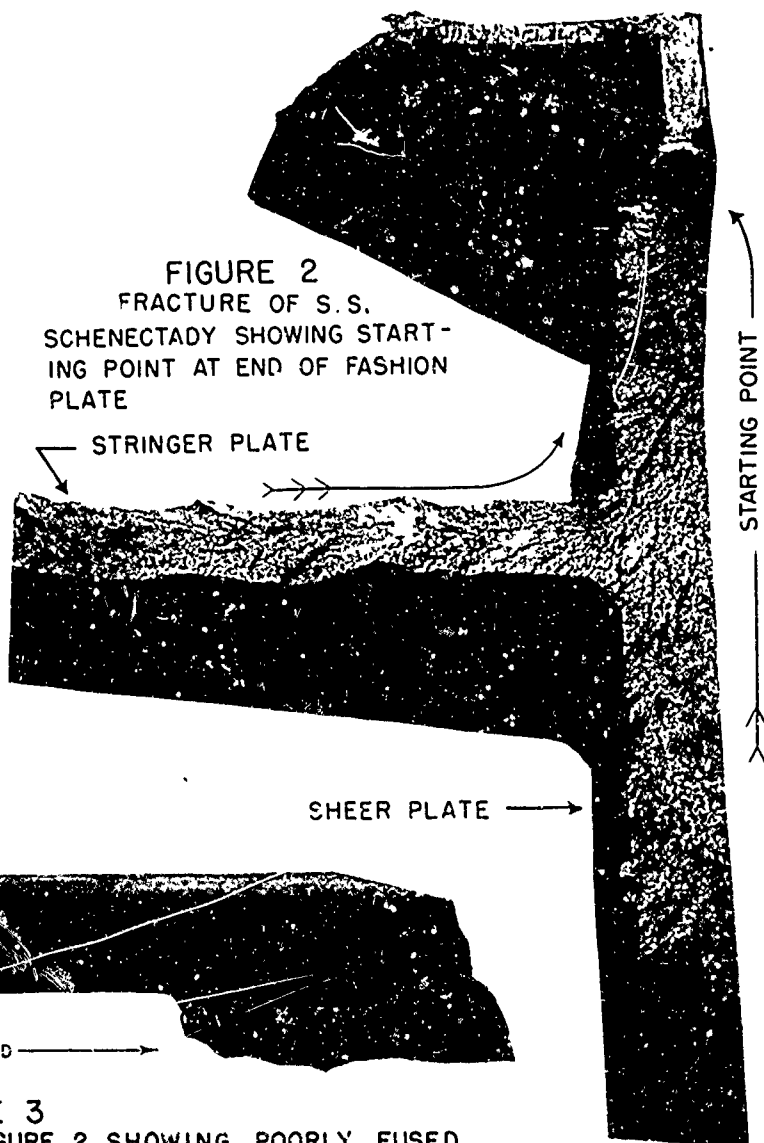
FIGURE 60.

FRACTURED 51* DECK PLATE FROM FIGURE 2 SHOWING POORLY FUSED WELD IN UPPER FLANGE OF LONGITUDINAL HATCH SIDE GIRDER.
