WT-74

# Operation UPSHOT-KNOTHOLE

Project 3.29

**BLAST EFFECTS OF ATOMIC WEAPONS  
UPON CURTAIN WALLS AND PARTITIONS  
OF MASONRY AND OTHER MATERIALS**

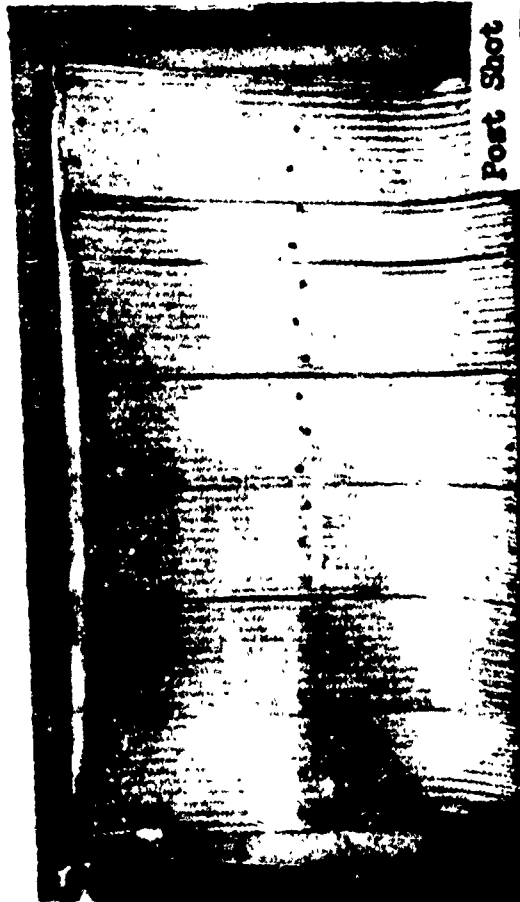
Fig. 2.14 Rear Wall - Cell No. 16a

The metal siding was in place but was bowed in from the top to bottom. The middle girt was sheared off its connection at the south edge with sheared bolts remaining in the wall. The bottom angle was ripped loose and tilted back 45°. The top girt was slightly bowed in.

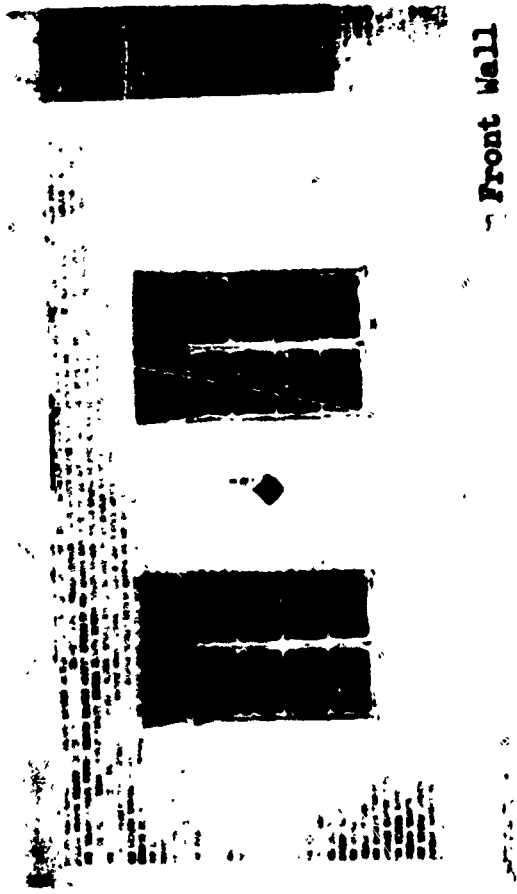
Fig. 2.48 Post Shot Photography - Cell No. 1b

The front wall was spalled at the top on the outside face. The window frames were bowed in slightly at the cross rail.

The rear wall was marked on the inside face and spalled on the outside face at the top, north edge.

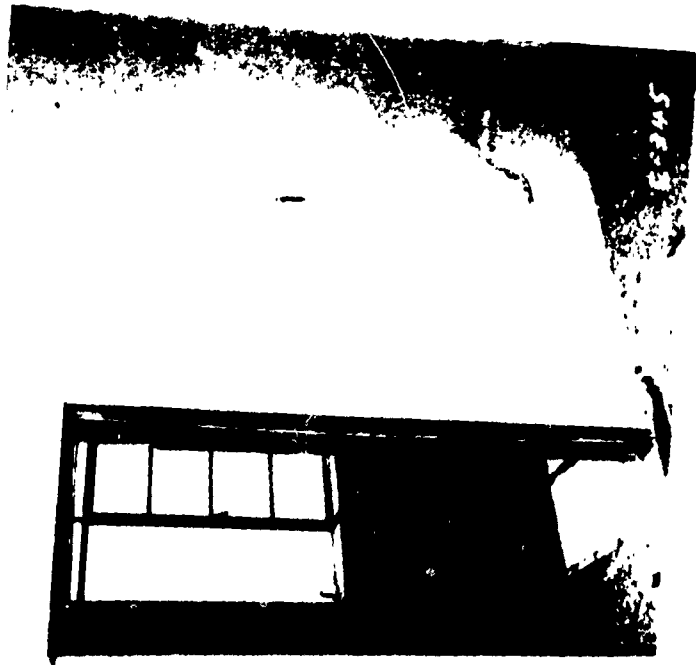
Fig. 2.49 Post Shot - Interior - Cell No. 1b

The front partition had its door torn out and was badly cracked. It was slightly bowed.

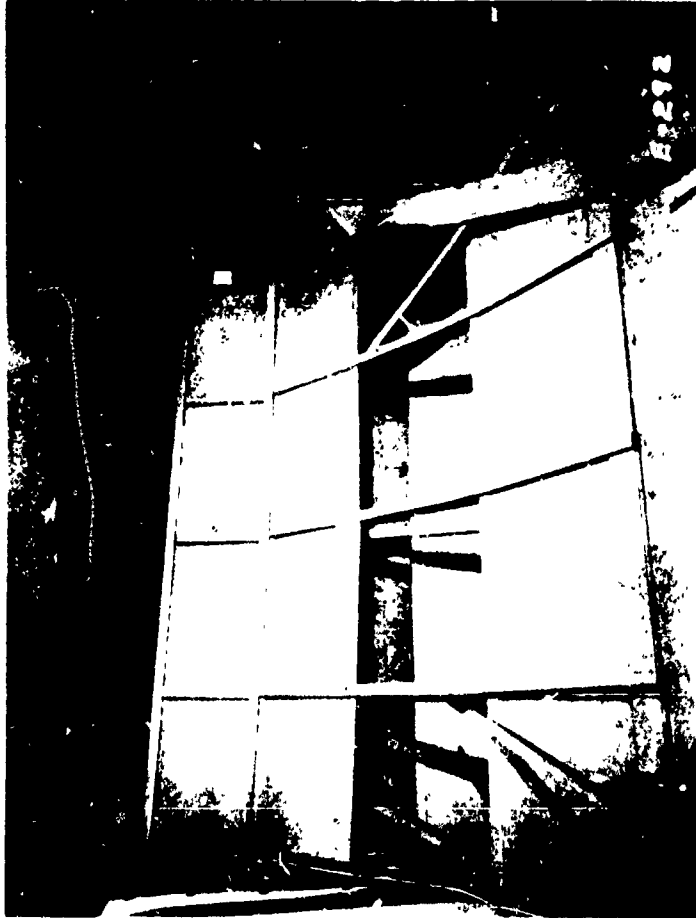
Fig. 2.68 Post Shot - Interior - Cell No. 6b

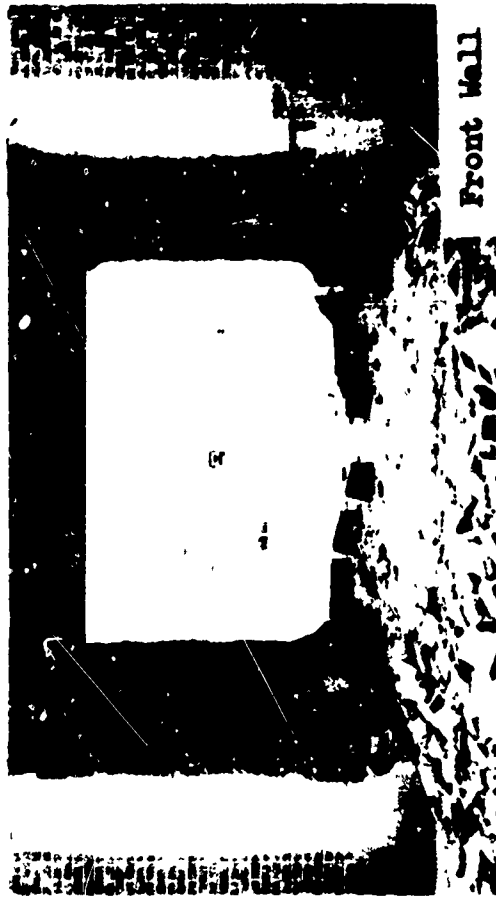
Fig. 2.109 Post Shot Photography - Cell No. 2c

The front and rear walls were blown through the rear of the cell. Rubble from the walls was found 60 feet to the rear of the structure.

The measured, pre shot, natural frequencies of the front and rear walls were 68.8 cps and 34.7 cps, respectively.

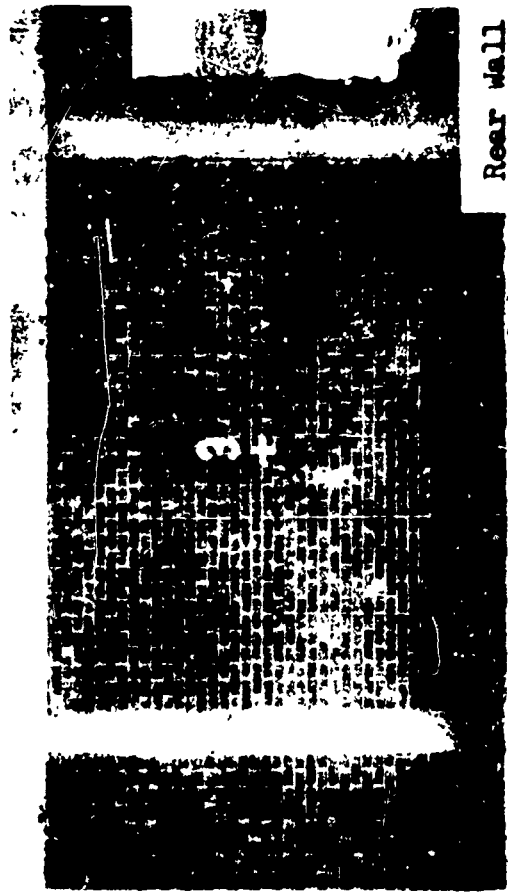
Fig. 2.112 Post Shot Photography - Cell No. 3c

The rear wall was slightly spalled, at the top and the north edge, on the outside face.

The measured, pre shot, natural frequency of the front wall was 41.7 cps. For the rear wall, the measured pre shot and post shot, natural frequencies were 40.3 cps and 36.1 cps, respectively.

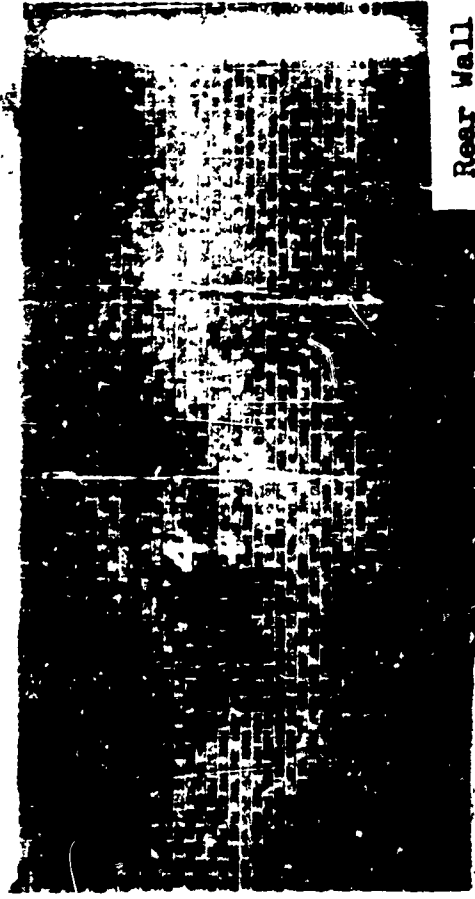
Fig. 2.114 Post Shot Photography - Cell No. 4c

The rear wall was cracked down the middle of the outside face and bowed out 3 in. to 4 in. at the top center and 1 in. to 2 in. at the bottom center. The south edge and lower half of the north edge were in place; the upper half of the north edge pushed out up to 1 in. The inside face was bowed out at the center and was cracked vertically near the side edges with several holes punched in the block cells.

The measured, pre shot, natural frequency of the front wall was 26.5 cps. For the rear wall, the measured, pre shot and post shot, natural frequencies were 31.2 cps and 36.3 cps, respectively.

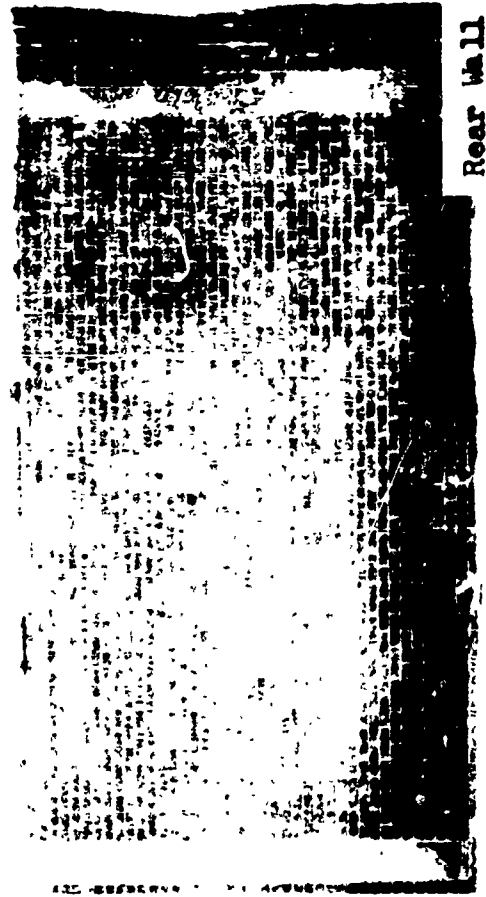
Fig. 2.116 Post Shot Photography - Cell No. 5c

The rear wall was spalled at the top and bottom of the outside face and bowed out at the top center about 1 in. with a vertical crack halfway down the middle. The outside face was also spalled at the lower north end. The inside face had minor missile damage.

The measured, pre shot and post shot, natural frequencies of the rear wall were 25.1 cps and 5.3 cps, respectively. For the front wall, the measured, pre shot, natural frequency was 23.2 cps.

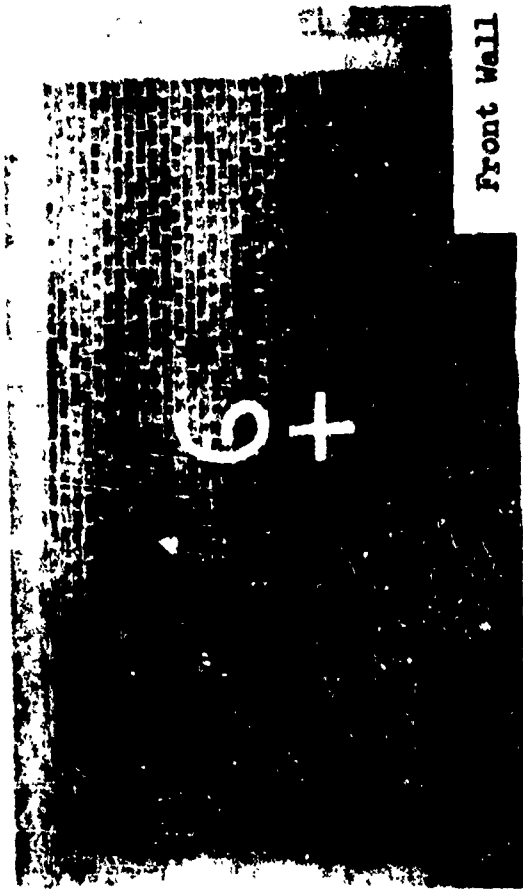
Fig. 2.119 Post Shot Photography - Cell No. 6c

The rear wall was spalled, at the top, on the outside face and was missile marked on the inside face.

The measured, pre shot, natural frequencies of the front and rear walls were 30.4 cps and 32.2 cps, respectively. The measured, post shot, natural frequency of the rear wall was 41.6 cps.

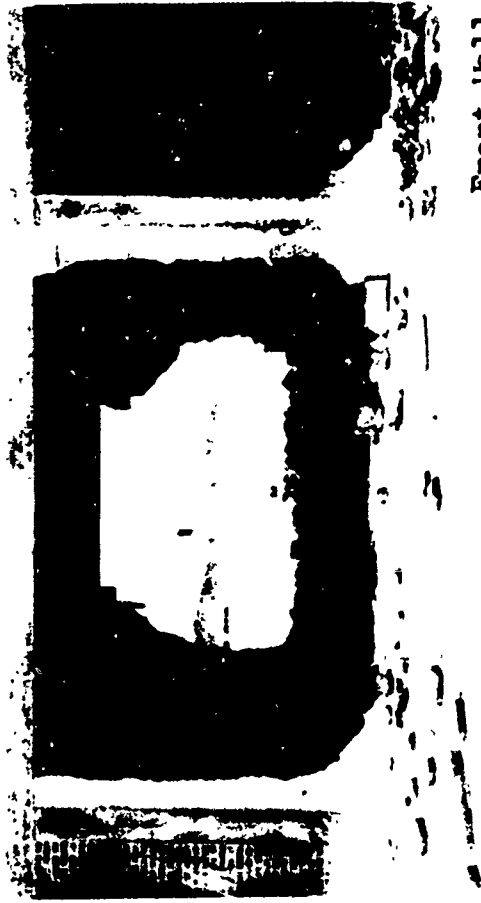
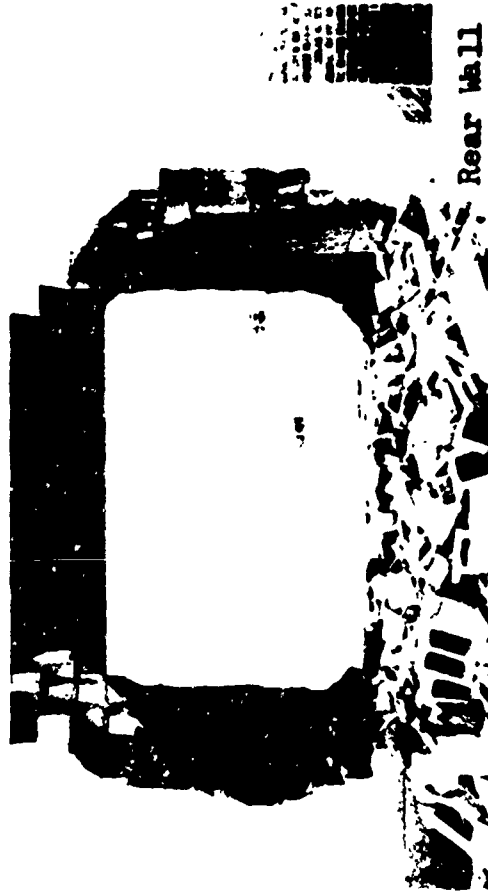
Fig. 2.124 Post Shot Photography - Cell No. 7c

The rear wall was 80 percent blown into the rear yard. Most of the debris from both walls was in the rear yard with rubble of block size as a maximum.

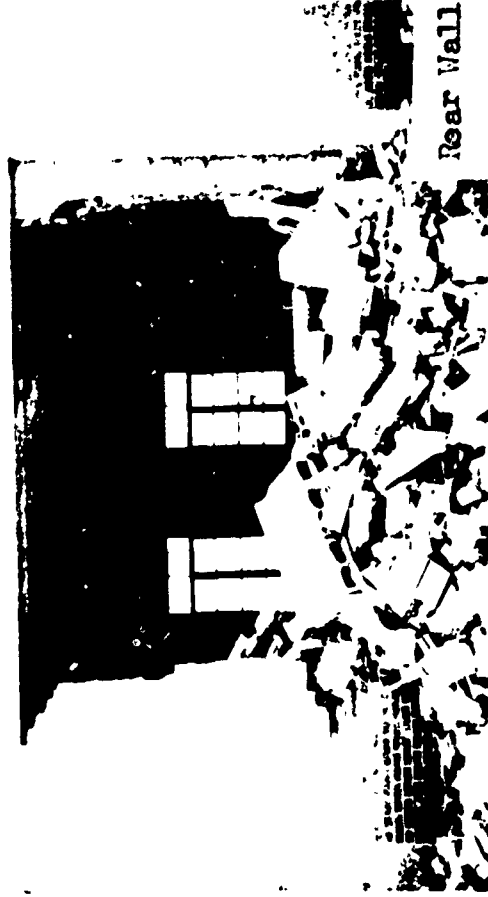
Fig. 2.204 Post Shot Photography - Cell No. 12d

The front wall was bowed in 1/2 in. at the top center. The center section was bowed in 1/8 in. to 1/4 in. at the sill line. The outside face, center section, had a crack along the sill line. Some other minor cracking and spalling was shown on the outside face. The window frames were bowed in. The inside face had a cinder block over the north window broken off. The lintels were blown part of the way out on the inside face.

The rear wall was blown out except for 1 ft at the south edge and 5 ft of cinder block and larger area of brick wall at the north edge. The debris was piled 5 ft high behind the front partition.

The measured, pre shot and post shot, natural frequencies of the front wall were 35.5 cps and 19.5 cps, respectively. For the rear wall, the measured, pre shot, natural frequency was 44.4 cps.

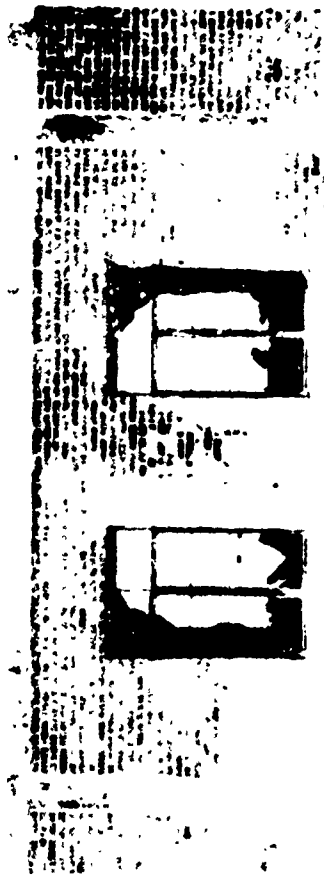
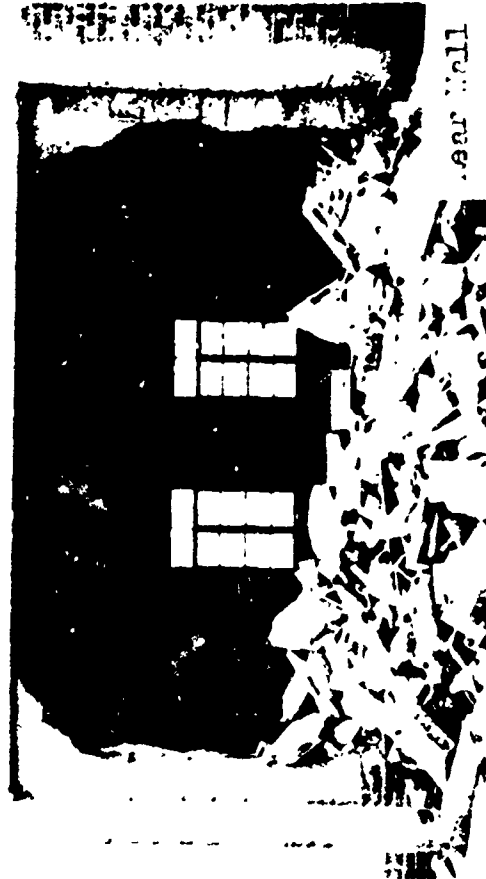
Fig. 2.208 Post Shot Photography - Cell No. 13d

The front wall was bowed out in the center, 3/8 in. The center section was cracked, on the outside face, at the sill line and bowed in 1/8 in. The outside face was spalled at the top and had minor cracking at the upper corners of the windows. The inside face was cracked at the 2nd and 4th block in the center section and had a diagonal crack in the cinder block above the southern window.

The rear wall was blown out except for 1 ft at the edges.

The measured, pre shot and post shot natural frequencies of the front wall were 34.4 cps and 18.6 cps, respectively. For the rear wall, the measured, pre shot, natural frequency was 55.4 cps.

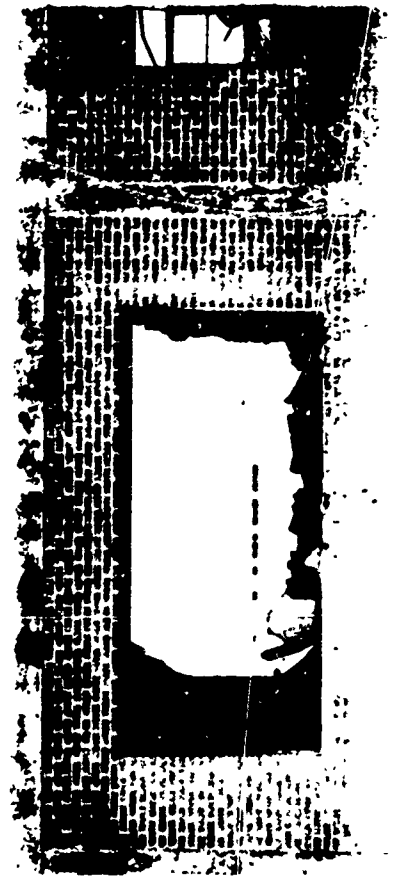
Fig. 2.214 Post Shot Photography - Cell No. 15d

The front wall was bowed in 1/4 in. at the top and bottom with a vertical crack in the center, above and below the window. The window was broken into 3 sections and blown into the cell with the inner angle of the lintel blown down.

The rear wall was blown out except for 1 ft at the edges.

The measured, pre shot, natural frequency of the rear wall was 51.9 cps.

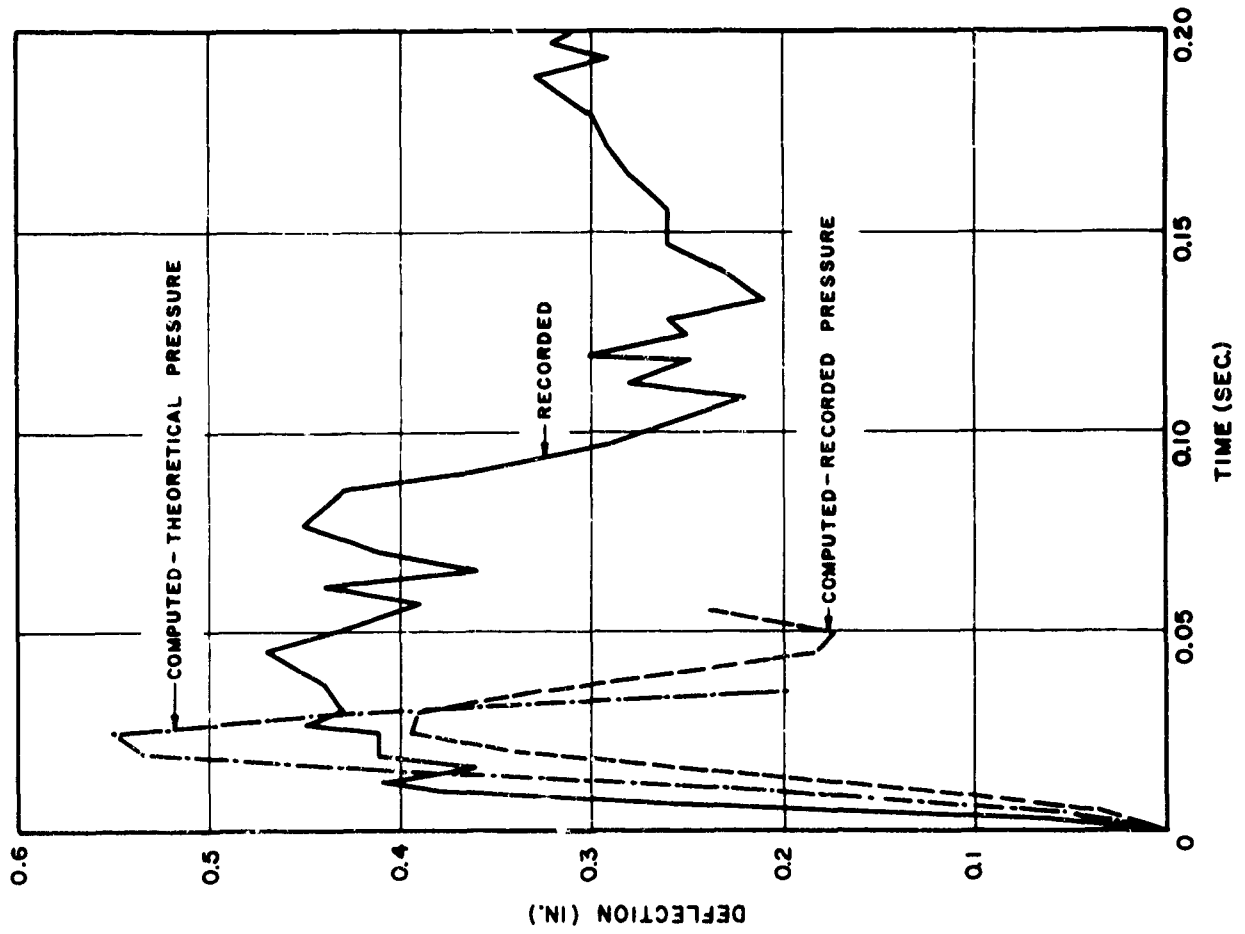
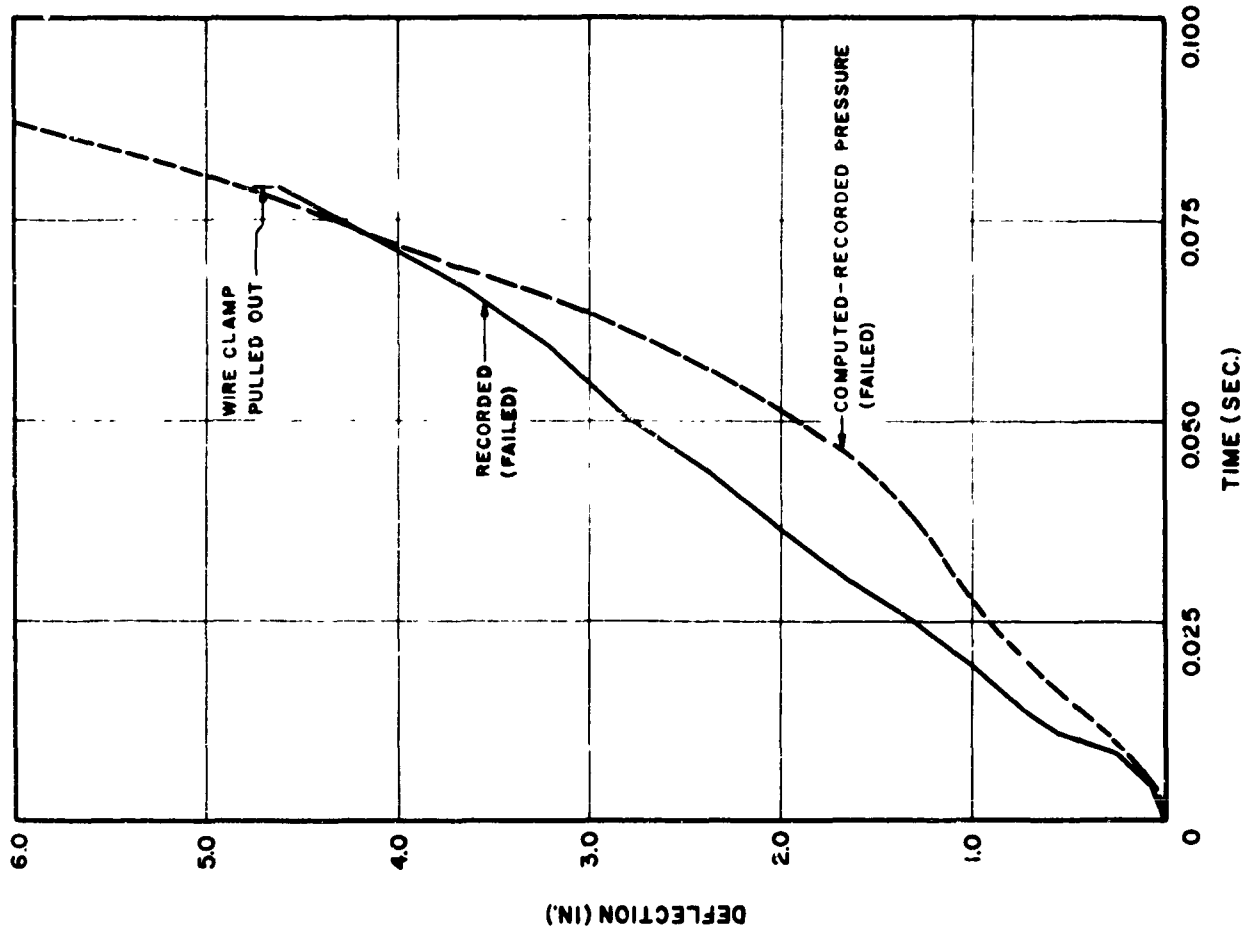
Fig. 3.5 Comparison of Recorded and Computed Deflections - Bldg. 3.49a - Panel 1F

Panel 1F. The comparison between computed and recorded response for Panel 1F (Figures 3.5 and 3.6), a 12-inch brick wall at both ranges, was extremely good. At the far range good agreement was obtained using both recorded and theoretical pressures, while at the near range the recorded pressures indicated failure and the theoretical pressures indicated no failure. As a check on the assumed masonry mortar unit strength of

$f'_c = 1,000$  psi, the near range panel, which failed, was analyzed with the recorded pressures for an assumed strength of  $f'_c = 1,100$  psi. The resulting analysis showed that failure would not occur, indicating that values of  $f'_c$  greater than 1,000 psi would not be consistent with the theoretical resistance function.

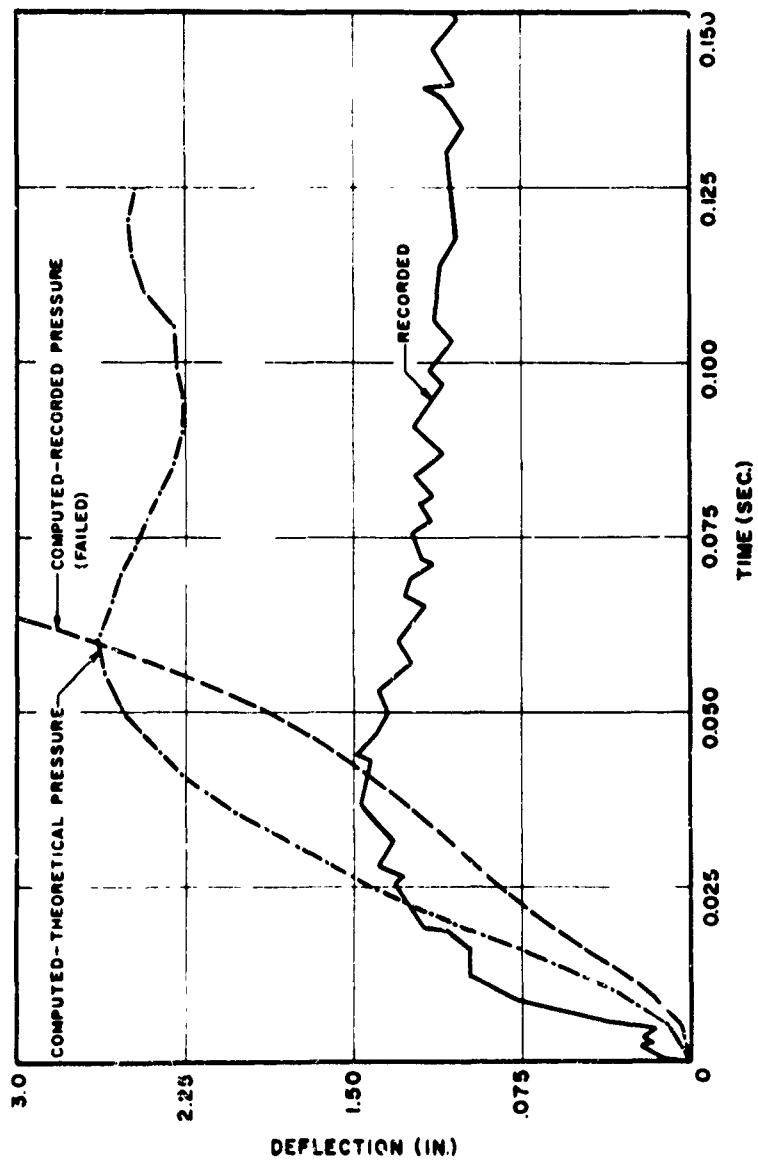
Fig. 3.7 Comparison of Recorded and Computed Deflections Bldg. 3.29a - Panel 10F

Panel 10 F. The computed response (using recorded pressures) for Panel 10F, a 4-inch-brick and 8-inch-block wall, at the far range (Figure 3.7) indicated that failure, which did not occur, would occur. A study was made to show the effect of possible variations in the strength (or the modulus of elasticity) of the masonry unit. The results of this study, as shown in Figure 3.8, demonstrate the sensitivity of the response function to small changes in strength. As shown, the computed response would compare extremely well with the recorded data if the assumed strength of the unit (1,000 psi) were to be increased by approximately 10 percent. The comparison between computed and recorded response for the corresponding panel at the near range (Figure 3.9) was satisfactory to the extent that failure was indicated by the analysis. The recorded response showed an initial time lag considerably larger than the response time of the recording instrument, otherwise the calculated response is shown to build up at a rate comparable to that of the recorded values.

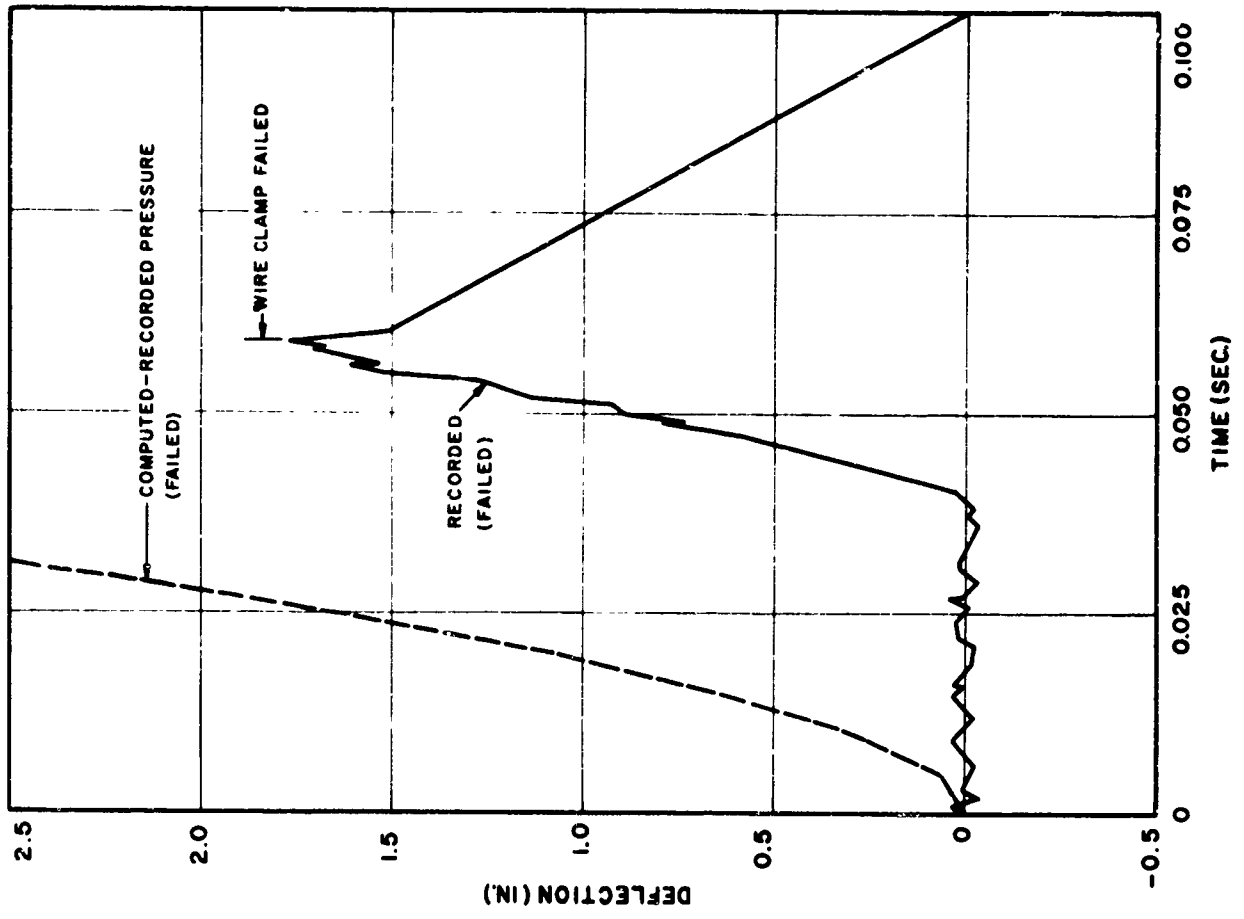
Fig. 3.10 Comparison of Recorded and Computed Deflections - Bldg. 3.29a - Panel 11F

Panel 11 F. The comparison between computed and recorded response for Panel 11F, a 4-inch-brick and 4-inch-block wall (Figure 3.10) at the far range, was satisfactory to the extent that failure was indicated by the analysis. Except for an initial time lag demonstrated by the recorded response, the rates of build-up of recorded and computed response compare extremely well. The corresponding panel at the near range also failed.

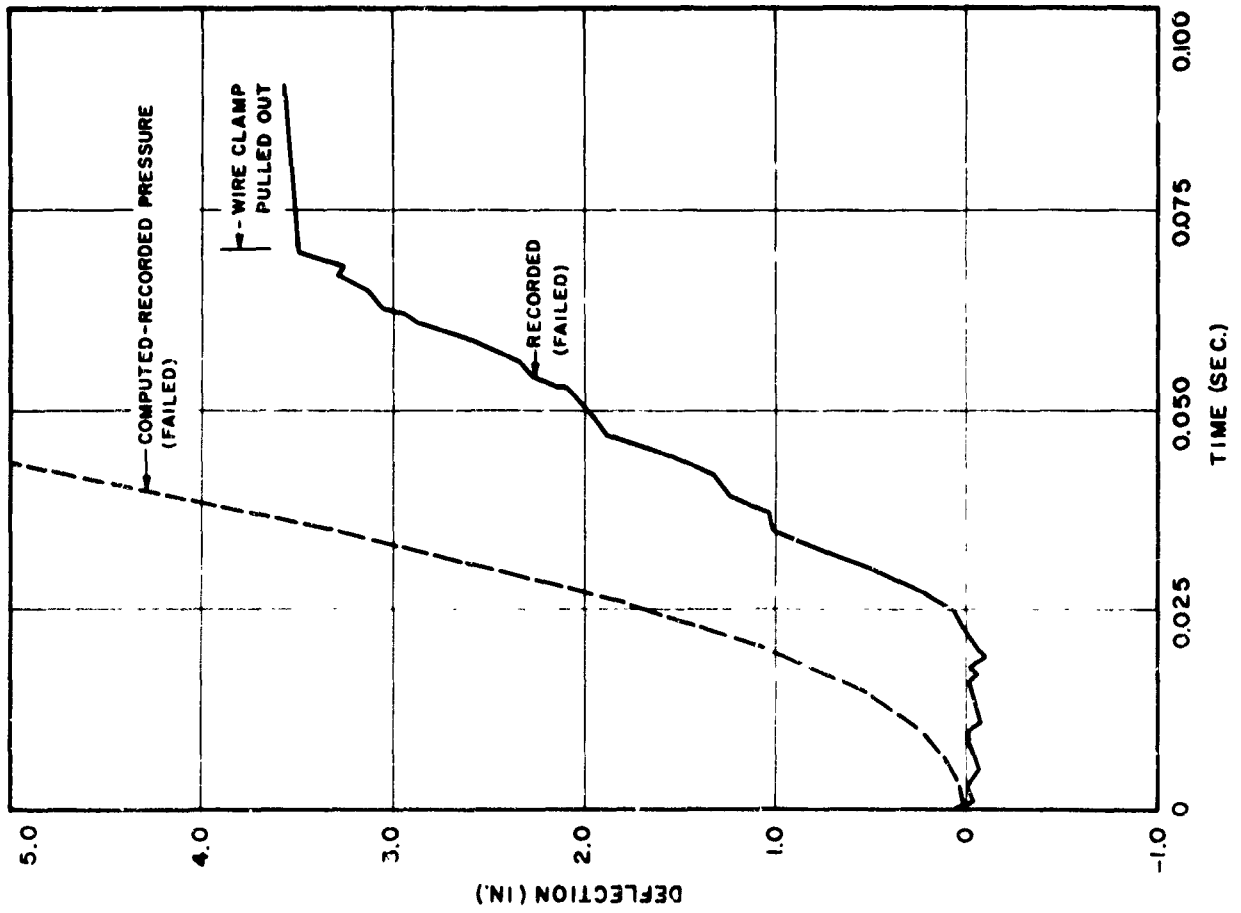
Fig. 3.11 Comparison of Recorded and Computed Deflections - Bldg. 3.29a - Panel 12F

Panel 12 F. The comparison between computed and recorded response for Panel 12F, a 4-inch-brick and 8-inch-block wall with a clearance of 0.75 inch between the top of the panel and the bottom of the roof slab (Figure 3.11) at the far range, was satisfactory to the extent that failure was indicated by the analysis. Except for an initial time lag demonstrated by the recorded response, the rates of build-up of recorded and computed response compare extremely well. The corresponding panel at the near range also failed.

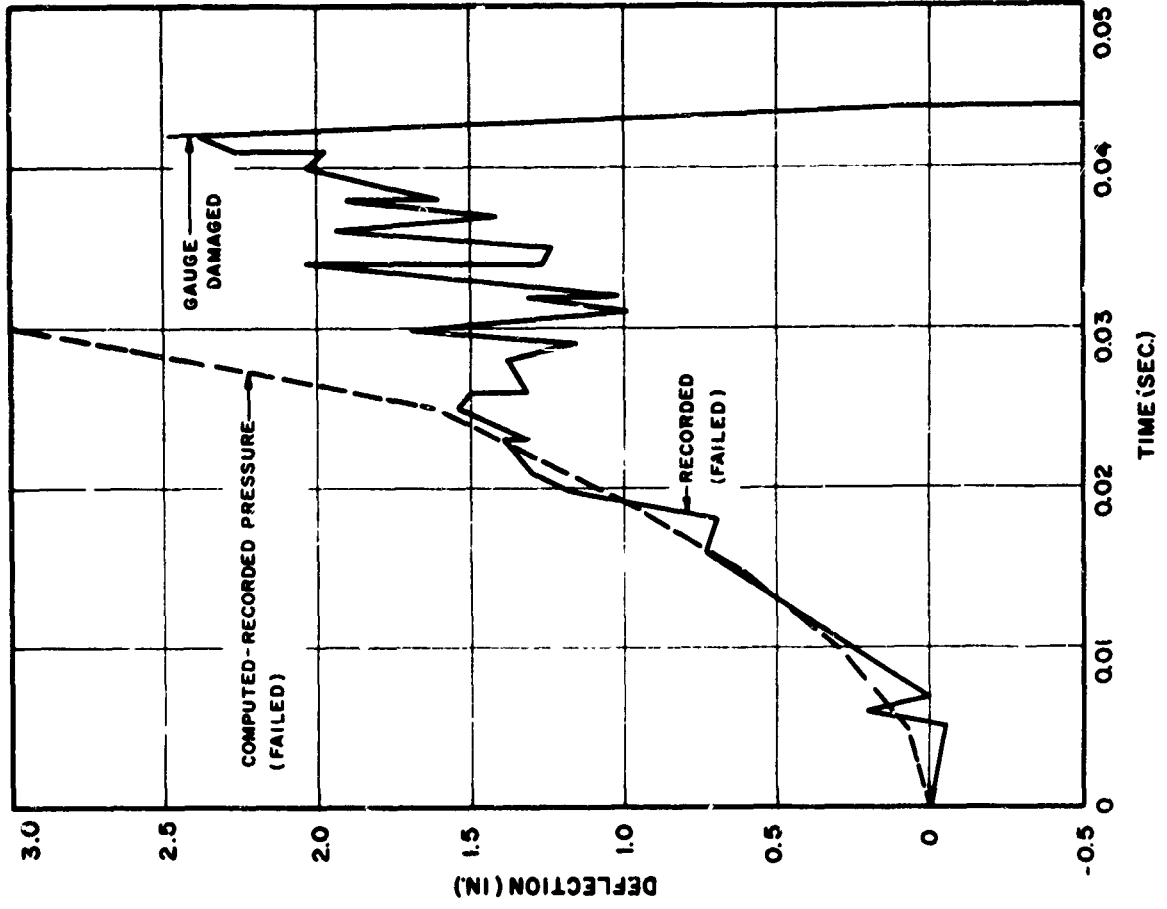
Fig. 3.12 Comparison of Recorded and Computed Deflections - Bldg. 3.29a - Panel 13F

Panel 13 F. The comparison between computed and recorded response for Panel 13F, a 4-inch-brick and 4-inch-tile wall (Figure 3.12) at the far range, was satisfactory to the extent that failure was indicated by the analysis. Very good agreement was obtained between the recorded and computed rates of build-up of the response function. The corresponding panel at the near range also failed.

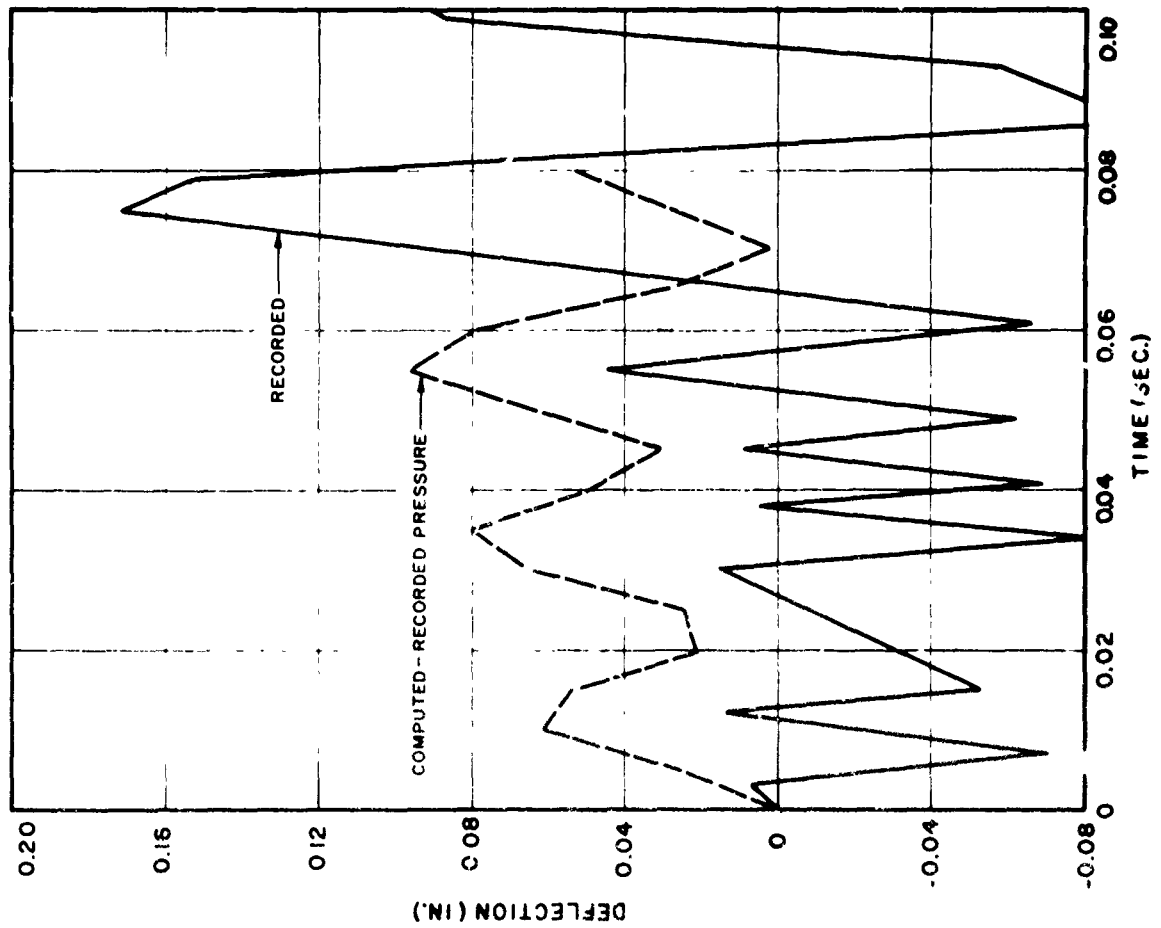
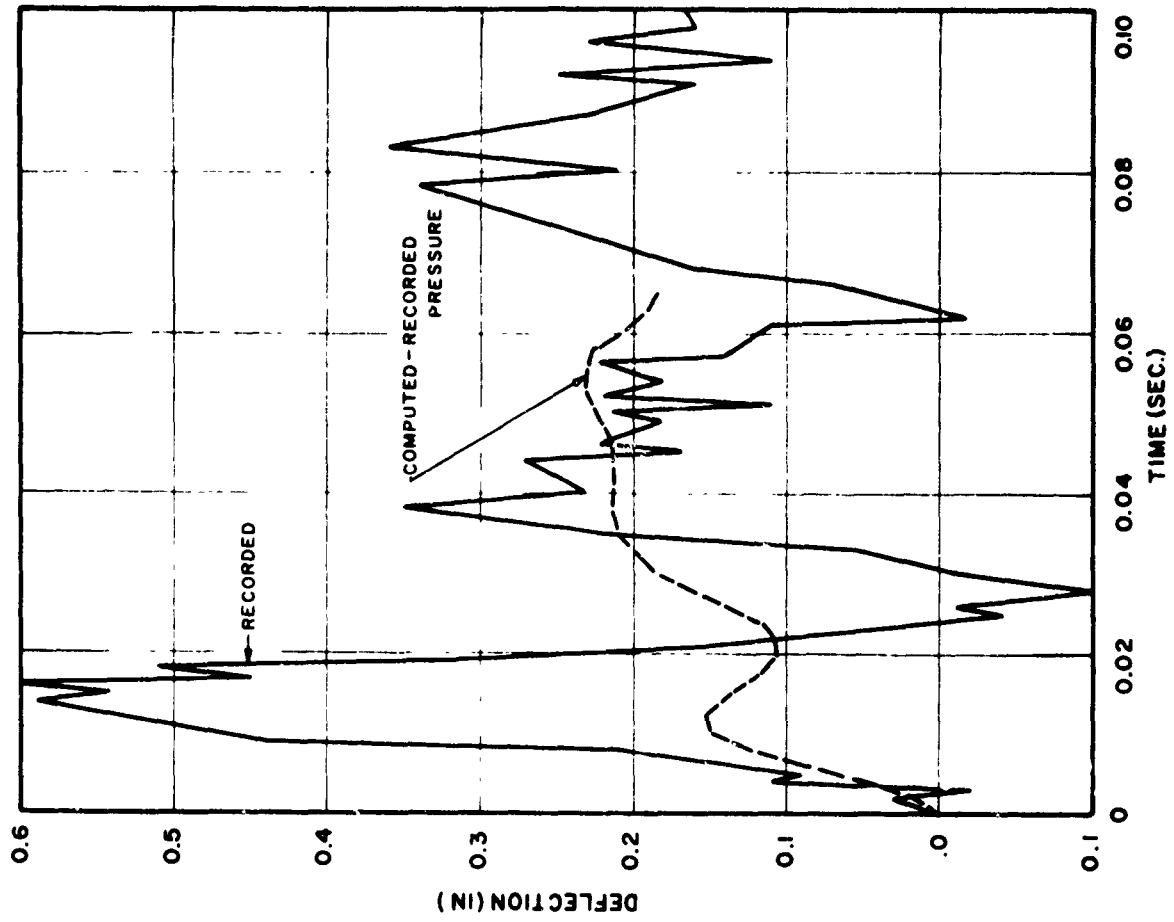
Fig. 3.13 Comparison of Recorded and Computed Deflections - Bldg. 3.29a - Panel 14F

Panel 14 F. The computed response values for Panel 14F, an 8-inch reinforced-concrete panel, restrained top and bottom (Figures 3.13 and 3.14) at both ranges, were lower than the recorded values. Closer agreement would be possible if the steel reinforcement, for which field test data is not available, were to exhibit a lower yield point than assumed for analysis, or if the panel reinforcing were not properly tied in at the roof or floor slab. Both panels showed better agreement when analyzed with the theoretical pressures.

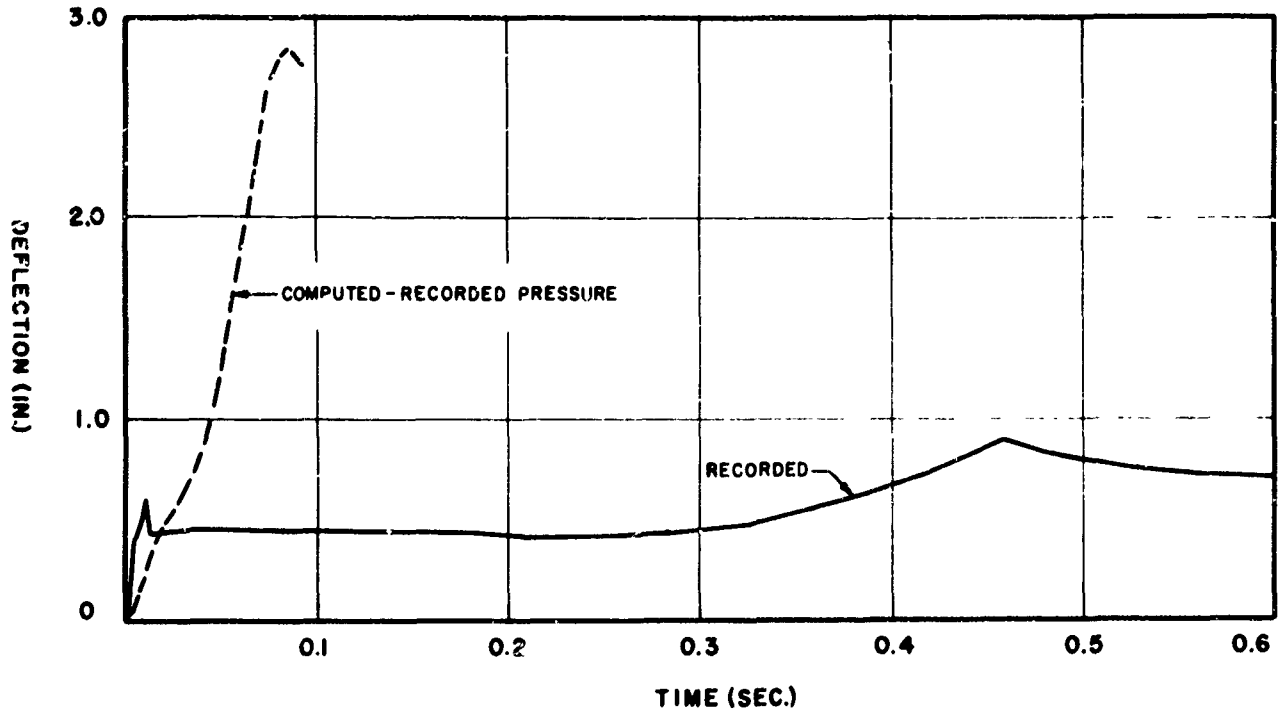
Fig. 3.15 Comparison of recorded and Computed Deflections - Bldg. 3.29c - Panel 15F

Panel 15 F. The resistance function for Panel 15F, a 12-inch reinforced-brick panel at the near range (Figure 3.15), is not as intended because of the field omission of negative-moment steel at the roof level. The panel deflected inward 1 foot along the top edge, and some extent of horizontal spanning was indicated by the presence of vertical cracks at the middle top third of the panel. Depending upon the tightness of the mortar joint at the roof level, the amount of cracking in the panel, and the magnitude of the vertical load, it is possible that the initial behavior of the panel was between that of a cantilever and a fixed-pinned member. The panel evidently did not develop a sufficient horizontal reaction at the roof level, and the effect of horizontal spanning may have prevented
