**U.S. Naval Supply Research & Development Facility  
Bayonne, New Jersey**

INTERIM REPORT ON THE INSTALLATION

CARBON MONOXIDE ELIMINATOR MUFFLERS

ENGINEERING REPORT NO. 5.2120  
Project Group No. NT-003-020(b)

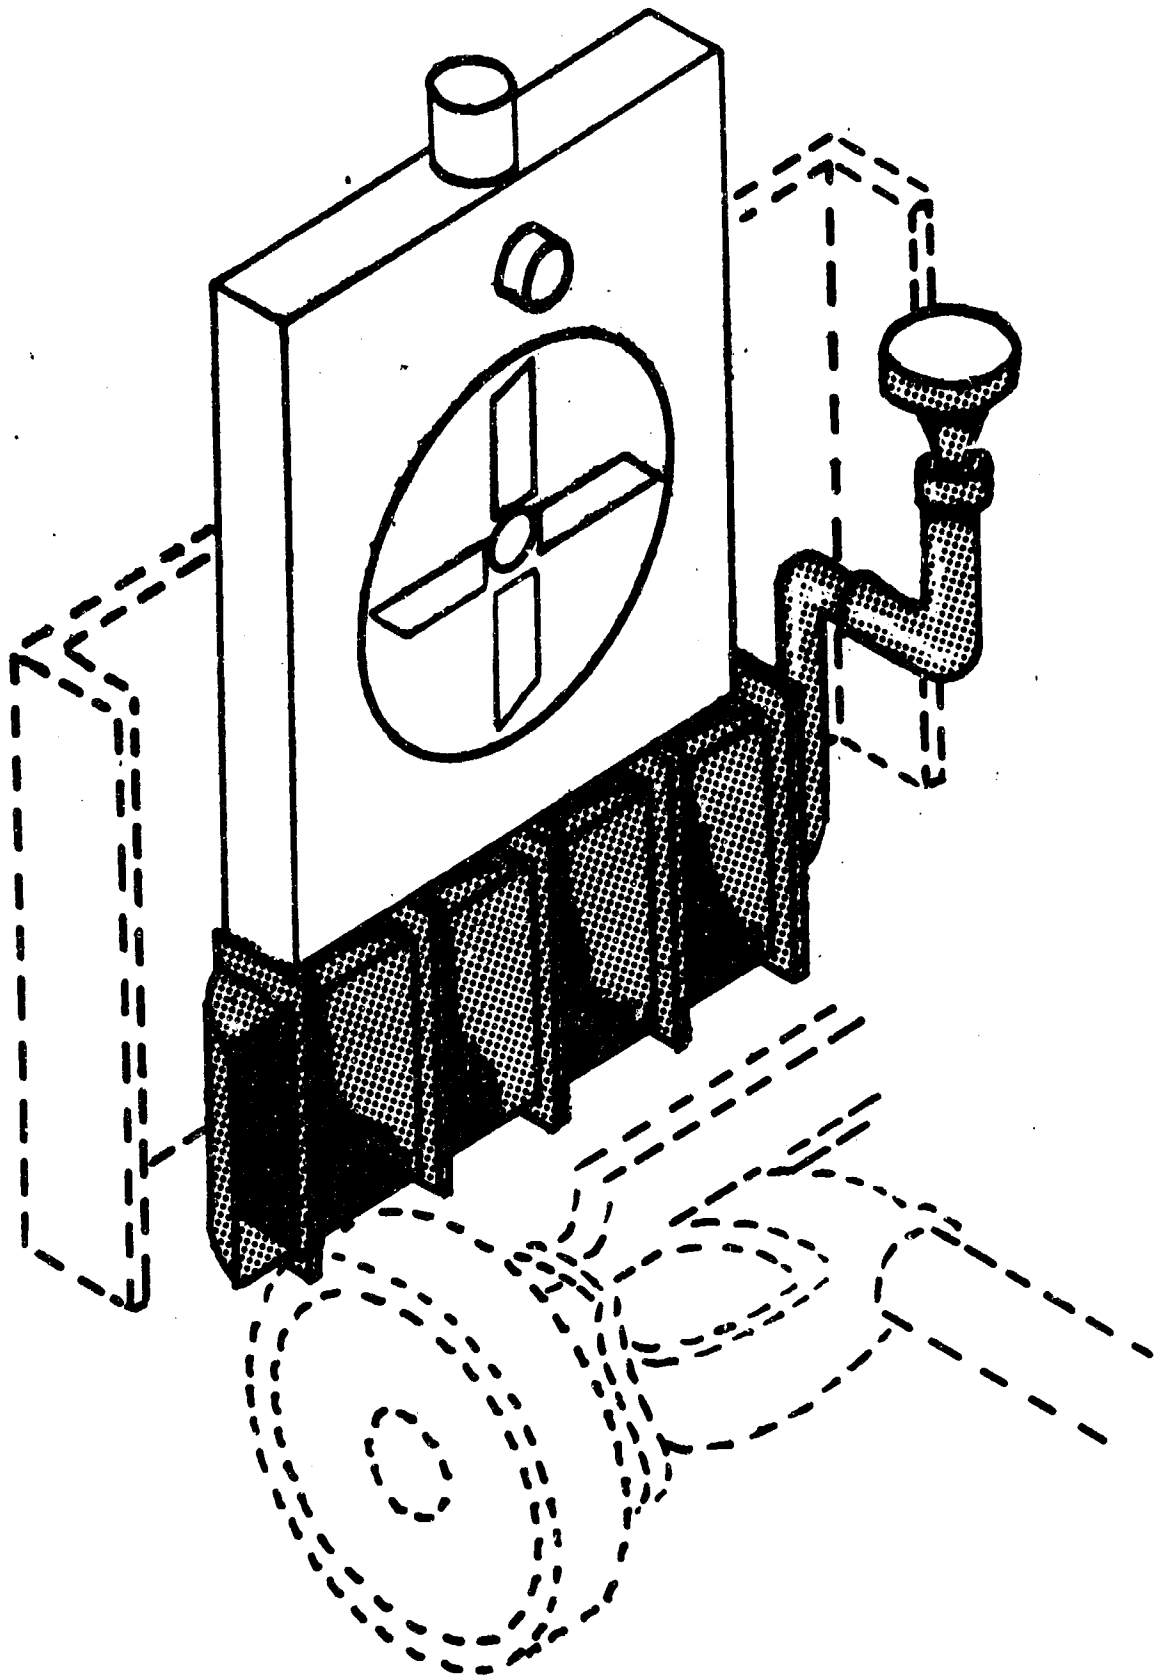
**FIG. 10**

**POSITION OF MUFFLER AS INSTALLED ON 6000 LB. FORK TRUCK.**

The Safety Department at Norfolk has commented on the installation of this muffler. They have recommended that the direction of the exhaust outlet be changed so that exhaust gas and the occasional sparks coming out of the muffler opening would be directed toward the floor rather than forward along the side of the engine.
