POSTIRRADIATION EXAMINATION OF THE
PM-3A TYPE 1 SERIAL 2 CORE
PART I. POSTIRRADIATION EXAMINATION
OF FUEL TUBES

February 28, 1967

John B. Brown, Victor W. Storhok, and John E. Gates

BATTELLE MEMORIAL INSTITUTE
Columbus Laboratories
505 King Avenue
Columbus, Ohio 43201

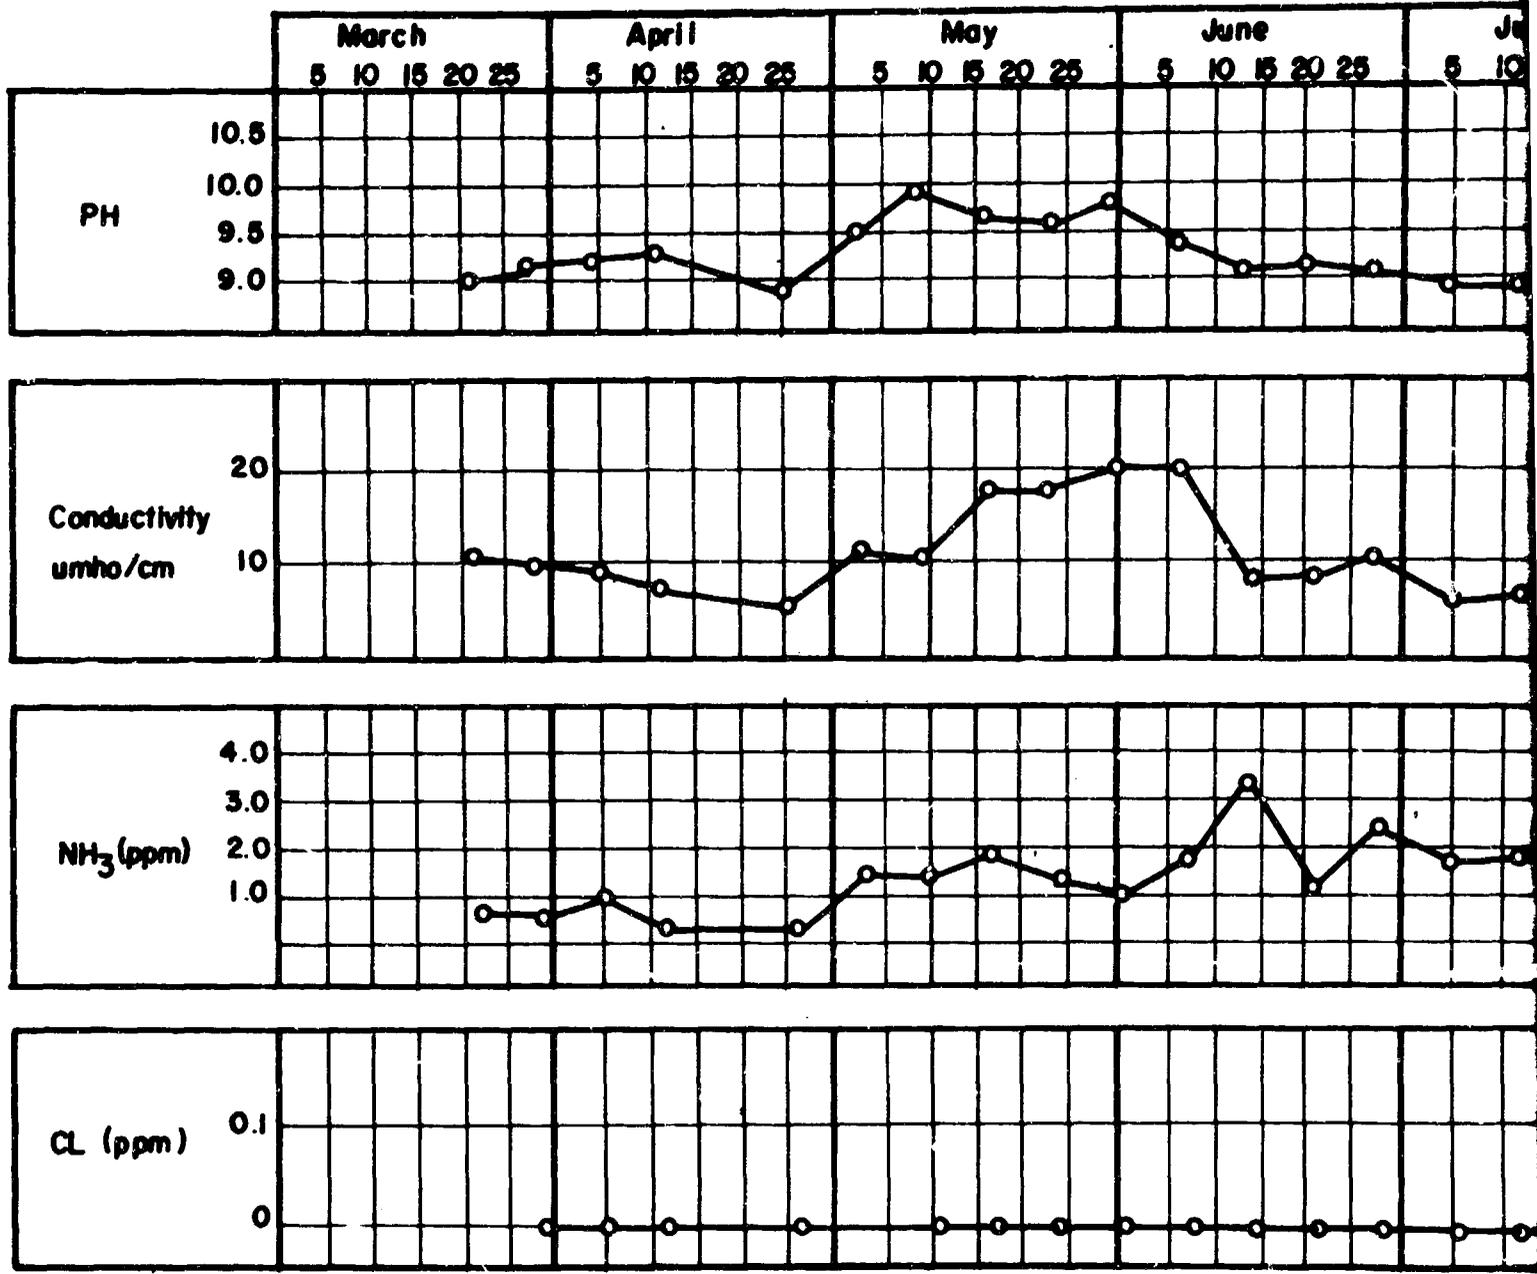
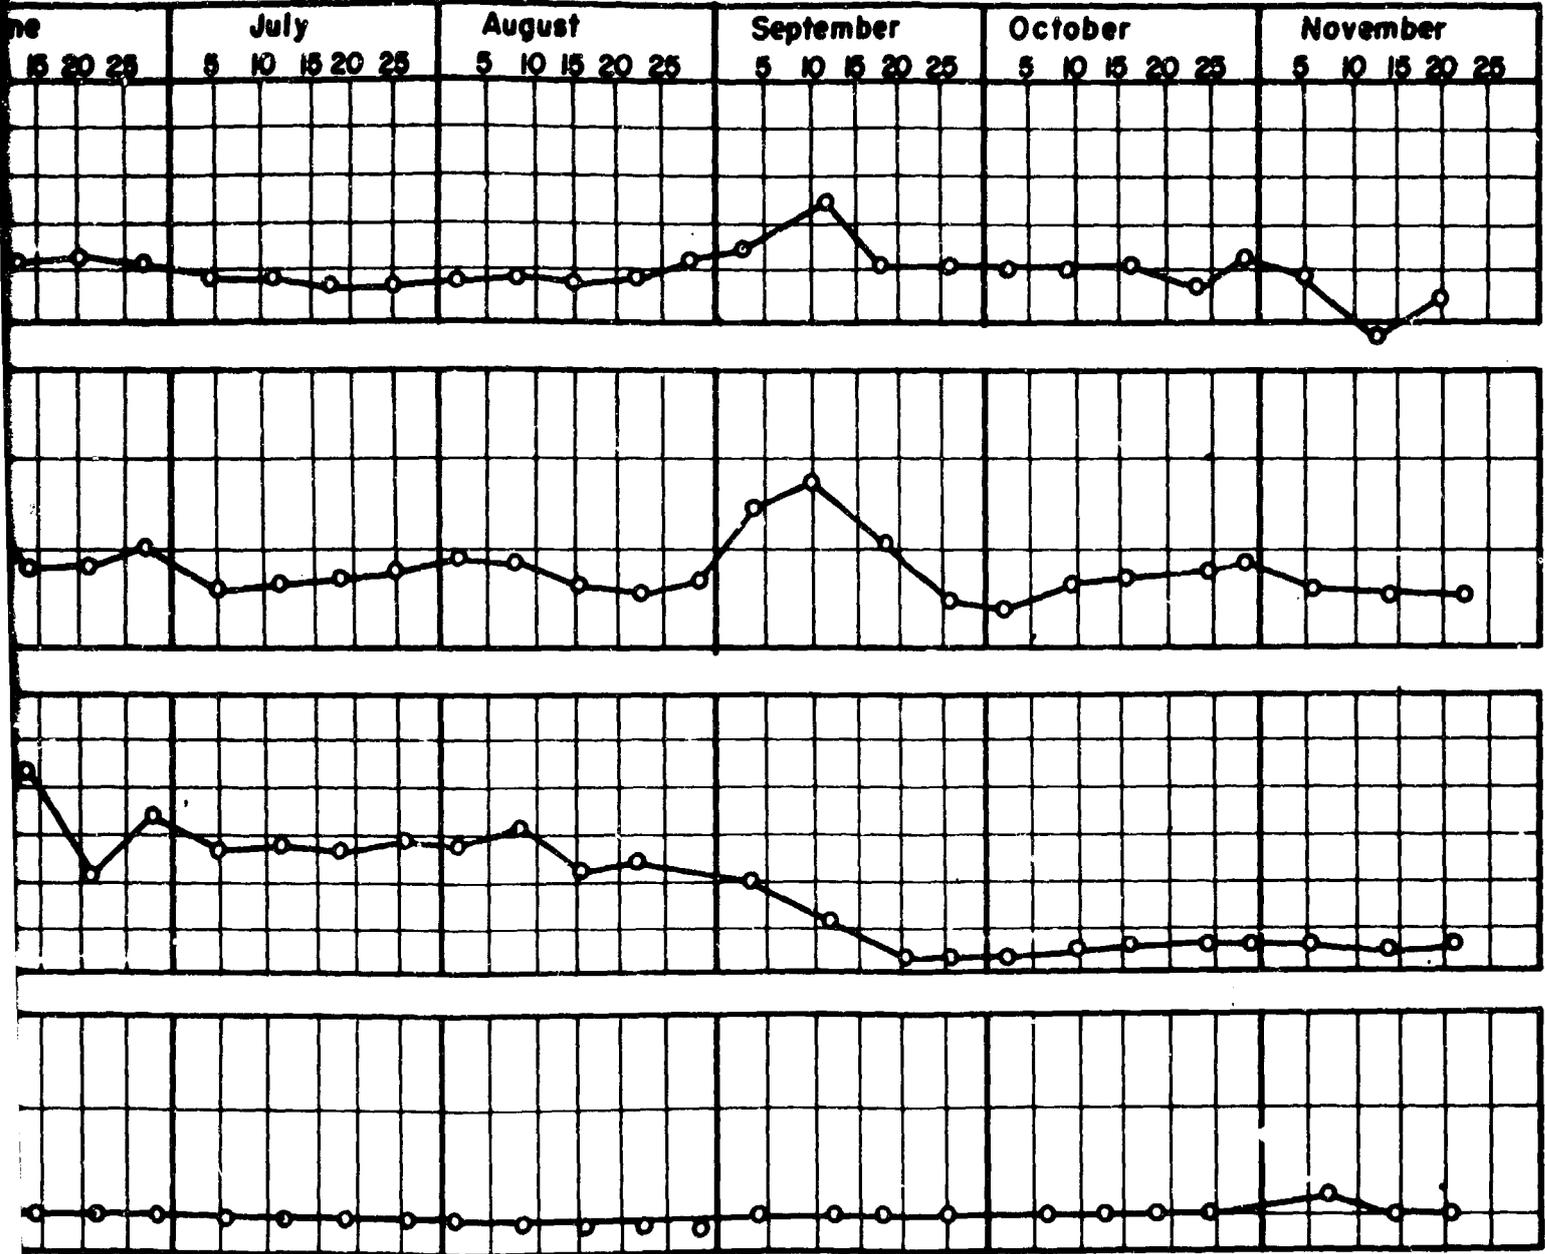
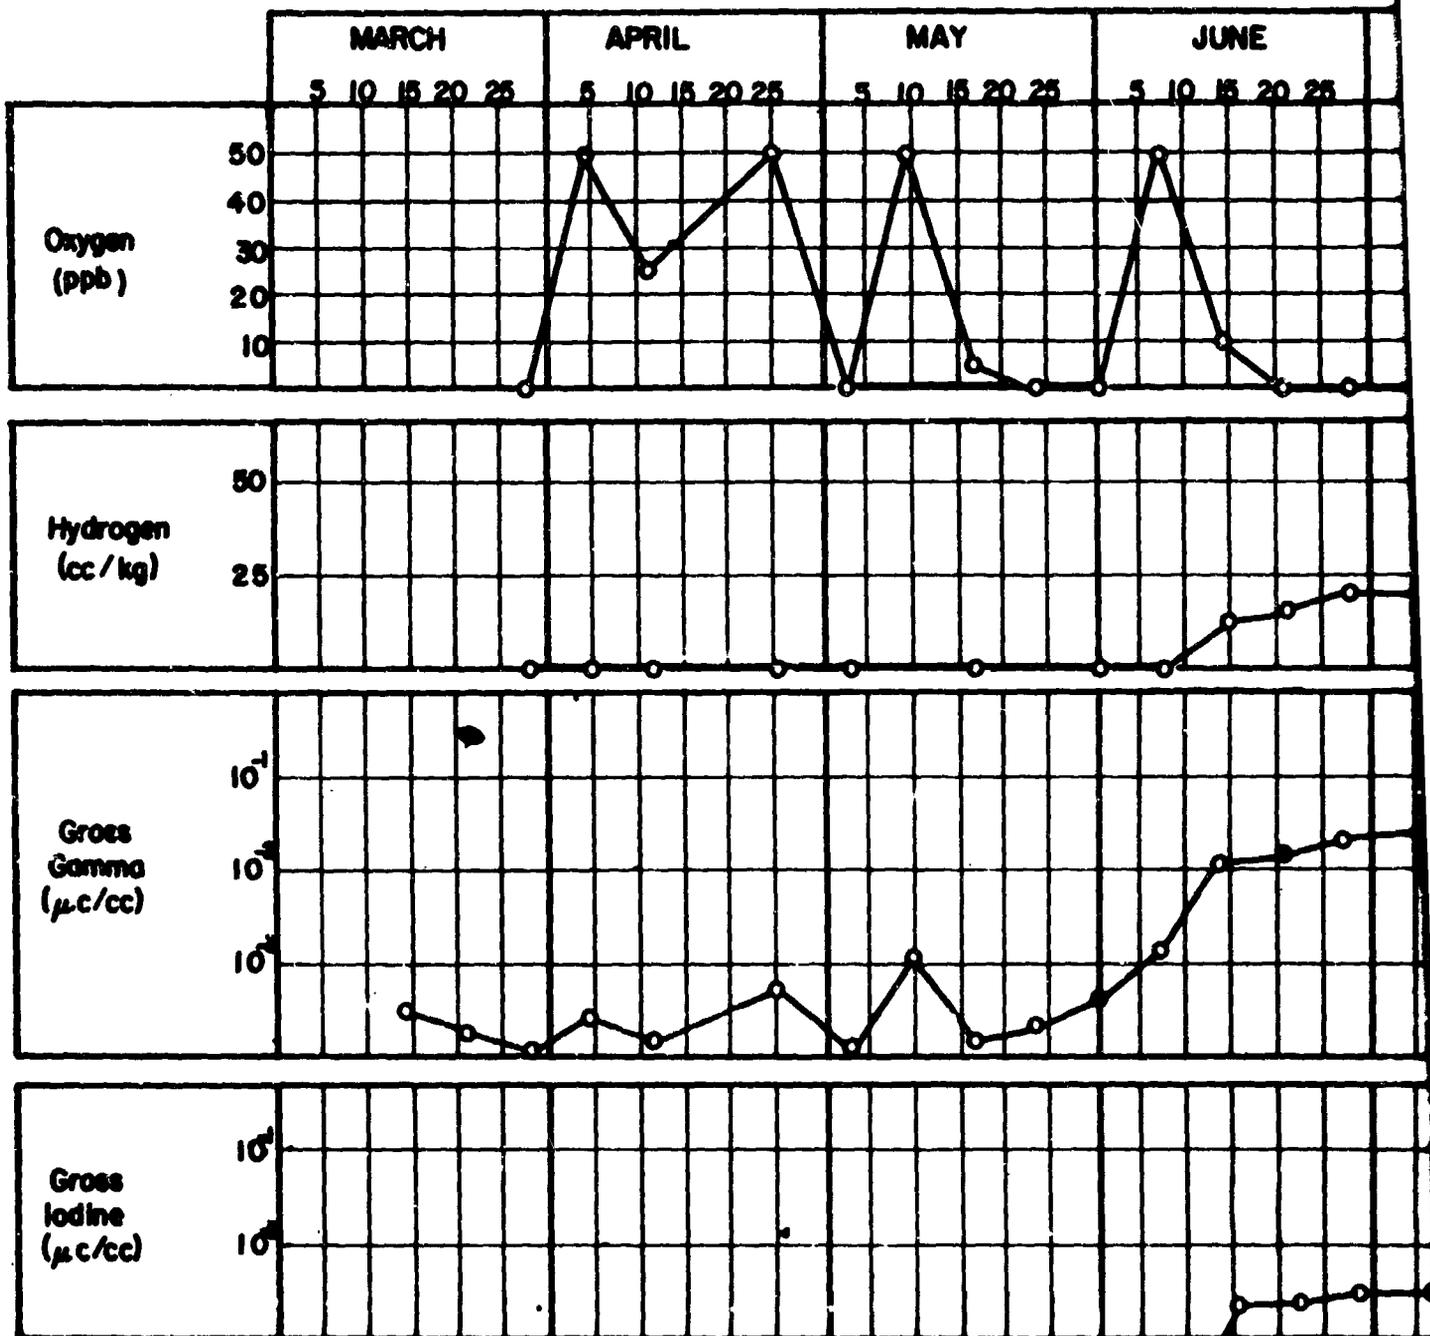
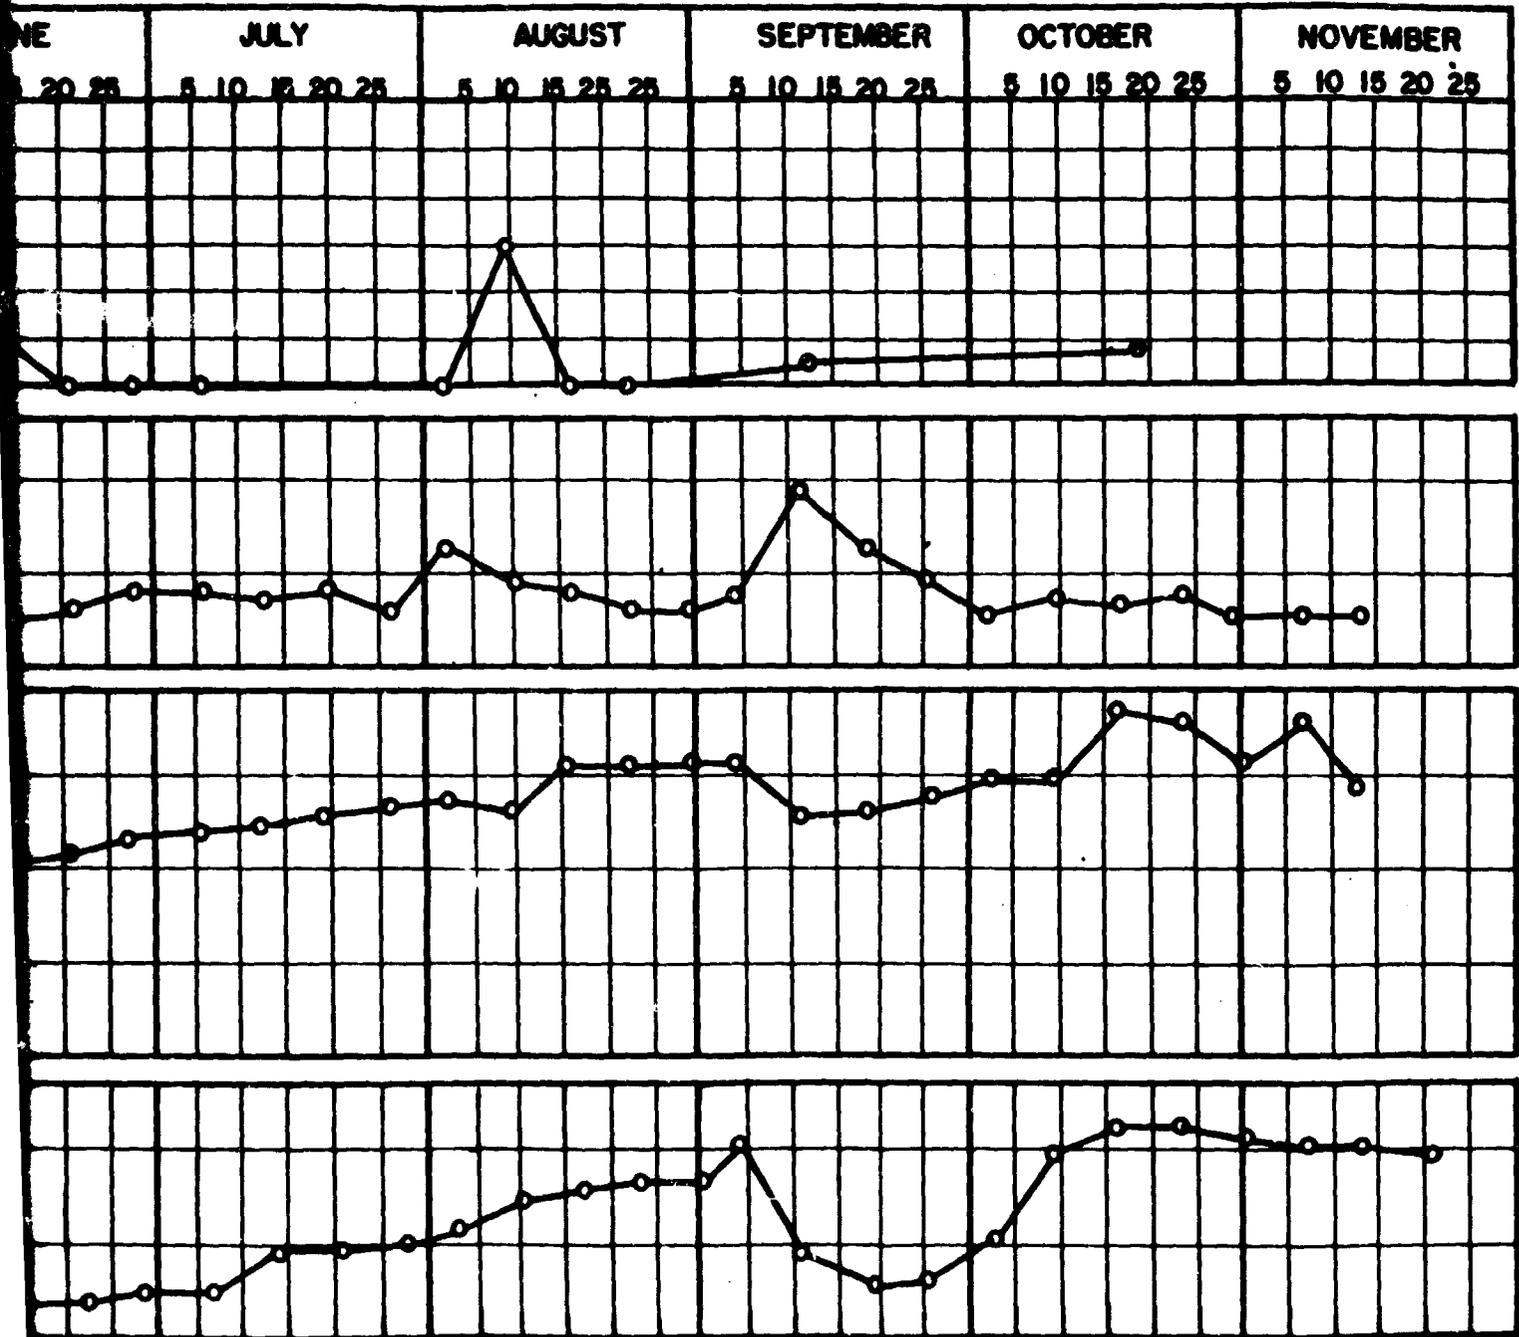
The gross activity level in the coolant increased steadily from mid-June to late August, 1964, where it appeared to level off at about 10^{-1} $\mu\text{c/ml}$ as shown in Figure 2. ⁽⁷⁾ A decrease to about 4×10^{-2} $\mu\text{c/ml}$ was observed in September, but during October the activity again rose to a high of 4.5×10^{-1} $\mu\text{c/ml}$ before shutdown in November. During the periods of high activity the gross activity was characterized by a predominance of fission products, rather than the usual activation and corrosion products.

The gross iodine activity levels rose from 4×10^{-3} to 10^{-2} $\mu\text{c/ml}$ and appeared to level off in July. In August, however, the activity increased to 10^{-1} $\mu\text{c/ml}$ and again appeared to level off. The iodine activity level decreased during September to a low of 4.5×10^{-3} before climbing to about 2.5×10^{-1} $\mu\text{c/ml}$ in October. The decrease in gross iodine after shutdown in November was very slow indicating a considerable inventory of I-131 in the system. Only intermittent purification flow was used during the shutdown; as a consequence, the reduction in coolant activity was largely the result of radioactive decay, rather than removal by the demineralizer.

The reason for the decrease in activity in September, 1964, was not readily discernible but may have been due to obtaining a poor sample as a result of a partially plugged line. Site personnel reported release of some unidentified material from the sample line early in October. ⁽⁶⁾

FIGURE 2a. PRIMARY COOLANT CHEMISTRY

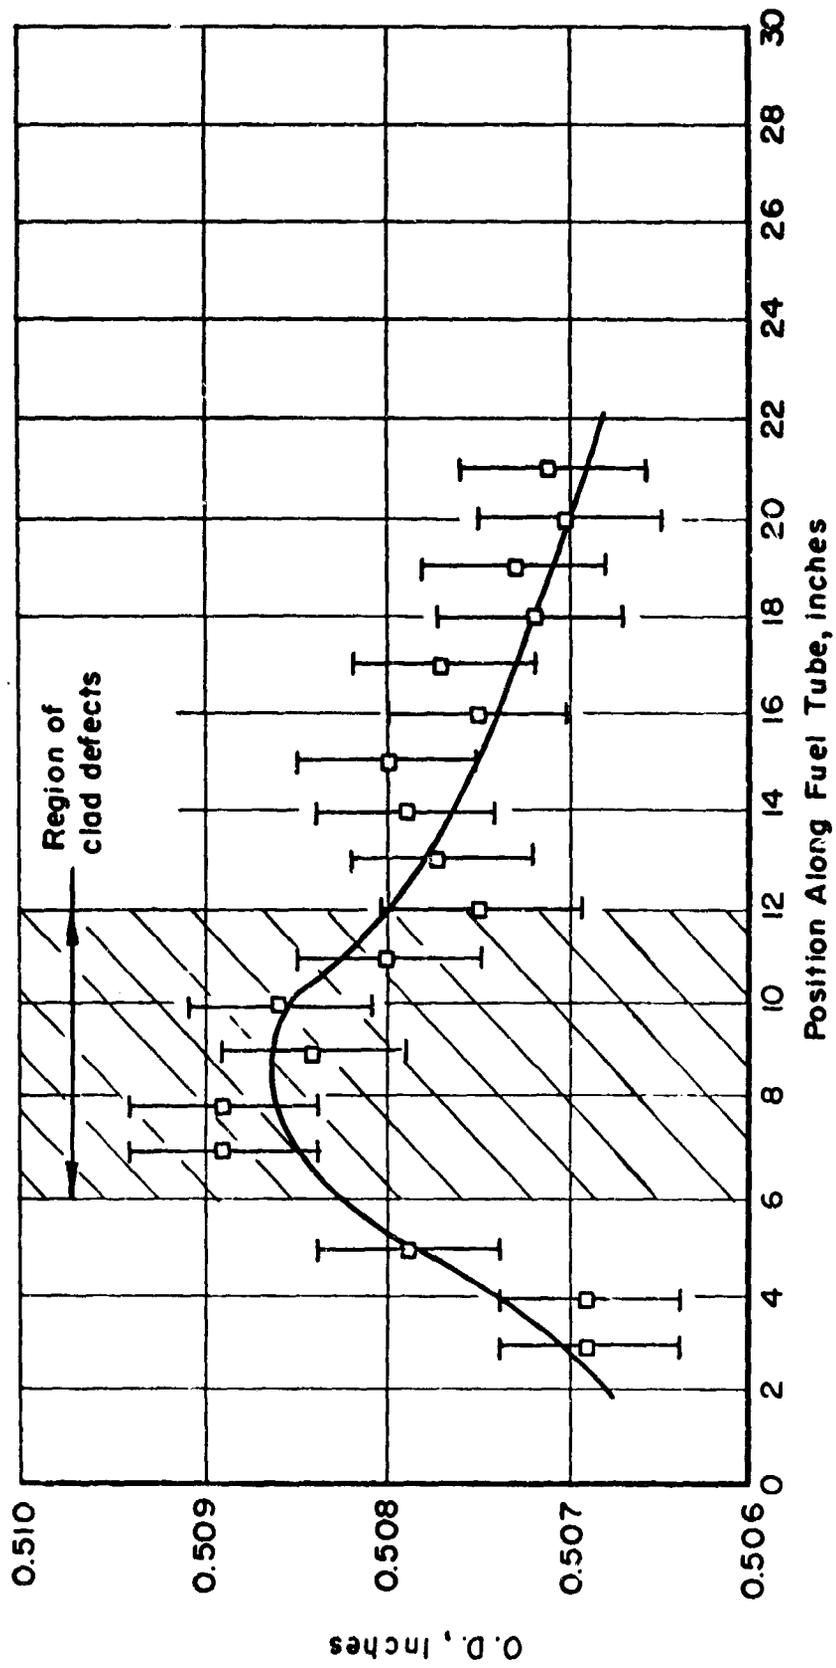
In an attempt to determine relative swelling behavior along fuel tube lengths, the outer diameters of six fuel tubes were measured at every inch of fuel length. The results of these measurements are tabulated in Table 1. Diameters of fuel tube 12-46 are plotted as a function of longitudinal position along the tube in Figure 11. No attempt was made to descale the fuel tubes before the diameters were measured and some scatter was introduced to the data because of the nonuniform scale on the tube surfaces. As mentioned previously, the black scale had flaked off the high-performance regions of the fuel tubes. Average measured diameters ranged from 0.506 (close to nominal as-fabricated diameter) at a position 10 in. from the top of the fuel to 0.509 in. at a position 22 in. from the top of the fuel. The trend toward larger diameters in the high-performance region is shown in Figure 11. The regions of large diameter also corresponded to defected regions suggesting that cracking of the clad was related to strain.

FIGURE 11. AVERAGE O.D. FOR FUEL TUBE 12-46

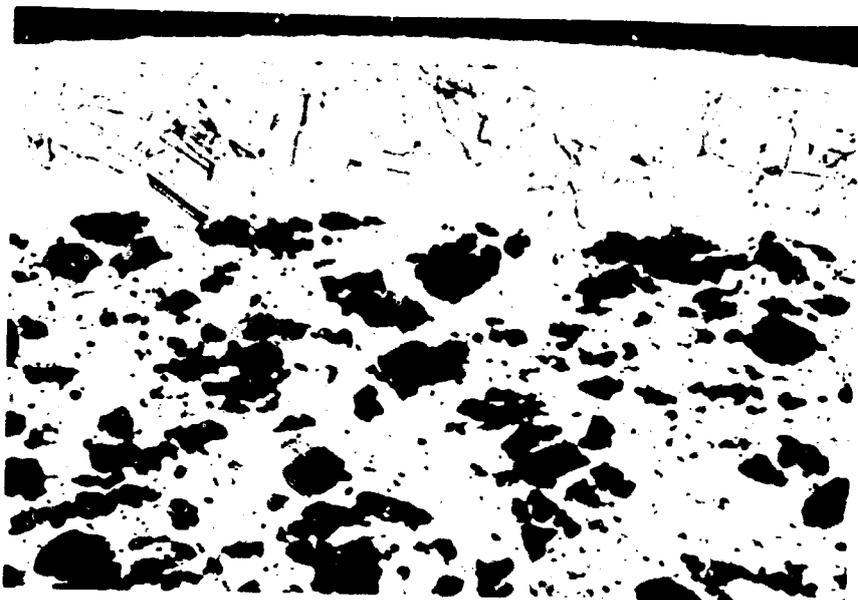
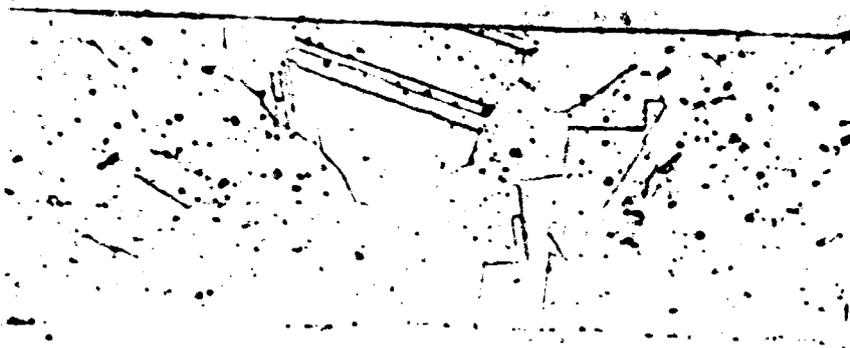
As-Fabricated Fuel Tube. Micrographs depicting the microstructure of an as-fabricated PM-3A fuel tube are shown in Figure 13. Examination of the microstructure indicated that the fuel dispersion was metallurgically bonded to the cladding. It was noted that the grain size and orientation was such that from 3 to 6 grains spanned the clad thickness (about 7 mils).

FIGURE 13. AS-FABRICATED PM-3A FUEL TUBE METALLOGRAPHY FUEL TUBE X3BK

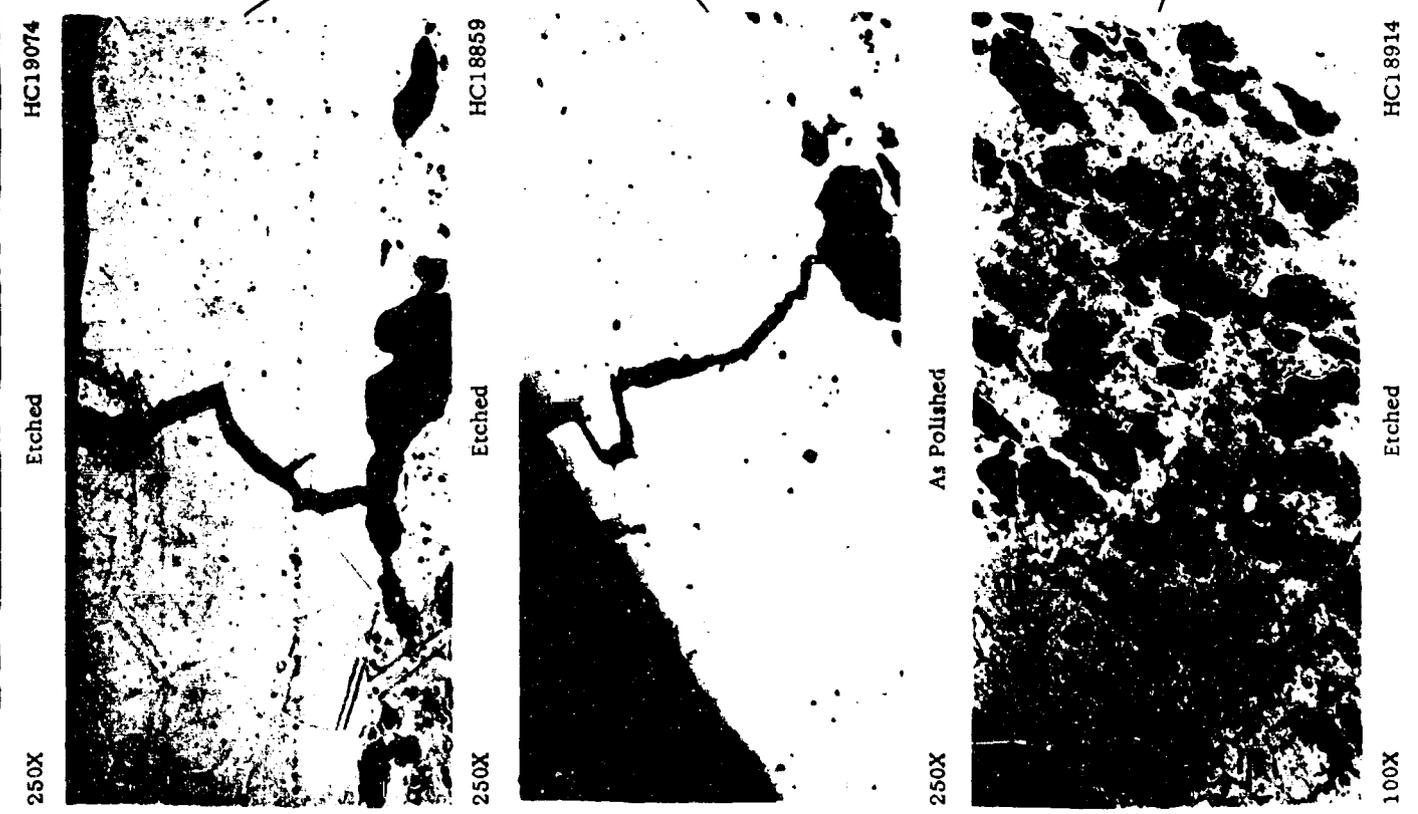
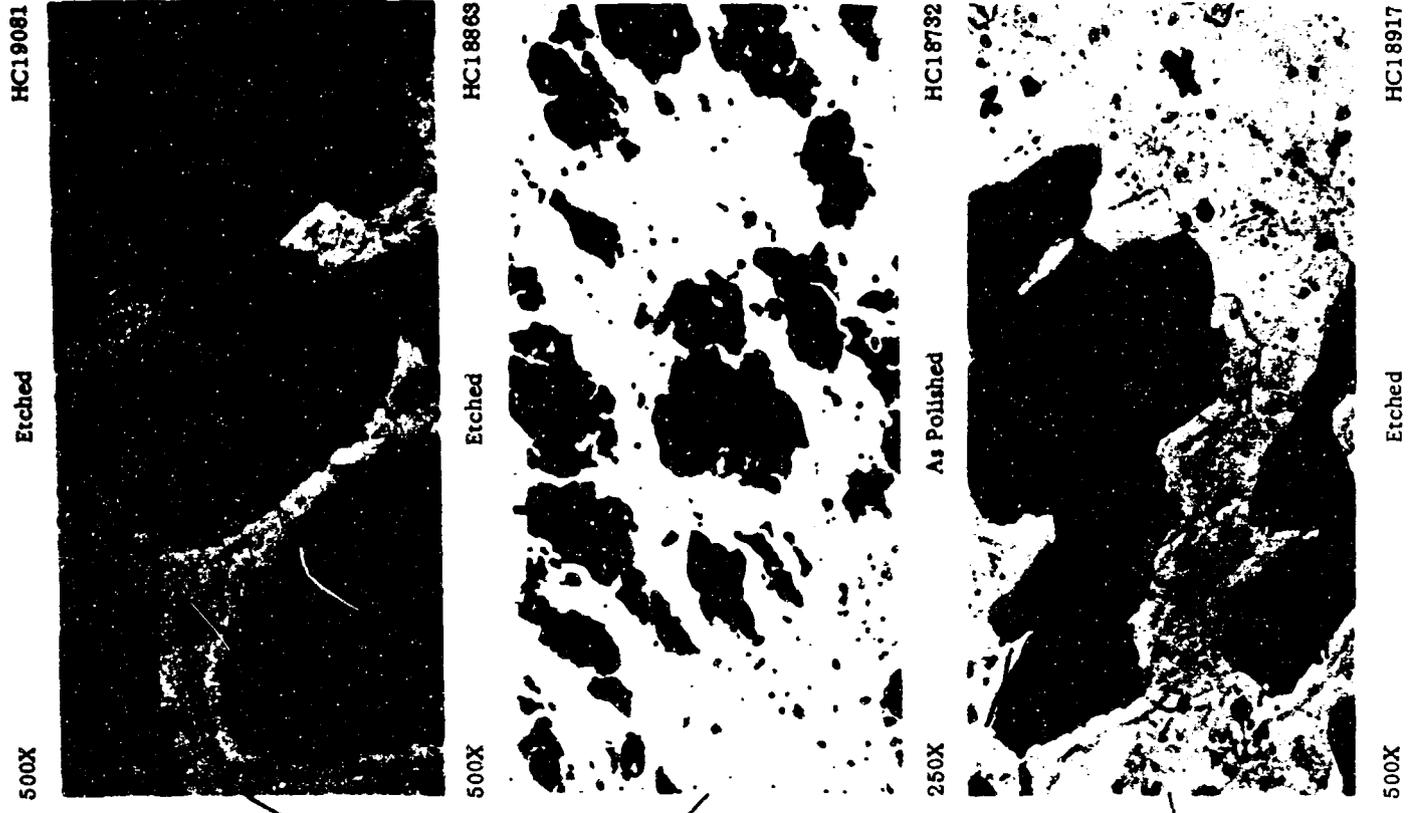
Figure 14 shows results of clad and fuel matrix metallography, respectively, for fuel tube 12-46. The following comments can be made concerning the six metallographic specimens at the indicated positions for fuel tube 12-46.

1. Position B: No cracks were found in the clad at this position on fuel element 12-46. Figure 14B-1 shows a typical micrograph of the clad and clad-fuel matrix interface. No damage was noted to clad or clad-fuel interface. Depending on size and orientation of grains, between 3 to 6 grains spanned the cladding thickness. Figure 14B-2 shows a typical micrograph of a UO_2 particle. Some porosity was observed in the UO_2 particles at this location.

FIGURE 14. MICROSTRUCTURES OBSERVED AT SEVERAL POSITIONS IN FUEL TUBE 12-46

- a. About 30 cracks were detected around the periphery of the outer clad.
- b. Many cracks (about 1/3) were double at the outer edge and combined into a single crack at some point within the clad and continued as a single crack which terminated at a fuel particle.

Figures 14D-2 and 14E-2 show typical micrographs of the UO_2 fuel particles at the D and E positions, respectively. Note that the size of the porosity in the UO_2 particles has increased.

3. Position F: Figure 14F shows a typical micrograph of the clad and fuel matrix at the F position of fuel element 12-46. No crack in the cladding was found to penetrate completely through the clad at this position. The micrograph shown represents the worst clad condition found in this position.
4. Positions G and H: Figures 14G and 14H show typical micrographs of the cladding and fuel matrix at the G and H positions of fuel element 12-46. No cracks or other damage was noted to the cladding or clad-meat interface at this position. Note the absence of spherical porosity in the UO_2 particles.

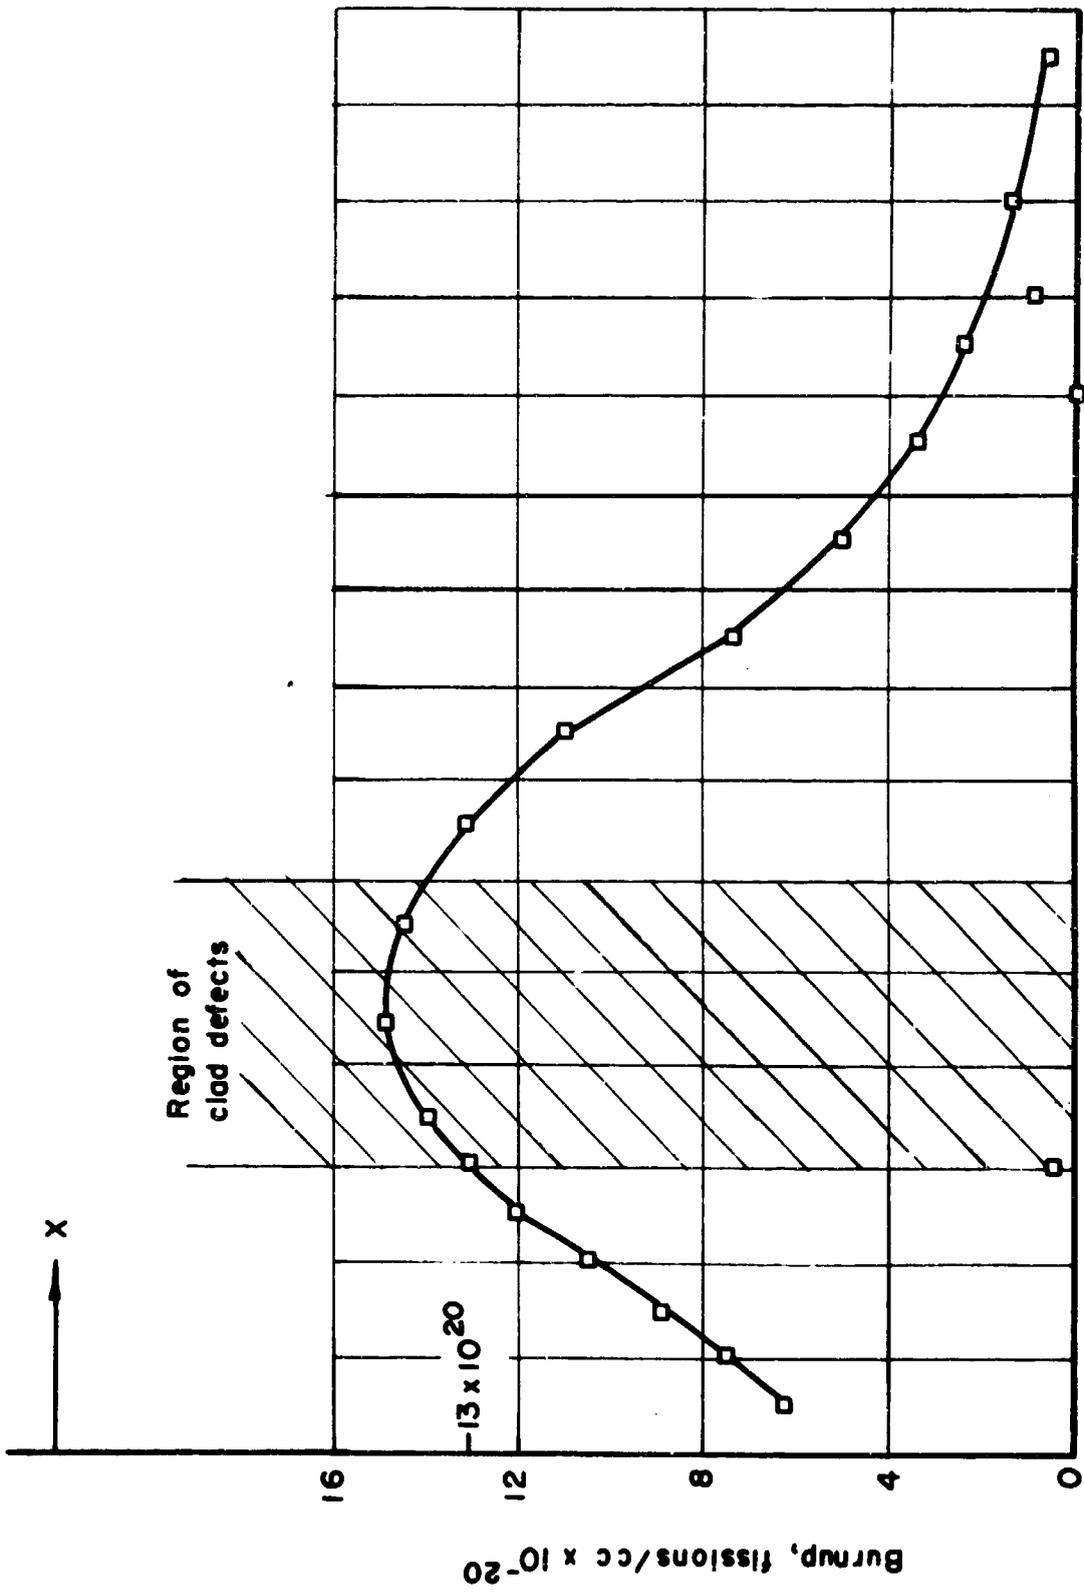
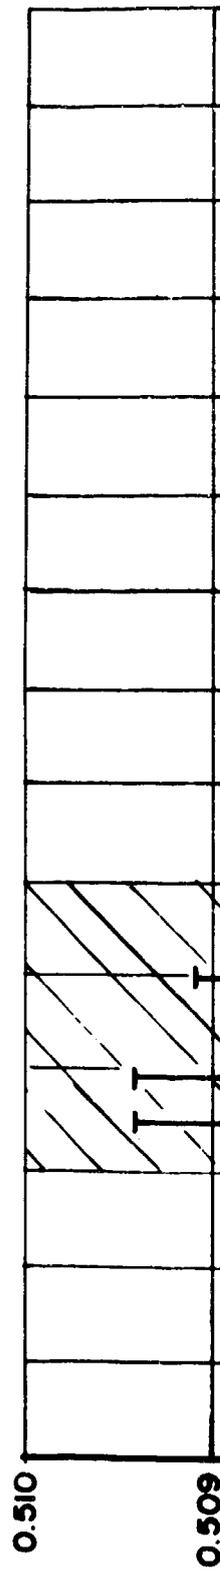
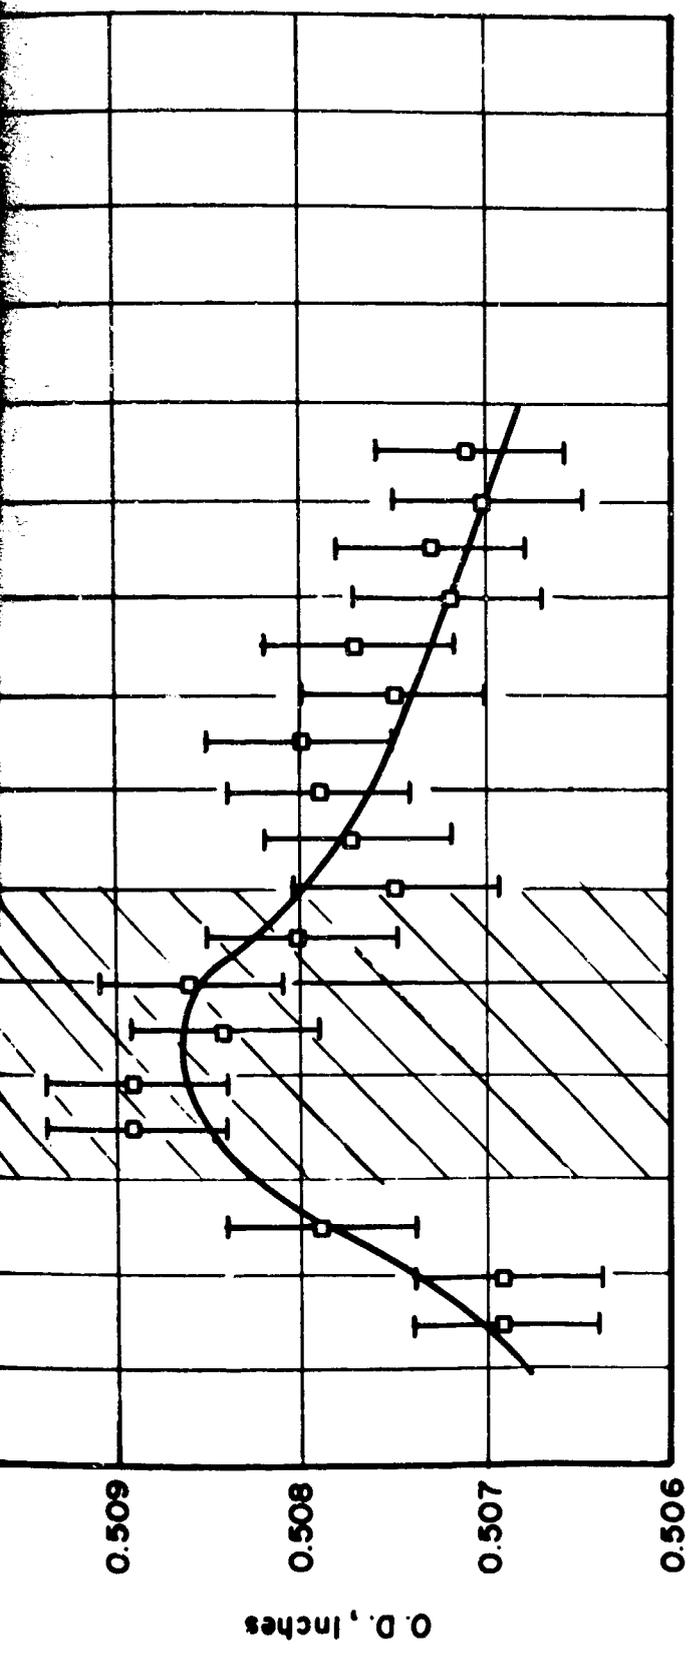
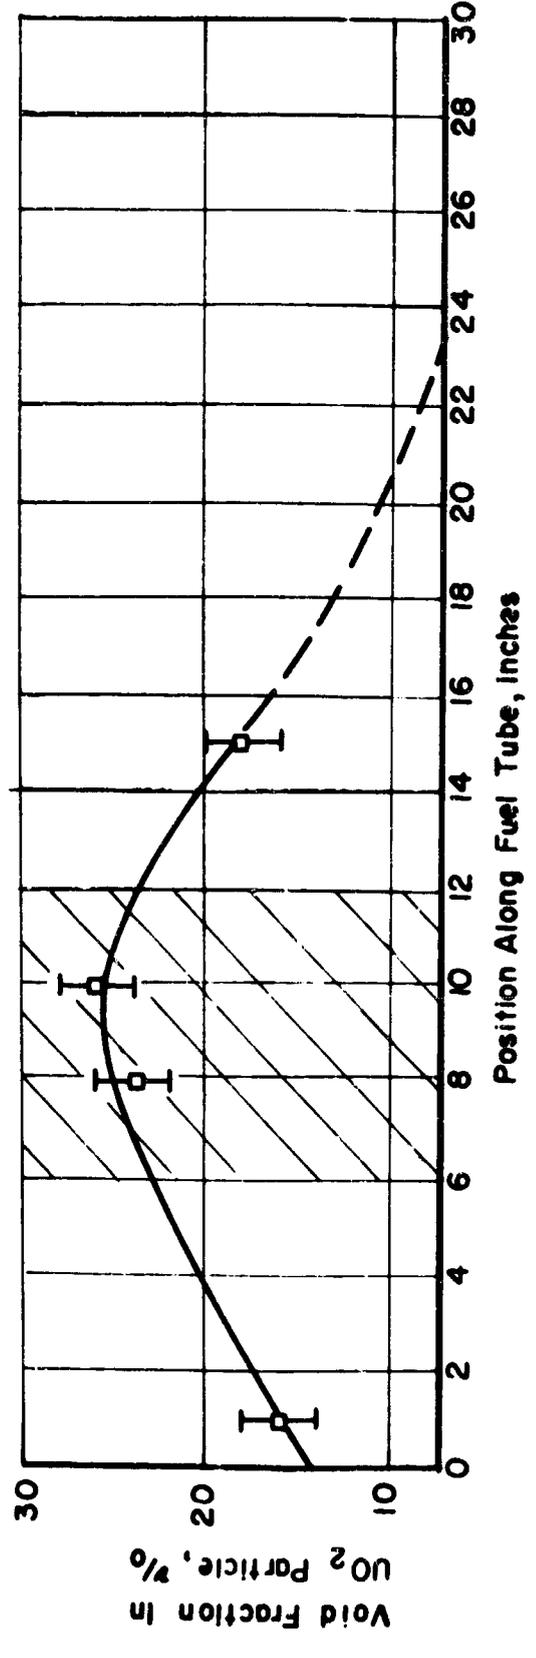
The results of the examination indicated that the fission products leaked through numerous intergranular cracks in the outer clads of fuel tubes from the high-performance region of the core (toward the core center). These cracks started on the outer surface of the clad and generally terminated at UO_2 particles near the fuel dispersion-clad interface. All the cracks were longitudinal, suggesting their association with hoop stresses. As shown in Figure 25, the cracks occurred only in high-performance regions of the fuel tubes where burnups exceeded about 13×10^{20} fissions/cm³ and where fuel swelling produced strains of about one percent in the clad.

FIGURE 25 RELATIONSHIP OF FUEL BURNUP, FUEL PIN SWELLING AND VOID FRACTION IN UO_2 PARTICLES TO FORMATION OF CLAD DEFECTS IN FUEL TUBE 12-46

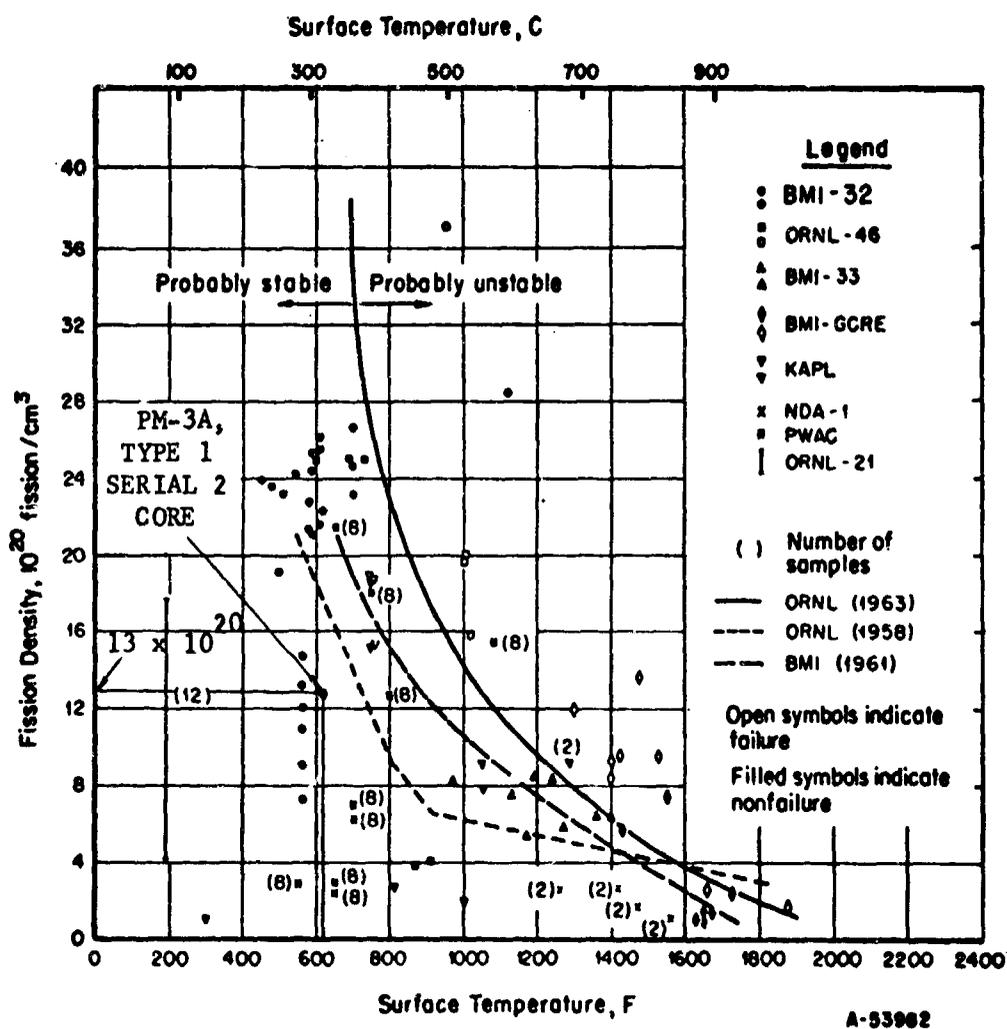
The cause of the failure is not clear. Based on the results of irradiation tests of plate specimens, other investigators⁽¹⁴⁾ have predicted failure of UO_2 -stainless steel dispersions as a function of burnup and temperature as shown in Figure 26. Based on the data shown in Figure 26, and a burnup of 13×10^{20} fissions/cm³ and a surface temperature of 620 F, the PM-3A, Type 1 Serial 2 Core clearly operated in the probably-stable-region of the plot for this type of fuel. Perturbations to heat flow introduced by the oxide scale on the PM-3A fuel tube surfaces may have raised fuel operating temperature slightly and shifted the operating point toward the stable-unstable boundary. However, it seems unlikely that the presence of the scale could

FIGURE 26. IRRADIATION PERFORMANCE OF STAINLESS STEEL-UO₂ DISPERSIONS⁽¹⁴⁾

have raised temperature sufficiently to bring the operating conditions into the non-stable region of the data shown in Figure 26.
