CLAY MOBILITY

PORTUGUESE BEND, CALIFORNIA

PAUL F. KERR and ISABELLA M. DREW

Scientific Report No. 1

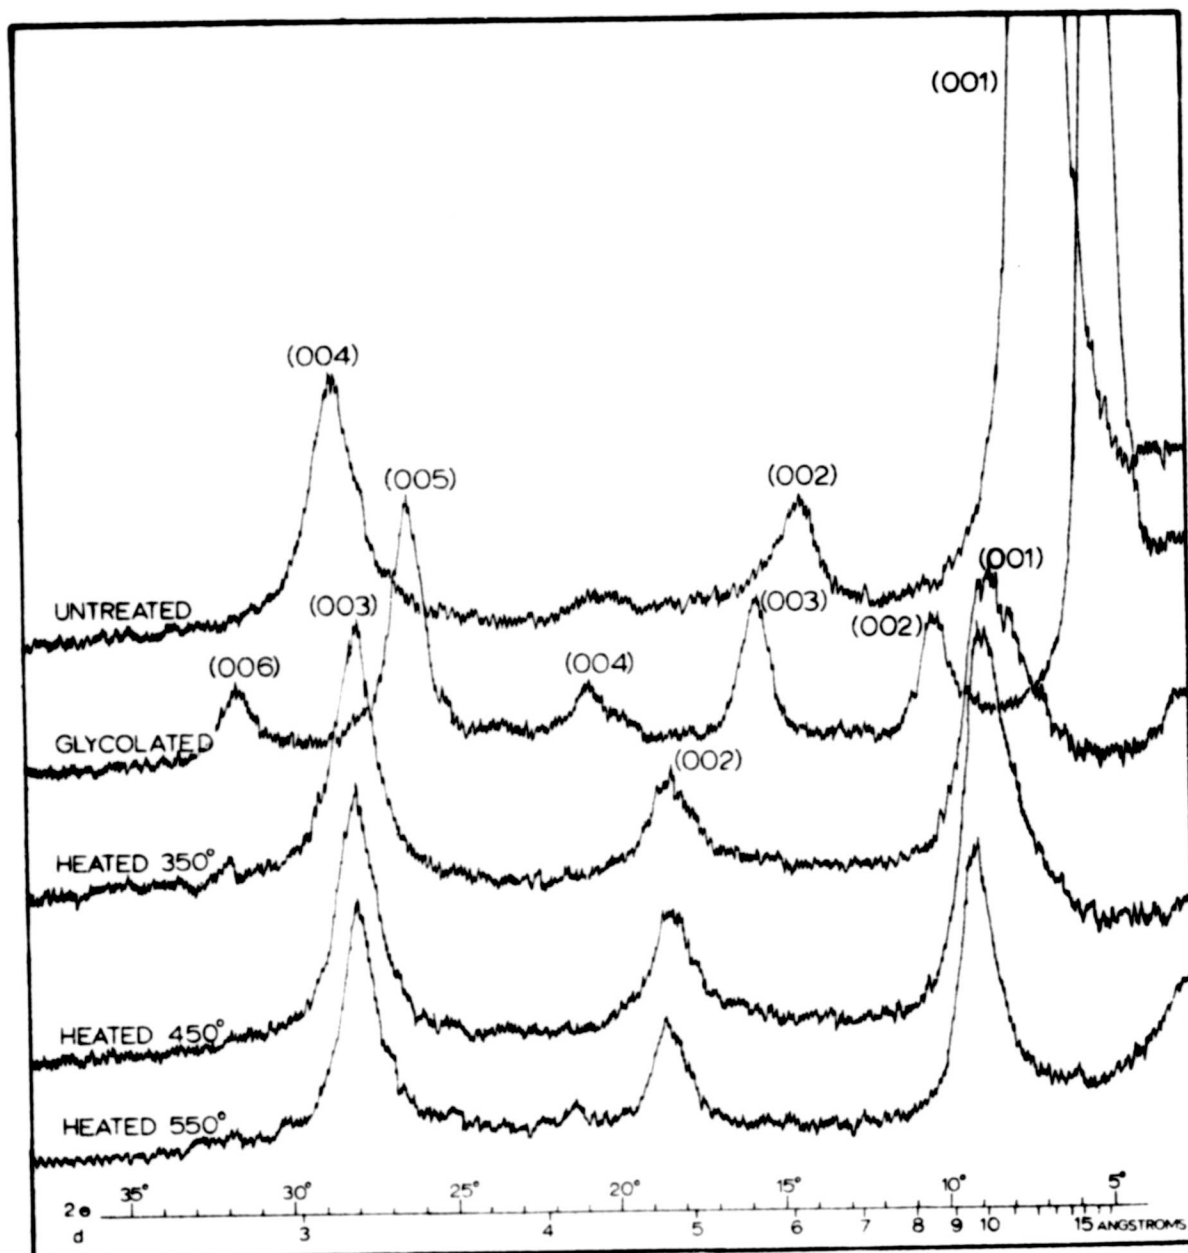
Fig. 4 X-ray diffractometer patterns of montrillonite in 2μ fraction of Sample 2. The (001) reflection expands 14 \AA to 17 \AA on glycolation. The structure collapses reversibly to 10 \AA at temperatures as low 350°C but irreversible collapse is not encountered until 550°C , when the montmorillonite anhydride or illitic structure is formed.

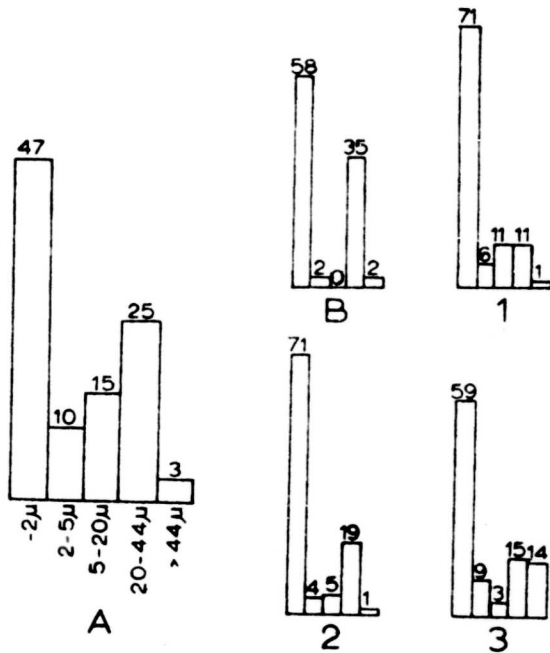
ASTM Method D-22, the hydrometer method (1965) was used to determine the particle size range of the bentonites from Portuguese Bend. These clays are characterized by an unusually high colloidal content. They are gap-graded with some silt-sized particles present in all samples. Since only traces of quartz or other mineral fragments are present, as shown by x-ray diffractometer and microscopic investigation, these coarser particles are thought to be tuff particles. Water-saturated samples of the Palos Verdes bentonite are granular in appearance, with the grains apparently consisting of aggregates of partially altered volcanic material. Histograms (Fig. 5) illustrate particle size distribution. Samples 1, 2, 3, and B are from active slide areas and contain 60-70 per cent clay-sized

(minus -2 μ) material. Sample A, from a road cut to the east of the active slide area, probably from the Portuguese Tuff Bed, contains considerably less fine clay (47 per cent). The particle size distribution curve shows this sample to vary from the others in being well-graded rather than gap-graded (Fig. 6).

Fig. 5 Histograms showing particle-size distributions in Palos Verdes bentonites. Note that Sample A, from outside the slide area, contains the smallest amount of clay-sized material.

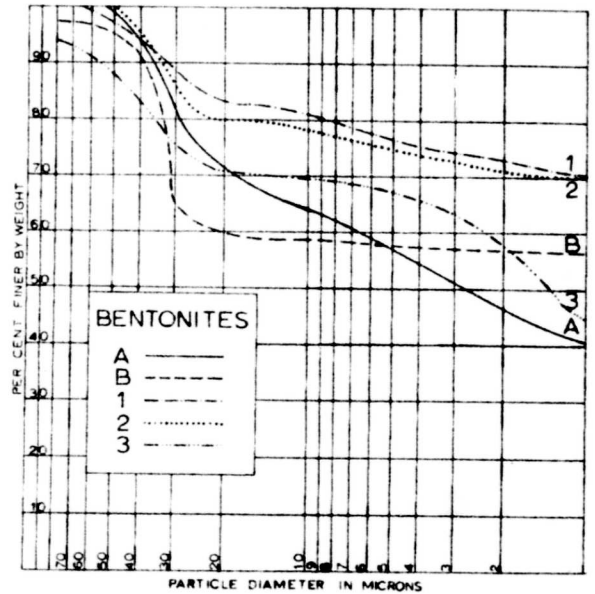
Fig. 6 Particle size distribution curves for the Palos Verdes bentonites. Most of these are gap-graded, consisting mostly of colloidal material and a few per cent coarser tuff particles.

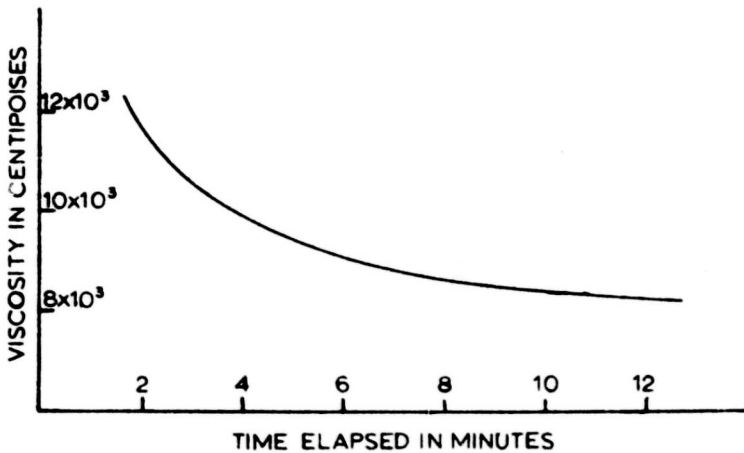
Fig. 7 Decrease in viscosity with time as the thixotropic gel breaks down.

The Palos Verdes bentonite is highly thixotropic. When the viscosity of the minus-2 μ clay fraction is plotted against the time elapsed, it is seen that the viscosity decreases as the system is subjected to constant shearing (Fig. 7). This is typical of thixotropic gels. The colloidal structure is almost completely destroyed in the bentonite after about 10 minutes at a rate of shear of 0.5 RPM.

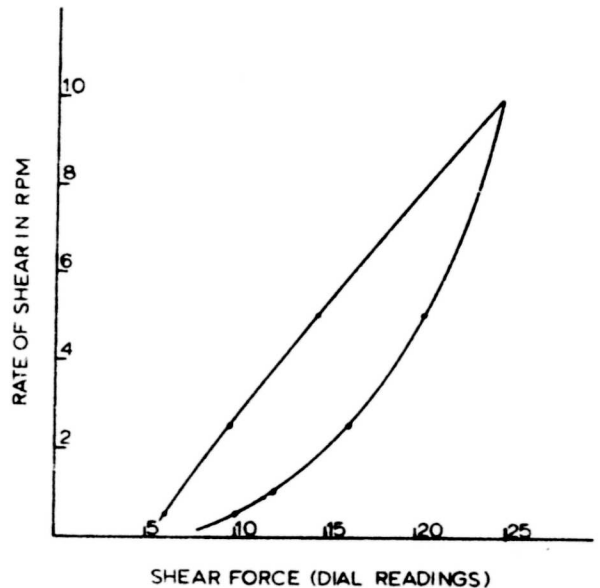
Fig. 8 Hysteresis Loop obtained for Palos Verdes clay.

When the rate of shear was increased from 0.5 to 10 RPM and then decreased again, a hysteresis loop (Fig. 8) was obtained, illustrating the fact that, in thixotropic clays, the shear force, (and viscosity) at any given rate of shear is dependent on the amount of previous shear the system has undergone. Shearing causes breakdown of the particle links in the skeleton structure of the more or less flocculated clay-water system, thus reducing the viscosity of sheared clays.

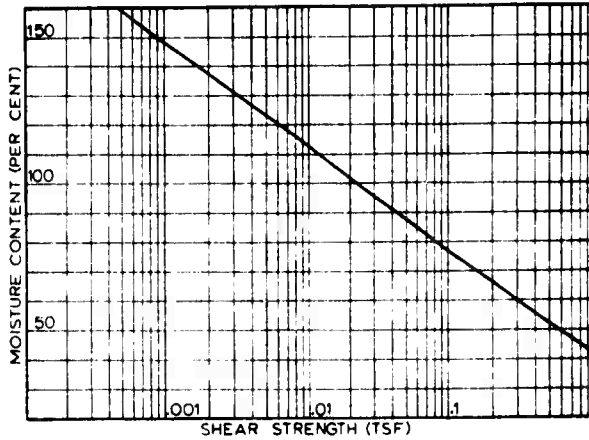
Water content has a great effect on the properties of the Palos Verdes bentonite. As can be seen from Fig. 9, doubling the moisture content decreases the unconfined shear strength by more than 10 times. At the moisture content measured for the Palos Verdes clay, shear strengths would be on the order of only 1/4 ton per square foot.

Fig. 9 Influence of water content on shear strength, as measured with Swedish Cone.

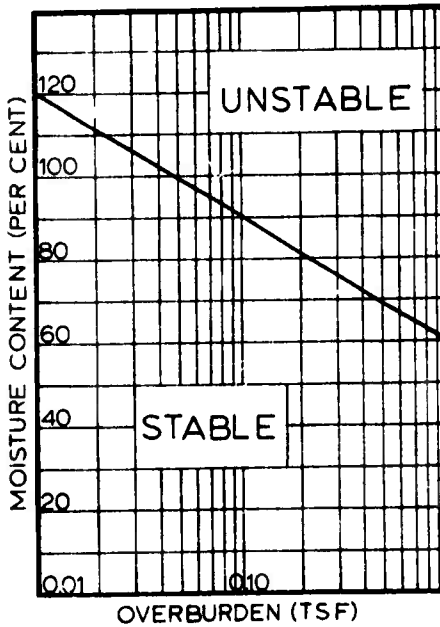
An experiment was devised in order to study the influence of water content and overburden pressure on the stability of the clay strata at Portuguese Bend. A layer of bentonite 1/2-inch thick was spread between two rigid boards and the system adjusted to a constant slope of 1:10. The water content of the clay stratum was changed by the addition of increments of distilled water. The exact water content was measured after each test by oven drying and weighing samples of the clay. Loading of the upper board was also varied. Clay flowage was measured by timing the relative movement of vertical marks on the boards. The results of this experiment are illustrated in Fig. 10. At moisture contents greater than 120 per cent, the clay exhibited a slow plastic flow without loading. Loads selected would cover a range of about 0 to 150 feet, the estimated thickness of material above the slip plane at Portuguese Bend. As the load was increased, the water content at which the clay would show movement within a 24 hour period decreased. In this way, regions of stability and instability could be identified. Although an artificial model, this experiment is at least suggestive in considering movement of rock masses on moist clay under the field conditions at Portuguese Bend.

Fig 10 Graph illustrating influence of water content and overburden pressure on the stability of Palos Verdes bentonite. The greater the overburden pressure, the lower the water content necessary to produce movement.
