X353-5B PROPULSION SYSTEM FLIGHTWORTHINESS TEST REPORT

LIFT FAN FLIGHT RESEARCH AIRCRAFT PROGRAM

CONTRACT DA 44-177-TC-715

GENERAL ELECTRIC COMPANY

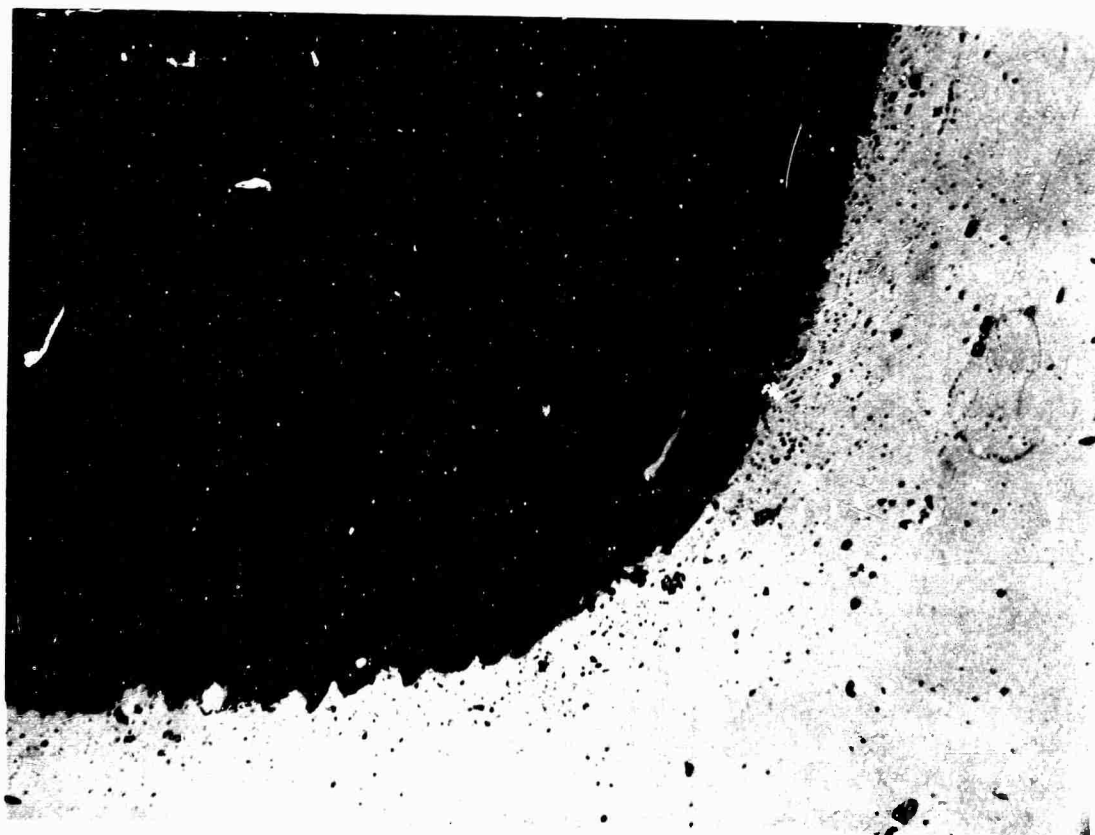
Figure I-70 250X Microscopic Examination of New AN Bolt
at Head to Stem Radius

Examination of unfailed carrier bolts and platform bolts all showed the same condition of IGA and surface oxidation. Examination of the AN bolts NAS-1003-1A indicated freedom from IGA as shown in Figure I-70.

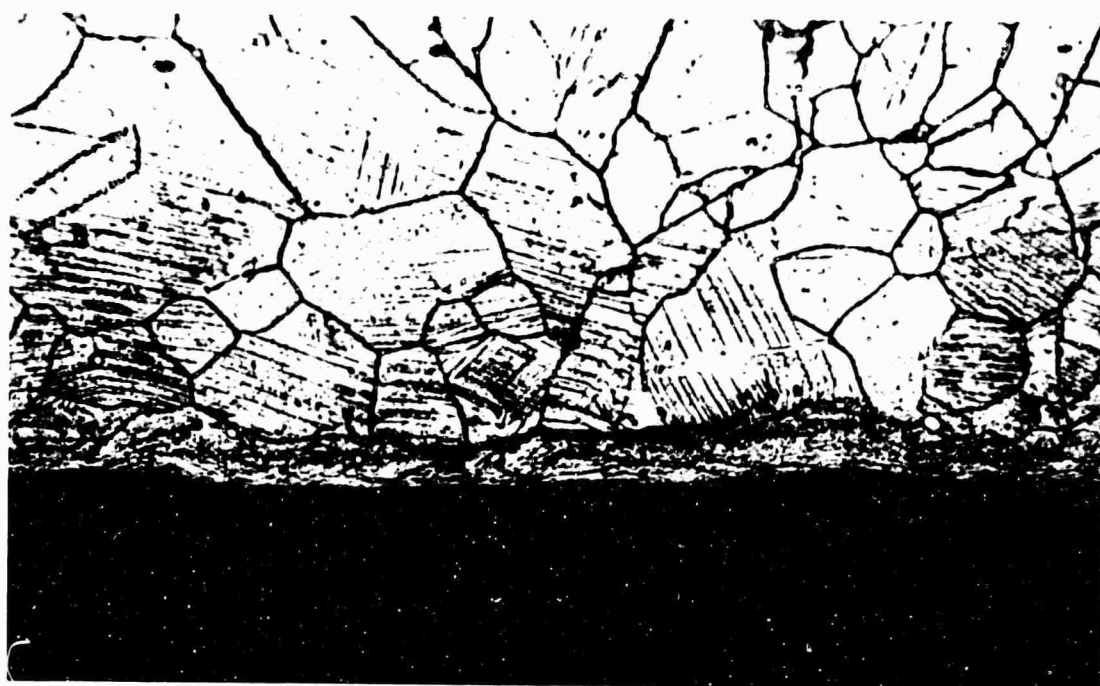
Figure I-72 A. Etched 500X Microscopic Examination of Grain Structure of Figure I-71A
B. Etched 500A Microscopic Examination of Grain Structure of Figure I-71D

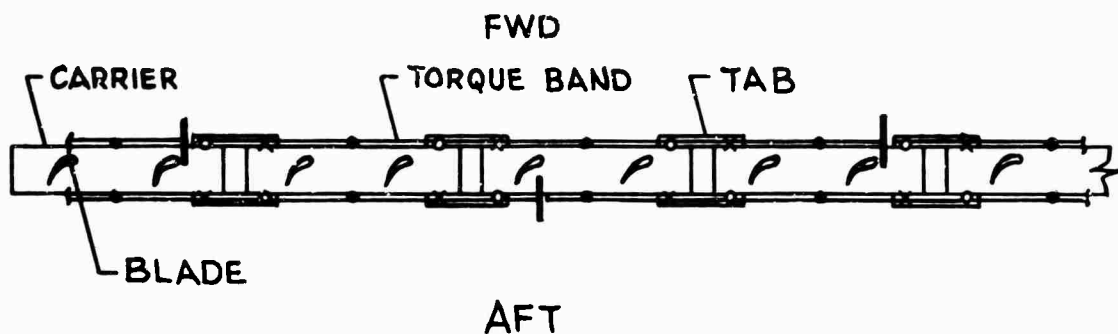
FIGURE I-73 Lift Fan Optimum Carrier Bolt Torquing Procedure

The schematic in Figure I-73 indicates the segmented band arrangement and the ideal torquing procedure to reduce fretting. Avoiding the combination of high loads in the opposite band from a cut joint and reducing fretting improves the fatigue life of the part.

- K. The carrier bolt torquing procedure be modified to establish a pattern for improved torque transmission at carrier joints which include a torque band cut (Reference Figure I-73).

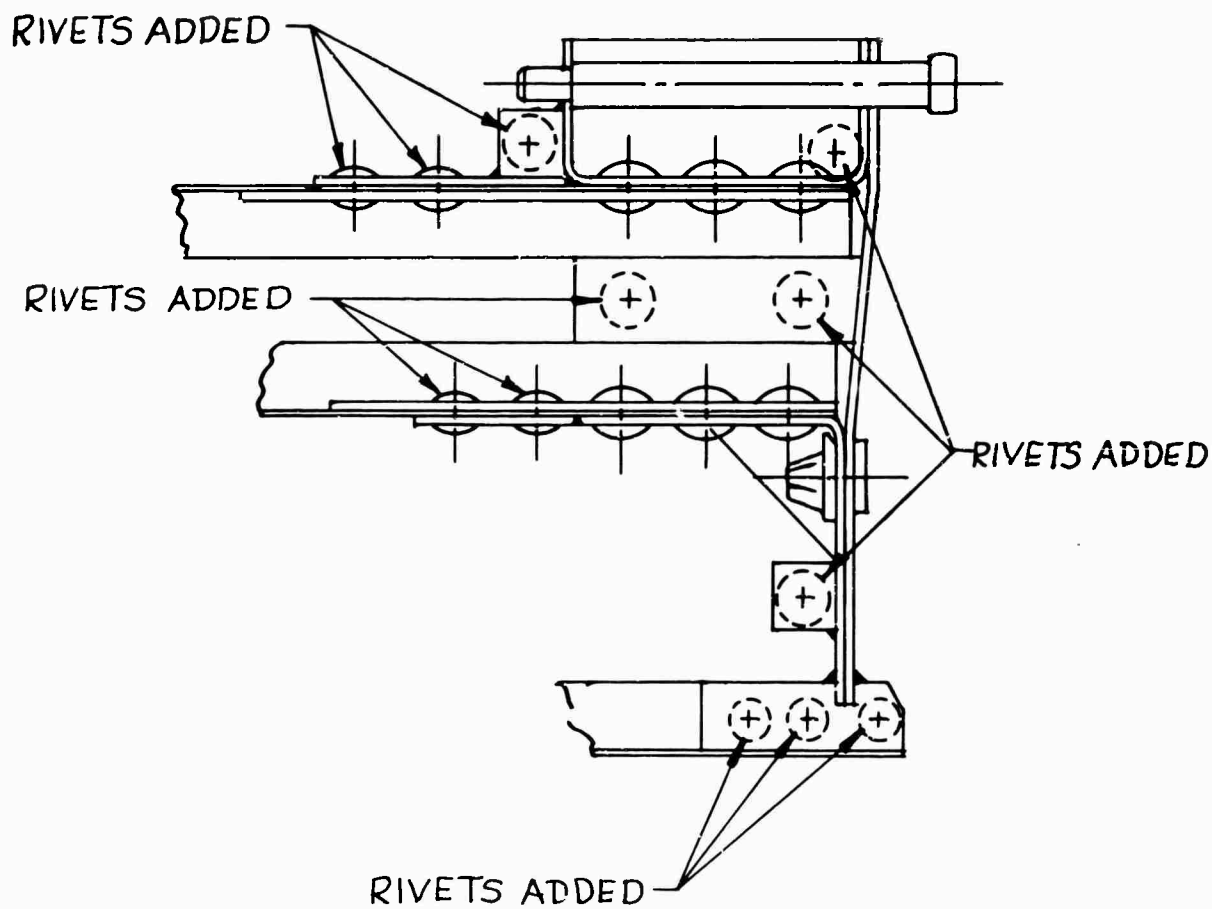
Figure I-76. Lift-Fan Exit Louver End Cap Design Change

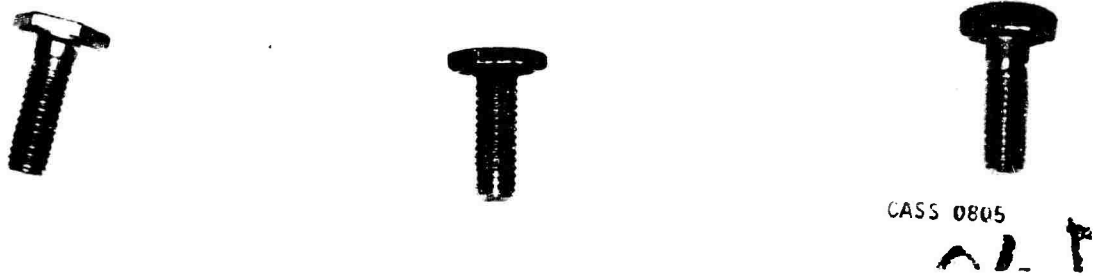
Figure I-78. Original And New Design Carrier Bolts (Lift Fan)

- J. Platform and carrier bolt quality control be expanded to include:
1. 100% hardness inspection.
 2. 100% dimensional inspection.
 3. Sample lots metallographically examined.

4. Vendor microscopic analysis to define drawing notes which will be necessary to avoid repetition of bolt condition during any re-orders.

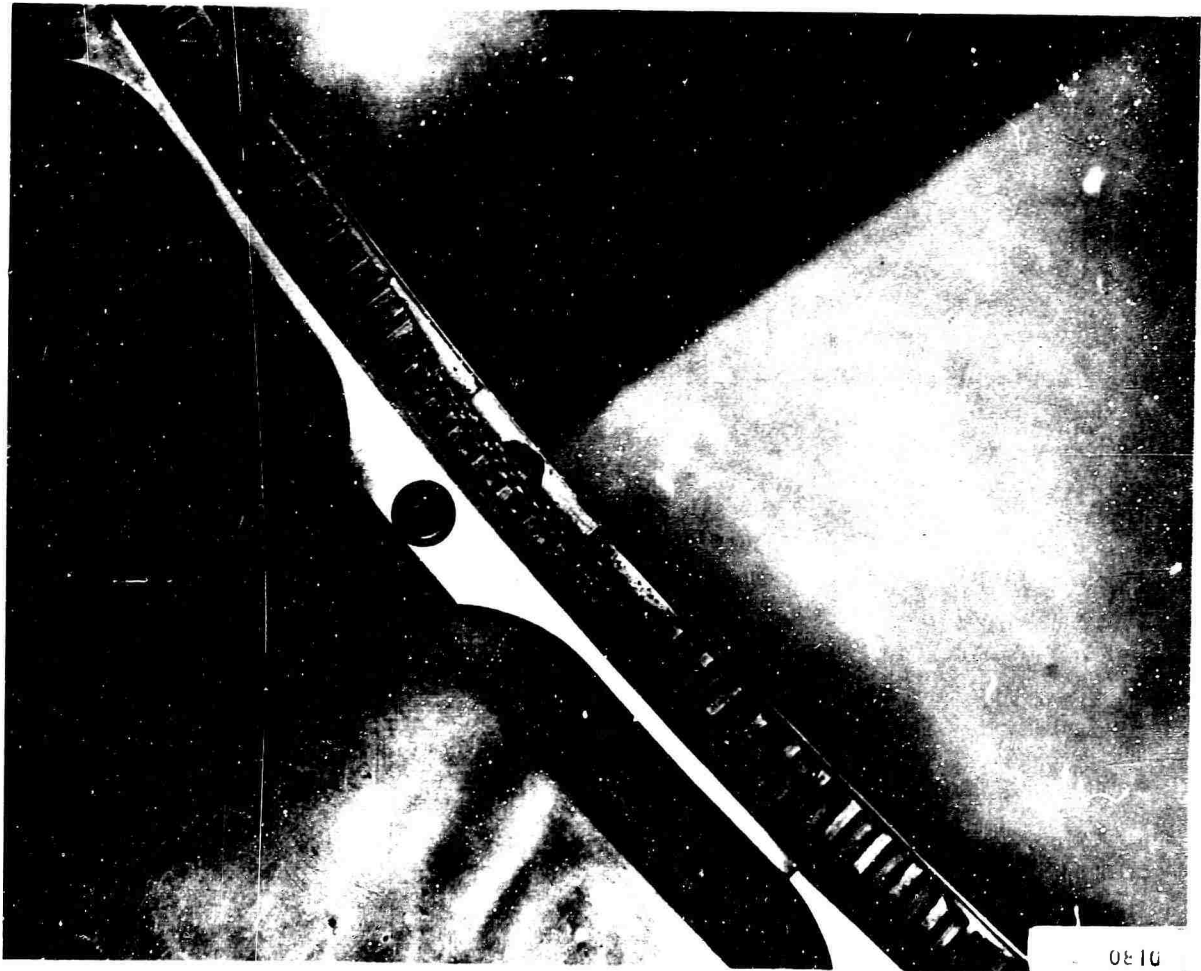
Figure I-79. Lift Fan Forward Air Seal Inspection Opening
(Lift Fan Forward Carrier Inspection)

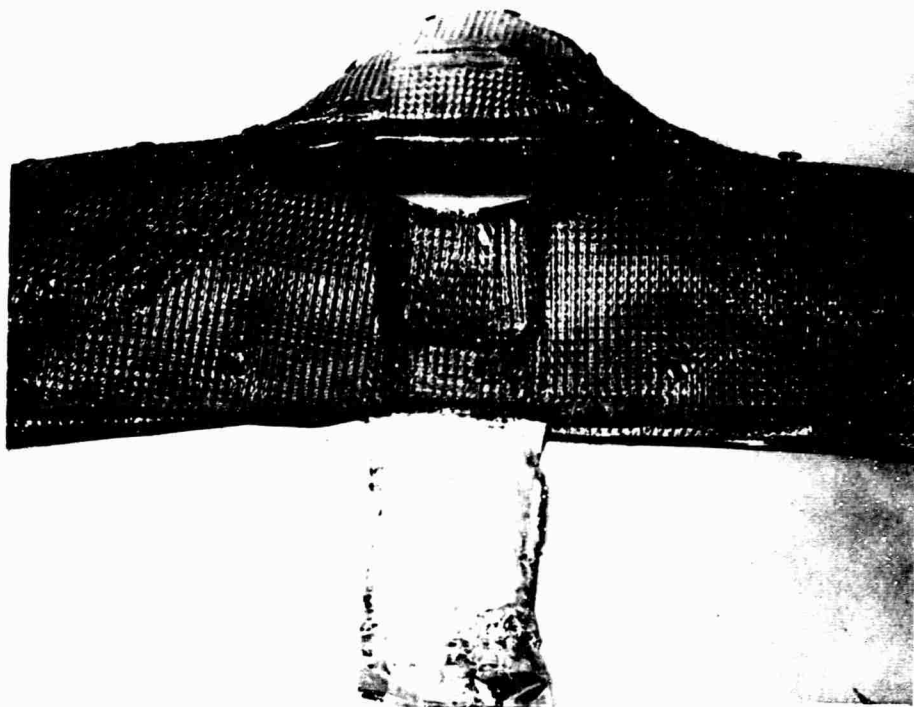
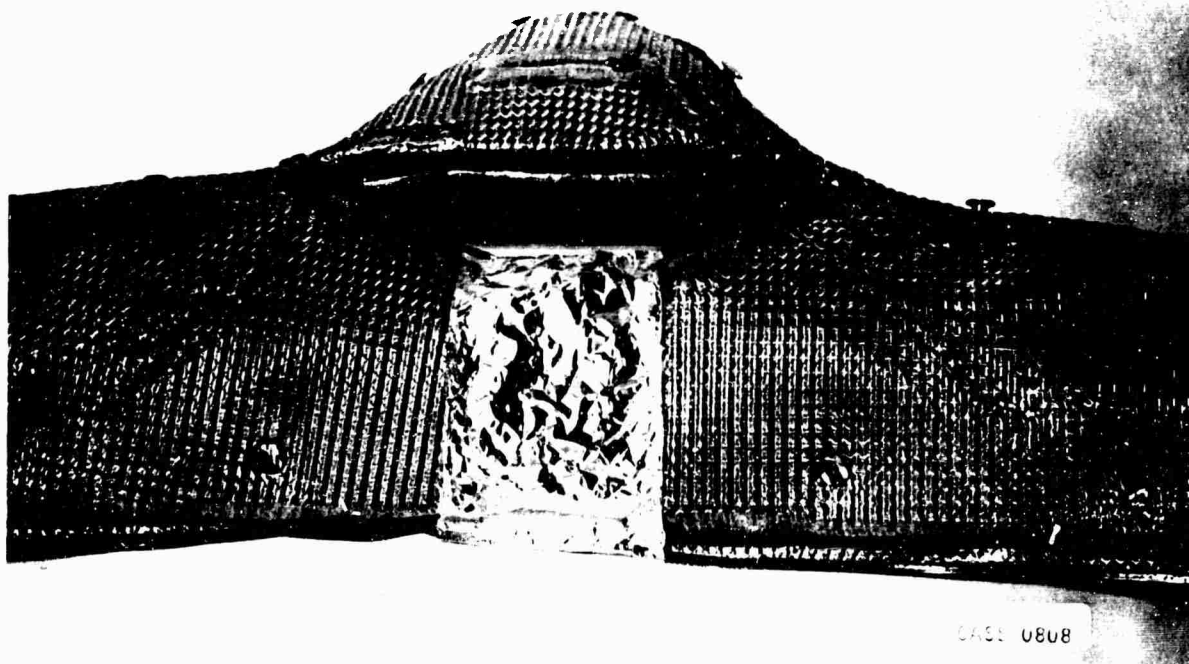
Figure I-82 Pitch Fan Scroll Insulation Modification
