**Final Report of the
Pre- and Postshot
Structural Survey**

FINAL REPORT OF THE
PRE- AND PCSTSHOT STRUCTURAL SURVEY
PROJECT DRIBBLE
SALMON EVENT

UNITED STATES ATOMIC ENERGY COMMISSION
NEVADA OPERATIONS OFFICE

Prepared By
HOLMES & NARVER, INC.
ON-CONTINENT TEST DIVISION
Las Vegas, Nevada

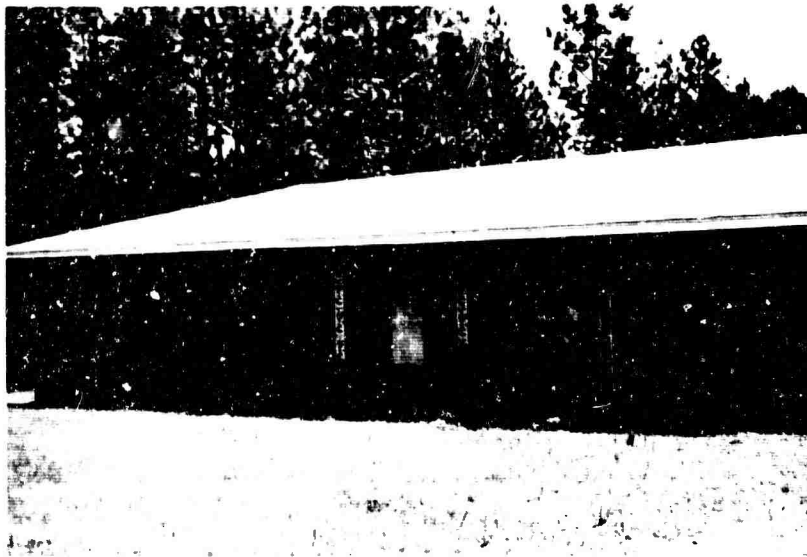
Photo No. 1 - Pre-Shot of H&N No. 47

A new one-story brick veneer house on a concrete slab (H&N 47) was located 3,505 meters from SZ (photo no. 1). The peak ground motion was predicted to be 11.5 cm/sec. No bracing was recommended and no damage was evident in the postshot survey of the structure.

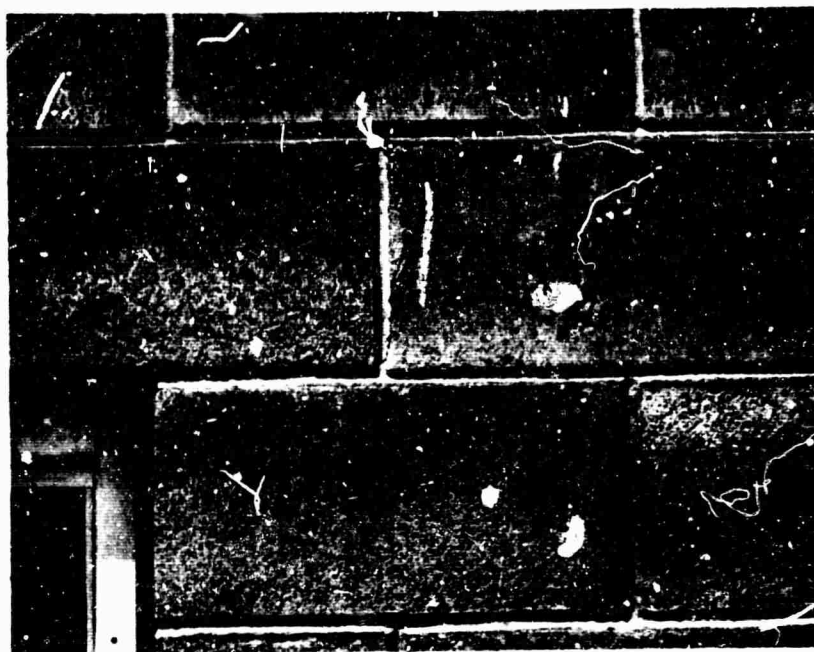
A new block house (H&N 83) under construction 5,060 meters from SZ revealed the type of construction practices followed in the area. No lintels were used over the openings as illustrated in photo no. 7. Very little reinforcing steel was used in the structure (photo no. 8). The peak ground motion was predicted to be 8 cm/sec. No observed new cracks were present in the concrete blocks of this structure (H&N 83) after the event, but some old cracks were aggravated and new cracks were evident in the brick chimney.

Photo No. 7 - Pre-Shot Window Construction, H&N No. 83

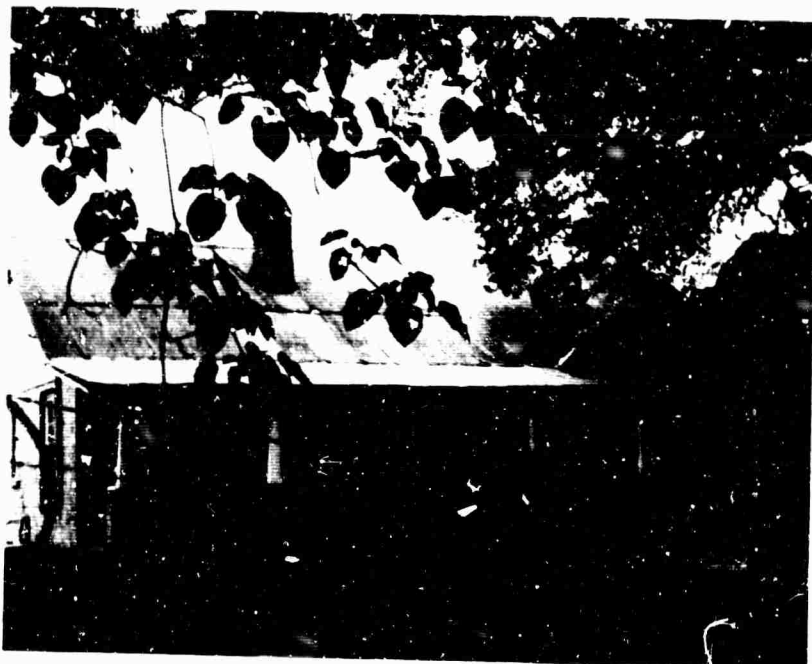
A house constructed of solid brick walls (H&N 190-1) was surveyed at 5,210 meters distance from SZ (photo no. 9). The brickwork was in good condition with few cracks in the mortar joints and through the bricks (photos no. 10 and 11). The house was supported on a continuous concrete footing with frame gables and galvanized iron roofing. The concrete front porch floor was supported on a continuous concrete block footing. This block footing had several mortar joints cracks (photos no. 12 and 13). The interior walls were either exposed brick, wood paneled, or taped sheetrock on wood studs. The central chimney appeared substantial in the Pre-shot survey. The predicted ground velocity was 7.6 cm/sec at this location and no bracing was recommended or installed. The postshot survey of this structure indicated that the old cracks noted in the pre-shot survey were aggravated (photo no. 14).

Photo No. 9 - Pre-Shot - Solid Brick House, H&N No. 190

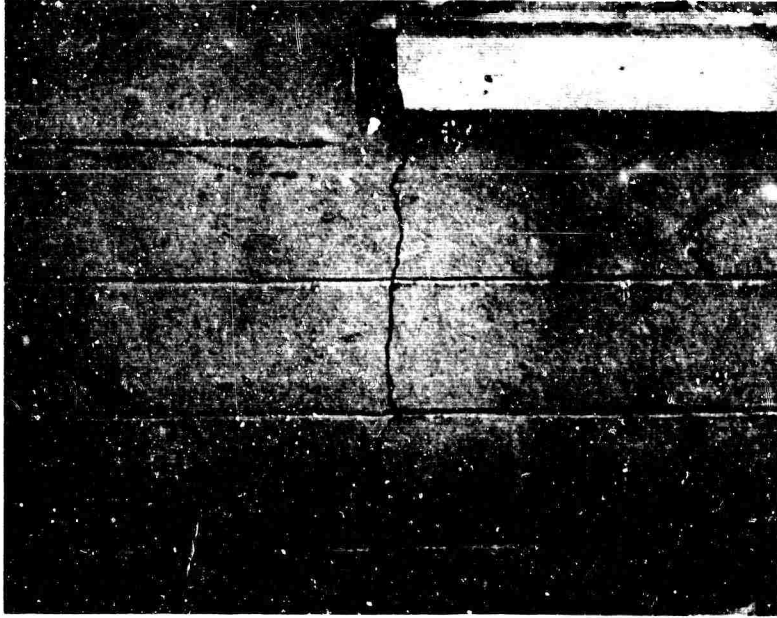
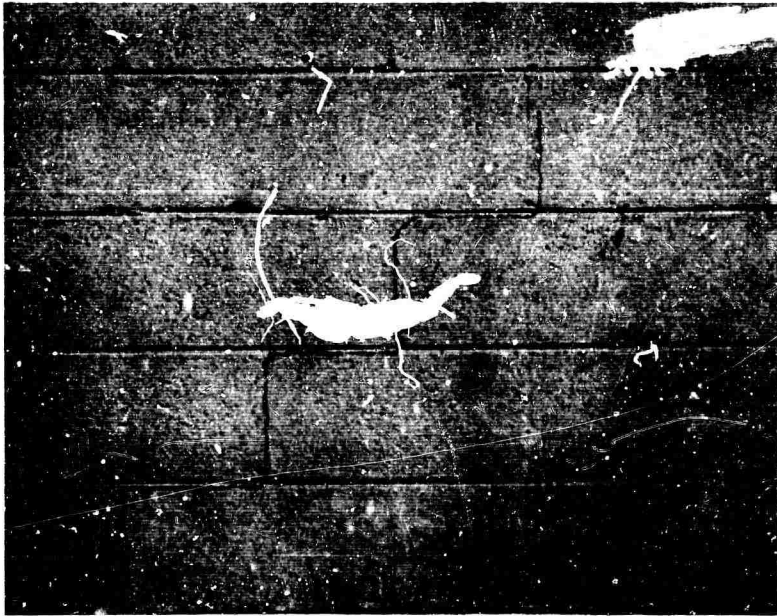
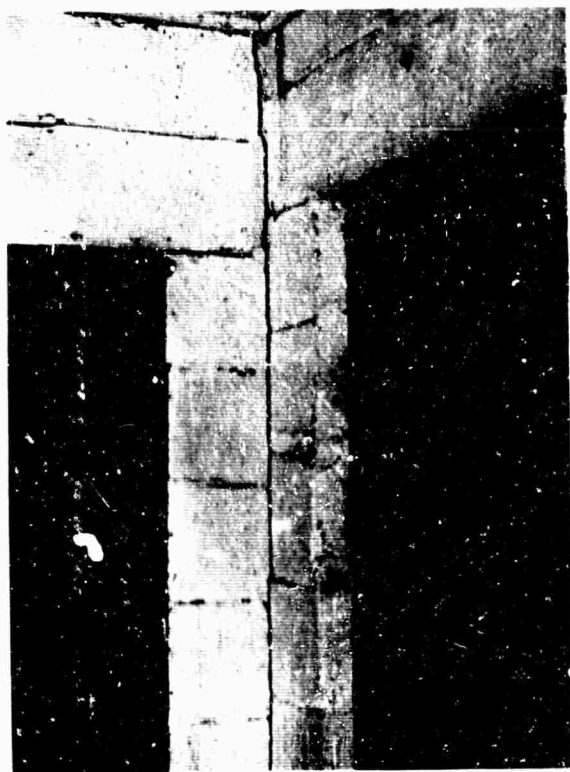
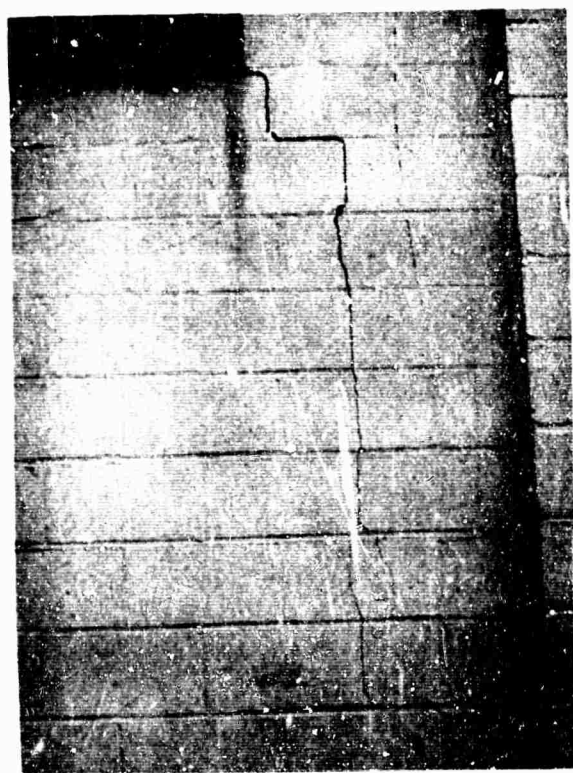
Photo No. 19 - Pre-Shot of H&N No. 116

A group of concrete block structures, the Baxterville School (H&N 116), were surveyed 6,950 meters from SZ. The ground motion was predicted to be 4 cm/sec. A large number of cracks were documented in the pre-shot survey (photos no. 19 to 22). The postshot survey indicated only possible minor aggravation. The engineer's report states, "It is remotely possible that some of the hairline cracks in the masonry have been aggravated". Photo no. 23 is a postshot picture of the crack illustrated in photo no. 22 taken immediately after the event. To determine the increase in the cracks with time, photo no. 24 was also taken of the same crack ten months after the event. It is apparent that there was only a small increase in the size of the crack.

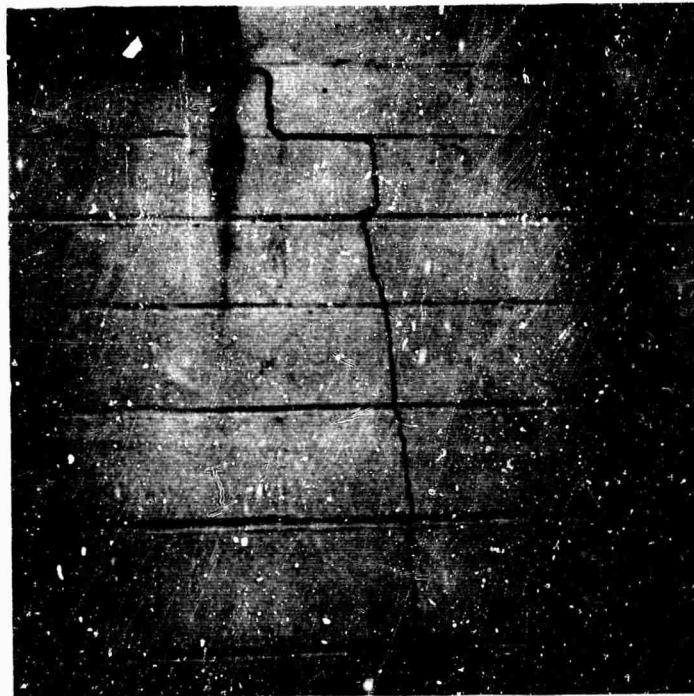
Photo No. 24 - Postshot of H&N No. 116, Ten Months After Event

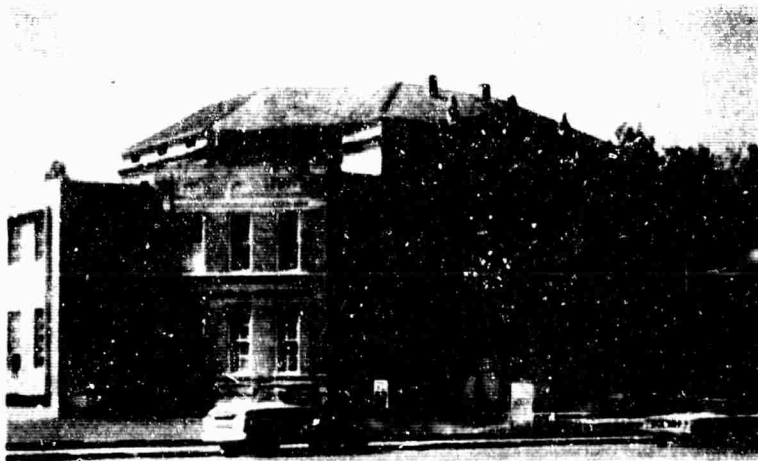
An old (1906) two-story brick building, the Lamar County Courthouse and Jail (H&N S-3) was surveyed 15,300 meters from SZ, where ground motion was about 1 cm/sec. The structure was in relatively good condition prior to the event with no noticeable cracks in the exterior brick walls or interior plaster walls and ceilings (photo no. 25). The postshot survey of the courthouse and jail identified one crack on both sides of the southwest corner of the basement wall (photo no. 26). The postshot survey also revealed hairline cracks in the interior plaster walls and ceilings of 12 rooms.

Photo No. 25 - Pre-Shot of Lamar County Courthouse

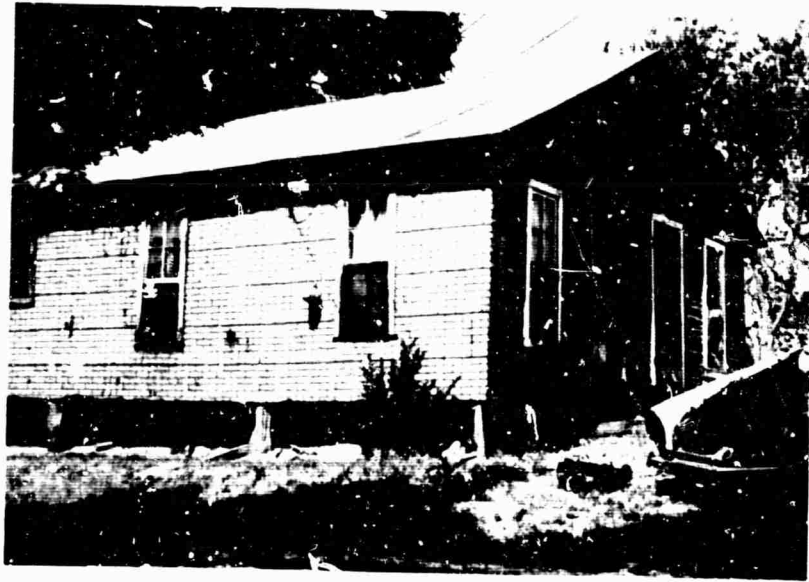
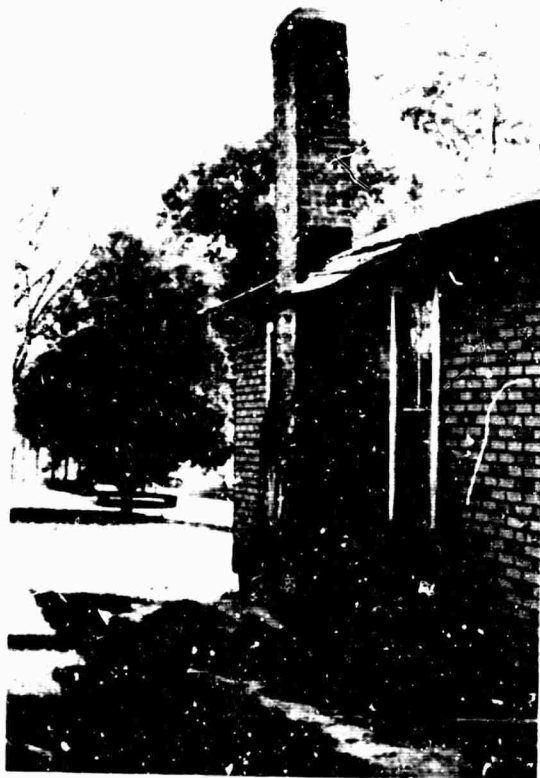
Photo No. 27 - Pre-Shot of H&N No. 56

A wood frame house (H&N 56) at 1,650 meters was supported on wood posts (photo no. 27). A chimney and fireplace (photo no. 28) were braced prior to the event, in accordance with the established standards, see sketch no. 8, of Appendix C. The predicted peak ground motion at this location was 35 cm/sec. After the event when the bracing was removed, the chimney was found to be demolished (photo no. 29). Floor beams and timber piers had been installed as a precautionary measure prior to the event. No other damage was evident in the postshot survey.

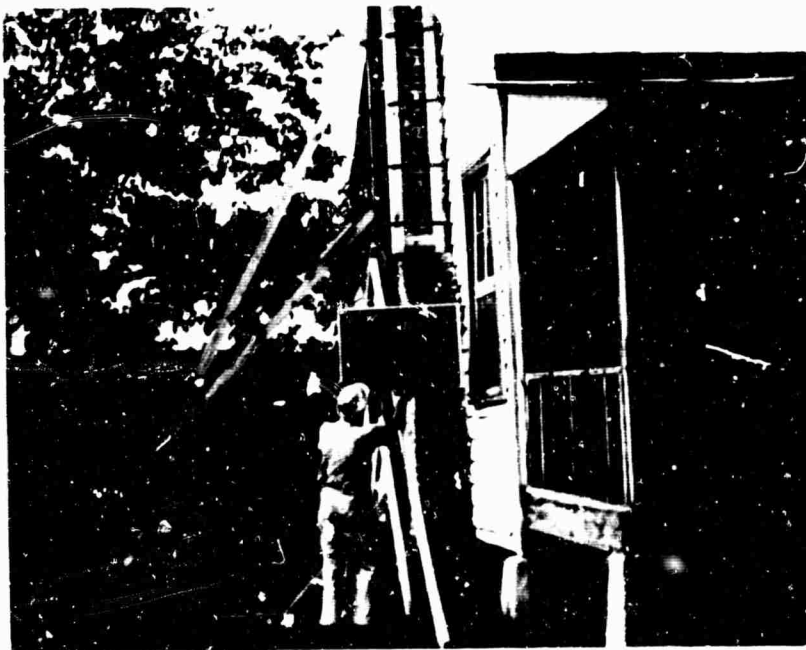
Photo No. 30 - Postshot of H&N No. 9 - Chimney Bracing

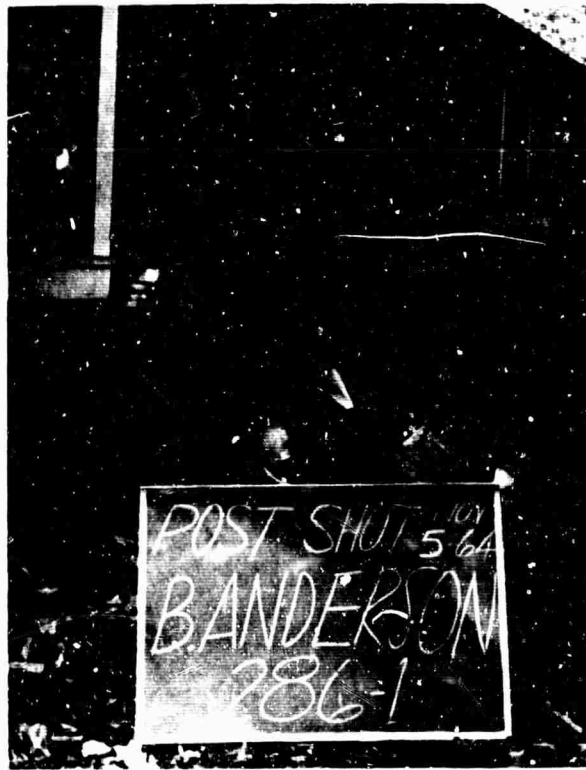
Photo No. 39 - Postshot of H&N No. 286 - Chimney

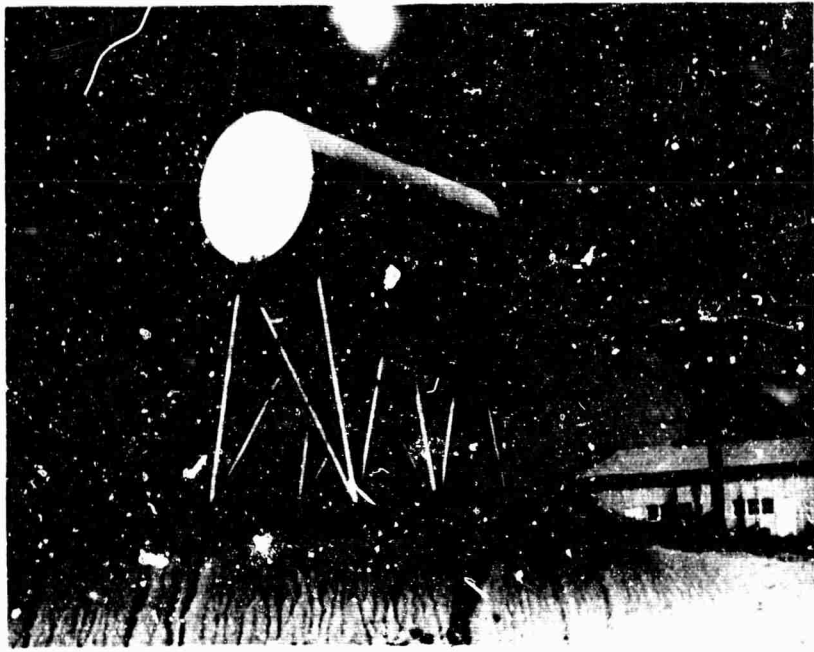
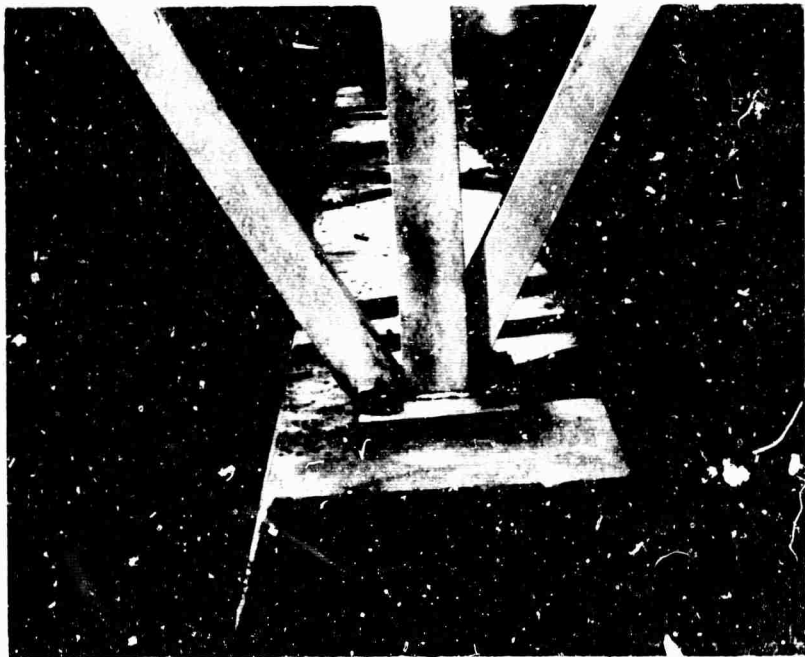
Photo No. 53 - Pre-Shot of T-16 Water Tower

The Patrick Harrisor water tower (T-16) consisted of a steel water tank, $4\frac{1}{2}$ meters long and 2 meters in diameter, supported horizontally on a steel frame. The tank was 4 meters above the ground and the frame was anchored to concrete foundation pads (photos no. 53 and 54). The water tank was located 543 meters from SZ and the peak ground motion was predicted to be 125 cm/sec velocity. It was recommended the tank be emptied, and on shot day it contained only a small amount of water. The postshot survey revealed no damage to the water tank or support; however, two of the three concrete foundation pads were cracked, as shown in sketch no. 4.

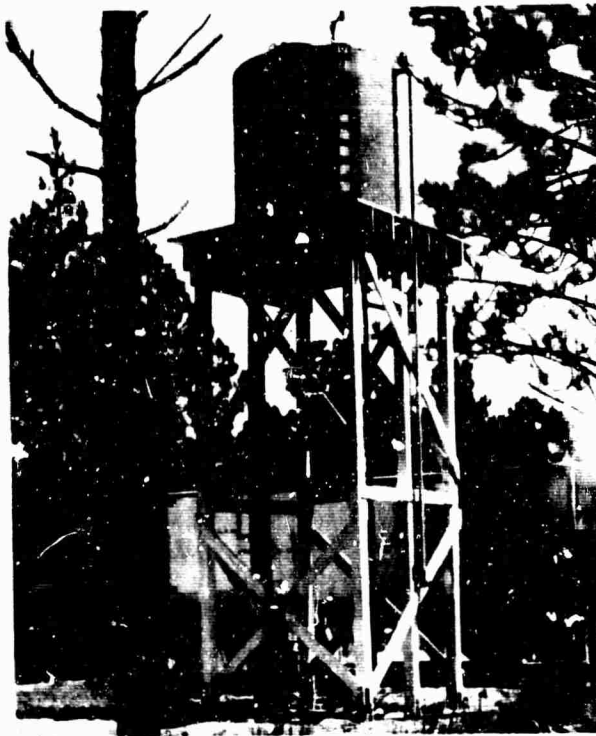
A water tank and tower (T-19) were located 610 meters from SZ. The steel tank, 2 meters high and 2 meters in diameter, was mounted vertically 4 meters above the ground on a wood platform (photo no. 55). The tower was constructed of six 15 x 15 cm posts braced with planks bolted diagonally as illustrated. The peak ground motion velocity was predicted to be 112 cm/sec at the tower, and it was almost empty on shot day. No damage was observed after the event.

Photo No. 55 - Pre-Shot of Water Tank and Tower
at First Aid Station

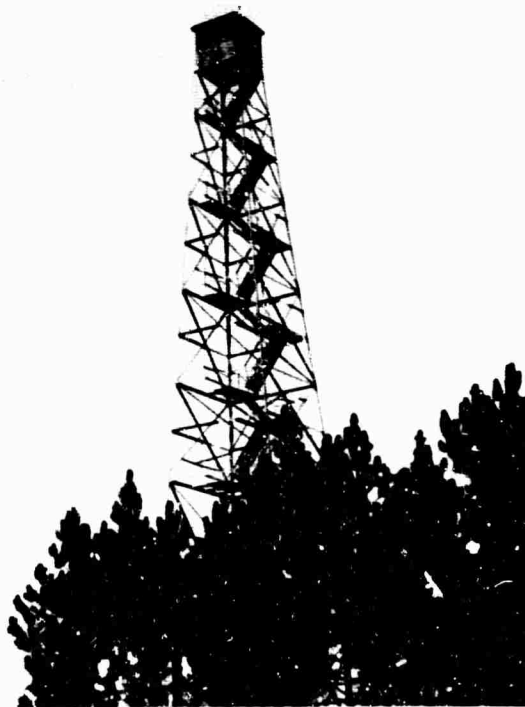
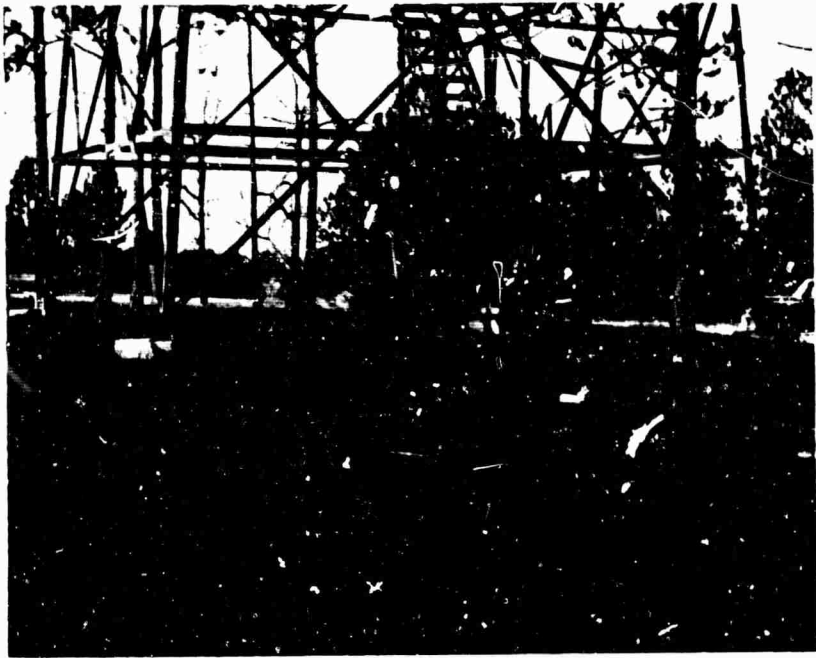
Photo No. 56 - Pre-Shot of Mississippi State
Forestry Service Fire Tower

A fire tower (S-4) occupied by the Mississippi State Forestry Service was surveyed 9.3 km from SZ. The steel frame, wood panelled cabin was supported on 10 x 10 cm angle columns, approximately 33.5 meters above the ground (photo no. 56). The columns were braced diagonally and horizontally with steel angles (photo no. 57). The tower is supported on individual concrete footings (photo no. 58) and anchored with two bolts through each base plate bracket. The predicted ground motion was 2 cm/sec. No damage was noted in the postshot survey of the tower.

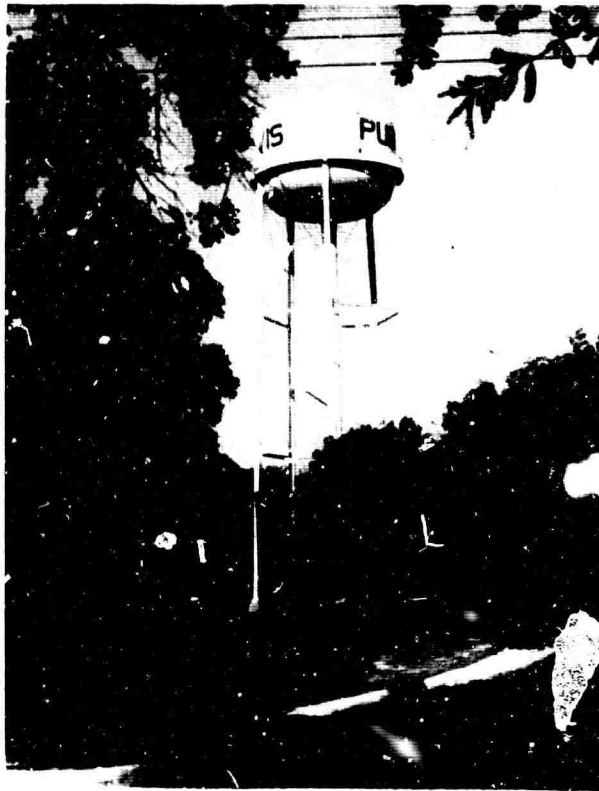
Photo No. 59 - Pre-Shot of Purvis Water Tower

Farther out from SZ, the Purvis City water tank (S-2) was surveyed. This elevated 946,000 liter steel tank was located 15.2 km from SZ (photo no. 59), where the ground motion was predicted to be 1 cm/sec. The tank was estimated to be about 37 meters above the ground and was supported on five 61 cm diameter steel pipe columns. The columns were cross-braced. The exterior columns were anchored to concrete foundation pads with four steel anchor bolts for each column (photo no. 60). An interior 122 cm diameter steel pipe extended down from the center of the bottom of the tank.

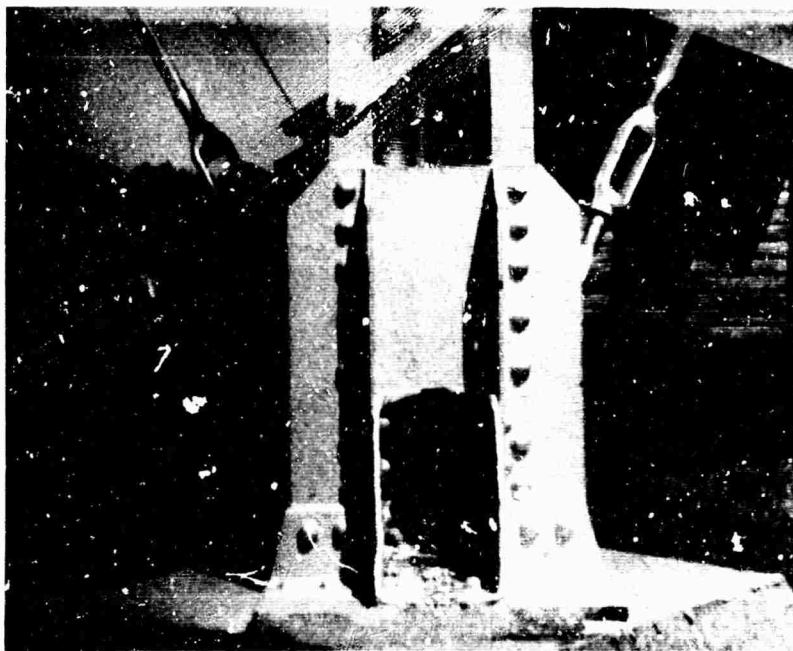
Photo No. 61 - Movie Star of Purvis Water Tower

Another water tower, the Movie Star of Purvis Corp. water tank (S-1) was surveyed also at a distance of 16.1 km from SZ. This is also a steel tank mounted approximately 30 meters above the ground on a steel tower (photo no. 61). The four tower legs, consisted of channel sections, with steel bars for diagonal bracing. Each column base plate was mounted to a concrete pad by one anchor bolt, as shown in photos no. 62 and 63. The ground motion at this location was also estimated to be 1 cm/sec.

The two Purvis water tanks were not expected to be damaged, and no precautionary measures were taken prior to the shot. Only the Movie Star of Purvis Corporation tank sustained any apparent damage from the Salmon Event, and this was only a small leak in the fill pipe. Since the postshot survey indicated only a small dripping, it is possible that the leak was aggravated by the ground motion from the event.

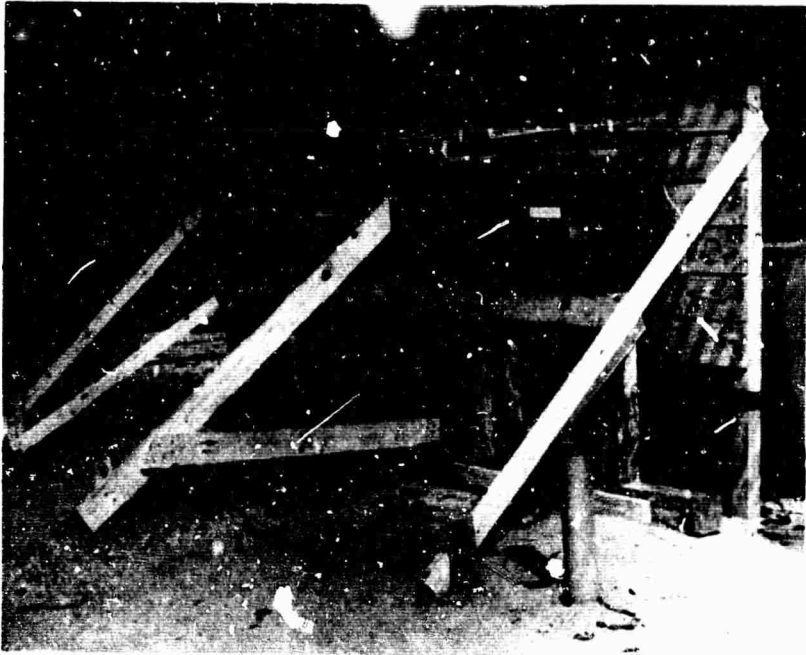
Photo No. 72 - Pre-Shot of Transformers and Oil Fuse Cut-Out Panel at Sta. 1-A After Bracing

Two electrical transformers and equipment boxes and two oil fuse cut-out panels (T-13) were located 107 meters from SZ (photos no. 70 and 71). The oil fuse cut-out panels were bolted to a wood frame. The transformers and other equipment had not been bolted down prior to the phase 3 survey, and with the predicated peak ground motion velocity at this location of approximately 227 cm/sec, it was recommended that bracing and guy cables be installed (photo no. 72). No damage was observed to the equipment during the postshot survey.

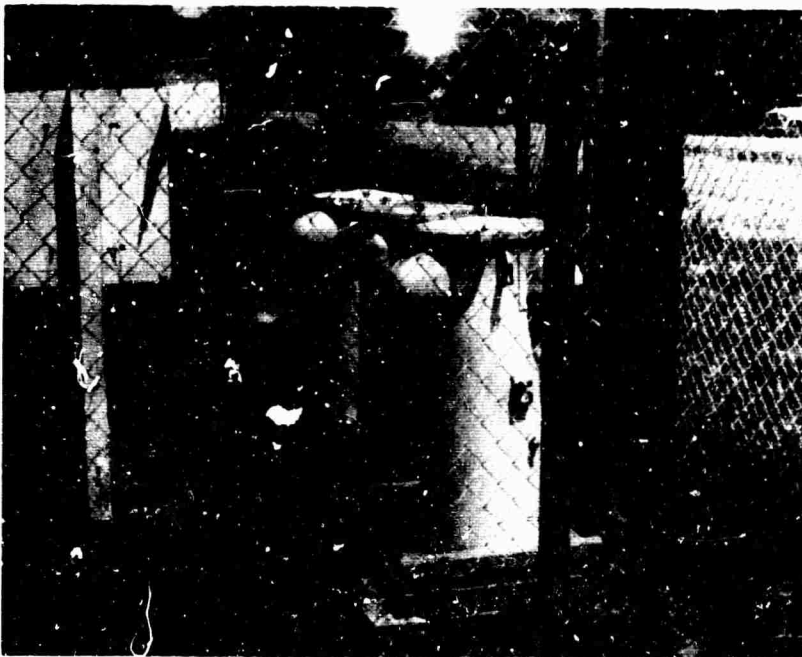
Three electrical transformers (T-12) were located at a substation 381 meters from SZ. The transformers were supported by blocking as indicated on (photo no. 73) and the predicted peak ground motion velocity at this location was 170 cm/sec. H&N recommended guy cables which were installed as indicated on photo no. 74. The postshot survey revealed no damage to the equipment.

Photo No. 73 - Pre-Shot of Transformers Near Entrance to Sta. 1-A (T-12) Prior to Installing Guy Wires

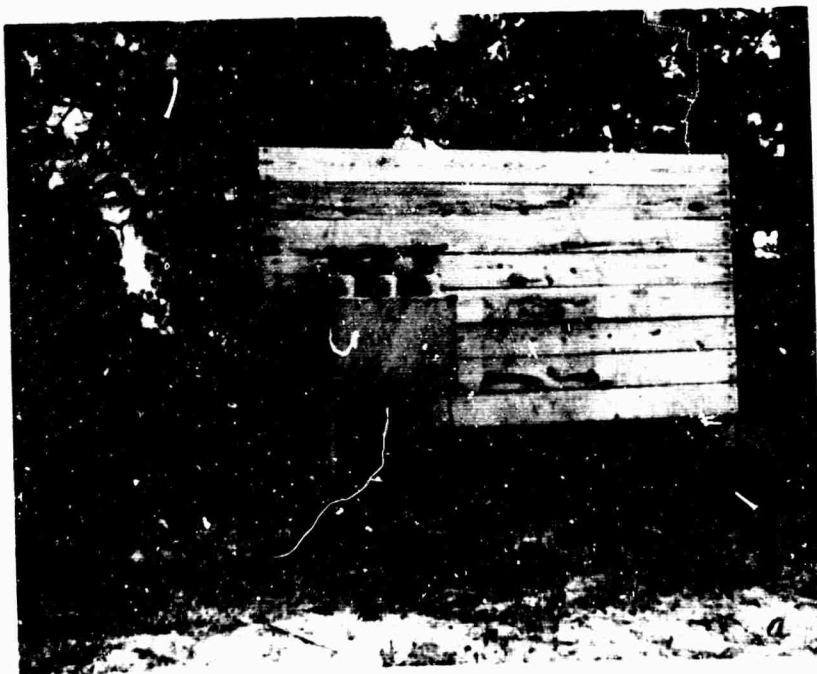
Photo No. 75 - Pre-Shot of Oil Fuse Cut-Out Panel (T-14)

An oil fuse electrical cut-out (T-14) was located 427 meters from SZ (photo no. 75), an electrical substation (T-5A) was located at 565 meters (photo no. 76), another (T-18) at 580 meters (photo no. 77), and another (T-17) at 594 meters (photo no. 78), from SZ. The predicted peak ground motion velocities were 155 cm/sec, 120 cm/sec, 115 cm/sec, and 110 cm/sec respectively.

The oil fuse panel at 427 meters was the only one requiring guy cabling. No damage was observed to any of this electrical equipment during the postshot survey.

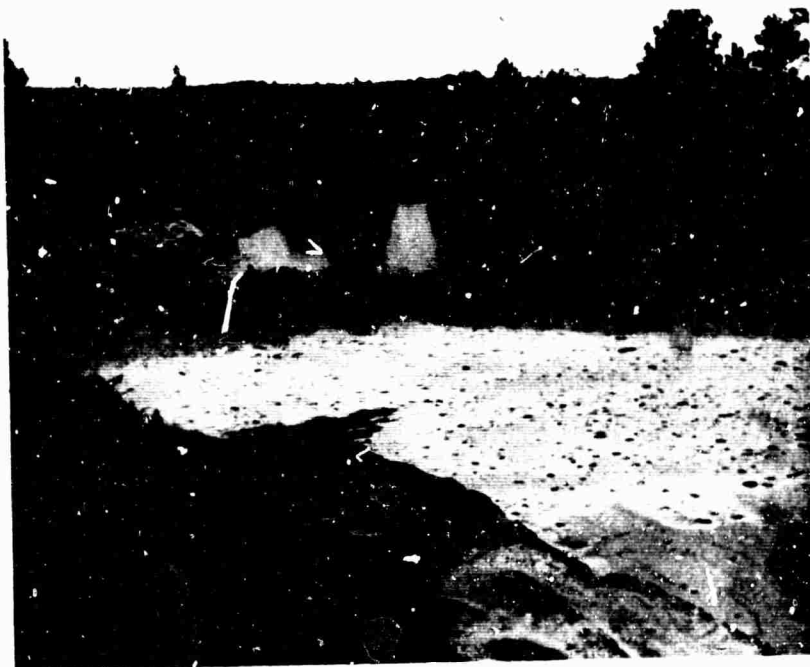
Pit no. 2 - This pit was also filled to full capacity of about 1,760,000 liters and a liquid depth of $1\frac{1}{2}$ meters. There was evident of seepage through the roadside dike prior to the test, as shown in photo no. 87. After the test longitudinal cracks developed on the berm of the dike (photo no. 88).

Photo No. 87 - Pre-Shot of Disposal Pit No. 2 (Background)
and Disposal Pit No. 3 (Foreground) on
September 30, 1964)

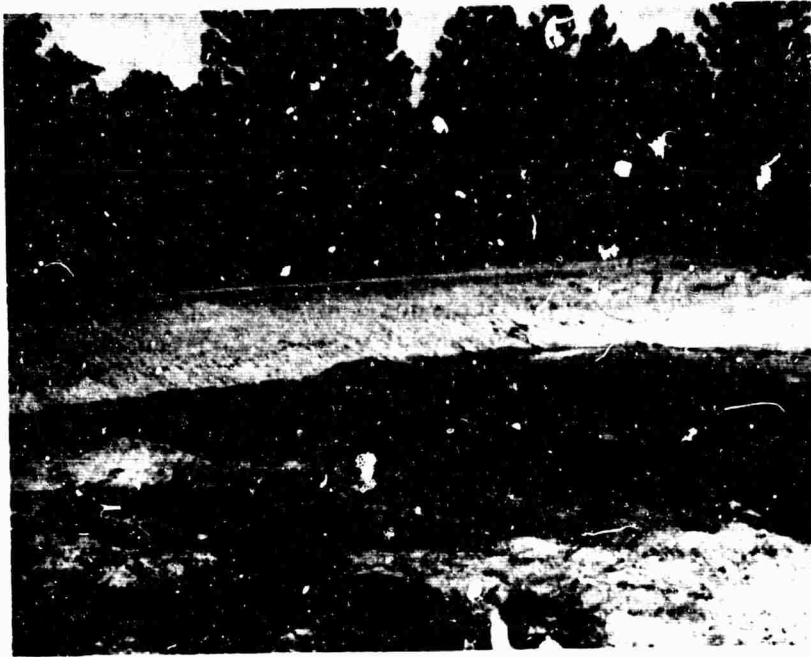
Photo No. 92 - Pre-Shot of Disposal Pit No. 5
(August 12, 1964)

Pit no. 5 - This pit was similar in height to no. 4, however, it was only partially filled and it was recommended that several of the other pits be reduced in quantity of liquid by pumping into no. 5. Prior to the event "mud" was pumped from no. 2 into no. 5 until the level of no. 5 was 2 meters (photo no. 92) from the top. After the event, many longitudinal cracks developed in the berm, and sloughing was evident on both the upstream and downstream faces (photo no. 93).
