CRA SHWORTHINESS OF AIRCREW PROTECTIVE ARMOR

TECHNICAL REPORT
68-57-CM

Aviation Safety Engineering and Research
A Division of
Flight Safety Foundation, Inc.
Phoenix, Arizona

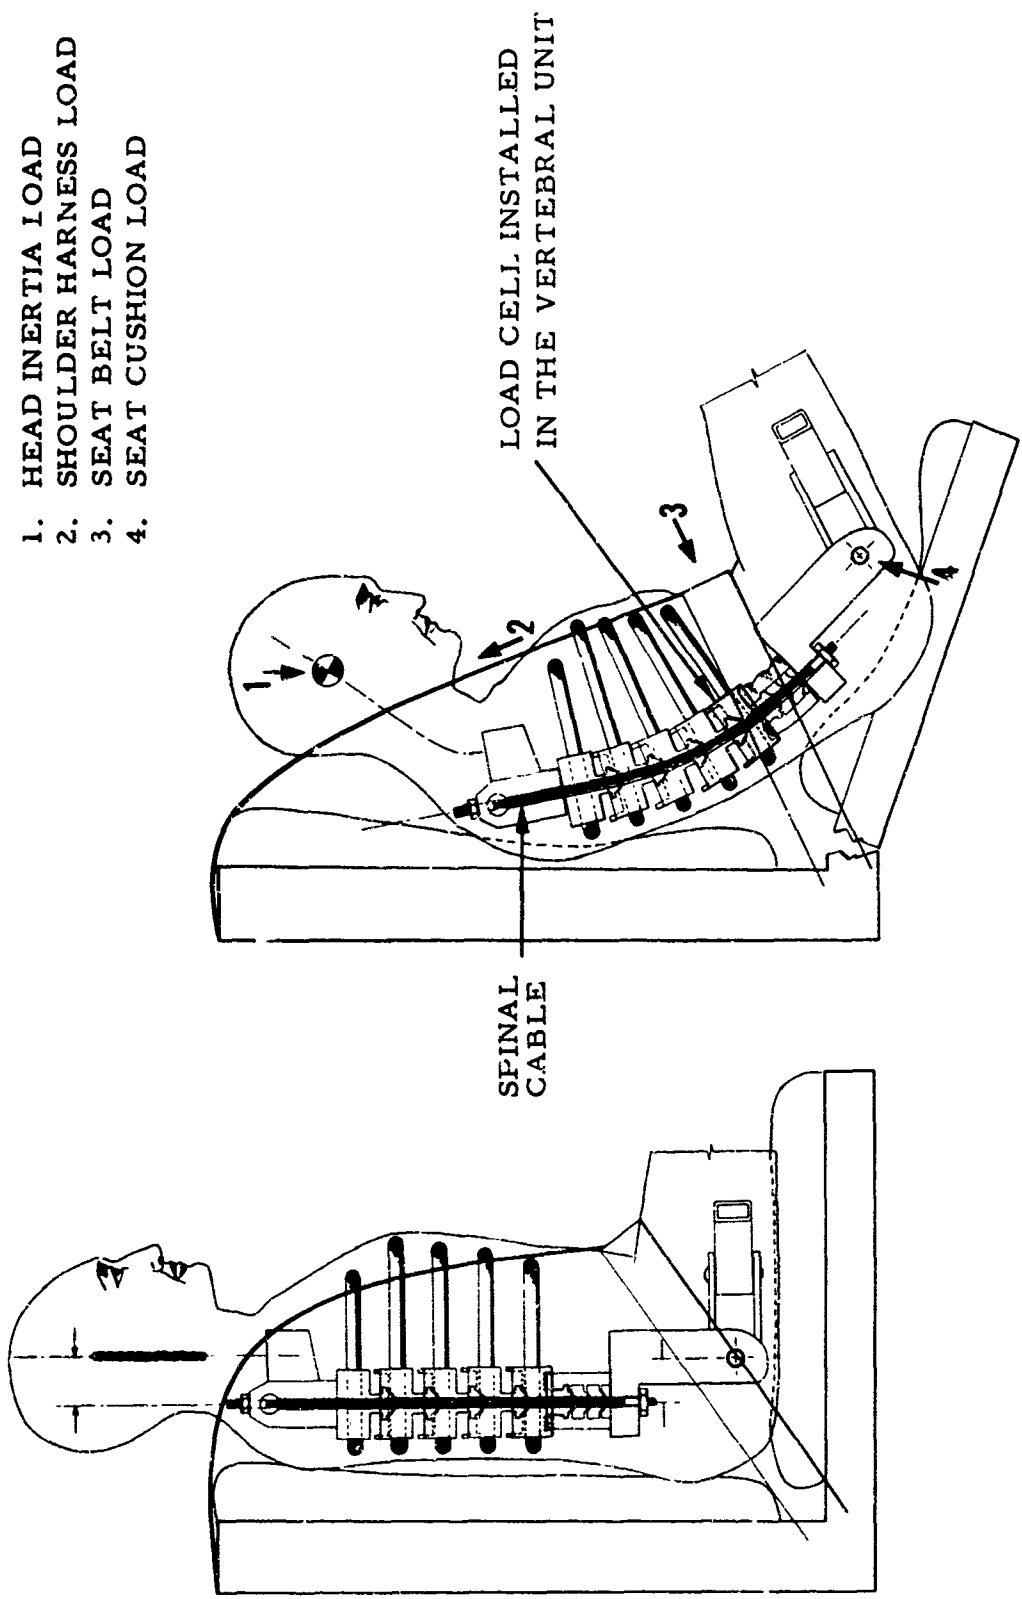
Figure 8. Flexion of Spine During Submerging.

The reasons for these large differences in vertebral readings (see Table II, column 17, for Tests No. 1 and 2, for example) have not been completely resolved. However, it is believed that the higher load readings were not indicative of vertical compressive load, but were associated with flexion of the spine due to either "submarining" or "jackknifing." It was clearly observed in the high-speed films taken during horizontal accelerator tests that the unarmored dummy in every case either submarined under the lap belt to a considerably greater degree than did the armored dummy, or jackknifed to a greater degree. This resulted in the unarmored dummy experiencing a more severe flexion in the lumbar region than the armored dummy. The mechanical design of the dummies used is such that bending of the spine beyond a certain limit will induce spurious load cell readings due to the tension induced in the cable which extends from the pelvis to the shoulders and ties the vertebrae of the dummy together, Figure 8. The vertebral load readings, in column 17 of both Tables I and II, which greatly exceed the product of the chest vertical acceleration and the chest mass (100 pounds x column 15 in Table I, and 100 pounds x column 17 of Table II), should be considered only as an indication of severe flexion.

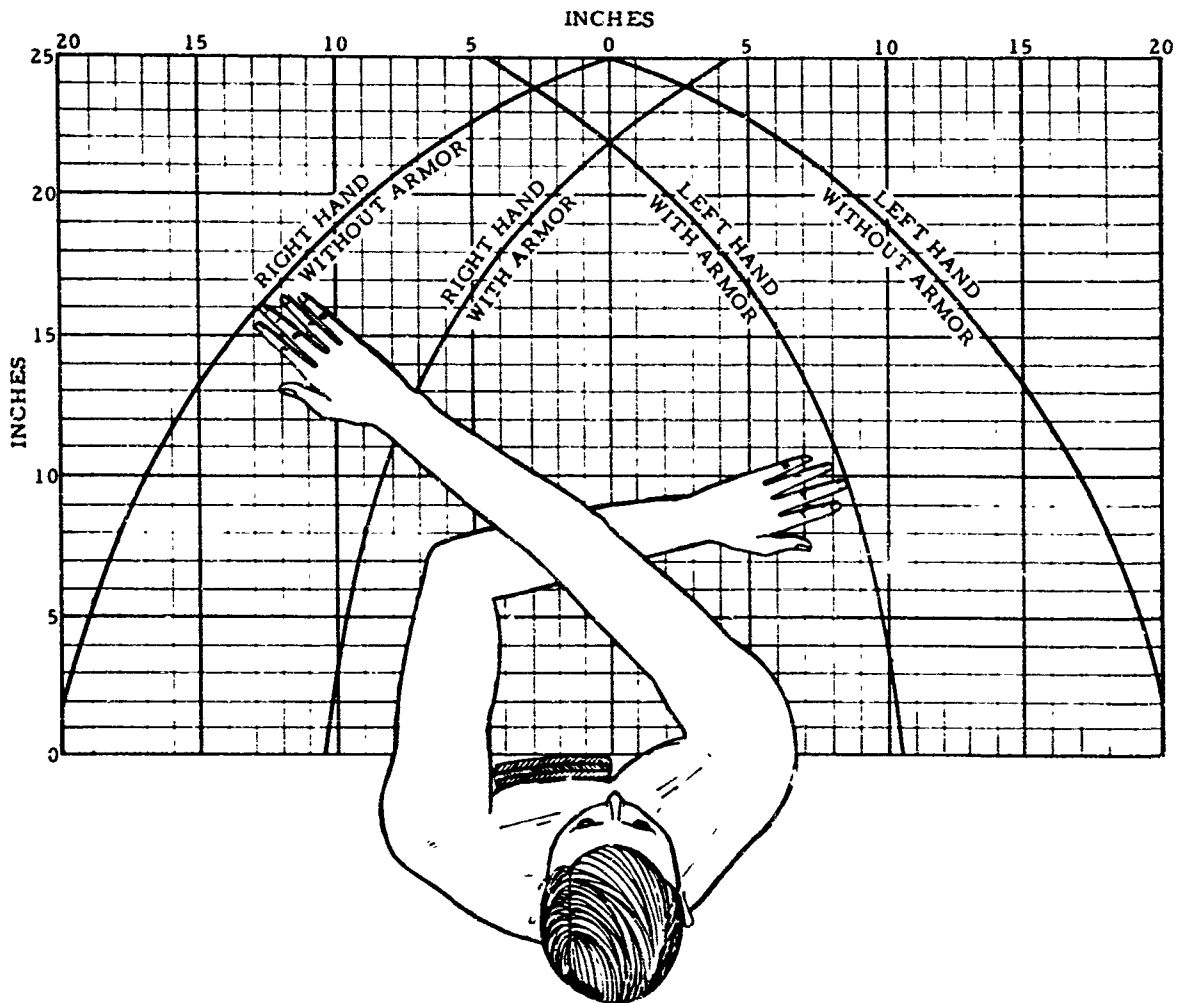
Figure 9 shows the range of useful arm reach, by a seated and restrained individual, with and without armor. There is some compromise of the across body reach span with the armor but its potential significance to aircraft operation or evacuation is considered minimal.

Figure 9. Cross Reach Restriction. (With and without front armor.)

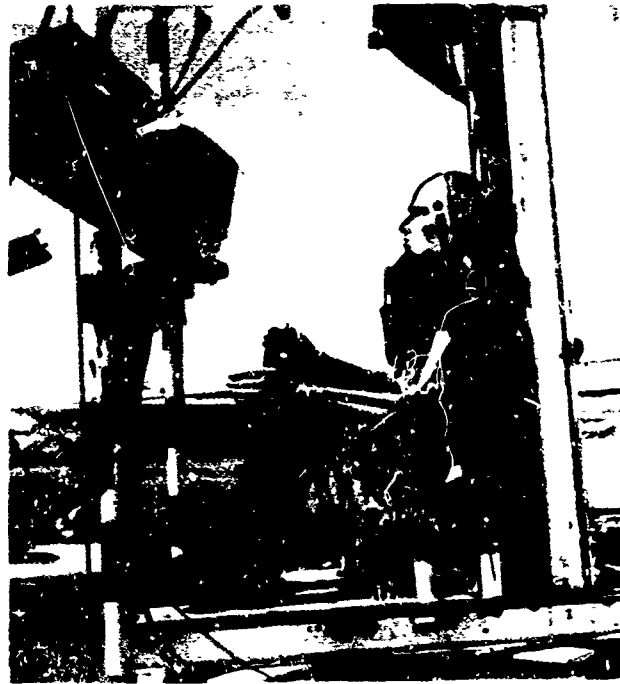
Figure 44. Posttest Position of Armored Dummy in Test 20.
(Note position of lap belt at midline of chest armor.)

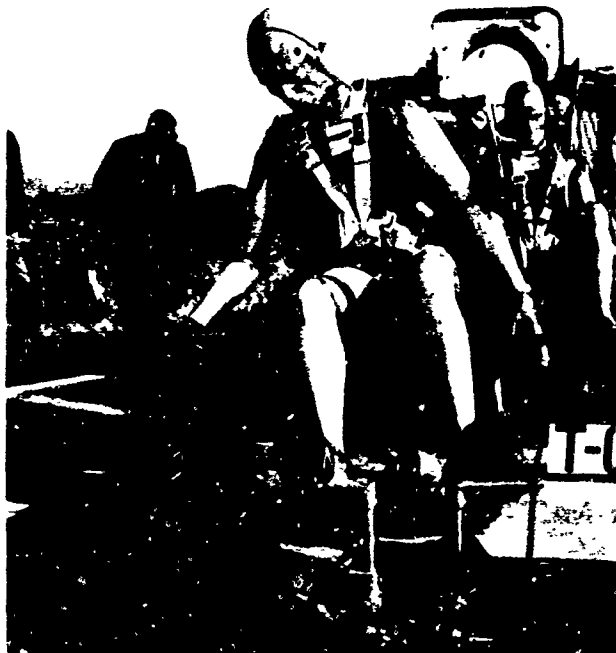
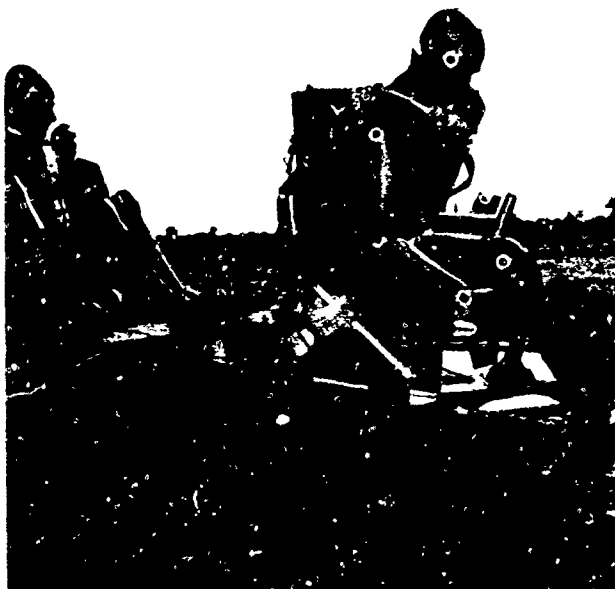
As previously mentioned, this seat was actually a copilot's seat, but was placed in this position so that the side armor would be inboard to avoid interfering with photographic coverage. The seat bucket stroked 5 inches vertically due to failure of the positioning pins in the seat height adjustment tubes. A partial failure of the weld on the support bracket for the side armor allowed the armor to deflect downward. Indentations in the foam thigh pads indicated that the chest armor impacted the right thigh with a force of 500 pounds. No appreciable crushing was found in either the left thigh pad or the chin pad. Analysis of the high-speed film indicates that the chin did not strike the armor. Figures 71 and 72 show front and side views of the final position of seat and dummy. Notice the extremely high position of the lap belt buckle. This is a result of the slack induced by the vertical movement of the bucket.

Figure 71. Postcrash Front View - Pilot Position.

Figure 72. Postcrash Side View - Pilot Position.

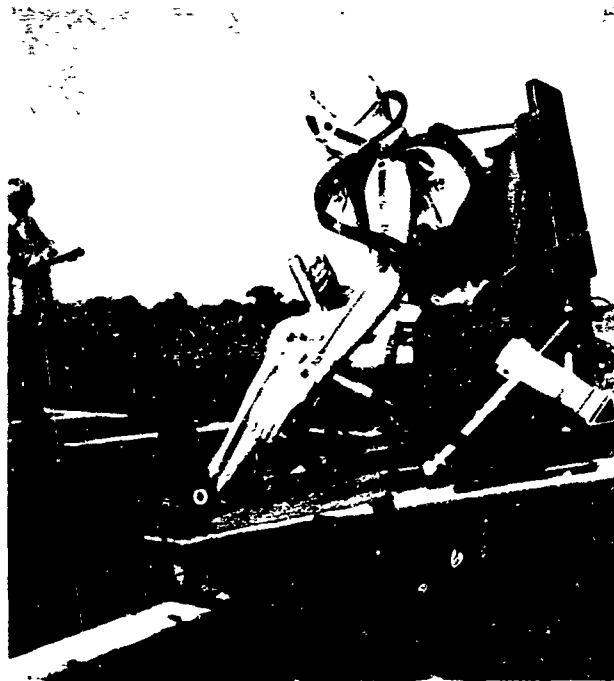
Figure 74. Postcrash Side View - Copilot Position.

Figures 73 and 74 show the final position of this seat and dummy. Notice again the extremely high position of the lap belt buckle caused by slack that was induced by the vertical displacement of the seat bucket.

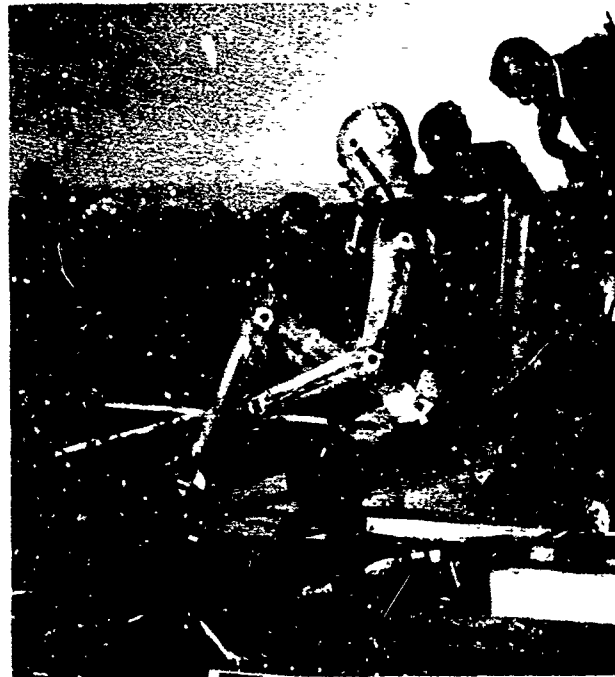
Figure 76. Postcrash Side View - CH-47 Seat.

This seat also displaced vertically due to failure of the height adjusting mechanism. The seat bottomed severely on the seat mount; however, no crushing was observed in the thigh pads or chin pad. This would indicate that the armor did not strike the thighs or chin with any appreciable force. Figures 75 and 76 show the final position of this seat and dummy. Note that the lap belt has remained in place. No slack was introduced by the vertical displacement since the belt is fastened to the seat.
