NRL Memorandum Report 1950

Analysis of the Failure of the AUTEC TOTO II Deep Sea Moor and the Performance of its Cathodic Protection System

R. E. GROOVER

November 1968

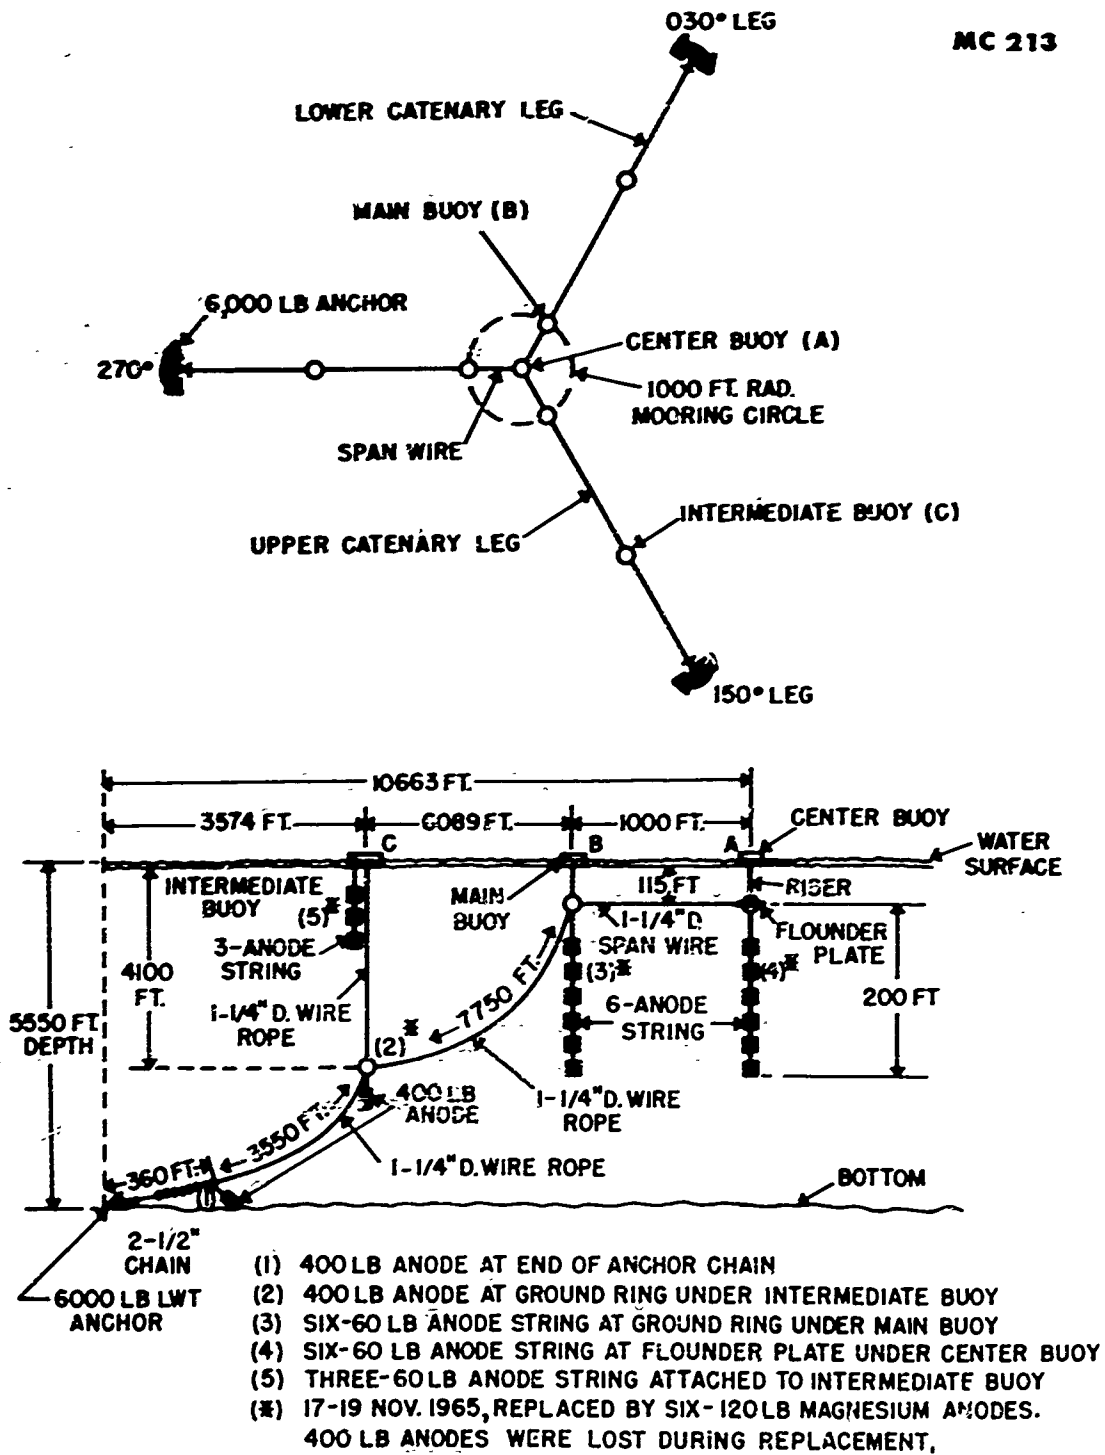
A three-point moor, designated AUTECH TOTO II, was designed by the Bureau of Ships (now Naval Ship Systems Command) to meet the set requirements (1). The moor consisted of three legs positioned 120° apart. Each leg was comprised of the center buoy, a main buoy, and an intermediate buoy. Approximately 11,000 ft of 1 1/4-in. 6x19 filler wire (WSC), extra improved plow steel, galvanized, bituminous coated wire rope connected each main buoy to an anchor chain and anchor positioned on the sea floor. A 4,100-ft vertical riser beneath each intermediate buoy supported the wire rope between the main buoy and the anchor to form an upper and lower catenary. The risers were also 1 1/4-in.-diam wire rope except the upper 105 ft of each which consisted of 30 ft of 2 1/2-in. chain and 75 ft of 1 5/8-in.-diam wire rope. A schematic diagram showing the moor and a typical anchor leg is shown in Fig. 1.

On 26-30 May 1962, the moor was laid in about 5400 ft of water in the TOTO. The late Mr. L. J. Waldron of NRL supervised the attachment of approximately 4400 lb of magnesium anodes to the moor at the locations shown in Fig. 1.

Fig. 1 - Plan view of the moor in the upper sketch and a typical mooring leg elevation in the lower sketch (not to scale).
