Technical Note N-832

CATHODIC PROTECTION OF MOORING BUOYS AND CHAIN

PART II. FURTHER FIELD STUDIES

U. S. NAVAL CIVIL ENGINEERING LABORATORY  
Port Huene, California

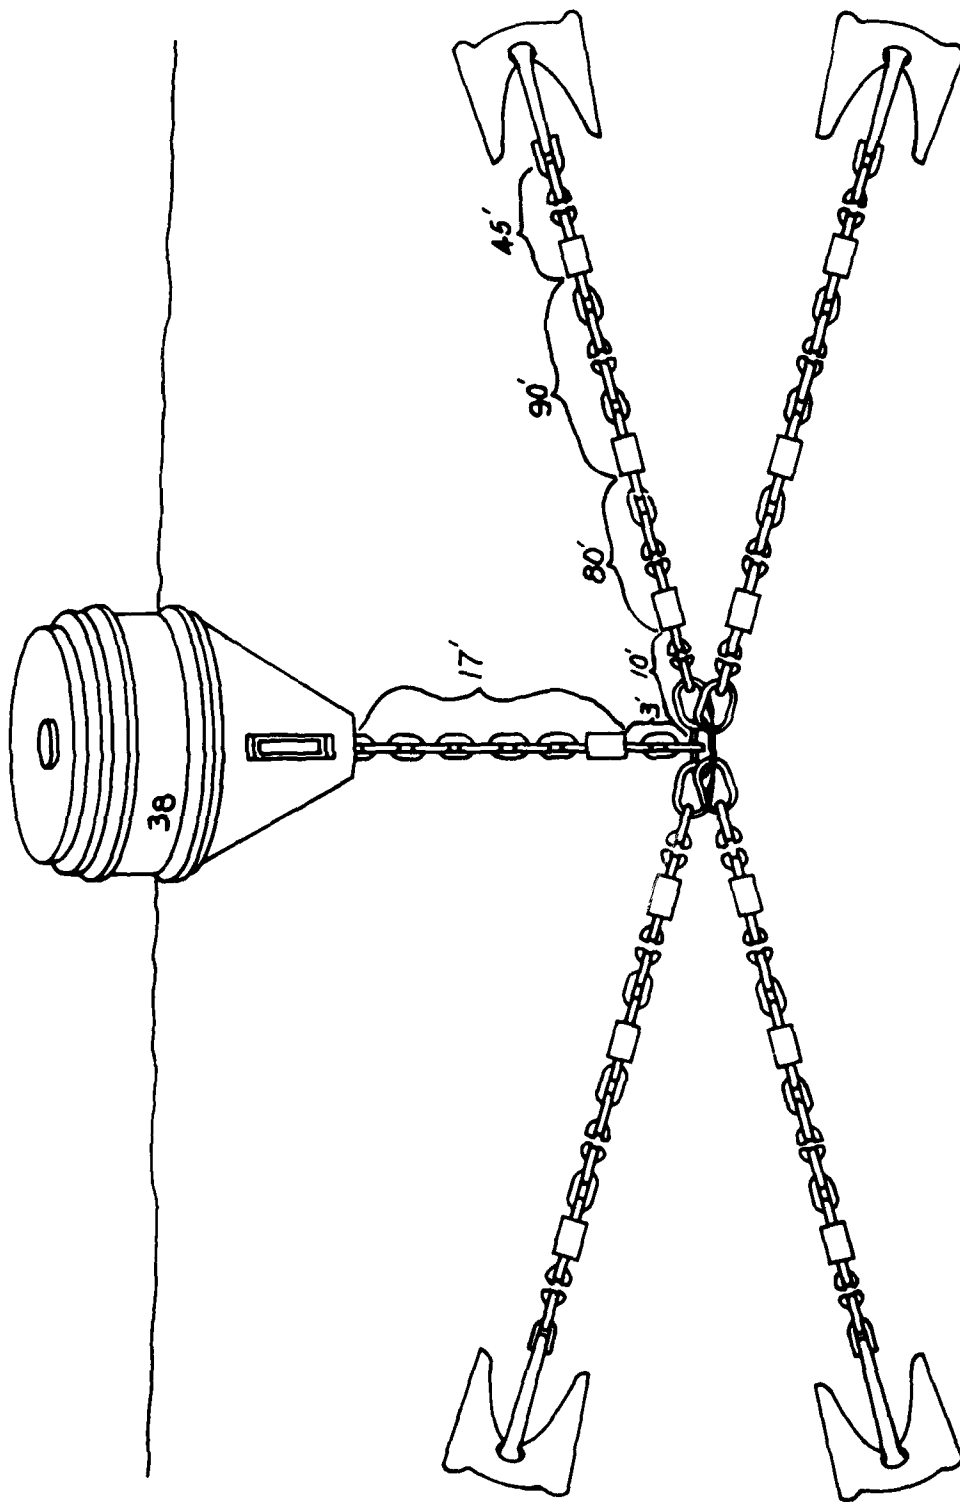
The design of the cathodic protection system is shown in Figure 2. Two of the smaller zinc anodes (approximately 144 lbs.) used in the previous study<sup>1</sup> were located in sea chests on opposite sides of the buoy cone. One of the special anodes was located on the riser-chain approximately three feet above the ground ring. Thus no place on the chain is further than 45 feet from an anode. The anodes were secured into the ground tackle using standard detachable links.

The specially prepared zinc anodes performed satisfactorily and showed no signs of passivation. They were present in sufficient quantity to provide complete protection to the mooring but lack of electrical continuity between chain links limited the amount of protection provided ground legs. Complete protection was provided to the underwater portion of the buoy and to the entire riser chain and the first twenty feet from the ground ring on each leg. These are the areas most corroded and the areas most costly in terms of both original purchase and maintenance. Thus the cathodic protection design in Figure 2, while not providing complete protection to

Figure 2. Cathodic Protection Design.
