WT-1454

OPERATION
PLUMB BOB

Project 30.7

TEST OF GERMAN UNDERGROUND
PERSONNEL SHELTERS

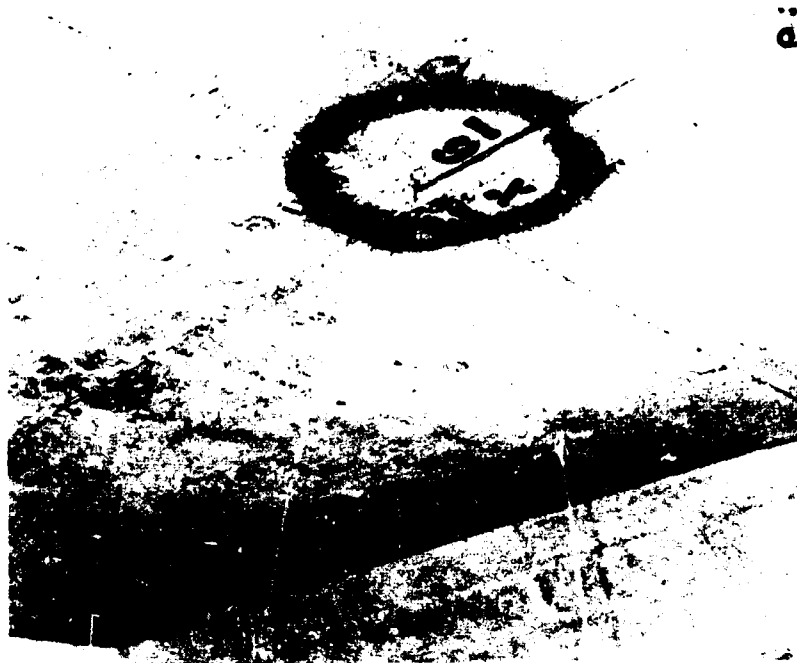
Fig. 3.6—Center of main-chamber roof slab (structure RAa). Note survey point X-6.
