RDTR NO. 160 3 DECEMBER 1969

SAFETY TEST OF FLARE EXTRUSION FACILITY

NAVAL AMMUNITION DEPOT, CRANE, INDIANA

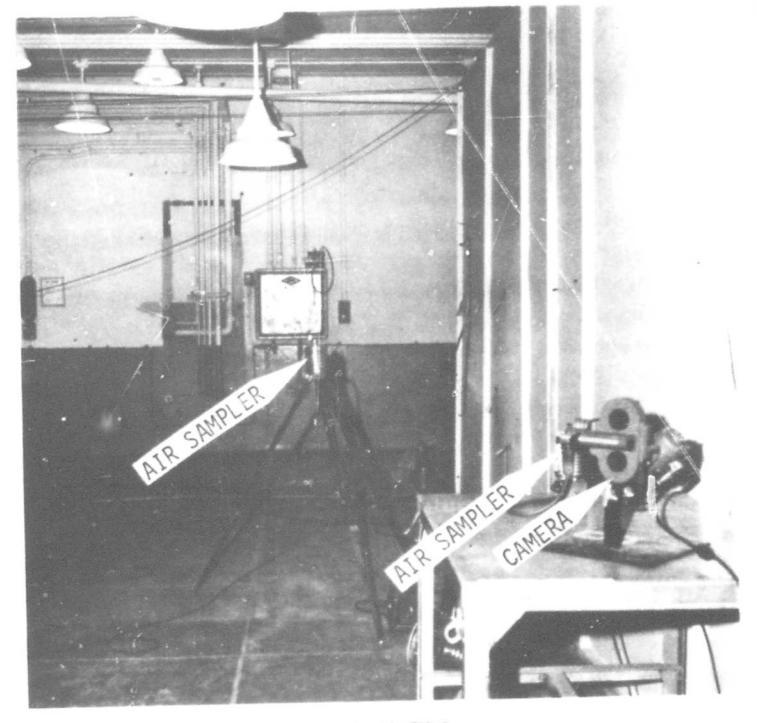
FIGURE 4a LEFT CAMERA

Instrumentation was set up in and around the press cell to collect temperature, pressure, toxicity, audio, and photographic information. Four 16mm movie cameras, running at 24 frames per second, were used. Figure 4a shows a camera aimed at the press cell from the left side. Figure 4b shows one camera aimed at the cell from the right side and another aimed

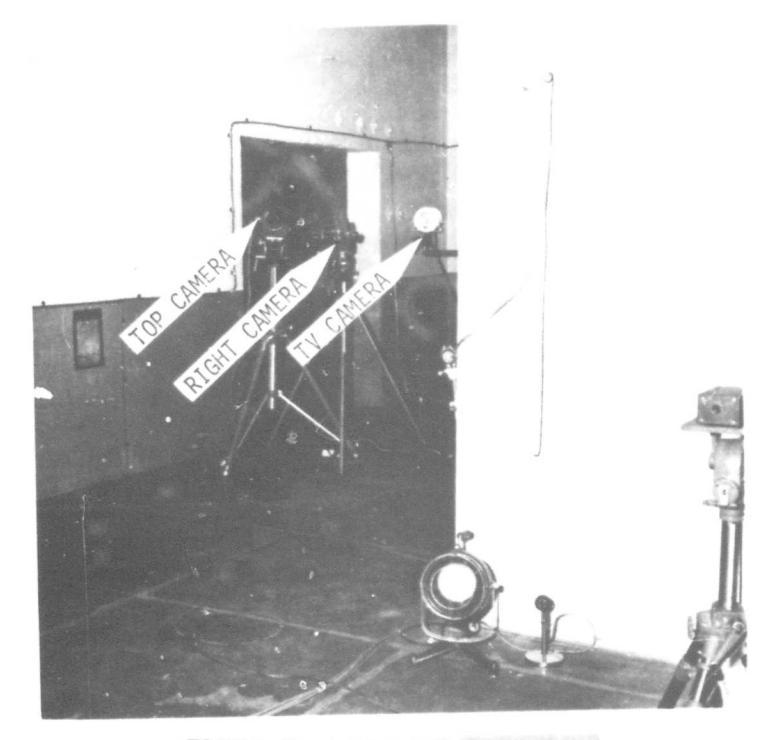
FIGURE 46 RIGHT AND TOP CAMERA

at the top of the cell. It also shows the IV camera used to monitor the test. Figure 5a shows the blowout windows before the test and the location of the outside camera which was aimed toward the bottom of the press. Two of the polyethylene panes were replaced with clear polystyrene names. Figure 5b shows the location of two photocells mounted on tripods and thermocouples, T1, T2, and T3. The photocell on the left detected visible energy and the photocell on the right detected infrared energy. Figure 6a shows the location of T4 and a pressure transducer. T5 was located on the press as shown by Figure 6b. Figure 3 also shows small pieces of newspaper taped to the doorway. Paper was also taped to the walls inside the cell at various locations. A book¹ by the AEC provides information with which a relationship can be made between the radiation energy level required to ignite newspaper and the radiation energy level that causes skin burns. From tables 7.45 and 7.65, it can be seen that the energy required to ignite newspaper would at least cause first degree burns and probably second degree burns. Flash time was also considered when making the relationship.

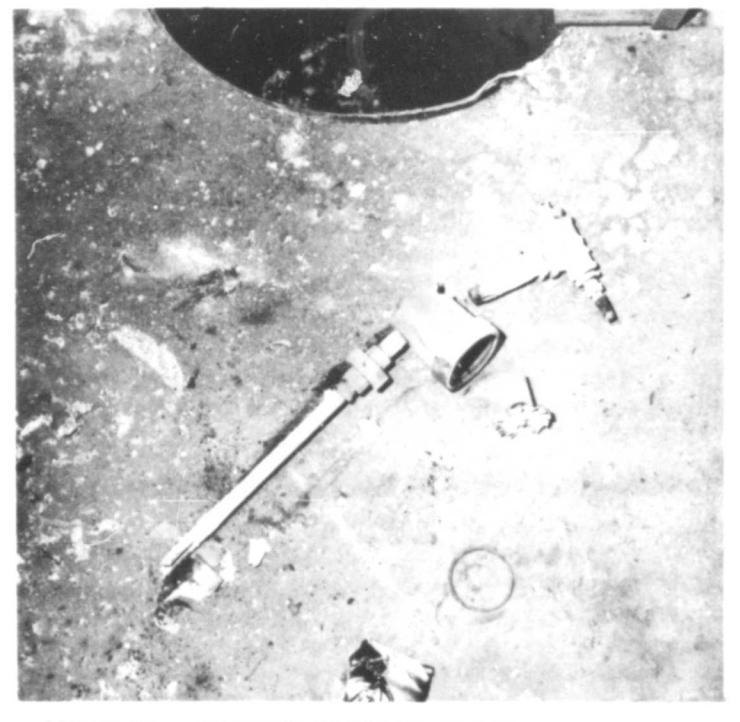
FIGURE 11a PLUMBING FROM TOP OF RAM

3. Burning inside the press was very vigorous and hot, as was expected. A total time of nine seconds of audible burning was indicated by the audio tape. The combustion pressure in the charge cylinder vented in two directions, up through the vacuum passage in the ram and down through the die. Flame venting through the ram melted steel pipe fittings as shown in Figure 11a. These fittings were originally located at the top of the ram-figure 11b. The beryllium copper ram was eroded as shown in figure 12a.
