FINAL REPORT  
(YSB Interim Report R6-1-0469)

ENVIRONMENTAL EXPOSURE OF  
SAMPLE MODEL MARINE FUEL TANKS

UL ASSIGNMENT 65WW63  
File MM-36

DATE: 27 February 1970

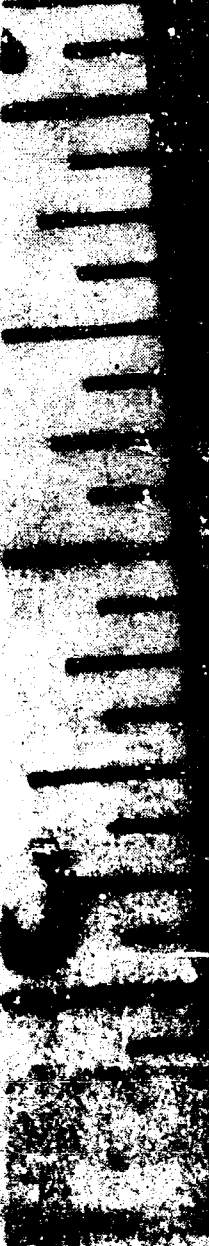
Final Inspection Report  
FIG. NO. 3

Top and bottom views of tank before removal of reservoir, and black bedding compound in way of wood-metal faying surfaces. Corrosion in way of welded seam and end chock liner is circled and marked 1, 5, 6 and 7. See Figs. No. 4 and 5.

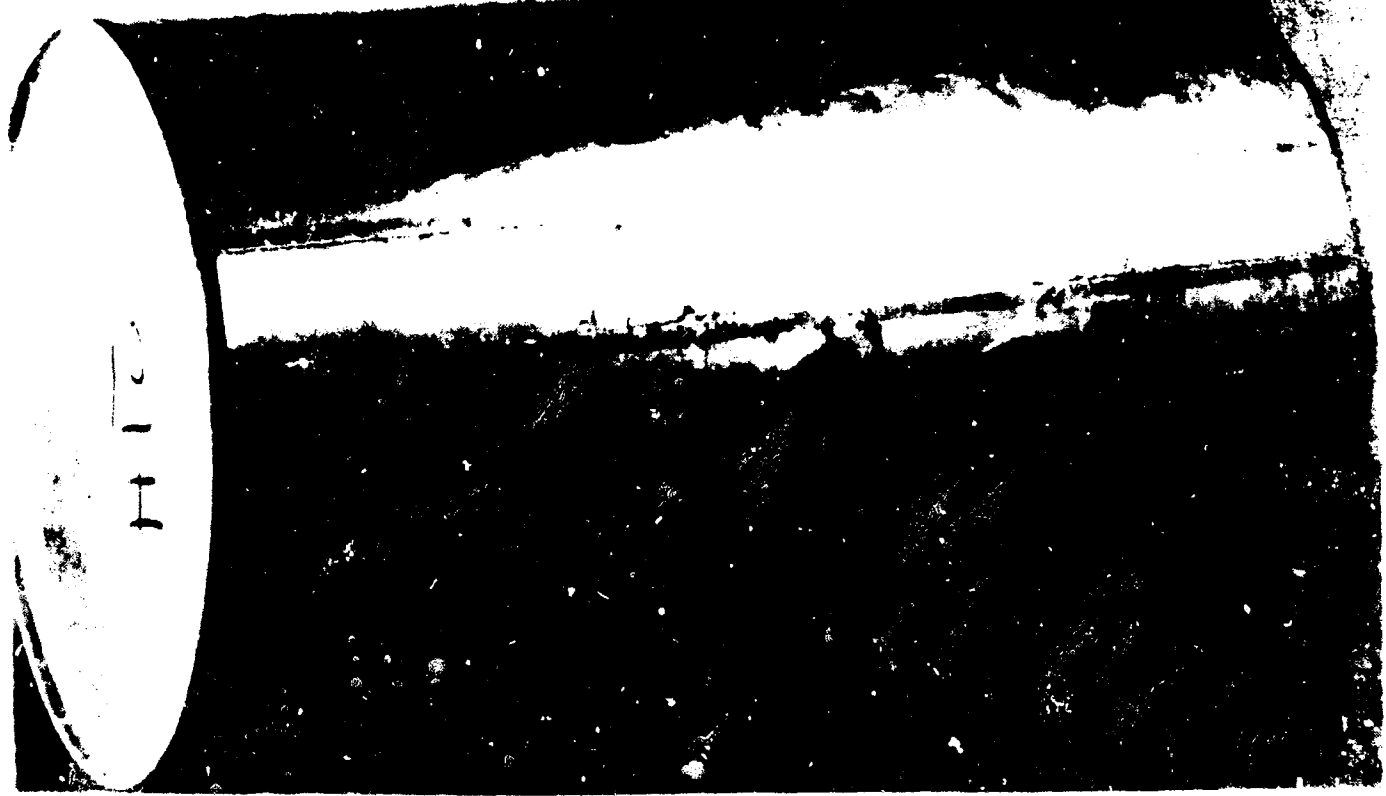
Final Inspection Report  
FIG. NO. 23

Upper and lower surfaces of tank show areas of corrosion,  
as indicated on the photo. It should be noted that "open",  
as well as "induced" areas were affected. No complete  
penetrations were noted. See Fig. No. 22 for view of deep  
etch.

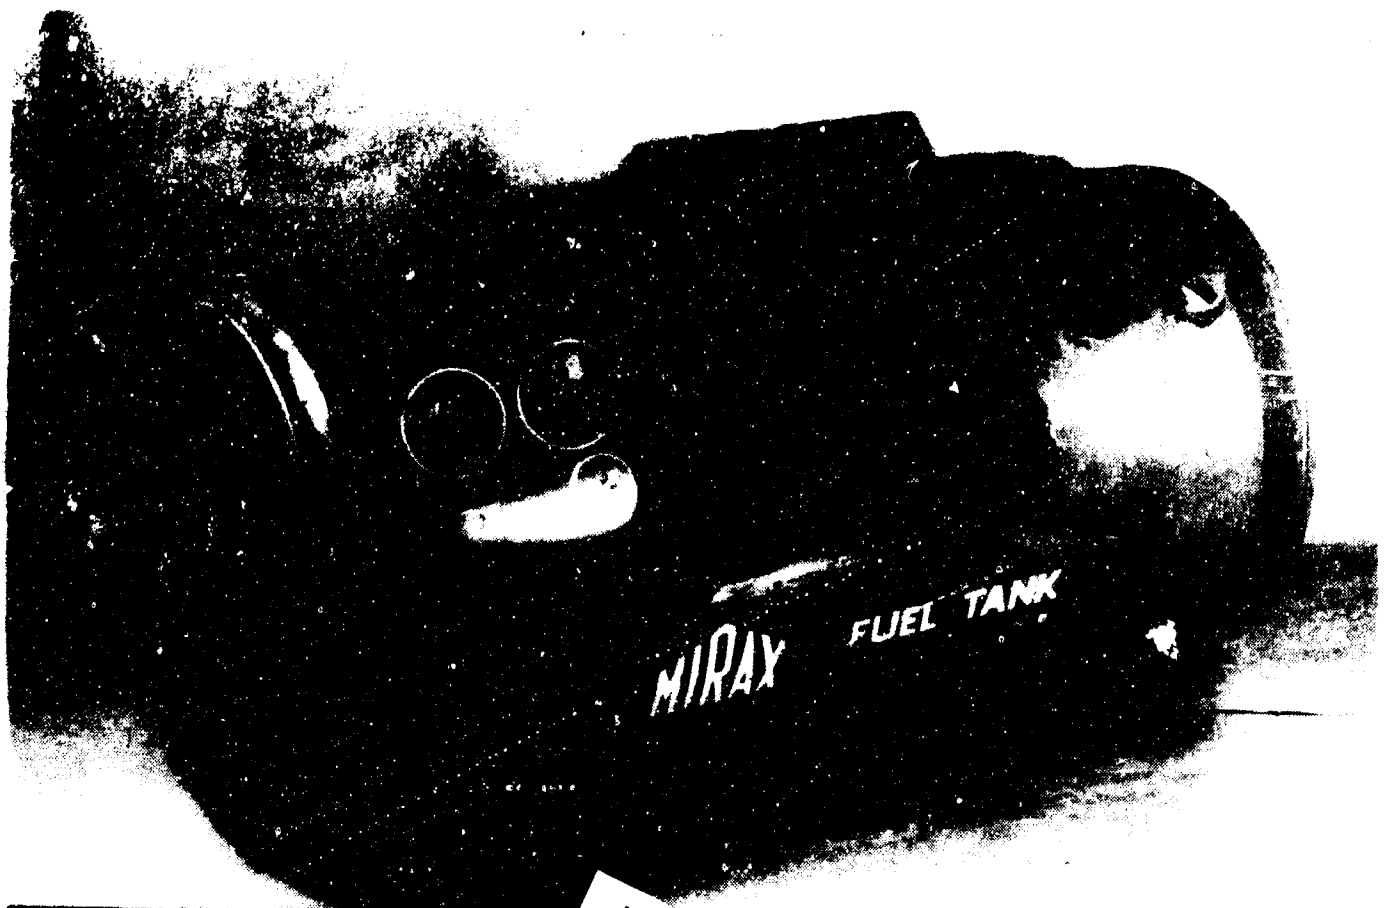
Final Inspection Report  
FIG. NO. 39

Upper and lower surfaces of tank show an infinite number of pits, to a depth of approximately 0.024 inch. No perforations were noted, but areas close to sea water reservoir, welded seam, and fittings would not withstand much more exposure. Interior photo marked Fig. No. 66 at end of this report reveals corrosion of interior surfaces occurred in the top radius of the tank. Humid air trapped between fuel and upper surface is the probable cause.

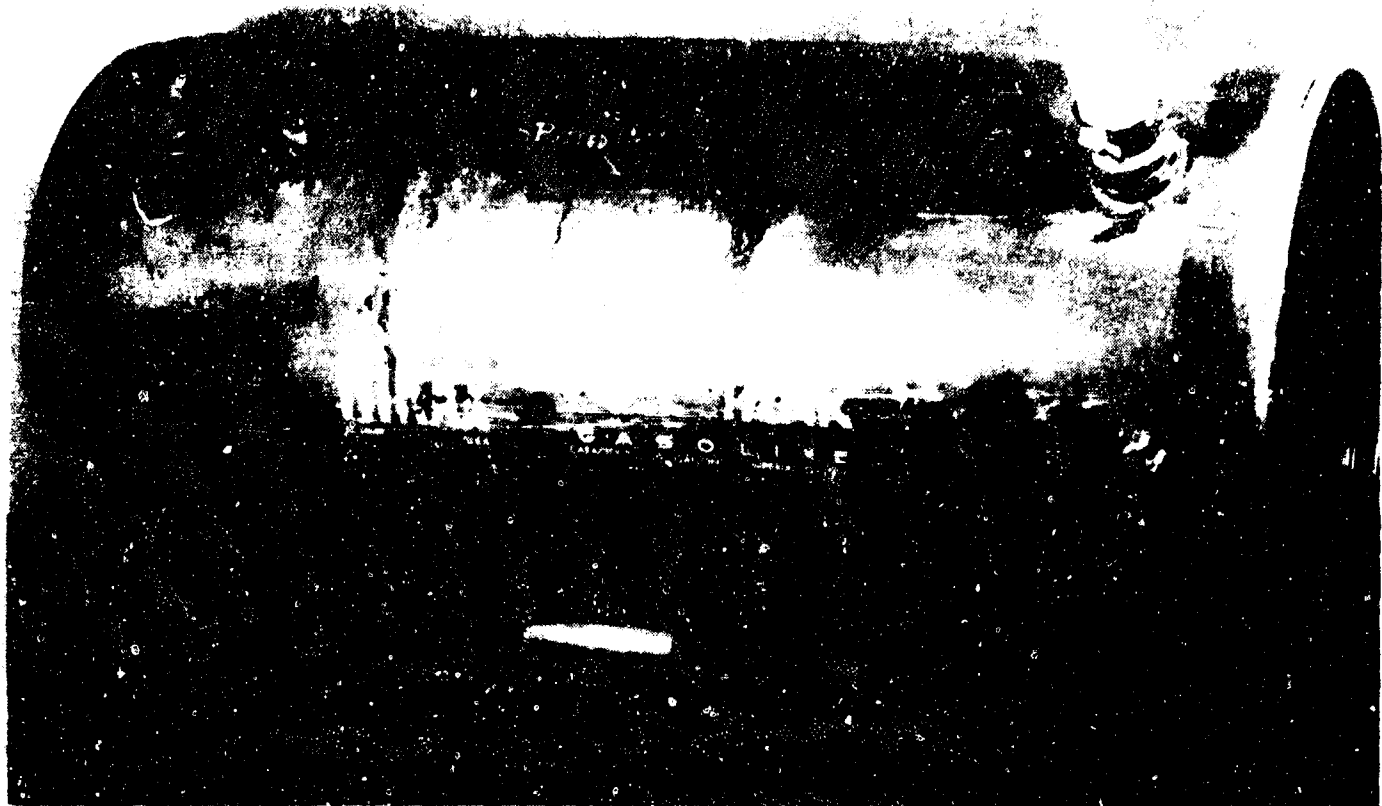
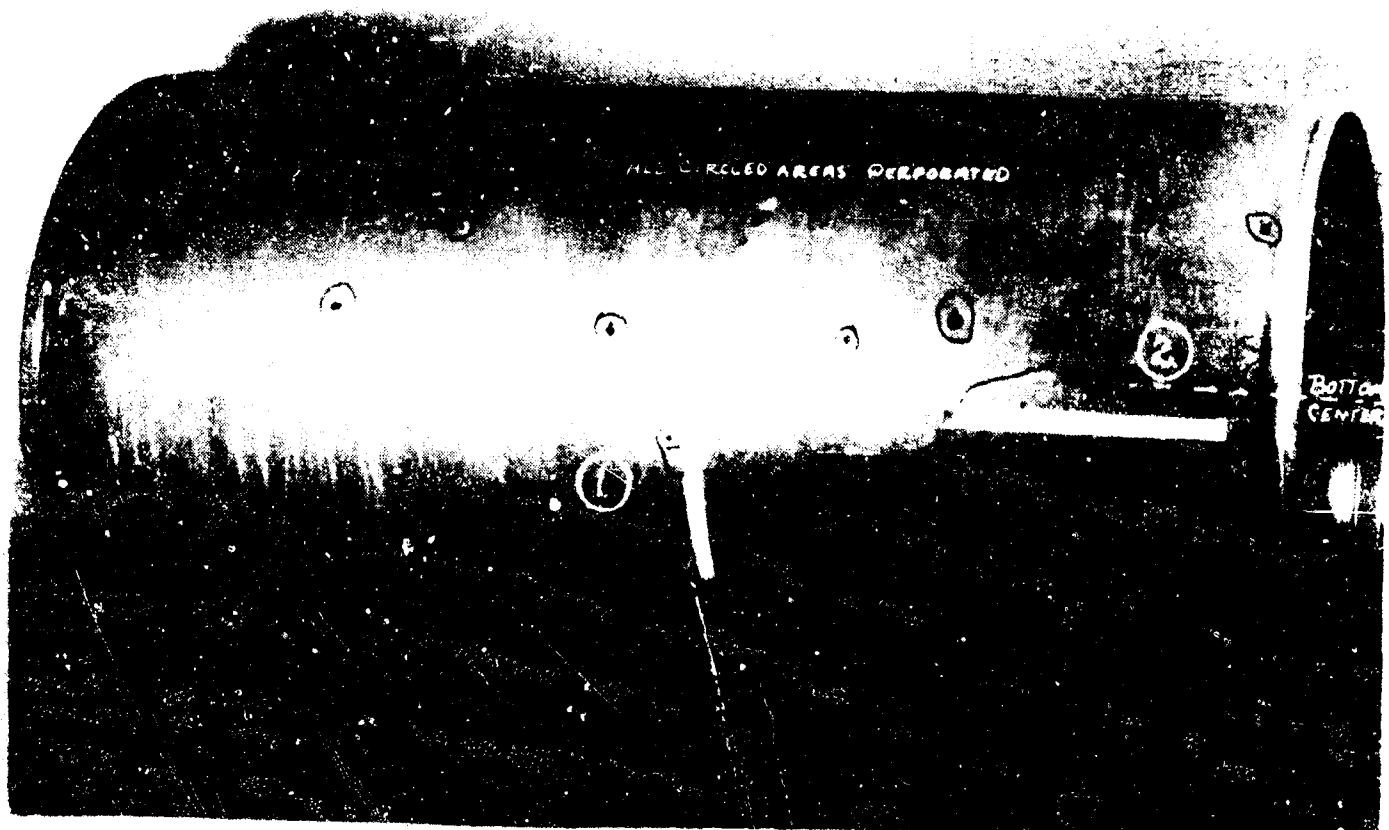
Final Inspection Report  
FIG. NO. 45

Close-up views of the two perforated areas indicated by  
tape on Fig. No. 44.

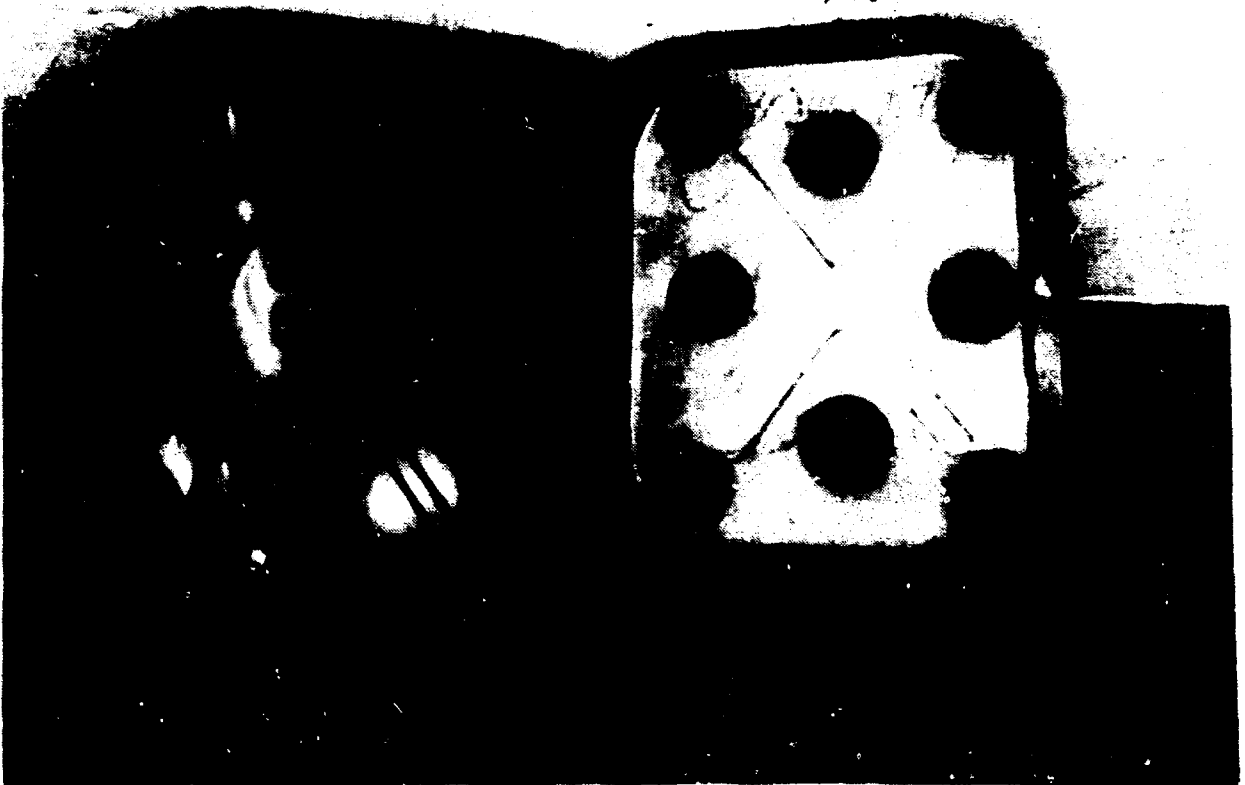
PHOTO NO. 15

PHOTOGRAPH NO. 15 - Interior view of two sections of Alloy 316(L) Resistance Welded Tank. No evidence of corrosion present.

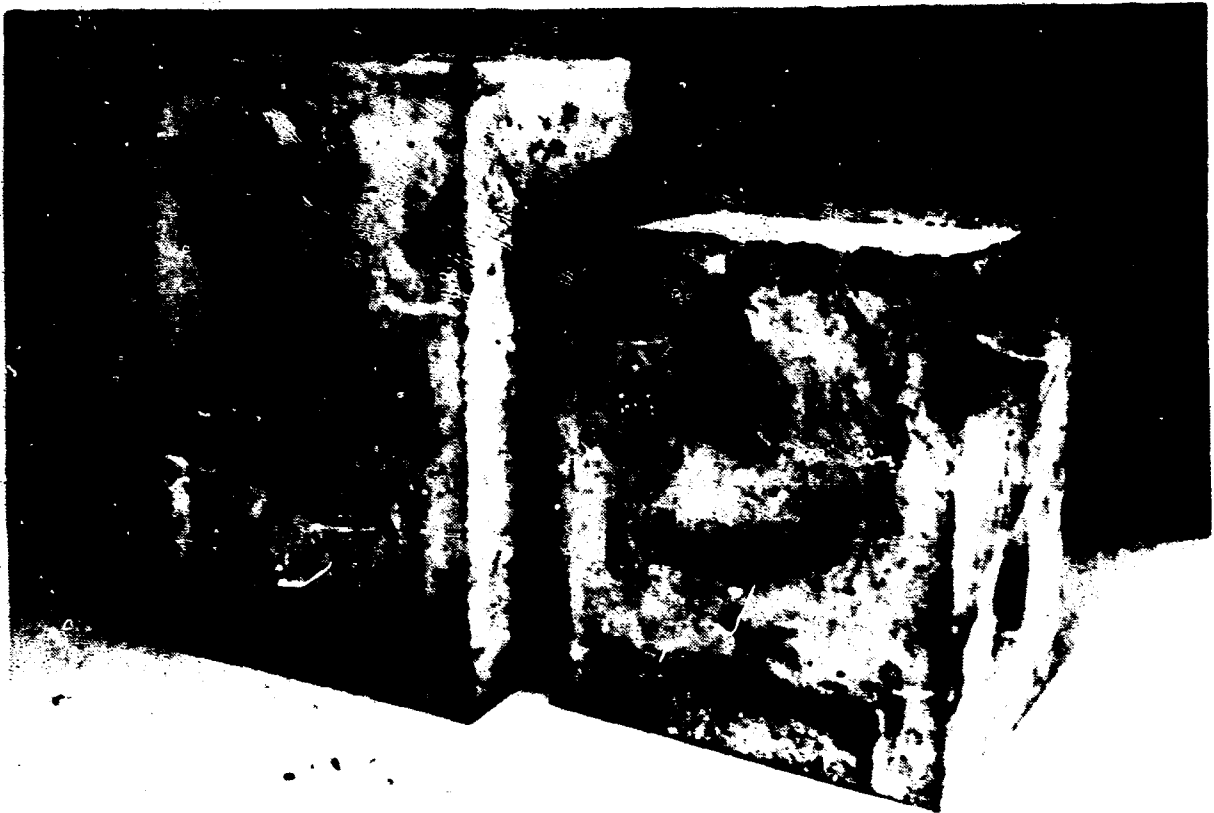
PHOTO NO. 21

PHOTOGRAPH NO. 21 - Interior view of two tank sections shown in Photograph No. 17. The surfaces show considerable rust discoloration that was probably induced when the tanks were washed out with water. The small dark areas particularly evident on the baffle, mark holidays in the lead coating where the base metal has rusted and siled through.

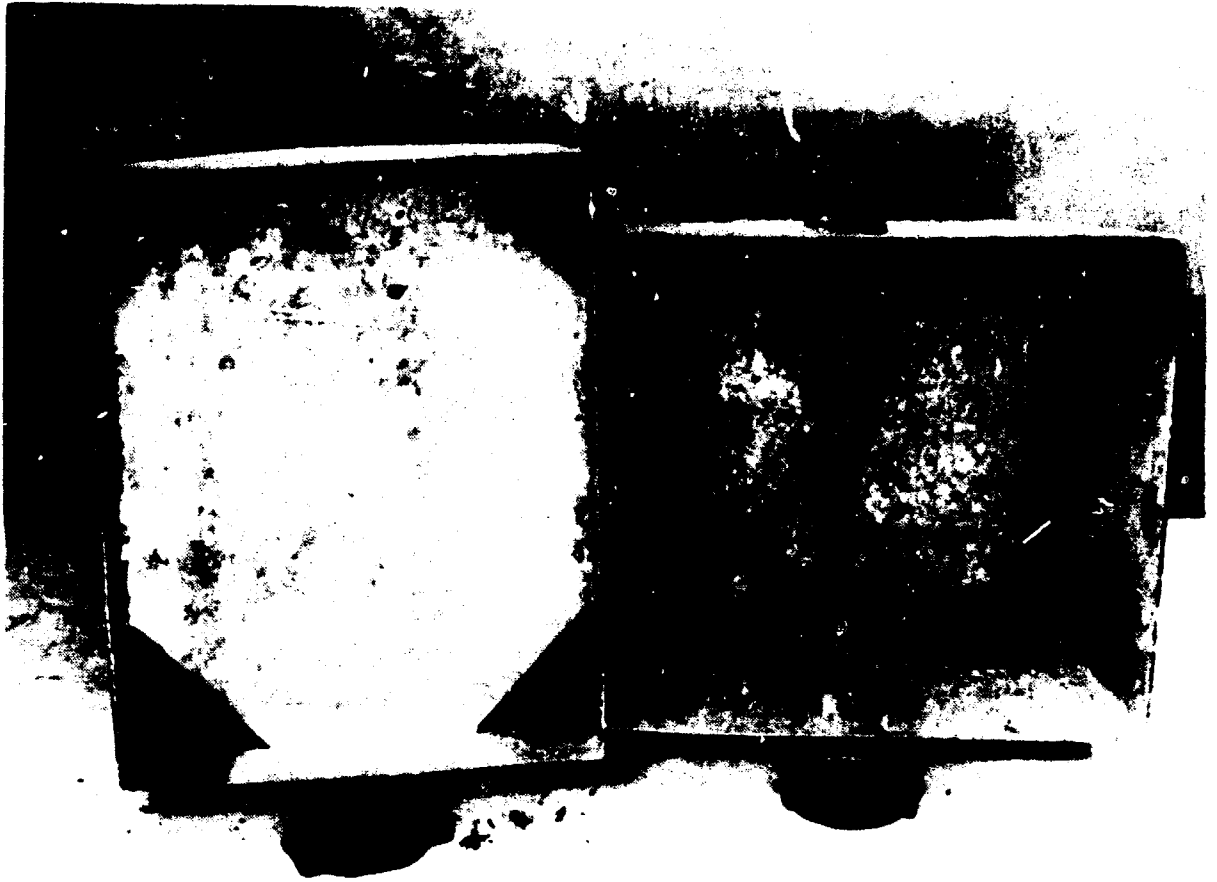
PHOTO NO. 22

PHOTOGRAPH NO. 22 - Two sections of Hot Dipped Galvanized Steel Tank showing general view of top and side surfaces. The position of the wet box is evident on both sections. Photograph No. 25 is a close-up photograph of the tank surface along the edge of the area that had been covered with bedding compound. The particular area is adjacent to the numeral 1 at the upper left corner of the wet box (larger tank section). There is no evidence of corrosion of the base steel except along the edges of the final closure. Photograph No. 26 is a close-up view of the painted edge and Photograph No. 27 of the fuel gauge transmitter and fuel pickup connection.

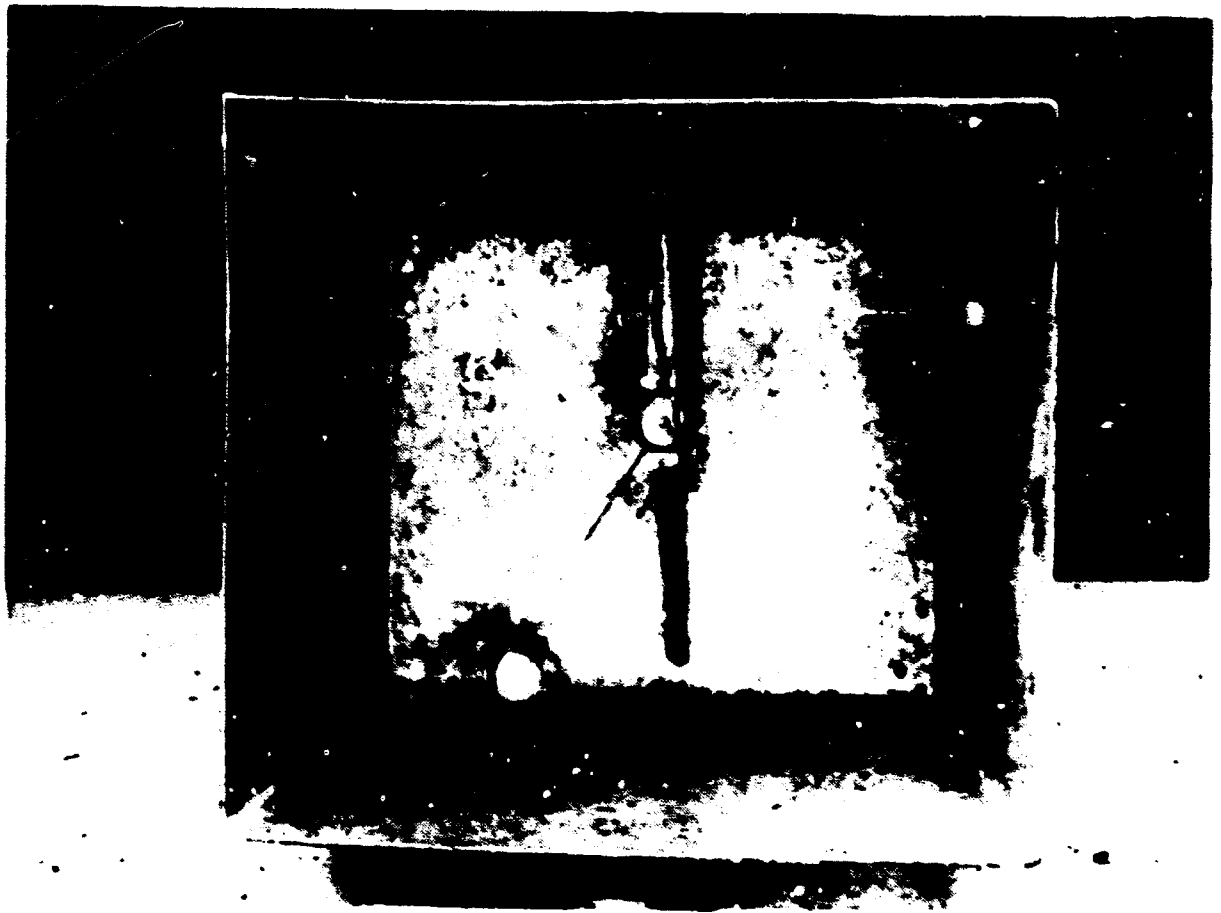
PHOTO NO. 23

PHOTOGRAPH NO. 23 - Interior view of tank sections shown in Photograph No. 22. The galvanized coating is completely intact with a few minute spots of rust that can be wiped off with no evidence of corrosion pitting.
