Special Report 150

CAMP CENTURY REVISITED A PICTORIAL VIEW - JUNE 1969

Austin Kovacs

July 1970

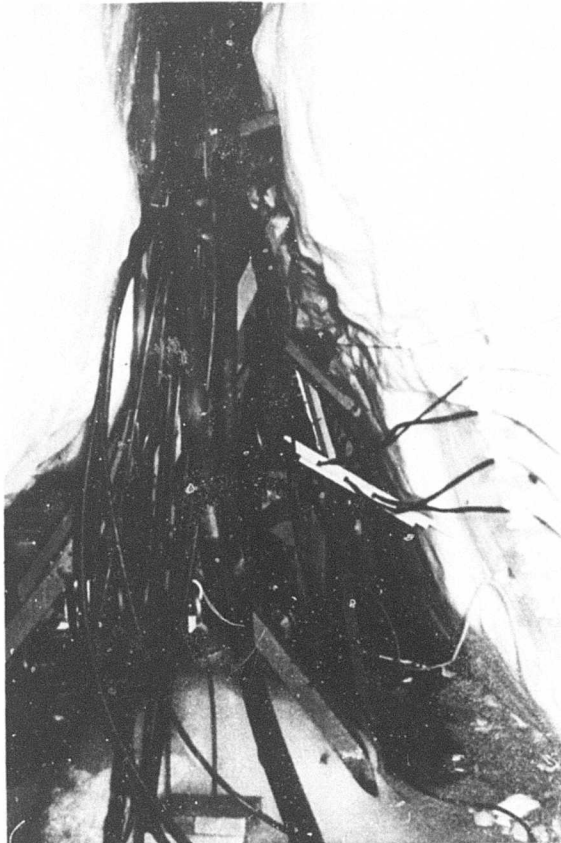
Figure 12. Snow deformation crushes the derrick over the glycol well.

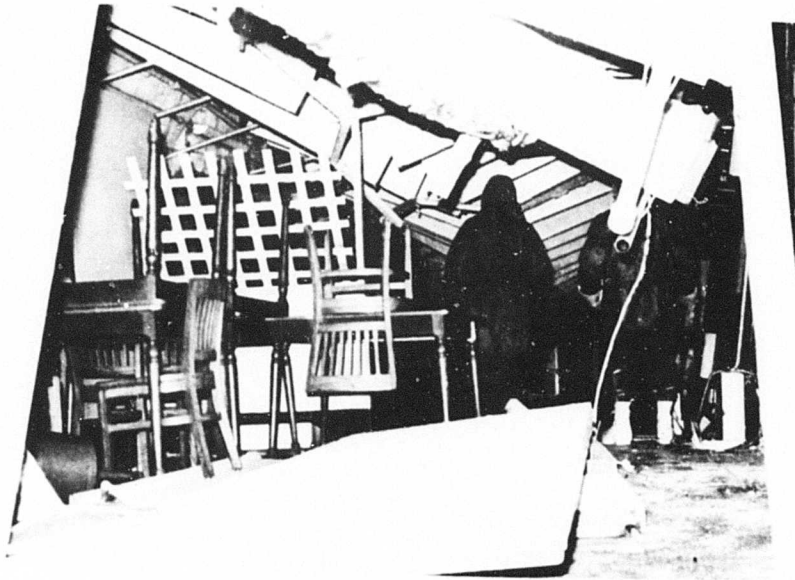
Figure 24. Ceiling joists pushed downward by snow encroachment upon mess hall roof.

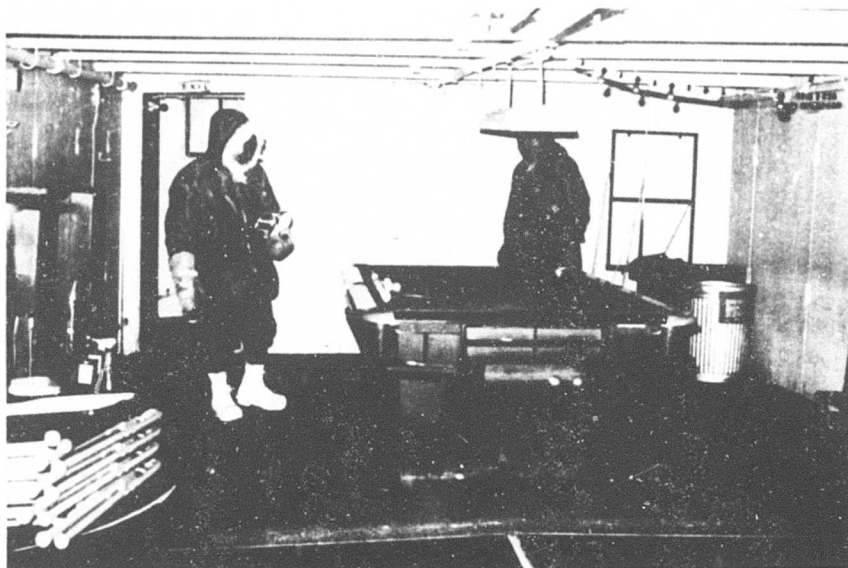
Figure 46. Floor buckling in EM club.
