MISCELLANEOUS PAPER S-68-22

**A STUDY OF THE CONDITION OF
PIEZOMETERS IN THE 1949 INSTALLATION
AT REID - BEDFORD, LOUISIANA**

November 1968

**U. S. Army Engineer Waterways Experiment Station
CORPS OF ENGINEERS
Vicksburg, Mississippi**

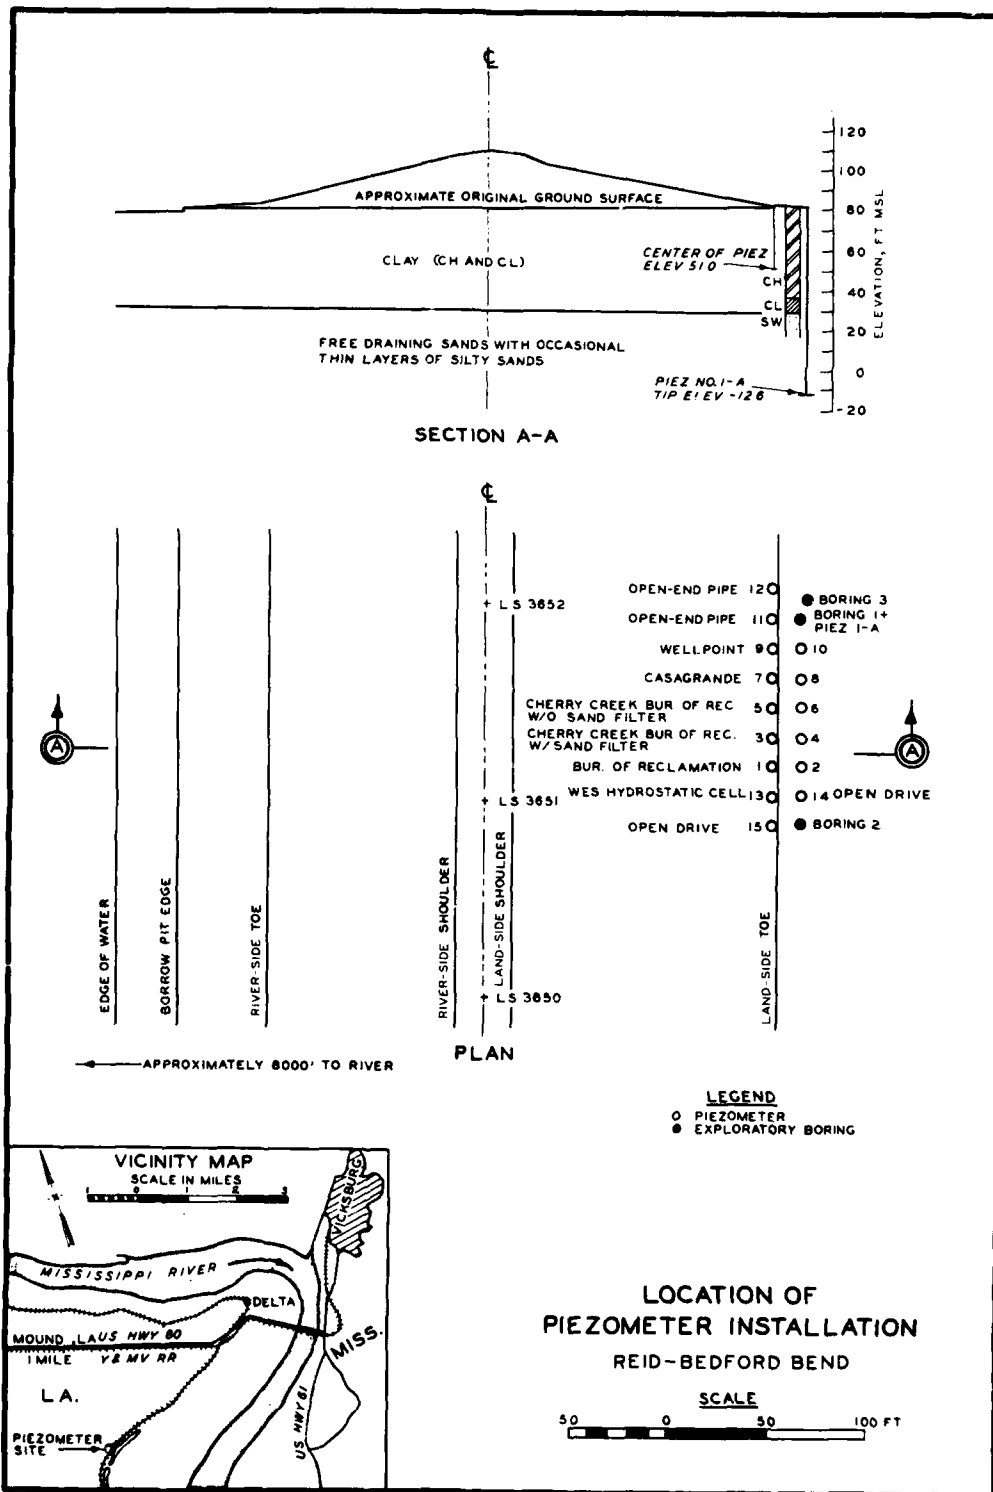
15	Drive point	Drilled	No	30.3 (total)	Standpipe not cor- roded; partially clogged near lower end	7
1A	Wellpoint	Drilled	No	26	Standpipe badly corroded	8

Photograph 8. Encrustation and corrosion of wellpoint piezometer 1A
