**MISCELLANEOUS PAPER S-69-29**

# EVALUATION OF HARVEY NONWELDED ALUMINUM LANDING MAT

July 1969

U. S. Army Engineer Waterways Experiment Station CORPS OF ENGINEERS Vicksburg, Mississippi

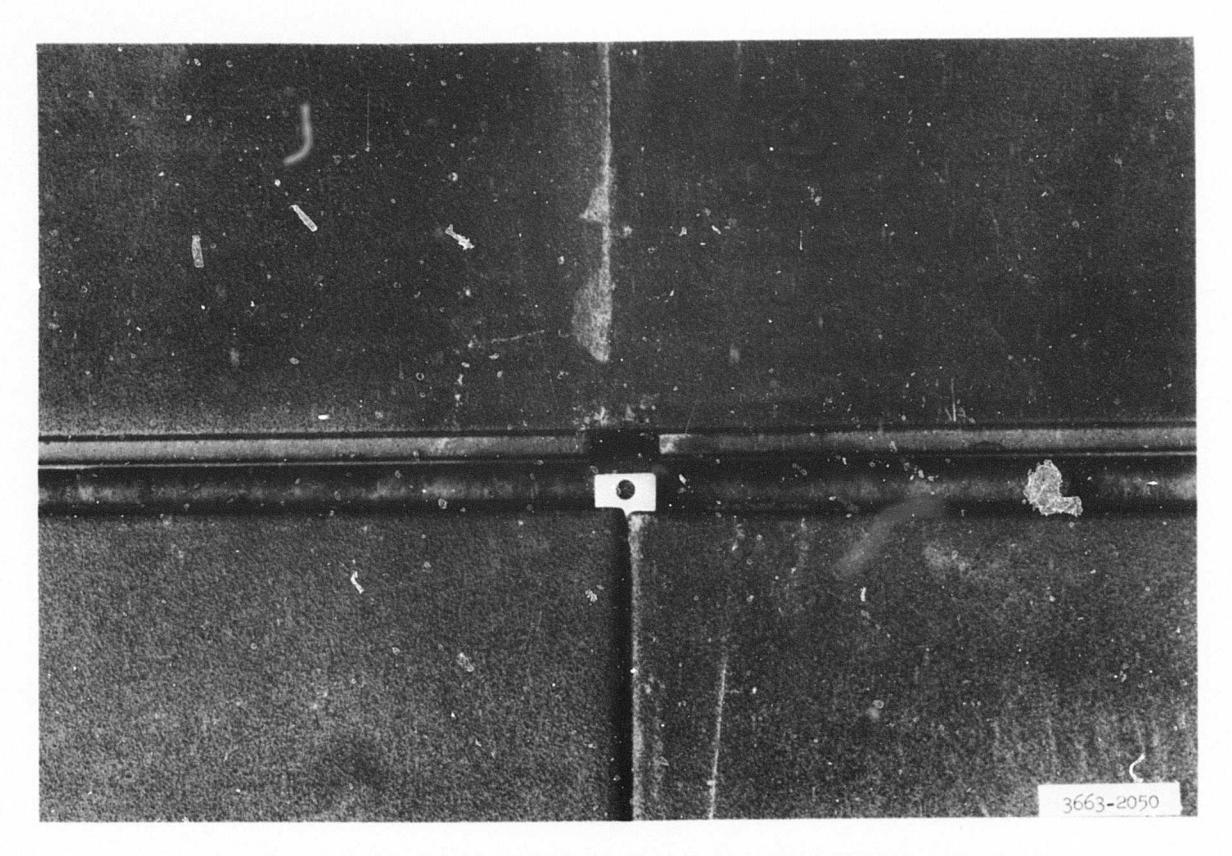
Fig. 4. View showing how the 1-in. web extension of the locking bar fits into the notched male side connector

bar (fig. 4) fitting into the notch cut in the male side connector of the plank in the adjacent run. Fig. 7 shows a close-up of the mat damage at a notch after 187 coverages of traffic. At the end of traffic, there were only five planks with breaks such as those labeled 1 and 3 in fig. 7, and one plank with a break such as that labeled 2 in fig. 7. These breaks were approximately 1 in. in length. Other damage that was observed when the mat was taken up was 18 C-rail splits that averaged 7-3/4 in., the longest being 13-1/2 in., and 1 to 12 ribs broken in 19 planks. The maximum deformation measured in item 2 after traffic was 0.5 in. A plot of deformation along the center line of the traffic lane is shown in plate 7.

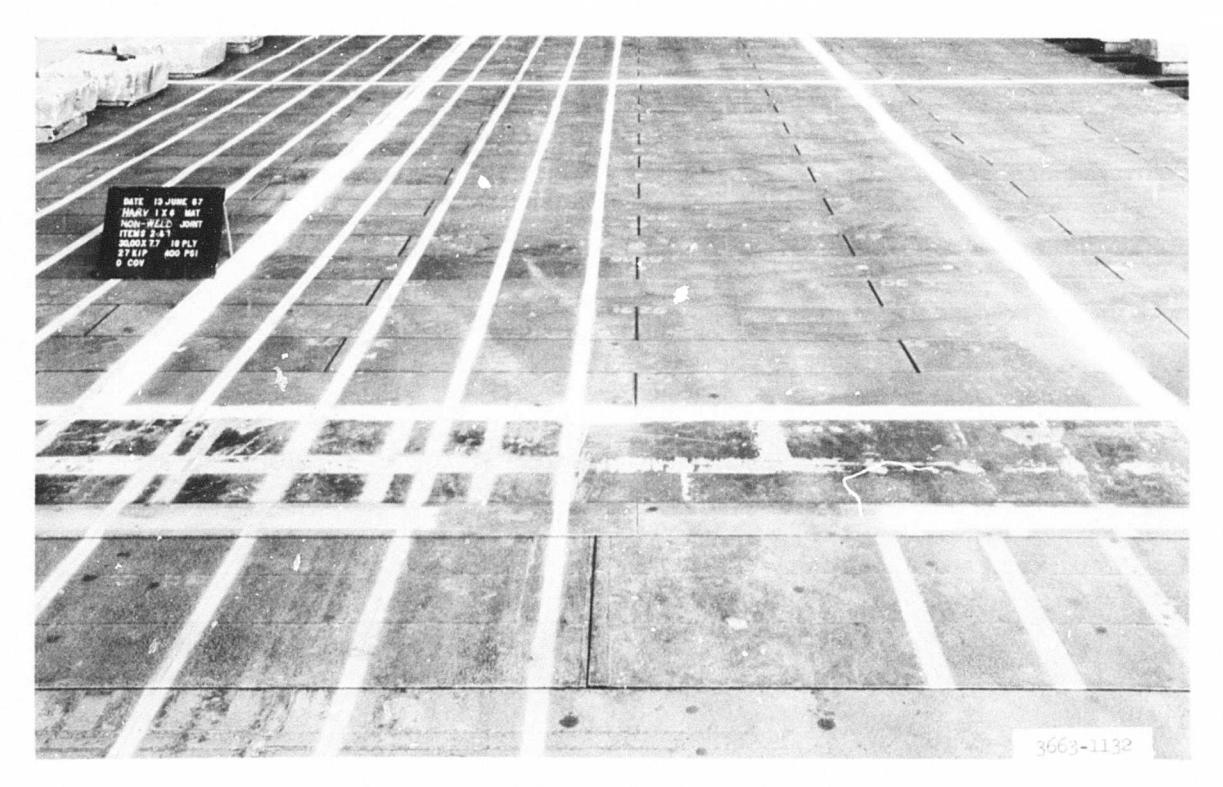
Photograph 1. Test section 1 prior to traffic

24. A general view of test section 1 is shown in photograph 1. After 10 coverages, the ends of the mat were slightly curled due to the planks flexing under traffic. At 48 coverages, the mat had moved longitudinally causing a slight bow in the transverse joints. There was approximately 2-1/2 in. of bow, as shown in photograph 8, due to the longitudinal movement of the mat after 100 coverages. Planks 27, 31, and 32 in item 1 showed a dish of about 3/16 in. along the center line after 150 coverages.

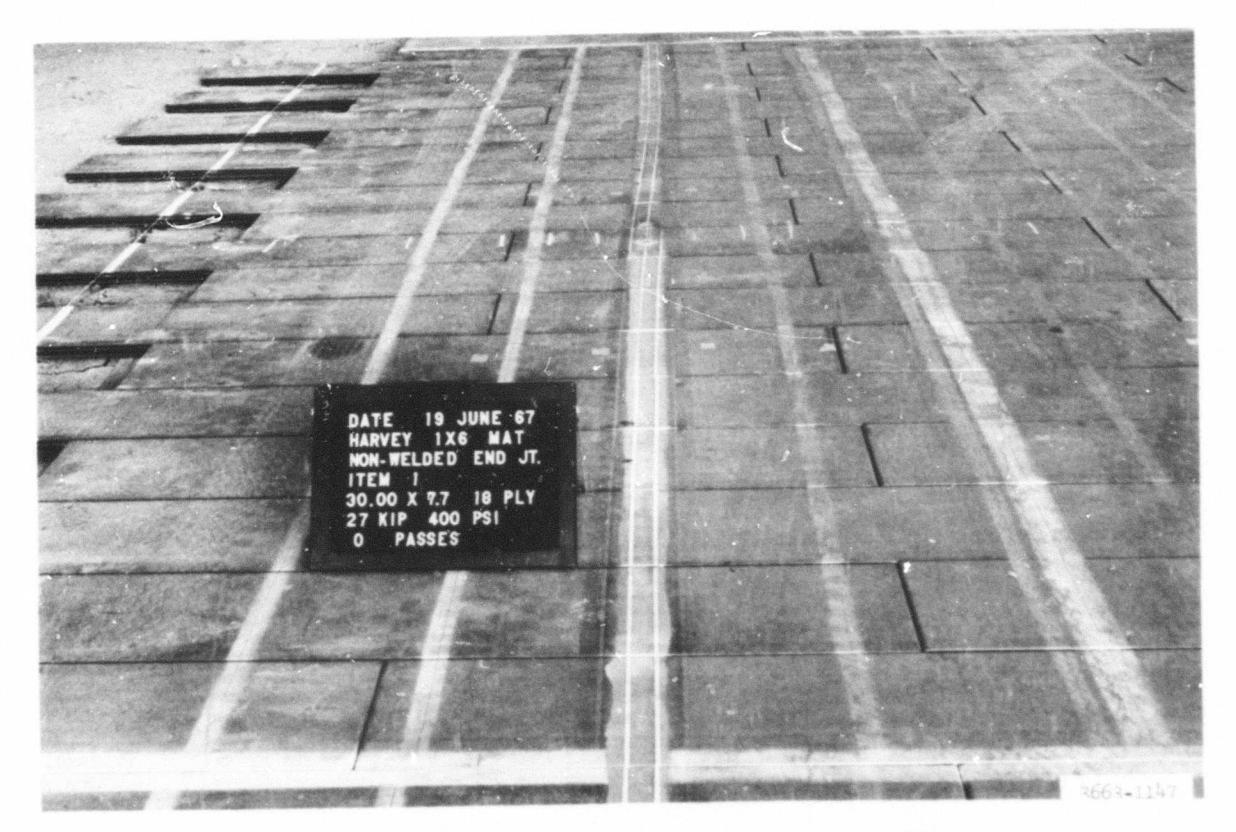
Photograph 12. Item 1, lane 2, prior to single-line traffic

29. The anchor weights were removed from the east edge of the mat before single-line traffic was applied. The traffic lane was located 1-1/2 ft from mat end joints. A general view of item 1 prior to traffic is shown in photograph 12. The mat planks had to be realigned at 760 passes as a result of lateral movement. Both items in the test section withstood 1600 passes of traffic with no apparent mat damage. A view of the test section after traffic is shown in photograph 13. The permanent mat deformation as determined from level readings taken at the end of traffic was 0.4 in. in item 1 and 0.2 in. in item 2.

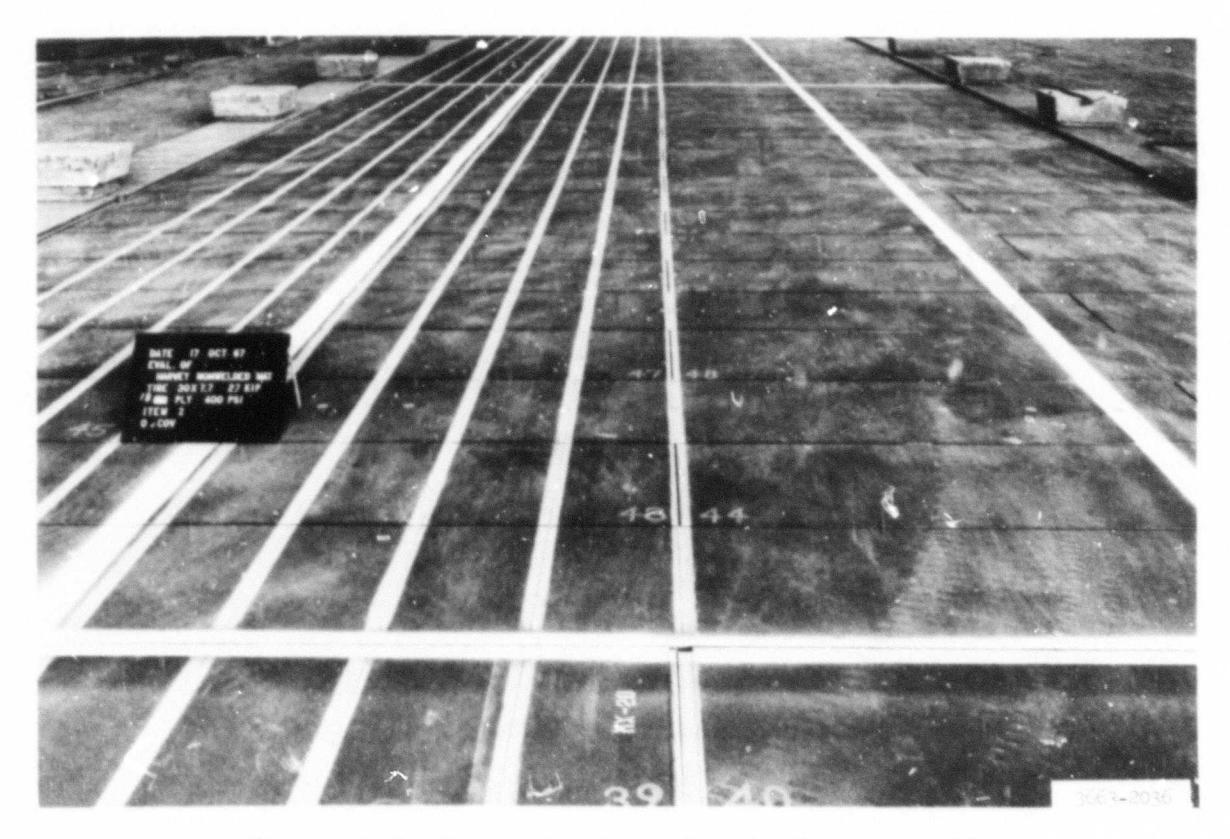
Photograph 15. General view of item 2, section 2, prior to traffic

32. A general view of item 2 prior to traffic is shown in photograph 15. Severe dishing in the mat occurred in runs that consisted of two full planks where the end joints were coincident with the center line of the traffic lane. Severe dishing and broken ribs were noted at the ends of the planks. This damage was caused by the reduced stiffness inherent in the design of the nonwelded end joints, not by breaks or shears of the end joints themselves; i.e., the integral end connectors appeared to be more flexible than the standard welded end connectors. After 10 coverages, a dish of 3/16 in. had developed at the end joints of planks 43 and 55. As the traffic test progressed, the dish in the mat increased. When traffic was stopped at 187 coverages, the dish in the 20 planks with end joints at the center of the traffic lane was approximately 1/2 in. The only other visible mat damage was an 11/32-in. skin tear on plank 43.
