AFRPL-TR-71-84

**ADVANCED ACS VALVE  
SEALING SURFACE COMPATIBILITY  
INVESTIGATION**

AD 735286

G. R. Pfeifer  
H. Wichmann  
Dr. R. Kratzer

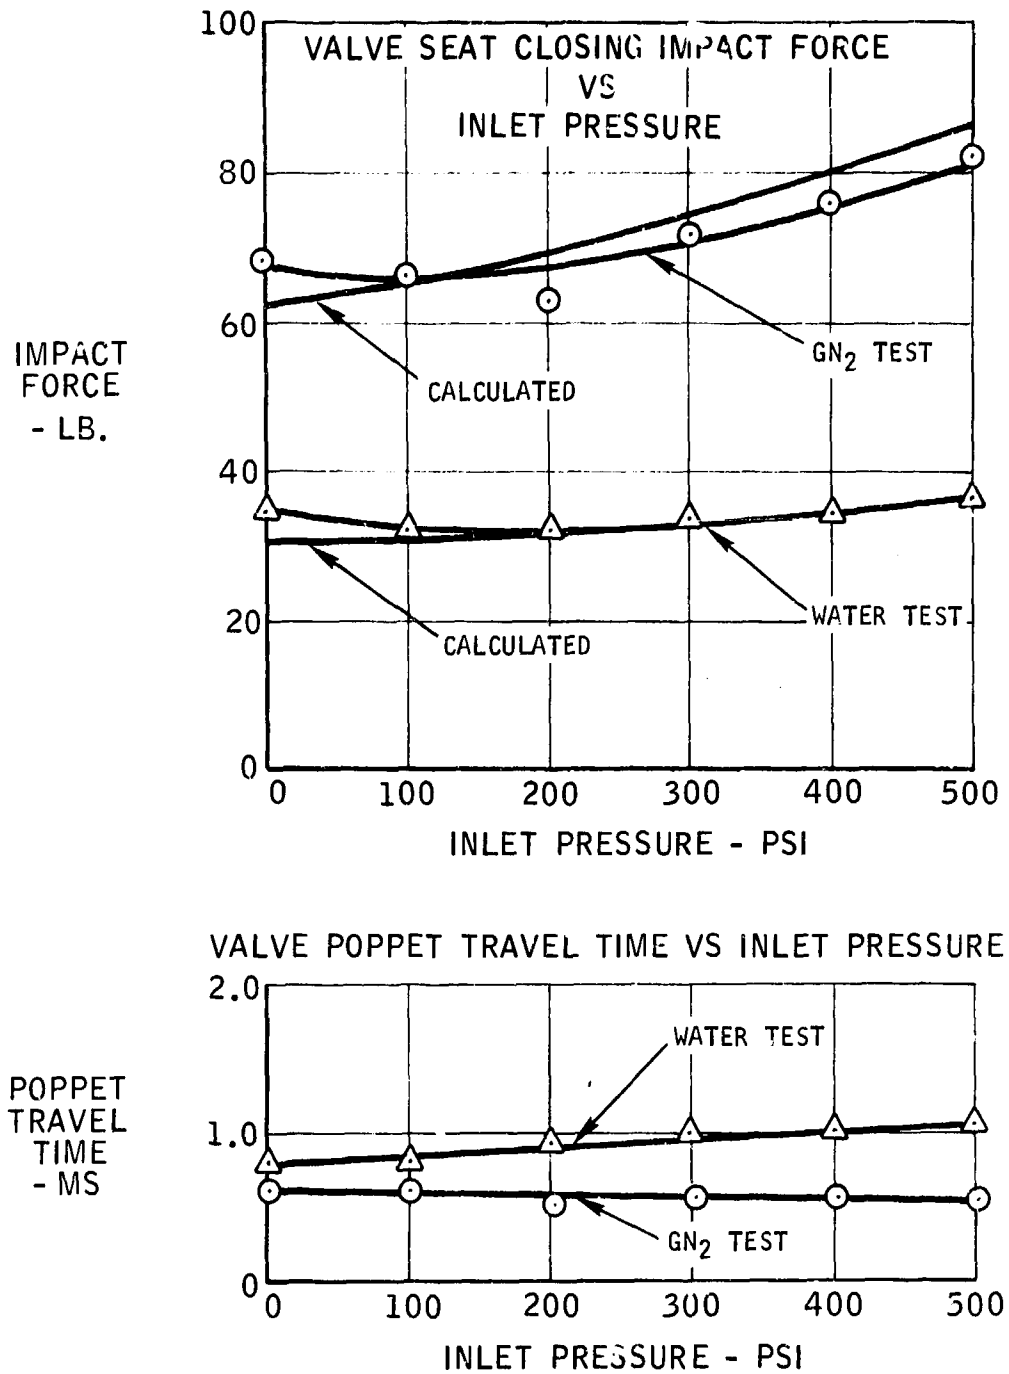
Figure 7

Typical maximum measured impact force and poppet travel time in both  $\text{GN}_2$  and water are shown in Figures 7, 8, 9 and 10 for test valve Configurations No. 1 through No. 4, respectively, as a function of inlet pressure. The figures allow direct comparison of impact forces measured in both  $\text{GN}_2$  and water for each test configuration as well as with the analytically predicted forces. The data obtained in water are consistently lower than the data taken using  $\text{GN}_2$  as the test fluid.

VALVE SEAT CLOSING IMPACT FORCE AND POPPET TRAVEL TIME AS A FUNCTION OF INLET PRESSURE FOR CONFIGURATION NO. 1

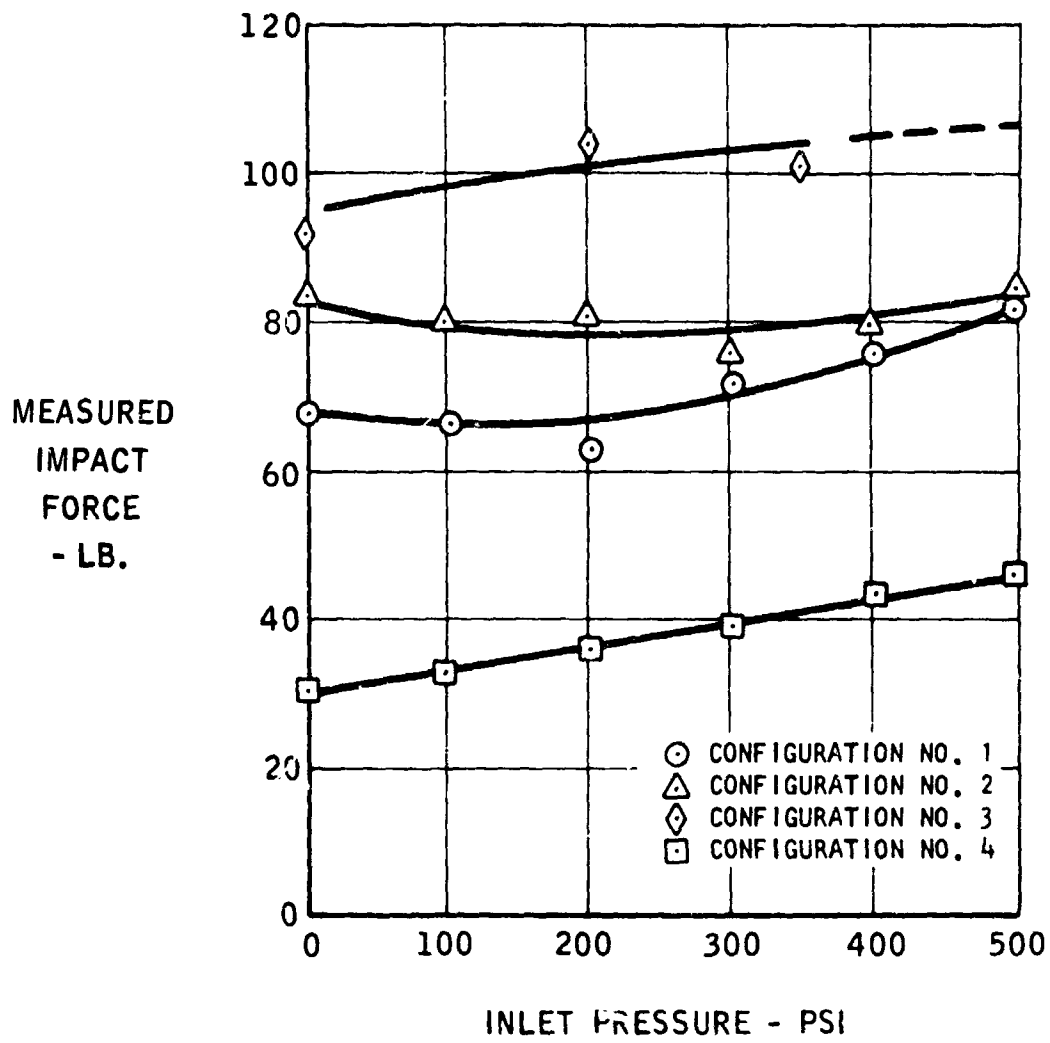
Figure 11 shows a comparison of measured closing impact for four configurations in  $\text{GN}_2$  and Figure 12 shows a comparison of the test results in water.

Analytically predicted and actual impact forces measured in  $\text{GN}_2$  agree reasonably well considering the possibilities for variation, including internal spring friction, viscous drag effect, misalignment of the poppet with respect to the seat, accuracy of data acquisition and other factors which could influence the impact forces measured under actual test conditions. A comparison of the analytical predictions and measured test results in  $\text{GN}_2$  is shown in Table IV.

### COMPARISON OF IMPACT FORCES IN GAS

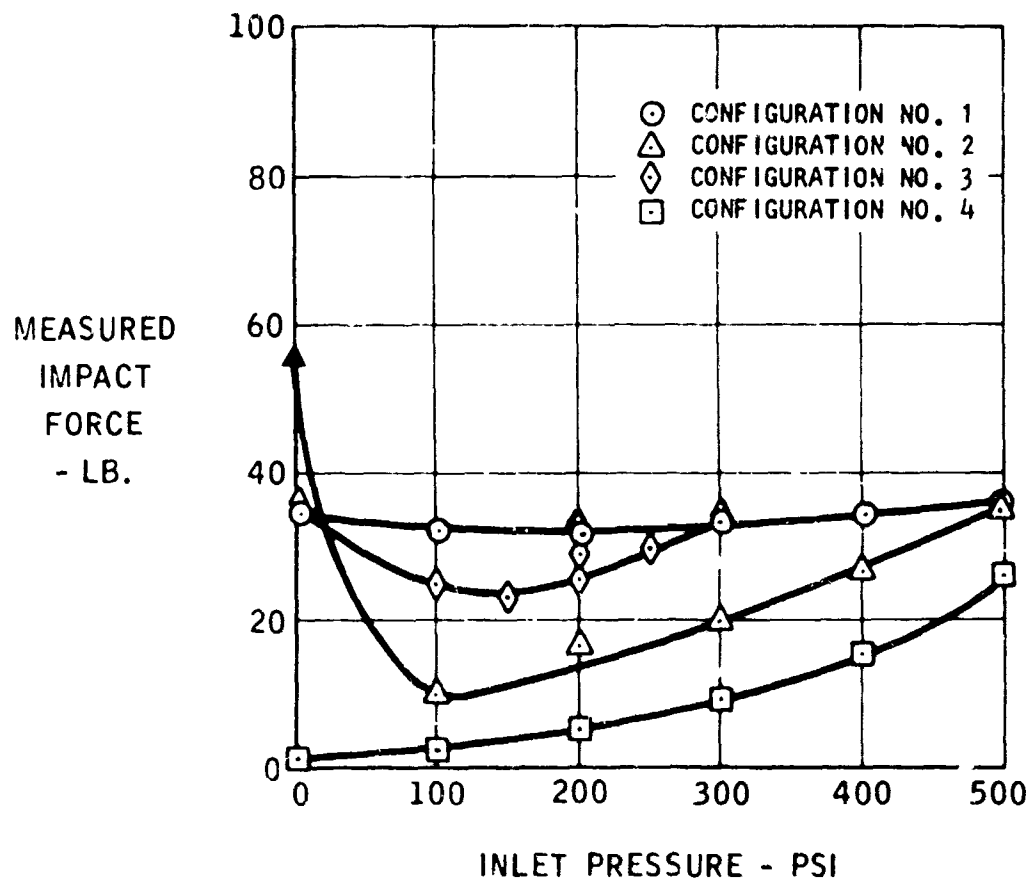
Figure 12

## COMPARISON OF IMPACT FORCES IN WATER

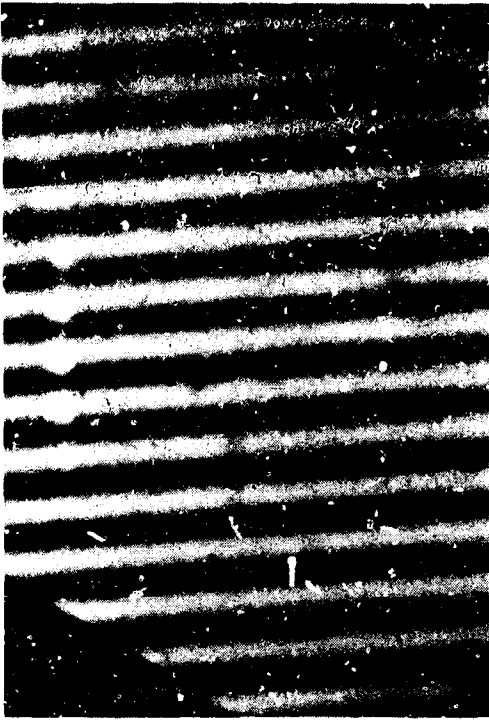
Figure 23

K-96 STATIC CIF<sub>5</sub> EXPOSURE POPPET NO. 3  
210X INTERFERENCE PHOTO BEFORE TEST

K-96 STATIC CIF<sub>5</sub> EXPOSURE POPPET NO. 3  
210X INTERFERENCE PHOTO AFTER TEST

K-96 STATIC CIF<sub>5</sub> EXPOSURE POPPET NO. 3  
210X SURFACE PHOTO BEFORE TEST

K-96 STATIC CIF<sub>5</sub> EXPOSURE POPPET NO. 3  
210X SURFACE PHOTO AFTER TEST

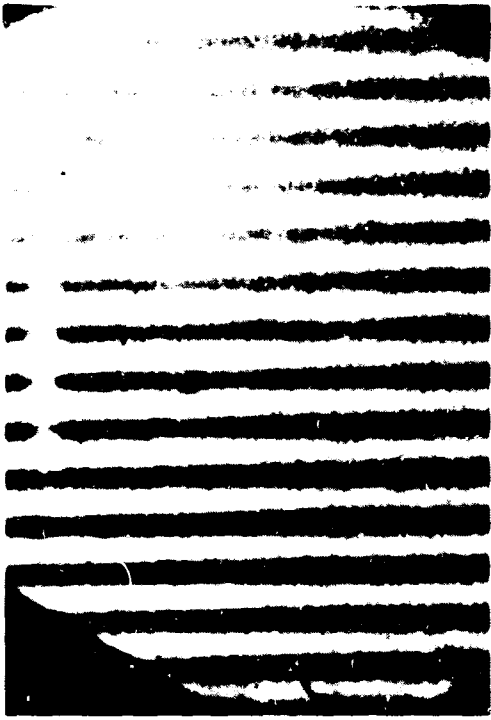
Figure 28 shows surface photographs and interferograms taken of the surface of the poppet exposed to gaseous fluorine both before and after exposure. Surface finish in general was not apparently affected by the exposure. Both interferograms indicate about the same surface finish before and after exposure. The surface of the exposed part does indicate the presence of randomly oriented lumps on the surface which were not apparent before exposure or in the scanning electron microscope examination. Figure 29 shows comparable photos of the sample poppet exposed to chlorine pentafluoride. Again, the only surface difference apparent is indicated to be the presence of randomly oriented high spots. These high spots were not identified during examination with the scanning electron microscope. Figure 30 shows electron microscope photographs at 200X, 1000X and 5000X of the sample surfaces which were used as unexposed references. Comparable sets of photographs taken of the gaseous fluorine and chlorine pentafluoride exposed parts are shown in Figures 31 and 32. These photographs indicate essentially no difference between the exposed and nonexposed parts. About the same surface texture is apparent on all parts and the lapping scratches appear

Ni-301 STATIC GF<sub>2</sub> EXPOSURE POPPET NO. 6  
210X INTERFERENCE PHOTO BEFORE TEST

Ni-301 STATIC GF<sub>2</sub> EXPOSURE POPPET NO. 6  
210X INTERFERENCE PHOTO AFTER TEST

Ni-301 STATIC GF<sub>2</sub> EXPOSURE POPPET NO. 6  
210X SURFACE PHOTO BEFORE TEST

Ni-301 STATIC GF<sub>2</sub> EXPOSURE POPPET NO. 6  
210X SURFACE PHOTO AFTER TEST

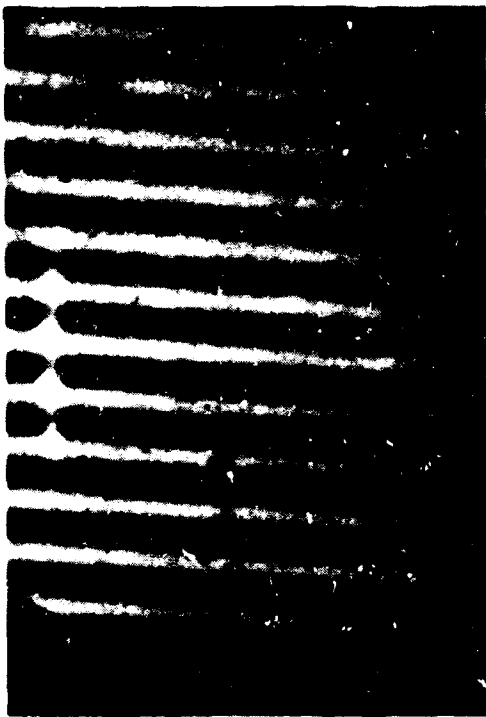
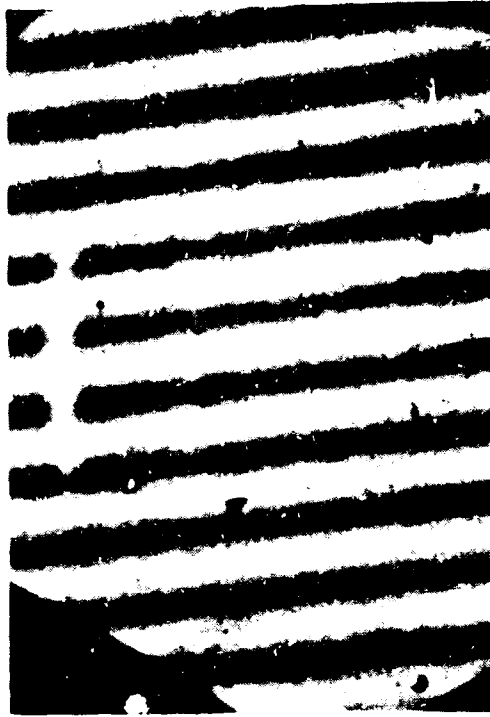
None of the Nickel 301 parts showed significant degradation as a result of static exposure to either chlorine pentafluoride or gaseous fluorine. The only changes in the parts which were exposed were the growth of random widely separated bumps on the surface which were about 10 microns high.

NI-301 STATIC CIF<sub>5</sub> EXPOSURE POPPET NO. 7  
210X INTERFERENCE PHOTO BEFORE TEST

NI-301 STATIC CIF<sub>5</sub> EXPOSURE POPPET NO. 7  
210X INTERFERENCE PHOTO AFTER TEST

NI-301 STATIC CIF<sub>5</sub> EXPOSURE POPPET NO. 7  
210X SURFACE PHOTO BEFORE TEST

NI-301 STATIC CIF<sub>5</sub> EXPOSURE POPPET NO. 7  
210X SURFACE PHOTO AFTER TEST

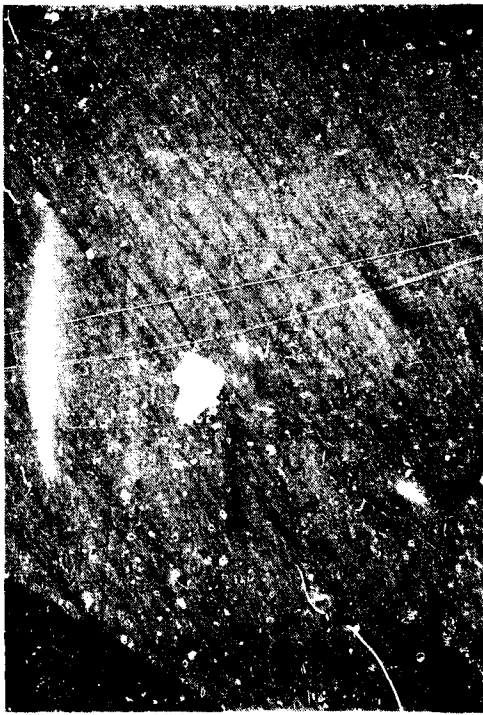
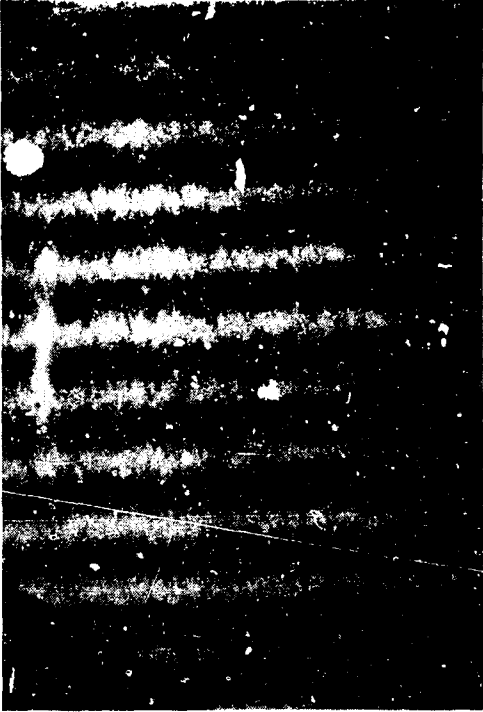
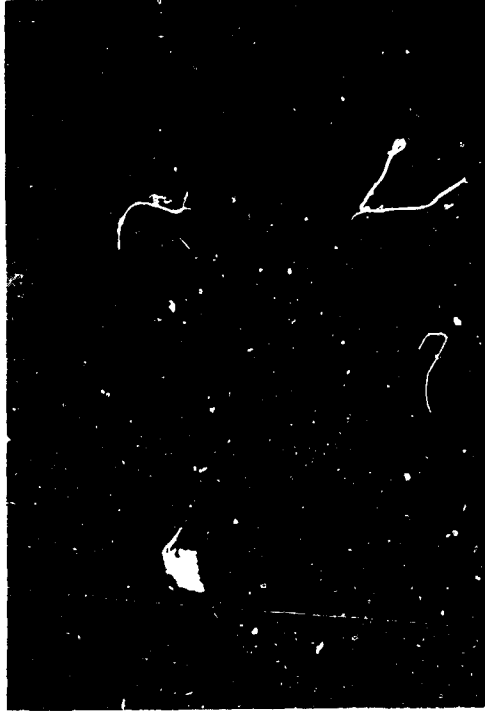
Figure 44 shows interference microscope photographs of the poppet exposed to chlorine pentafluoride prior to and after exposure. The comparable set of photographs for the poppet exposed to gaseous fluorine is not shown because of similarity in the parts. No change in the poppet surface finish is apparent from either set of photographs. The lap marks are still as sharp and clear as on the pre-test condition. Proficorder traces of the poppet profile prior to and after exposure are shown in Figure 45 for the poppet exposed to chlorine pentafluoride. These traces would indicate that none of the minor sharp edged lap marks were removed by the exposure process.

Al<sub>2</sub>O<sub>3</sub> STATIC CIF<sub>5</sub> EXPOSURE POPPET NO. 11  
210X SURFACE PHOTO BEFORE TEST

Al<sub>2</sub>O<sub>3</sub> STATIC CIF<sub>5</sub> EXPOSURE POPPET NO. 11  
210X INTERFERENCE PHOTO BEFORE TEST

Al<sub>2</sub>O<sub>3</sub> STATIC CIF<sub>5</sub> EXPOSURE POPPET NO. 11  
210X SURFACE PHOTO AFTER TEST

Al<sub>2</sub>O<sub>3</sub> STATIC CIF<sub>5</sub> EXPOSURE POPPET NO. 11  
210X INTERFERENCE PHOTO AFTER TEST

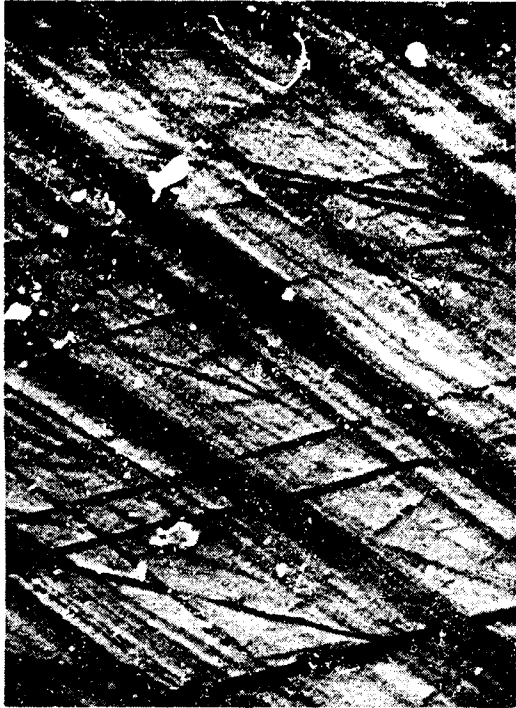
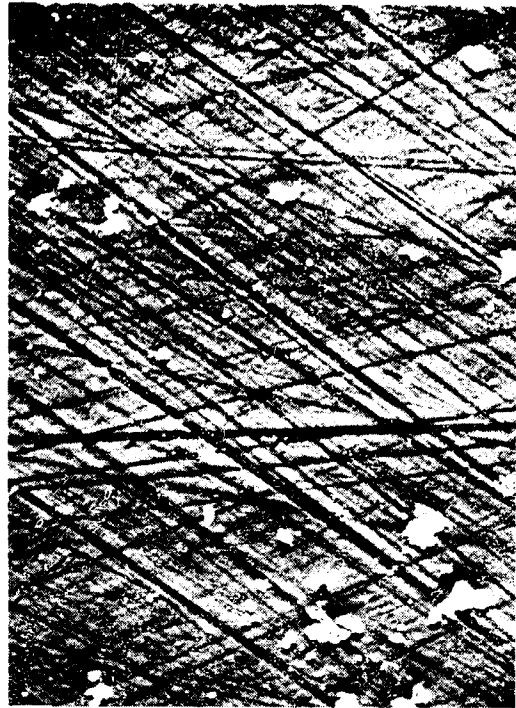
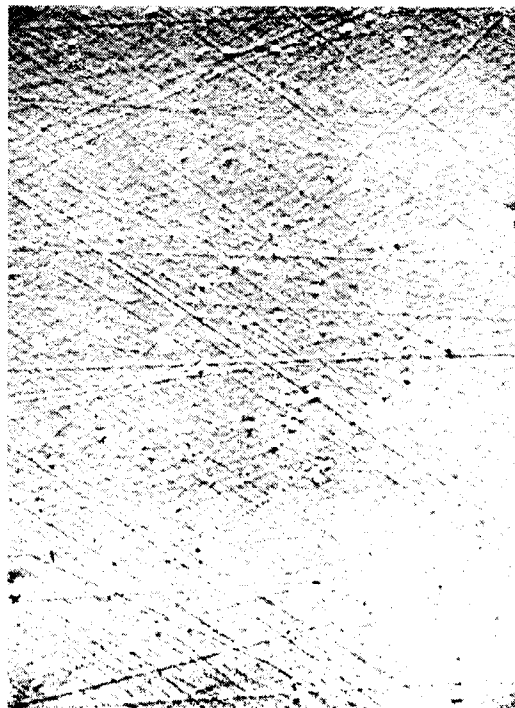
ALUMINUM OXIDE- $\text{Al}_2\text{O}_3$  - SAMPLE NO. 10  
S.E.M. PHOTOS AFTER STATIC  $\text{GF}_2$  EXPOSURE

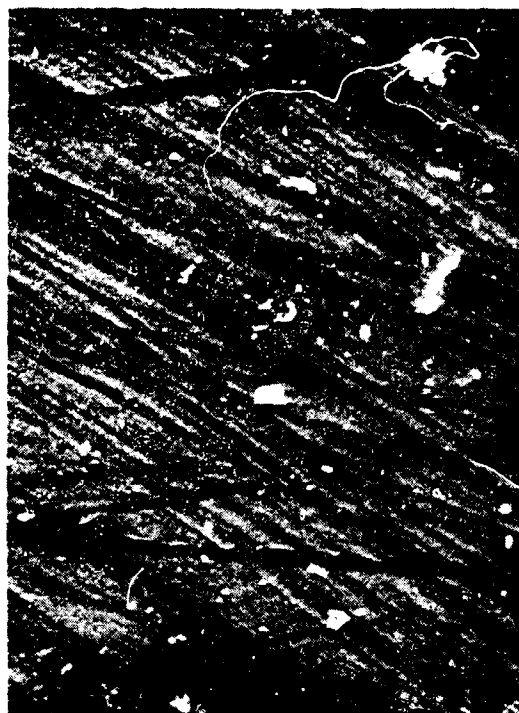
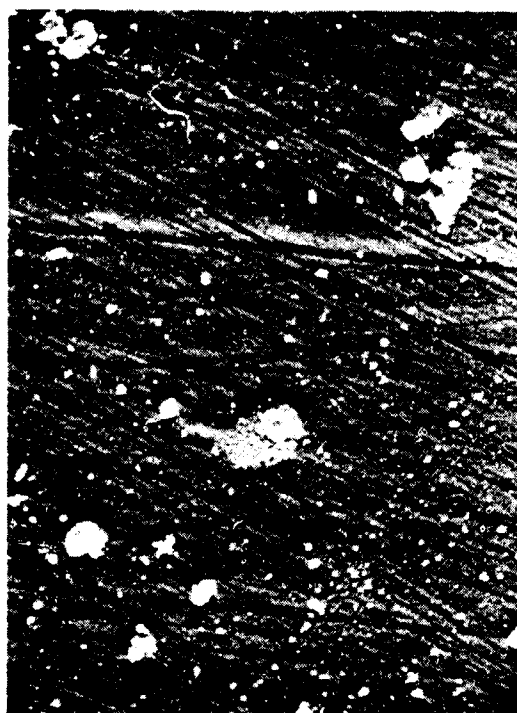
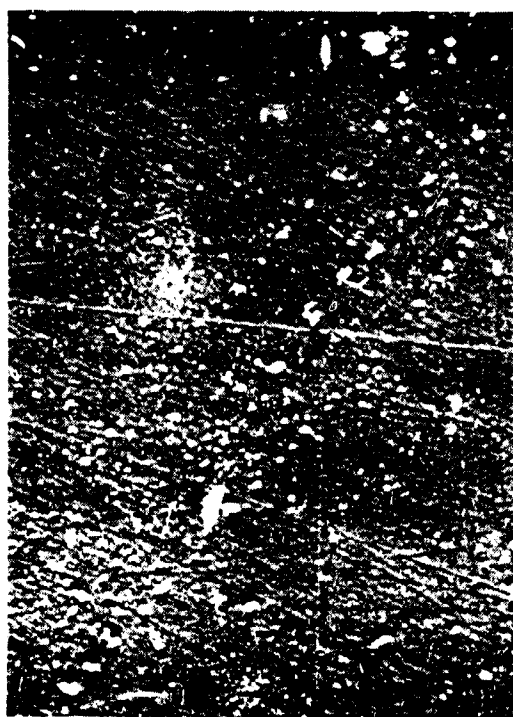
Scanning electron microscope photographs were taken of each of the exposed poppets to further document the surfaces as exposed to chlorine pentafluoride. No S.E.M. photograph was taken on an "as lapped" poppet for comparison due to a shortage of time at the microscope; however, all data indicates that no significant degradation of the surface took place. Figure 46 shows S.E.M. photographs of the sample surface which had been exposed to gaseous fluorine at 200X, 1000X and 5000X. A comparable set of photos is shown in Figure 47 of the sample poppet exposed to chlorine pentafluoride. Both sets of photographs confirm that the reactivity of the aluminum oxide with the propellants was extremely low.

ALUMINUM OXIDE- $\text{Al}_2\text{O}_3$  - SAMPLE NO. 11  
S.E.M. PHOTOS AFTER STATIC  $\text{ClF}_5$  EXPOSURE

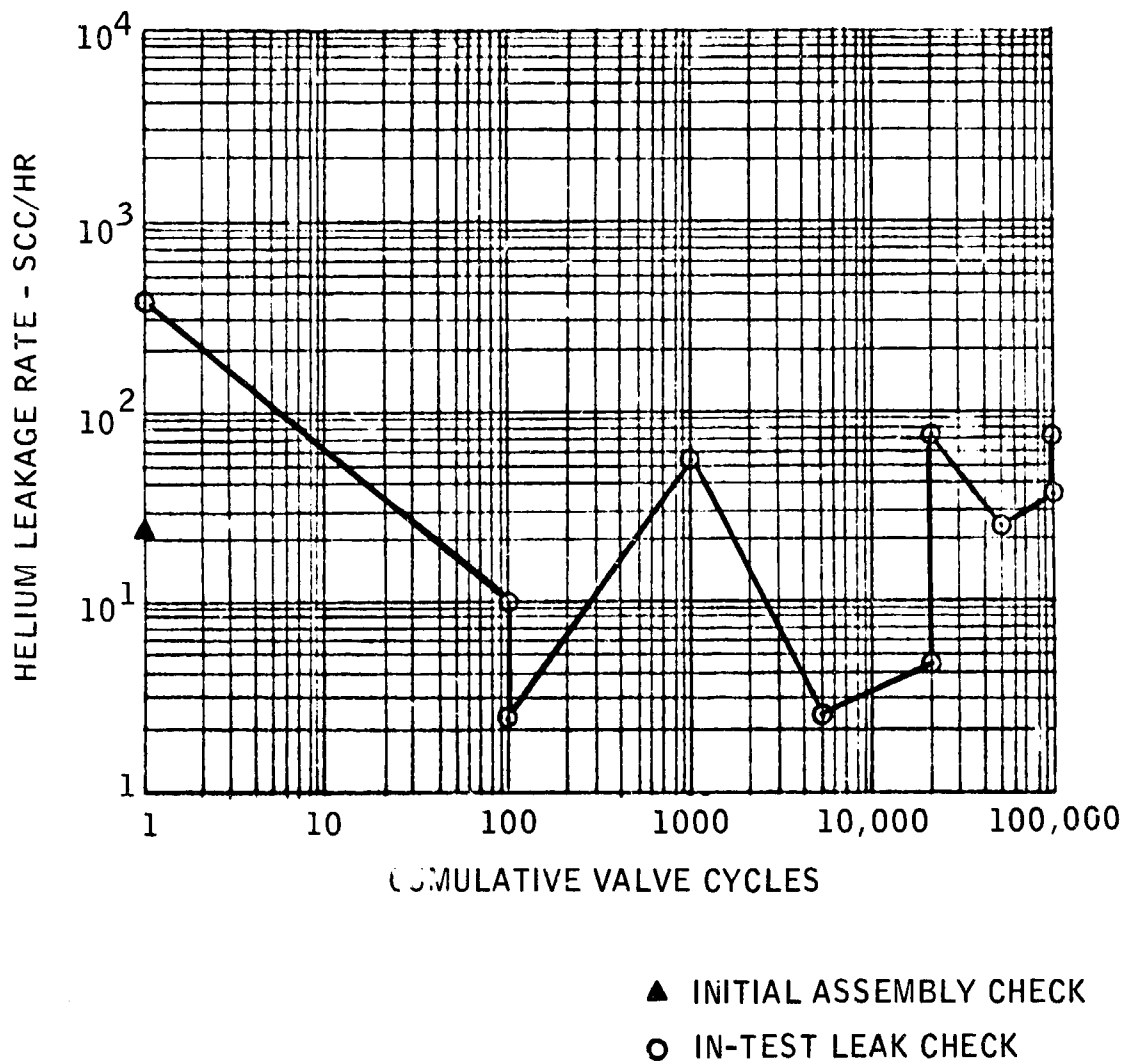
Figure 50

Figures 50 through 57 show the leakage rates measured on each of the valve configurations as a function of valve cycles. The figures are presented in the order in which the valves were tested. Some of the valve leakage tests demonstrated considerable variability between successive tests. This variability is believed to be more a function of total valve and seat to poppet to seat seal performance than test setup problems. Several checks were made between initial buildup leakage rates measured by positive displacement of water in burette and the initial leakage test made prior to fluorine passivation of the valves in the propellant test facility. These tests indicated excellent correlation (within one or two SCCH measured difference) of the two leak rate measurement techniques. Several sources of problems in determining actual leakage in the test facility are apparent. Three of the valves (Ni-301, K-96 and WC) showed a significant change in leak rate immediately after  $\text{GF}_2$  passivation. The immediate rise in excessive leak rates for these valves suggests that a static seal in the valve assembly which has a leak path parallel to the seat seal failed at passivation causing a significant percentage of the apparent leakage.

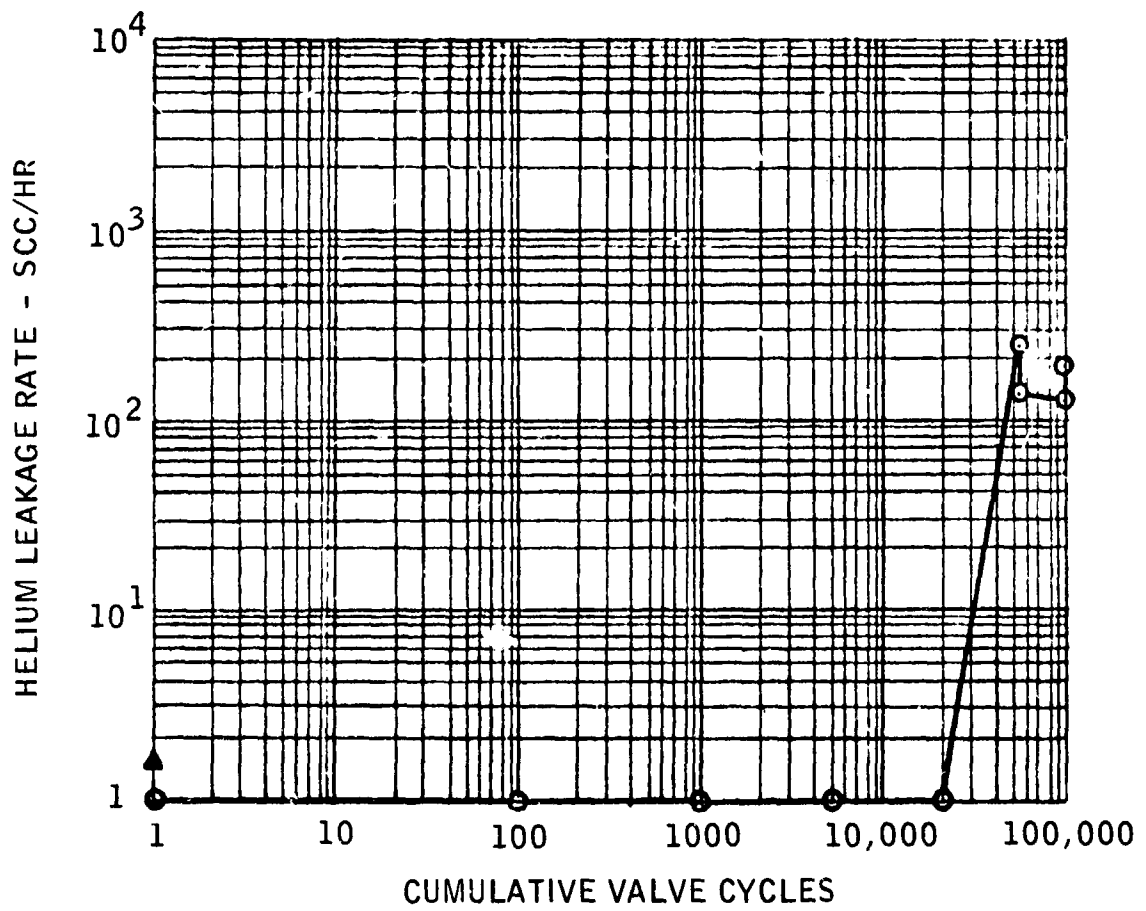
Figure 52

The seat and poppet tested in the normal impact version of the valve also provided within design goal leakage rates for a significant number of cycles. As shown in Figure 52, less than one SCCH leakage at 450 psig inlet pressure was measured up to and including 20,000 accumulated valve cycles. At conclusion of the test, leakage rates had increased rapidly to the order of 150 to 200 SCCH. Examination of the parts with the interference microscope and S. E. M. reveal the probable cause for the leakage rate recorded at the end of the test. Figure 72 shows surface photos and interferograms of the seat surface prior to and after completion of the 100,000 cycle test in chlorine pentafluoride. As with the K-96 tested in the normal impact valve, the post test seat surface was considerably degraded from the initial surface finish. Again, like the K-96 and WC poppets, the seat surface is grooved with average groove peak to Valley heights of up to 150 microinches, with the mean seat surface level eroded by 80 to 100 microinches from the original surface level as shown in Figure 77.

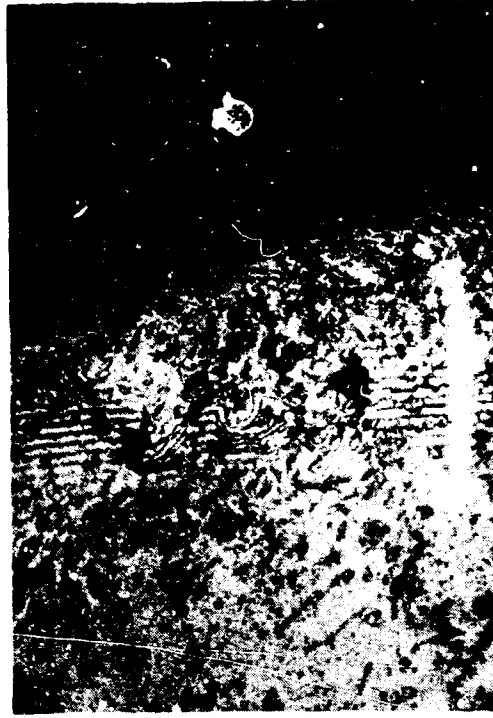
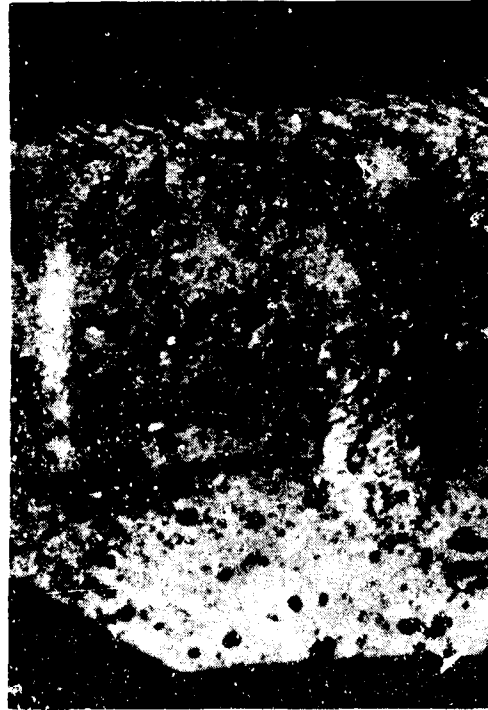
The Ni-301 parts tested were about the best of all the test parts in terms of surface finish of the poppet and seat at the time of valve buildup. During the test period, however, the seating surfaces were degraded significantly. Figure 58 shows surface photographs and interferograms of the seat land surface prior to and after subjecting the seat to 100,000 cycles at low impact in chlorine pentafluoride. The original seat surface was considerably less than one microinch in surface finish after lapping. After testing, the seat surface subjected to valve closing impact was significantly degraded with the presence of a large concentration of lumps on the impact surfaces. The profilometer trace comparisons of the seat surface before and after testing (Figure 59) show that the mean level of the seating surface is the same as prior to testing with the surface lumps rising above the surface to a height of 30 to 35 micro-inches.

NI-301 SEAT NO. 8 BEFORE LOW IMPACT  
VALVE TEST IN CIF<sub>5</sub> - 210X INTERFERENCE PHOTO

NI-301 SEAT NO. 8 AFTER LOW IMPACT  
VALVE TEST IN CIF<sub>5</sub> - 210X INTERFERENCE PHOTO

NI-301 SEAT NO. 8 BEFORE LOW IMPACT  
VALVE TEST IN CIF<sub>5</sub> - 210X SURFACE PHOTO

NI-301 SEAT NO. 8 AFTER LOW IMPACT  
VALVE TEST IN CIF<sub>5</sub> - 210X SURFACE PHOTO

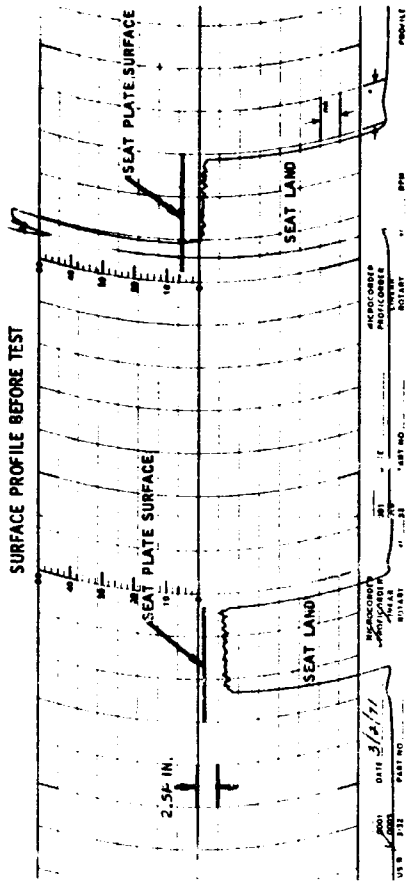
Figure 59

These results are similar to previous test results which indicated positive growth of deposits in the seating surface. Examination of some further photographs of the seat surface (Figure 60) shows that the nonimpacted zones are very similar to the surfaces of the statically exposed poppets. The general seat land surface was domed after the valve test exposure indicating some loss of material from the edges of the seat.

NI-301 SEAT  
SURFACE PROFILE BEFORE AND AFTER 100,000 CYCLE VALVE TEST - LOW IMPACT - CIF5

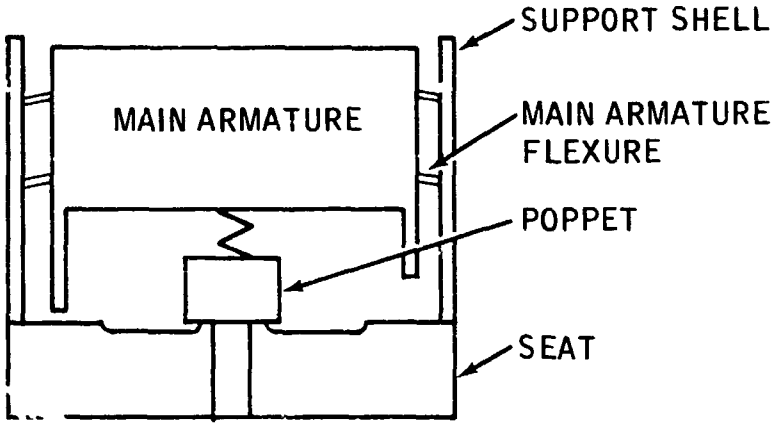
# NONUNIFORM BUMPER IMPACT

POPPET STRIKES FIRST

NONUNIFORM BUMPER IMPACT CAUSES COUPLE

RESULT - LATERAL MOTION

1. Seat material erosion resulting from dragging of the poppet across the seat as a result of nonuniform bumper impact with the stop surface. This resulted in grooving of the surface through abrasive chemical wear with variability in leakage rates measured resulting from nonrepeatable location of the poppet relative to the seat.
2. Intermittent contribution to leakage by the center downstream seal. Total contribution of this cause to total leakage measured is an undefinable quantity.

Satisfactory leakage measurements have been recorded using K-96 as the poppet and seat material. It is felt that even though leakage goals were not met throughout this test program, the material has demonstrated capability to adequately perform provided there are no outside contributing factors causing unnecessary problems. The results indicate that the material might perform quite satisfactorily if the possibility of abrasive contribution to chemical wear were removed by a minor redesign of the valve to remove the bumper as an outside influence or make provisions for the bumper contact surfaces to be parallel to the seat, thus avoiding lateral movement and abrasion.

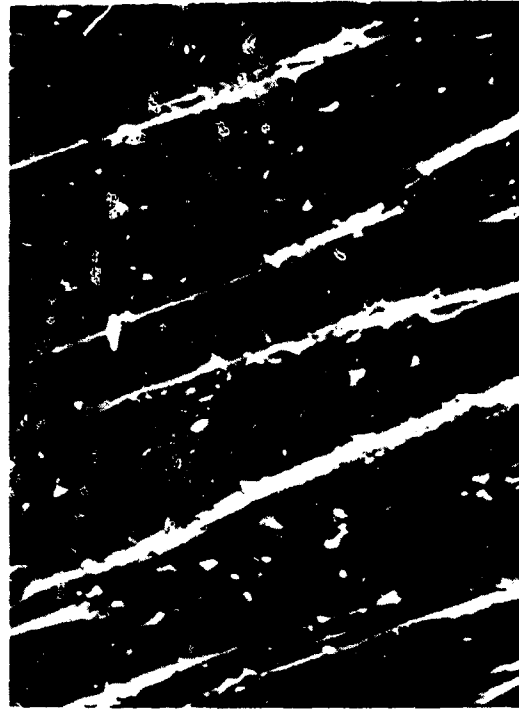
S.E.M. PHOTOS AFTER 100,000 CYCLE - CIF<sub>5</sub> VALVE TEST (NORMAL IMPACT)

PHOTOS ARE AT 1000X

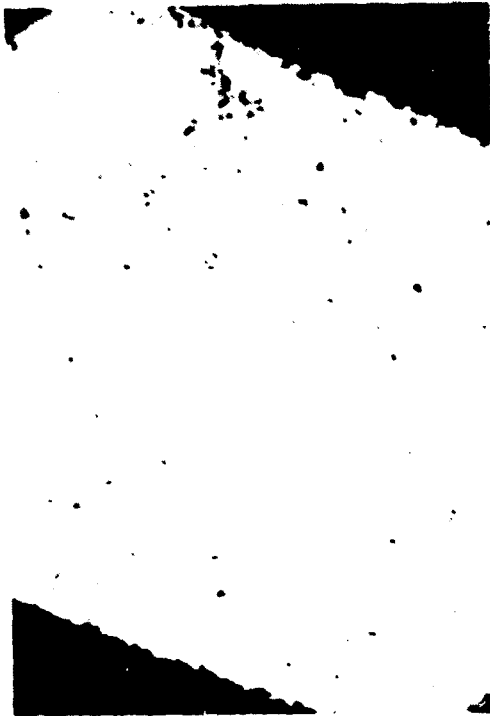
WC SEAT NO. 18 BEFORE NORMAL IMPACT VALVE TEST IN CIF<sub>5</sub> - 210X SURFACE PHOTO

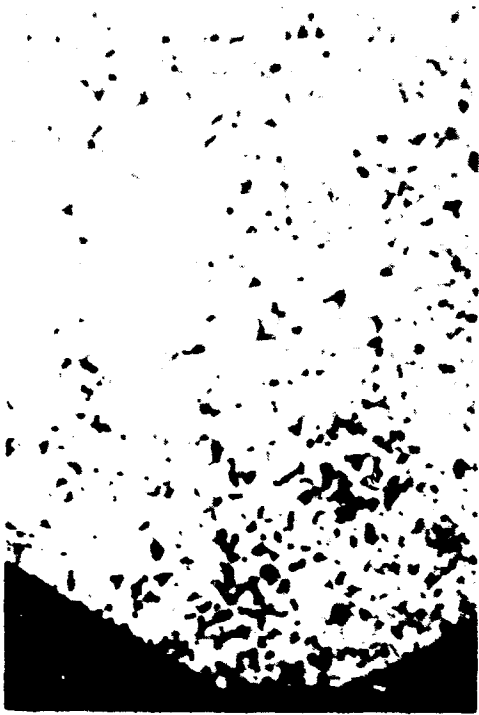
WC SEAT NO. 18  
NONIMPACT ZONE AND BUMPER IMPACT ZONES - 210X PHOTOS

NONIMPACT ZONE SURFACE PHOTO

NONIMPACT ZONE INTERFERENCE PHOTO

BUMPER ZONE IMPACT AREA INTERFERENCE PHOTO

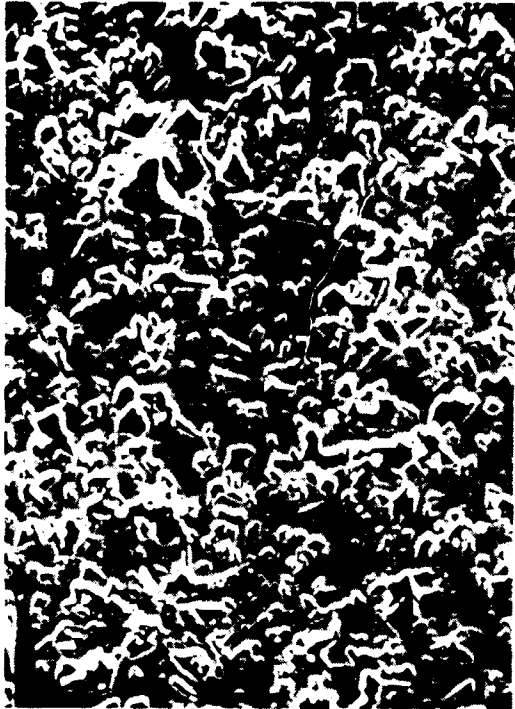
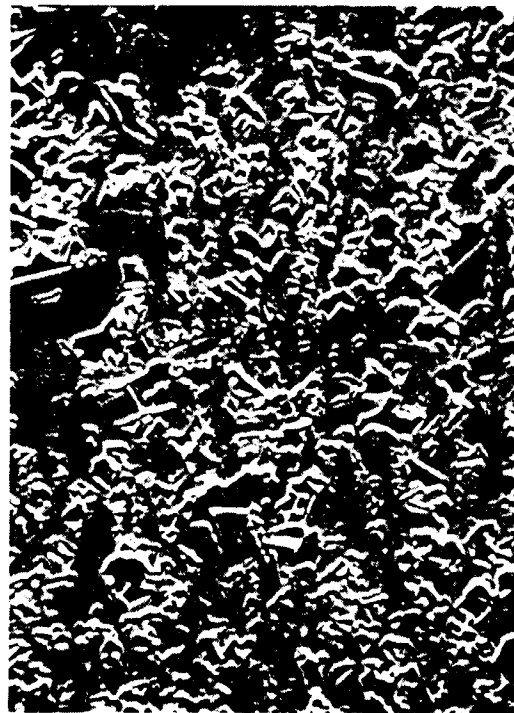
Scanning electron microscope studies were performed using the poppet tests to further define the effects of exposure and dynamic impact on the seat surface. Figure 84 shows a set of 200X photos taken of the seat land, and just inside and outside the seat land. The seat land is clearly defined with about the same distribution of holes on the surface in and out of the seat area. At 1000X, Figure 85, the structure of the tungsten carbide crystals is more clearly defined and the surface grooves are more apparent. At 5000X, Figure 86, the large grain crystal structure is clearly defined. Lap marks are still evident on the nonimpact areas indicating relatively even corrosion rates. The crystal structure in the seal area appears to be the same as in the adjacent areas except that all evidence of lap marks is gone and the surface of the seat area is worn smooth, between grooves.

TUNGSTEN CARBIDE-WC - POPPET NO. 18  
S.E.M. PHOTOS AFTER 100,000 CYCLE - CIF<sub>5</sub> VALVE TEST (NORMAL IMPACT)  
PHOTOS ARE AT 1000X

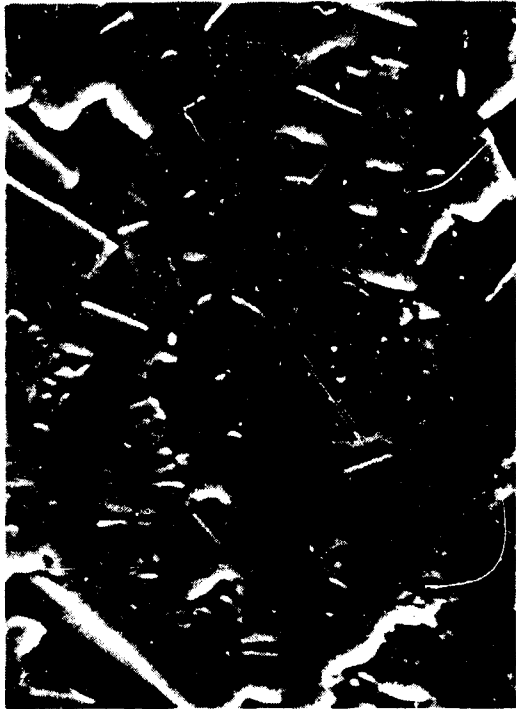
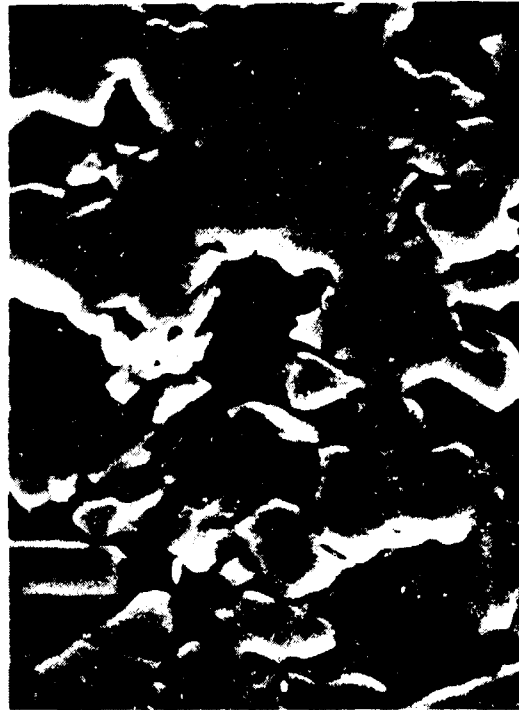
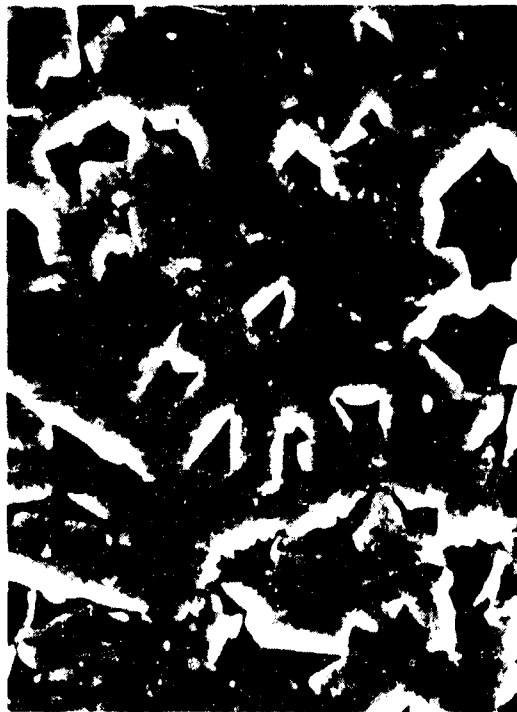
Figure 85

TUNGSTEN CARBIDE-WC - POPPET NO. 18  
S.E.M. PHOTOS AFTER 100,000 CYCLE - CIF<sub>5</sub> VALVE TEST (NORMAL IMPACT)  
PHOTOS ARE AT 5000X

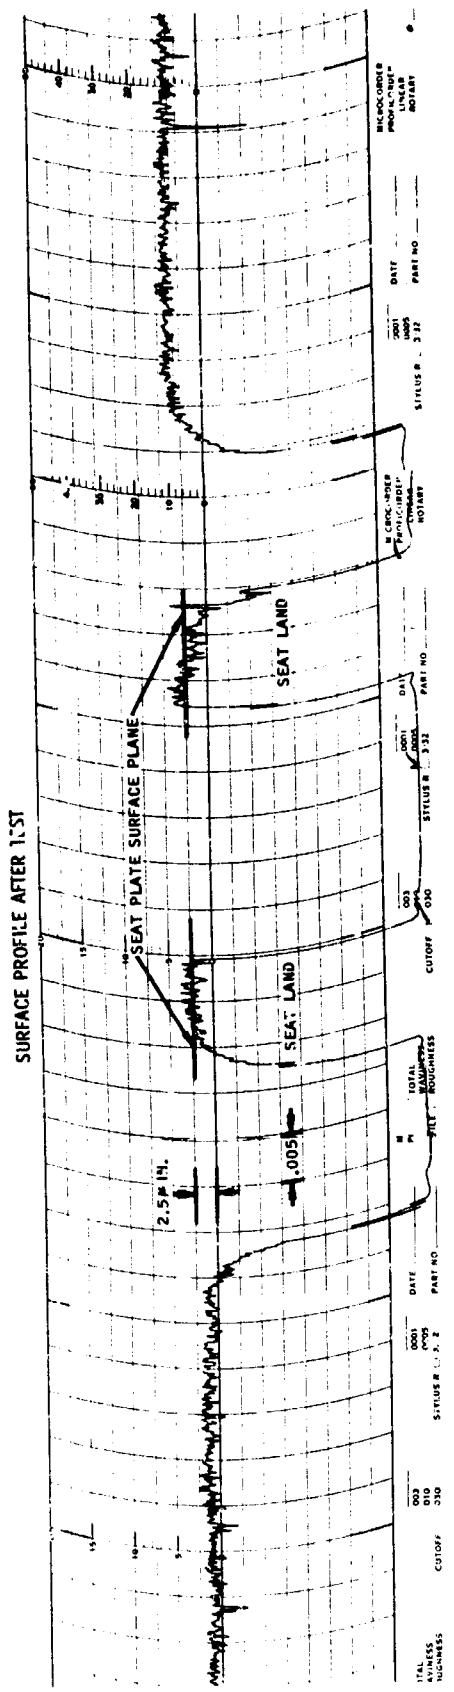
Figure 93

Appearance of the seat which was tested at low impact levels in gaseous fluorine was almost identical to that of the low impact seat tested in chlorine pentafluoride. Figure 92 shows surface photos and interferograms of the seat tested in gaseous fluorine at low impact prior to and after the test. As with the chlorine pentafluoride seat, the only change in the seat surface noticeable is the occurrence of random occasional lumps or surface contamination. No evaluation was made of the poppet from the valve tested at low impact in gaseous fluorine. It was necessary to coat the aluminum oxide parts with a thin carbon film to make them conductive for examination with the scanning electron microscope. Since there was some possibility of requiring parts for further examination which had been maintained in an inert atmosphere to prevent contamination and which had not been coated with carbon, it was decided to skip the electron microscope examination because two other parts were available which had been tested in both propellants. As it turned out, there was insufficient time available in the S. E. M. to examine all parts so the poppet would have been skipped in any case. Comparison of proficorder traces made of the seat land showed similar results to that obtained on the low impact seat tested in chlorine pentafluoride (Figure 93) with no significant differences apparent.

AL2 O3 SEAT  
 SURFACE PROFILE AFTER 100,000 CYCLE VALVE TEST - LOW IMPACT - GF2

NOTE:  
 NO PRETEST PROFICORDING  
 COMPARE SURFACE WITH  
 STATIC TEST EXPOSURE  
 POPPET, Fig. VI - 26

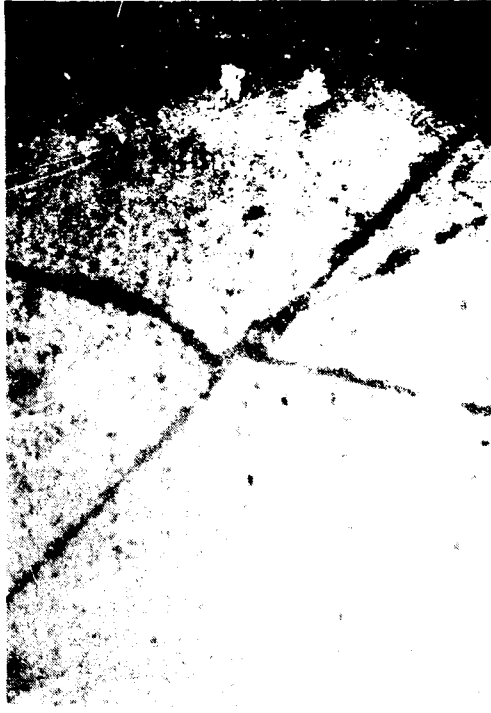
The third aluminum oxide seat and poppet was tested in the normal impact valve using  $GF_2$ . Leakage rates during the test progressively increased up to 1000 cycles and then decreased to the end of the test. Primary cause for the excessive leakage measured with the valve was discovered upon examination of the poppet and seat after the test. The seat land was found to have shattered in several areas. None of the cracks propagated completely across the seat explaining why the valve sealed to a degree. Figure 94 shows surface photographs and interferograms of the seat prior to and after the test. As with the other materials tested in the normal impact valve, there was evidence of some grooving of the seat surface. The average groove depth, however, was considerably less than the groove depth measured on the other test seats, only being 2 to 5 microinches deep. This was considerably less "wear" than seen on the other materials tested in the normal impact valve. Total erosion of the integral portion of the seat remaining was also less than that of any of the other seats tested. Figure 95 shows comparative proficorder traces made of the seat land prior to and after the test. These data indicate that the surface finish of the seat in general is still quite good even in the impact area, probably better than the surface of any of the other valve seats after testing. The poppet used for the normal impact test in gaseous fluorine was examined using the S. E. M. to evaluate the seating surface and to attempt to further define the cause of the leakage experienced. In addition to the cracks in the seat, there was considerable amount of debris found in the seat land area similar to that found on the other

Al<sub>2</sub>O<sub>3</sub> SEAT NO. 14 BEFORE NORMAL IMPACT VALVE TEST IN GF<sub>2</sub> - 210X INTERFERENCE PHOTO

Al<sub>2</sub>O<sub>3</sub> SEAT NO. 14 AFTER NORMAL IMPACT VALVE TEST IN GF<sub>2</sub> - 210X INTERFERENCE PHOTO

Al<sub>2</sub>O<sub>3</sub> SEAT NO. 14 BEFORE NORMAL IMPACT VALVE TEST IN GF<sub>2</sub> - 210X SURFACE PHOTO

Al<sub>2</sub>O<sub>3</sub> SEAT NO. 14 AFTER NORMAL IMPACT VALVE TEST IN GF<sub>2</sub> - 210X SURFACE PHOTO
