MISCELLANEOUS PAPER NO. 4-759

# EVALUATION OF U. S. STEEL TYPE 4.5 AIR-DEK LANDING MAT

November 1965

**U. S. Army Engineer Waterways Experiment Station  
CORPS OF ENGINEERS  
Vicksburg, Mississippi**

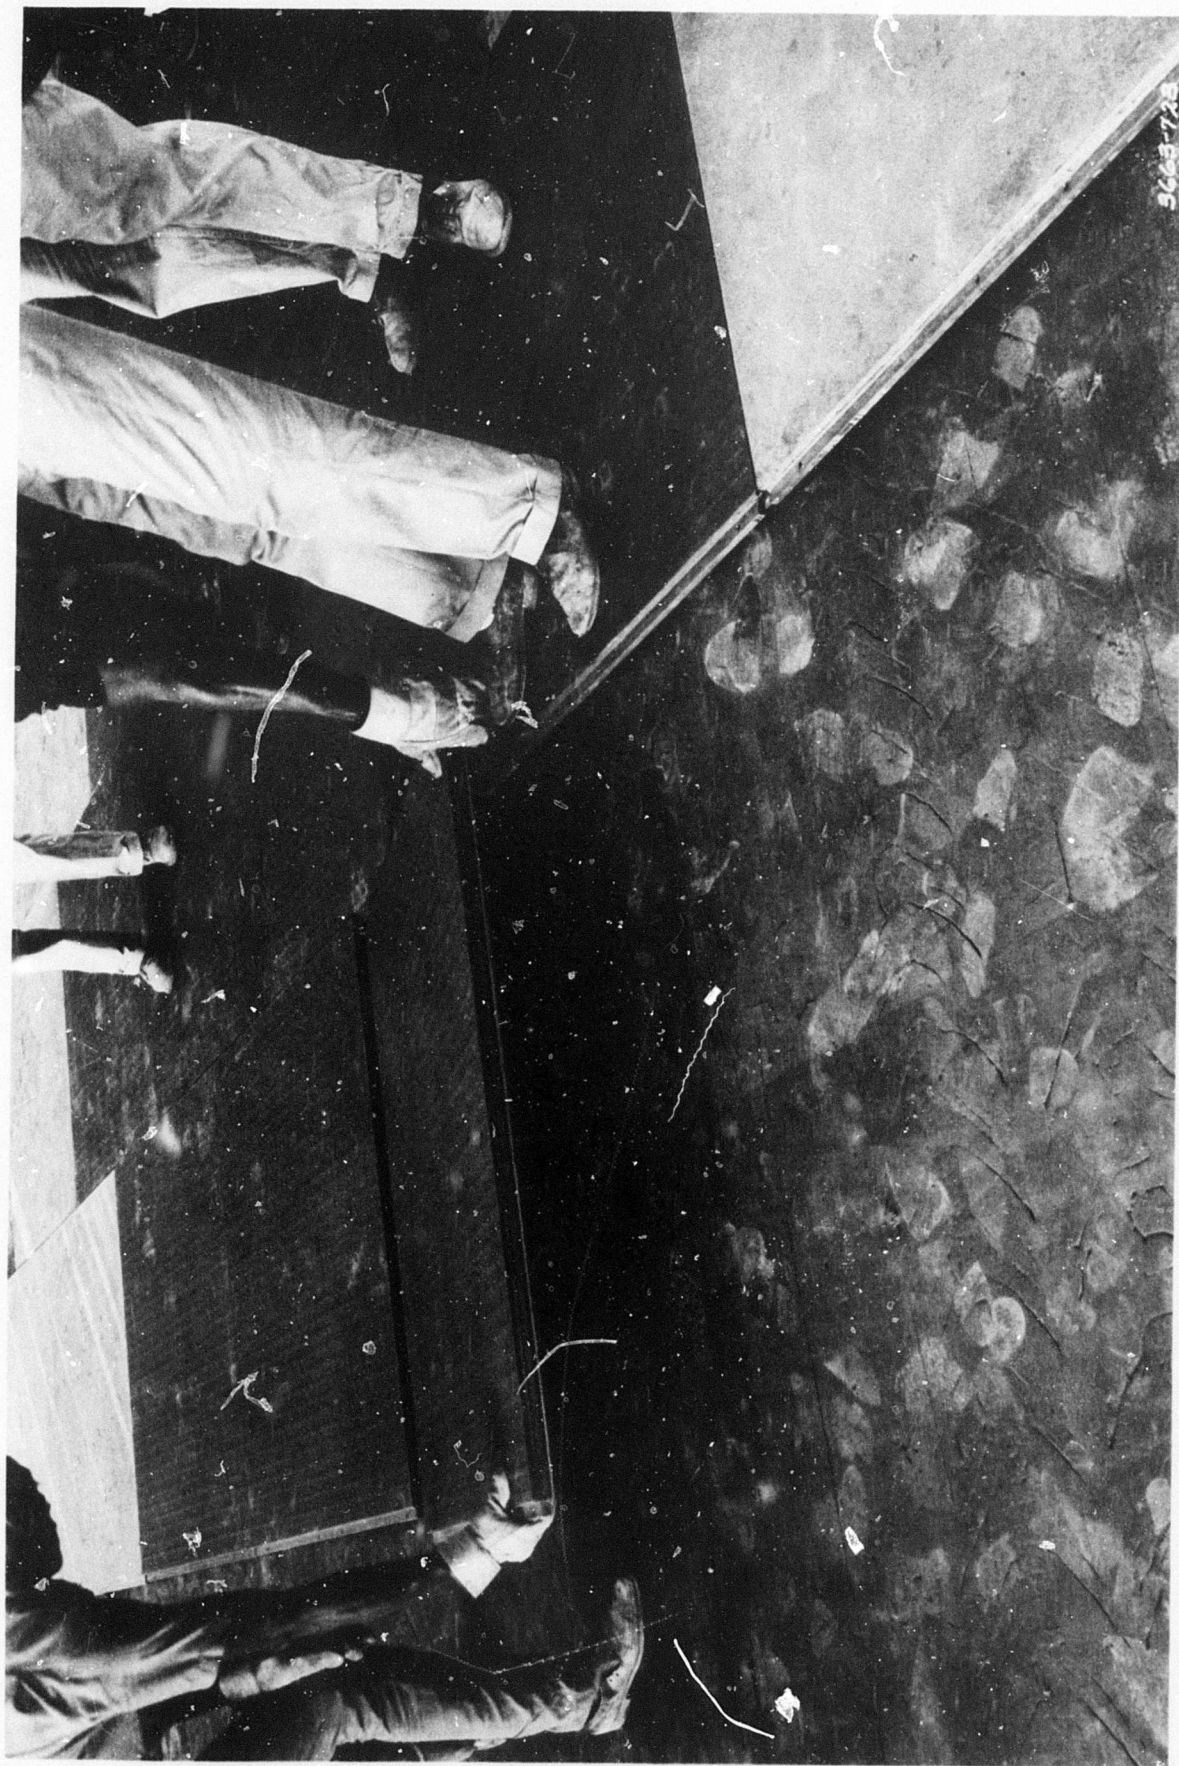
Photograph 1. Composite view of U. S. Steel Air-Dek landing mat

5. The U. S. Steel Type 4.5 Air-Dek panel is a sandwich-type structure (photograph 1) fabricated from high-strength "Cor-Ten" steel. The core is composed of an "egg-crate" type configuration with structural members bonded together by an adhesive. The core is bonded on top and bottom to 0.025-in.-thick steel facings, with the top facing having a dimpled design for improved strength. Individual panels are approximately 4 ft square and 1.6 in. thick, and weigh 74.9 lb. Panel connections are made by use of tongue-and-groove connectors which are integral parts of the panels. The connections are secured by a total of 12 stainless steel pins per panel. The actual weight per square foot of placing area is 4.65 lb (as compared with 4.5 lb proposed in design). The top facing of the panels is coated with an antiskid compound developed by the W. P. Fuller Paint Co. Minor fabrication changes were made by variations in the adhesives in some of the panels and are described in paragraph 7. A layout of the test section is shown in plate 1.
