USAARL REPORT NO. 72-07

DYNAMIC AND CRASHWORTHY EVALUATION
OF THE UH-1B, C, D, H, MEDICAL ATTENDANT'S SEAT

January 1972

U. S. ARMY AEROMEDICAL RESEARCH LABORATORY

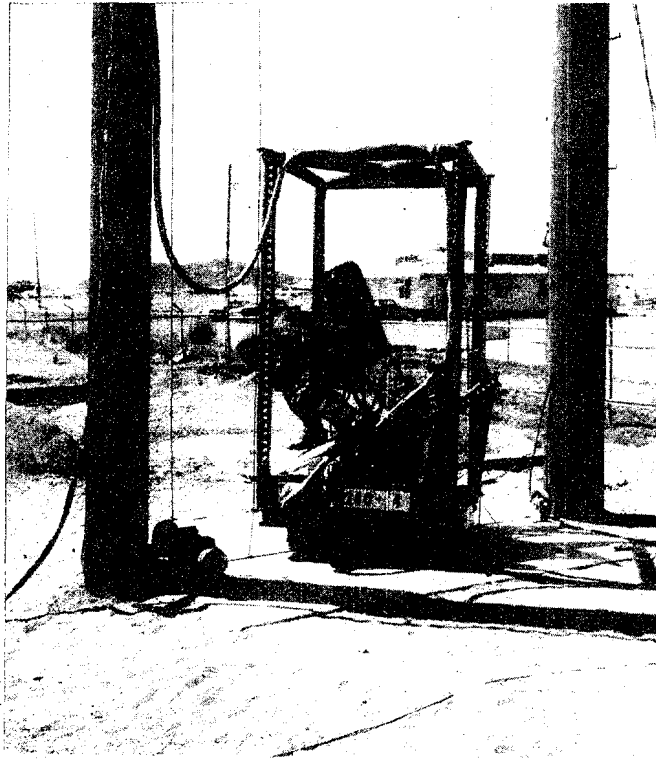
Figure 20. Seat Configuration 2 after Test 4.

Post-test inspection revealed no apparent damage. Figure 20 shows a post-test side view. The dummy chest showed a very high peak vertical deceleration of 33.2G. The peak pelvic deceleration was 13.4G.

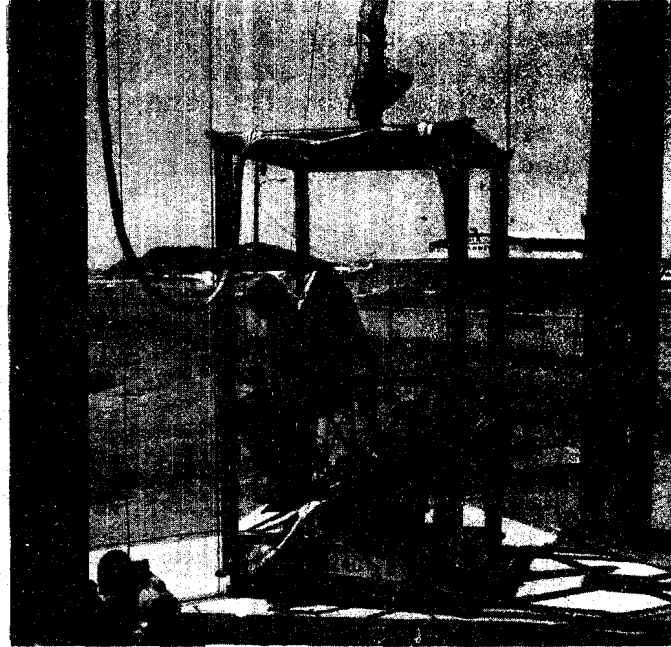
Figure 24. Seat Configuration 3 Before Test 8.

Test 8: This test on seat Configuration 3 was planned to be a 16G resultant pulse with a velocity change of 35 fps and a rate of onset of 400 G/sec. The resulting input pulse had a peak of 16.9G, a velocity change of 27.9 fps, and a rate of onset of 242 G/sec. Figure 24 shows a side view of the seat mounted in the drop tower cage just prior to test.

Post-test inspection revealed seat failure in four places. The seat front lateral cross tube failed in the center at a 1/8-inch diameter hole where a screw fastens the seat canvas to the structure, the seat right front corner joint pulled out, the seat back tube failed on the left side at the back brace tube, and the canvas seat also failed. Figure 26 shows a post-test seat side view. Peak dummy chest vertical deceleration was 23.8G. The pelvis experienced a very high vertical deceleration of 40G. (See Figures 24 thru 31.)

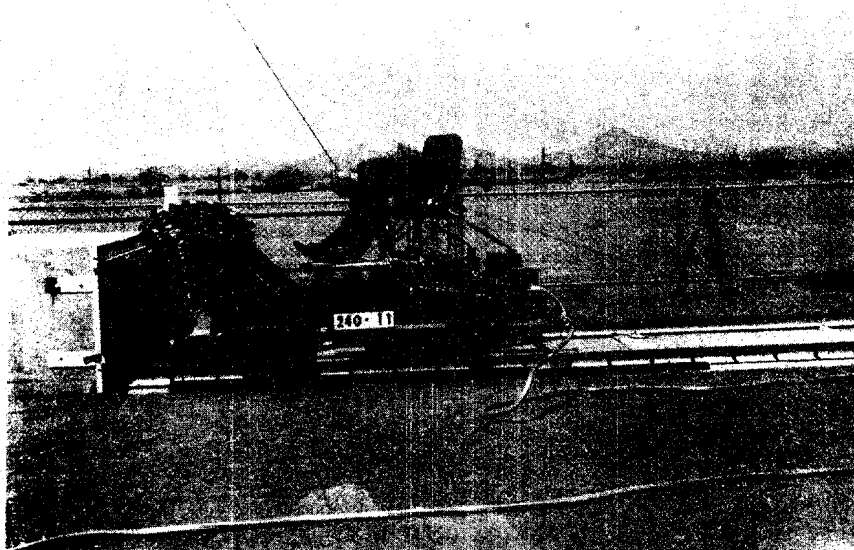
Figure 38. Seat Configuration 2 after Test 11.

Post-test inspection revealed no apparent damage. Figure 38 shows a post-test side view. The maximum deceleration measured in the dummy was 12.1G vertical in the chest.
