CONDITION SURVEY, ROBERT GRAY ARMY AIRFIELD, FORT HOOD, TEXAS

P. J. Vedros

April 1968

CONDITION SURVEY, ROBERT GRAY ARMY AIRFIELD

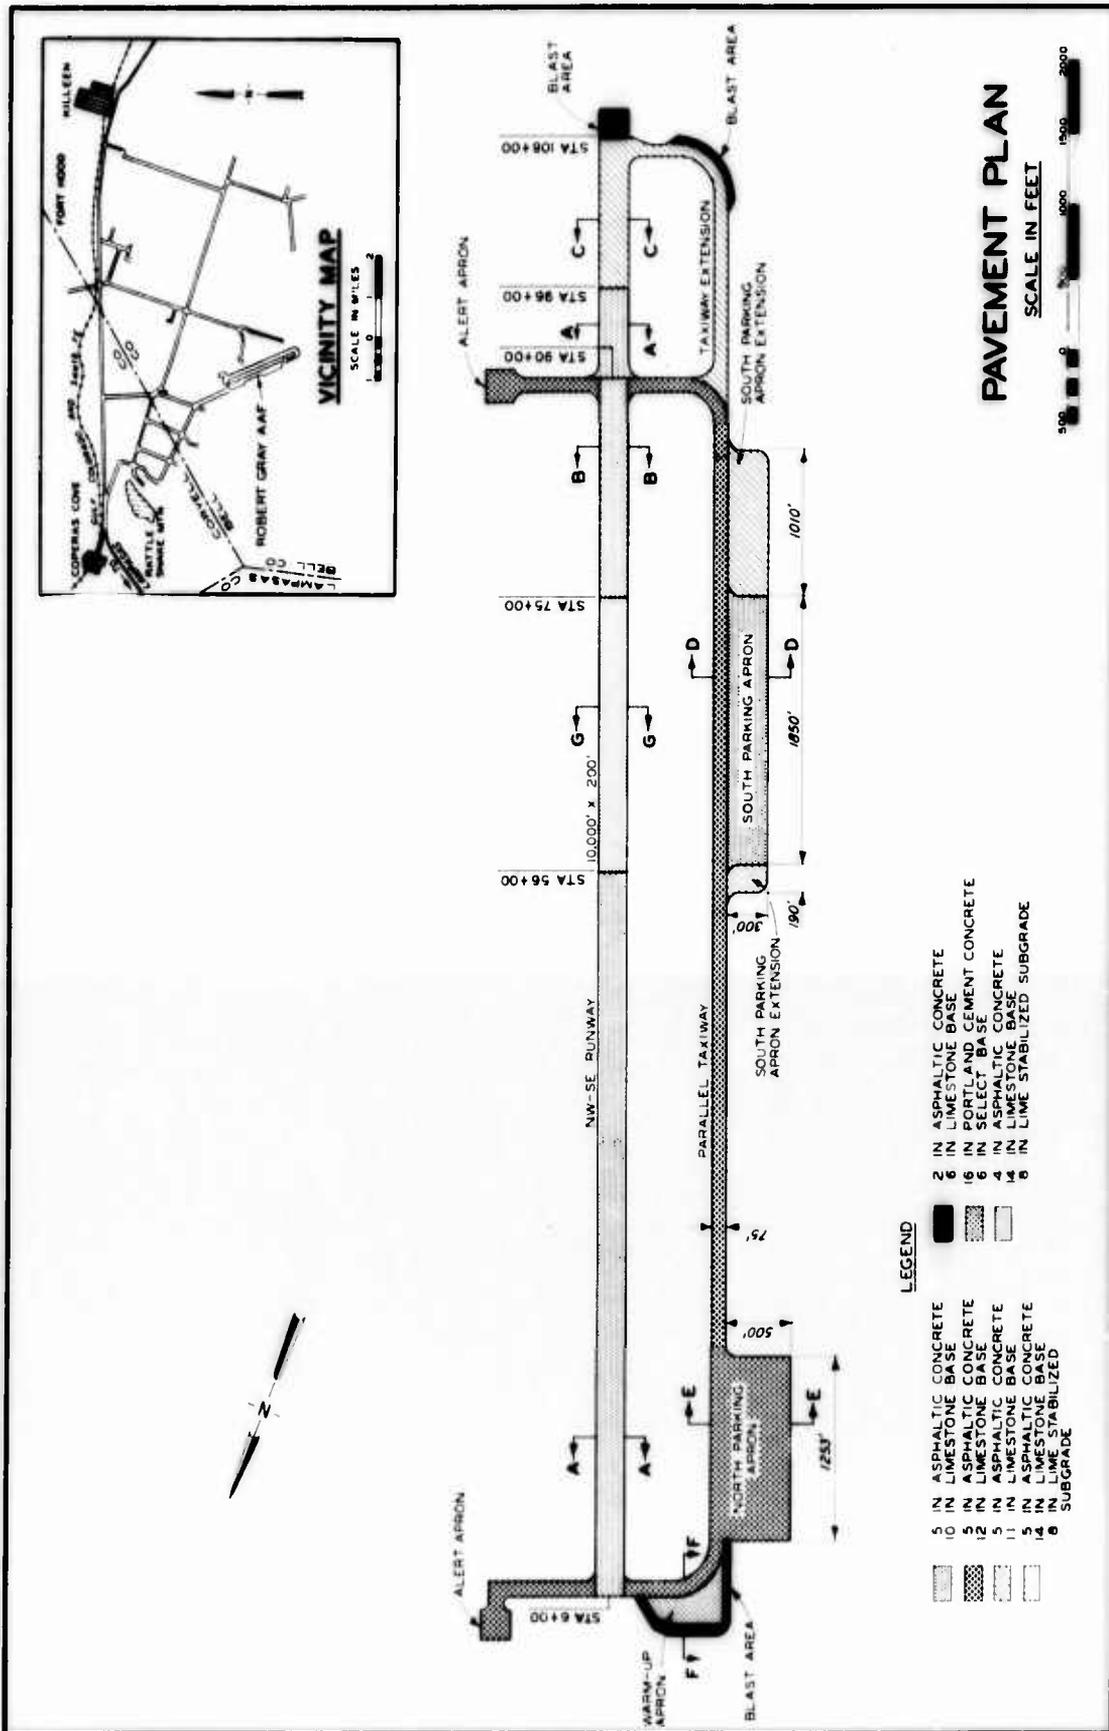
b. Installation on west side of runway from sta 88+40 to 90+00

10. In an attempt to eliminate seepage in this area, the Post Engineer has installed a series of subsurface drains (photograph 5). Locations of the drains are shown in plate 3. It was reported that these drains are functioning and helping to keep the pavement relatively dry. The subsurface drains were installed at the time that the area from sta 56+00 to 75+00 was reconstructed. Layout of the drainage system is shown in plate 3.

Photograph 5. Subdrains installed to eliminate seepage
