DEEP MOORED INSTRUMENT STATION CRUISE REPORT

NORTH PACIFIC STUDY

Cruise 2

U.S.C.G.C. ACUSHNET

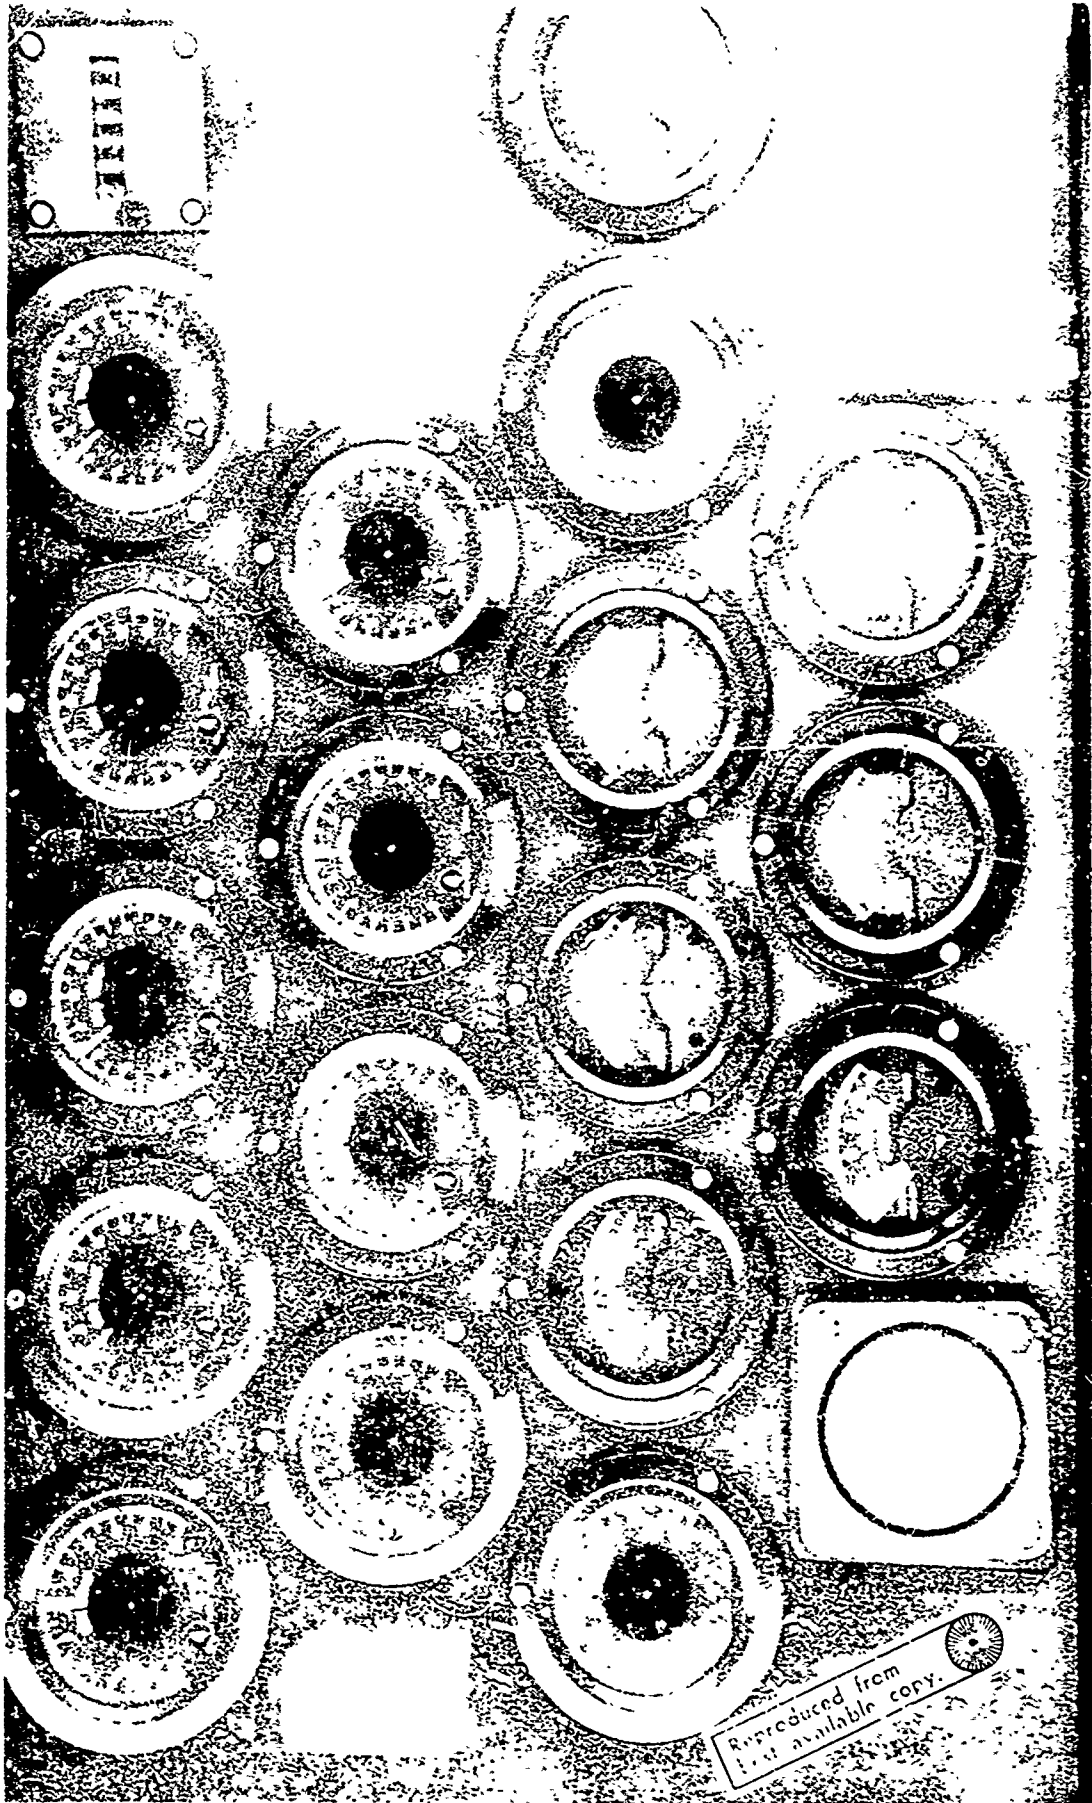
The cable clamps on the instrument lines through the bulkheads were corroded. Evidently the clips are not stainless steel.

All instrumentation with the possible exception of the load cell was operational and no meters were removed.

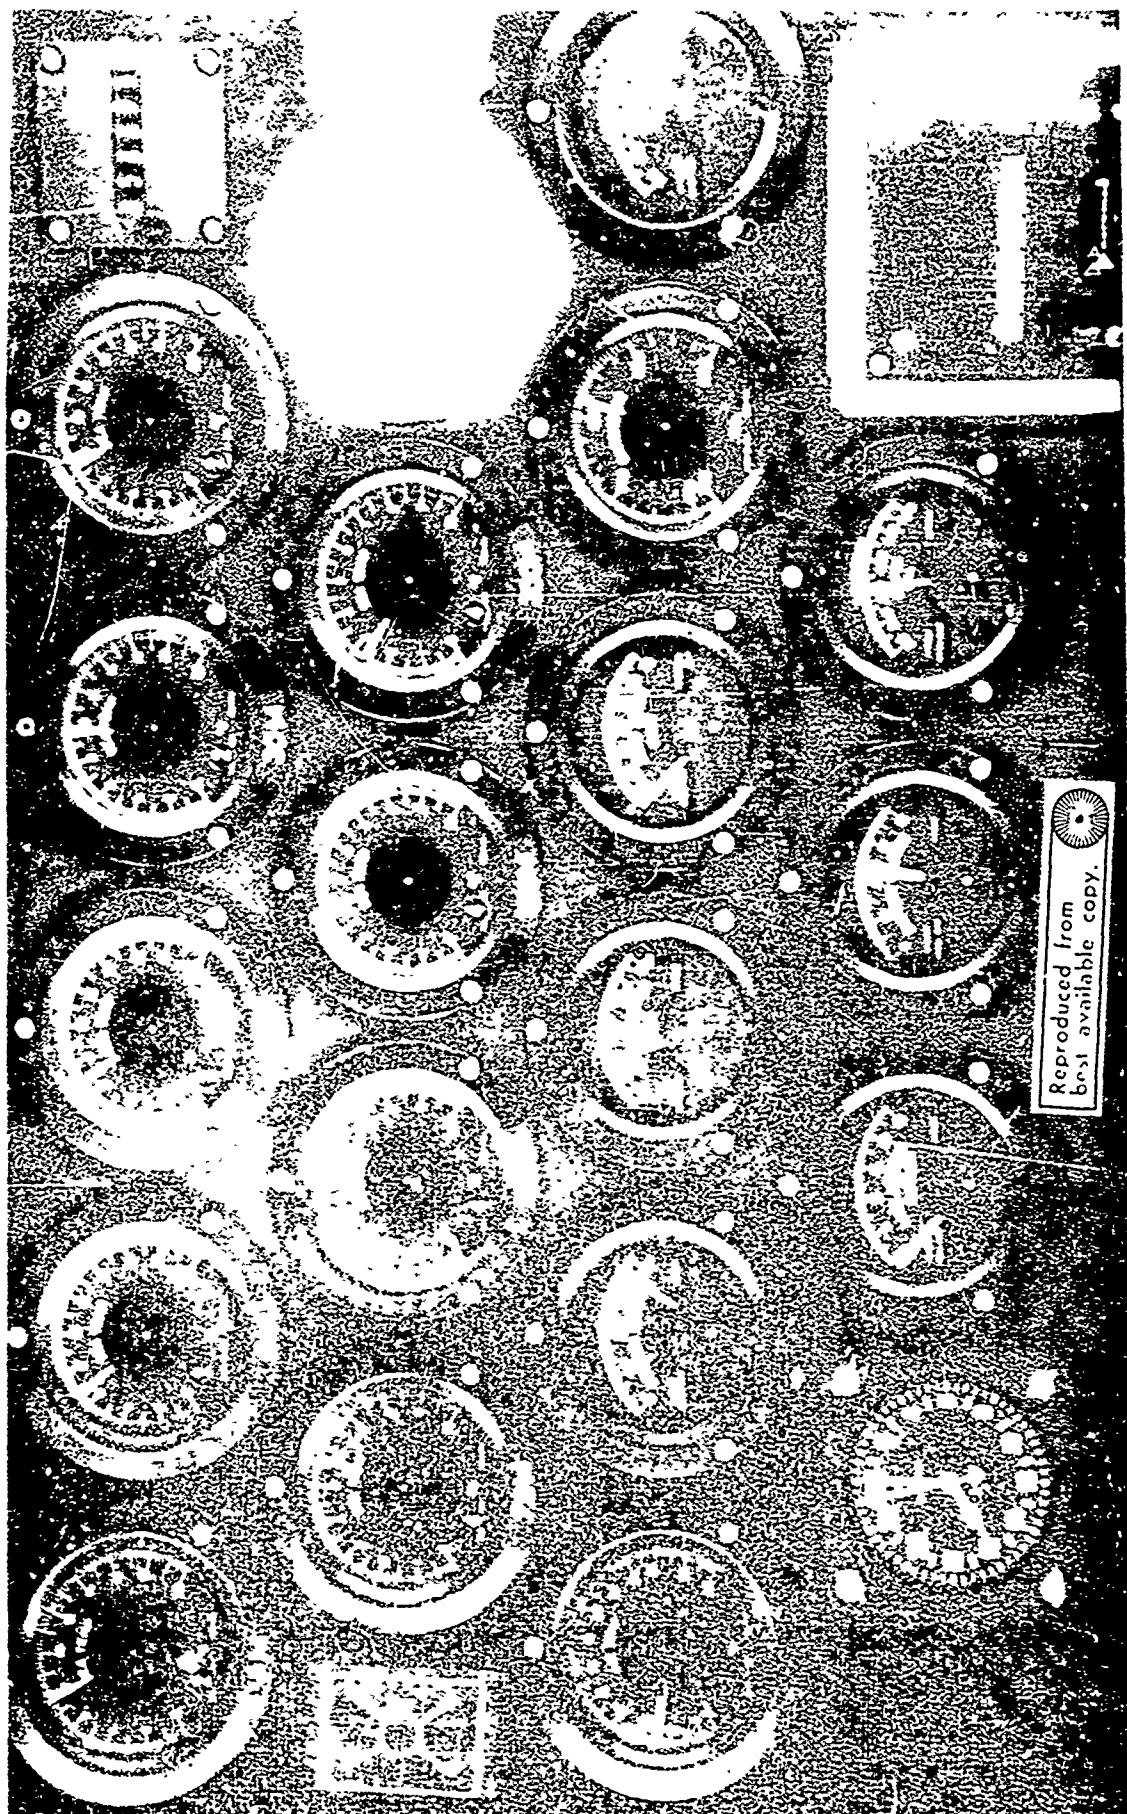
All cable clamps on the starboard side cables through the bulkheads were corroded.

When the new data camera was installed, its microswitch would not shut off the instrument box. Another camera had to be sent for and installed.

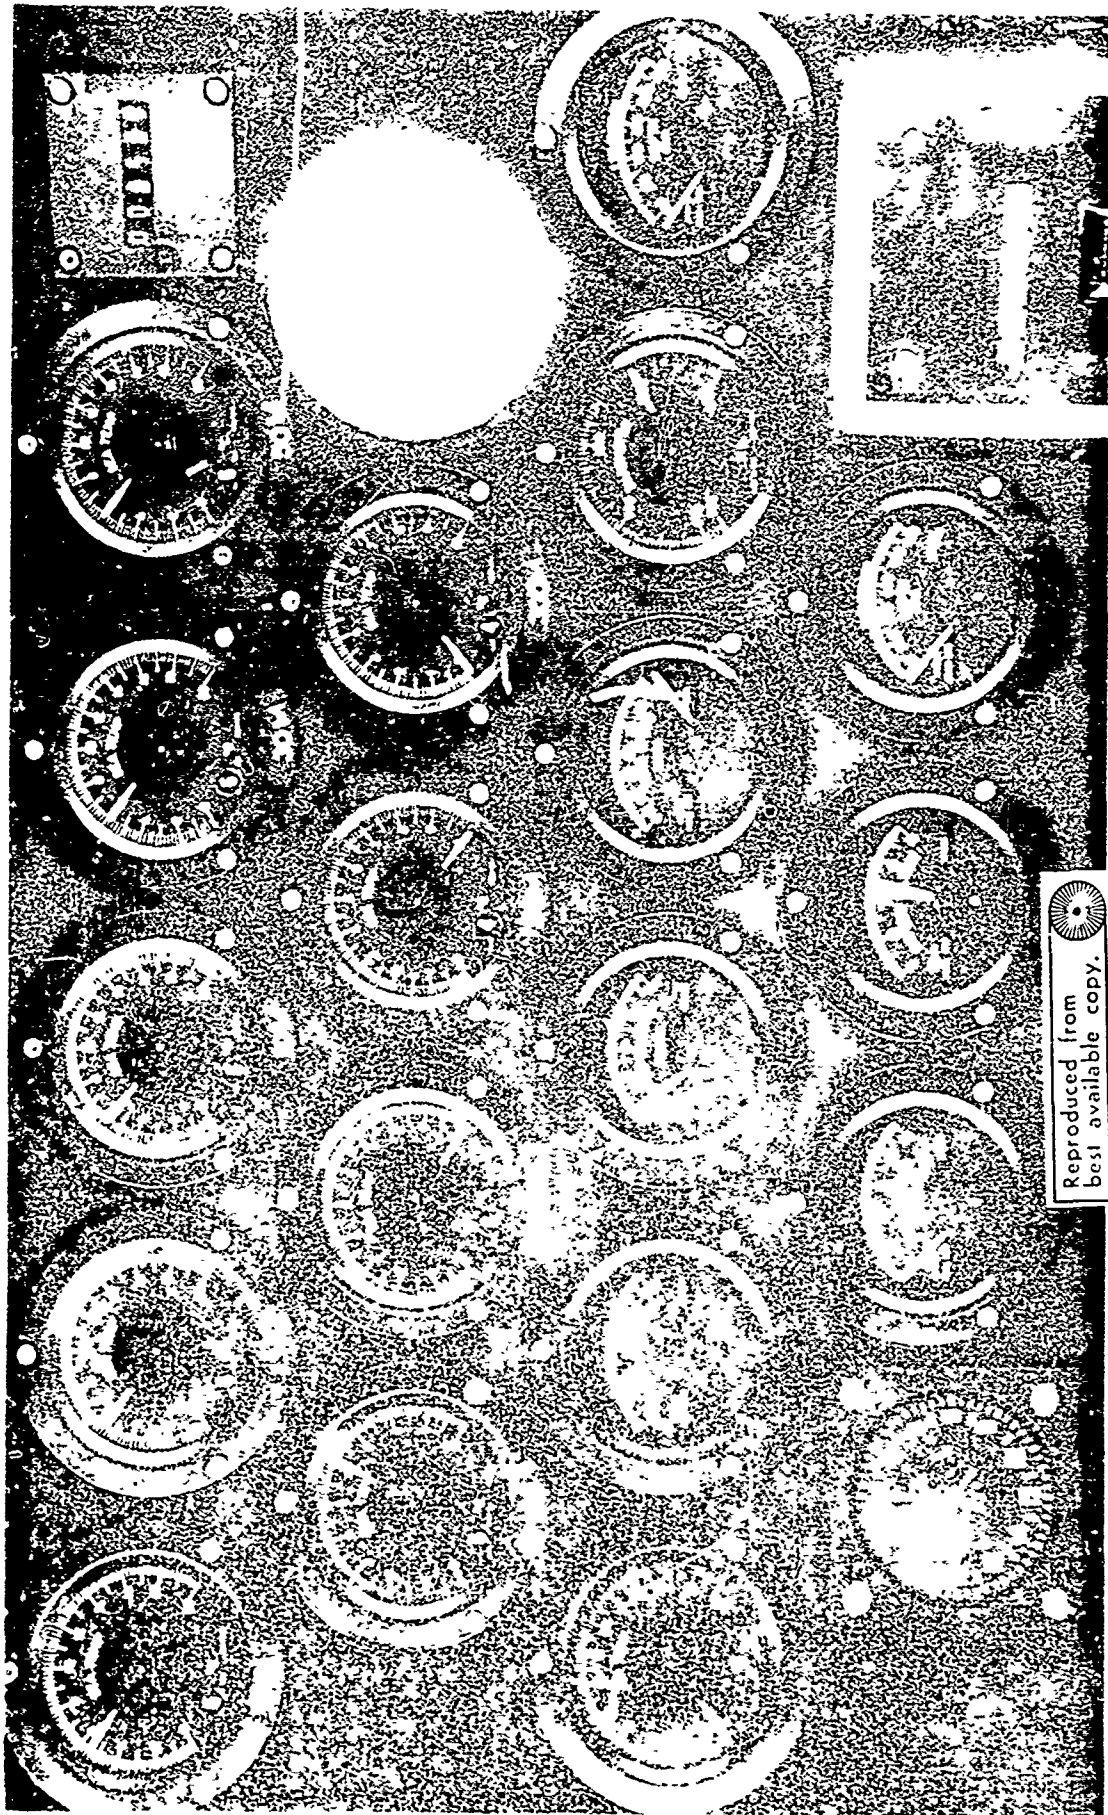
The 150 and 300m pressure indicators were removed as the pressure transducer circuits were open.

The line tension indicator was removed as it was inoperative.
