MISCELLANEOUS PAPER S-72-27

EROSION CONTROL AT THE ARES FACILITY KIRTLAND AIR FORCE BASE, NEW MEXICO

C. R. Styron III

Conducted by **U. S. Army Engineer Waterways Experiment Station**
Soils and Pavements Laboratory
Vicksburg, Mississippi

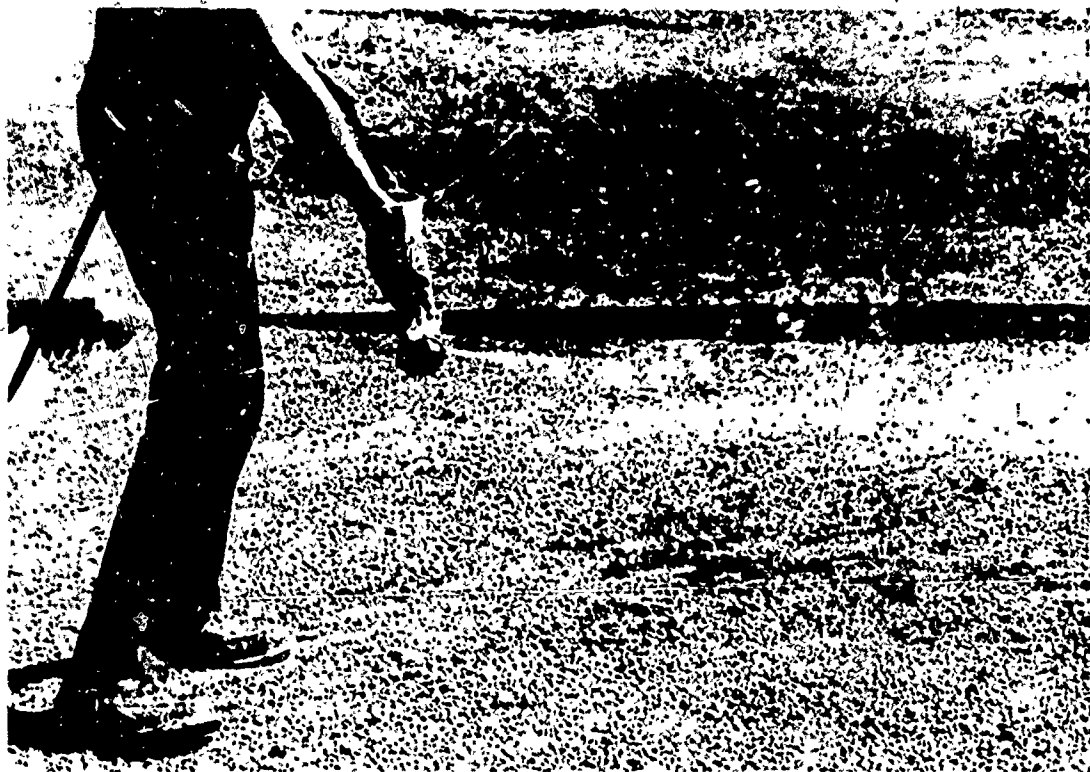
Photo 7. Hand-held, air-activated cutter gun in operation

34. Chopped glass was uniquely suited for application on the east and west slopes of the ARES facility because it was necessary to keep the wire mesh surface of these slopes free of all obstruction. The fiberglass strands were chopped at the site with the cutter gun as shown in photo 7. The fiberglass strands were cut to approximately 1/2-in. lengths and blown about 10 ft from the gun. The cutter required about 8 min to cut up 30 lb (one box) of the Unistrand fiberglass. A typical operation of one of these guns is shown in photo 8, which shows the air hose from the compressed air supply that activates the gun, the wheeled fiberglass dispenser, and the ground wire that prevents the buildup of static electricity. The guns worked very well and required only a periodic change of blades. Placing chopped glass at the design rate of 1/4 lb/sq yd resulted in a placing rate of 15 sq yd per minute.

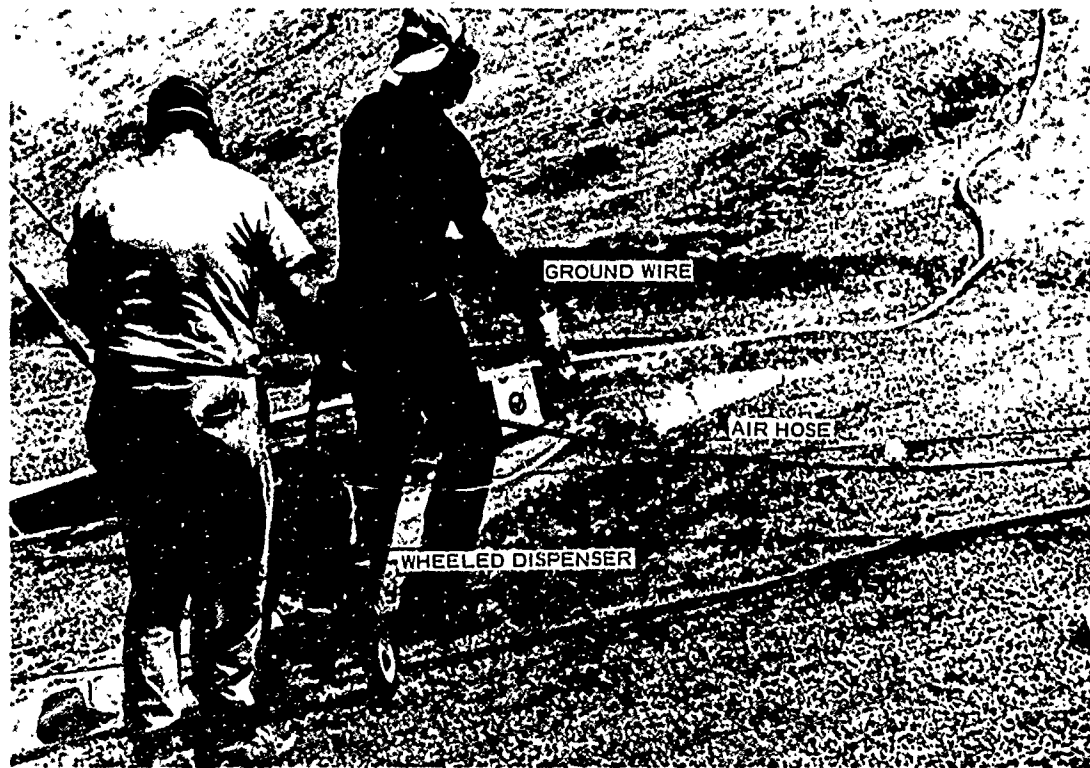
Photo 8. Typical operation showing cutter gun, dispenser, and crew

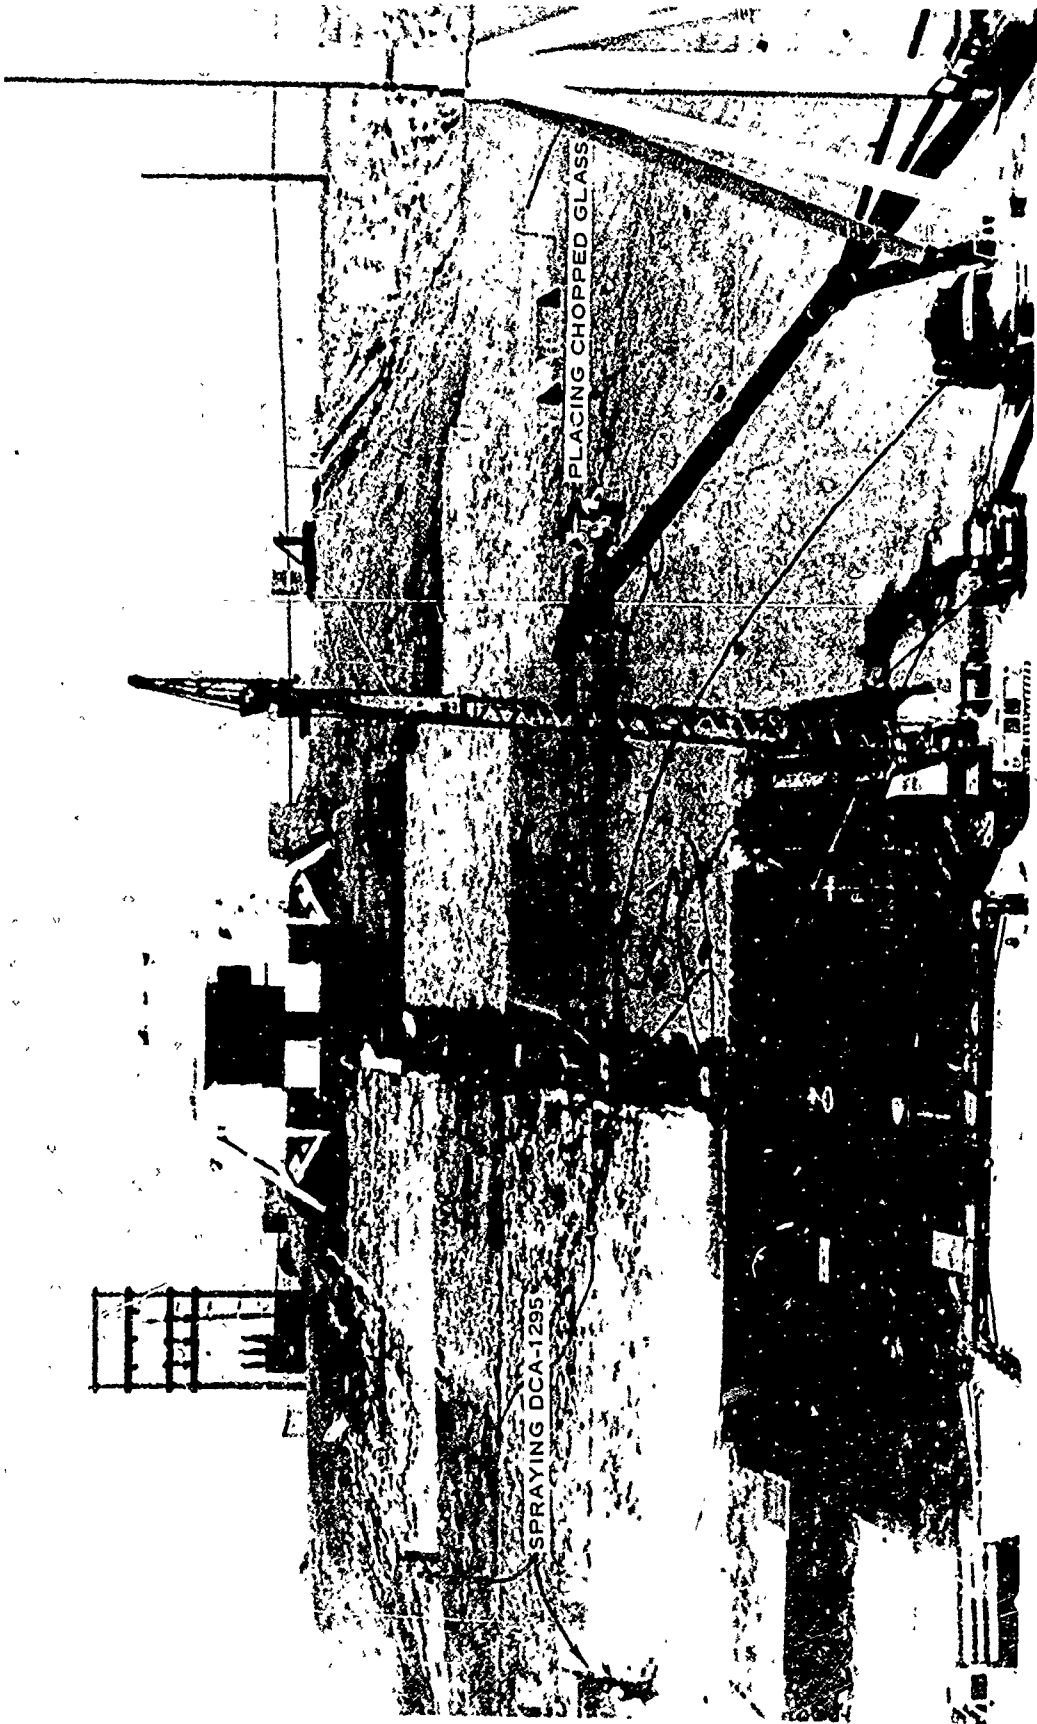
Photo 10. Placing chopped glass and spraying DCA-1295 on west slope

38. An operator and one laborer placing chopped glass and two teams spraying the DCA-1295 over the west slope where the chopped glass has already been placed are shown in photo 10. Close examination of this photograph will reveal the boxes of continuous-strand fiberglass roving positioned on the slope to increase production rates by having material stockpiled in areas close to chopper operations. One box is just to the right of the two men placing the chopped fiberglass. Photo 11 shows a close-up of the chopped fiberglass and DCA-1295 placed in a section covered by 4-in.-grid wire mesh. A broader view of a typical area adjacent to the wire mesh is shown in photo 12.

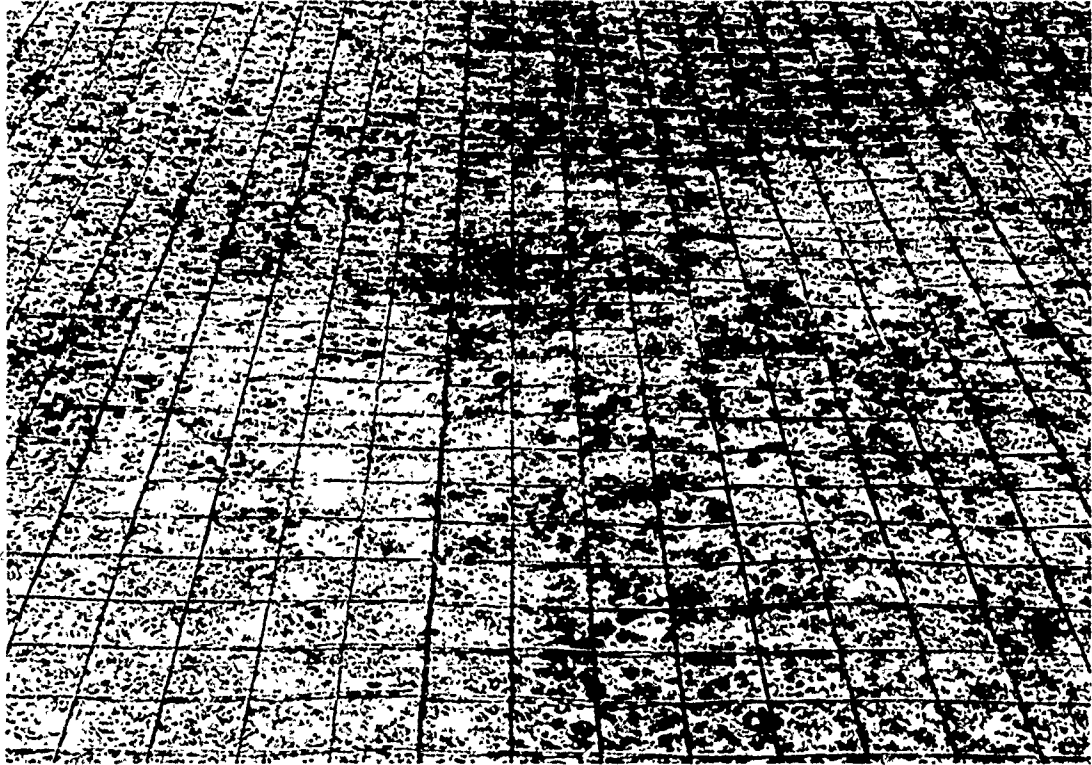
Photo 11. Chopped glass and DCA-1295 in wire mesh area

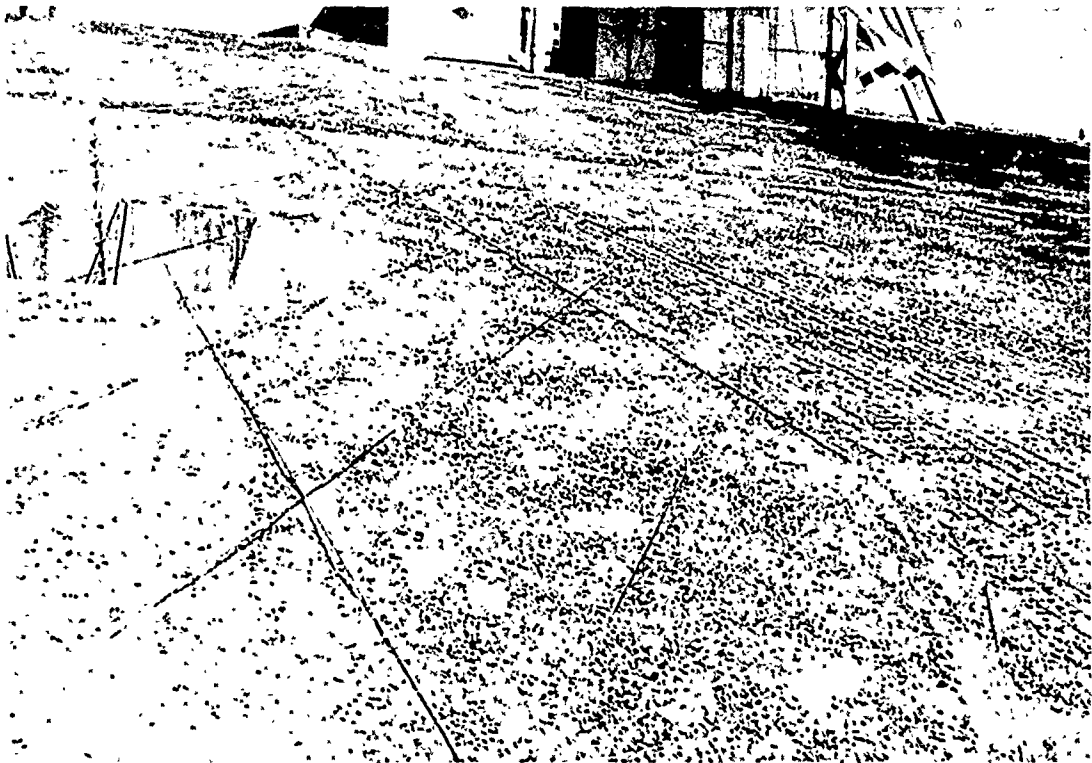
Photo 12. Chopped glass and DCA-1295 in area adjacent to wire mesh

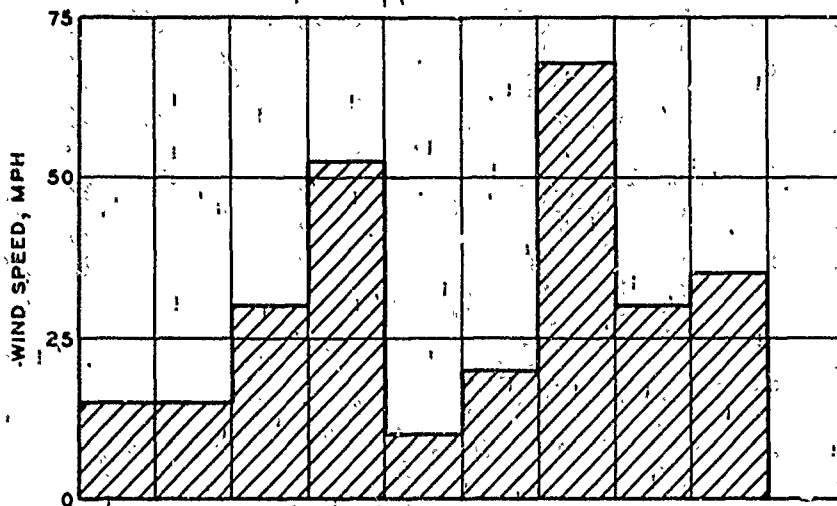
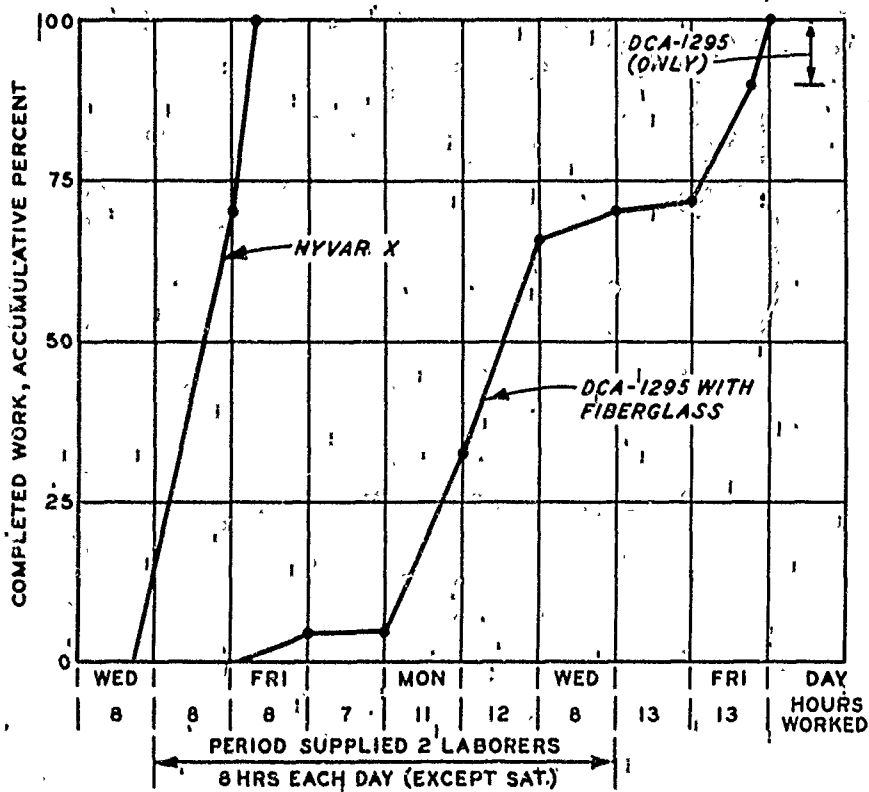
42. The wind proved to be a major obstacle during the entire project. The need for restricting placement of the scrim/DCA-1295 system to periods in which wind velocity is below an established limit is well illustrated in plate 2 where the daily wind velocity is superimposed on a chart representing the accumulative percent of work completed versus days worked at the ARES facility. Actually, the Qualitative Material Requirement for Dust-Control Materials excludes application during periods when the wind velocity is greater than 20 knots (23 mph). Since this project was authorized by another agency under a contract bid with a firm deadline for the completion of all work, a determined effort was made to place the materials regardless of the wind.
