Marine Corrosion Studies

The Effects of Dissimilar Metal Couples and Toxicants from Antifouling Paints on the Corrosion of 5086 and 6061 Aluminum Alloys and Their Response to Cathodic Protection

(Fourteenth Interim Report of Progress)

NAVAL RESEARCH LABORATORY
Washington, D.C.

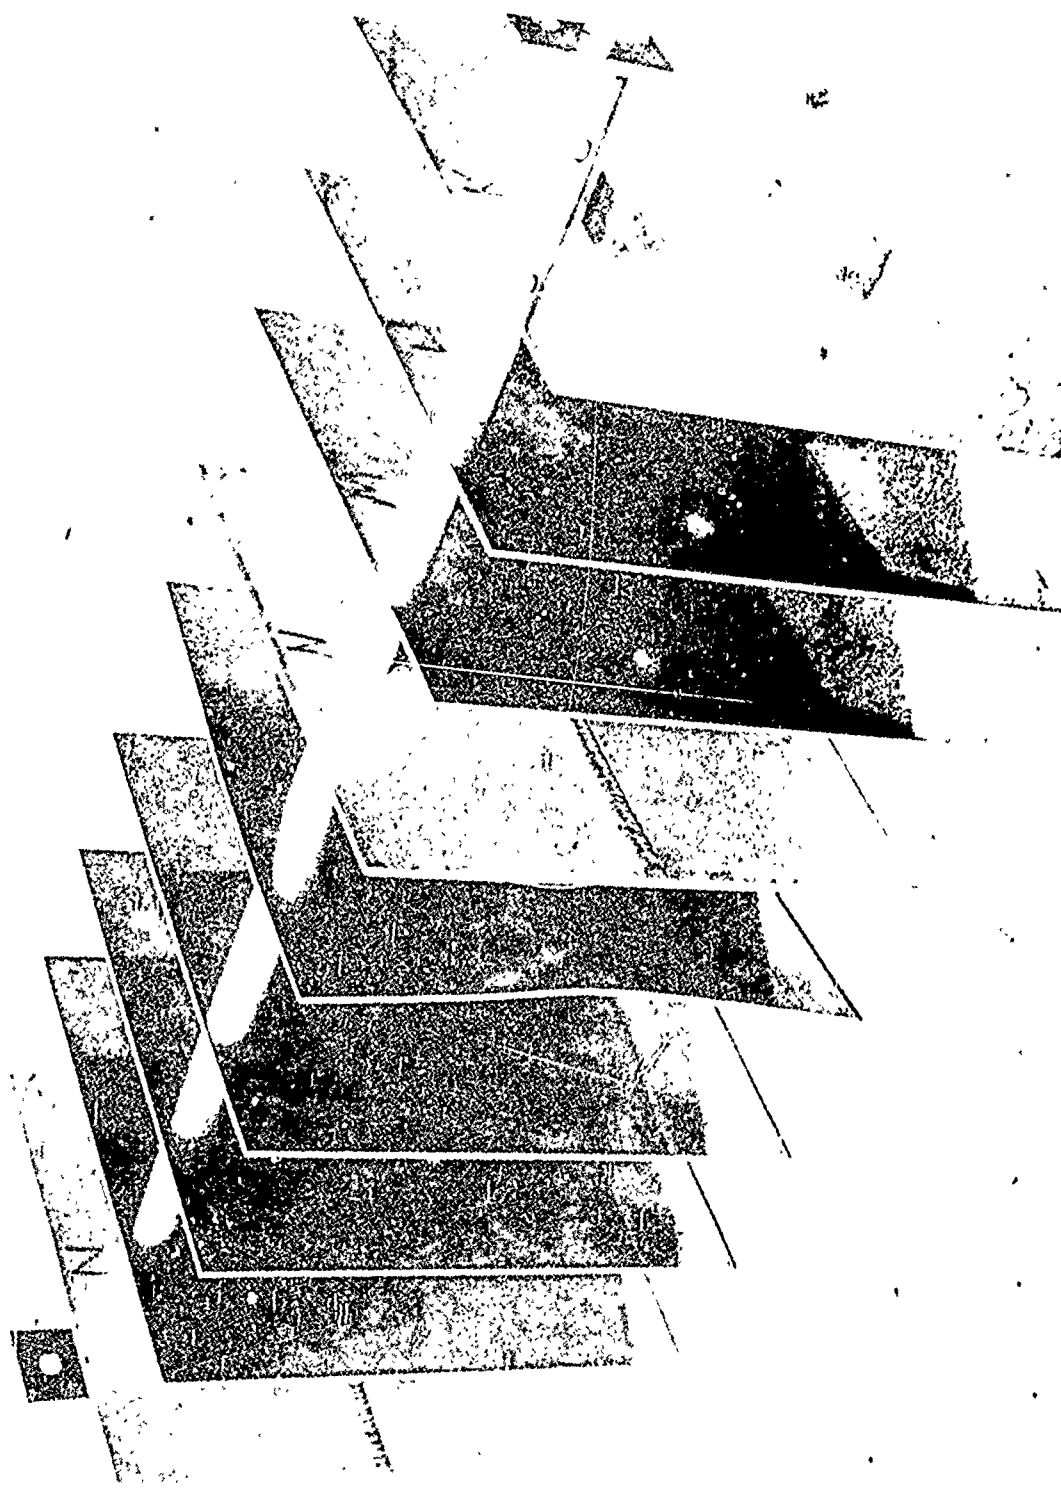
Specimens were mounted on reinforced phenolic rods and spacers with the flat surfaces of the specimens parallel and were exposed in the totally immersed condition. Individual specimens were spaced approximately 4 inches apart. This mounting method provided an intentional crevice and reduced the number of support racks required for the experiment. A typical exposure rack is shown in Fig. 1.

Fig. 1 - Typical exposure rack.

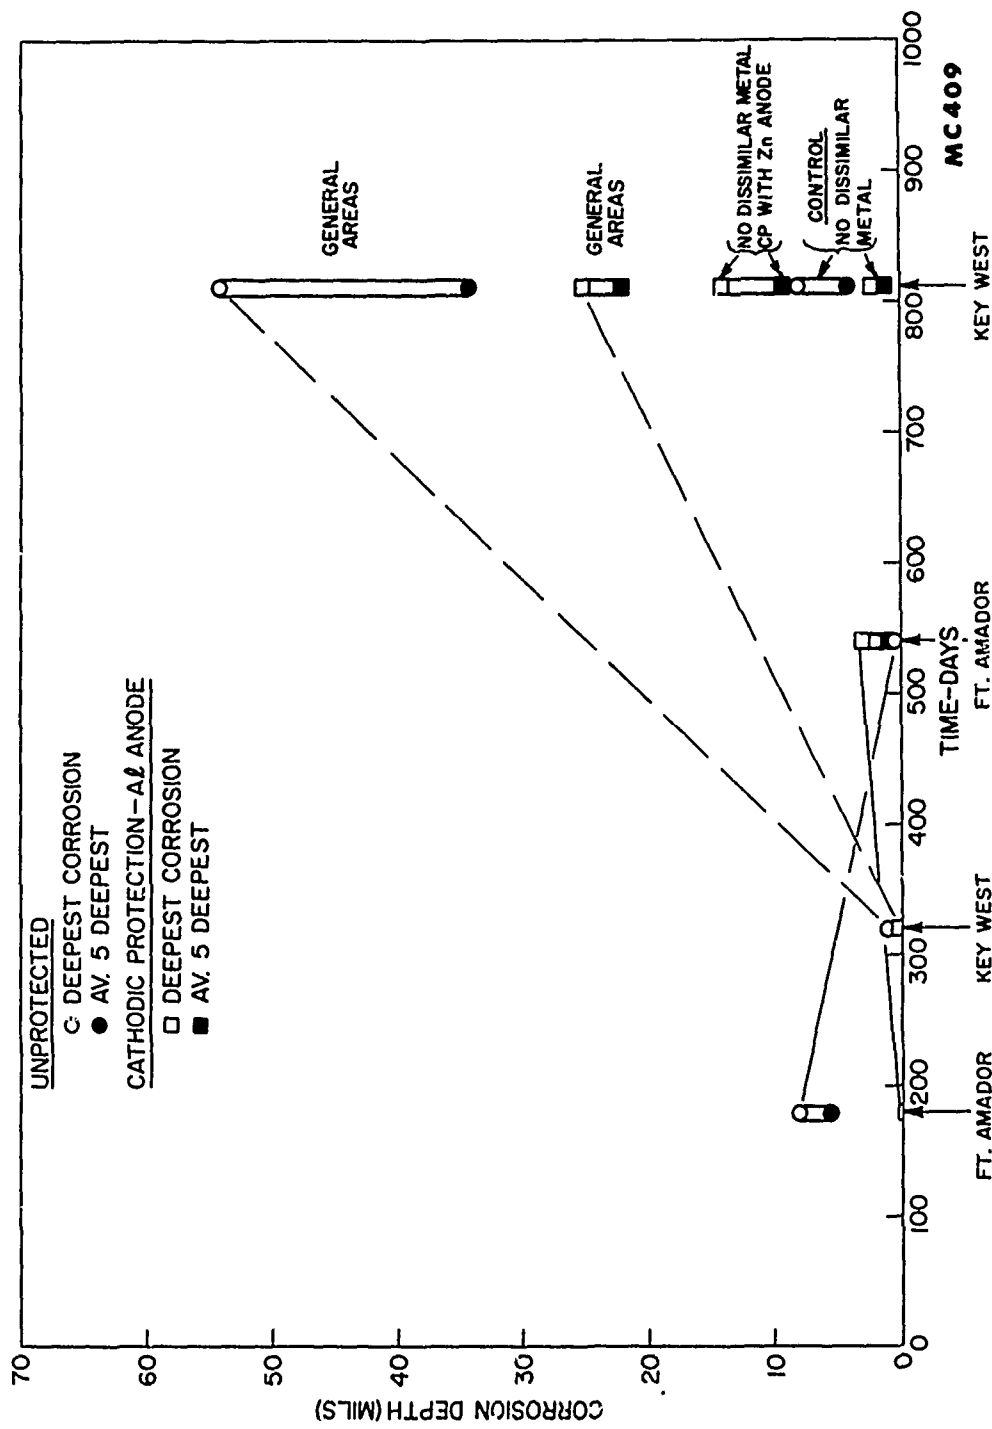
Comparative data showing the depth of corrosion on 5086-H32 aluminum and the effectiveness of cathodic protection in counteracting the detrimental effects of the dissimilar metals are shown in Figs. 20 thru 23. These data were obtained for two time periods from exposures at Key West, and two time periods from exposures at Ft. Amador, Canal Zone. The depth of corrosion on unprotected specimens was generally greater at Key West than at Ft. Amador. This was evident except when copper nickel was the dissimilar metal and the exposure time at Key West was relatively short.

The Ft. Amador experiments did not indicate an increase of corrosion depth with time. The 540 days Ft. Amador data and the 319 days Key West data also indicated that cathodic protection from an aluminum anode was completely effective in preventing corrosion caused by the dissimilar metals. The longer term (809 days) Key West data indicated, however, that a prolonged incubation period existed before the detrimental effects of the dissimilar metals copper nickel, 10% and 304 stainless steel became evident (Figs. 20 and 22). The longer term Key West data also showed that cathodic protection was not completely effective in counteracting the detrimental effects on the aluminum caused by any of the dissimilar metals studied.

Fig. 20 - 5086-H32 aluminum coupled to copper nickel, 10%; with and without cathodic protection (CP). Data from various exposure times in seawater at Key West, Florida and Ft. Amador, Canal Zone.

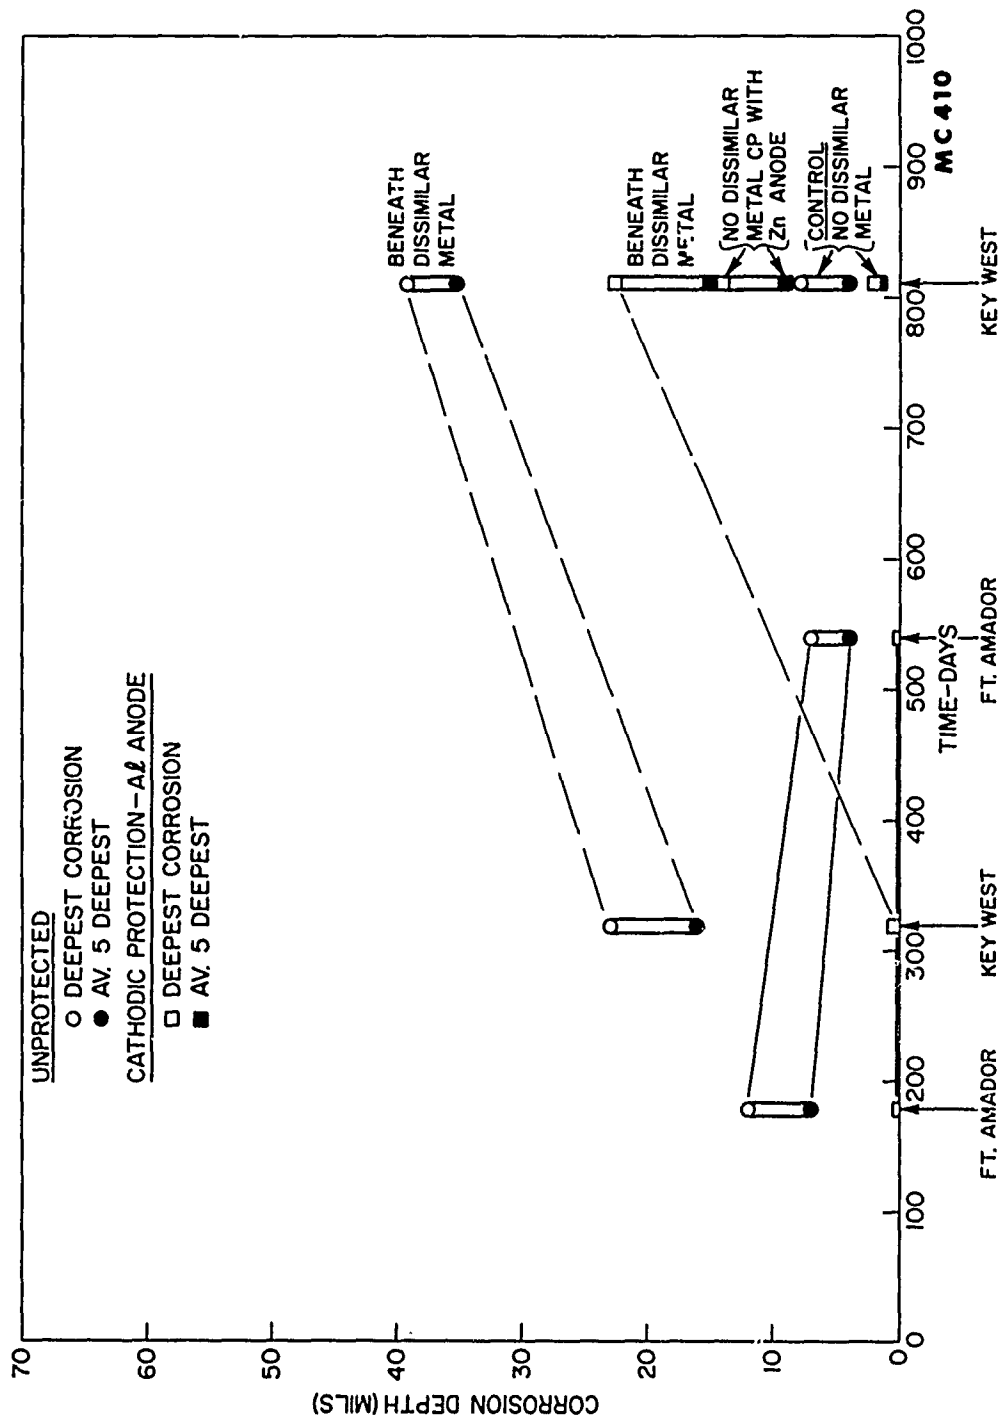
Fig. 21 - 5086-H32 aluminum coupled to yellow brass; with and without cathodic protection (CP). Data from various exposure times in seawater at Key West, Florida and Ft Amador, Canal Zone.

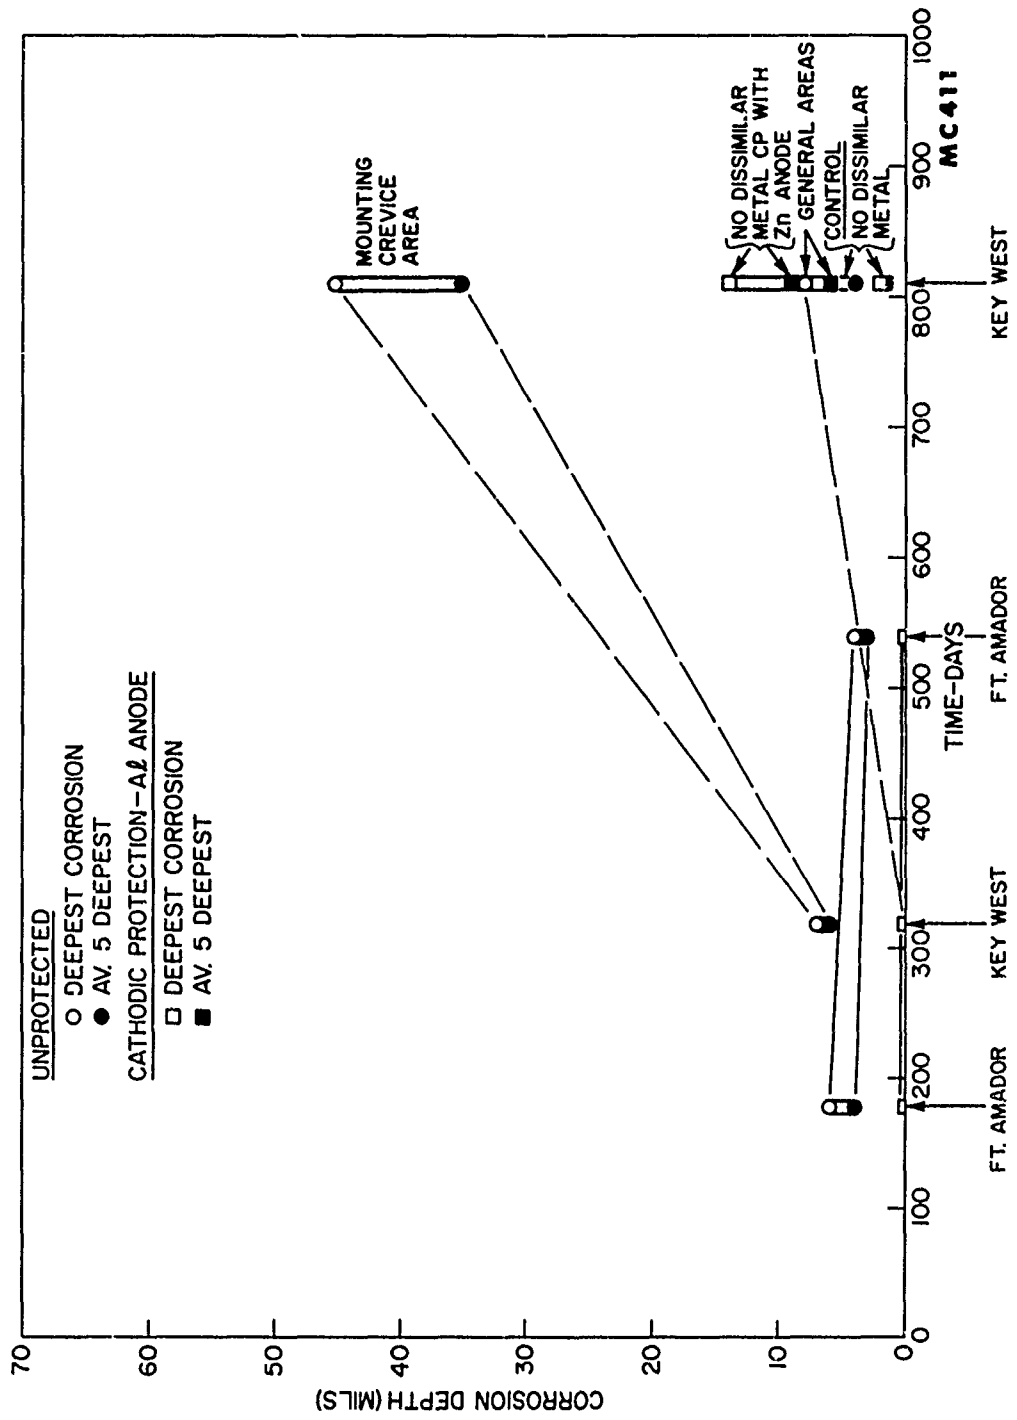
Fig. 22 - 5086-H32 aluminum coupled to 304 stainless steel; with and without cathodic protection (CP). Data from various exposure times in seawater at Key West, Florida and Ft. Amador, Canal Zone.

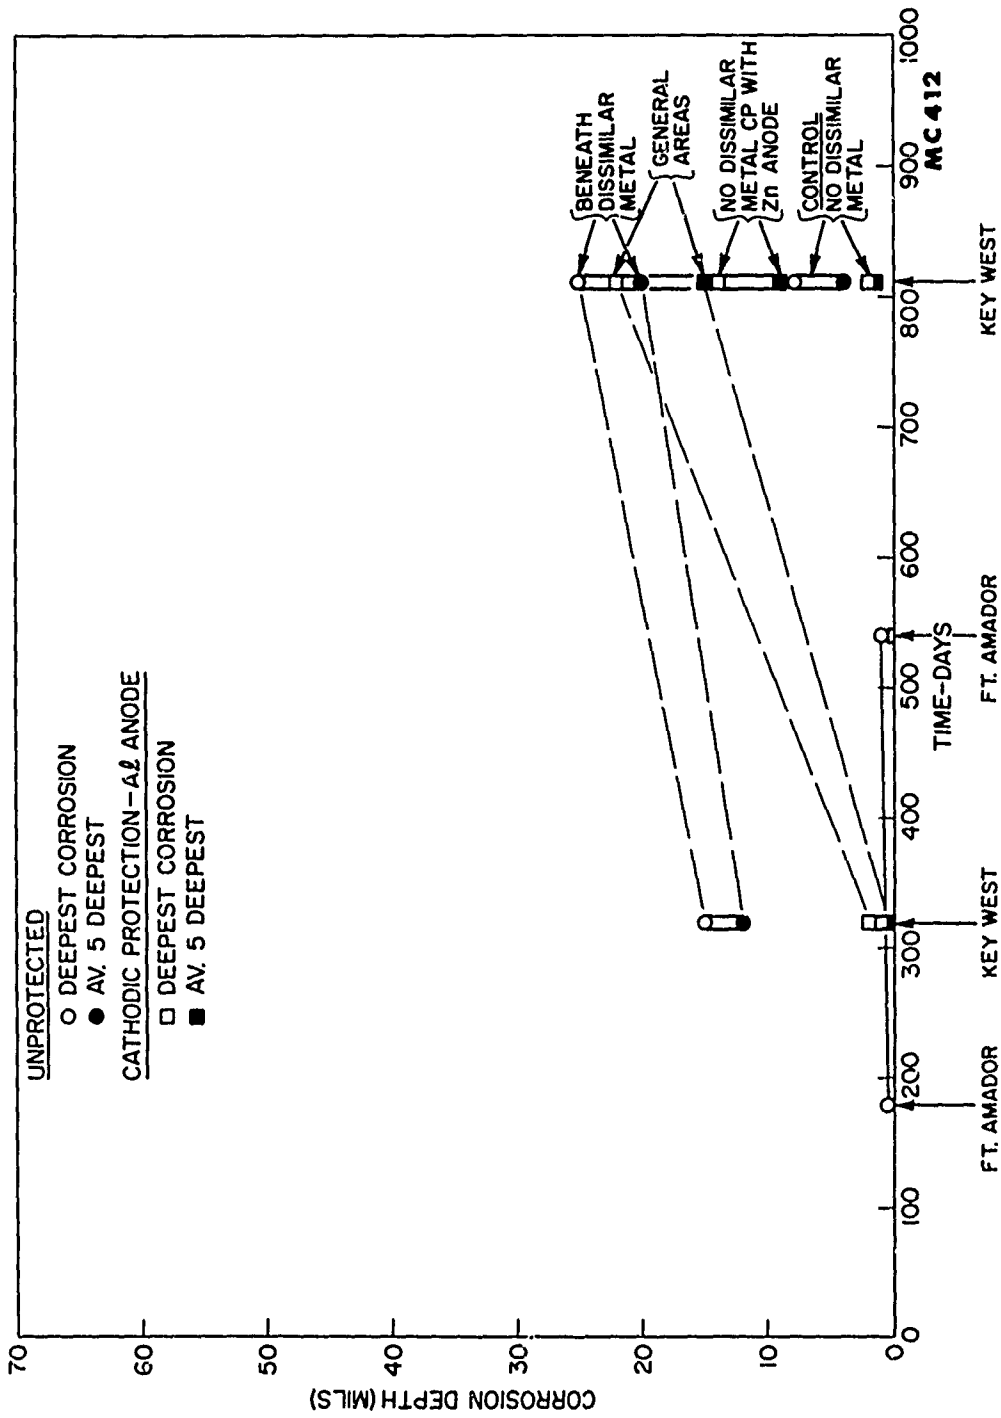
Fig. 23 - 5086-H32 aluminum coupled to mild steel; with and without cathodic protection (CP). Data from various exposure times in seawater at Key West, Florida and Ft. Amador, Canal Zone.

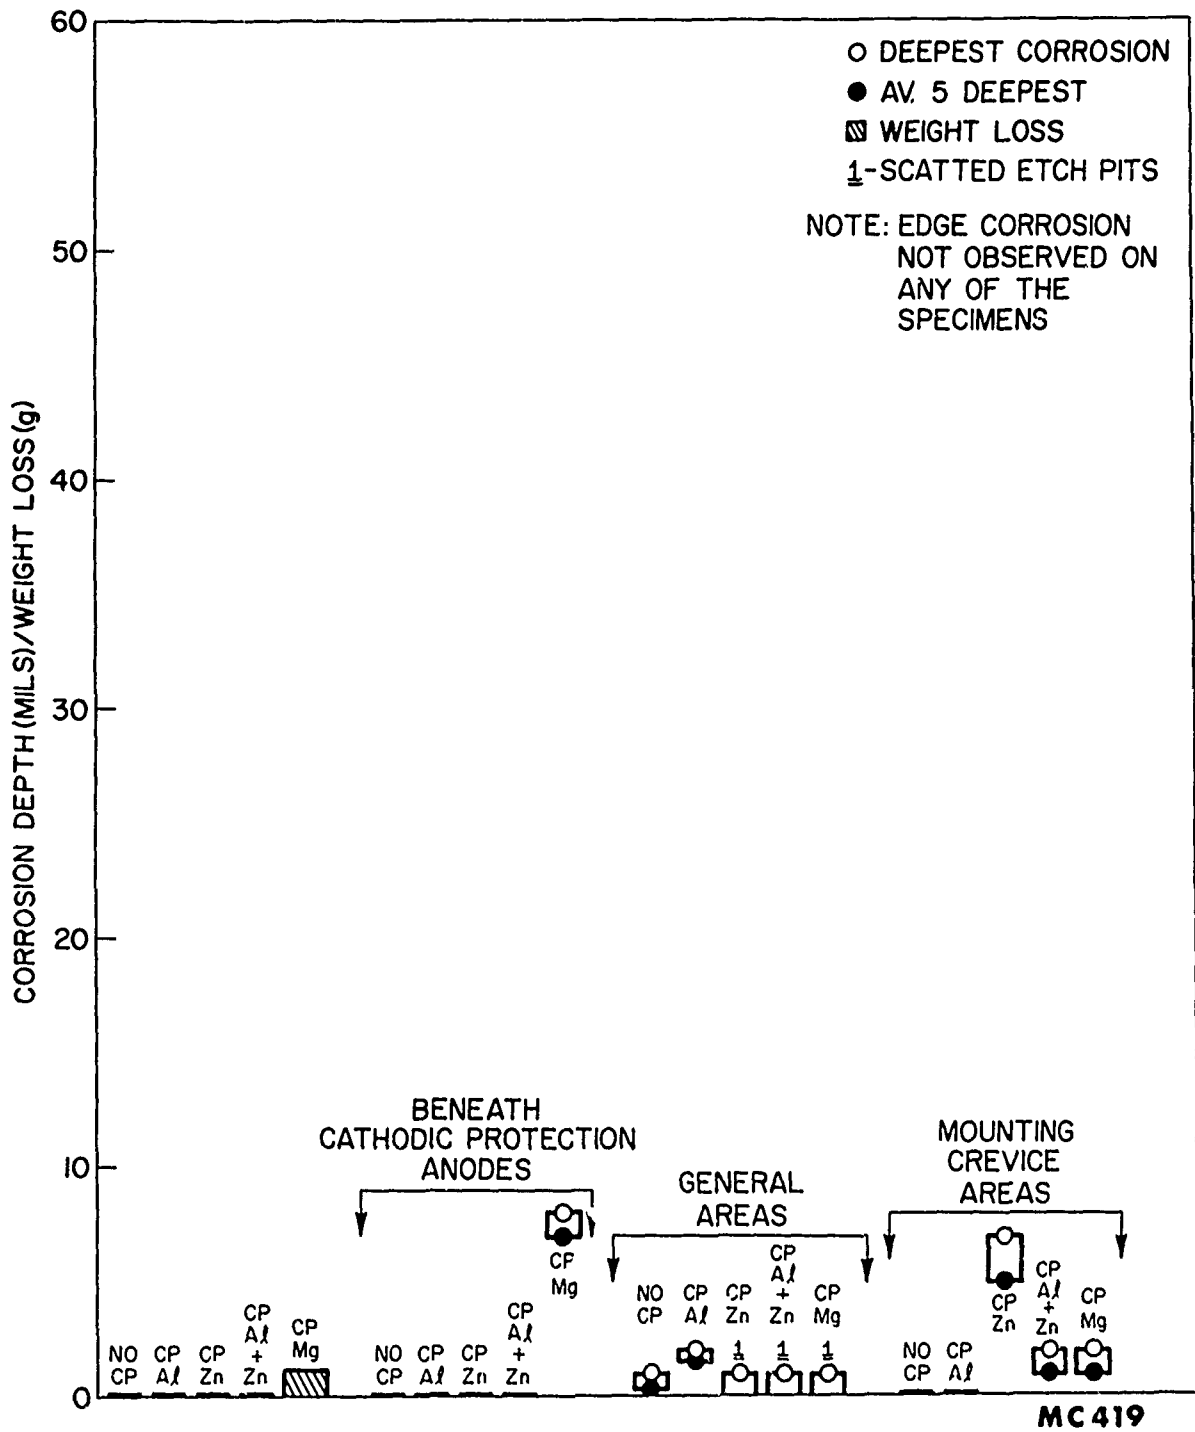
Figure 41 shows the area on 5086-H32 aluminum beneath a magnesium anode used for cathodic protection in the Potomac River. This photograph and the data in Fig. 30 indicate that the magnesium anode caused some corrosion on the 5086-H32 aluminum, but it was much less severe than the accelerated corrosion observed in seawater (compare Figs. 9 and 30).

Fig. 30 - 5086-H32 aluminum; with and without cathodic protection (CP), 675 days in the Potomac River.

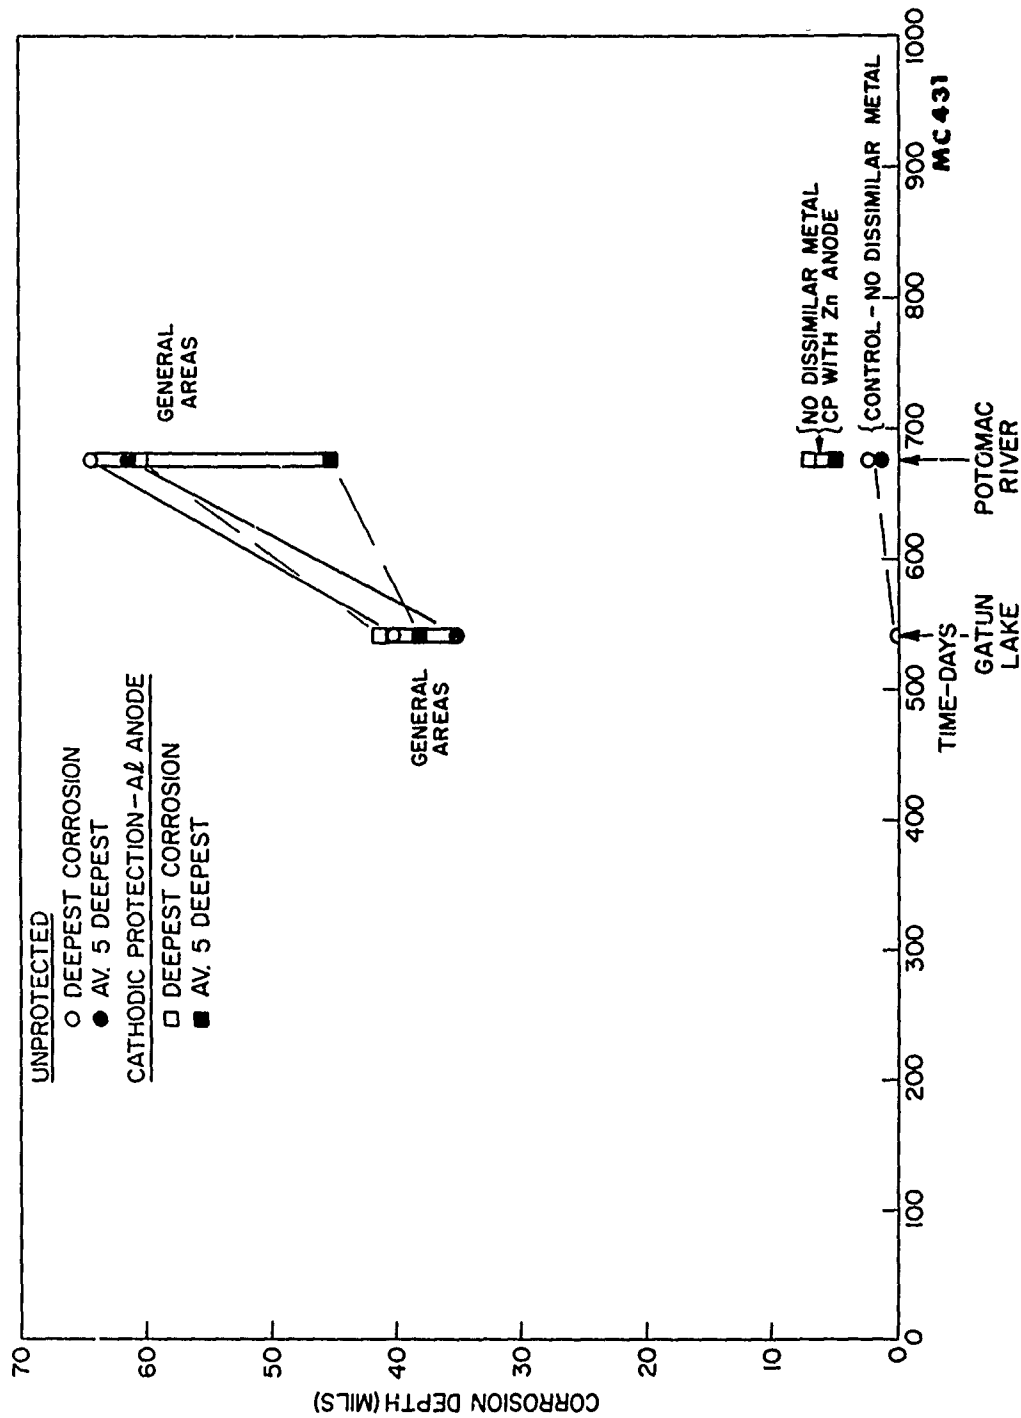
Figures 42 through 45 compare the depth of corrosion after 540 days in Gatun Lake, Canal Zone and after 675 days in the Potomac River. The depth of corrosion data from specimens at these two locations indicate the severe detrimental effects caused by the copper nickel, 10%; yellow brass; and 304 stainless steel at both sites, and the ineffectiveness of cathodic protection from an aluminum anode in counteracting this corrosion, Figs. 42 thru 44. The detrimental effect of the mild steel couple was not significantly reduced by cathodic protection in the Gatun Lake although cathodic protection was effective in the Potomac River, Fig. 45.

Fig. 42 - 5086-H32 aluminum coupled to copper nickel, 10%; with and without cathodic protection (CP). Data from Gatun Lake and the Potomac River exposures.

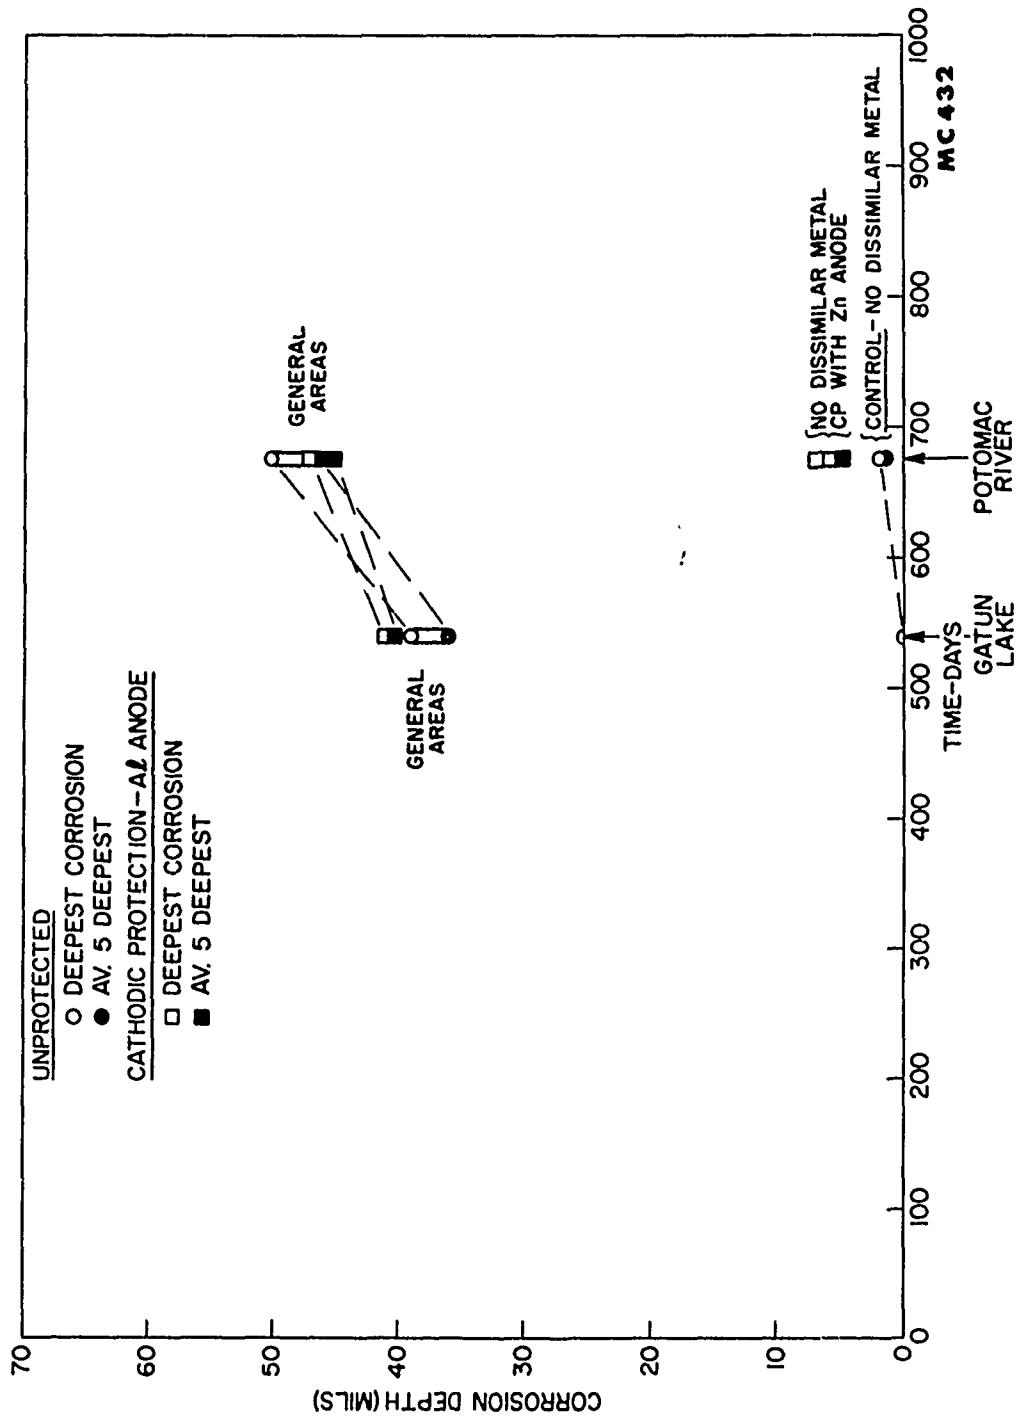
Fig. 43 - 5086-H32 aluminum coupled to yellow brass; with and without cathodic protection (CP). Data from Gatun Lake and the Potomac River exposures.

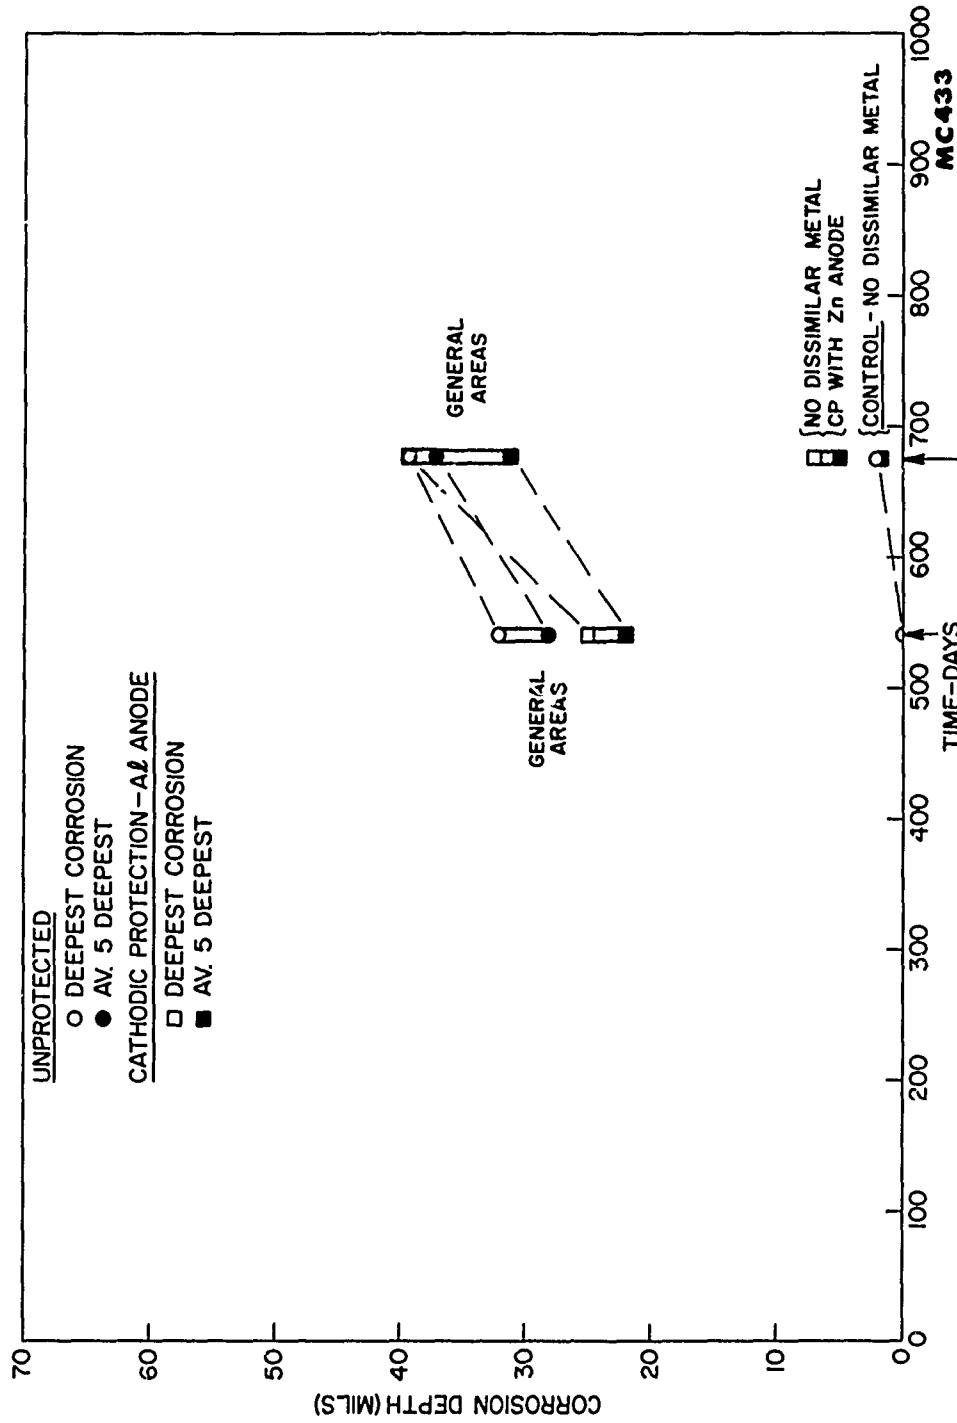
Fig. 44 - 5086-H32 aluminum coupled to 304 stainless steel; with and without cathodic protection (CP). Data from Gatun Lake and the Potomac River exposures.

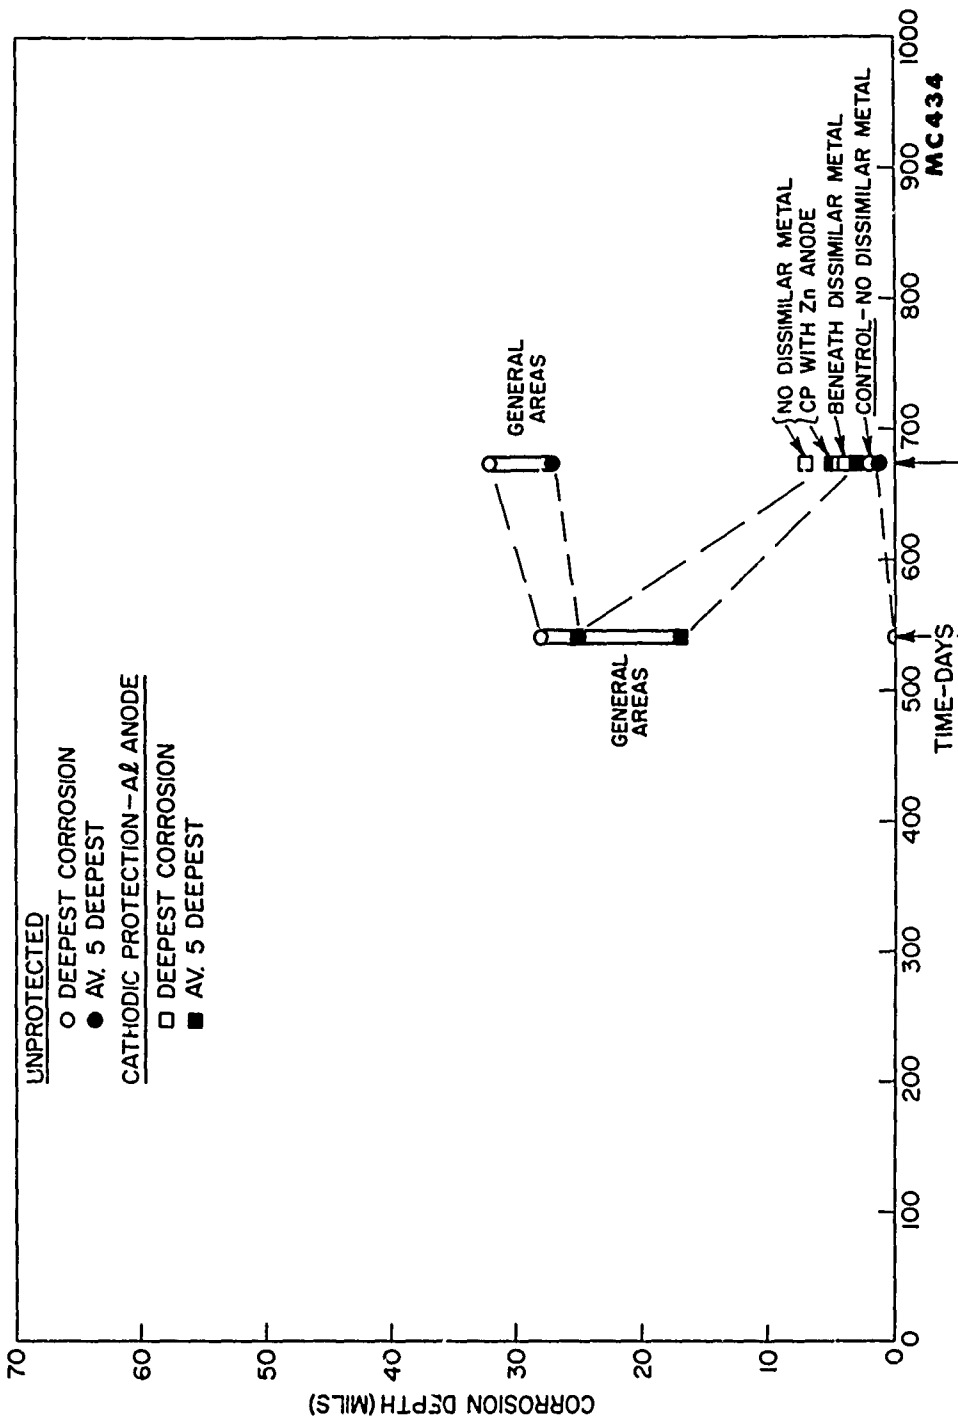
Fig. 45 - 5086-H32 aluminum coupled to mild steel; with and without cathodic protection (CP). Data from Gatun Lake and the Potomac River exposures.

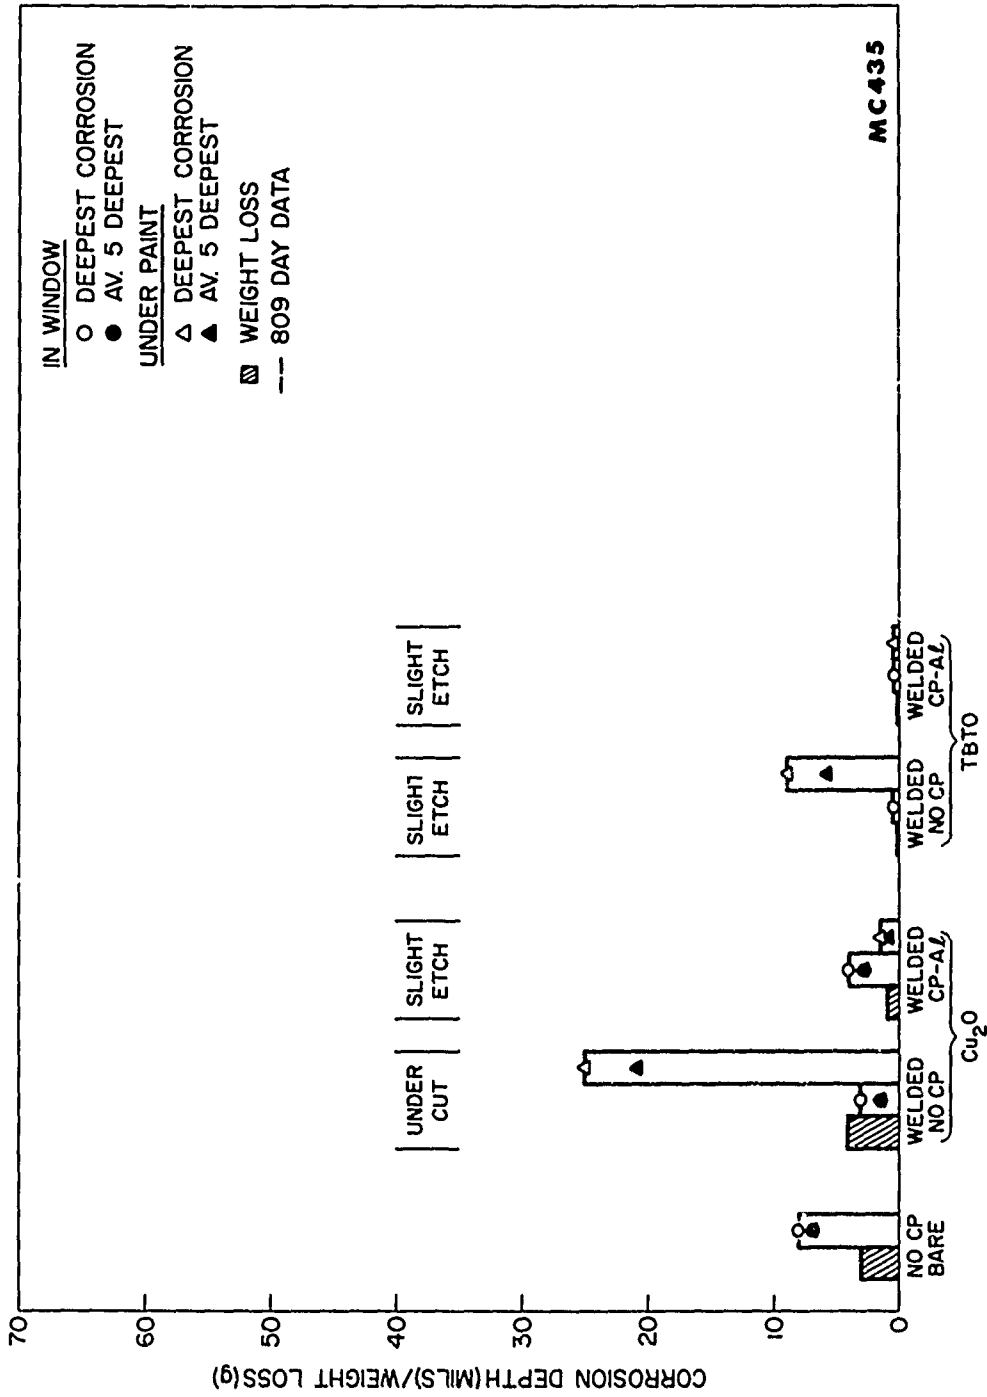
The depth of corrosion and response to cathodic protection at the intentionally bared areas and under the paint on the welded 5086-H32 aluminum specimens exposed for 1264 days in quiescent seawater at Key West are shown in Fig. 46. These data and the photographs in Fig. 47 show that the Cu_2O antifouling coating caused accelerated corrosion of the aluminum even with the vinyl anticorrosive barrier coating between the metal and the antifouling coating. Figs. 46 and 47 also indicate that cathodic protection from the aluminum anode was effective in preventing the detrimental effects of the Cu_2O antifouling coating. The data (Fig. 46) also show that the TBTO antifouling coating was not detrimental to the 5086-H32 welded aluminum and that cathodic protection was completely effective in preventing any corrosion of the aluminum when TBTO was the toxicant in the antifouling paint. Figure 48 shows the welded specimens coated with TBTO, with and without cathodic protection, and the one area on the unprotected specimen which showed some corrosion.

Fig. 46 - Welded 5086-H32 aluminum coated with the Standard Navy Vinyl Anticorrosive Barrier and Cu_2O or TBTO Antifouling Toxicants; with and without cathodic protection (CP), 1264 days in seawater at Key West, Florida.

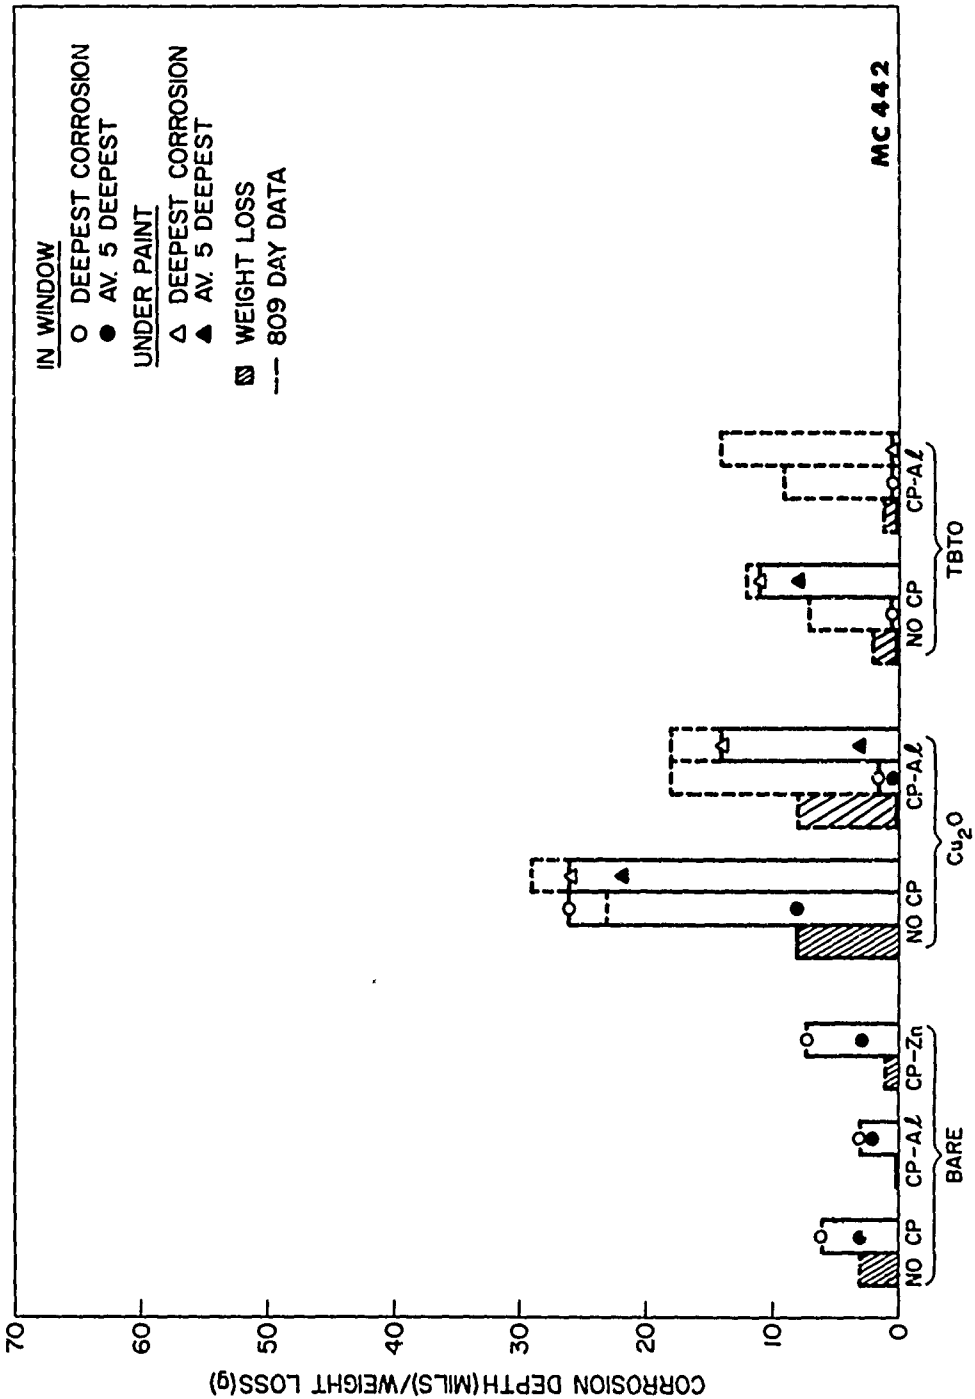
The accelerated corrosion caused by the Cu_2O in the antifouling paint on unwelded 5086-H32 aluminum and the effectiveness of cathodic protection in preventing this corrosion are shown in Figs. 49 and 50. Cathodic protection reduced the corrosion on the specimen coated with the Cu_2O antifouling paint but the least corrosion was observed on the cathodically protected specimen with the TBTO as the toxicant. (Figs. 49 and 51.)

The depth of corrosion data after 809 days exposure in quiescent seawater at Key West have also been included in Fig. 49. The 809 day data would appear to indicate that cathodic protection was less effective in reducing the corrosion caused by the Cu_2O and that TBTO antifouling paint

Fig. 49 - 5086-H32 aluminum coated with the Standard Navy Vinyl Anticorrosive Barrier and Cu₂O or TBTO Antifouling Toxicants; with and without cathodic protection (CP), 1264 in seawater at Key West, Florida.

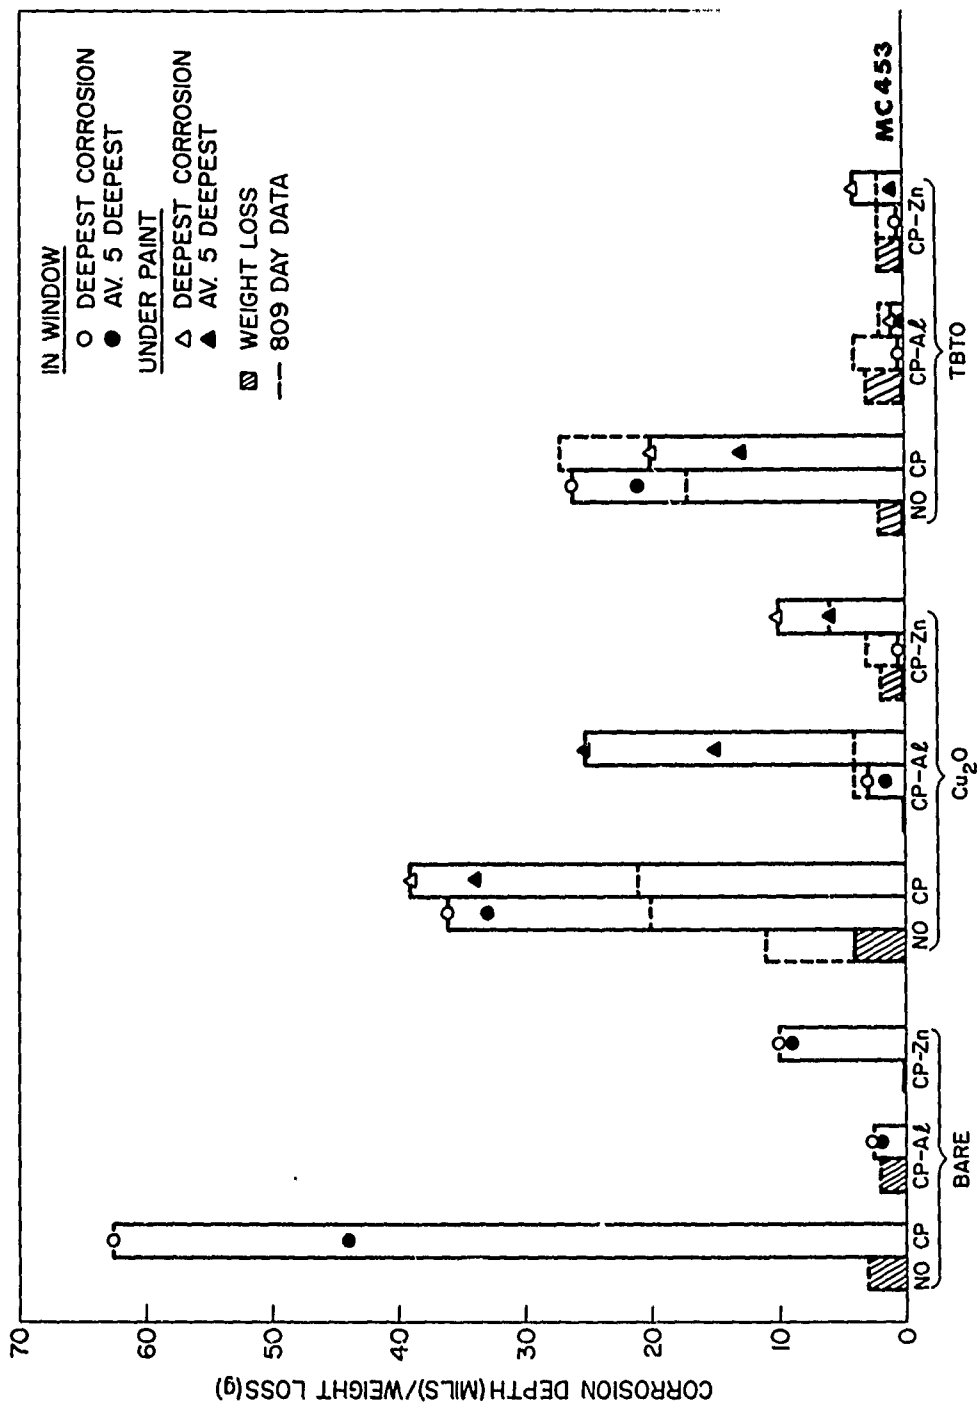
Fig. 57 - 6061-T6 aluminum coated with the Standard Navy Vinyl Anticorrosive Barrier and Cu₂O or TBTO Antifouling Toxicants; with and without cathodic protection (CP), 1264 days in seawater at Key West, Florida.

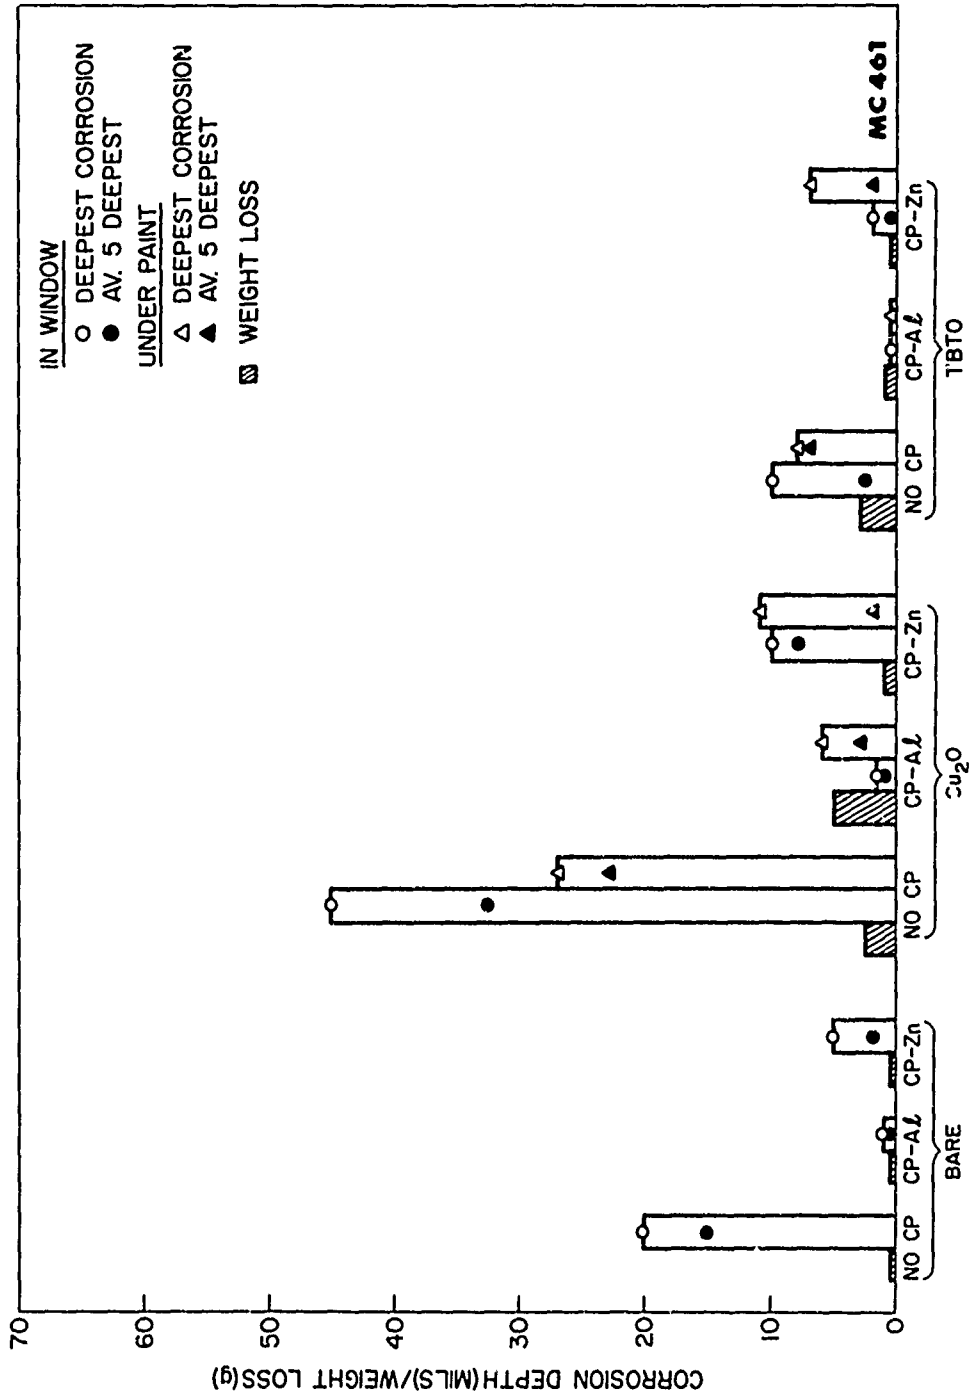
Fig. 60 - 6061T6 aluminum coated with the Standard Navy Vinyl Anticorrosive Barrier and Cu₂O or TBTO Antifouling Toxicants; with and without cathodic protection (CP), 675 days in the Potomac River.
