IMPROVEMENT OF
TITANIUM ALLOY INGOT CONSOLIDATION

F.W. Wood
and
R.L. Carpenter
U.S. Bureau of Mines
Albany Metallurgy Research Center

Technical Report AFML-TR-72-46

May 1972

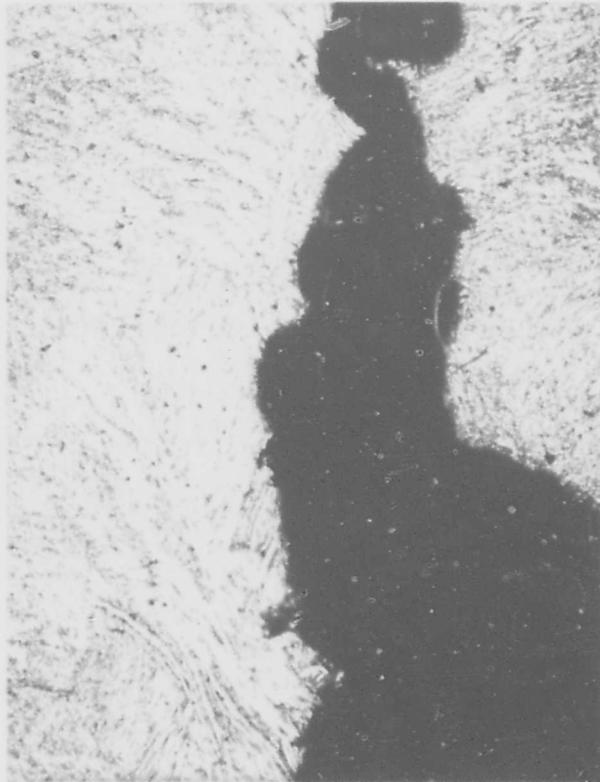
Melting of buttons by electron bombardment may have been more successful, but the results were really inconclusive. Three 60 to 70-gram buttons of Ti-6Al-4V alloy were melted with implanted nitride seeds, but without in-process metal feed. Each button was melted on one side, turned and melted on the other side. The melting times were 10 minutes (5 min per side), 20 minutes (10 min per side), and 30 minutes (15 min per side). After some futile attempts to find residual nitride inclusions by random cutting, remaining material was rolled at 850°C to 40-mil sheet. It was expected that any nitride inclusions of significant size would cause bumps or cracks on the surfaces. Indeed, some flaws were found on the surfaces, especially on the sheet from buttons melted 10 and 20 minutes. Metal containing the defects was cut out and metallographically prepared. The specimens were examined optically and by electron microprobe. Optically, each specimen appeared to include some hard material. In general, the flaw size decreased for the longer melting times. In addition, it was only in the metal melted for 10 minutes that flaws had a reaction zone associated with them. An example is shown in Figure 1. With the microprobe, X-ray analysis indicated that a Ti-Al-V oxide was associated with all flaws, and only one specimen, from metal melted 10 minutes, contained some material with high nitrogen content (near 7%).

It is likely that the oxides were formed during hot rolling as the surface flaws opened up. However, the question of what happened to the nitride seeds is still unanswered. It is possible that small nitride inclusions caused the surface defects, but that the nitrides themselves were either lost or oxidized during the rolling. Even so, the size and number of the flaws indicates that most of the added nitride was either decomposed or dissolved. But this result is strictly conjecture, and

FIGURE 1. - Micrograph (originally 150X) of
inclusion EB-1

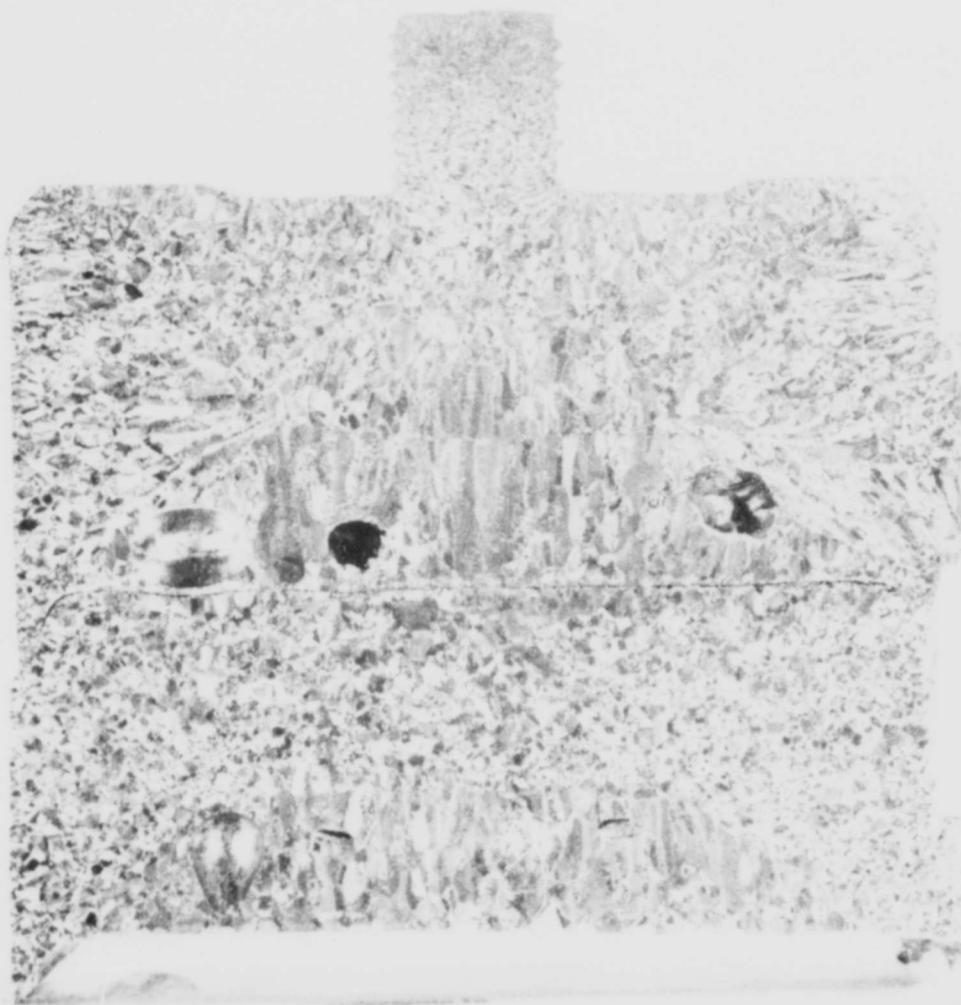
When the casting shown in Fig. 4 was cut up, no inclusions were discovered. However, several Type I and II defects were found in the associated sprue, mainly at the bottom of the upper trap section. With this reassurance, the side-gated skull casting process was retained in completing the rest of the program.

FIGURE 4. - Cross section of a skull-cast ingot
with gates and sprue removed

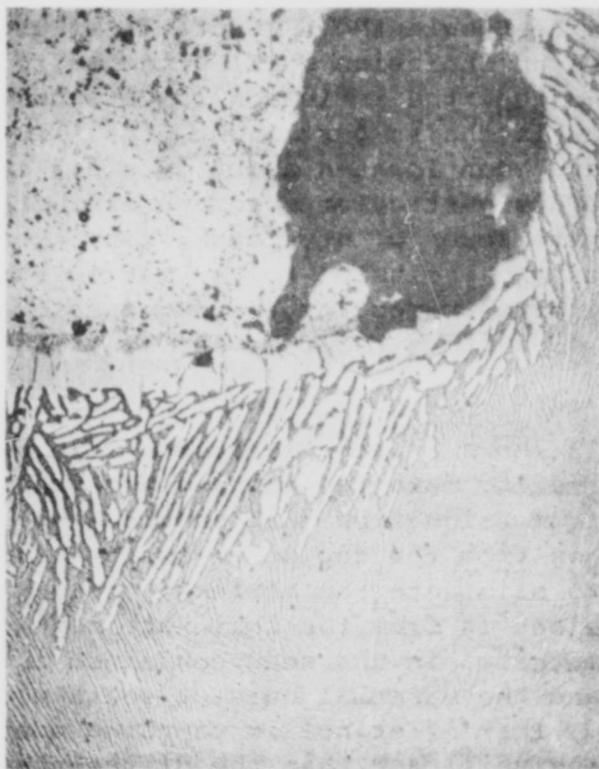
FIGURE 11. - Micrograph (originally 100X) of specimen R12,
mount F992, from plate SA 26,975-BB

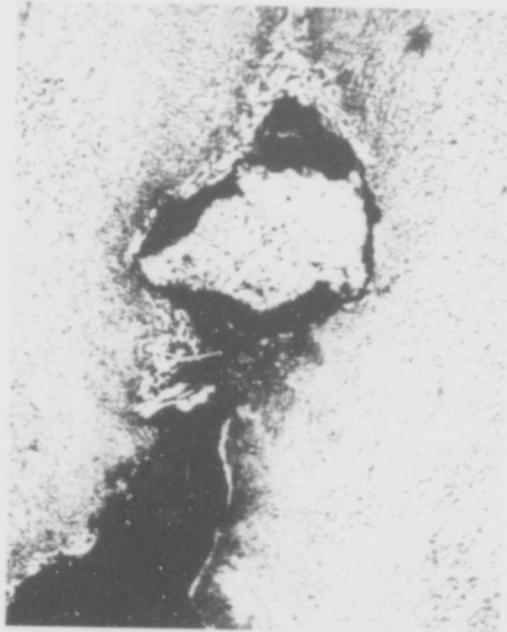
FIGURE 13. - Micrograph (originally 50X) of specimen R11,
mount F991, from plate SA 26,975-BB

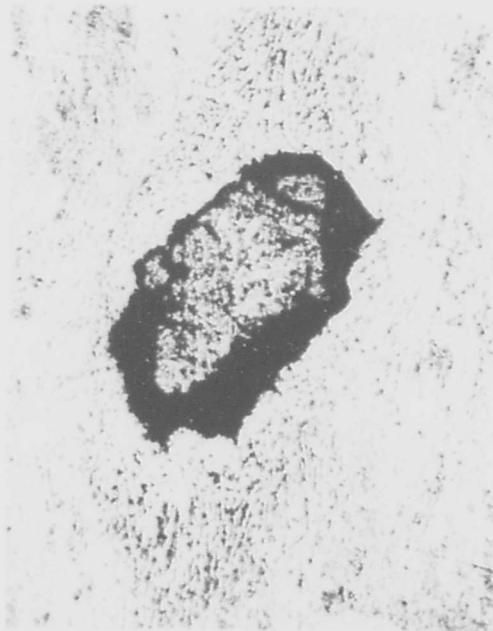
Figure 12 shows a large inclusion with a seam or vein of contrasting material running through it. The specimen is from a location that should have been about 1 to 1.5 inches from the top of an as-cast ingot that was not cropped to eliminate the shrinkage region. In other words, the defect is from the shrinkage region of the ingot. The material in the seam contained about 12% N and 1.8% V, and the material outside contained about 16% N and 0.5% V. The difference in vanadium content is probably more significant than the difference of nitrogen content. Another inclusion with a contrasting seam through it is shown in Figure 13. Apparently, this structural feature is not uncommon. Neither is the occurrence restricted to a particular part of an ingot. This example was formed about 4 to 4.5 inches from the ingot bottom. Figure 14 illustrates an acicular structure sometimes exhibited by inclusions instead of the spongier structure

FIGURE 14. - Micrograph (originally 50X) of specimen R25,
mount F1092, from plate SA 26,956-B-TB

already mentioned. It represents a site that should have been about 5.5 to 6 inches from the bottom of the as-cast ingot. Microprobe analysis of this inclusion indicated about 9.5% N, a trace of Al, and no V. The nitrogen content is near the stoichiometry of Ti_3N (8.9% N) that has been identified with the epsilon-phase nitride of titanium (5). However, the epsilon-phase stoichiometry has also been specified as Ti_2N (12.7% N) (4).

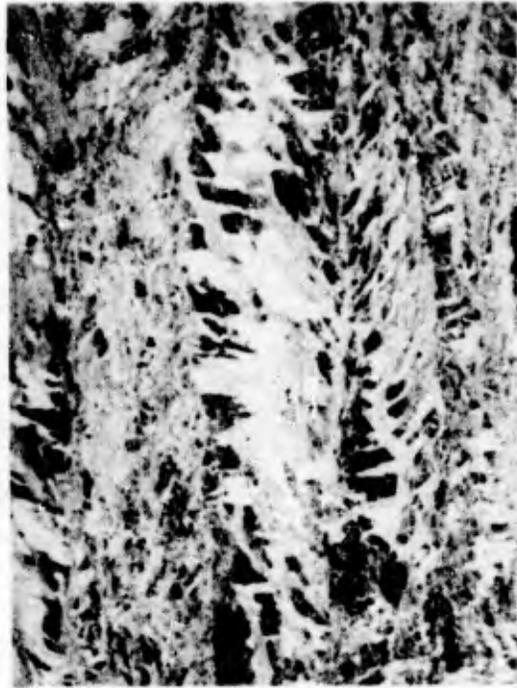
FIGURE 21. - Unusual transverse microstructure (originally 50X), specimen R43, mount G21, from plate SA 27,030-TB

many flaws, only one was found metallographically. The confirmed defect was a nitride inclusion and its position, related back to the as-cast ingot, was about 4 to 4.5 inches from the bottom. Other prominent indications of flaws in the plate from the bottom of the ingot could not be confirmed. The plate SA 27,030 (TB) contained 64 flaws >60 mils according to the ultrasonic inspection. Of these, 7 appeared to be more than an inch long and 2 appeared to be more than 2 inches long. Saw cuts were laid out to intersect each of the two largest flaws plus numerous smaller ones. The closest thing to a flaw that could be found metallographically was the sort of structural anomaly shown in Figure 21. Incidentally, results of destructively examining plate SA 27,172 (TT) from the unseeded ingot were similar. Indicated flaws were not verified, but a few structural oddities, similar in appearance but smaller than the one in Figure 21, were found.

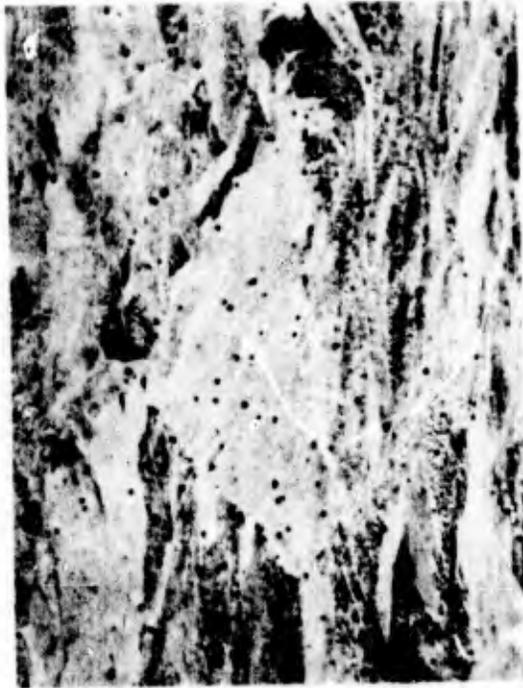
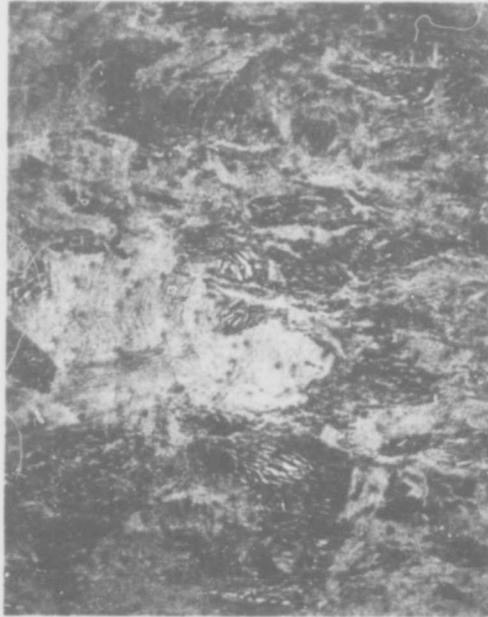
One more kind of information was obtained by preliminary metallography. There were some definite differences in matrix structures, as shown in Figures 33 through 28. The illustrations are arranged roughly in order of increasing prominence of prior beta grains and coarseness of alpha. The differences are most likely due to a relative shifting of the $\beta : (\alpha+\beta)$ transus and the thermal conditions of mechanical conversion. Ingot SA 26,869 is known to have been completely converted in the $\alpha+\beta$ range, so the equiaxed α with transformed β structure (Fig. 22) is explainable in that case. However, for the rest of the ingots, it is uncertain whether thermomechanical conditions were too variable or compositional differences actually shifted the transus.
