CYCLE TESTING OF ACS VALVES IN CLF₅ FINAL REPORT

TECHNICAL REPORT AFRPL-TR-72-82

AUGUST 1972

AIR FORCE ROCKET PROPULSION LABORATORY

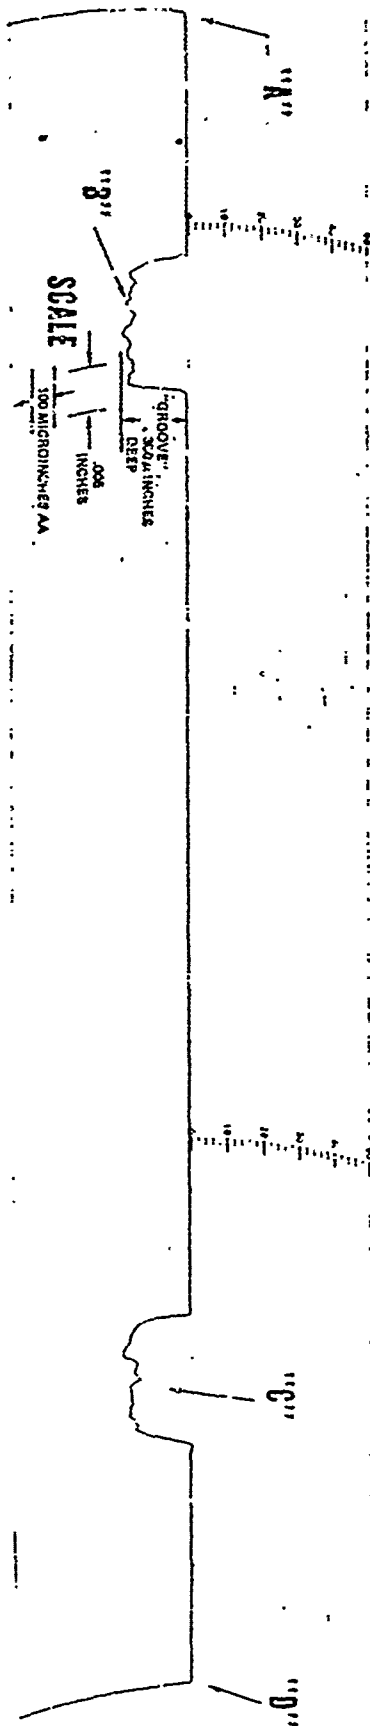
Figure 14. Profile of Trace, K-36 Popper, Point-Target 14.
56 Q

The seat and poppet are shown in Figures 12 and 13, respectively. Figure 14 is a proficorder trace of the poppet sealing surface which clearly shows the 300 μ inch groove that was worn into it.

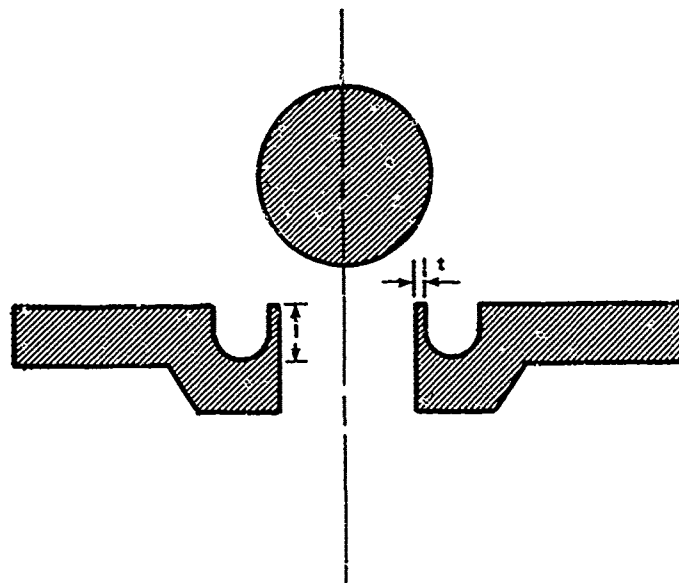
Figure 25. Schematic, Moog Lip-Seal Seat and Poppet
(Approximately 10X)

Continuing the three-way approach taken to solve the ClF_5 ACS valve leakage problem, the second sealing concept investigated was the lip seal. This technique depends upon the scrubbing and flexing action of poppet/seat combinations and not the extremely smooth surfaces necessary in the flat-on-flat specimens. Figure 25 depicts schematically the configuration that was tested in ClF_5 under this program.

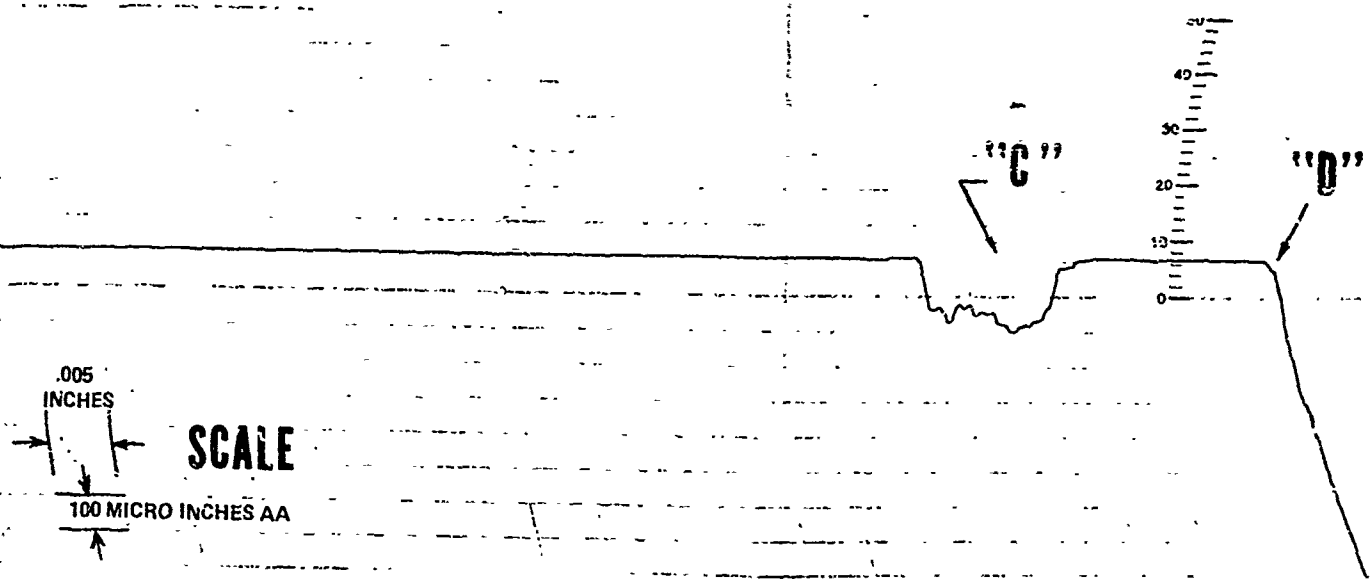
Figure 46. Proficorder Trace, Aluminum on Ni 301 Poppet,
Post ClF₅ Testing

WORN AREA ON POPPET FACE
WHERE SEAT CONTACT IS MADE
