IMPROVED MATERIALS AND MANUFACTURING
METHODS FOR GUN BARRELS. PART I

Army Weapons Command

August 1972

SWERR-TR-72-54

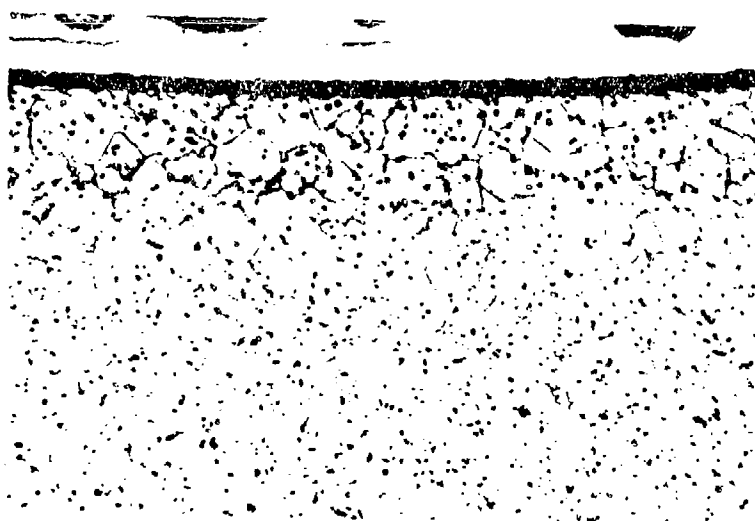
Figures 34 and 35 depict the typical appearance of the bore surface of the 446 alloy inserts after one and five shots in the vented bomb. In these firing sequences one small crack was observed on the bore surface of the five-shot insert.

FIGURE 34 PHOTOMICROGRAPHS SHOWING THE STRUCTURE ALONG
THE BORE SURFACE OF THE 446 ALLOY INSERT AFTER ONE
VENTED BOMB SHOT WITH WC846 PROPELLANT. (10%
SULFURIC ACID ELECTROLYTIC ETCH)

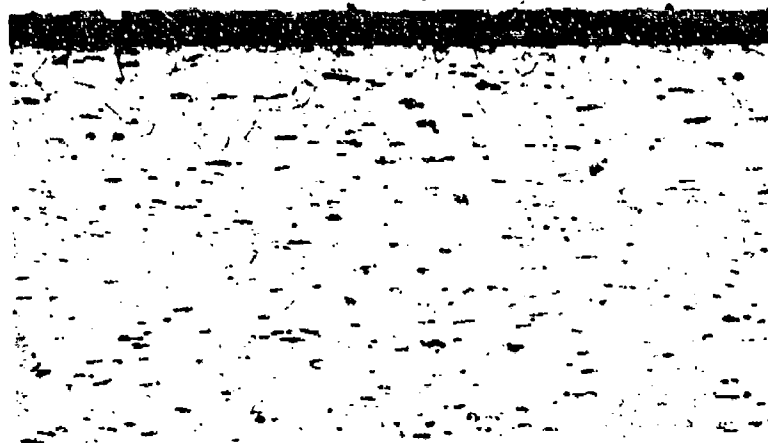
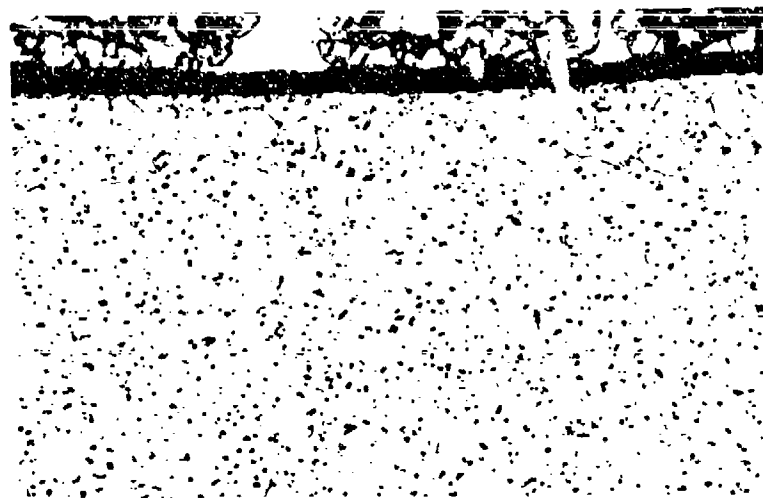
FIGURE 35 PHOTOMICROGRAPHS SHOWING THE STRUCTURE ALONG THE BORE SURFACE OF THE 446 ALLOY INSERT AFTER FIVE VENTED BOMB SHOTS WITH WC846 PROPELLANT. (10% SULFURIC ACID ELECTROLYTIC ETCH)

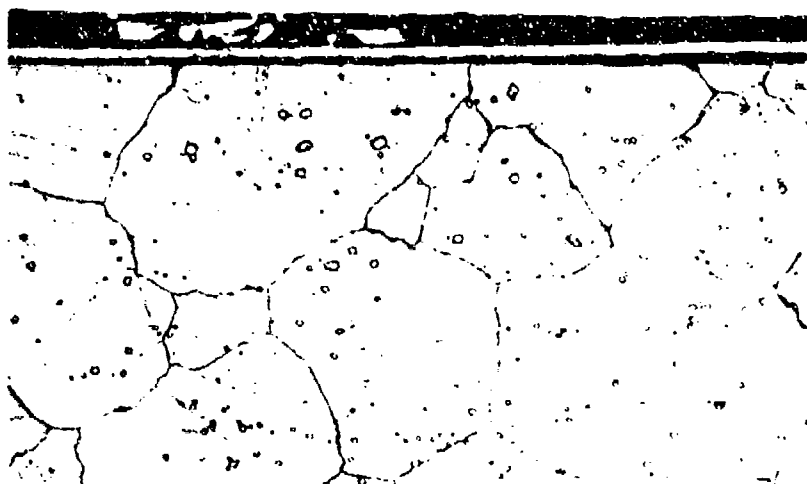
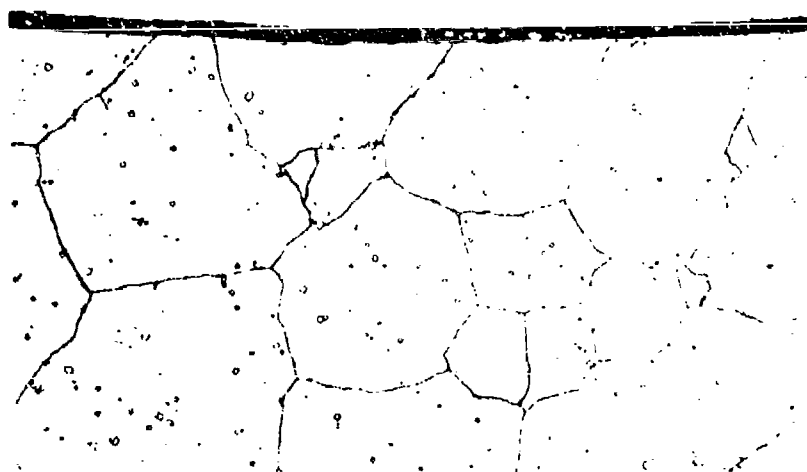
Figures 36 and 37 are typical photomicrographs along the bore surface of the L605 inserts which had received 1 and 5 shots. The surfaces have been nickel plated. Cracking is readily apparent in the insert which received 5 shots.

FIGURE 36 PHOTOMICROGRAPHS SHOWING THE STRUCTURE ALONG THE BORE SURFACE OF AN I605 ALLOY INSERT AFTER ONE VENTED BOMB SHOT WITH WC846 PROPELLANT. (5% CHROMIC OXIDE ELECTROLYTIC ETCH)

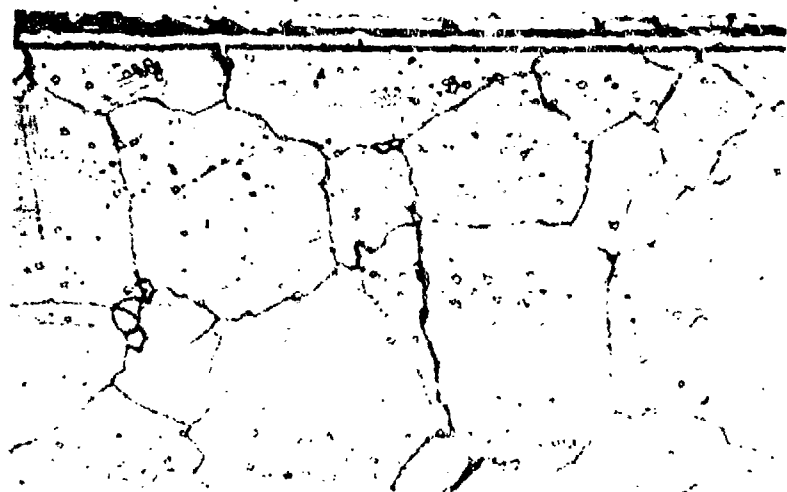
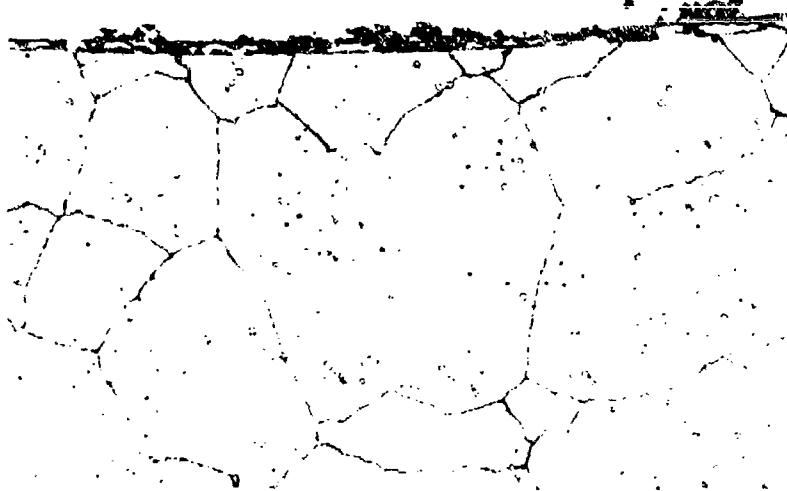
FIGURE 37 PHOTOMICROGRAPHS SHOWING THE STRUCTURE ALONG THE BORE SURFACE OF AN L605 ALLOY INSERT AFTER FIVE VENTED BOMB SHOTS WITH WC846 PROPELLANT. (5% CHROMIC OXIDE ELECTROLYTIC ETCH)

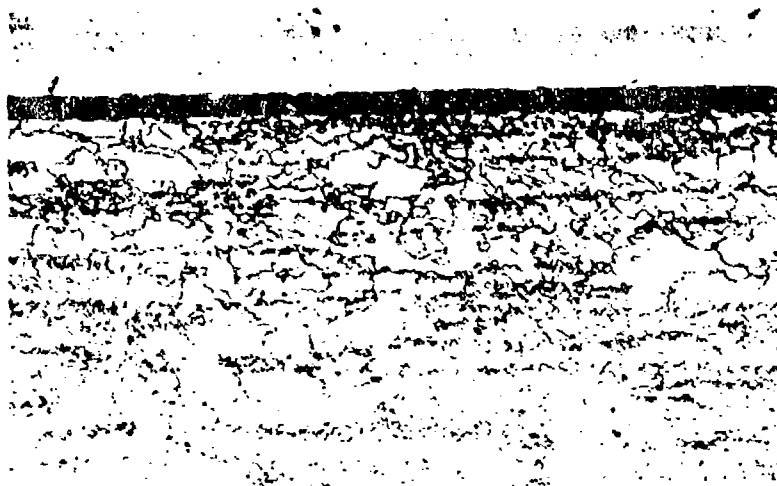
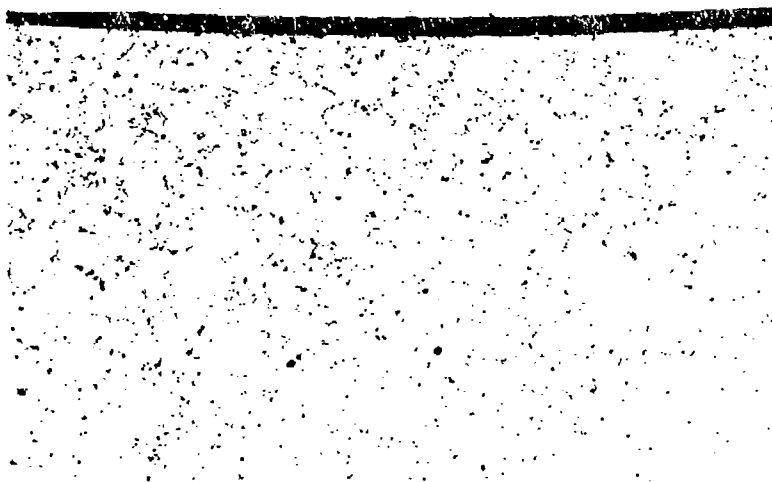
FIGURE 38 PHOTOMICROGRAPHS SHOWING THE STRUCTURE ALONG THE BORE SURFACE OF AN HS-31 ALLOY INSERT AFTER ONE VENTED BOMB SHOT WITH WC846 PROPELLANT. (5% CHROMIC OXIDE ELECTROLYTIC ETCH)

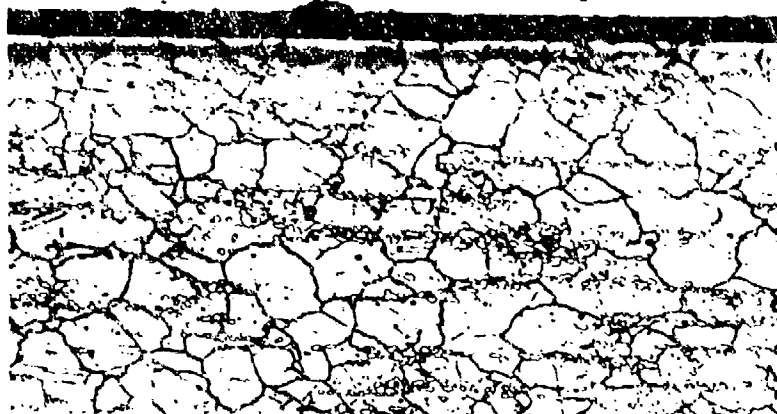
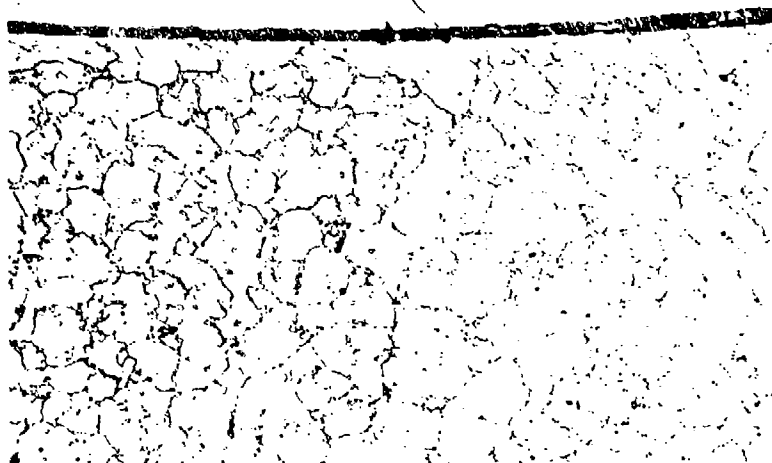
FIGURE 39 PHOTOMICROGRAPHS SHOWING THE STRUCTURE ALONG THE BORE SURFACE OF AN HS-31 ALLOY INSERT AFTER FIVE VENTED BOMB SHOTS WITH WC846 PROPELLANT. (5% CHROMIC OXIDE ELECTROLYTIC ETCH)

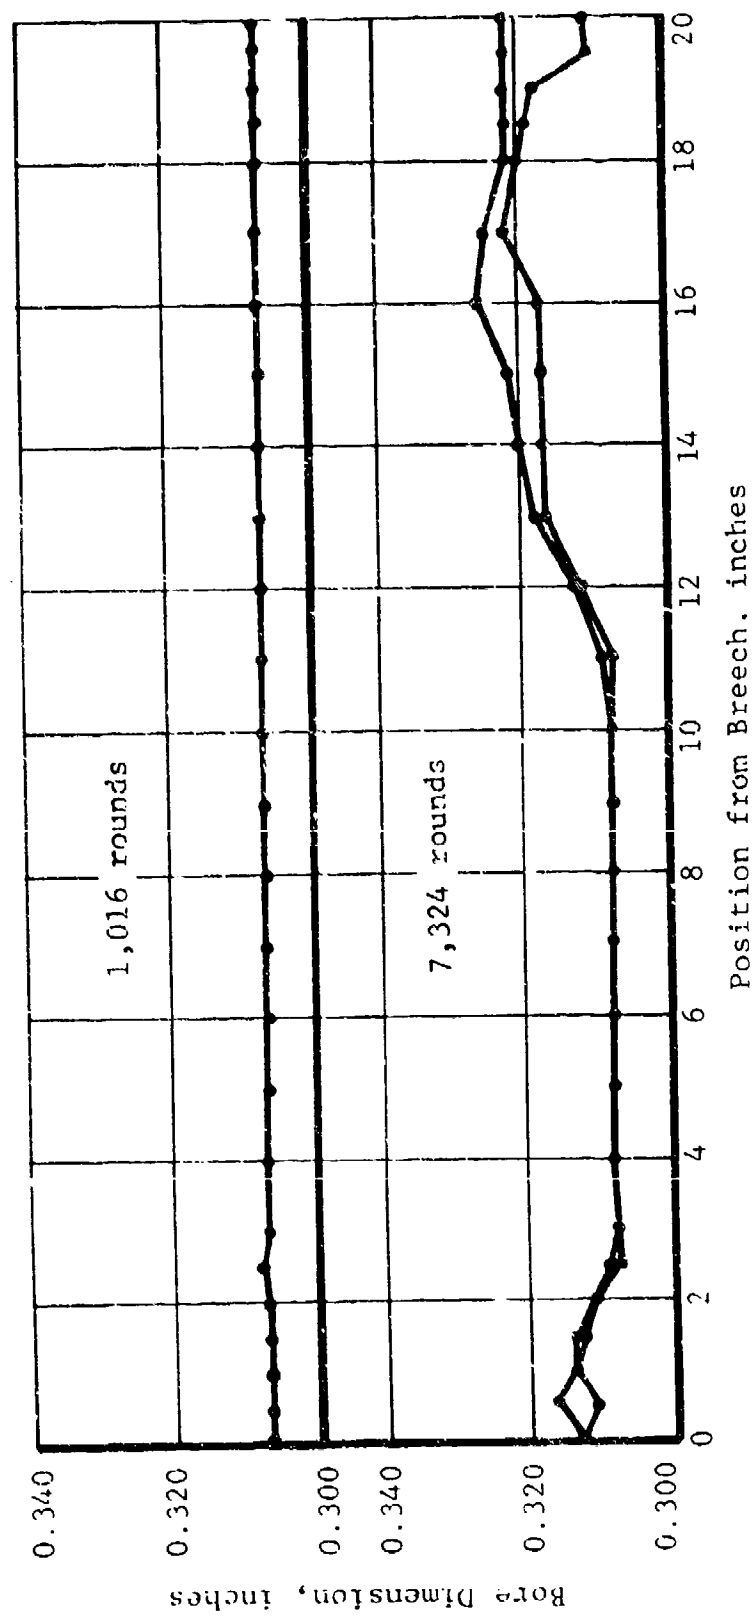
According to these graphs, with chrome-plated H11 barrels and the standard gun barrels, when failure occurs severe erosion is present in the barrel just forward of the breech area. With the CG-27 chrome-plated barrels, when failure occurs severe erosion is present in the muzzle area of the barrel. Another representation of these data is shown in Figure 48. Here, the maximum bore diameter--regardless of position--is plotted as a function of number of rounds fired. Since two bore measurements were made at each position at 90° intervals, two data points for each measurement are shown.

FIGURE 43 BORE PROFILE FOR CG-27 MATERIAL FOR VARIOUS NUMBERS OF TOTAL ROUNDS FIRED.

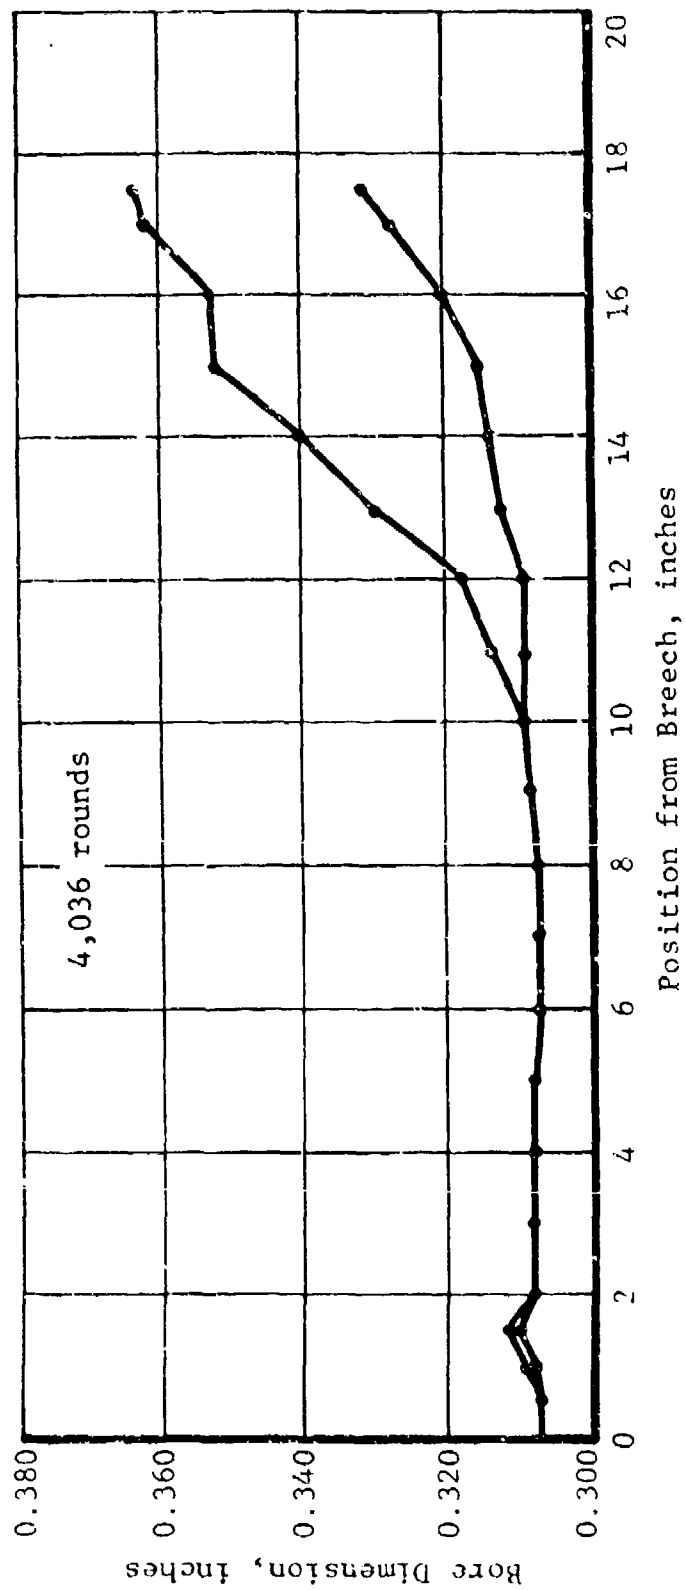
FIGURE 44 BORE PROFILE FOR CG-27 MATERIAL FOR 4036 TOTAL ROUNDS FIRED.

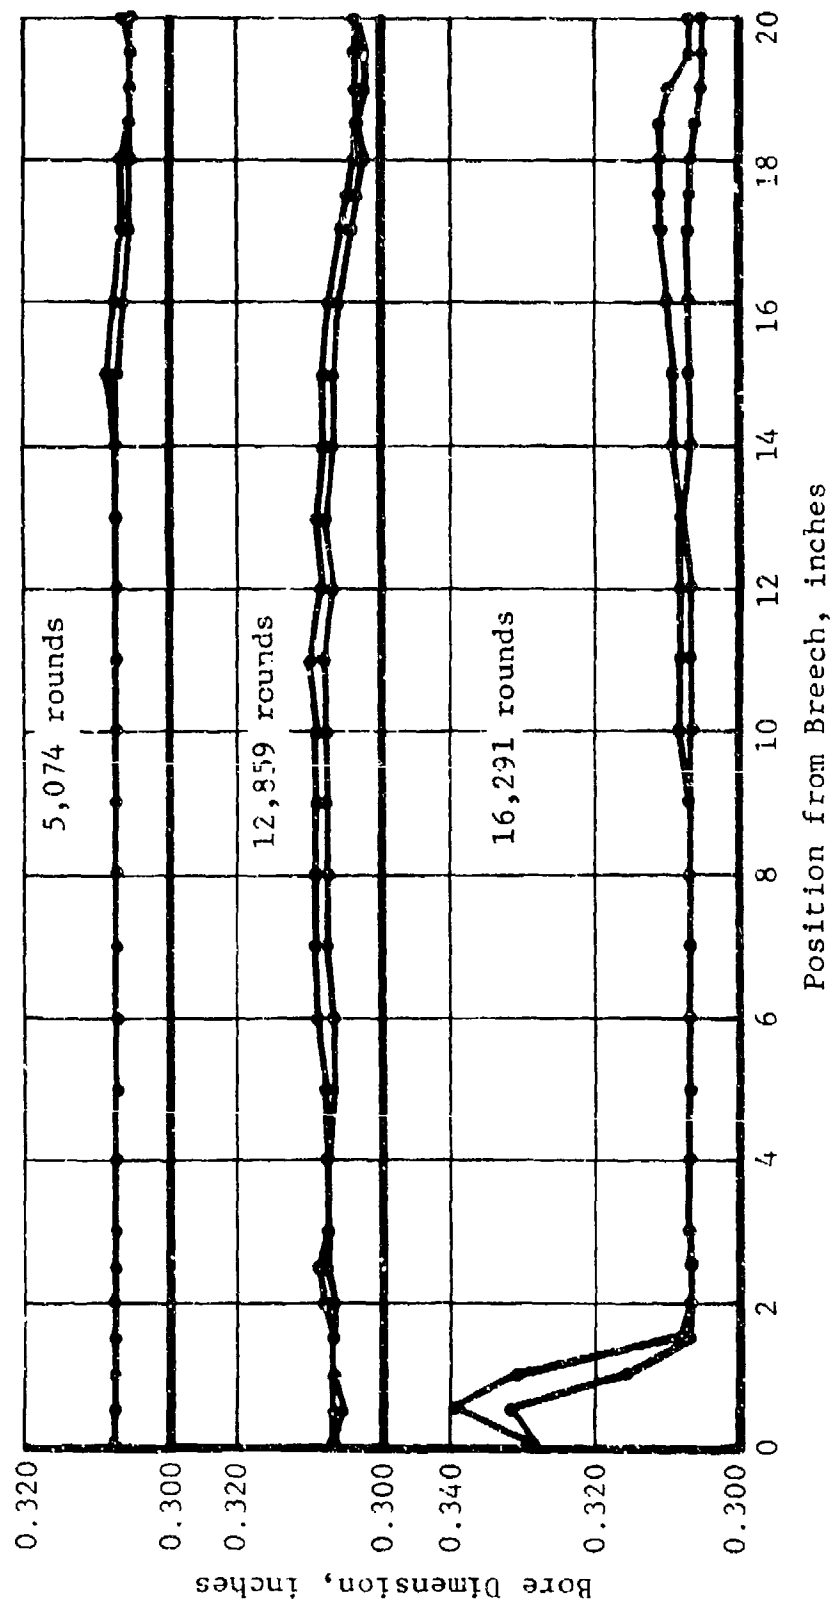
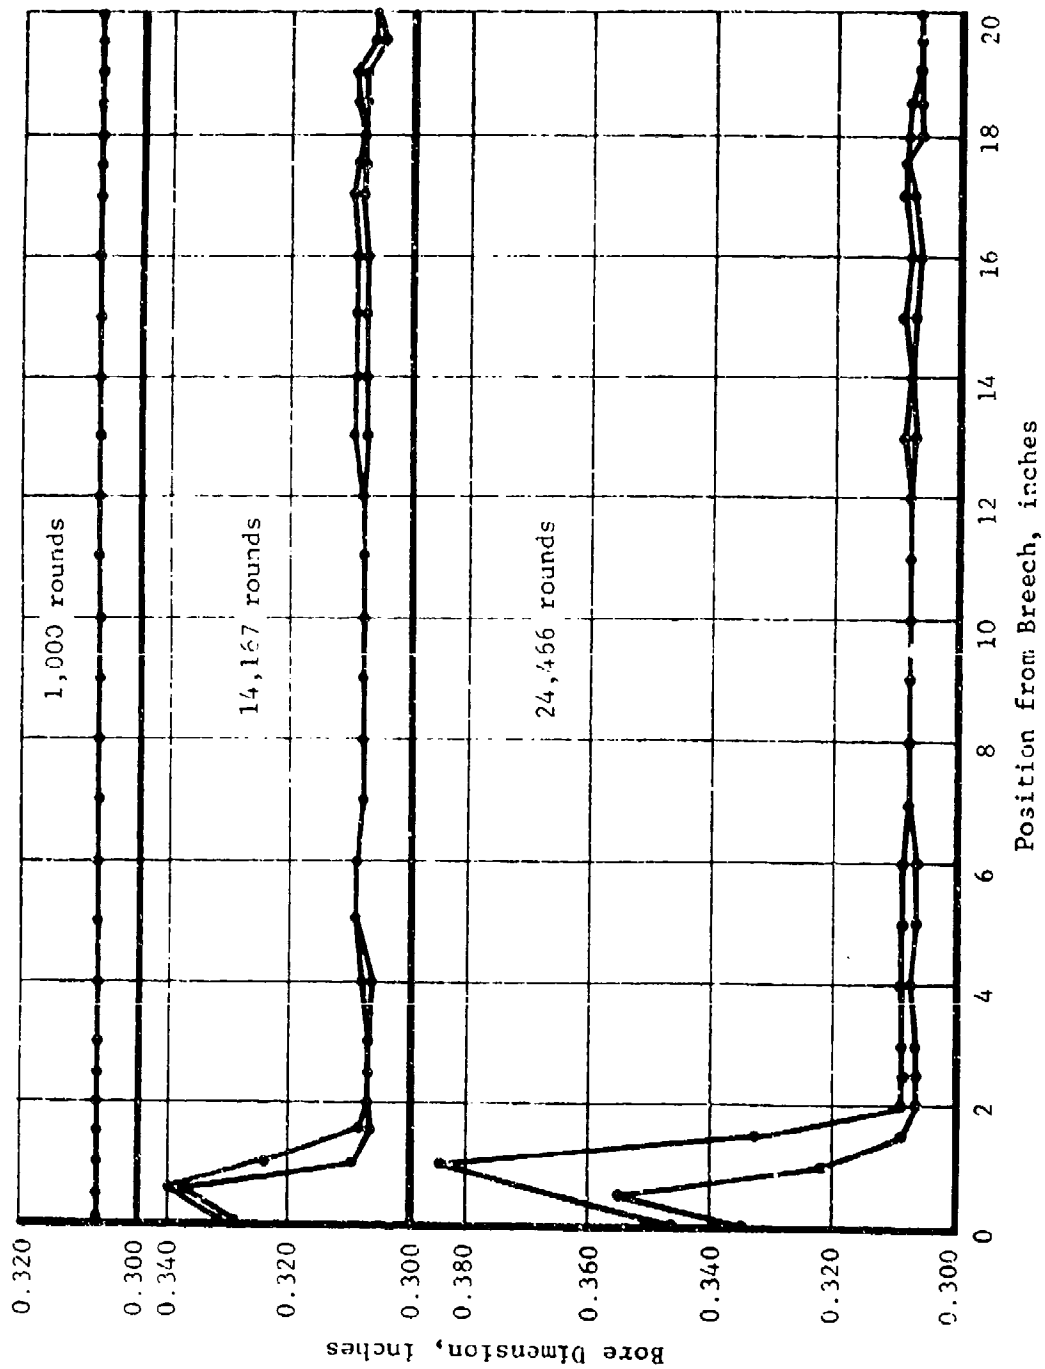
FIGURE 45 BORE PROFILE FOR H11 MATERIAL FOR VARIOUS NUMBERS OF TOTAL ROUNDS FIRED.

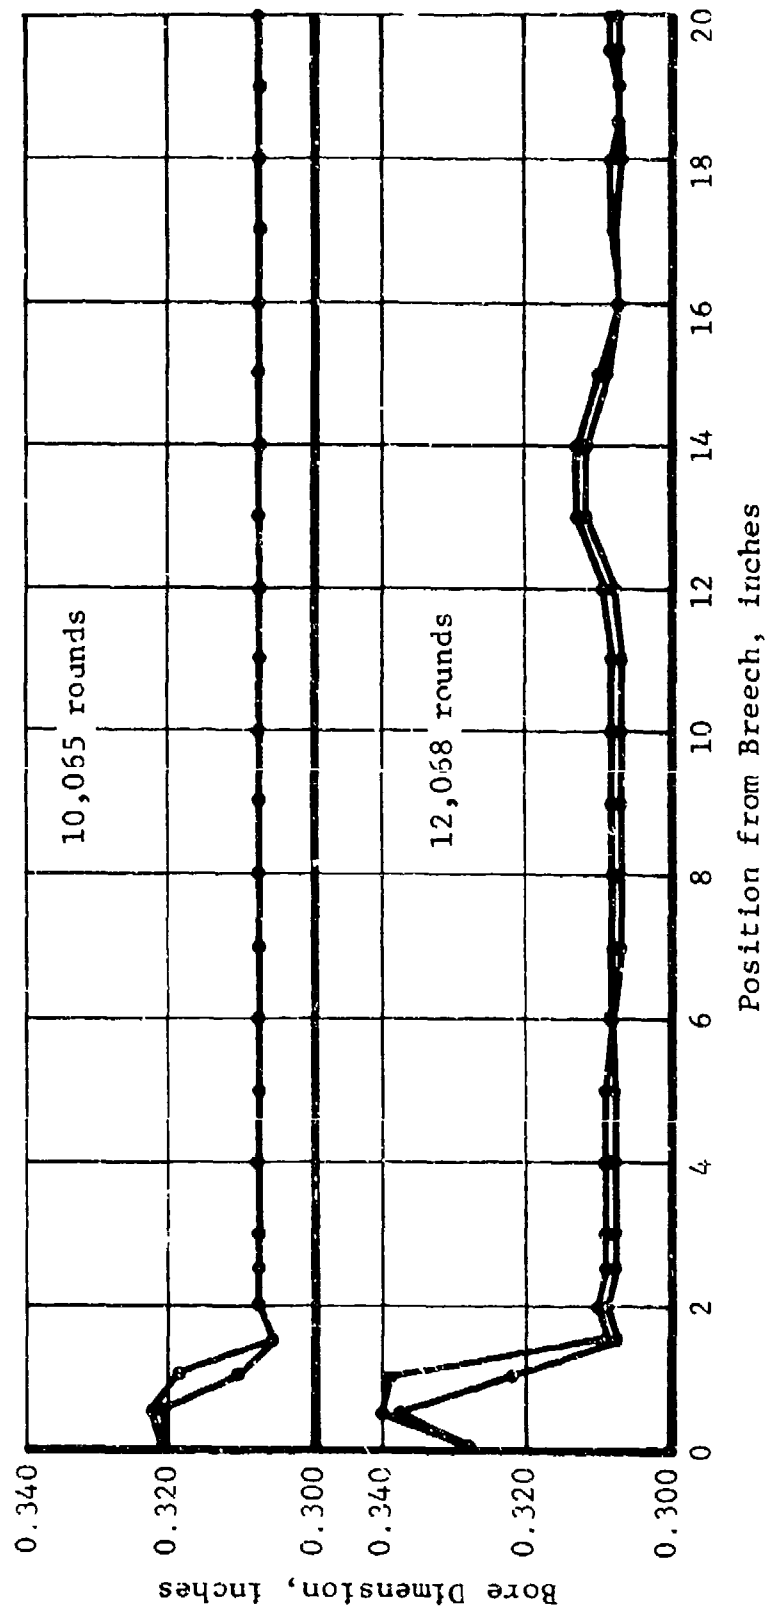
Chrome-Plated Gun Steel Barrels - Examination of the bore measurements indicated that for chrome-plated gun steel, the maximum erosion occurs in the area just forward of the breech. Additionally, there appears to be an increase in erosion in the region 11 to 16 inches from the breech. Also revealed in the silicone rubber molds is the general removal of the rifling at the muzzle end of the barrel. To determine changes which were produced by firing until the two steel barrels were unserviceable, transverse metallographic specimens were prepared at 1/2, 1 1/2, 2, 10, 17 1/2, and 19 1/2 inches from the chamber. Photomicrographs taken at these positions on the two chrome-plated gun steel barrels are shown in Figures 49 through 60. Figures 49 through 54 show the structure of the standard chrome-plated barrel which failed after 11,283 rounds by a large crack extending from the bore surface to the outer edge of the barrel. Figure 49 is a transverse section at 1/2 inch from the chamber. It will be noticed that a massive crack is present, and this particular crack typifies many of the cracks in this region: all of the chrome plate has been removed; massive amounts of the steel have been removed by general erosion; the microstructure near the crack and the bore surface appears to be ferrite and carbide; it also appears as though some decarburization along the bore has occurred; and, additionally,

FIGURE 47 BORE PROFILE OF STANDARD STEEL BARREL FOR VARIOUS NUMBERS OF TOTAL ROUNDS FIRED.

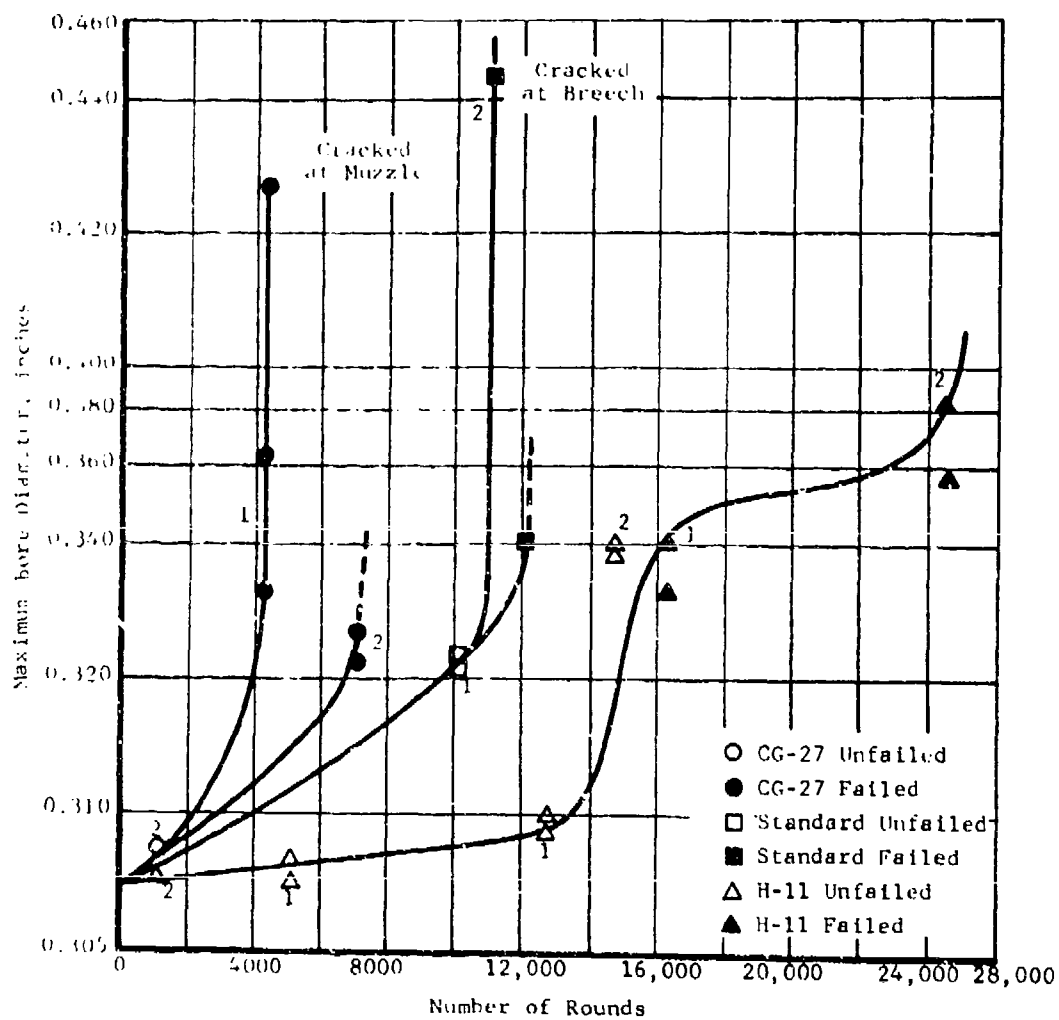
FIGURE 48 MAXIMUM CRACK OR EROSION DEPTH FOR VARIOUS GUN BARRELS AS A FUNCTION OF NUMBER OF ROUNDS FIRED.

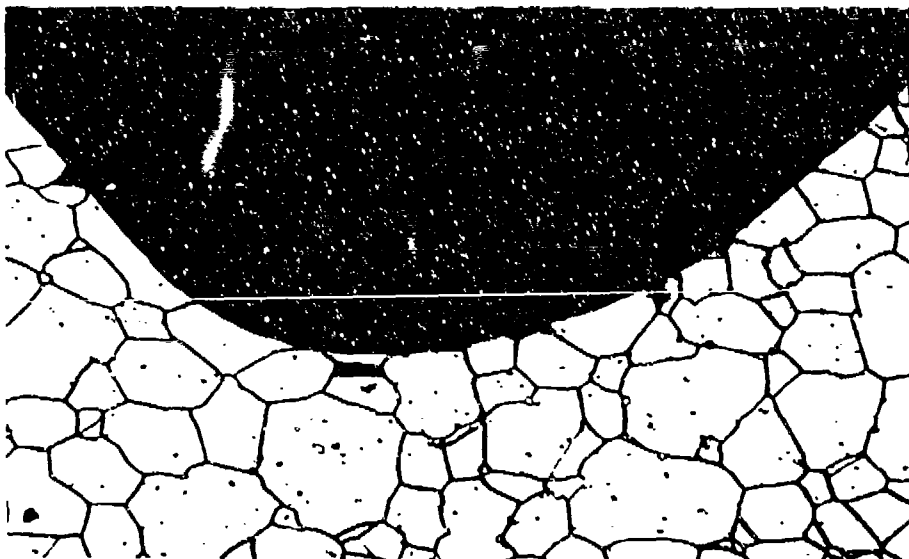
The structure of the bore at the 17 1/2 inch and 18 inch positions from the chamber is shown in Figures 77 and 78. In both positions it appears that extensive material has been removed from the bore surface. This can be attributed to a gas-metal reaction in which the nickel has probably combined with sulfur in the propellant gases to form a low-melting alloy which has washed away.

FIGURE 77 TRANSVERSE SECTION AT 17 1/2 INCHES FROM THE CHAMBER OF A CHROME-PLATED CG-27 ALLOY BARREL AFTER FIRING 4,036 ROUNDS AND BEING DECLARED UNSERVICEABLE.

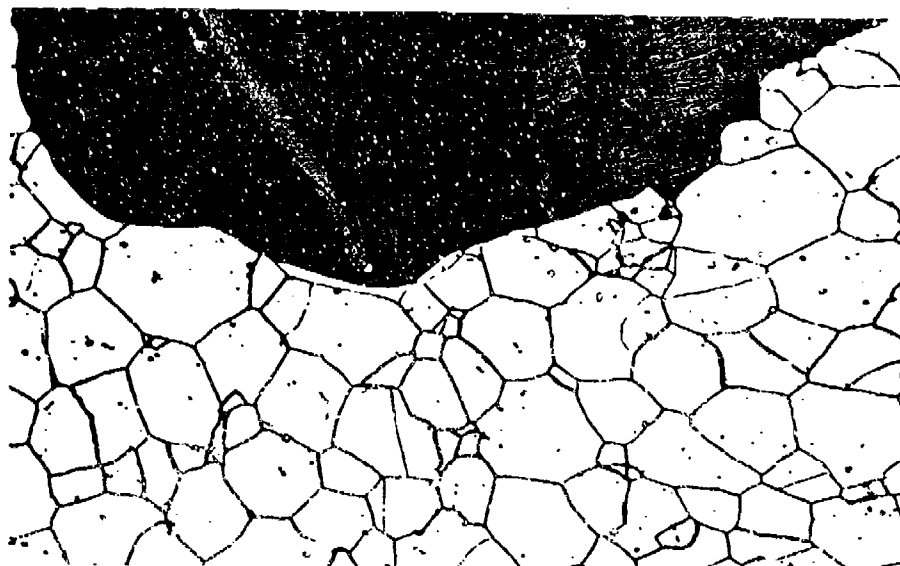
Figure 82 shows the bore surface of the barrel at the 10 inch position. Portions of the chrome plate have been removed, and intergranular attack has occurred.

FIGURE 82 TRANSVERSE SECTION AT 10 INCHES FROM THE CHAMBER OF A CHROME-PLATED CG-27 ALLOY BARREL AFTER FIRING 7,324 ROUNDS AND BEING DECLARED UNSERVICEABLE.

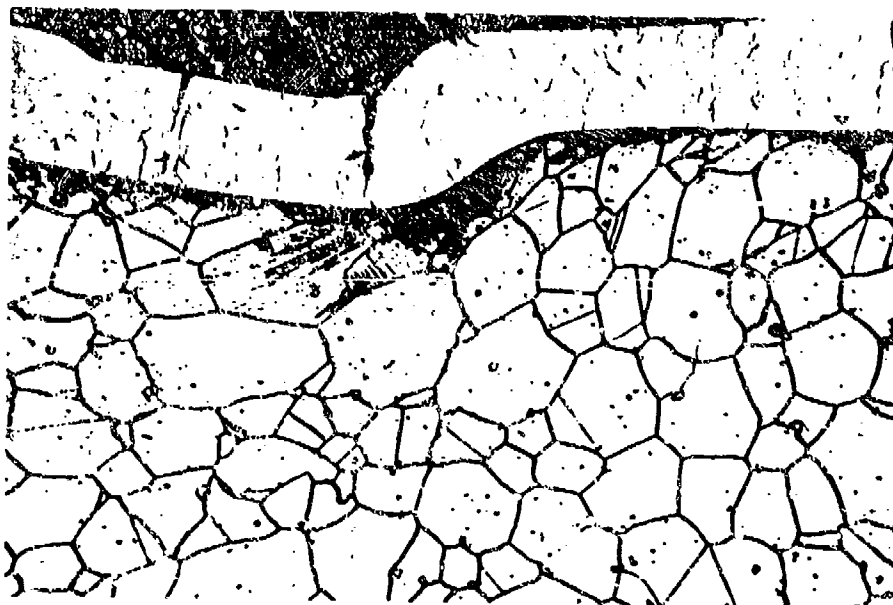
The structure of the bore surface at the 17 1/2 inch position from the chamber is revealed in Figure 83. Massive erosion has occurred at this site.

FIGURE 83 TRANSVERSE SECTION AT 17 1/2 INCHES FROM THE CHAMBER OF A CHROME-PLATED CG-27 ALLOY BARREL AFTER FIRING 7,324 ROUNDS AND BEING DECLARED UNSERVICEABLE.

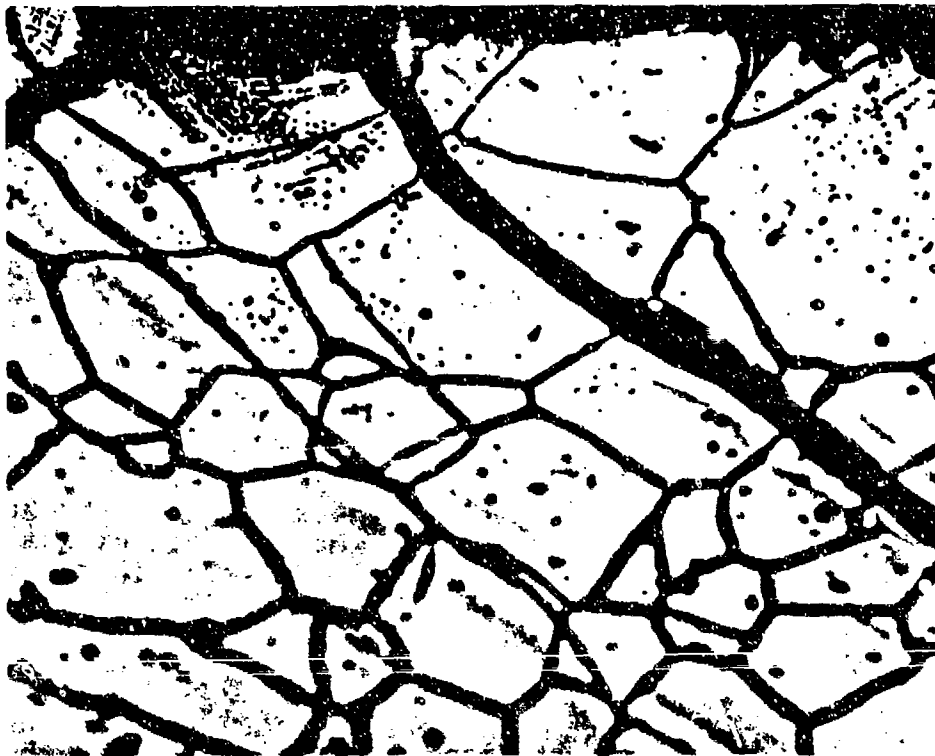
Figure 84 shows the transverse section at the 19 1/2 inch position. The structure present is similar to that observed at the 2 inch position, Figure 81. Figure 85 reveals the structure of the precipitate having the Widmanstatten morphology.

FIGURE 84 TRANSVERSE SECTION AT 19 1/2 INCHES FROM THE CHAMBER OF A CHROME-PLATED CG-27 ALLOY BARREL AFTER FIRING 7,324 ROUNDS AND BEING DECLARED UNSERVICEABLE.
