FILAMENT COMPOSITE MATERIAL LANDING  
GEAR PROGRAM, VOLUME I

Bendix Corporation

Air Force Flight Dynamics Laboratory

AFFDL TR 72-78, Vol. I

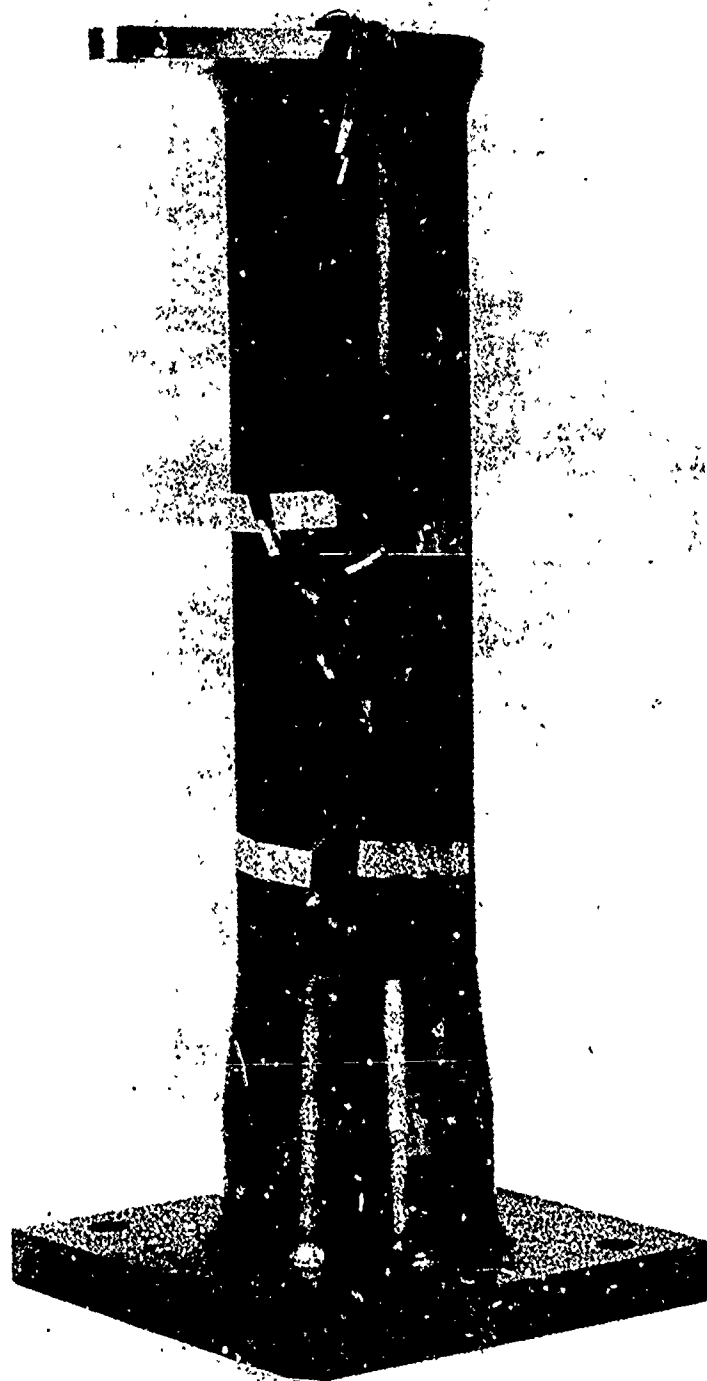
Figure 5-65. Forty-Eight-Ply Specimen After Test (Original Design)

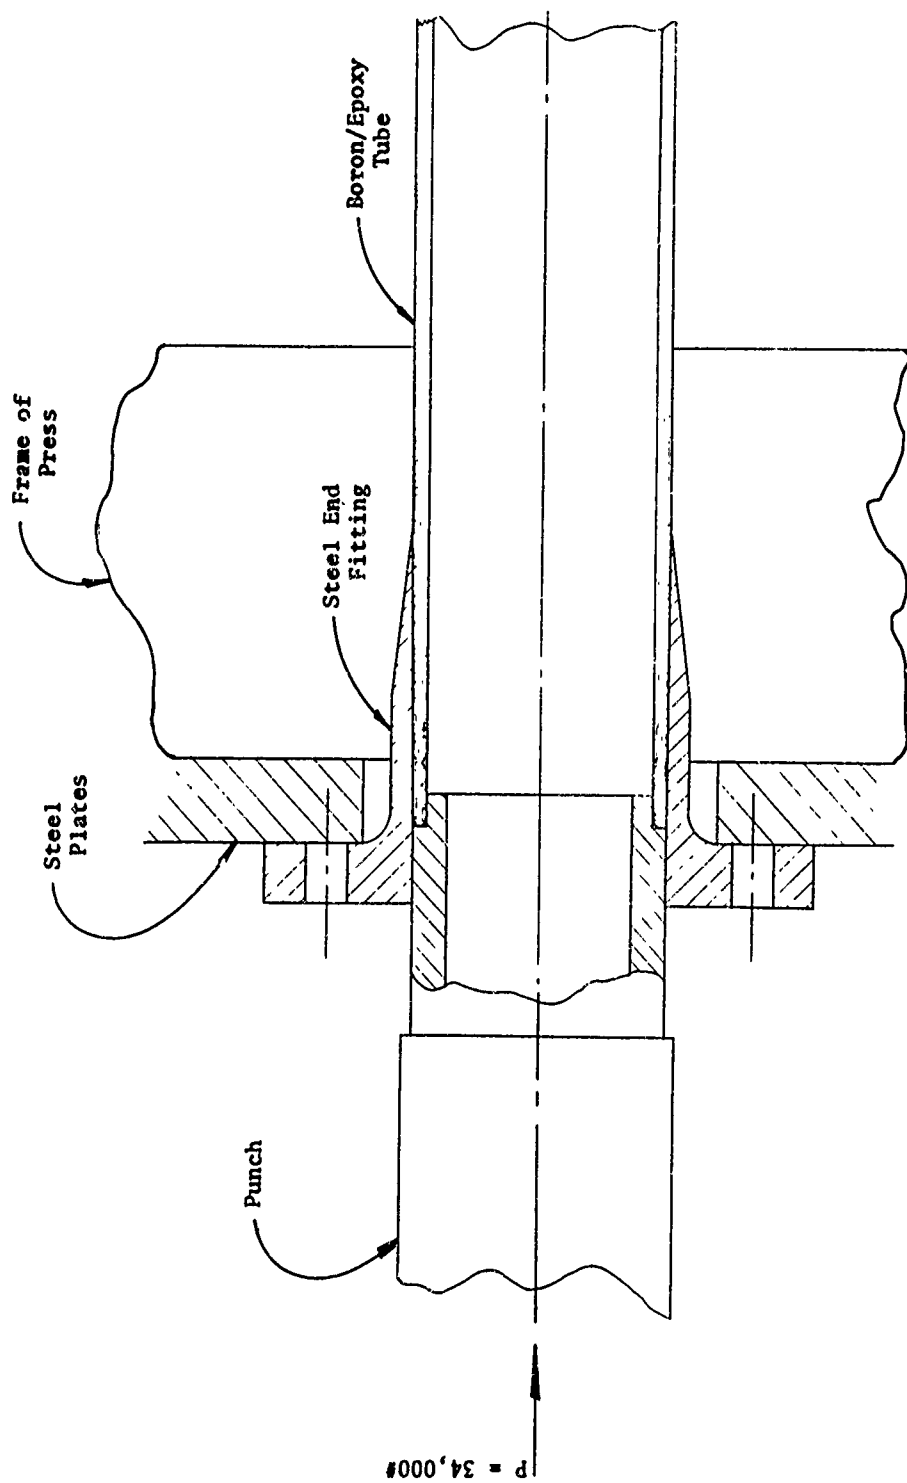
Figure 5-66. Removal of Cylinder from Fitting

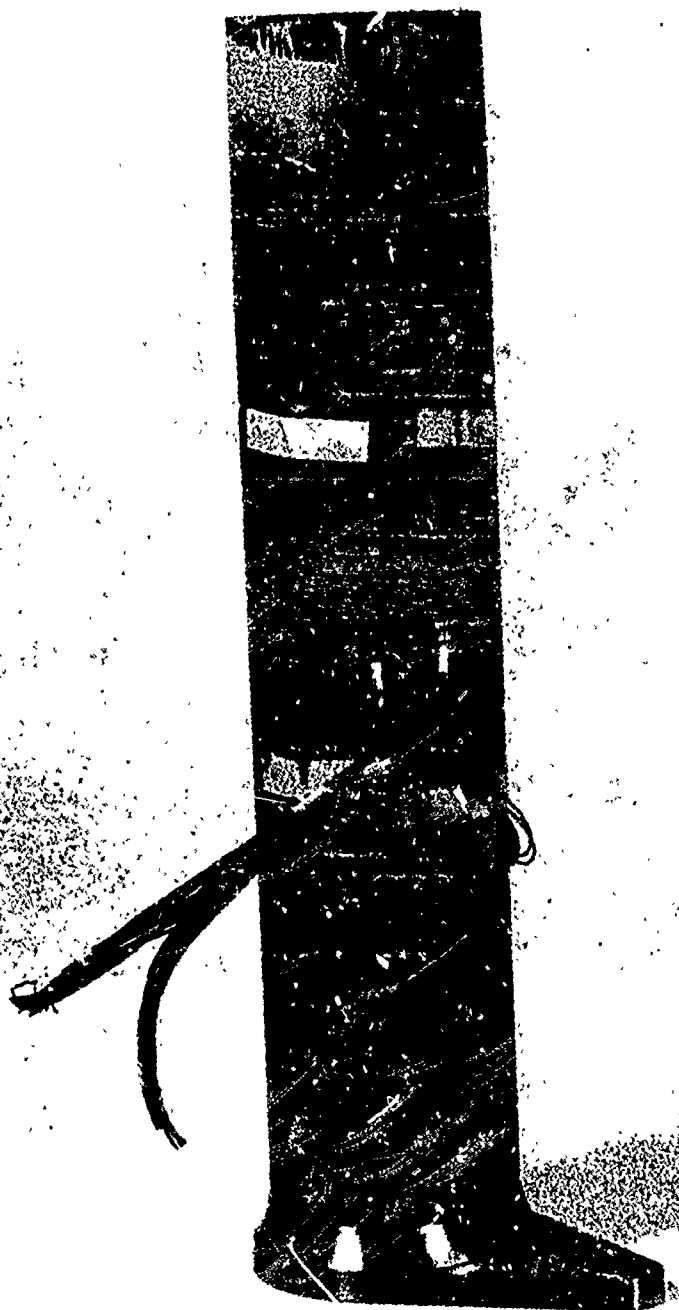
Figure 5-67. Cylinder Removed from Fitting

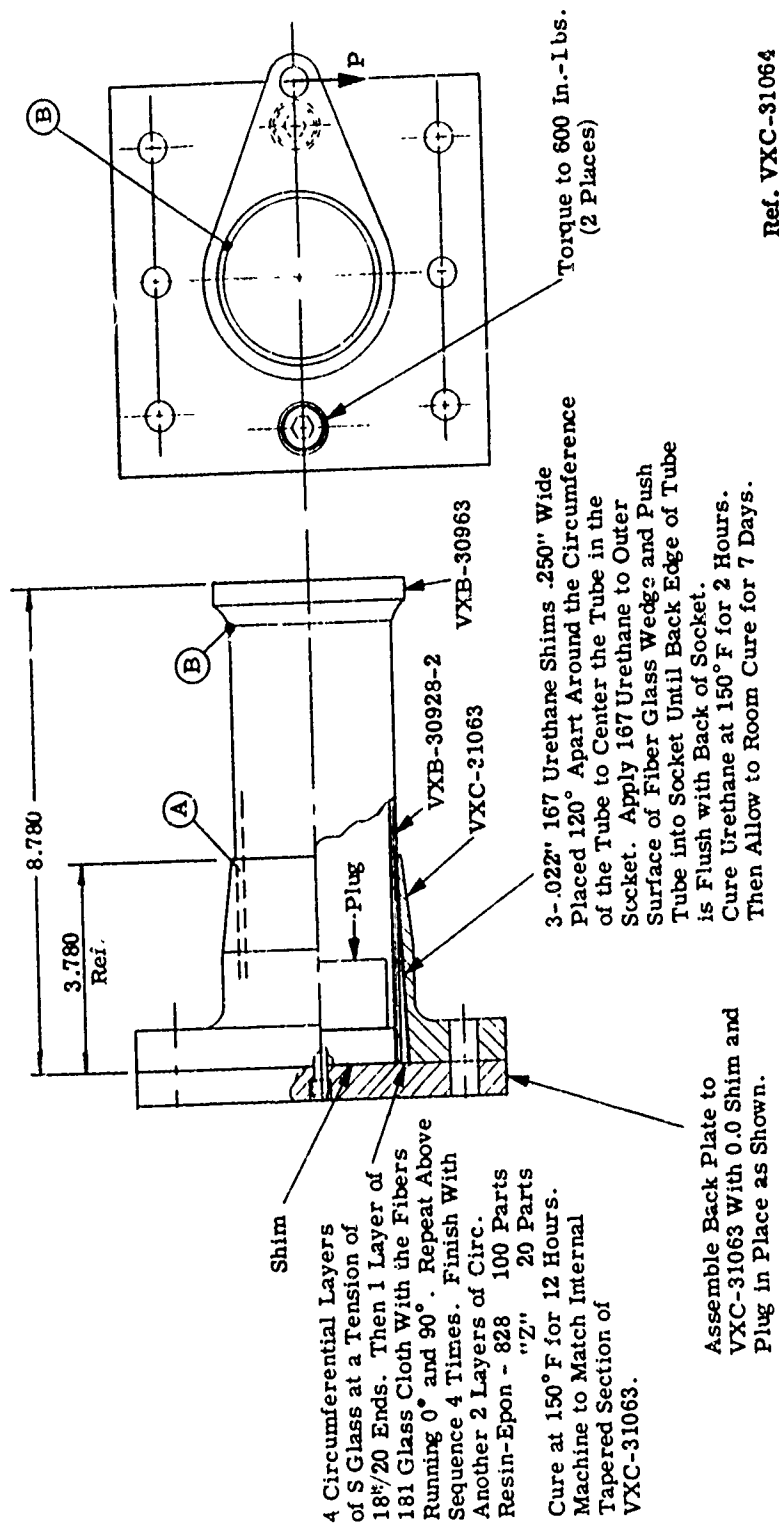
During the test the specimen failed by rupture of the cylinder in the region around Point **A**, Figures 5-78 and 5-79, at 13000 pounds. Therefore the cylinder sustained a load of 13/15 or 0.87 of the predicted value. This test also indicated that the loading lug joint was capable of supporting a shear stress in excess of 3360 psi.

Figure 5-78. Cylinder Specimen, Boron-Epoxy Thirty-Two-Ply (Second Design)

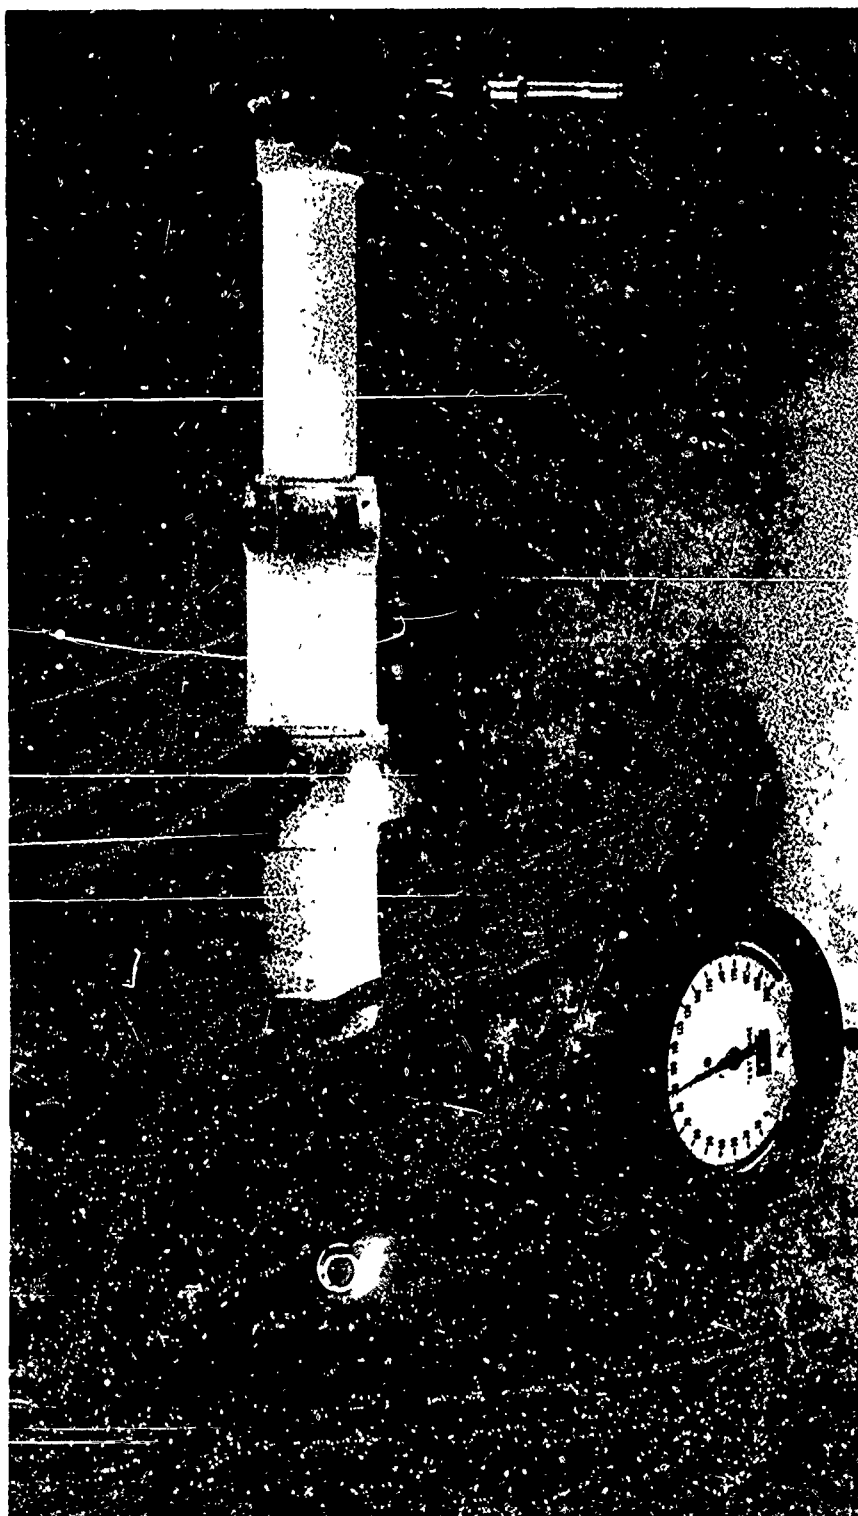
Results - No perceptible leakage or loss of pressure occurred during this test.

Figure 7-3. Setup for Horizontal Position Leakage  $\tau_{est}$  (P-25150X)

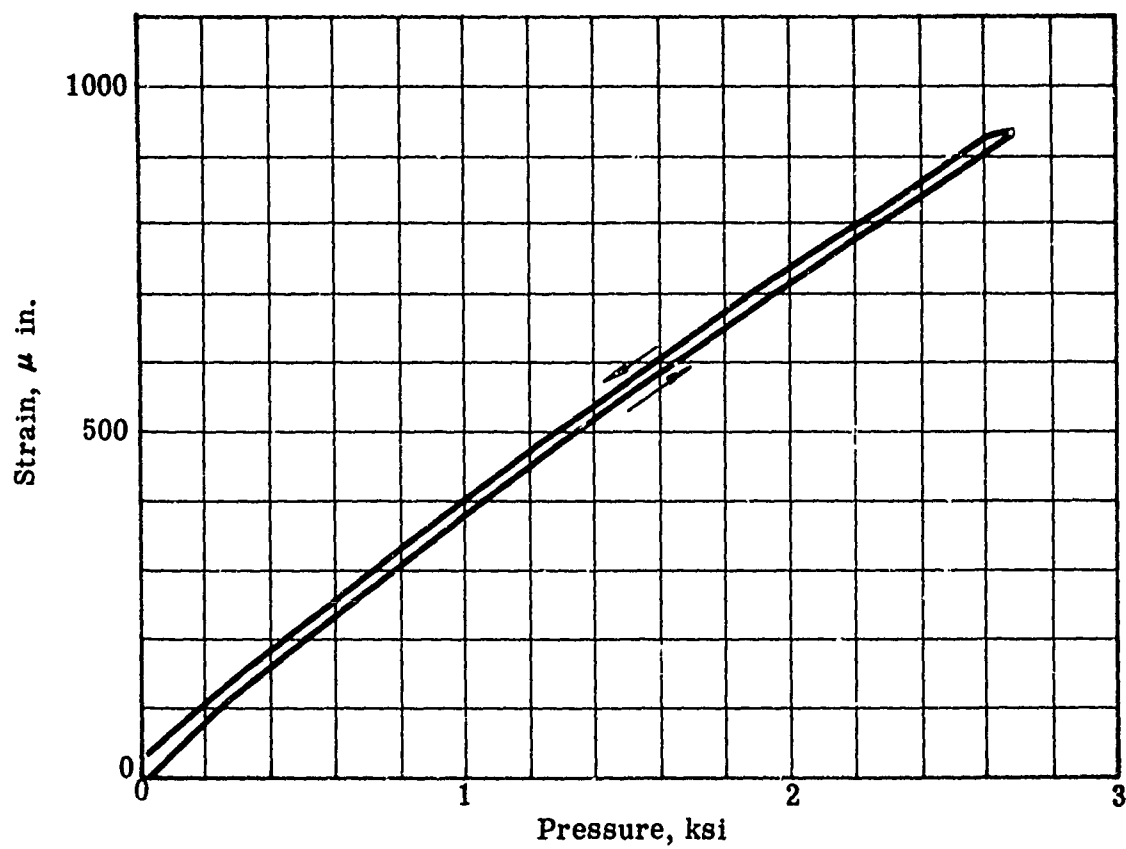
**Results** - There were no signs of yielding, leakage, or permanent deformation after any of the three tests. The OD of the piston measured 2.676 inches before testing and there was no change after completion of testing.

Only one of the two strain gages functioned properly during the test. The results from this gage are shown in Figure 7-7. The plot is shown for the highest loading only. The curves for the lower loads coincided in slope and reversal with the curve shown.

Figure 7-7. Strain Gage Response Piston Proof Pressure Test

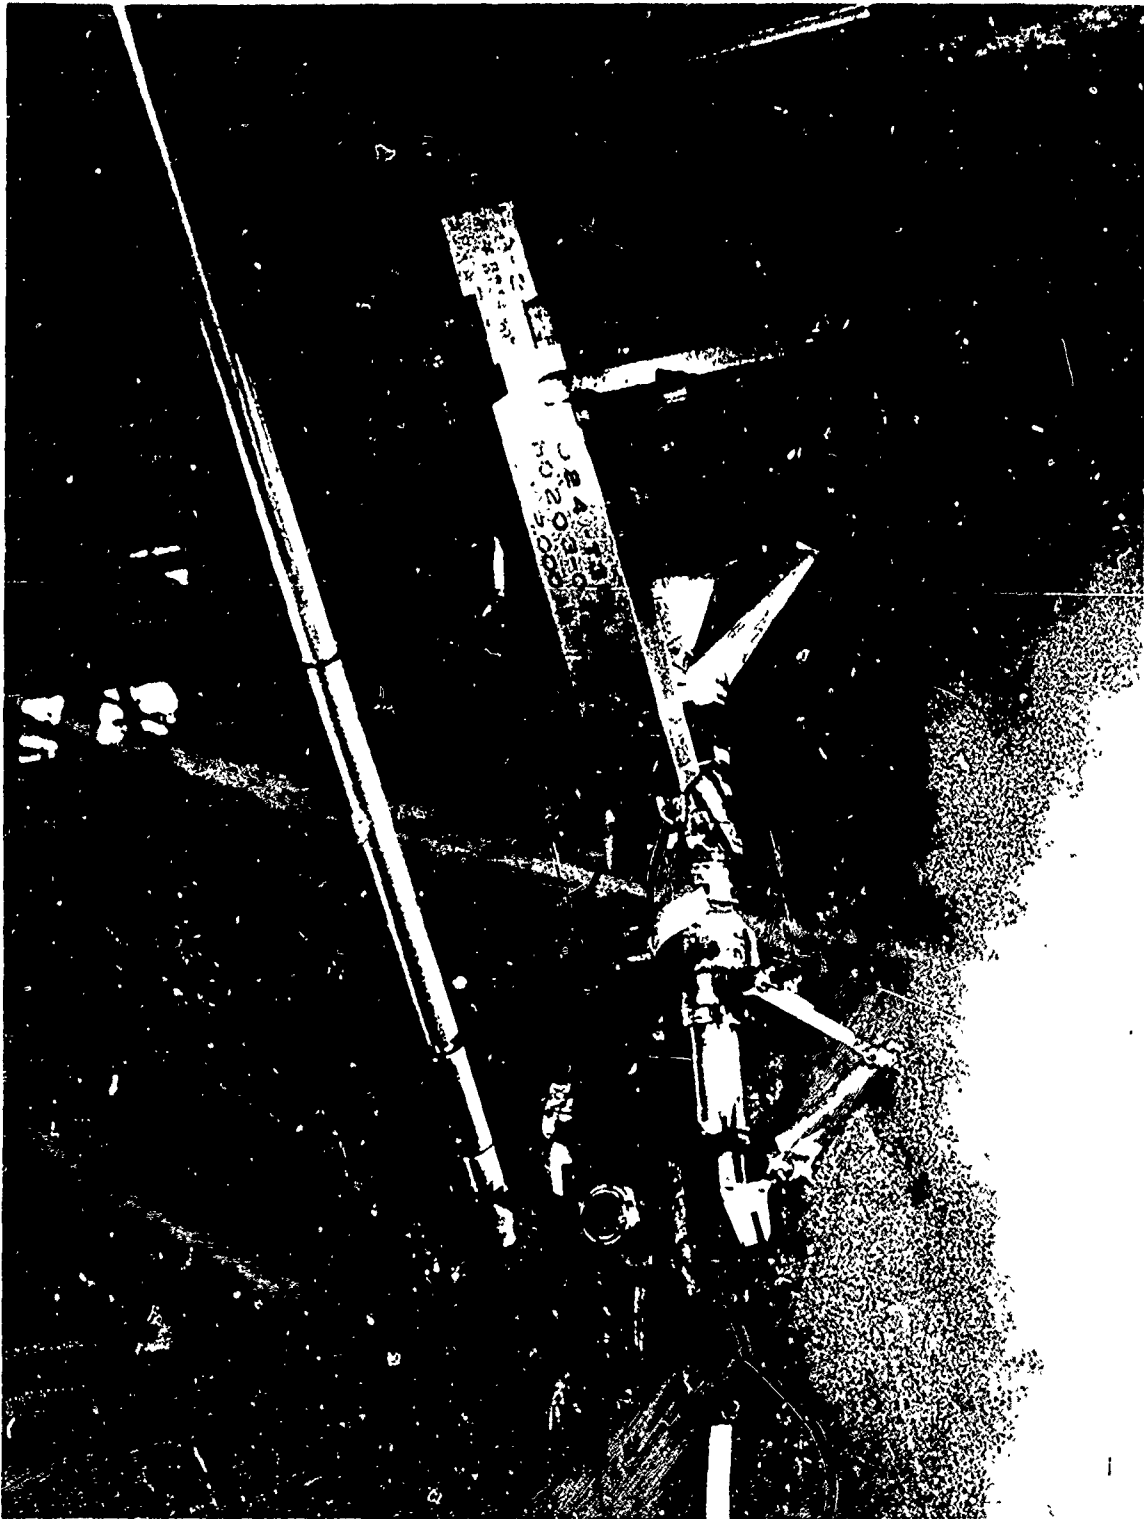
Figure 7-17. Simulated Side Brace Installation (P-25175BB)

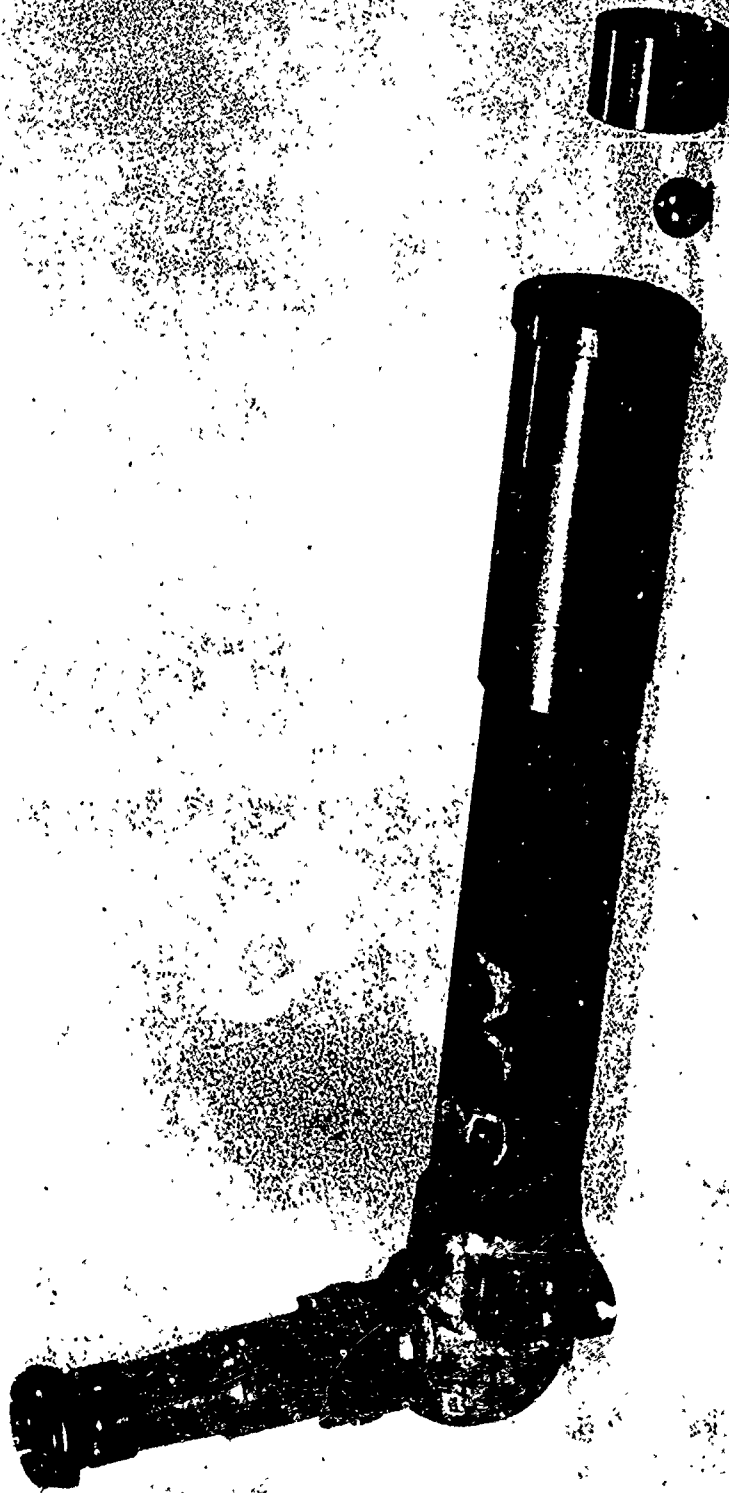
Figure 7-24. Simulated Piston (P-25190T)

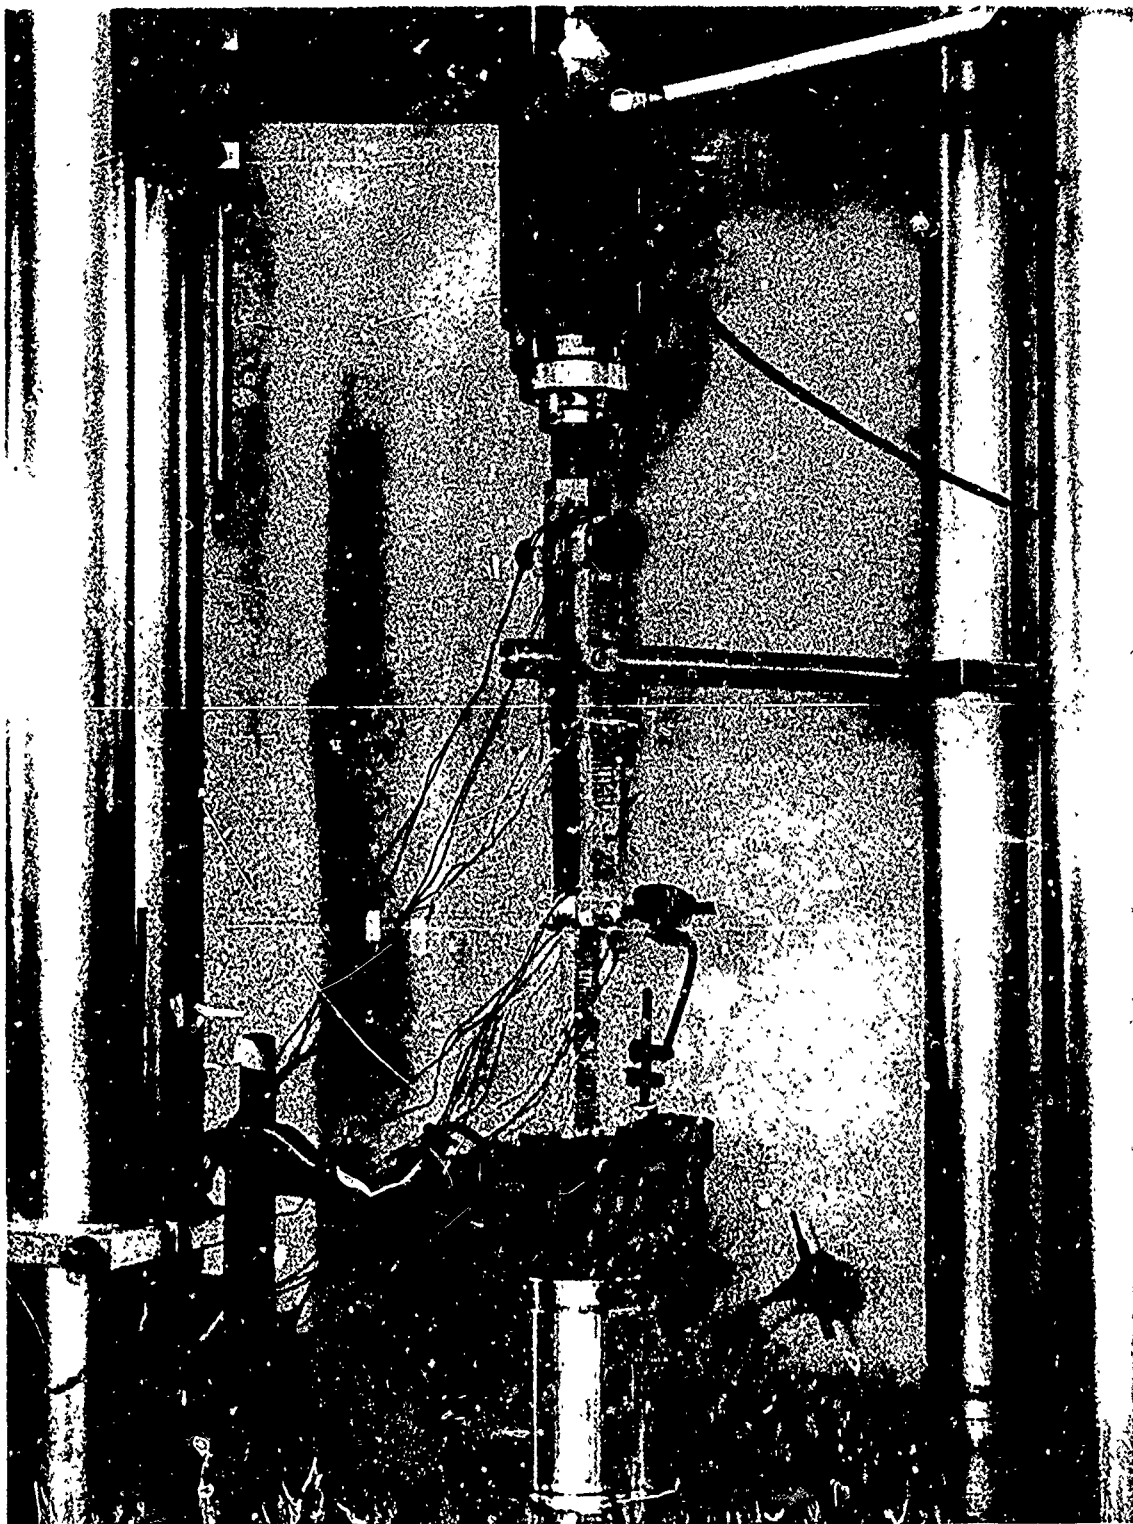
The brace was tested in two stages. In Stage 1, the brace was tested as an assembly combining the upper and lower links, Figure 7-29. Loading was increased until failure occurred at the lower end of the upper links during compression loading, Figure 7-30. During Stage 2, loads were applied to the lower link which was still structurally intact after the previous failure, Figure 7-31. This member sustained a failure during compression loading, Figure 7-32.

Figure 7-29. Side Brace Assembly in Test Machine (P-25190C)

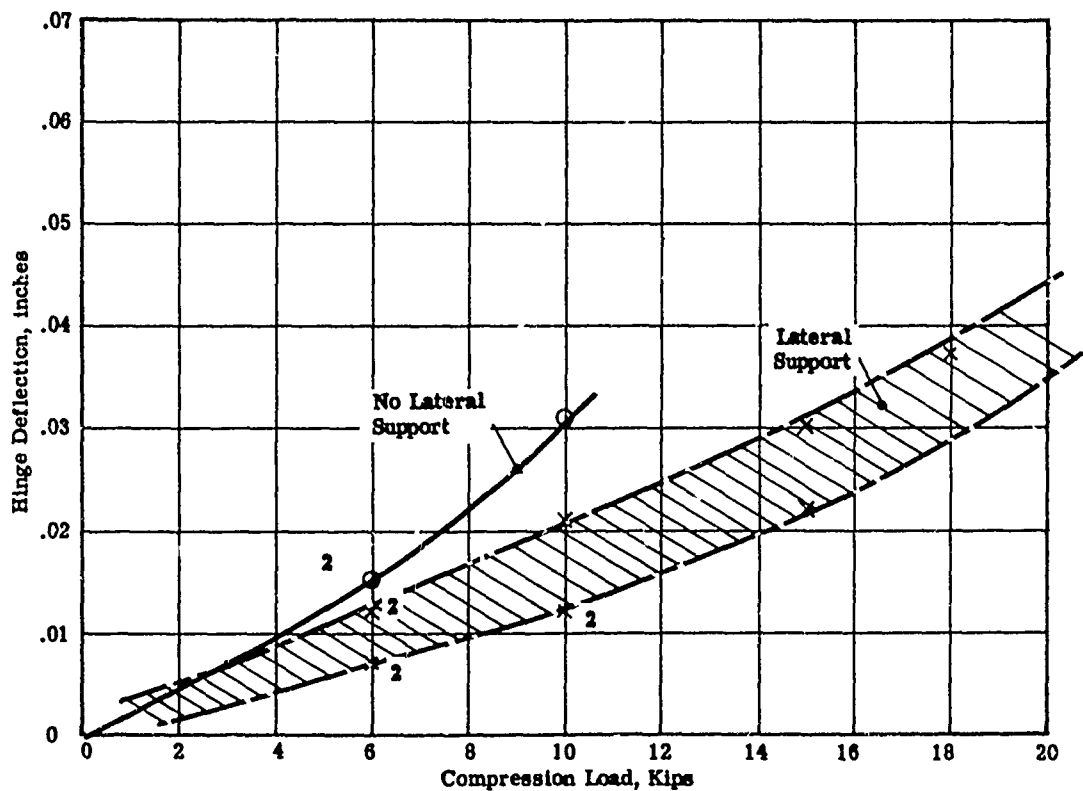
Hinge pin deflections were measured for loadings 4 and 5. These deflections are shown plotted against load in Figure 7-33, curve labelled "no lateral support."

Prior to the application of further compression loadings, an analysis was made of the lateral hinge pin deflections measured during loadings 4 and 5. The deflections plot, Figure 7-33, indicated that with the brace supported as a simple pin ended column, excessive deflections would be experienced at the higher loads, which would lead to premature collapse. It was therefore decided to install the lateral support illustrated in Figure 7-29. This support simulates the aircraft installation which includes a landing gear extension downlock mechanism which attaches to the side brace at this location.

Compression loadings 8 through 9, Table 7-3, produced the hinge pin deflections plotted in Figure 7-33 and labelled "lateral support." It is apparent that considerably less lateral deflection was experienced with the lateral support installed.

Figure 7-33. Side Brace Hinge Deflections

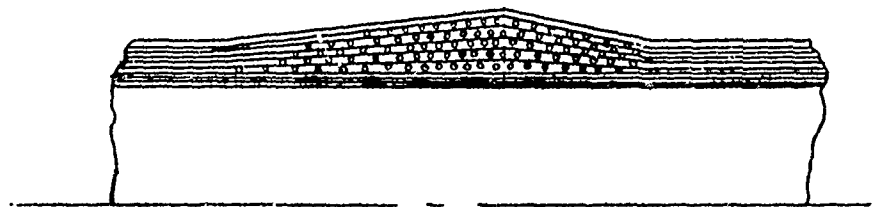
Primary failure of this attachment occurred as a result of the separation of the glass overwrap from the boron cylinder, Figure 7-20. This indicates the desirability of a design which eliminates the weak interface between the conical build-up and the basic cylinder. Such a concept is illustrated schematically below.

The build-up is an integral part of the cylinder wall with uninterrupted filaments flowing continuously from the basic wall through the conical build-up. Circumferential filaments would be added to accommodate the increased thickness at this point. Contact forces from the fitting would flow along the continuous filaments directly into the cylinder wall without passing through an intervening weak bond surface.

The load intensity on this type of attachment is relatively low. The results of this design and test activity indicate that a successful joint is possible. First, this requires improved load transfer from the fitting to the composite surface. This may be accomplished by increasing the taper angle on the conical build-up, and also by increasing the adhesive friction between the two surfaces. Secondly, the tapered build-up must be strengthened by constructing it as an integral part of the cylinder.

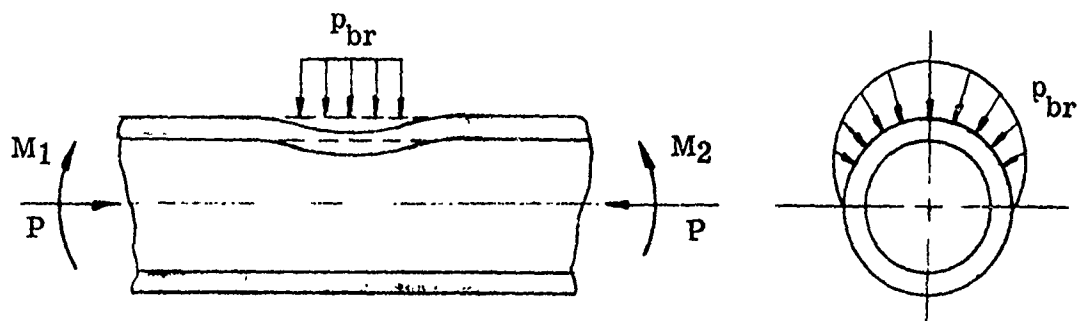
However, further consideration must be given to the possibility that the stresses are more critical on the compression side, particularly with respect to the contribution from the localized bearing load. This situation is illustrated by the simplified model below.

There is the prospect that the compression stresses due to local wall bending produced by the bearing pressure  $p_{br}$  when combined with the compression stresses due to the nominal loads  $M$  and  $P$  may result in a more critical situation compared to material strength than on the tension side. Consideration of localized effects of this type is more important with composite construction than with the more ductile conventional materials. Further detailed analysis of this particular loading configuration appears warranted.

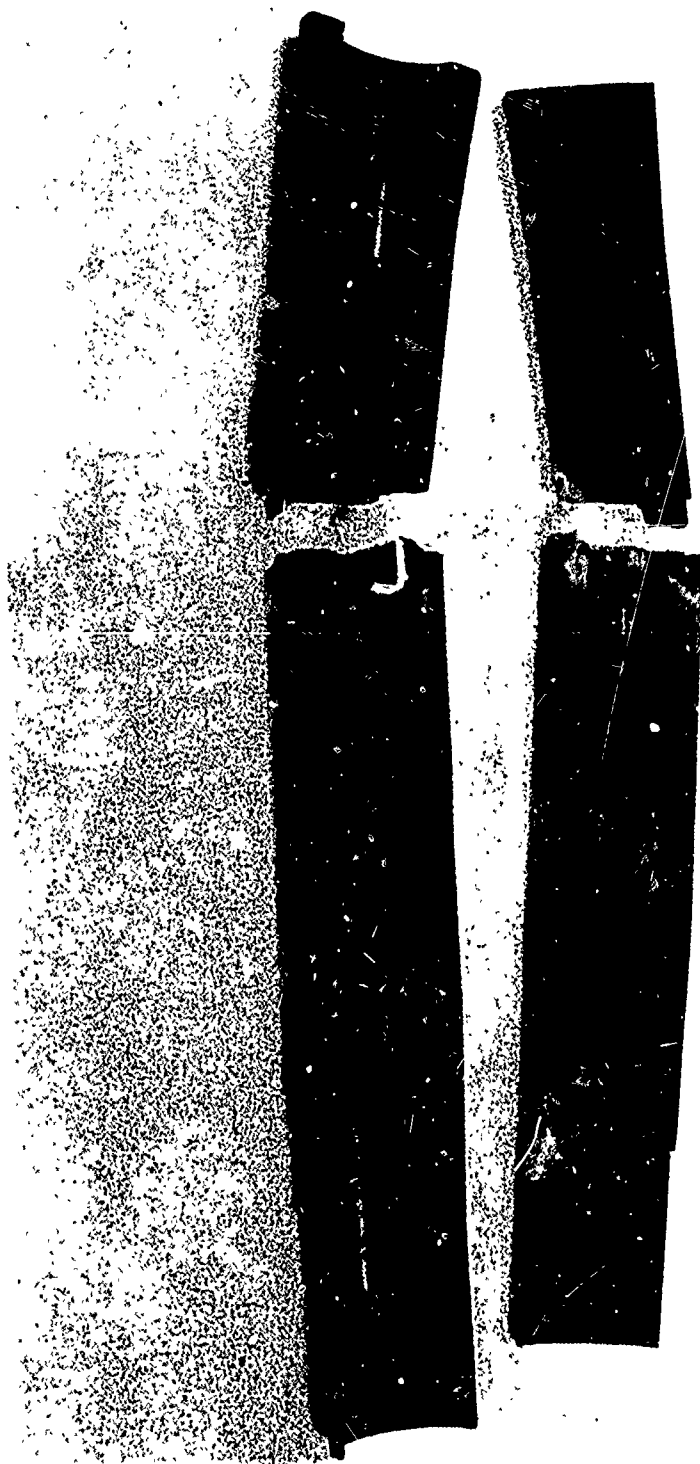
1. Layup Consolidation - As indicated in Paragraphs 8.2.5 and 8.2.6, there were indications during the fabrication phase of ply separations in the cylindrical products. These were apparent by both visual and C-scan inspection. The existence of these flaws was confirmed by sectioning the cylinders after structural testing, Figures 7-34, 7-35, 7-36 and 7-37.

Such ply separations arise from difficulty in consolidating the circumferential and 45 degree plies during the layup operation. For a successful result, each ply must be compacted precisely into its prescribed radial position above the mandrel, while it is being laid down. One cannot rely on subsequent overwraps or ply applications to exert the necessary compaction on the layers below. Any loose circumferential or 45-degree filaments or plies will either bunch up and wrinkle, or fail to move from their original incorrect location, thus promoting delamination in the cylinder wall.

Figure 7-34. Sectioned Piston Cylinder (P-25190BB)
