EVALUATION OF GOODYEAR MEDIUM-DUTY  
ALUMINUM HONEYCOMB LANDING MAT

Army Engineering Waterways Experiment Station

March 1973

MISCELLANEOUS PAPER S-73-8

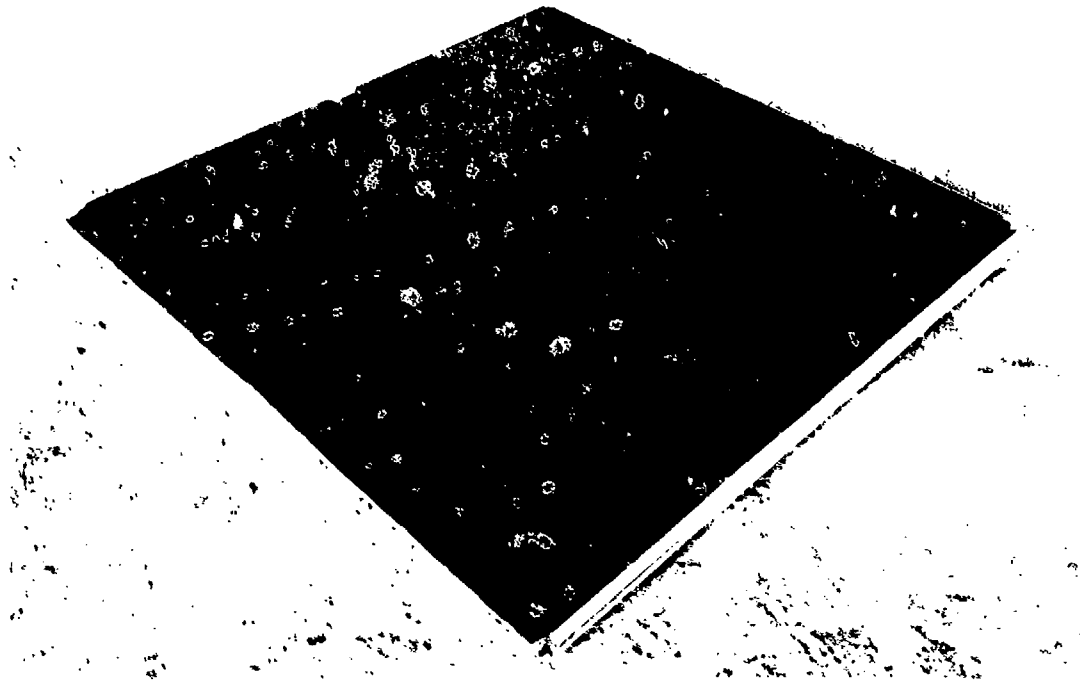
Fig. 1. Goodyear medium-duty landing mat

8. The 4- by 4-ft Goodyear medium-duty landing mat (fig. 1) consisted of an aluminum honeycomb core bonded into a sandwich-type structure with 0.063-in.-thick top and bottom sheets by an epoxy fiber-film adhesive. Extruded edge-connecting members were also bonded to the top and bottom sheets and to the aluminum honeycomb core with a film adhesive. The core was formed from 5056-H19\* aluminum alloy foil. The foil was 0.0027 in. thick and was formed into 1/8-in. hexagonal cells. All surface pieces of the panel were formed from 6061 aluminum alloy artificially aged to the .6\* condition, which resulted from a process involving solution heat treatment and oven cycling to produce a stable temper.

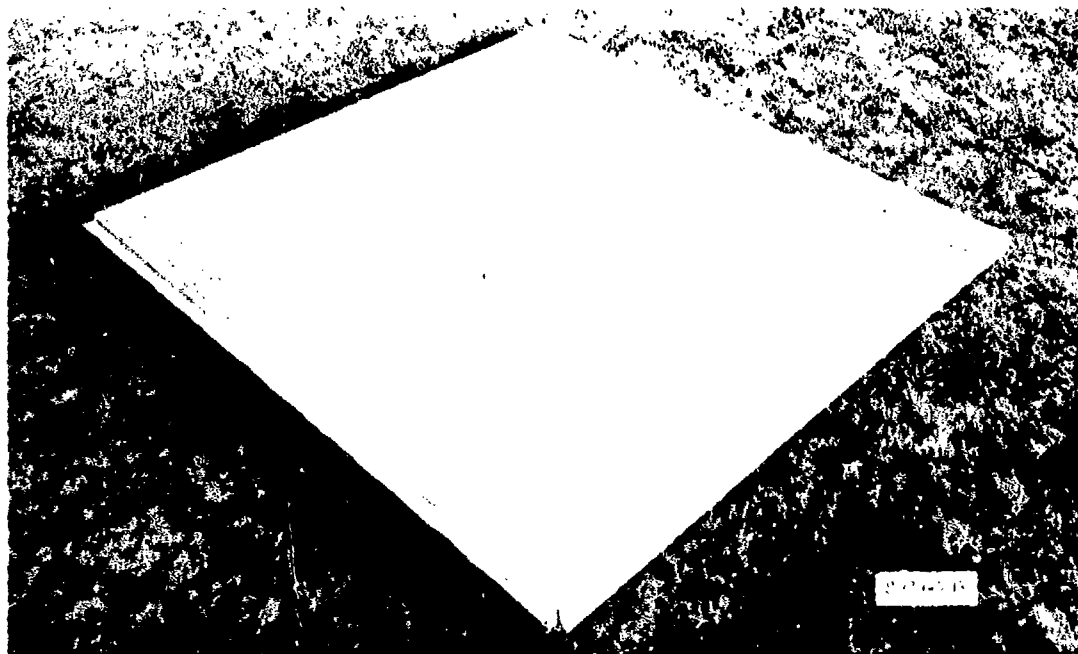
Fig. 2. Goodyear medium-duty landing mat with 5052 core

10. At the manufacturer's request, two special panels (fig. 2) were included in the test. The structure of these panels was the same as that of the mat described in paragraphs 8 and 9 except that the core

was made from 5052 aluminum alloy and the panels were not coated with an antiskid compound and painted. Use of the 5052 alloy would represent a cost savings of 20 to 25 percent of the cost per square foot of core material. The location of these two panels is indicated in plate 1.

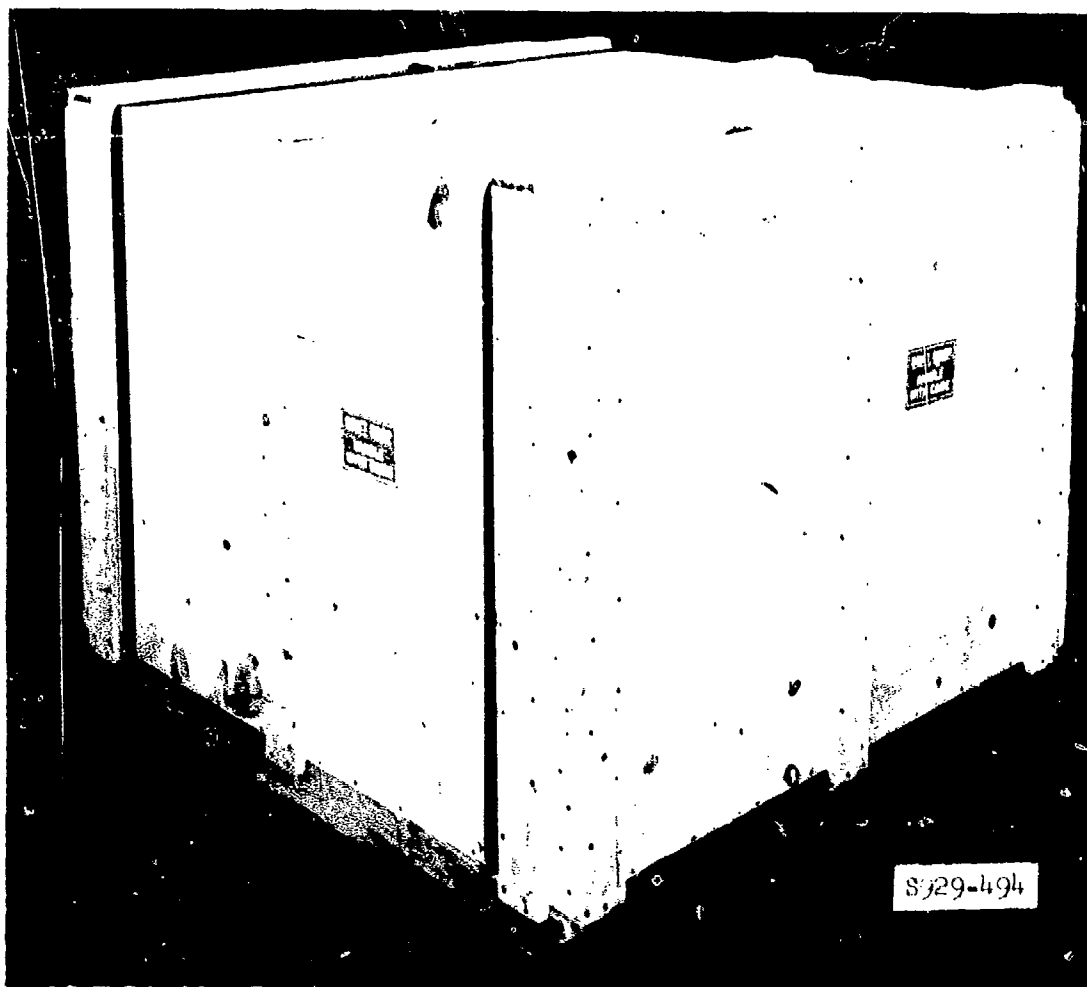
Fig. 3. Bundle of Goodyear medium-duty landing mat

11. The mats were shipped in bundles (fig. 3) containing an average of 18 panels and weighing approximately  $3/4$  ton. The panels were approximately 4 ft square and 1.5 in. thick. No panels were damaged during shipment. The average weight of the locking bars was 0.5 lb .

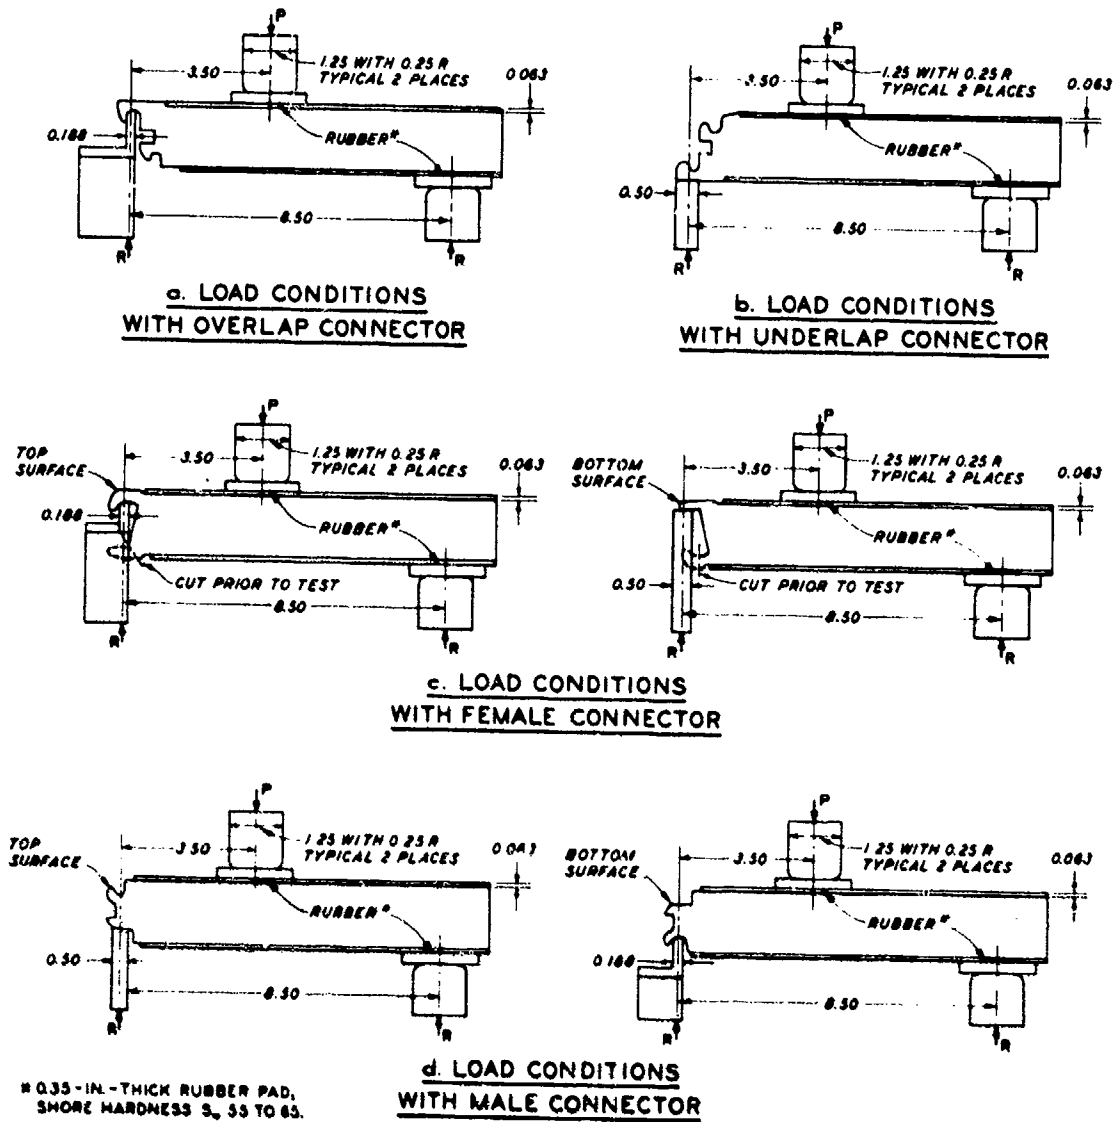
Fig. 5. Static edge member tests

b. Specimens were subjected to static edge member tests. In these tests, the connector was left along one of the narrower edges of the specimen, and this edge was used as a support along with one other support area (fig. 5). The specimen size was 9.5 by 10.5 by 1.5 in. These tests were used to determine if the adhesive joining the core

to the edge connectors was as strong in shear strength as the honeycomb core, rather than to determine the strength of the edge connectors. (For structural balance, the shear strength of the adhesive bond should equal or exceed the shear strength of the panel core.) The shear strength was calculated using the equation:

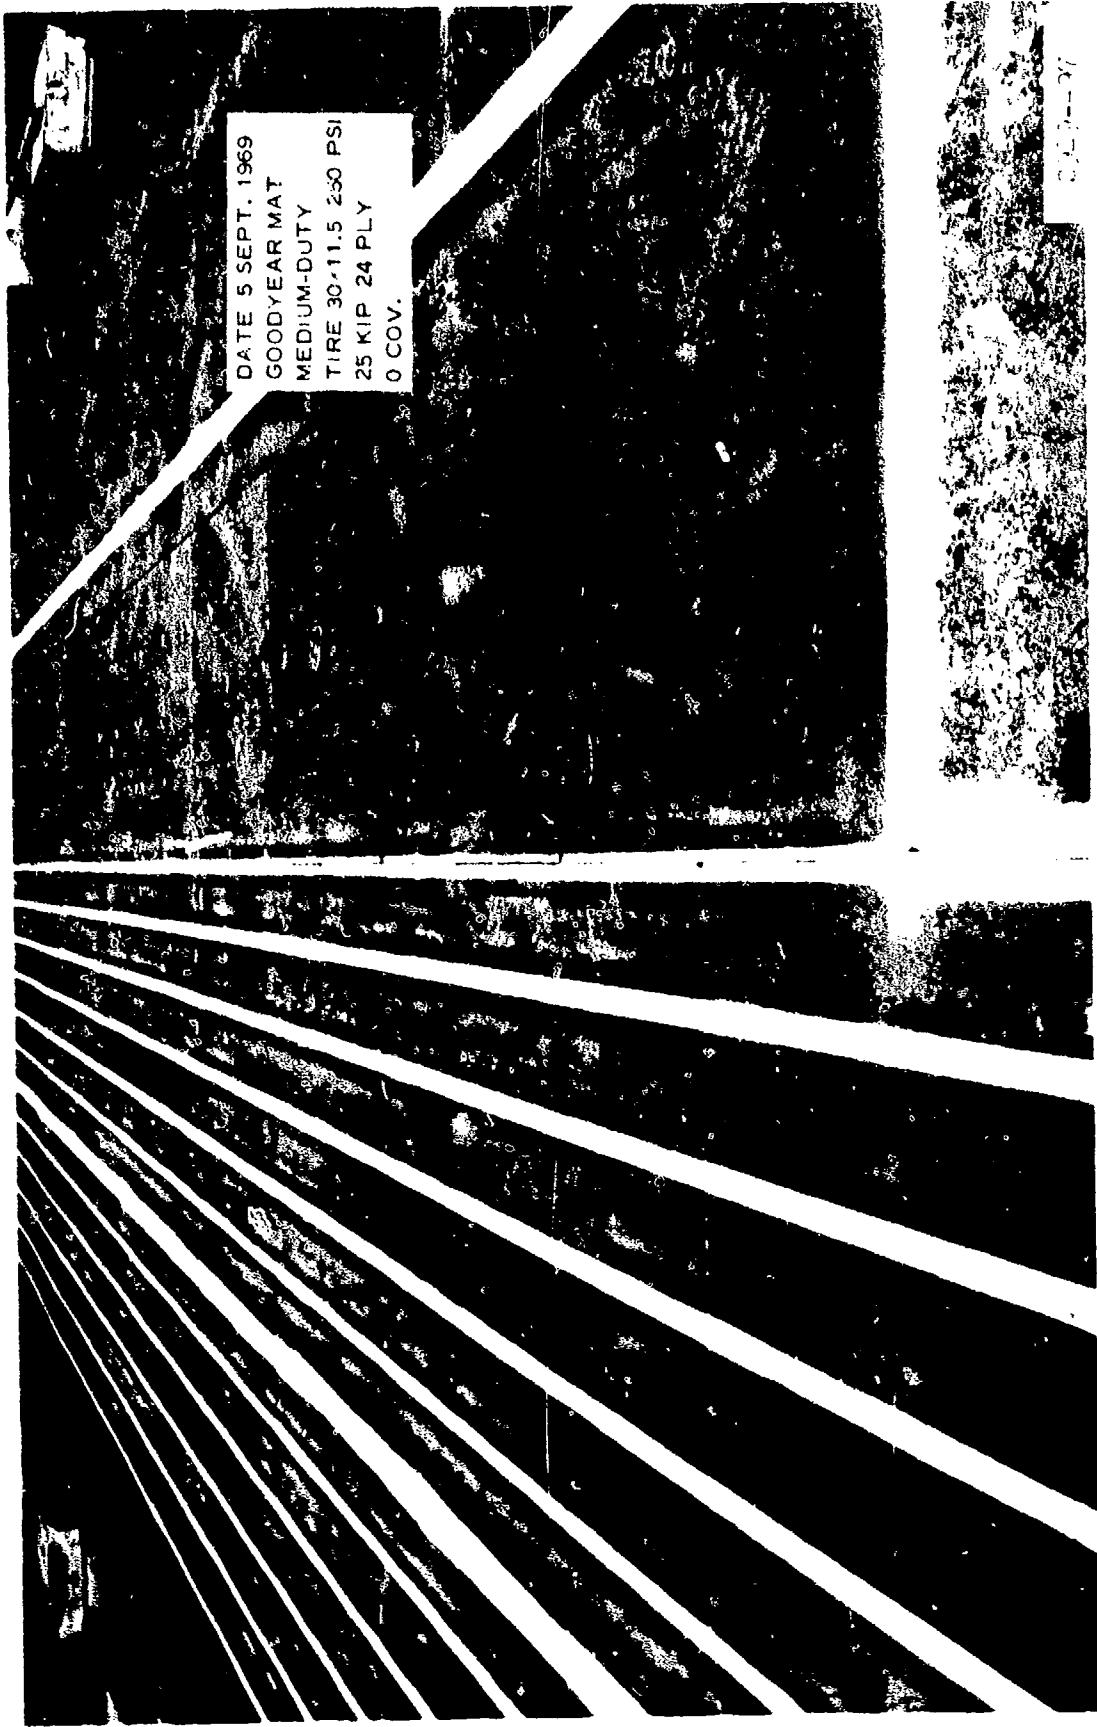
Photo 3. Test section prior to traffic

26. The test section prior to traffic (photo 3) was generally smooth, and the average CBR of the subgrade was 3.4 (table 1).

DATE 5 SEPT. 1969  
GOODYEAR MAT  
MEDIUM-DUTY  
TIRE 30-11.5 230 PSI  
25 KIP 24 PLY  
0 COV.
