EVALUATION OF KAISER MX19-B AND MX19-C
ALUMINUM HONEYCOMB LANDING MAT

MISCELLANEOUS PAPER S-73 II

G. L. Carr, D. A. Ellison

March 1973

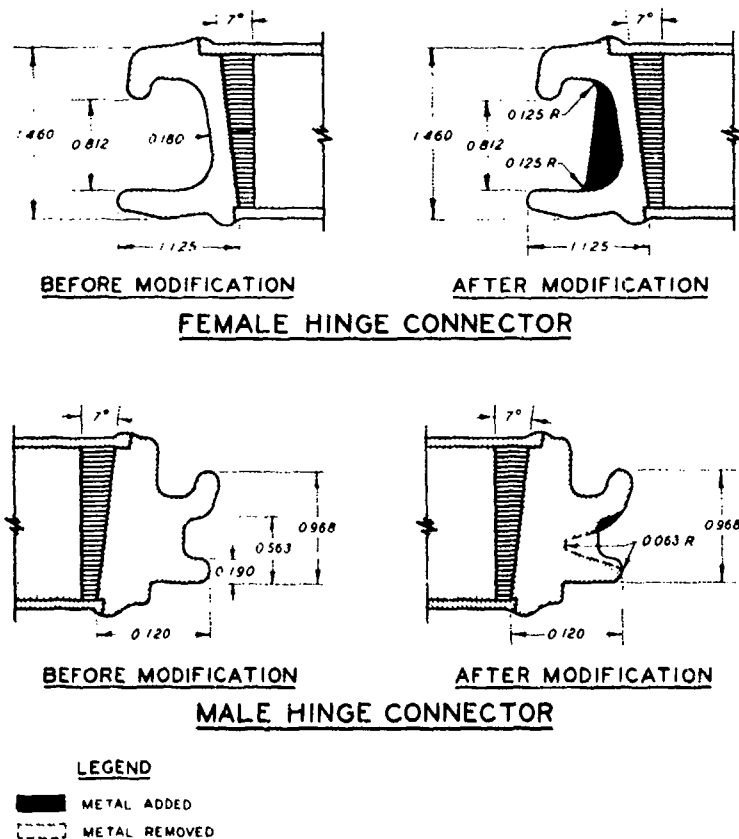
10. Since previous EDT's of MX19 mat had established a fairly consistent failure mode along the female connector,^{1,2} modifications of the male and female connectors, directed towards extending the service life of the mat, were incorporated in the design (see fig. 2). The MX19-B had the following modifications:

- a. The female connector was strengthened by increasing the thickness of the vertical member to reduce flexure and deflection.
- b. A wedge of metal was removed from between the lip and flange of the male connector (fig. 2) to relieve the concentrated stresses between the male and female connectors at the load transfer point.

Fig. 2. Modification of MX19 male and female connectors

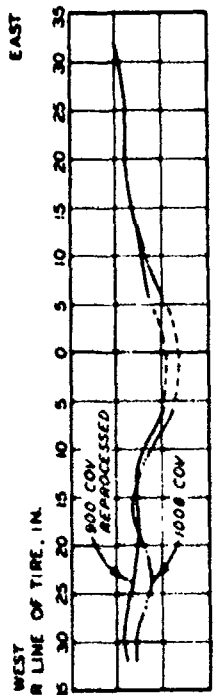
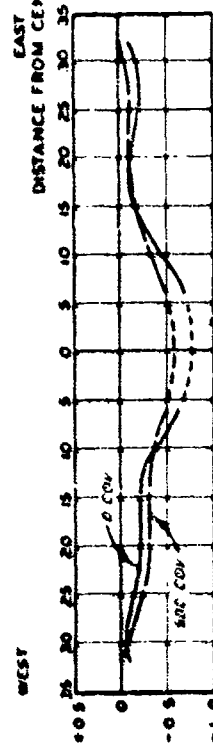
30. The rated CBR of the subgrade of item 1 ranged from 4.1 to 4.3 (table 1). The maximum static deflection was 1.0 in., measured at the joint of three panels after 2400 coverages (table 2); and the maximum permanent deformation was 0.6 in., recorded after 2756 coverages (plate 7). These maximum measurements occurred on subgrades with an average CBR of 4.7 and 4.9, respectively.

STATIC DEFLECTION
ITEM 1, MX19-C MAT

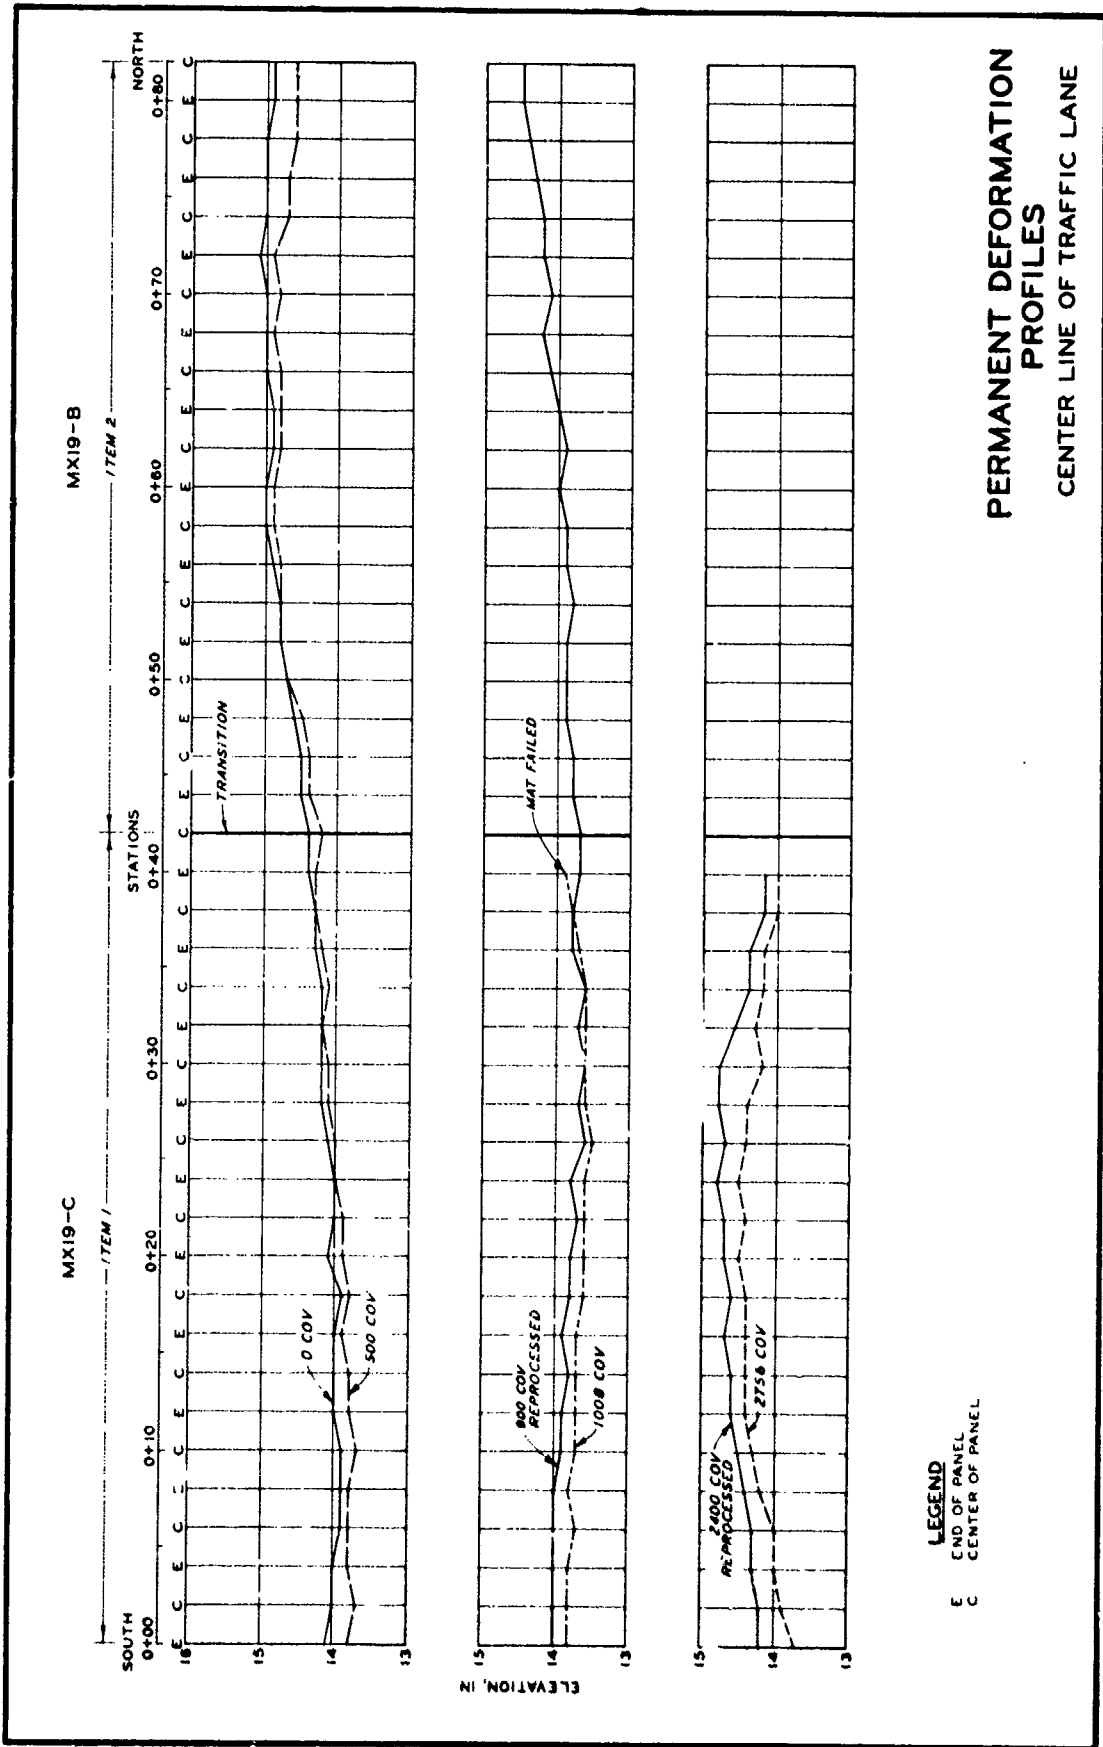
34. At this point, soil tests were performed under panels 70 and 78 (table 1). The general condition of item 2, other than panels 43 and 78, at 1008 coverages was good (photo 14). The maximum permanent deformation measured was 0.4 in. (plate 7), which occurred at 500 coverages, and the maximum static deflection was 0.7 in., measured at the joint of two panels at 1008 coverages (plate 5).

PERMANENT DEFORMATION
 PROFILES
 CENTER LINE OF TRAFFIC LANE

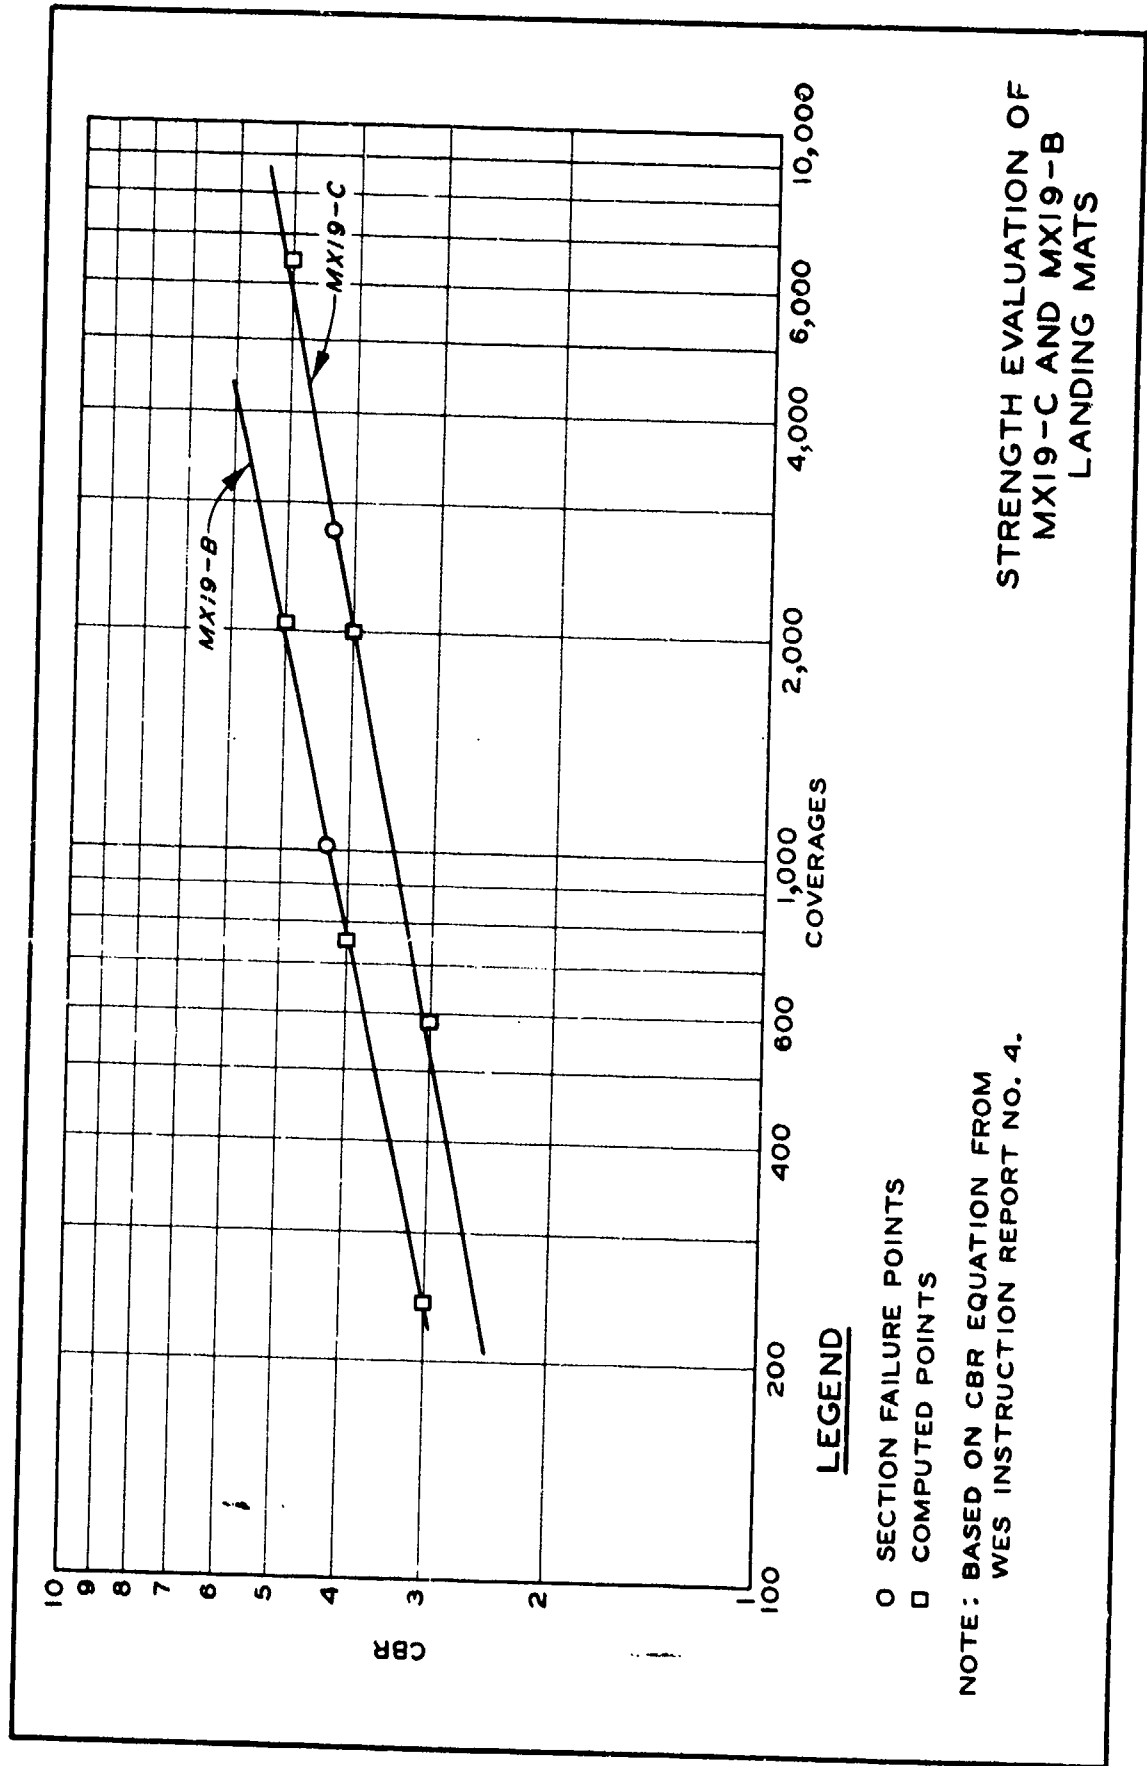
STRENGTH EVALUATION OF
 MX19-C AND MX19-B
 LANDING MATS
