STRENGTHENING OF KEYED LONGITUDINAL
CONSTRUCTION JOINTS IN RIGID PAVEMENTS

Army Engineer Waterways Experiment Station

TECHNICAL REPORT NO. AFWL-TR-72-174

March 1973

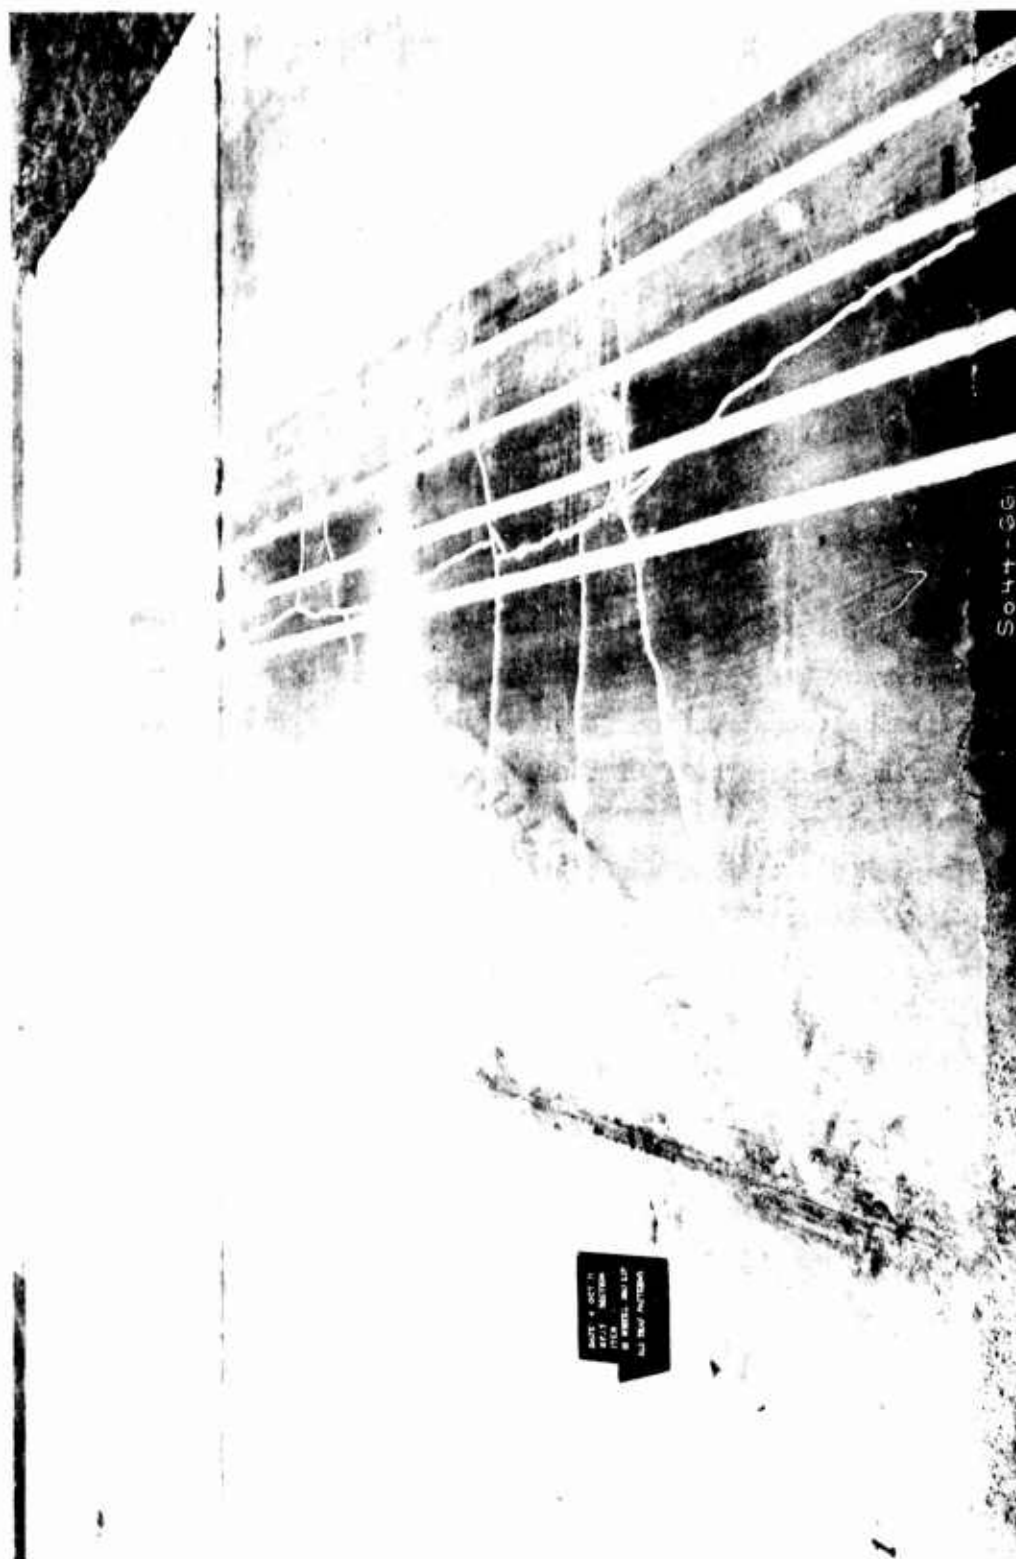
Figure 29. Item 1, 360-kip, 12-wheel-assembly lane after 504 coverages.

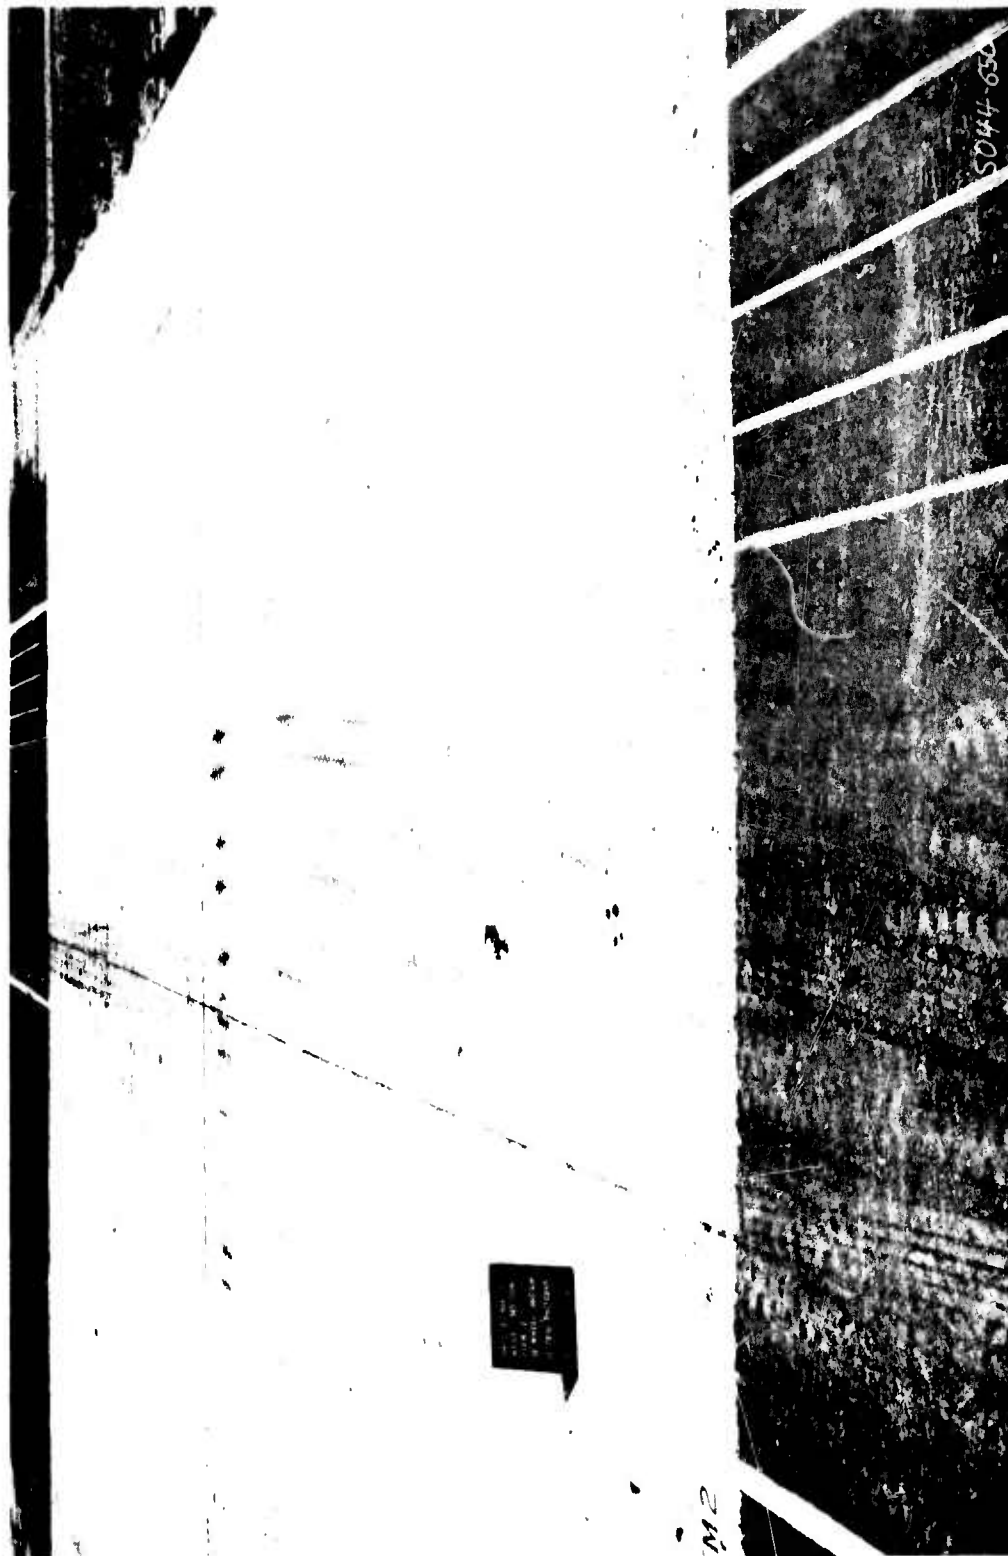
There were no structural cracks in the slabs in item 2 before traffic was commenced (figure 35). The only defect noticed prior to traffic

Figure 35. General view of item 2, 360-kip, 12-wheel-assembly lane prior to traffic.

on the surface of the pavement was a spall along the transverse joint between the northeast and northwest slabs. Pumping at the transverse joint between the east edge of the item and the transition section was noted after 8 coverages. After 16 coverages, passage of the test cart caused a small amount of clear water to squirt out around the edges of two of the 8-in.-diam holes located at the longitudinal construction joint in the western half of the item. This indicated that there was a very poor, if any, bond between the slab and the sand-cement grout used to fill the underreamed void and 8-in.-diam access holes. The lack of bond did not appear to have any effect on the strengthening characteristics. Slight spalling and flaking were also observed around the edges of the access holes after 16 coverages of traffic.

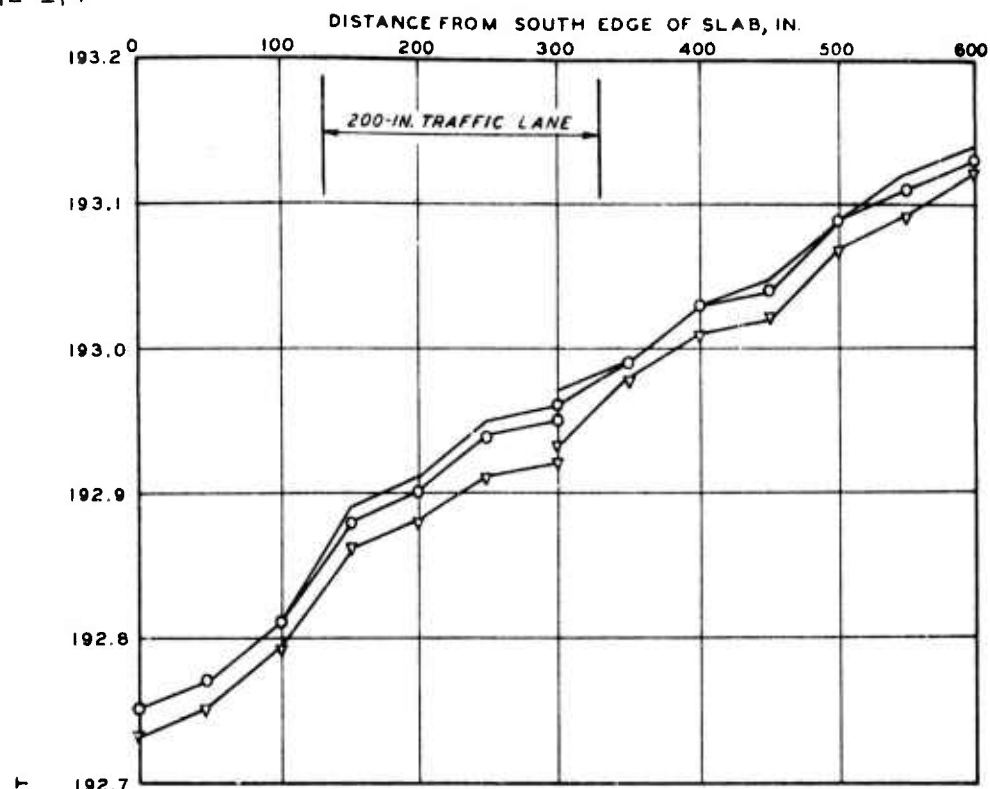
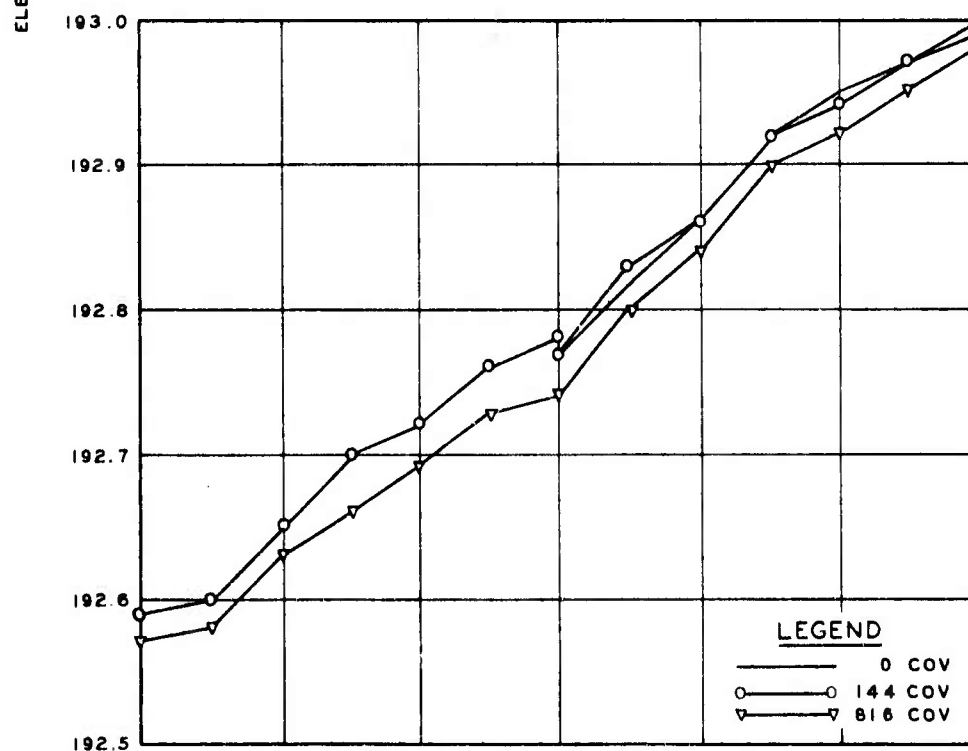
Typical cross sections at the center of each slab show the permanent deformation in the test lane due to traffic (figure 43). The average permanent deformation was about 0.24 in. with maximum deformation of 0.48 in.

Figure 43. Typical cross sections of item 2, 360-kip, 12-wheel-assembly lane.

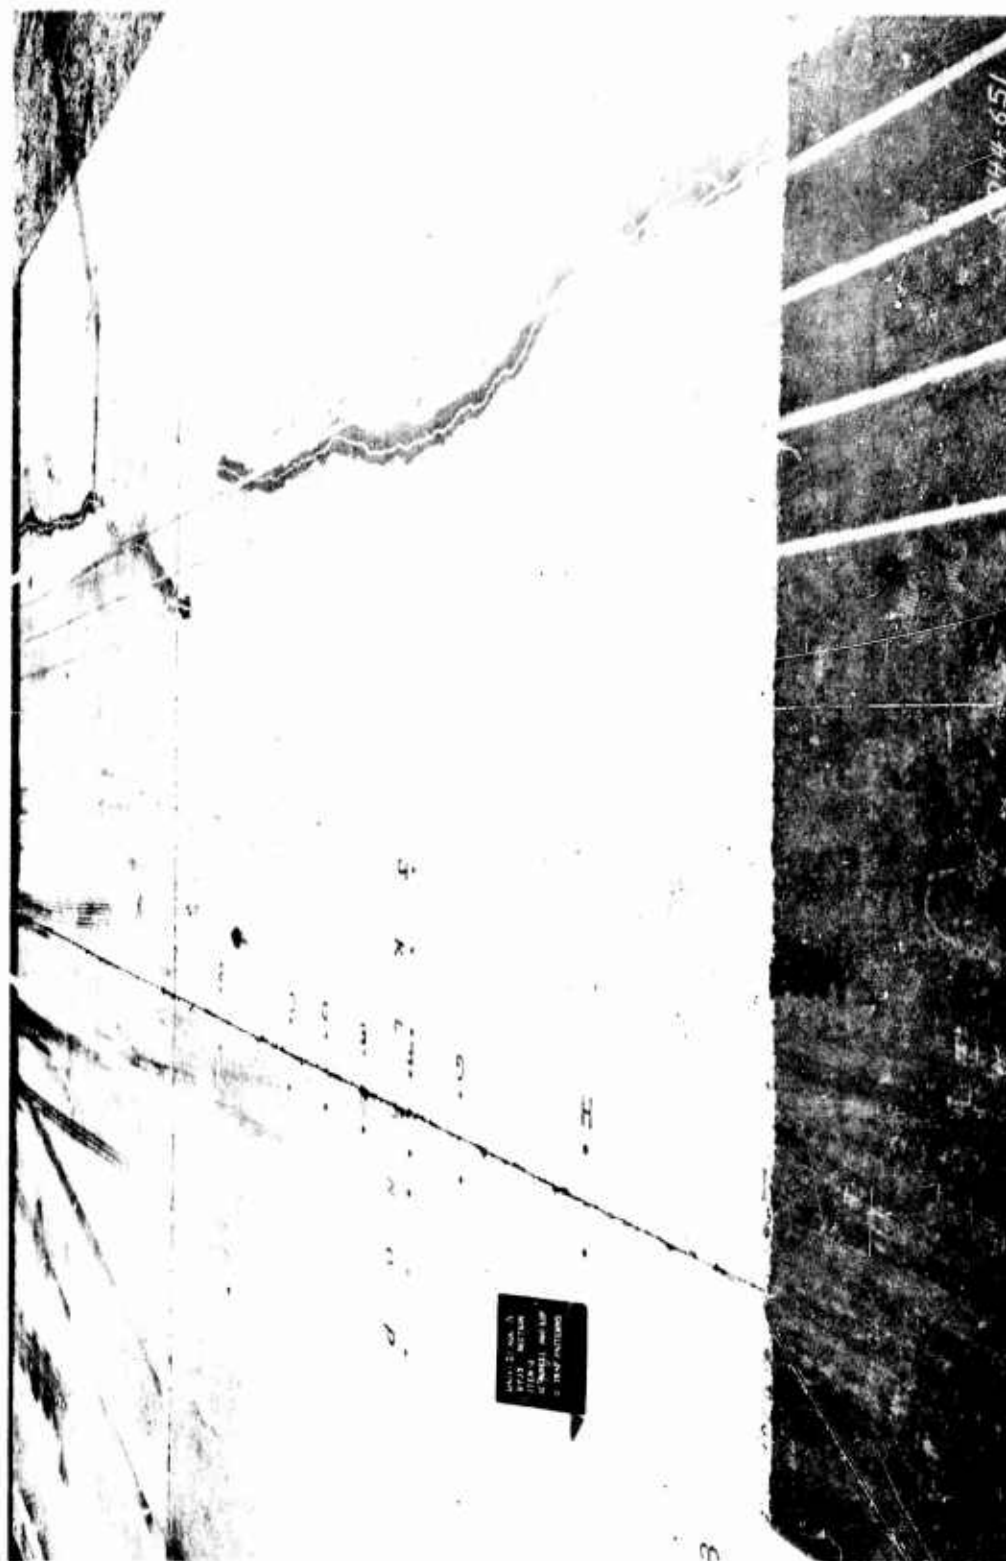
A general view of item 3 prior to test traffic is shown in figure 45. As can be seen in this photograph, several cracks developed during the curing of the slab. An epoxy cement was placed under pressure (10 psi) into the longitudinal cracks located in the southeast slab running from the south free edge of the slab to the longitudinal joint. Epoxy cement was first applied to the surface of the pavement and allowed to cure before the epoxy cement was forced under 10-psi pressure into the cracks. There was also a transverse crack between the southwest and southeast slabs parallel to the weakened-plane construction joint. However, since this crack developed prior to the construction of the weakened-plane joint, it was decided to consider the crack as the joint between the two slabs.

Figure 45. Item 3, 360-kip, 12-wheel-assembly lane prior to traffic.

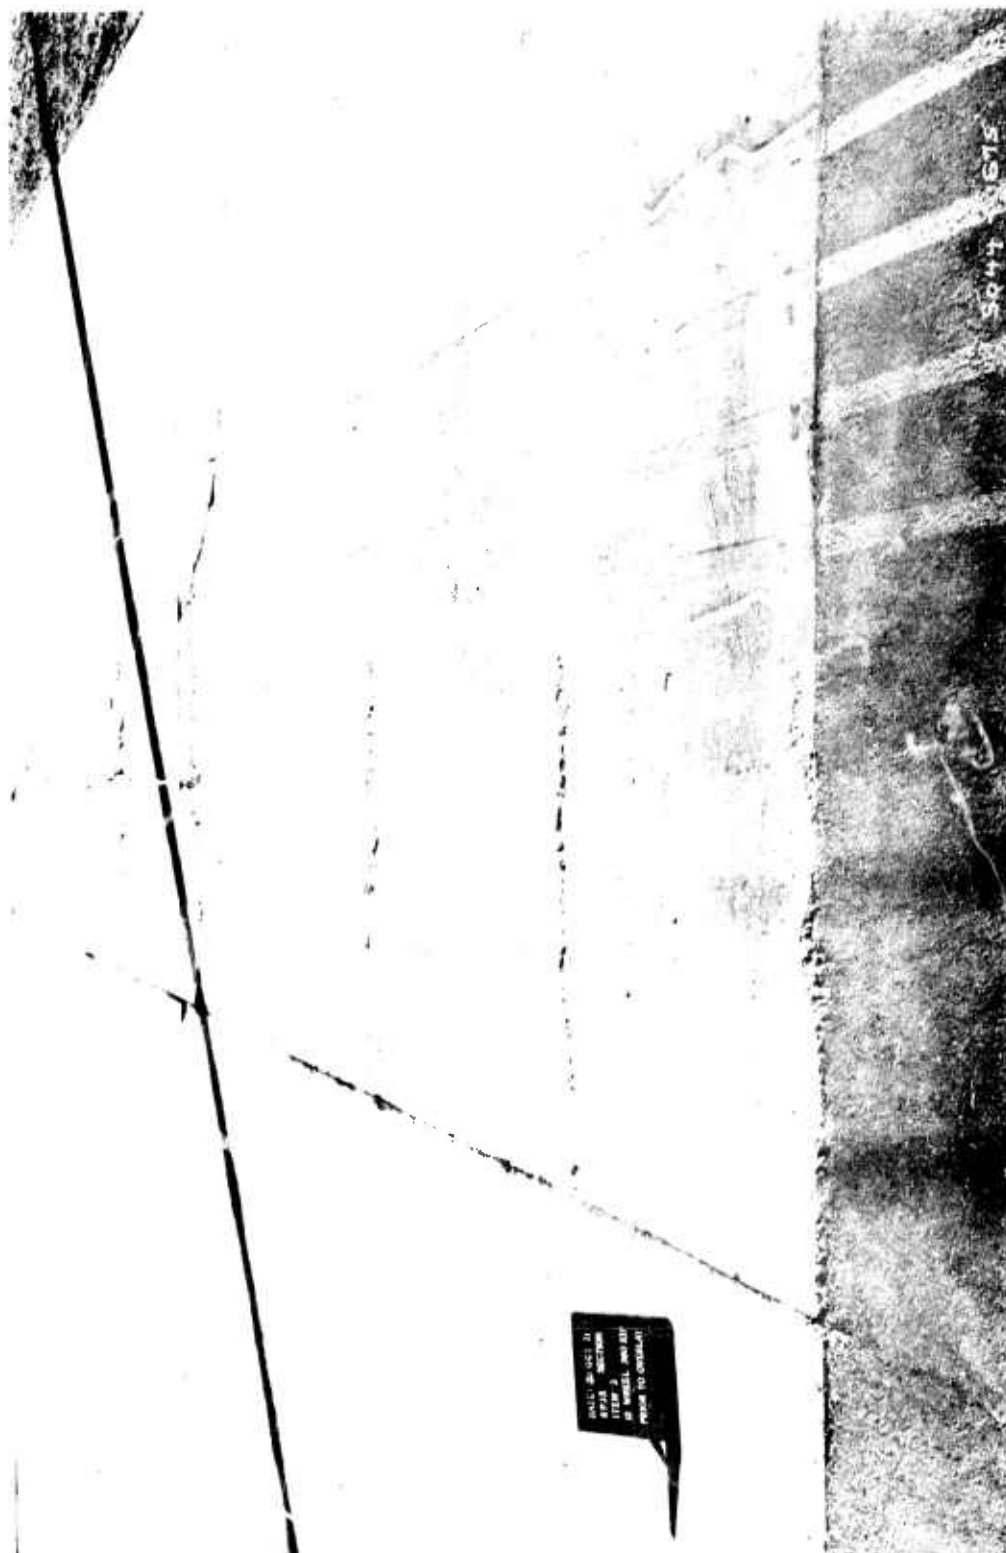
Figure 50. Item 3, 360-kip, 12-wheel-assembly lane after 688 coverages.

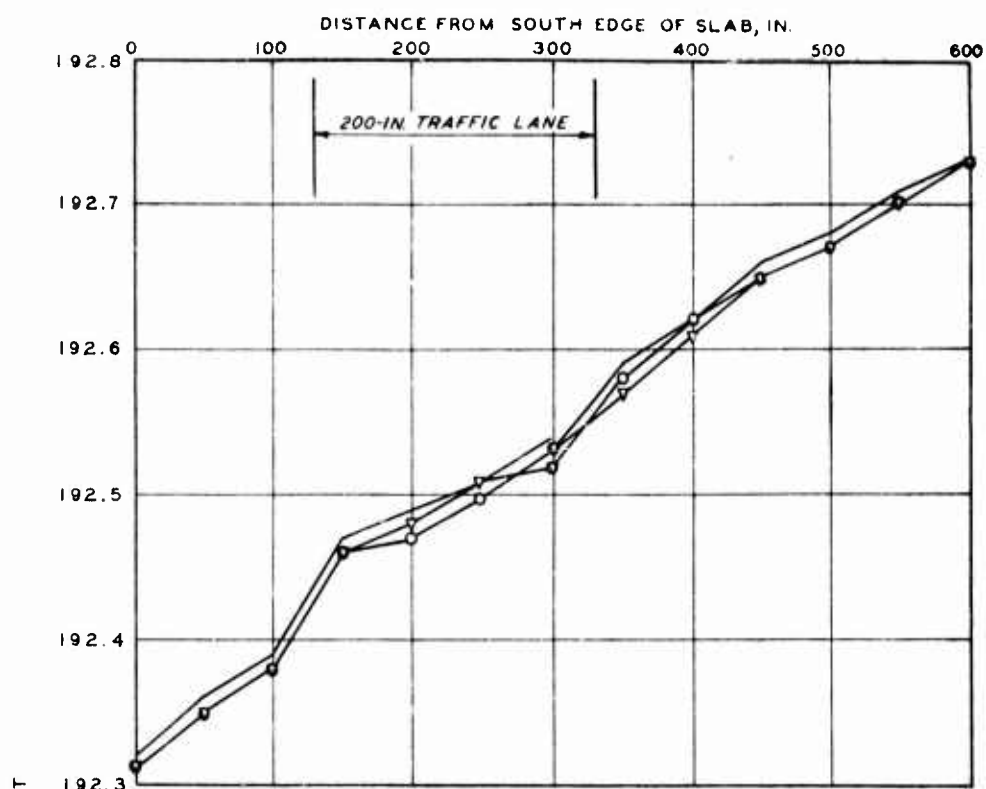
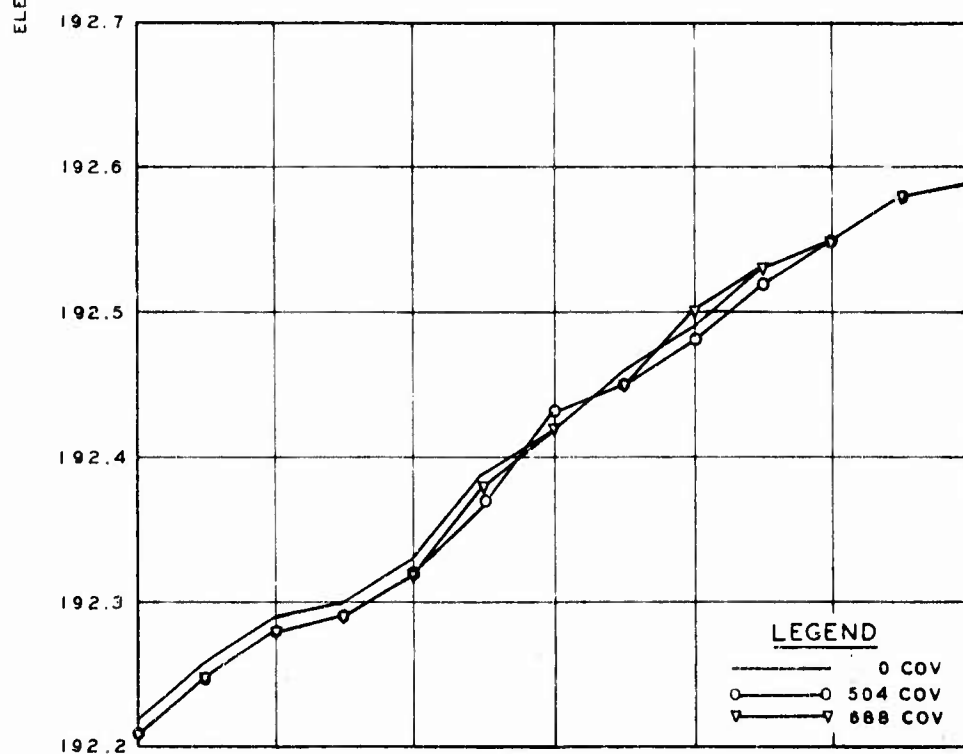
The typical cross-section plot of item 3 shown in figure 52 indicate that the average permanent deformation after 688 coverages (prior to overlaying) was about 0.18 in., and the maximum deformation measured was 0.24 in.

Figure 52. Typical cross sections of item 3, 360-kip, 12-wheel-assembly lane.

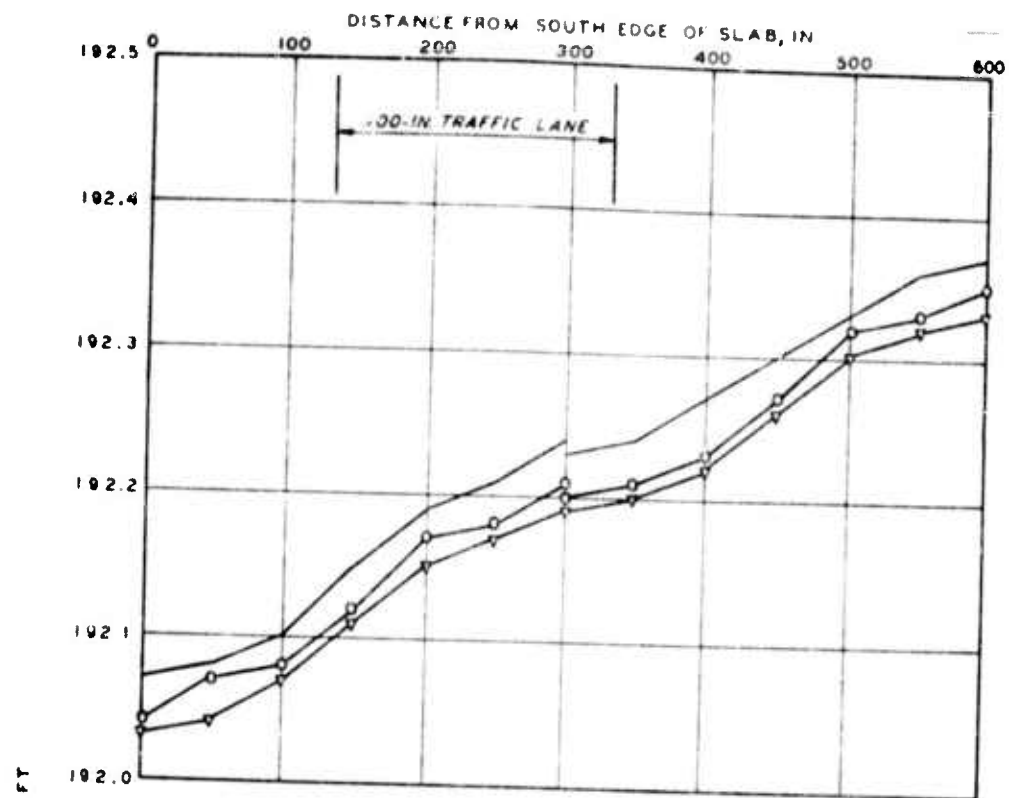
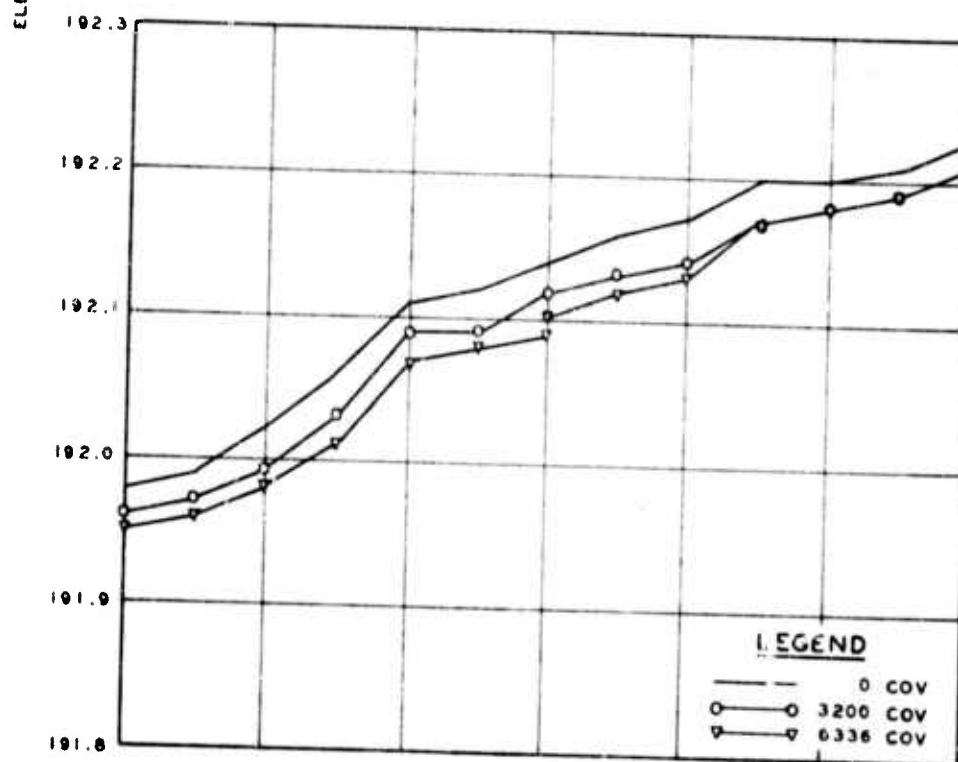
A typical cross section for this item indicating the permanent deformation due to traffic is shown in figure 58. The average permanent deformation was about 0.48 in. and the maximum deformation was 0.60 in. This plot indicates that about 75 percent of the average

Figure 58. Typical cross sections of item 4, 360-kip, 12-wheel-assembly lane.

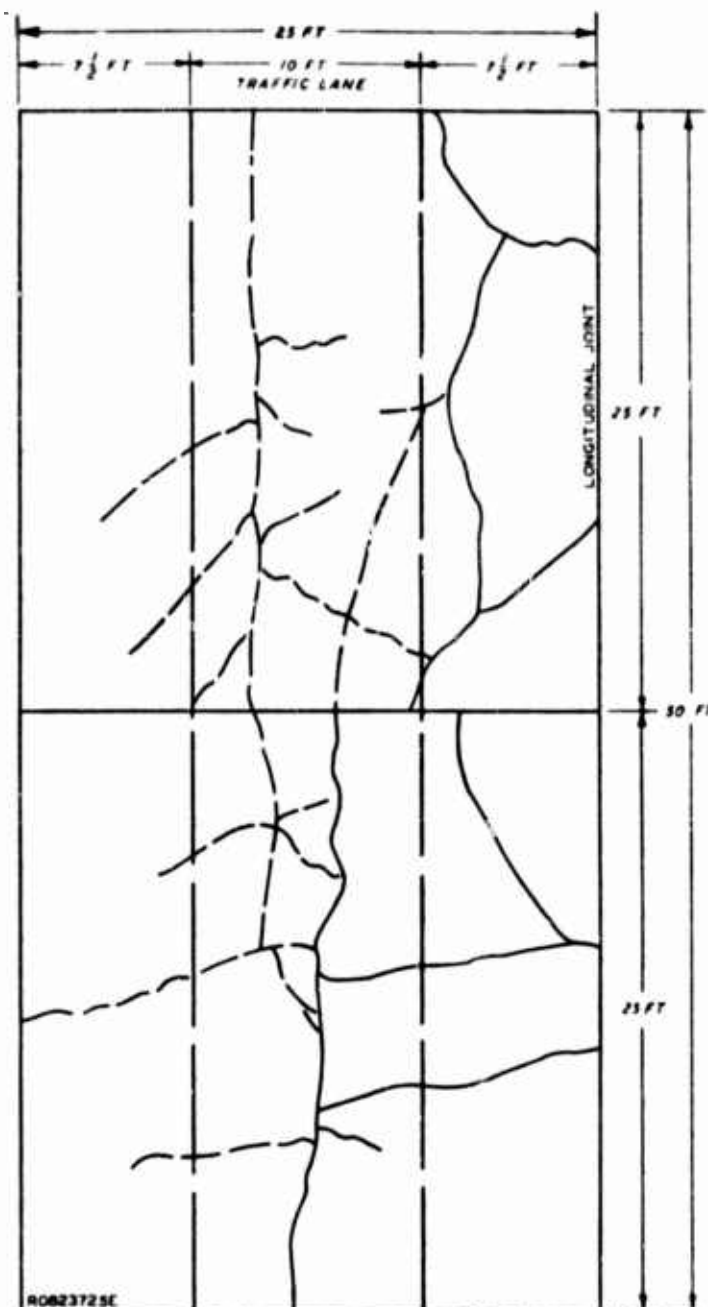
A general view of the item prior to traffic is shown in figure 60. As can be seen, both slabs contained cracks prior to traffic. The longitudinal crack in about the center of the traffic lane of the northwest slab was detected prior to the 12-wheel-assembly traffic; the remaining cracks developed during the 12-wheel-assembly traffic. When the twin-tandem traffic was commenced, pumping was observed at the existing longitudinal crack in the northwest slab. The initial crack due to traffic, a 6-ft-long longitudinal crack in the northeast slab, was detected after 4 coverages of traffic and continued to progress and extended the length of the slab after 35 coverages. After 35 coverages, several diagonal cracks and another longitudinal crack had developed in the northeast slab, and a longitudinal and several transverse cracks were observed in the northwest slab. Traffic was discontinued after 35 coverages when the item was considered to be a shattered-slab failure. A general view of the item at failure is shown in figure 61. The progression and extent of cracking during the traffic period is shown in figure 62.

Figure 62. Crack development in item 1 under 166-kip, twin-tandem-assembly traffic.

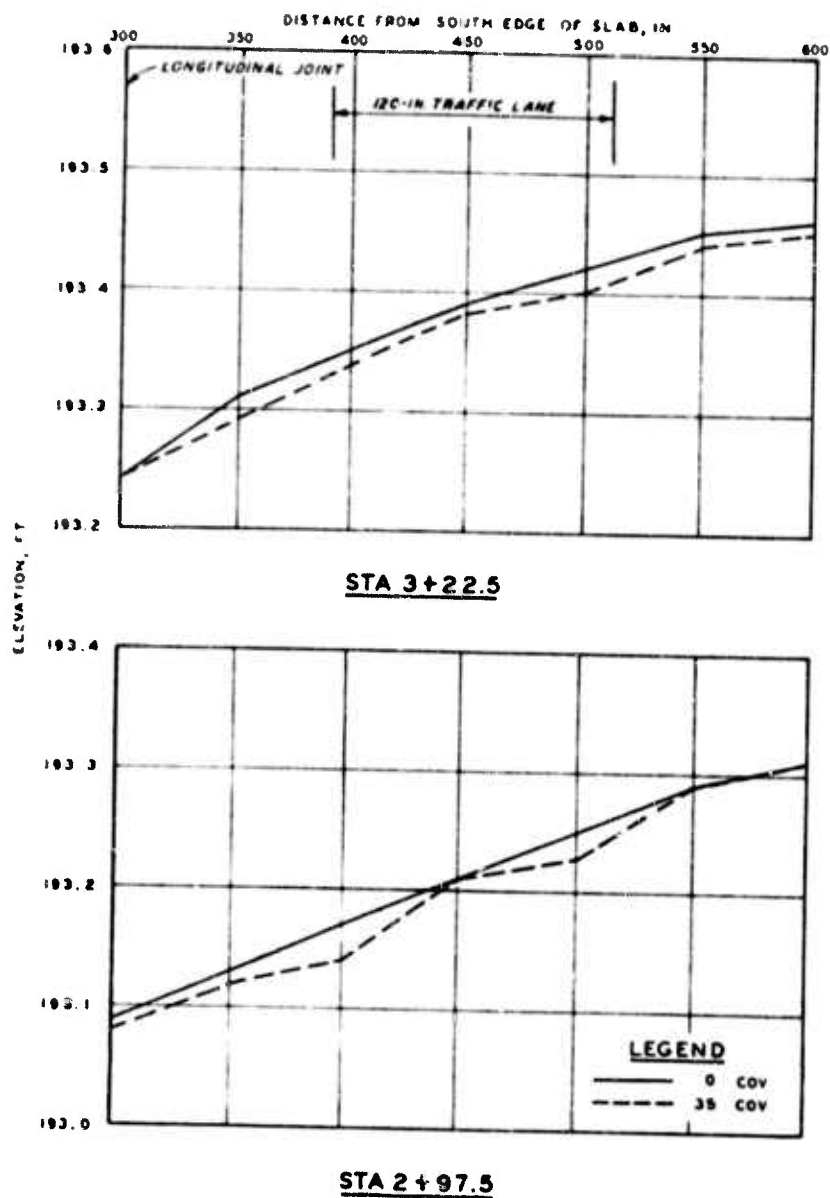
Typical permanent deformations, which occurred as a result of traffic, are shown by the typical cross-sections taken at the center of each slab (figure 63). An average deformation of about 0.15 in. and a maximum of 0.36 in. were recorded. The maximum total deflection measured prior to traffic was about 0.12 in. Plots of deflection measurements taken prior to traffic are shown in figure 64.

Figure 63. Typical cross sections of item 1, twin-tandem-assembly lane.

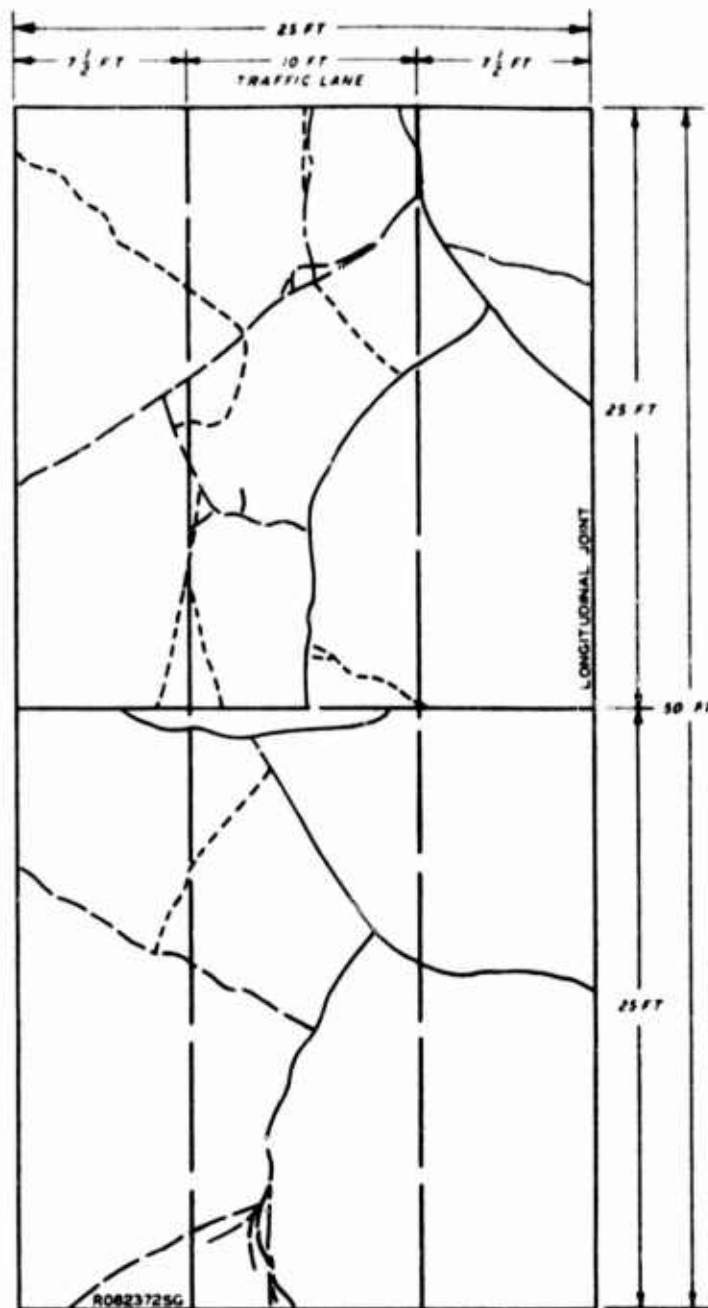
Figure 67. Crack development in item 2 under 166-kip, twin-tandem-assembly traffic.

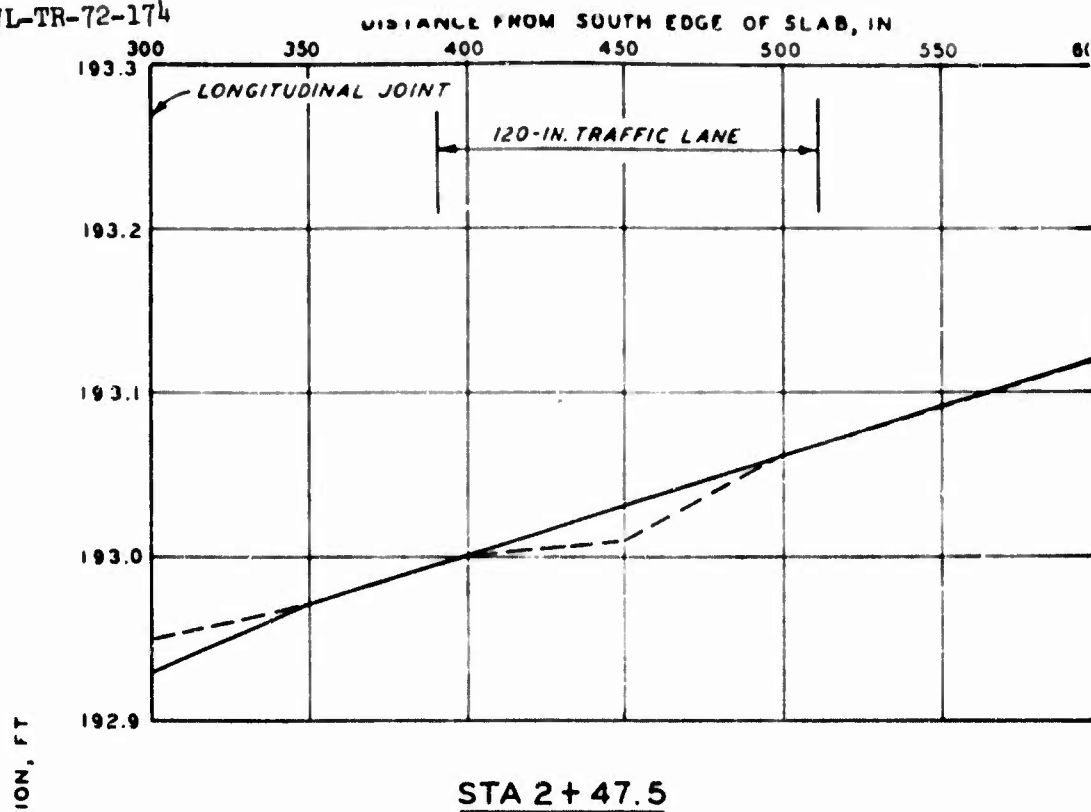
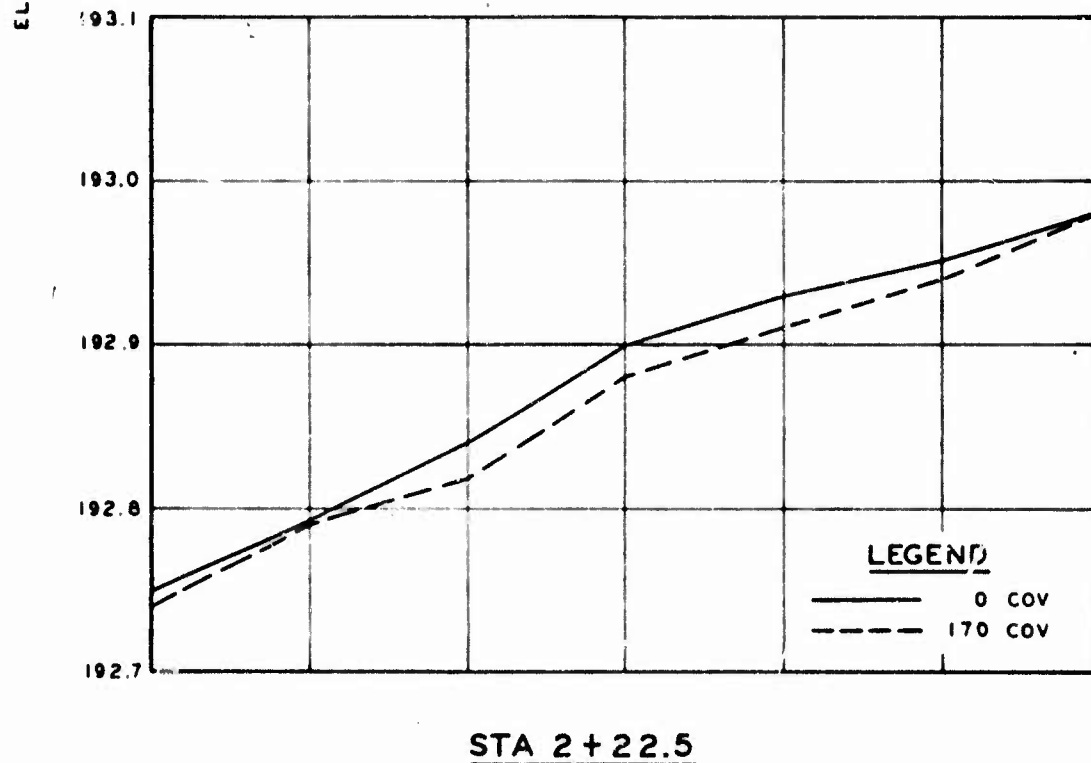
Typical cross-section plot showing the permanent deformation that occurred during traffic is shown in figure 68. The maximum deformation measured at the conclusion of traffic was 0.24 in. As shown in figure 69, a maximum total deflection of about 0.13 in. was measured prior to traffic.

Figure 68. Typical cross sections of item 2, 166-kip, twin-tandem-assembly lane.

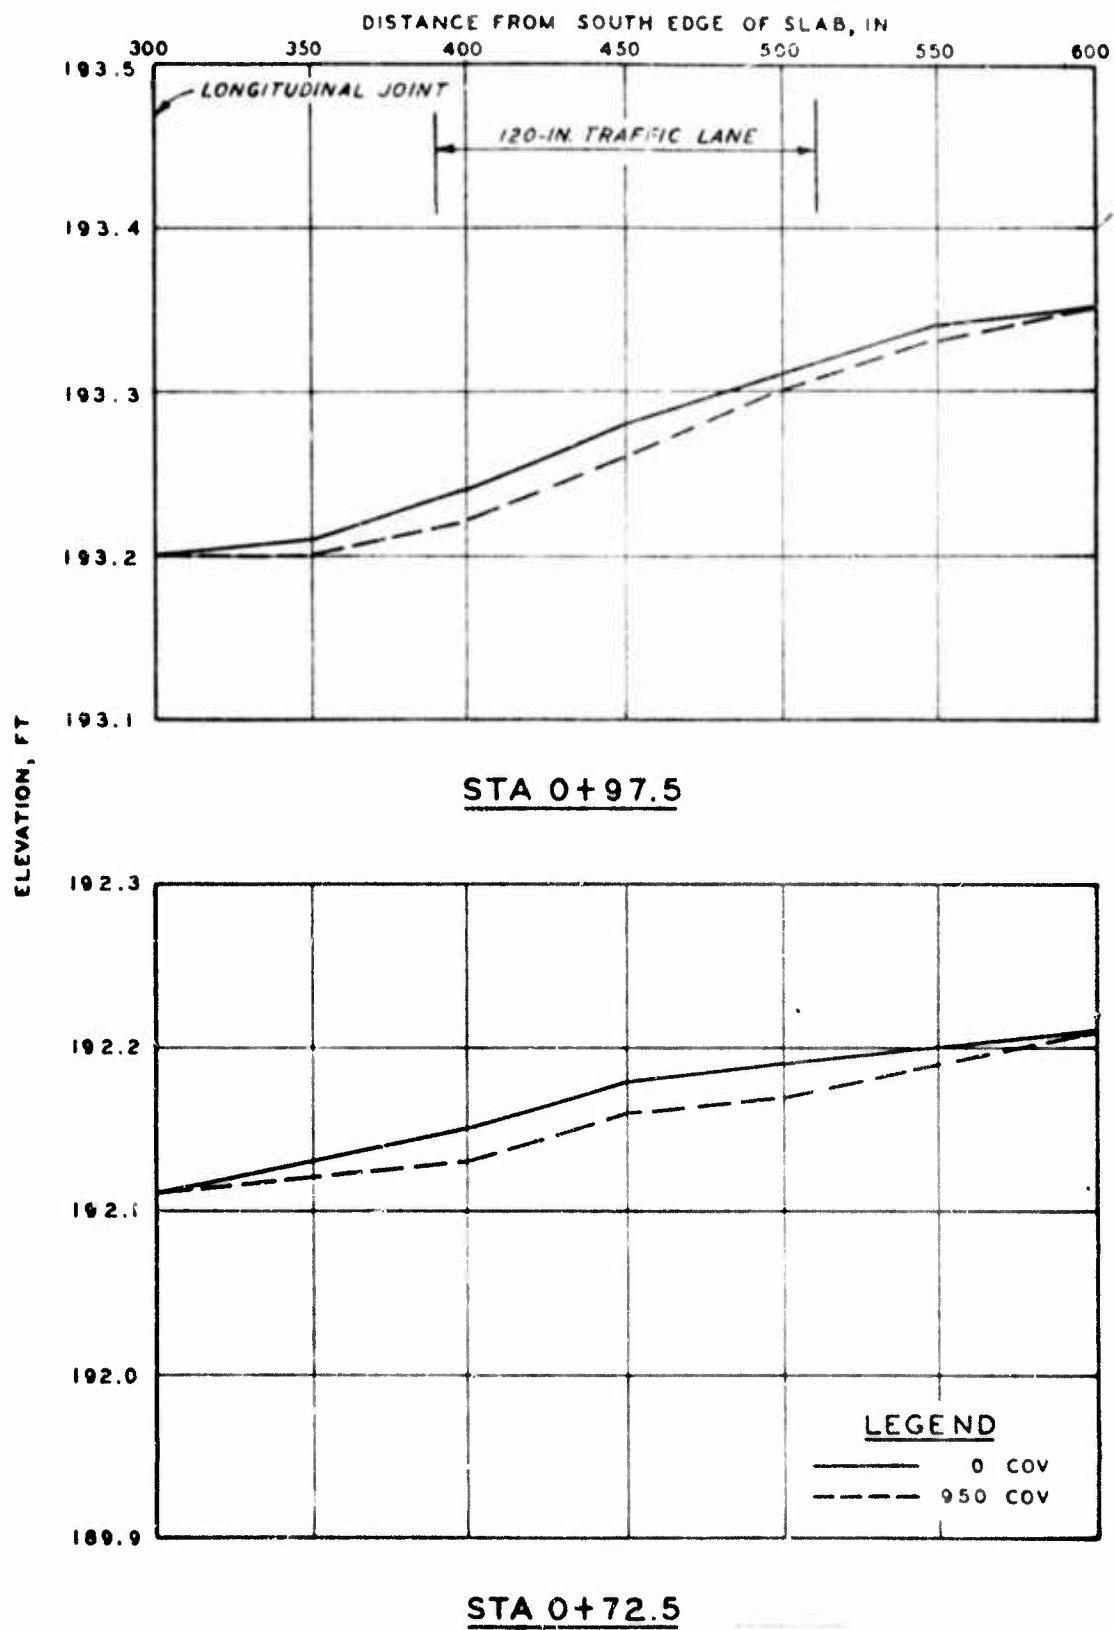
The maximum total deflection measured prior to traffic was about 0.09 in. A plot of the deflection basin measured before applying test traffic is shown in figure 74. As can be seen from the typical cross-section plots shown in figure 75, the average permanent deformation after failure was about 0.18 in., and the maximum permanent deformation was 0.24 in.

Figure 75. Typical cross sections of item 4, 166-kip, twin-tandem-assembly lane.
