ANALYSIS OF HYDROPHONE SUPPORT STRUCTURE
AFTER 52-1/2 MONTHS EXPOSURE AT A DEPTH
OF 5270 FEET IN THE BARKING SANDS TEST
RANGE, KAUAI, HAWAII

James F. Jenkins

Naval Civil Engineering Laboratory
Port Hueneme, California

Technical Note N-1267

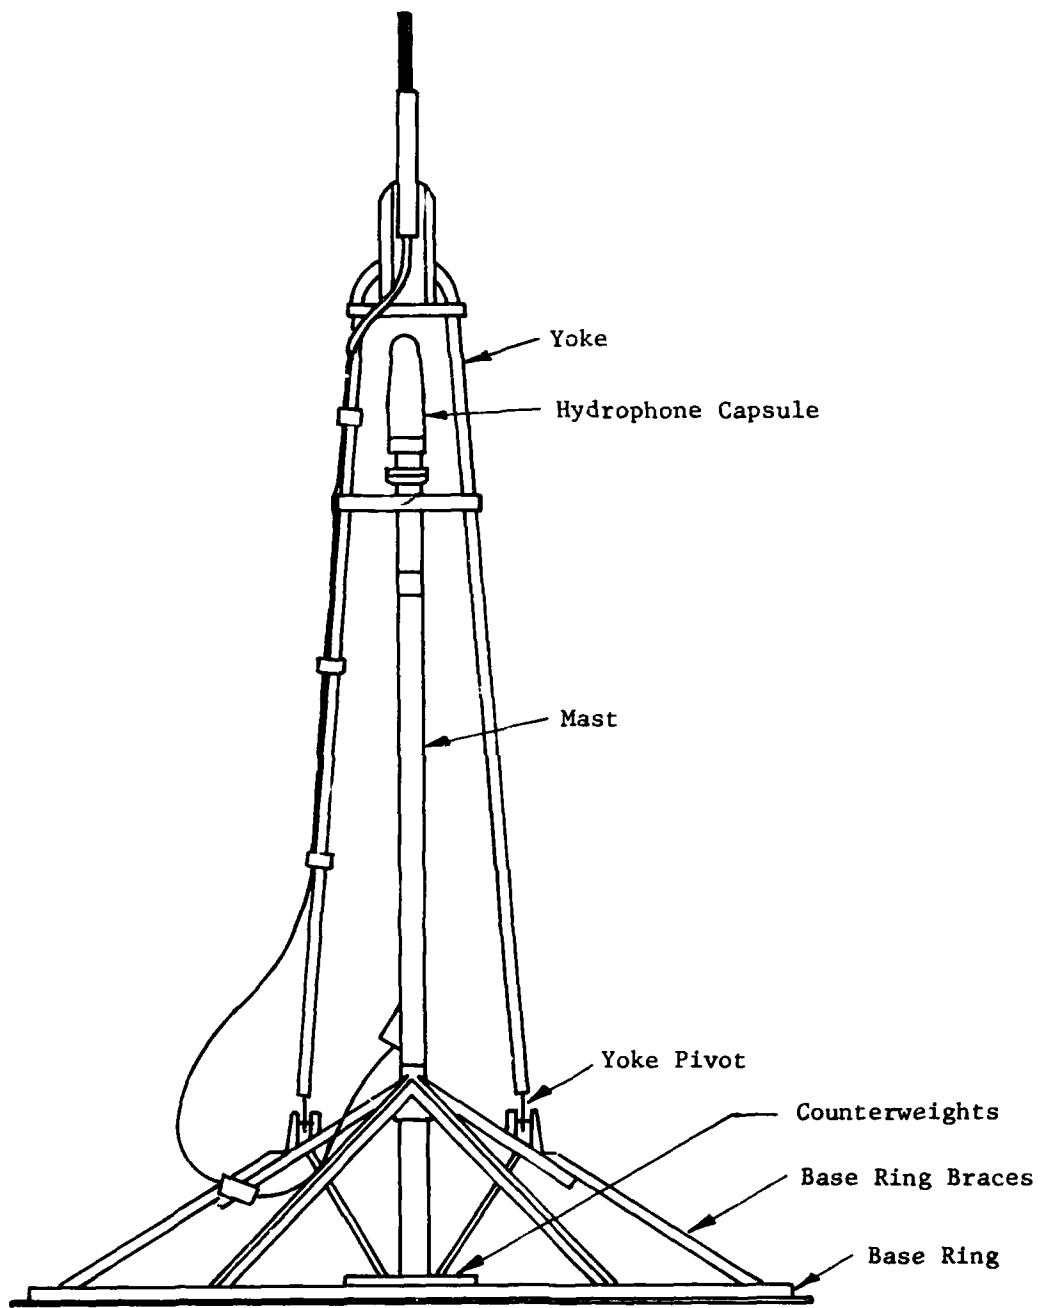
The hydrophone support structure, when assembled, is approximately 15 feet high and 12 feet in diameter at its base. A sketch of the structure is shown in Figure 1. The structure was constructed from aluminum alloy bar, plate, channel and extruded tubing, and from PVC, steel, and Ni-Cu alloy 400. Spectrochemical analyses of the aluminum components showed that they were Aluminum Magnesium alloy 5086 which contains nominally 4% Magnesium. Microstructural analysis of polished component sections showed the plate and tube to be in the strain hardened and stabilized condition (H-32) while the channel and bar were in the as extruded condition (H-111). Welds on the aluminum structure were also analyzed and found to conform to the chemical specifications for alloy 5086. Weld deposits of this composition can be obtained by using the filler wire alloy 5356 as specified. Chemical spot tests confirmed that all fasteners were made from Nickel-Copper alloy 400 (67% Ni-33% Cu).

Figure 1. Hydrophone support structure.
