THRESHOLD DAMAGE IN RADOME MATERIALS
BY DISCRETE WATER IMPACT (BALLISTICS
RANGE INVESTIGATION)

Naval Ordnance Laboratory
White Oak, Maryland

13 February 1973

NOLTR 73-34

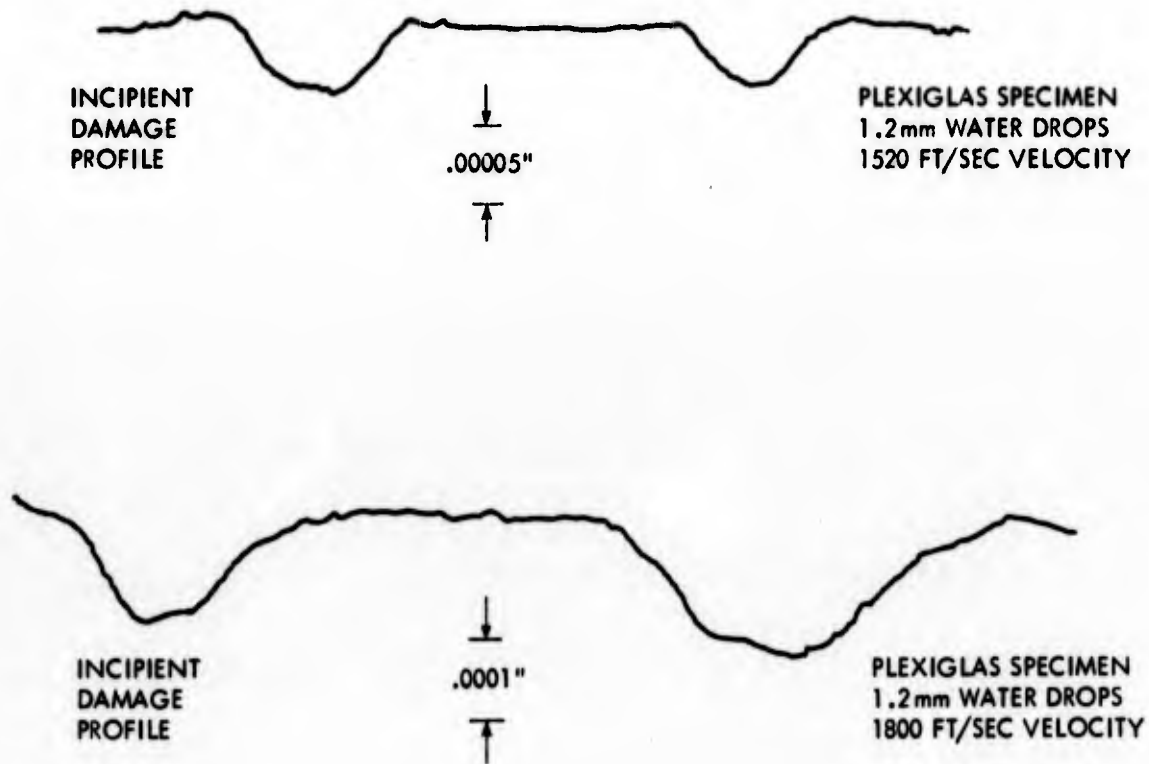
applied to the evaluation of pitting and surface roughening as indicated in Figures 4 and 6. The profilometer is also directly applicable to surface deformation evaluation as indicated in Figure 8.

FIG. 8 PROFILES OF SURFACE DEFORMATION USING A ROUGHNESS PROFILOMETER
