INVESTIGATION OF THERMAL FATIGUE IN
NON-TUBULAR REGENERATIVELY COOLED
THRUST CHAMBERS. VOLUME II

AFRPL-TR-73-10
VOLUME II

FINAL REPORT
VOLUME II

ROCKETDYNE DIVISION, ROCKWELL INTERNATIONAL
6633 Canoga Avenue, Canoga Park, California

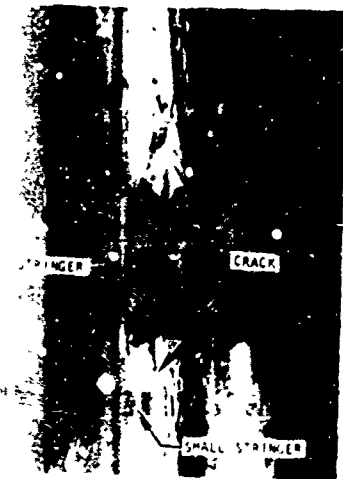
20X

APPEARANCE AFTER OPENING BY BENDING
