EVALUATION OF REDESIGNED XW18 MEMBRANE
AND ACCESSORIES

Army Engineer Waterways Experiment Station
Vicksburg, Mississippi

May 1973

TECHNICAL REPORT S-73-3

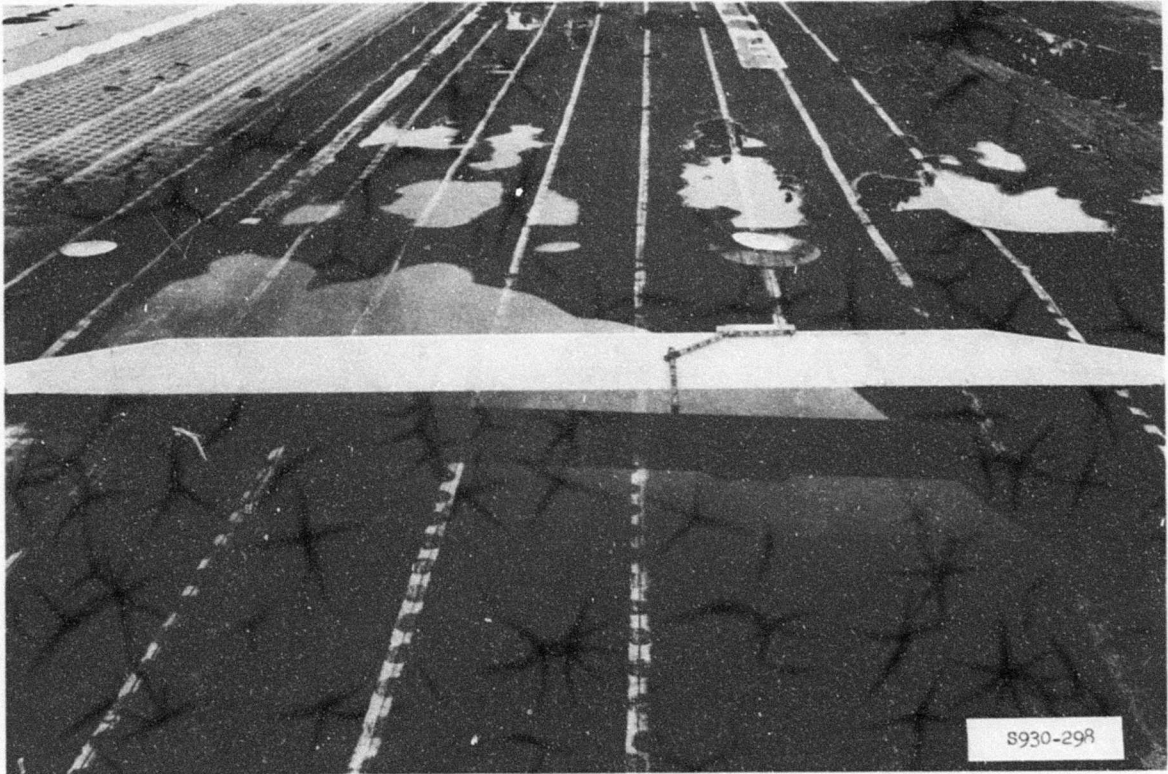
Photo 55. Rutting of subgrade of test section 1, sta 1+05, after 538 coverages

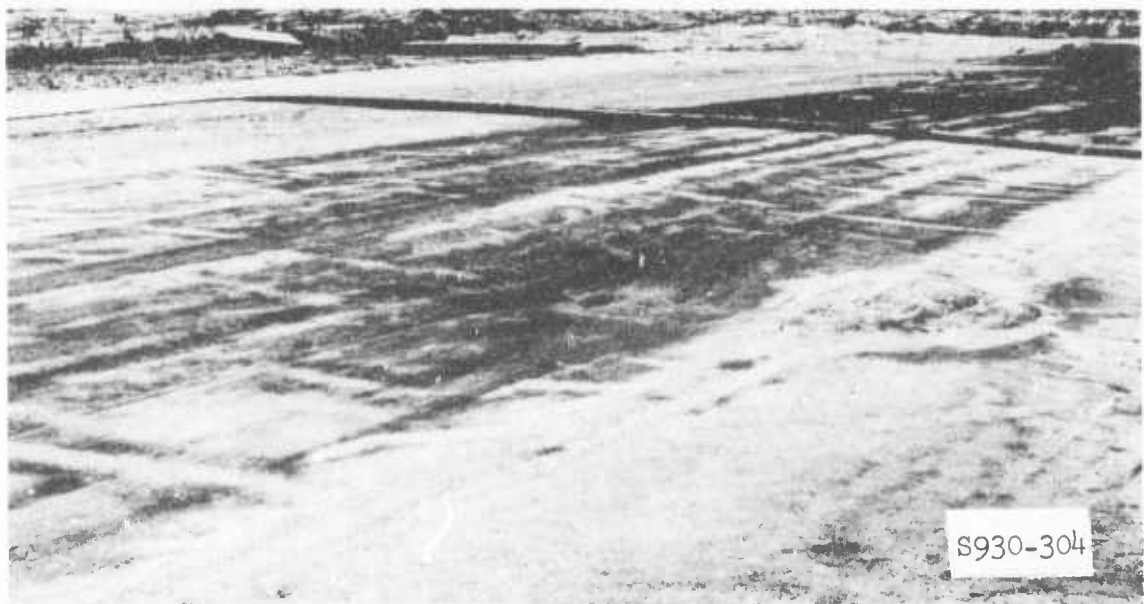
Photo 58. Sheet 2 of test section 1 cut along sides and folded back for repair of subgrade (538 coverages); note depressed area at center

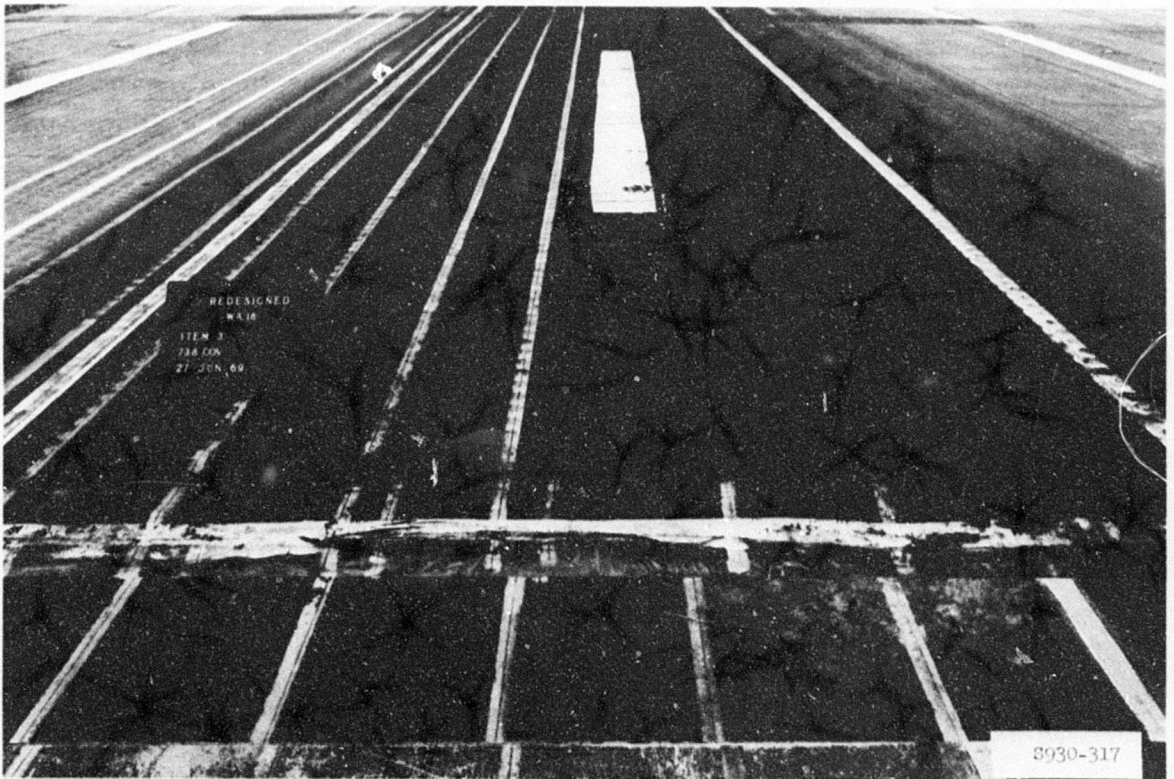
72. With the repair of the subgrade and replacement of sheet 3 completed, trafficking was resumed. At 738 coverages, no rutting of the subgrade was noted. The general condition of sheets 1, 2, and 3 at this time is shown in photos 64-66. The neoprene coating on one run of sheet 1 had worn down to the fabric. Photo 67 is a close-up of this condition showing the top ply of the fabric exposed in most areas except where the nonskid pattern remained. After 738 coverages, an inspection of the nonskid pattern on sheets 1 and 2 revealed that an average of 64 and 86 percent, respectively, of the nonskid remained. After 200 coverages, 84 percent of the nonskid pattern remained on sheet 3A (plate 17). The general condition of both sealants used along the edges of the reinforcing strips was good (photo 68). Both sealants exhibited adequate resistance to the wear of the test wheel, adhered well to the membrane, and provided watertight seals.

Photo 66. Sheet 3A of test section 1 after 200 coverages (total of 738 coverages on test section)

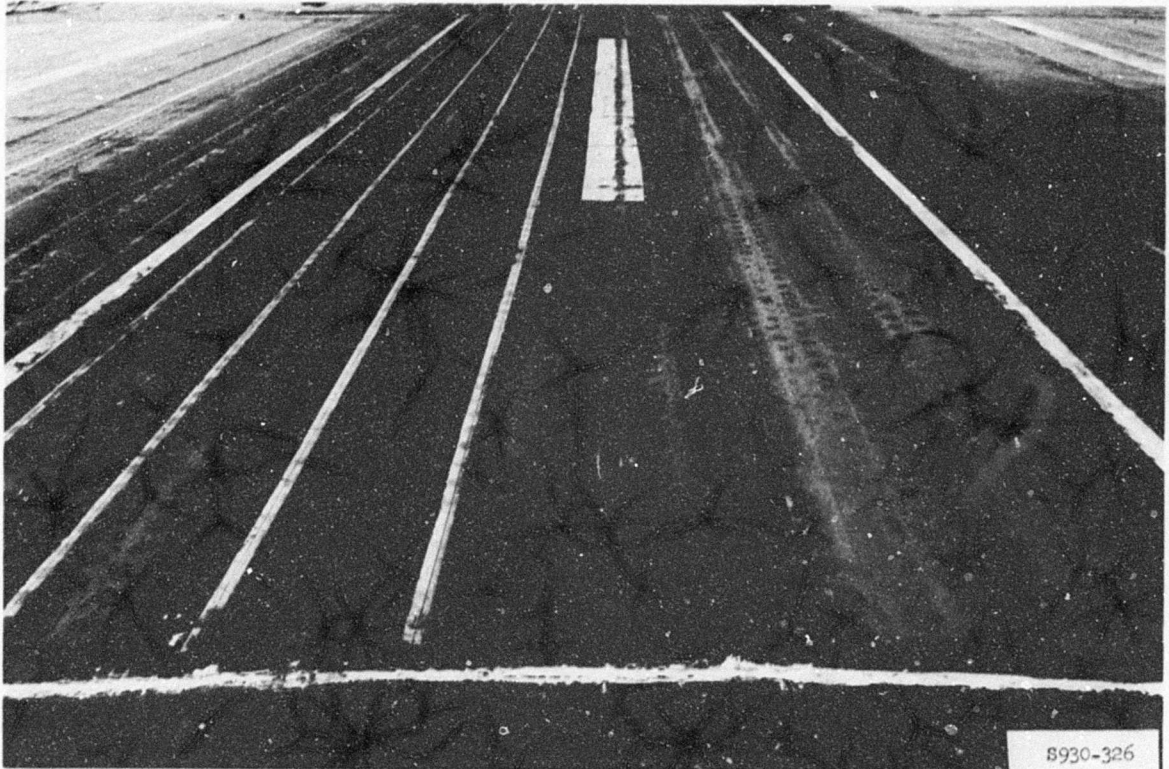
73. After 910 coverages, considerable wear had occurred on sheets 1 and 2, as shown in photos 69 and 70. The light areas in the traffic lane shown in the photos are areas where the neoprene coating was removed by the abrasion of the test wheel and the top ply of nylon fabric was exposed. The 6-in.-wide factory fabrication joints, however, were still in good condition. No repairs were necessary, and the membrane remained weatherproof. Sheet 3A also exhibited signs of wear, but to a lesser degree than sheets 1 and 2 (photo 71). However, a total of only 372 coverages of the test wheel had been applied to sheet 3A since it had been placed when the subgrade was repaired after

Photo 69. Condition of membrane sheet 1 of test section 1 after 910 coverages

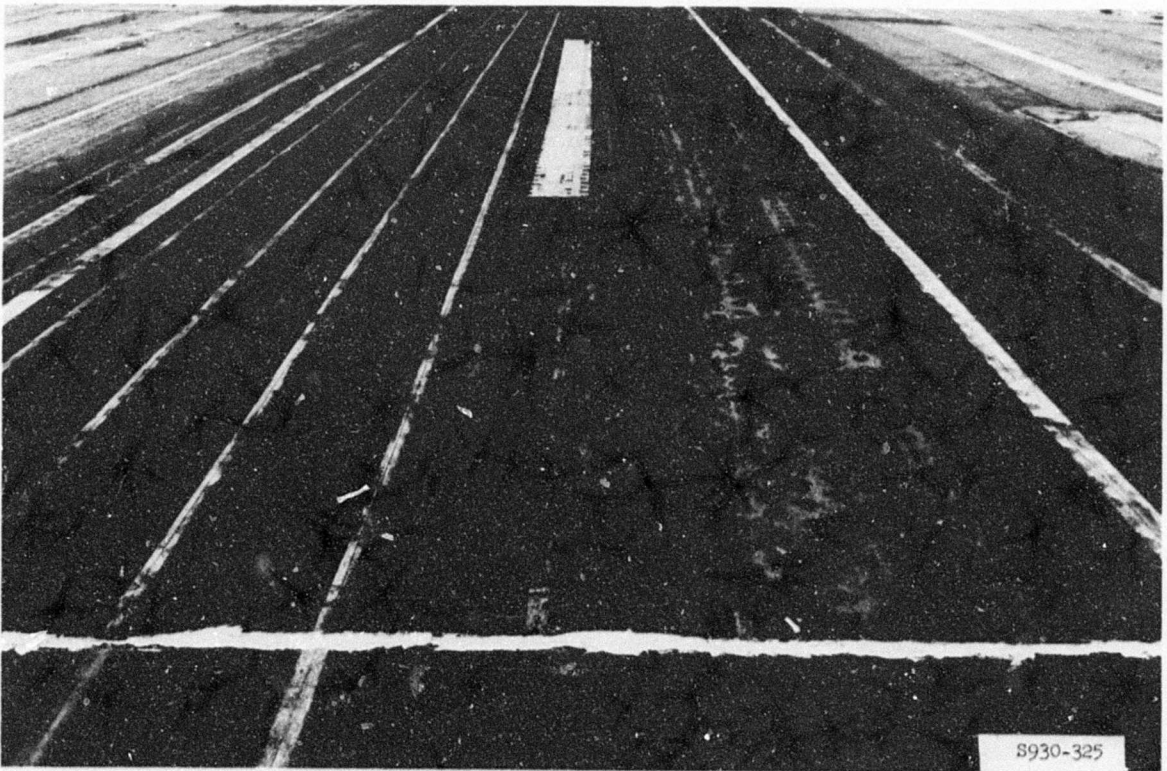
Photo 70. Condition of membrane sheet 2 of test section 1 after 910 coverages

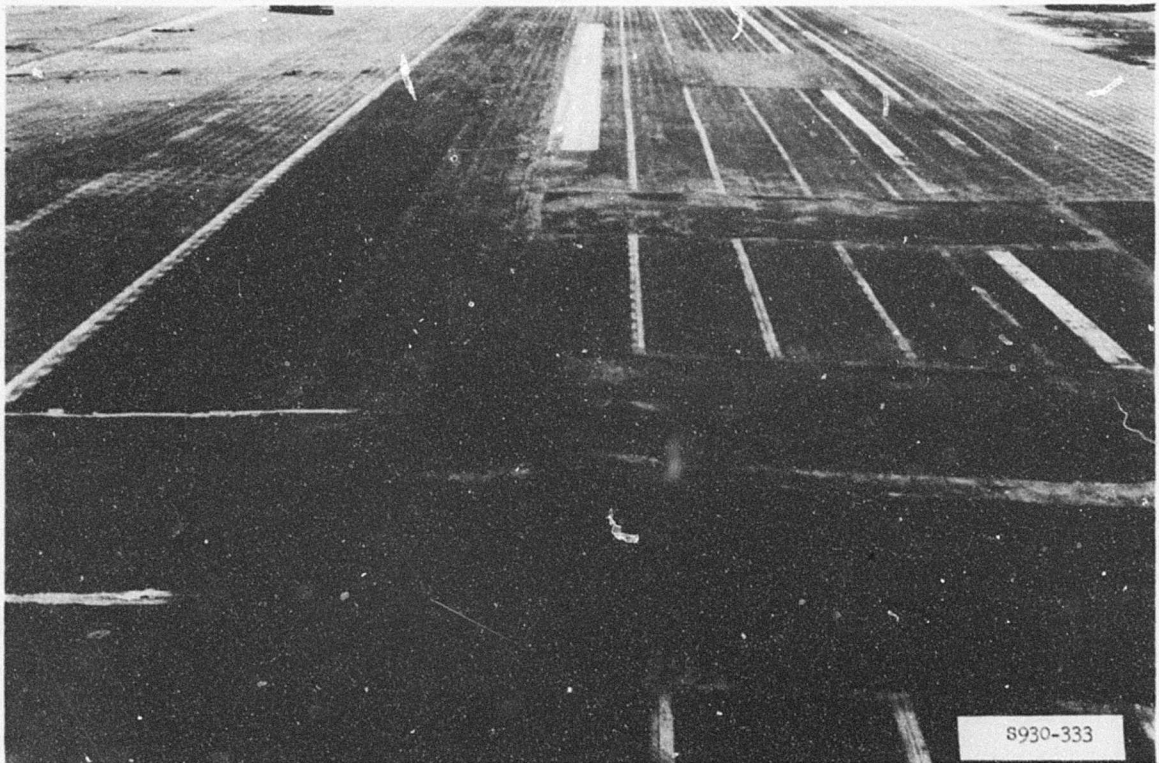
74. At 1200 coverages, the condition of the surfacing was generally unchanged. Photos 72-74 are general views of sheets 1, 2, and 3A, respectively. The patches shown on the membrane surfaces in the photos are areas where the membrane had been cut for CBR determinations. Severe wear of the neoprene coating on sheets 1 and 2 had been caused by the abrasion of the test wheel at this coverage level. Photos 75 and 76 show a close-up of the wear on sheets 1 and 2, respectively. Severe wear of the neoprene coating of this type was present on approximately half of the area of both sheets. Sheet 3A (photo 77), which had received a total of 662 coverages since it had been placed at 538 coverages, showed no degree of wear approaching that of sheets 1 and 2.

Photo 73. Condition of sheet 2 of test section 1 after 1200 coverages
