EVALUATION OF STRUCTURAL LAYERS IN FLEXIBLE  
PAVEMENT

ARMY ENGINEER WATERWAYS EXPERIMENT STATION

MISCELLANEOUS PAPER S-73-26

May 1973

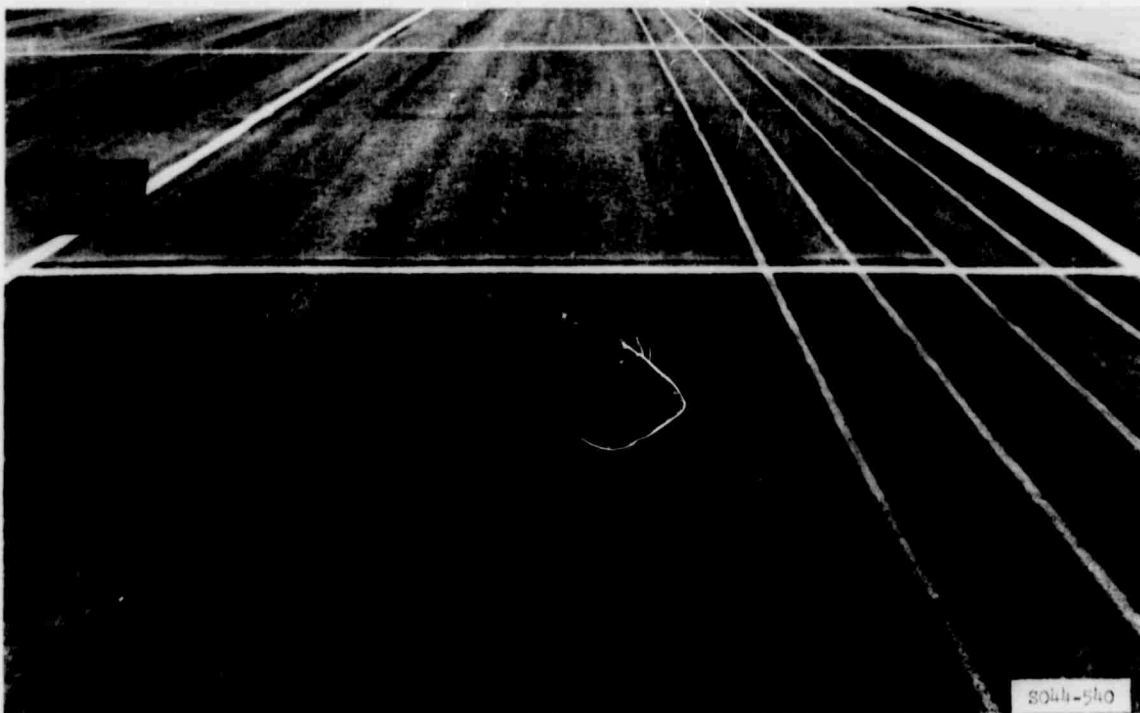
3. Item 2 (cement-stabilized lean clay subbase). An overall view of item 2 prior to traffic is shown in photo B4. Distress of the pavement was first noticed at 172 coverages of traffic. This distress was a continuation of the construction-joint cracking that originated in item 1. As traffic was continued, the cracks on either side of the 10-ft-wide paving lane became longer. After 201 coverages, they were approximately 1/32 in. wide and extended the length of the item. A close-up of this type of pavement cracking is shown in photo B5. At 268 coverages, hairline cracks were noticed at the transition of items 2 and 3. As traffic continued, these cracks rapidly became wider. After 783 coverages, an area between 2 to 3 ft either side of this transition had cracked completely through the pavement.

Photo B4. Item 2, lane 1, prior to traffic

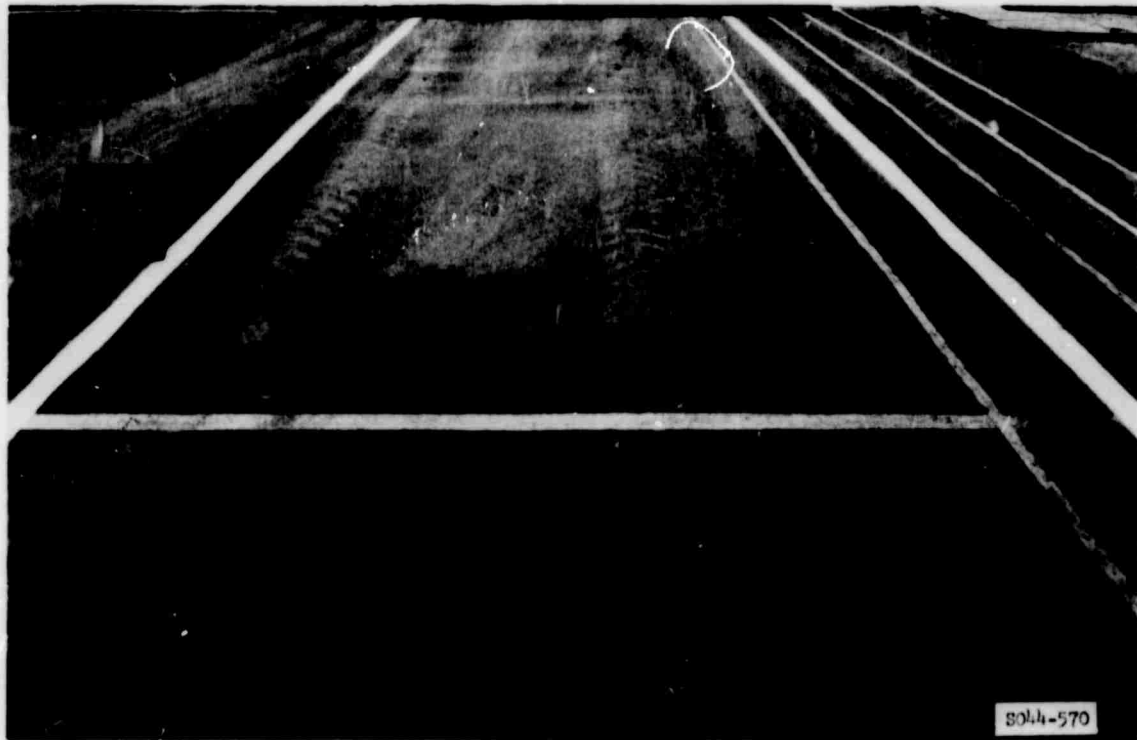
Photo B18. Item 2, lane 2, prior to traffic

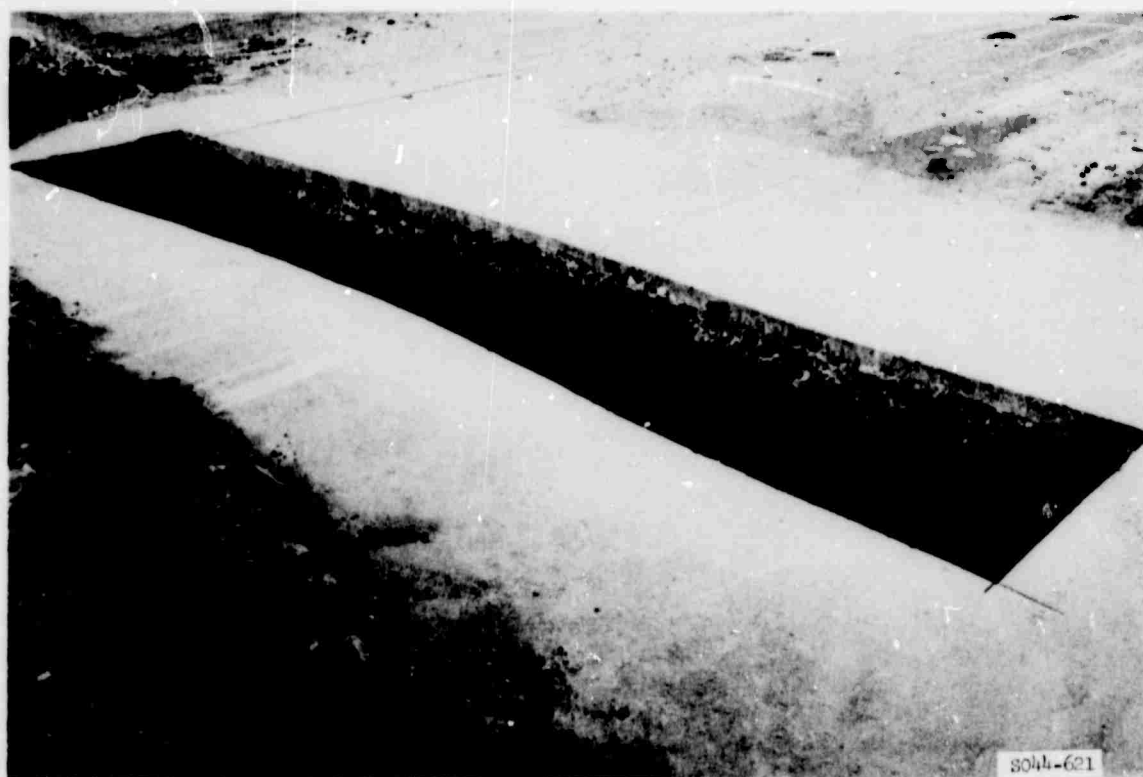
Photo B21. Test trench across item 1, lanes 2 and 3

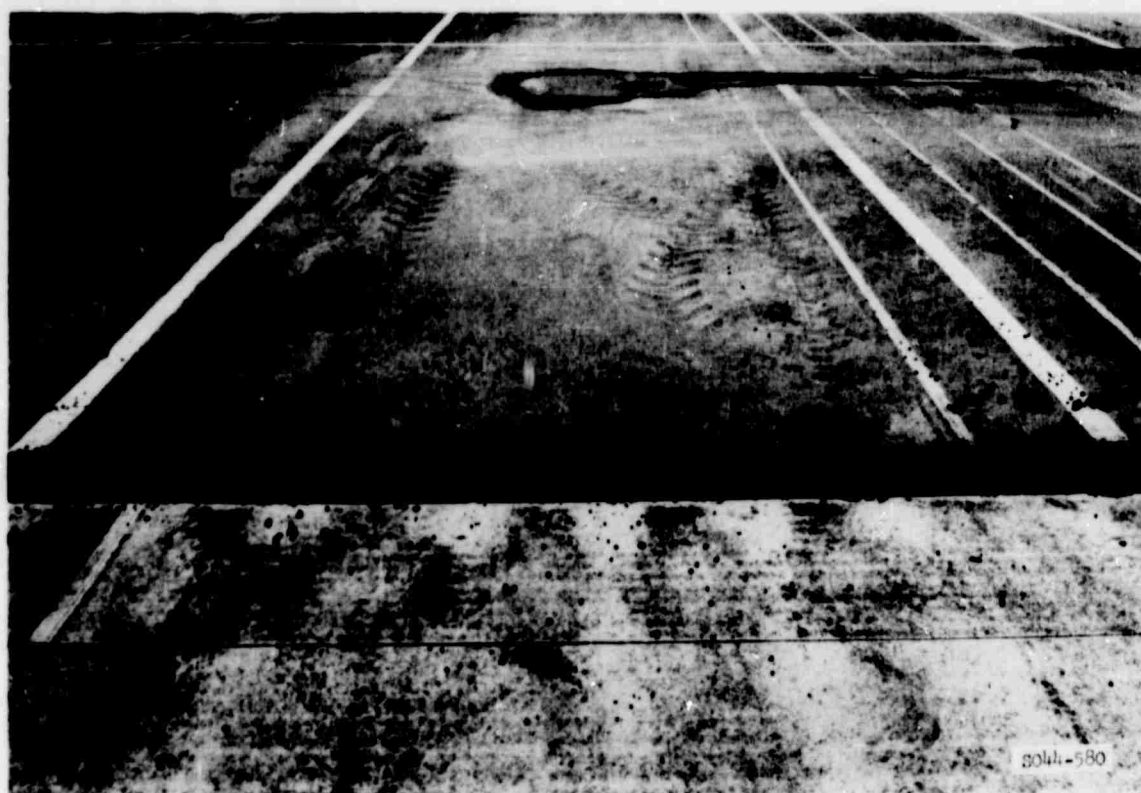
Photo B22. Item 3, lane 2, prior to traffic

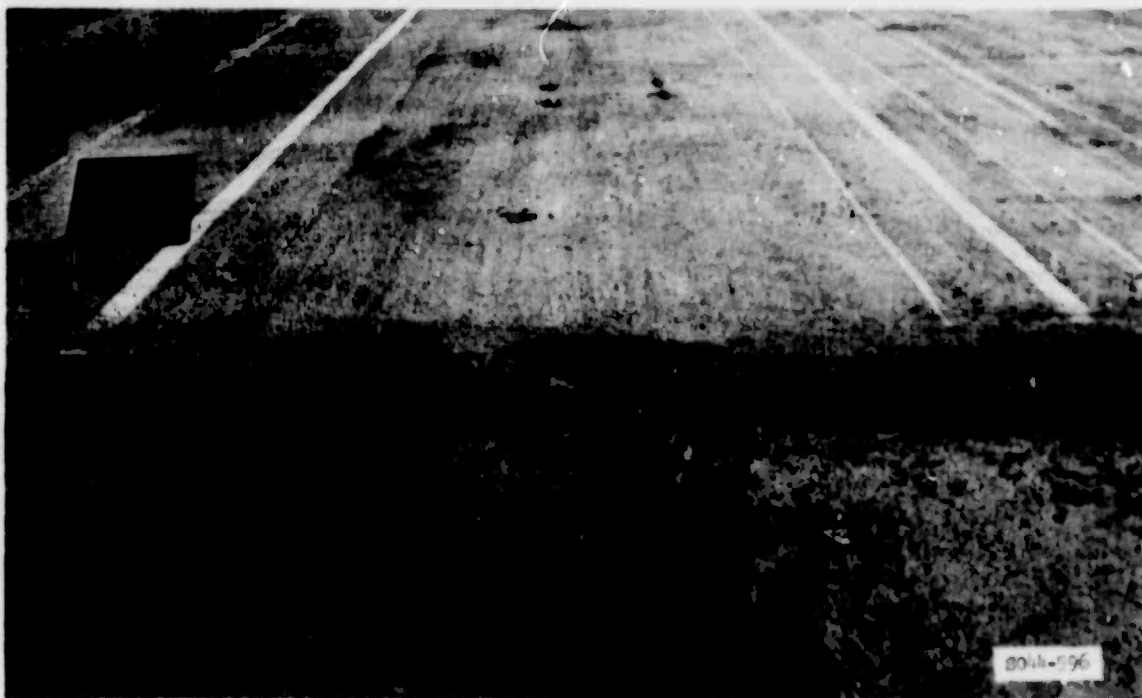
Photo B38. General view of item 4, lane 1, after 10,406 coverages of the 360-kip, 12-wheel assembly and prior to trafficking with the 75-kip, single-wheel assembly
