STRENGTHENING OF KEYED LONGITUDINAL CONSTRUCTION
JOINTS IN RIGID PAVEMENTS

ARMY ENGINEER WATERWAYS EXPERIMENT STATION

Report No. FAA-RD-72-106

AUGUST 1972
FINAL REPORT

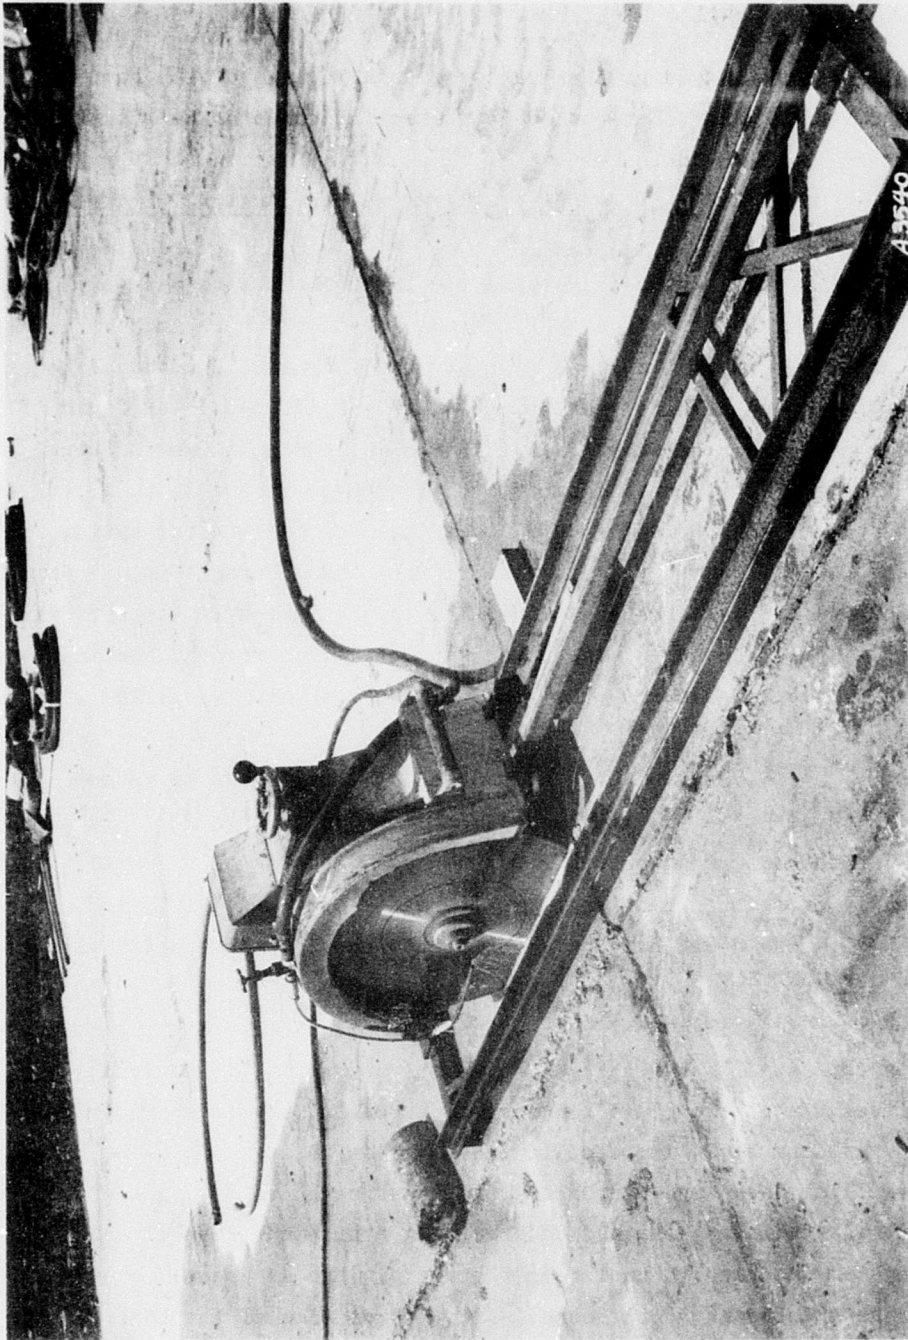
Figure 15. Sawing kerfs across longitudinal construction joint in item 2.

A plan of each of the three methods used to strengthen the longitudinal joint in item 2 and the locations where each method was used are shown in figure 1. A concrete saw, figure 15, was used to cut the 1-1/2-in.-wide kerfs, which were spaced 12 in. c-c. The depth of these kerfs ranged between 4-1/2 to 5-5/8 in., and the lengths were approximately 28 in. at the surface of the pavement and 12 to 13 in. at the bottom of the kerfs. Figure 16 depicts the kerfs after sawing. Any loose material was removed from the kerfs. Dowel bars, 1 in. in diam by 12 in. long, were bonded to the slab in the bottom of the kerf with epoxy mortar. One end of the dowel was greased to prevent bonding. After the epoxy grout had cured, the remainder of the void was filled with an epoxy mortar (figure 17).

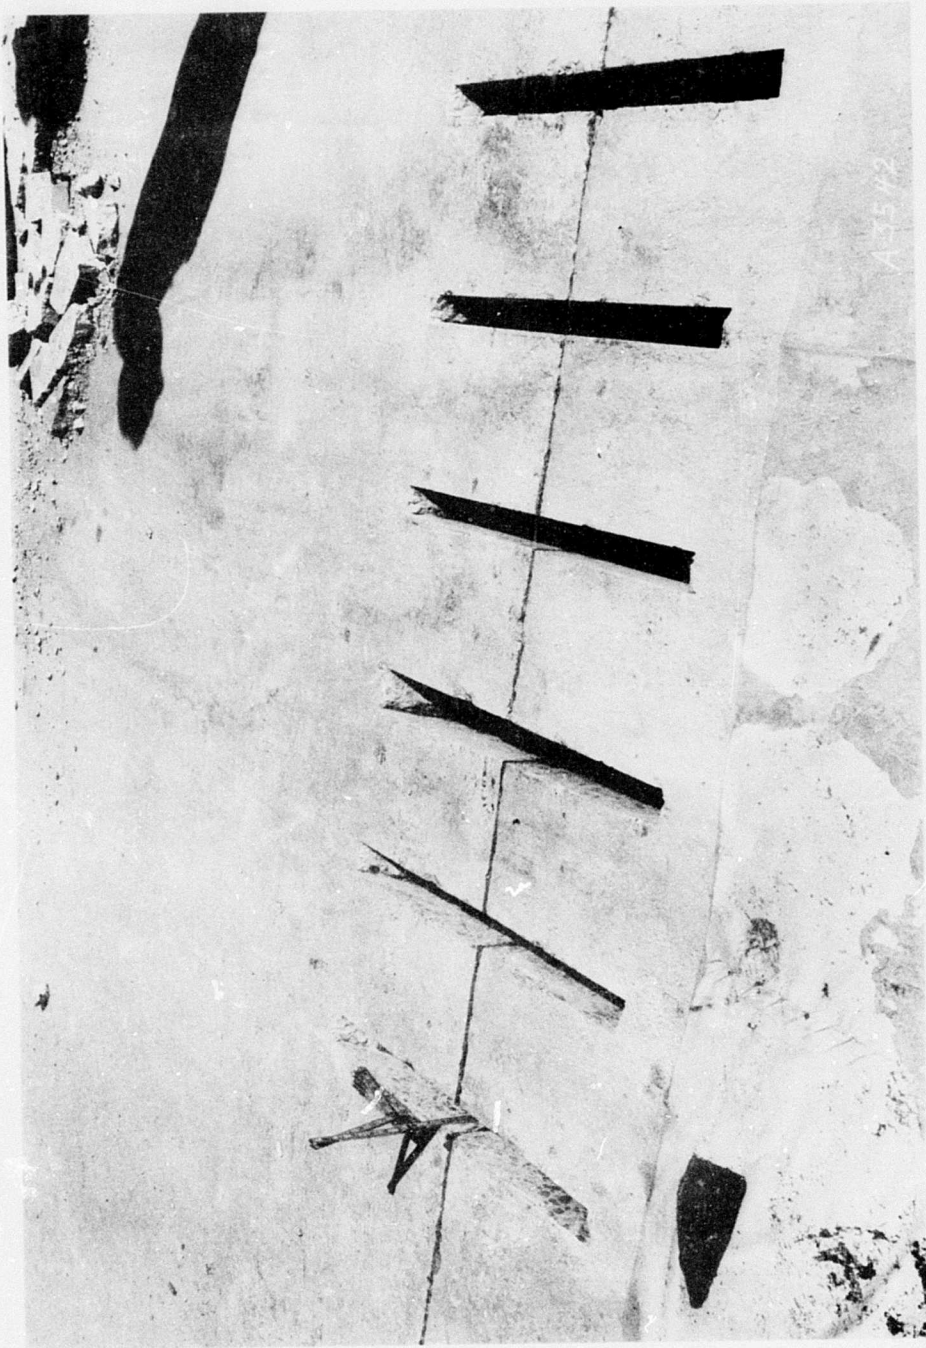
Figure 16. 1-1/2-in.-wide sawed kerfs in item 2.

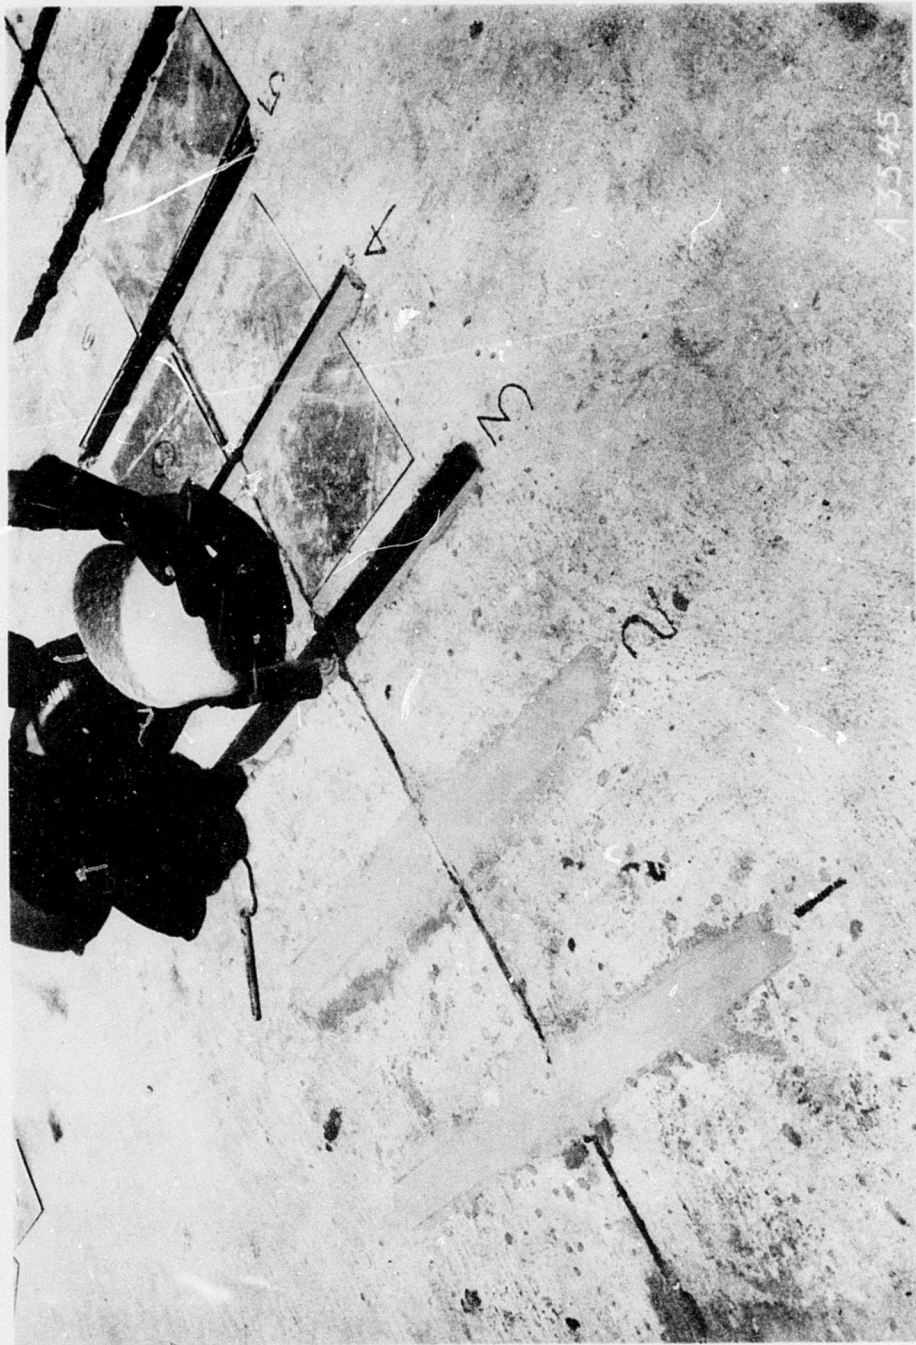
Figure 17. Filling sawed kerfs with epoxy mortar after tie bar has been bonded in bottom of kerf with epoxy grout.

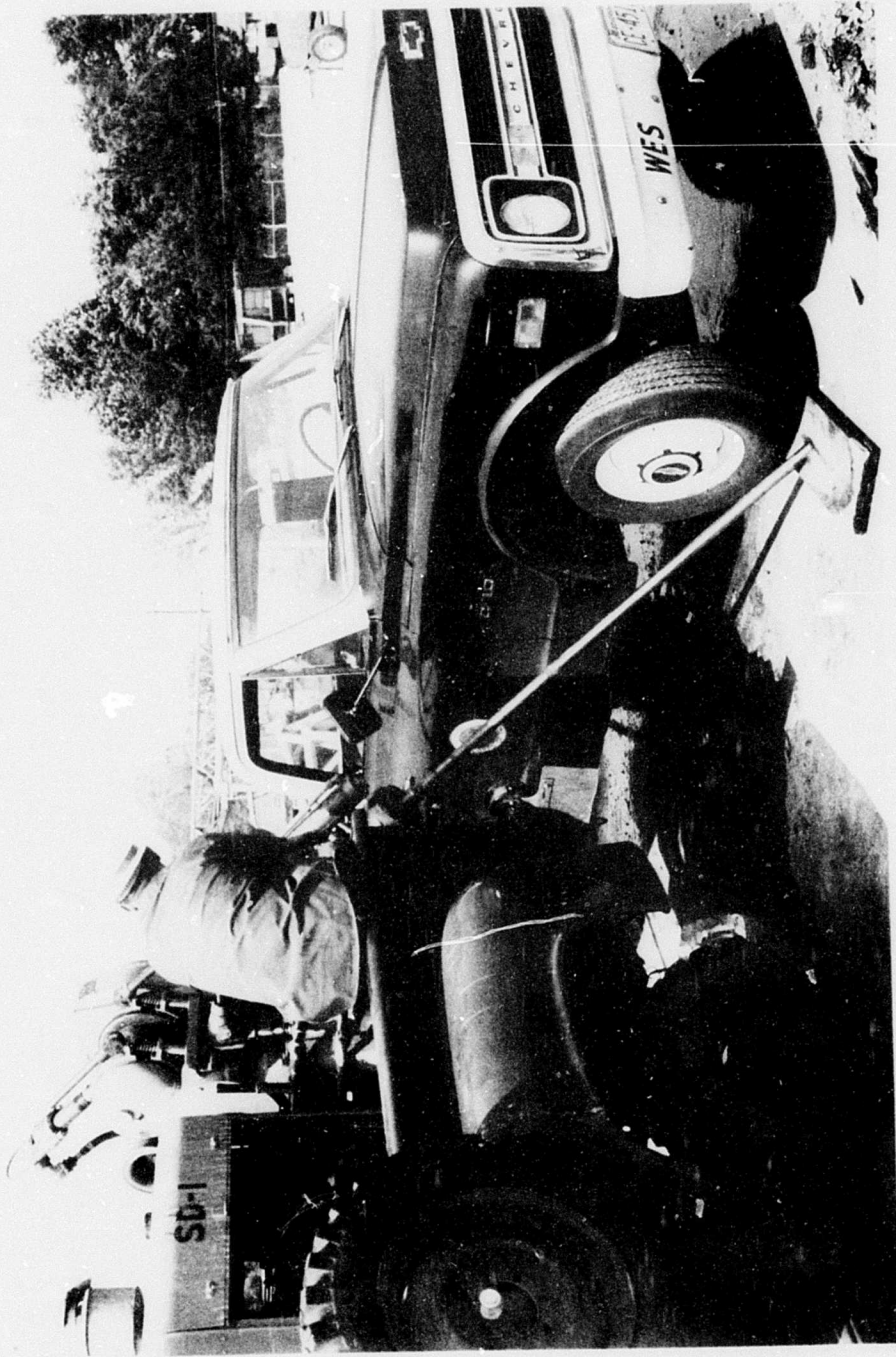
Figure 18. Coring 1-1/2-in.-diam hole at a 45° angle through the longitudinal joint in item 2.

A small truck-mounted drill rig was used to core 1-1/2-in.-diam holes at a 45° angle on 12-in. centers (figure 18). These holes were located through the center of the keyed construction joint and were sloped in opposite directions for alternate holes. A 1-in.-diam by 12-3/4-in.-long dowel bar was grouted into each of these holes with an epoxy grout.

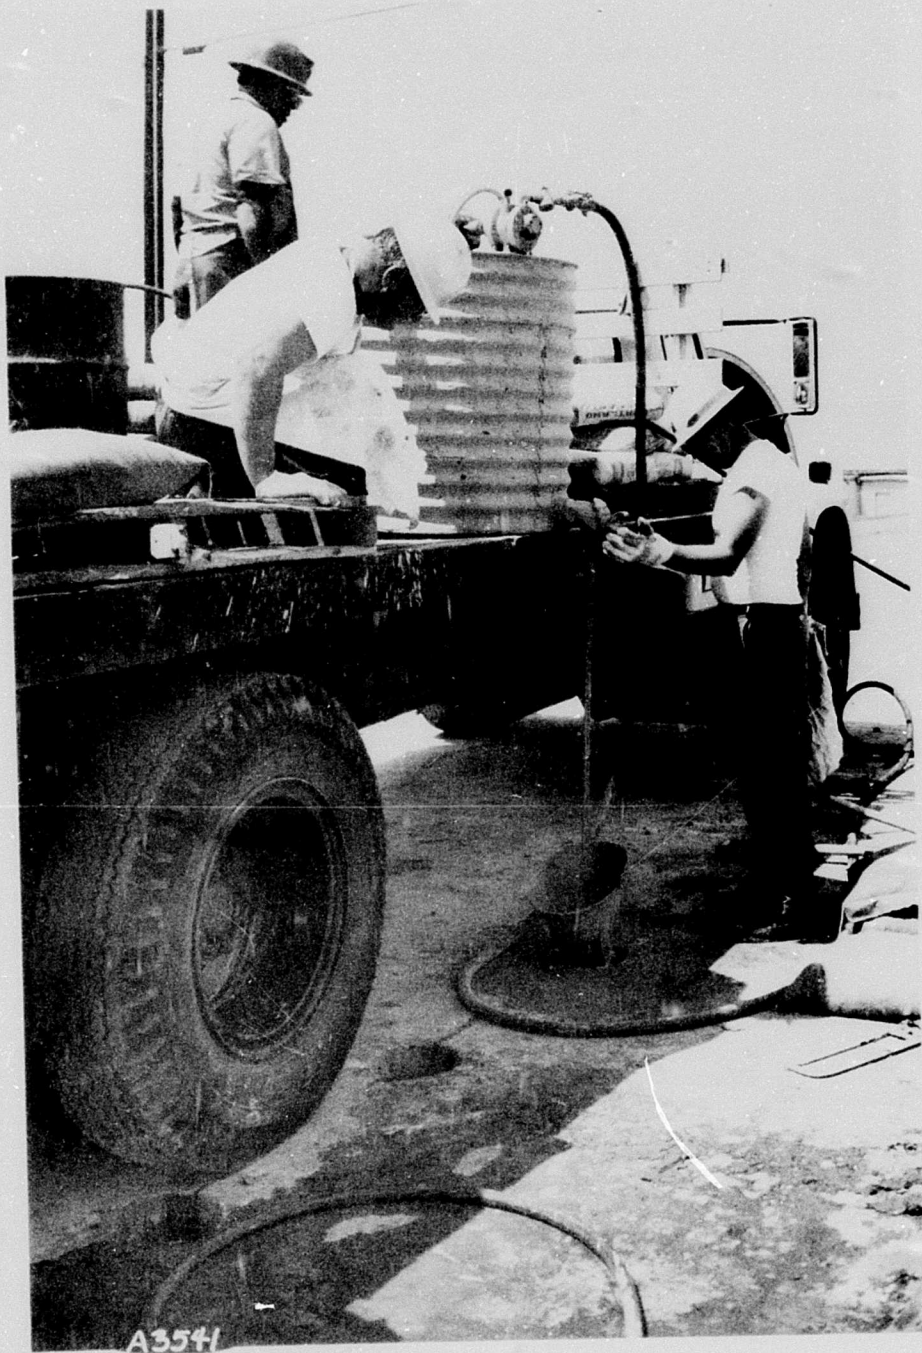
Figure 22. Filling underreamed void under the longitudinal joint in item 2 with sand-cement grout.

The third strengthening method of keyed longitudinal joints consisted of coring 8-in.-diam holes through the pavement at the longitudinal joint on 3-ft centers, underreaming a void approximately 42 in. in diam by 24 in. deep in the subgrade through the 8-in. holes, and then filling the 8-in.-diam holes and underreamed void with sand-cement grout. A specially designed underreaming attachment connected to the drill stem was used to underream the void in the subgrade. Figures 19-21 show the underreaming procedure. After completion of the underreaming, the sand-cement grout was pumped into the void as shown in figure 22. The

28-day compressive strengths of the sand-cement grout placed in the underreamed holes and the 8-in.-diam access holes were 3000 and 4000 psi, respectively.

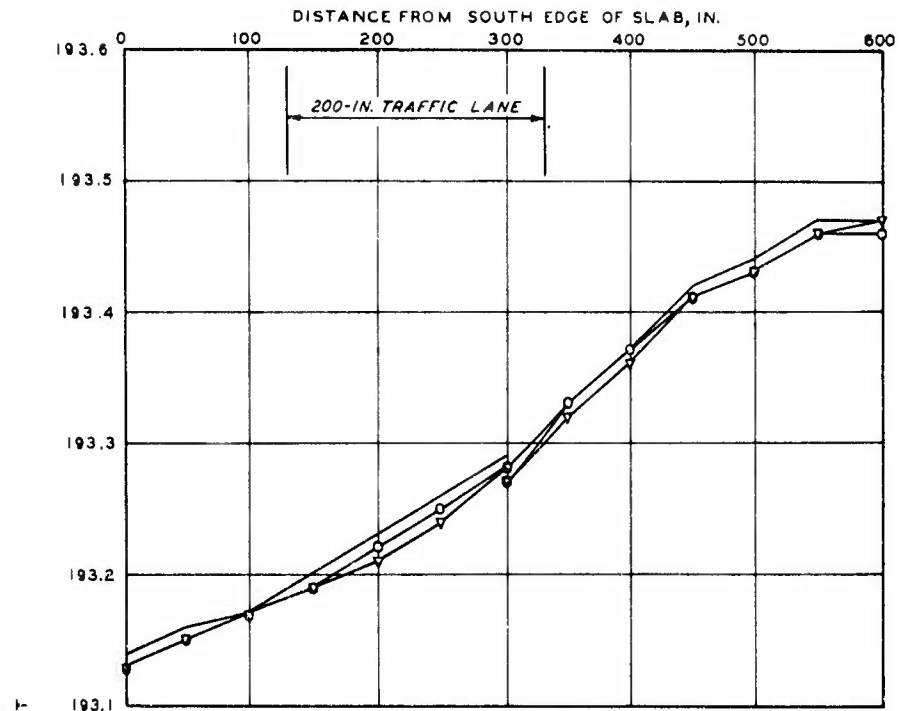
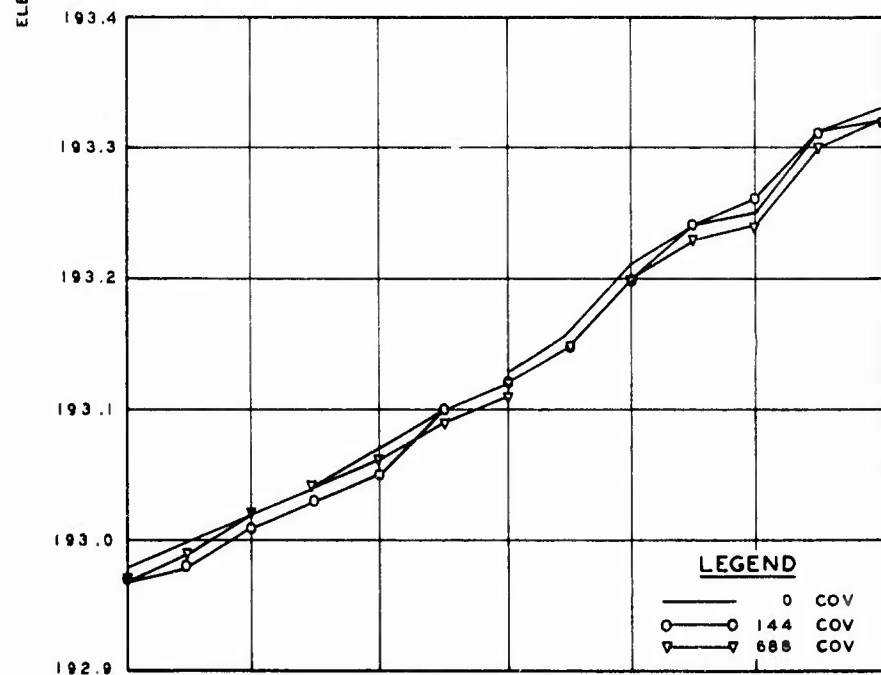
Figure 34. Typical cross sections of item 1, 360-kip, 12-wheel-assembly lane.

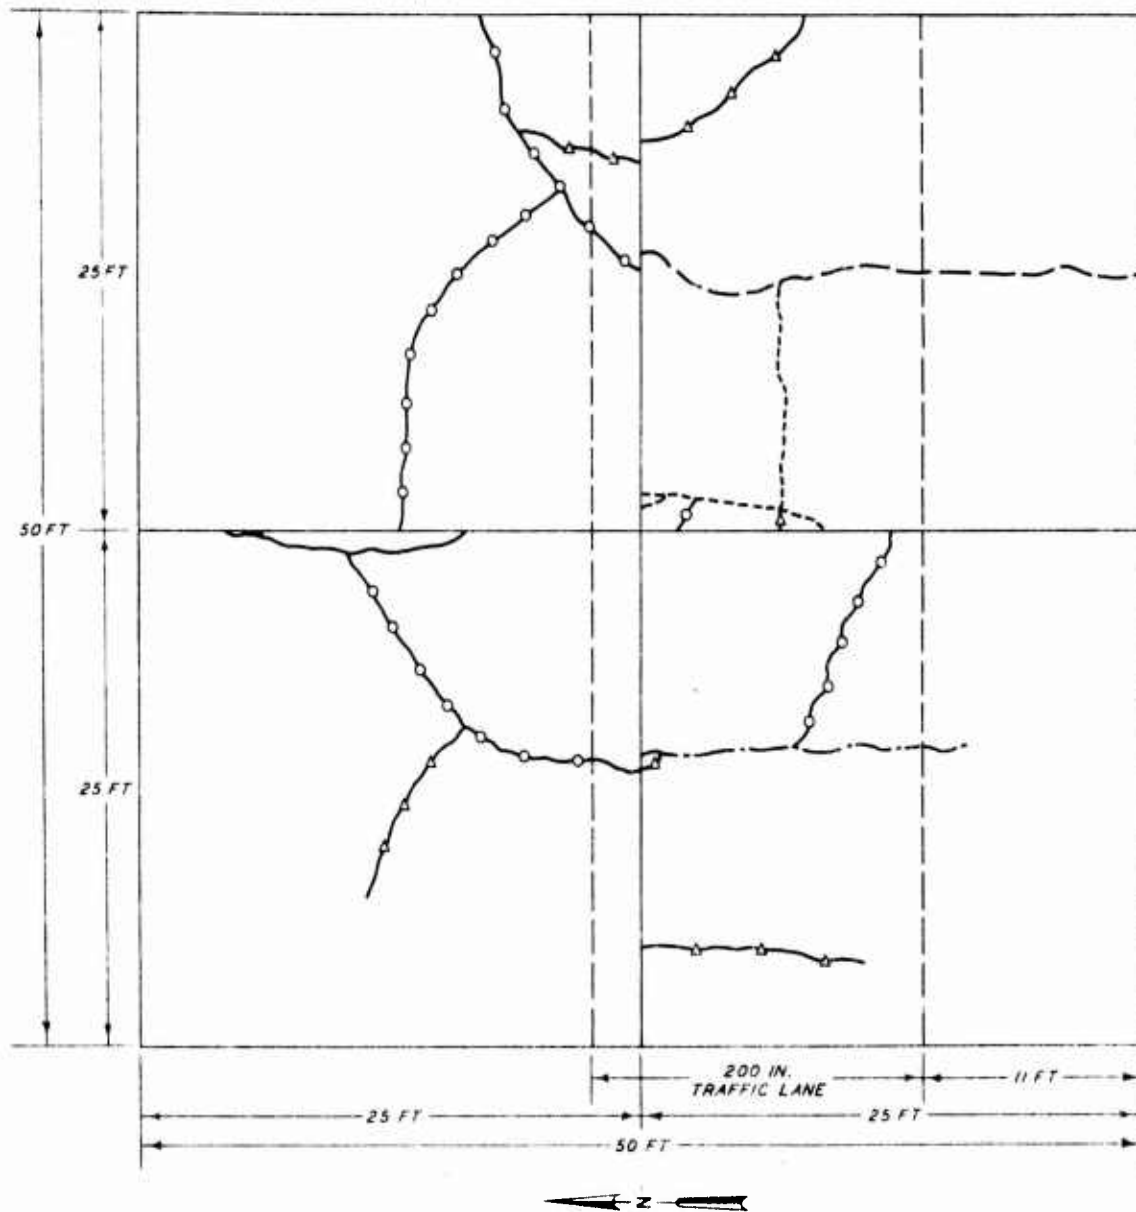
Figure 42. Crack development in item 2 under 360-kip, 12-wheel-assembly traffic.

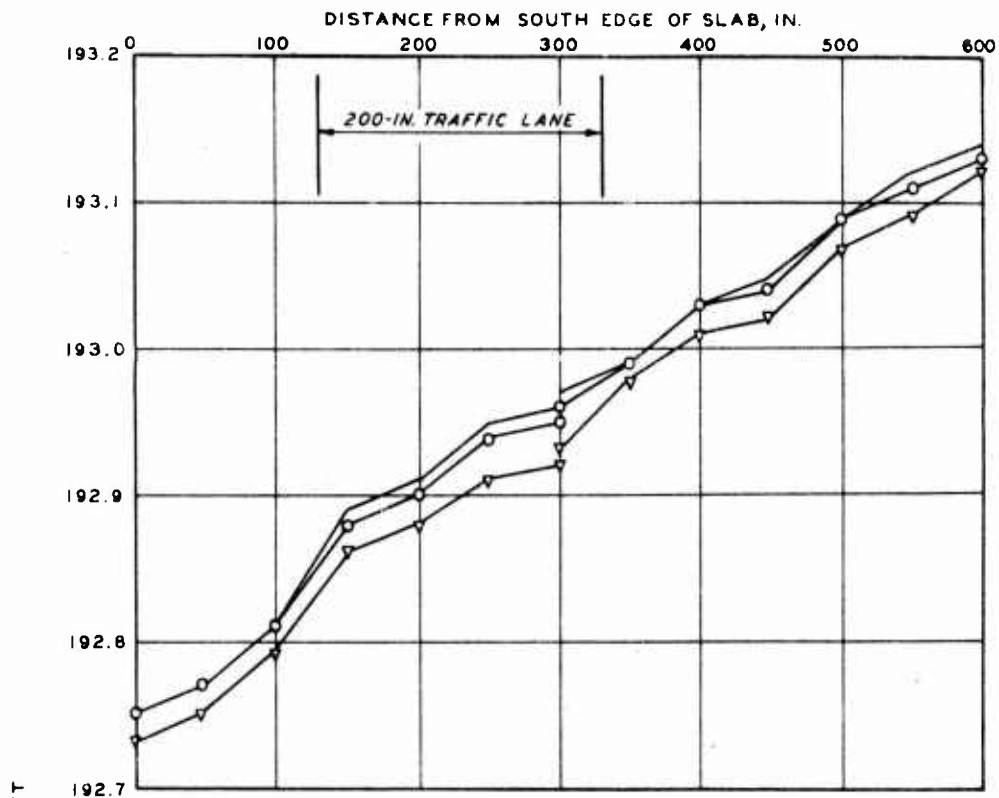
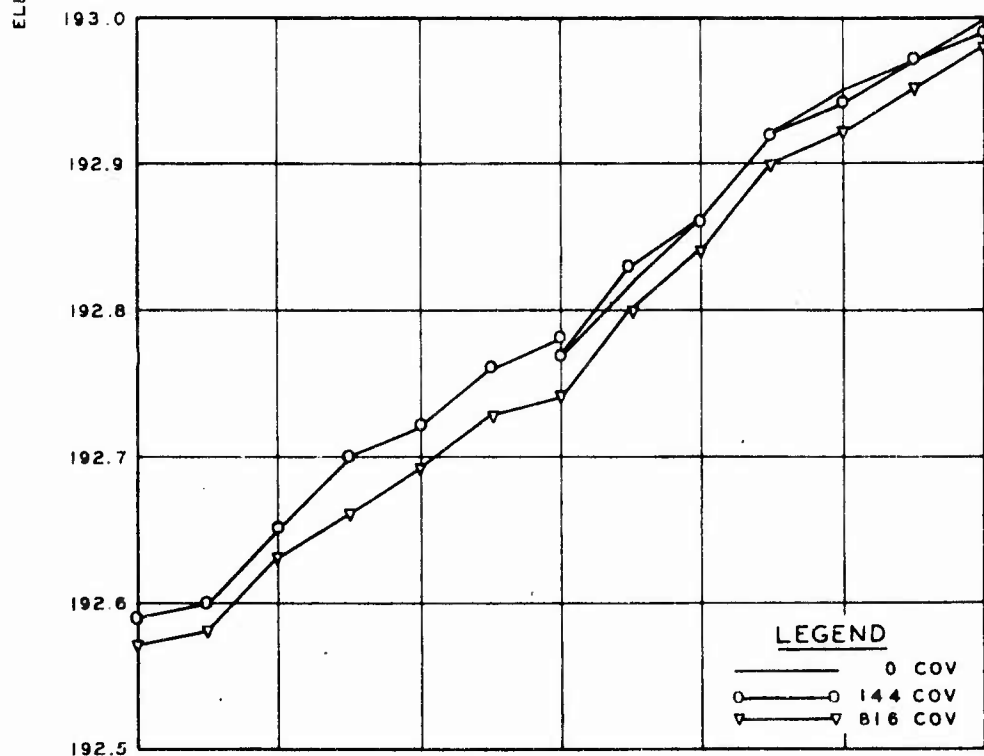
Typical cross sections at the center of each slab show the permanent deformation in the test lane due to traffic (figure 43). The average permanent deformation was about 0.24 in. with maximum deformation of 0.48 in.

Figure 43. Typical cross sections of item 2, 360-kip, 12-wheel-assembly lane.

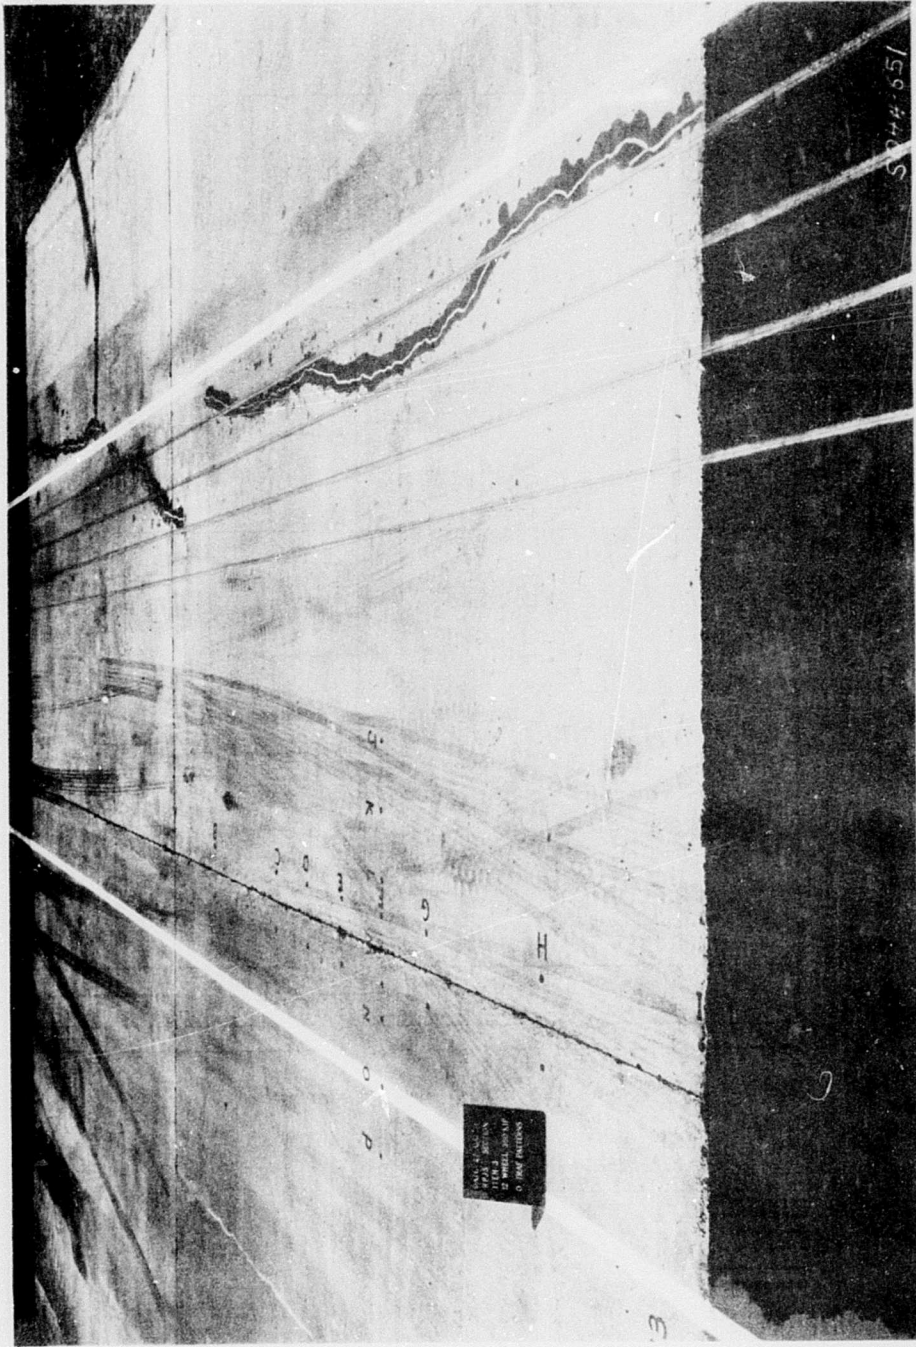
A general view of item 3 prior to test traffic is shown in figure 45. As can be seen in this photograph, several cracks developed during the curing of the slab. An epoxy cement was placed under pressure (10 psi) into the longitudinal cracks located in the southeast slab running from the south free edge of the slab to the longitudinal joint. Epoxy cement was first applied to the surface of the pavement and allowed to cure before the epoxy cement was forced under 10-psi pressure into the cracks. There was also a transverse crack between the southwest and southeast slabs parallel to the weakened-plane construction joint. However, since this crack developed prior to the construction of the weakened-plane joint, it was decided to consider the crack as the joint between the two slabs.

Figure 45. Item 3, 360-kip, 12-wheel-assembly lane prior to traffic.

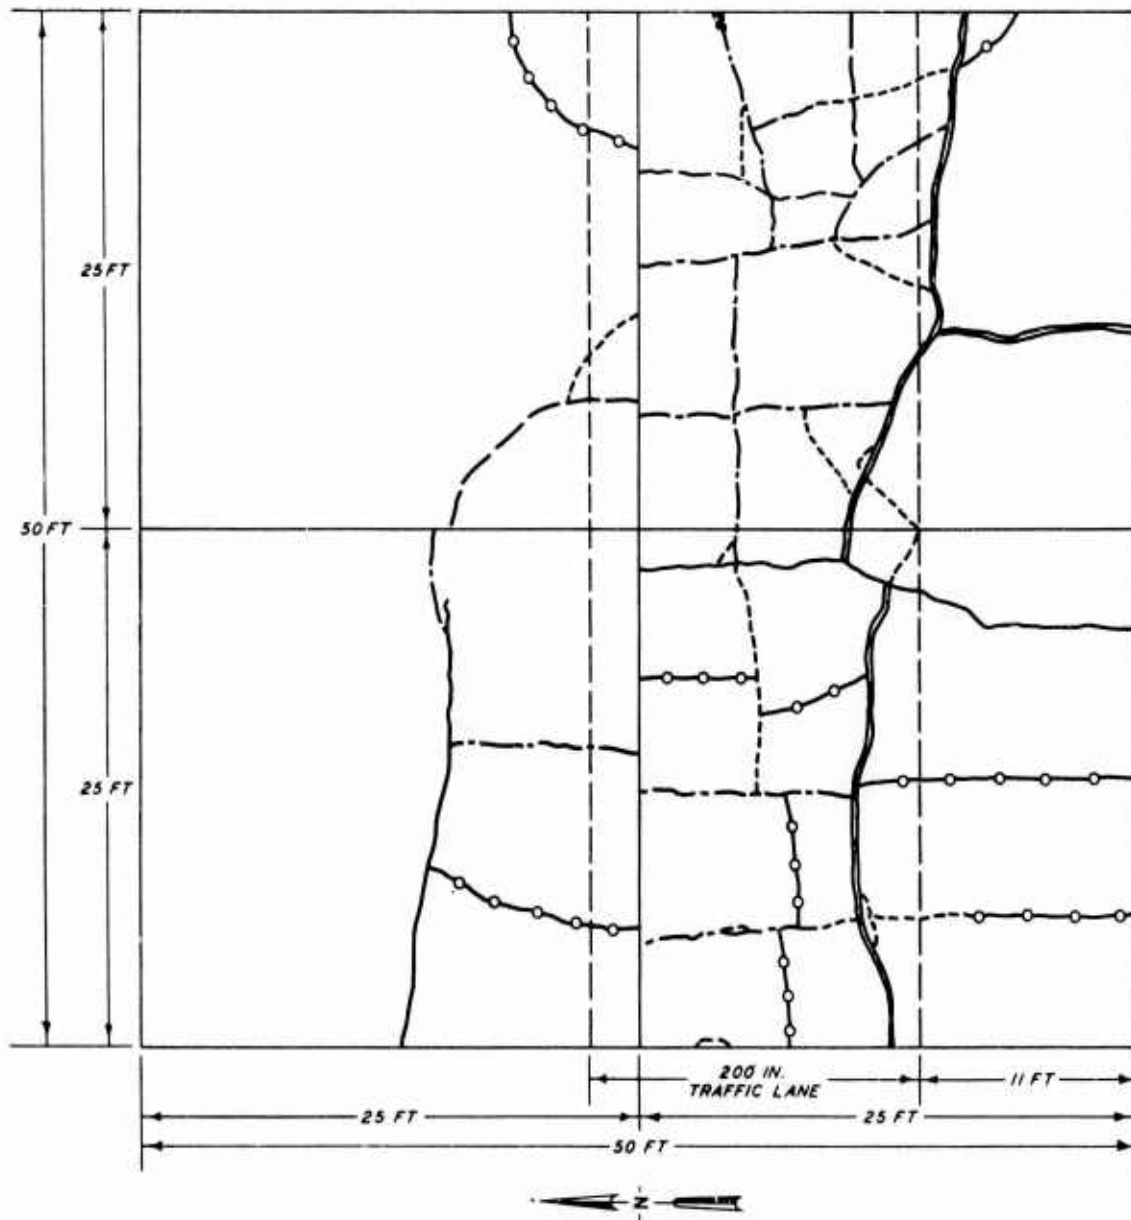
Figure 46. Crack development in item 3 under 360-kip, 12-wheel-assembly traffic.

the doweled longitudinal construction joint. After 96 coverages, the crack had progressed approximately 14 ft across the slab to a longitudinal crack that had been epoxied prior to traffic. After 9 patterns of traffic (144 coverages), the surfaces of the southwest and southeast slabs had subdivided into 4 and 8 pieces, respectively, as indicated in figures 46 and 47. Although the southeast slab met the shattered-slab failure criterion at this time, traffic was continued because the longitudinal construction joint was performing satisfactory.

EPOXY APPLIED TO
CRACKS PRIOR TO
TRAFFIC

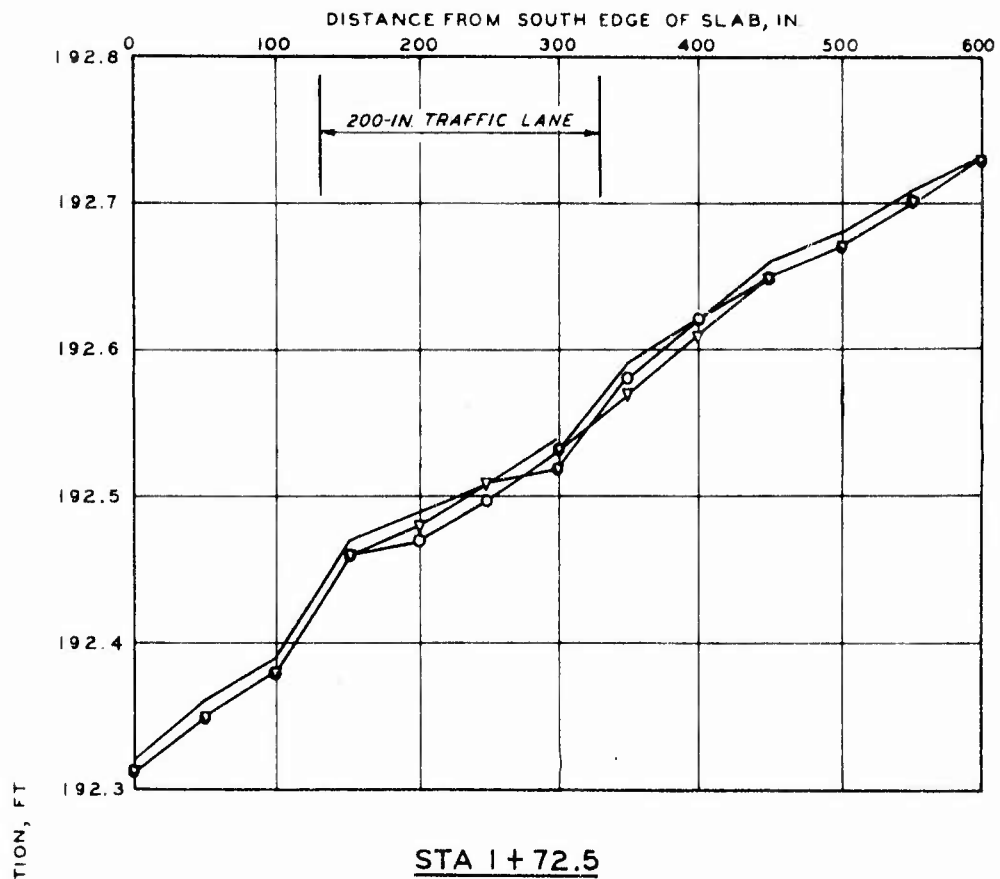
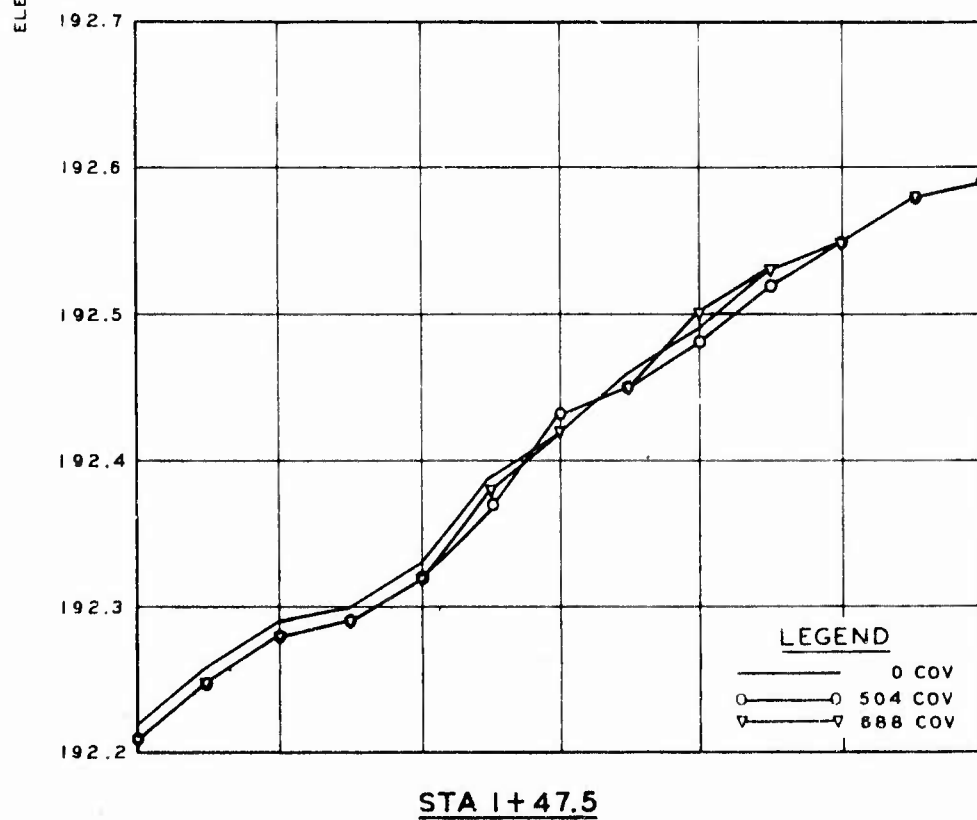
The typical cross-section plot of item 3 shown in figure 52 indicate that the average permanent deformation after 688 coverages (prior to overlaying) was about 0.18 in., and the maximum deformation measured was 0.24 in.

Figure 52. Typical cross sections of item 3, 360-kip, 12-wheel-assembly lane.

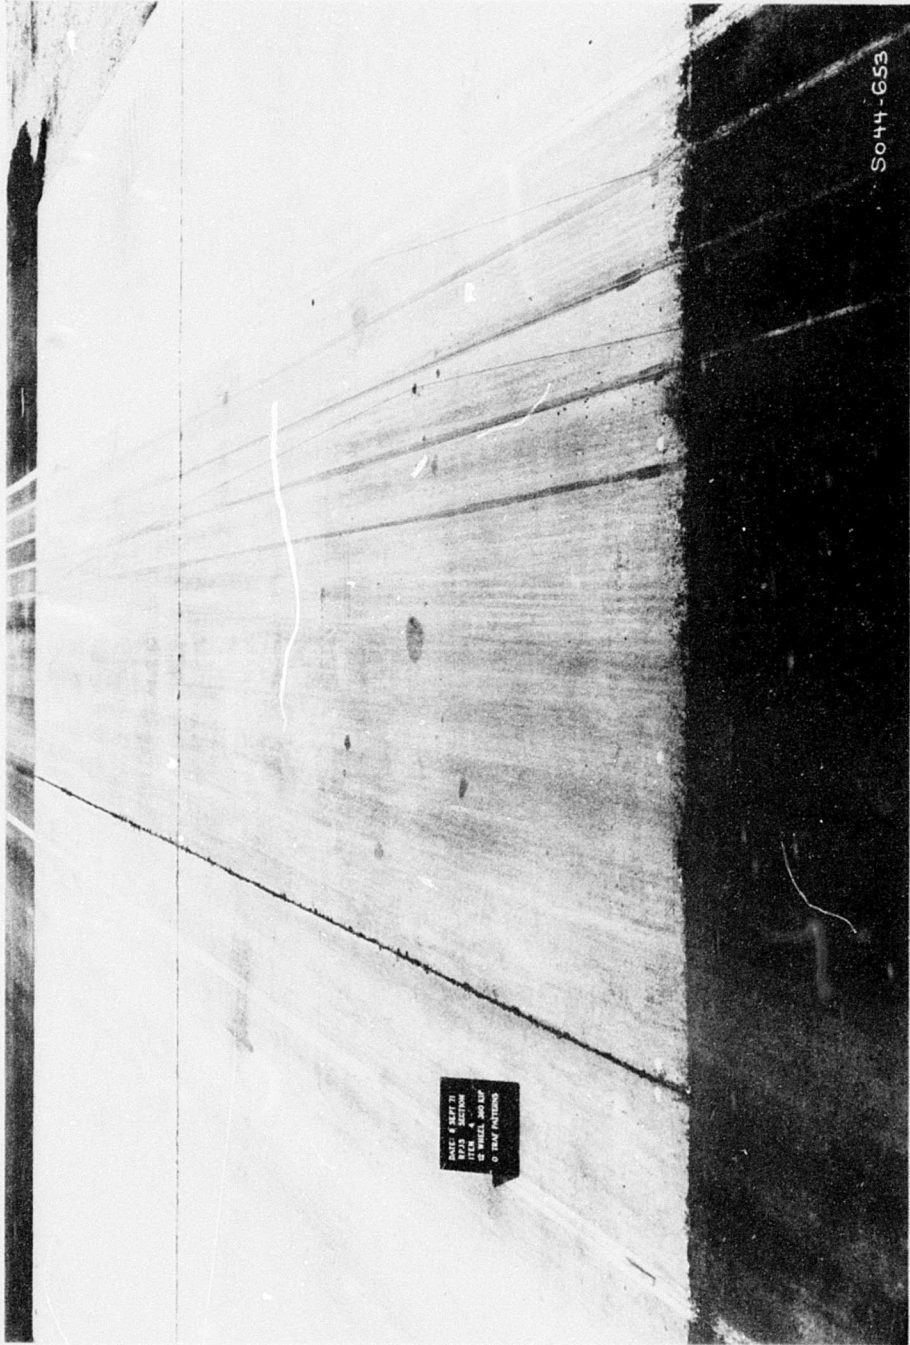
There were no defects in item 4 prior to traffic, as shown in figure 54. Pumping at the joints between the transition areas and the east and west ends of the item was noted after only 1.5 traffic patterns (24 coverages) and became progressively worse as traffic continued. The first crack was observed during the 54th traffic pattern (864 coverages). This was a half-moon-shaped crack located at the west end of the item. The pumping is believed to have contributed to this break and to the large corner breaks detected in the southeast and northeast slabs after 83 patterns of traffic (1328 coverages). These two corner breaks were the only additional distress observed at the 1328-coverage level. A general view of this item showing the crack pattern after 83 traffic patterns is shown in figure 55. After 146 traffic patterns (2336 coverages), the western edge of the half-moon-shaped crack in the southwest slab was approximately 1/2-in. below its original elevation due to the pumping of the subgrade material beneath the slab, and a 4-ft longitudinal crack was observed running from the west edge of the slab to the existing half-moon-shaped crack. These moon-shaped cracks at each end of the test item were

Figure 54. Item 4, 360-kip, 12-wheel-assembly lane prior to traffic.

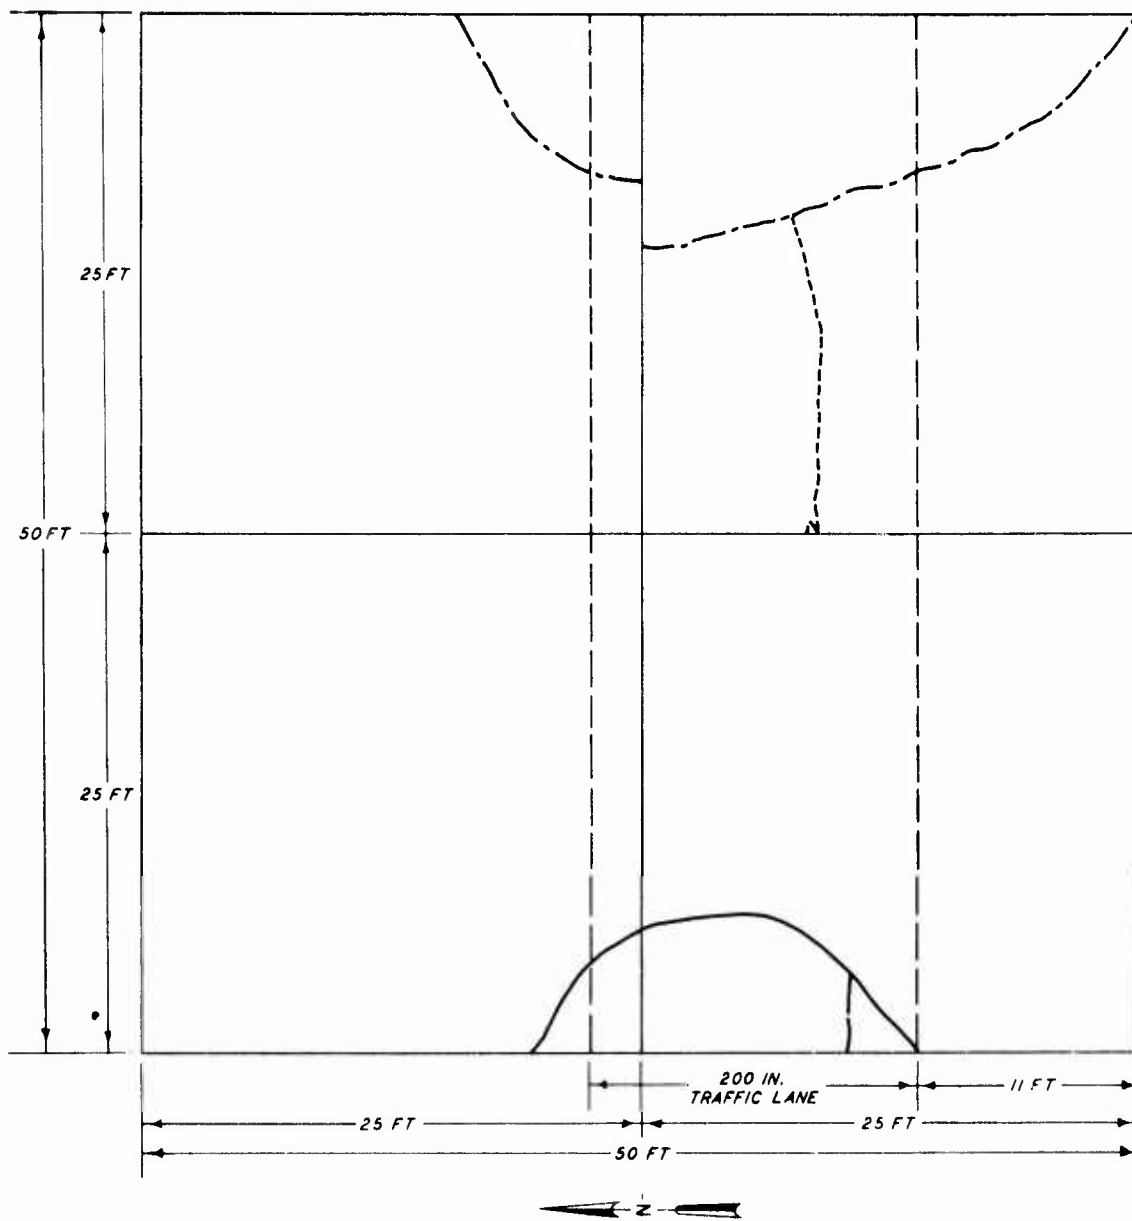
After 200 patterns (3200 coverages), approximately 6 ft of the western end of the item was overlaid with landing mat to provide a smooth transition between the test item and transition area because the test slab had sunk about 2 in. due to severe pumping. A longitudinal crack located in the southeast slab was the only other crack observed during test traffic. This crack was detected at the end of traffic, 396 patterns (6336 coverages); however, it could have occurred prior to this and not detected due to the mud and muddy water covering the slab during the last 197 traffic patterns. The mud and muddy water covering the slab was the result of a combination of rain and of pumping at both ends of this test item. The progression of cracking is shown in figure 56; a general view of the item after traffic is shown in figure 57.

Figure 56. Crack development in item 4 under 360-kip, 12-wheel-assembly traffic.

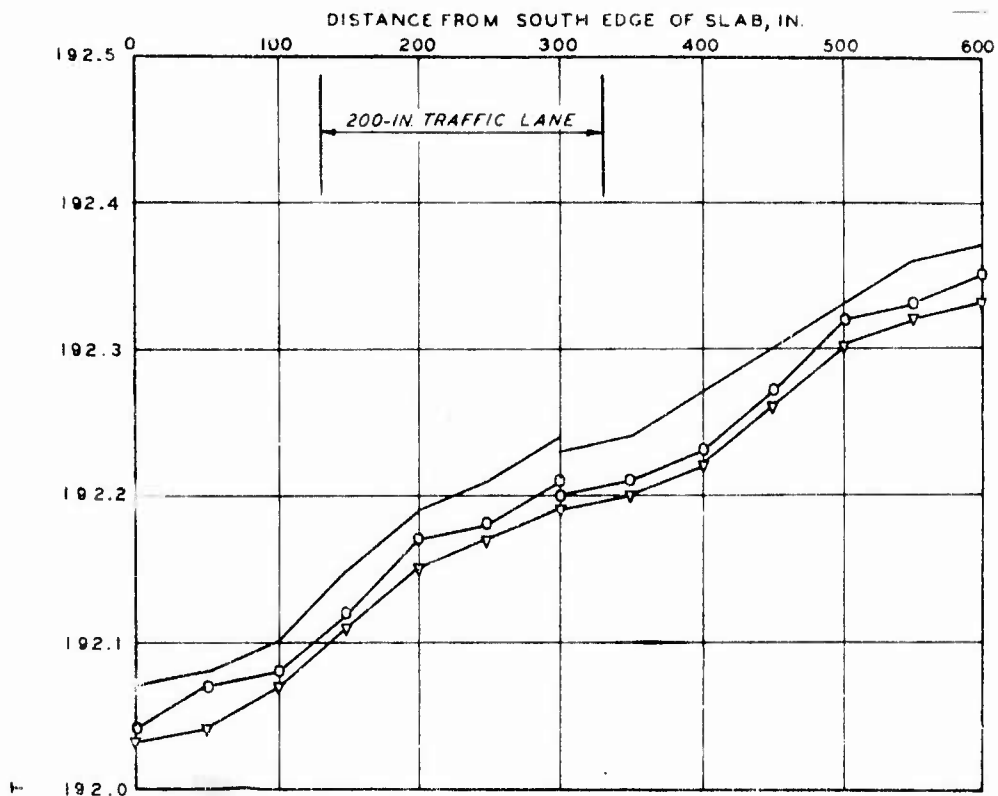
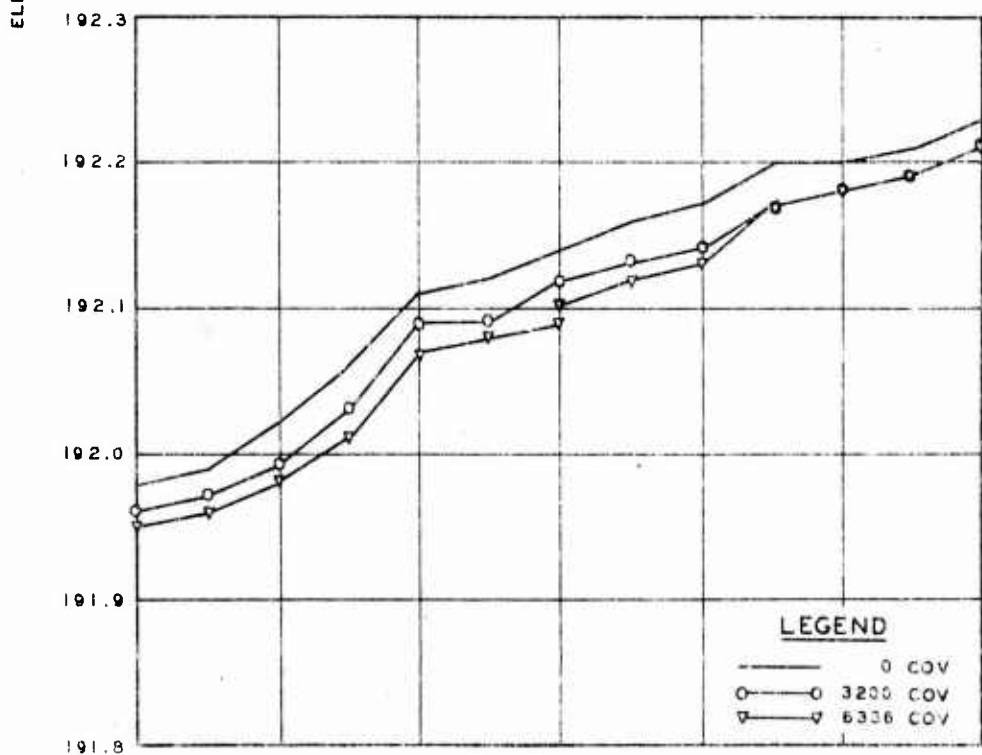
A typical cross section for this item indicating the permanent deformation due to traffic is shown in figure 58. The average permanent deformation was about 0.48 in. and the maximum deformation was 0.60 in. This plot indicates that about 75 percent of the average

Figure 58. Typical cross sections of item 4, 360-kip, 12-wheel-assembly lane.

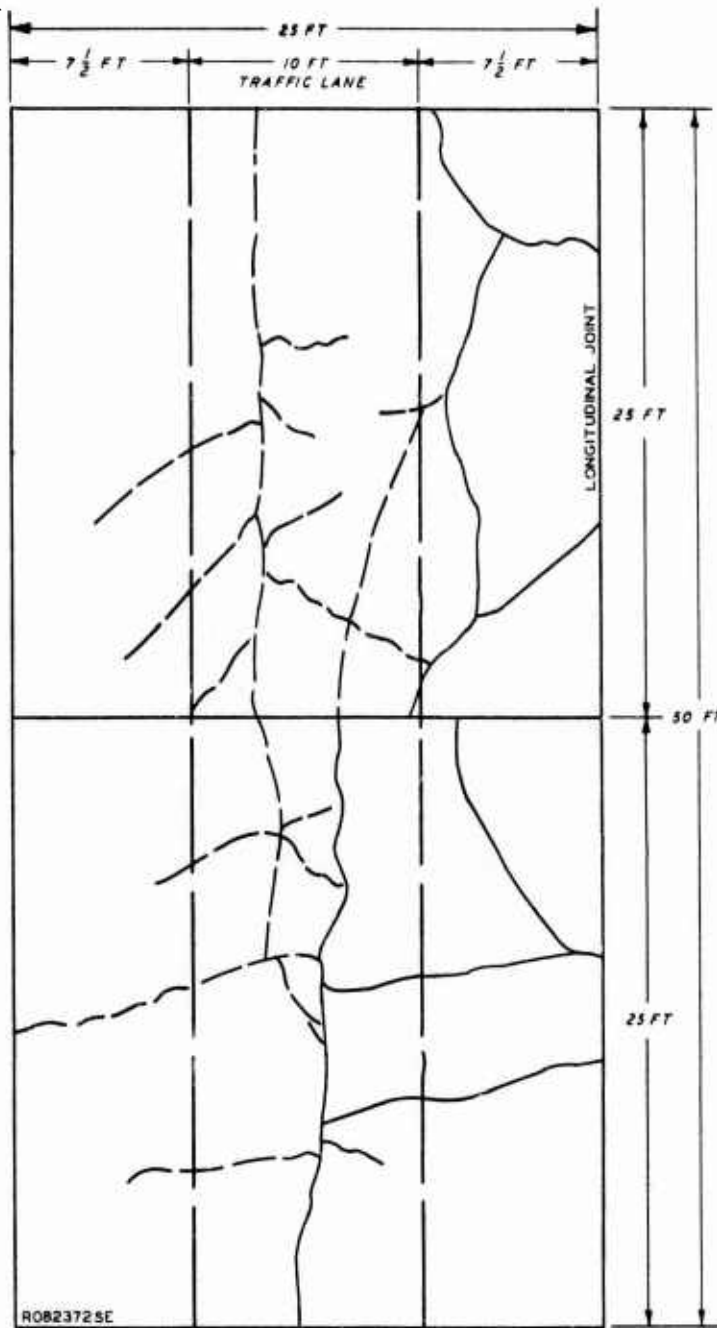
A general view of the item prior to traffic is shown in figure 60. As can be seen, both slabs contained cracks prior to traffic. The longitudinal crack in about the center of the traffic lane of the northwest slab was detected prior to the 12-wheel-assembly traffic; the remaining cracks developed during the 12-wheel-assembly traffic. When the twin-tandem traffic was commenced, pumping was observed at the existing longitudinal crack in the northwest slab. The initial crack due to traffic, a 6-ft-long longitudinal crack in the northeast slab, was detected after 4 coverages of traffic and continued to progress and extended the length of the slab after 35 coverages. After 35 coverages, several diagonal cracks and another longitudinal crack had developed in the northeast slab, and a longitudinal and several transverse cracks were observed in the northwest slab. Traffic was discontinued after 35 coverages when the item was considered to be a shattered-slab failure. A general view of the item at failure is shown in figure 61. The progression and extent of cracking during the traffic period is shown in figure 62.

Figure 62. Crack development in item 1 under 166-kip, twin-tandem-assembly traffic.

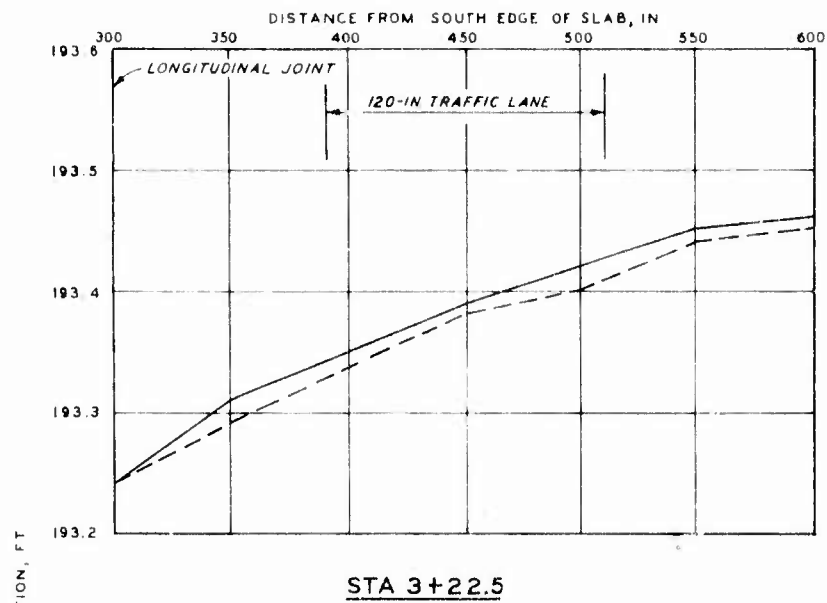
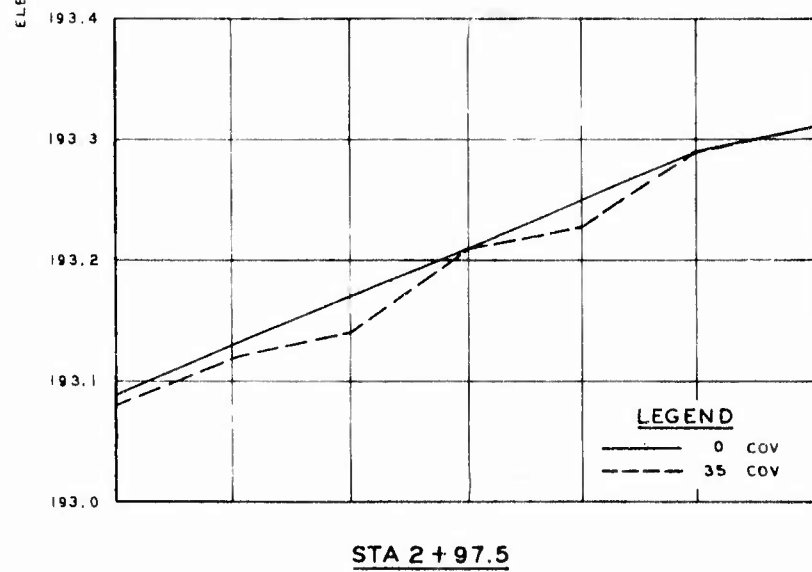
Typical permanent deformations, which occurred as a result of traffic, are shown by the typical cross-sections taken at the center of each slab (figure 63). An average deformation of about 0.15 in. and a maximum of 0.36 in. were recorded. The maximum total deflection measured prior to traffic was about 0.12 in. Plots of deflection measurements taken prior to traffic are shown in figure 64.

Figure 63. Typical cross sections of item 1, twin-tandem-assembly lane.
