STRENGTHENING OF KEYED LONGITUDINAL CONSTRUCTION
JOINTS IN RIGID PAVEMENTS

ARMY ENGINEER WATERWAYS EXPERIMENT STATION

Report No. FAA-RD-72-106

AUGUST 1972
FINAL REPORT

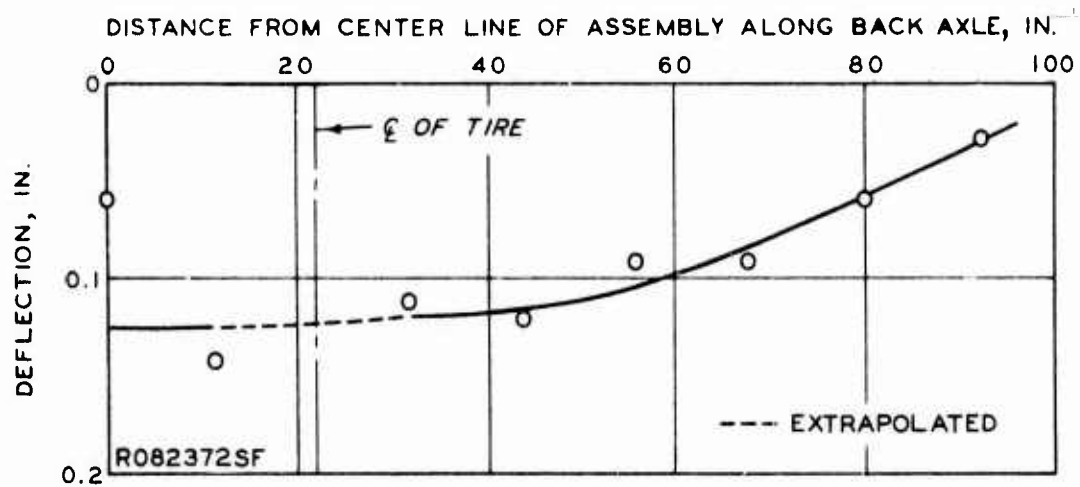
Typical permanent deformations, which occurred as a result of traffic, are shown by the typical cross-sections taken at the center of each slab (figure 63). An average deformation of about 0.15 in. and a maximum of 0.36 in. were recorded. The maximum total deflection measured prior to traffic was about 0.12 in. Plots of deflection measurements taken prior to traffic are shown in figure 64.

Figure 64. Total deflection in item 1, 166-kip, twin-tandem-assembly lane measured prior to traffic.

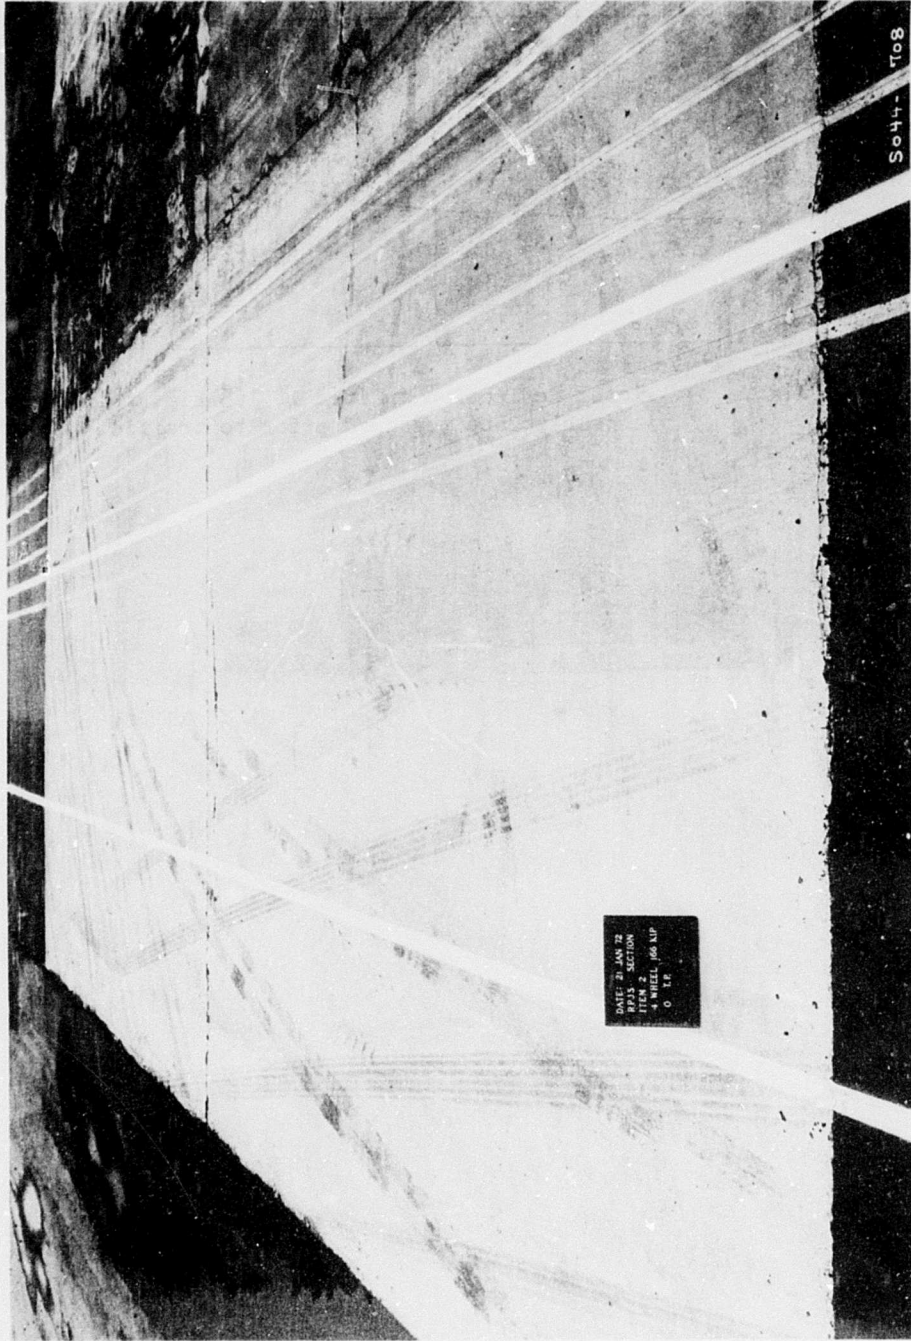
The condition of item 2 prior to traffic is shown in figure 65. Corner cracks were present in both slabs before traffic commenced. The first distress observed under traffic occurred at 120 coverages and consisted of longitudinal cracks commencing at either end of the item and running about 6 ft into the item. As traffic was continued, pavement cracking progressed rather rapidly. After 170 coverages, traffic was stopped and the item was considered to be a shattered-slab failure. At the end of traffic, both slabs contained several diagonal cracks, spalling and flaking were present at the existing cracks, and each slab was subdivided into six or more pieces. A general view of the item at failure is depicted in figure 66; a plot indicating the extent and progression of cracking during traffic is shown in figure 67.

Figure 65. Item 2, 166-kip, twin-tandem-assembly lane prior to traffic.

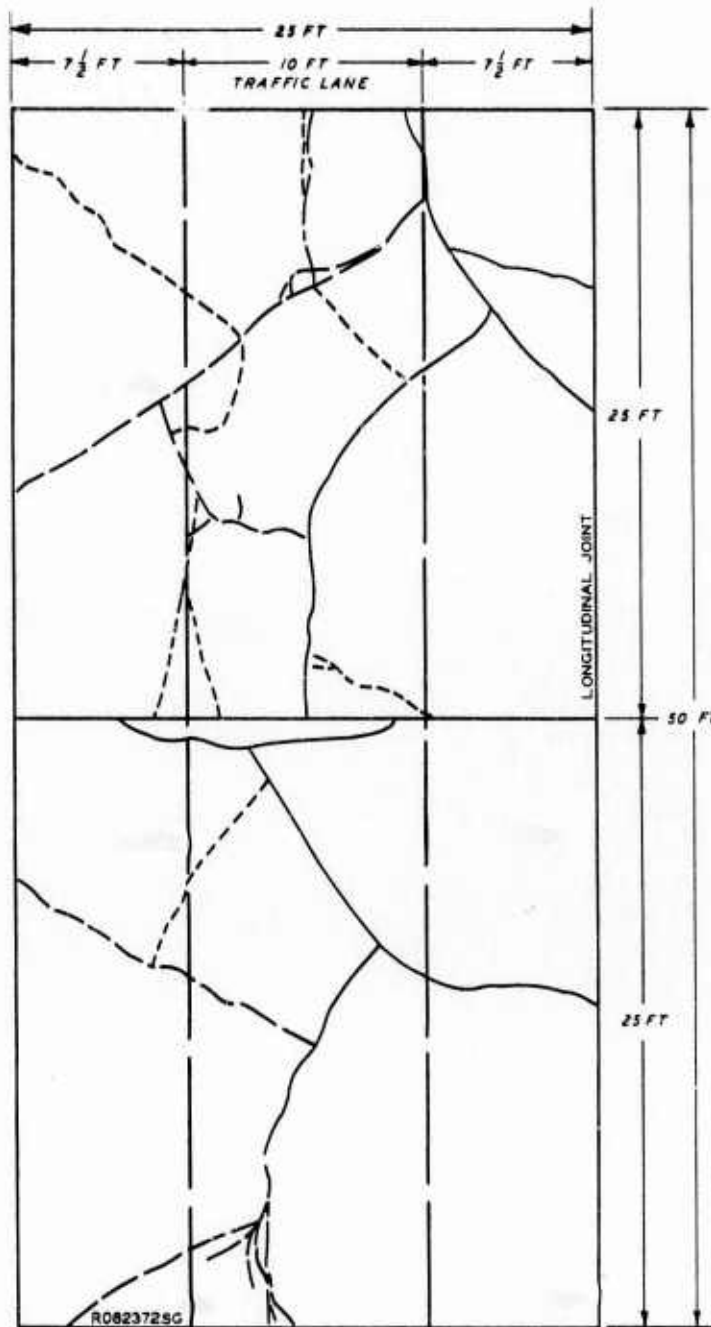
Figure 67. Crack development in item 2 under 166-kip, twin-tandem-assembly traffic.

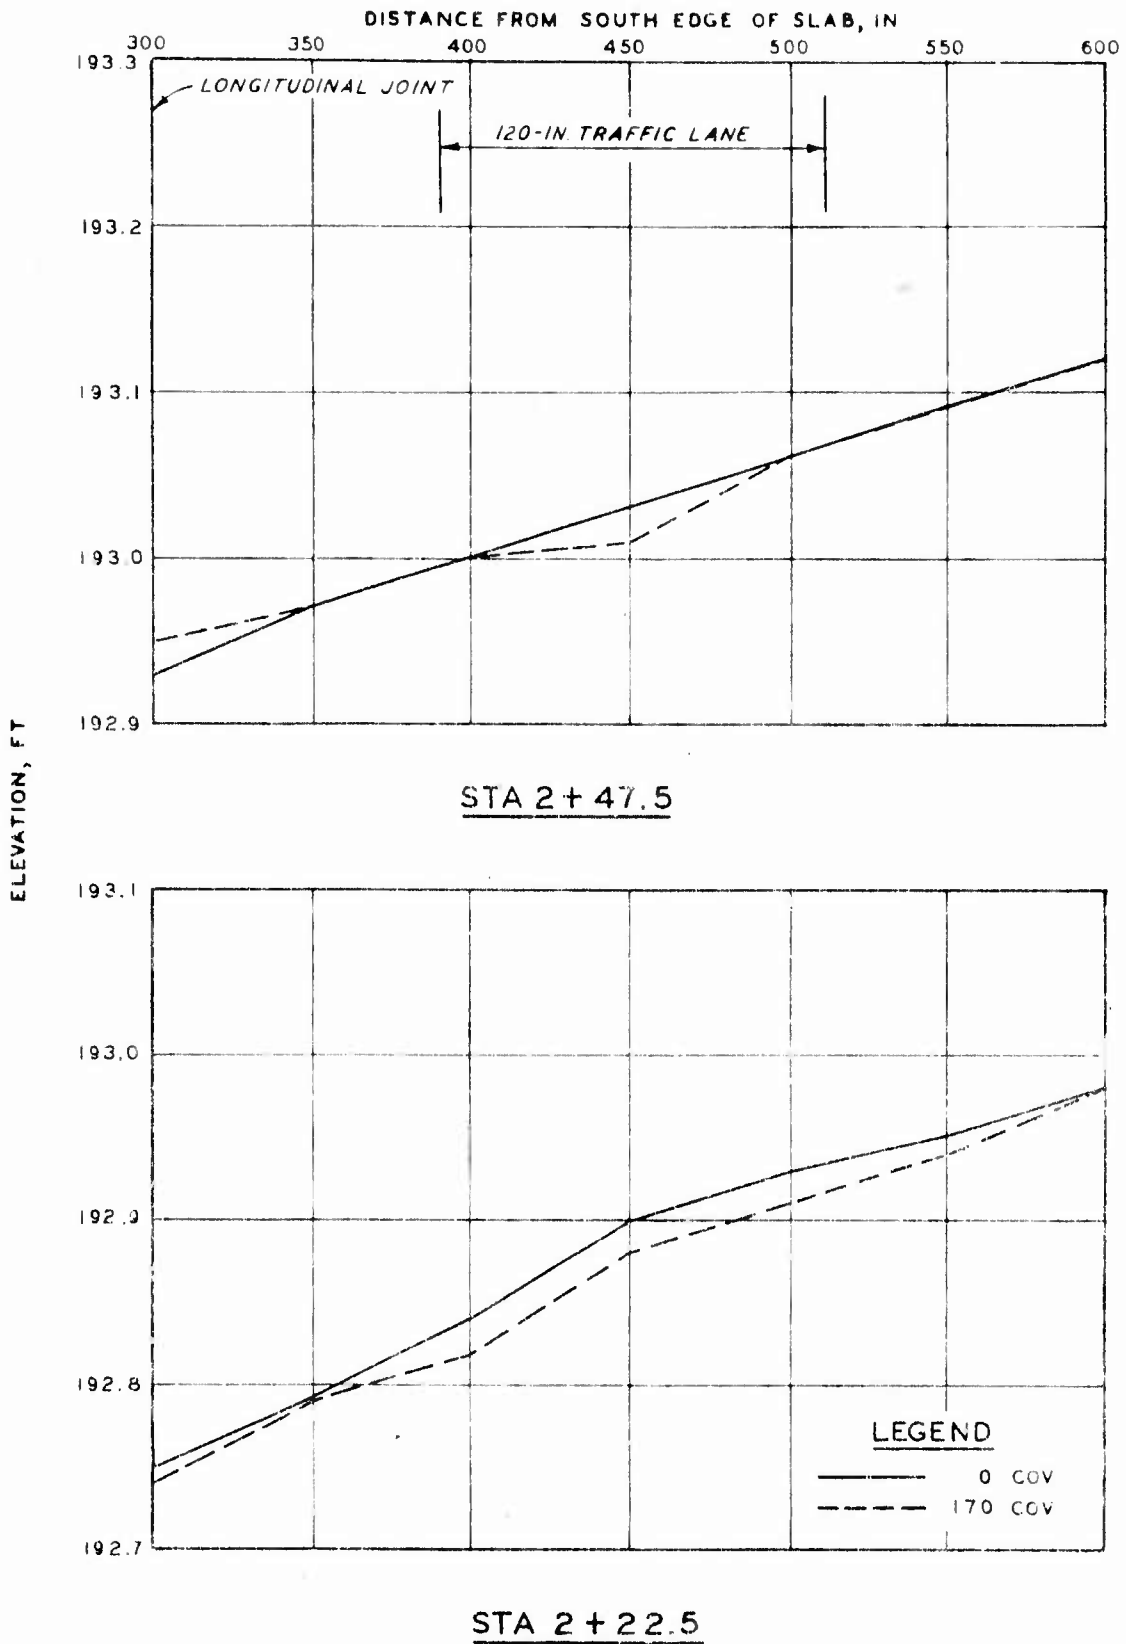
Typical cross-section plot showing the permanent deformation that occurred during traffic is shown in figure 68. The maximum deformation measured at the conclusion of traffic was 0.24 in. As shown in figure 69, a maximum total deflection of about 0.13 in. was measured prior to traffic.

Figure 68. Typical cross sections of item 2, 166-kip, twin-tandem-assembly lane.

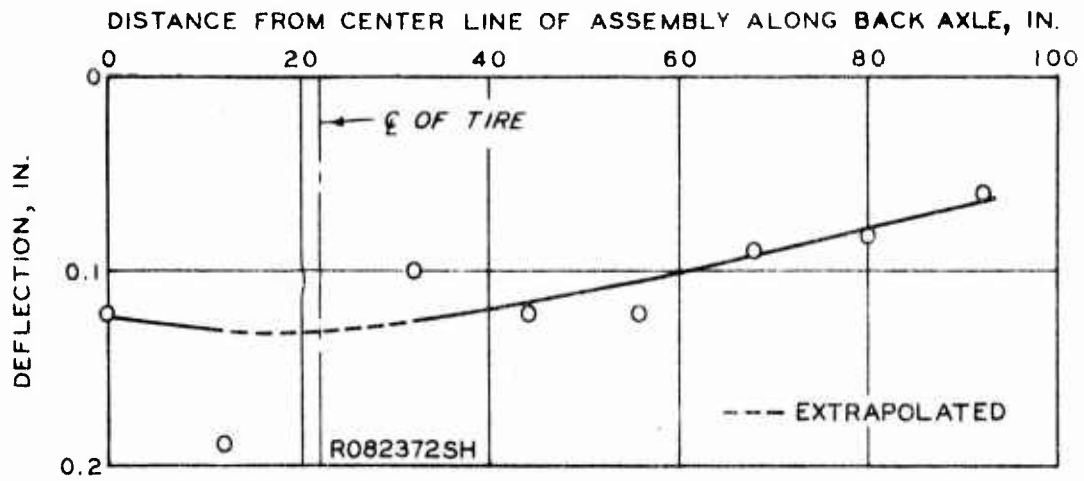
Figure 69. Total deflection in item 2, 166-kip, twin-tandem-assembly lane measured prior to traffic.

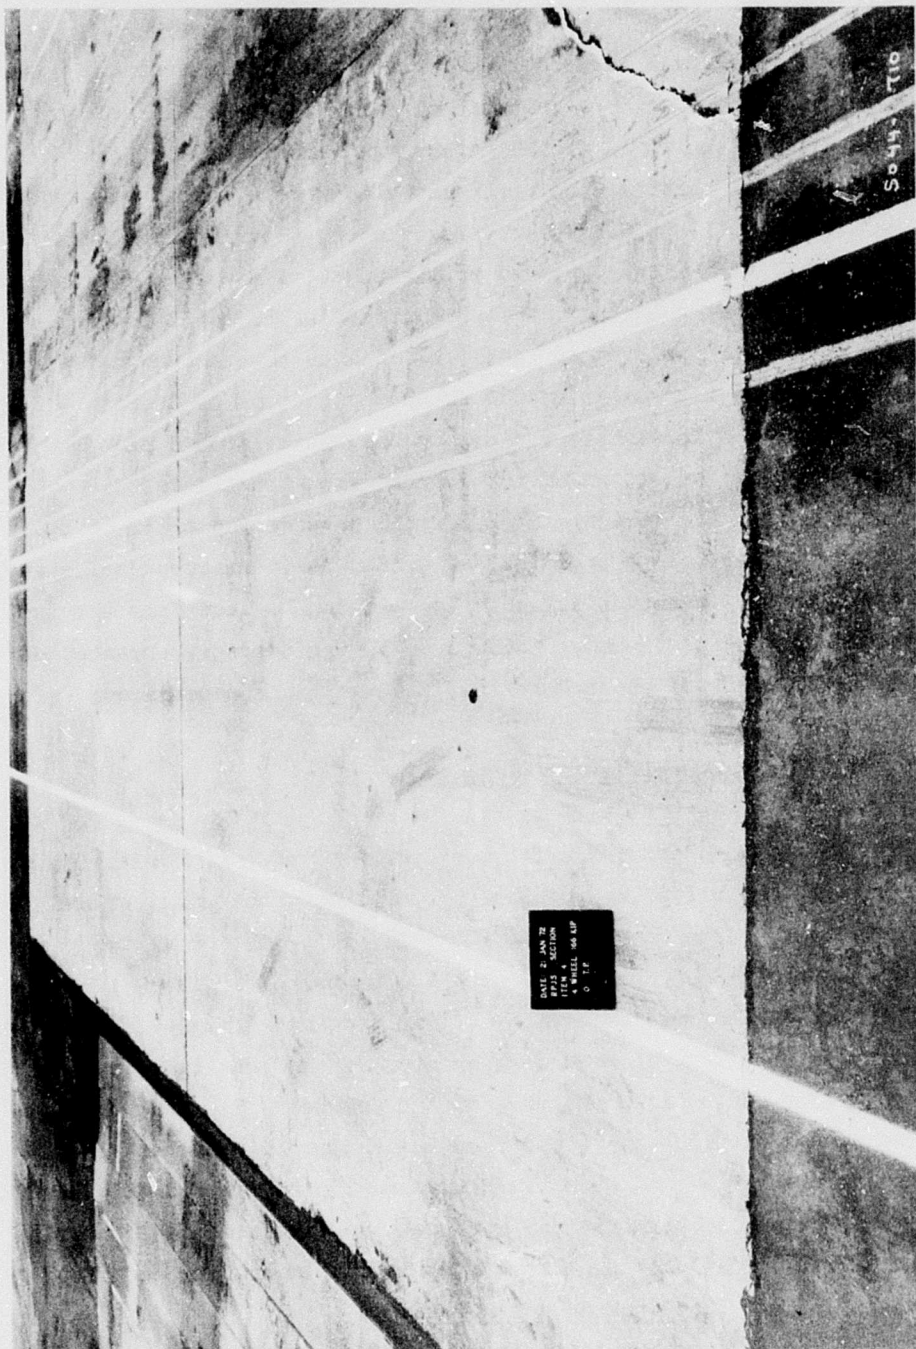
Prior to test traffic, there were corner cracks located at the southeast corner of the northeast slab and at the southwest corner of the northwest slab of item 4. Figure 70 is a general view of the item prior to traffic. The first crack observed during traffic was a hairline longitudinal crack in approximately the center of the traffic lane and extending the length of the item. This crack was detected after 320 coverages. Slight spalling of the existing longitudinal crack at the east end of the item was noticed after about 360 coverages. After 630

Figure 70. Item 4, 166-kip, twin-tandem-assembly lane prior to traffic.

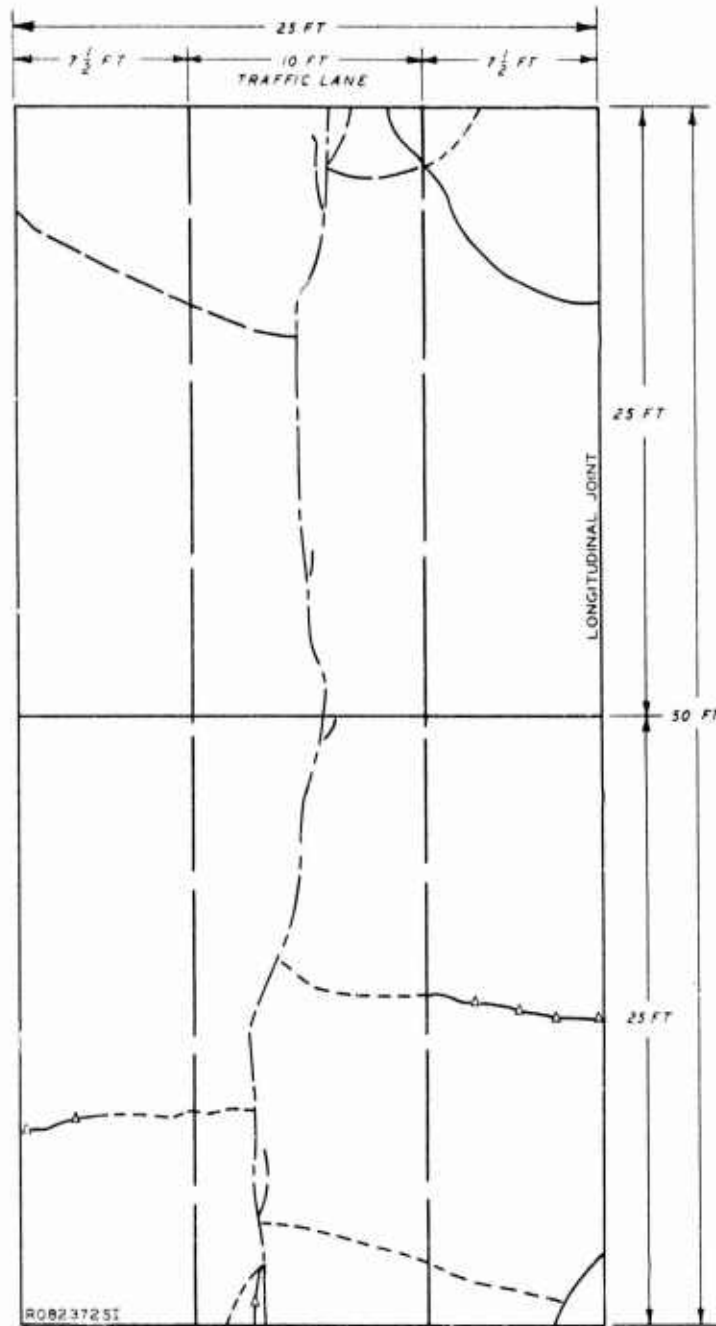
coverages, a crack was observed running diagonally from the north edge of the pavement to the longitudinal crack in the middle of the traffic lane. Small hairline cracks extending transversely out from the longitudinal crack in the northwest slab were observed between 710 and 880 coverages. At the 950-coverage level, the transverse cracks in the northwest slab had progressed to the edges of the slab, which resulted in subdividing the slab into the shattered-slab condition, and traffic was stopped. Spalling and flaking, such as that shown in figure 71, were evident along most of the cracks at the end of traffic. The progression of cracking is shown by the crack pattern plot in figure 72, and the final condition of the item is shown in figure 73.

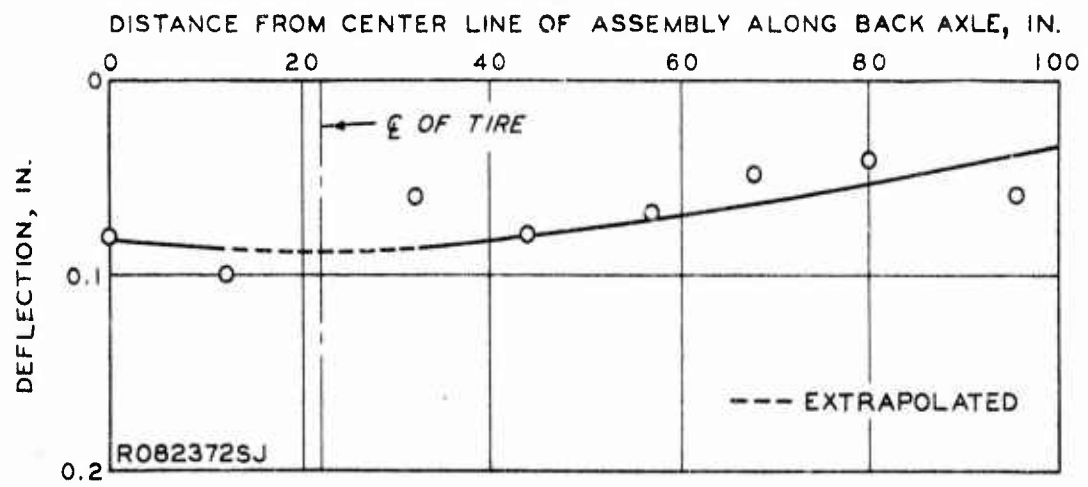
The maximum total deflection measured prior to traffic was about 0.09 in. A plot of the deflection basin measured before applying test traffic is shown in figure 74. As can be seen from the typical cross-section plots shown in figure 75, the average permanent deformation after failure was about 0.18 in., and the maximum permanent deformation was 0.24 in.

Figure 74. Total deflection in item 4, 166-kip, twin-tandem-assembly lane measured prior to traffic.

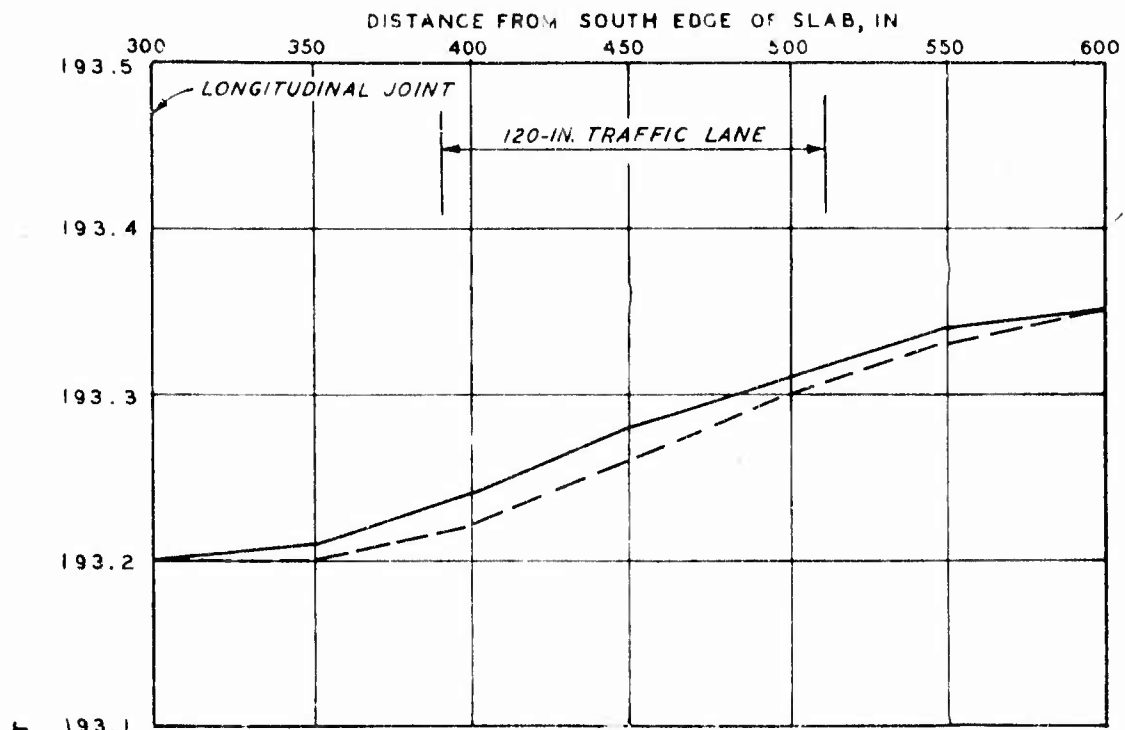
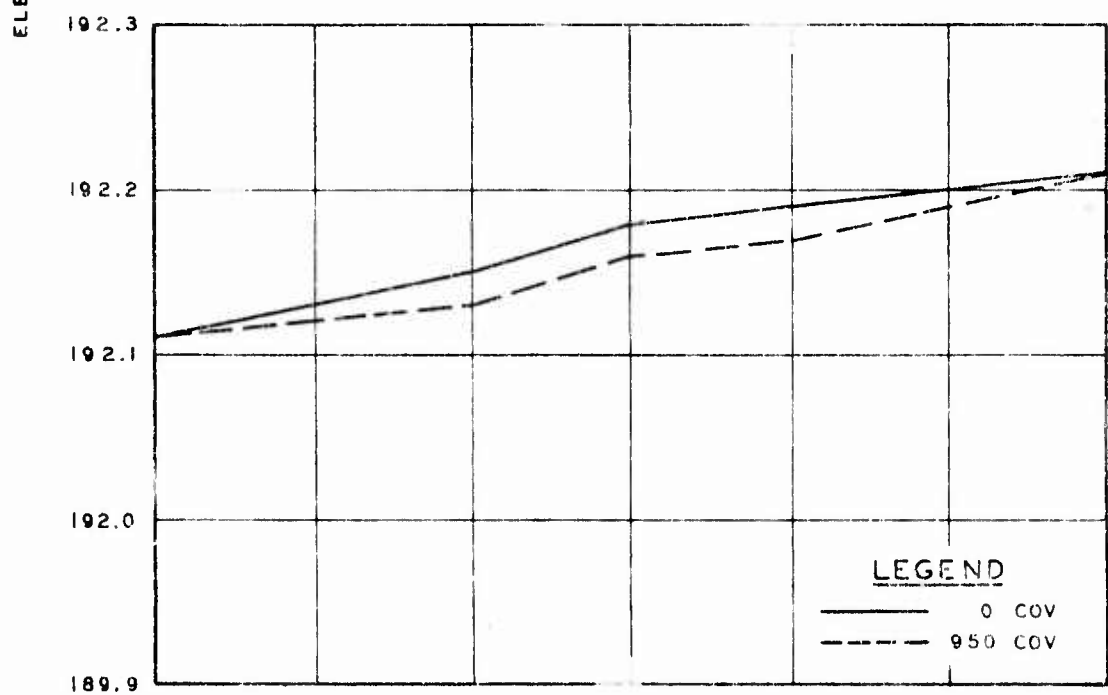
Figure 75. Typical cross sections of item 4, 166-kip, twin-tandem-assembly lane.
