# USAAMRDL TECHNICAL REPORT 73-20

## MANUFACTURING METHODS TECHNOLOGY (MM&T) FOR BALLISTIC-TOLERANT FLIGHT CONTROL COMPONENTS

R. L. Van Auken

May 1973

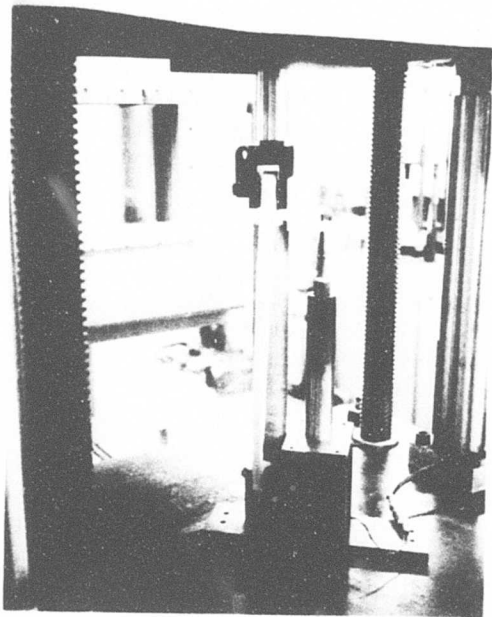
Figure 39. Test Setup for Connecting Link.

Figure 39 shows a typical static loading test being performed on a connecting link assembly. The detail at the right-hand portion of the assembly is an extensometer for measuring load/deflection during the test. Figure 40 shows a typical failure of the connecting link.

The base line static load requirement of the connecting link assembly was -4,060 lb. The lowest failure load was from set no. 2, which had been ballistically impacted. The failure load for this component was 6,700 lb, with a total deflection of 0.052 inch. All other failing loads were in excess of 300% of the base line requirement. The test reports show that the temperature cyclic test series and ultra-violet radiation tests appear to have the least effect on the performance of the component. Both of these components failed in excess of 500% of the base line requirement. The two components which were exposed to the fire resistance and the fuel and oil resistance tests are in excess of 400% of base line. The components which were exposed to the environments of sand and dust, humidity, fungus, and salt spray, and the component which was exposed to the vibration environment failed at over 300% of the base line requirement.

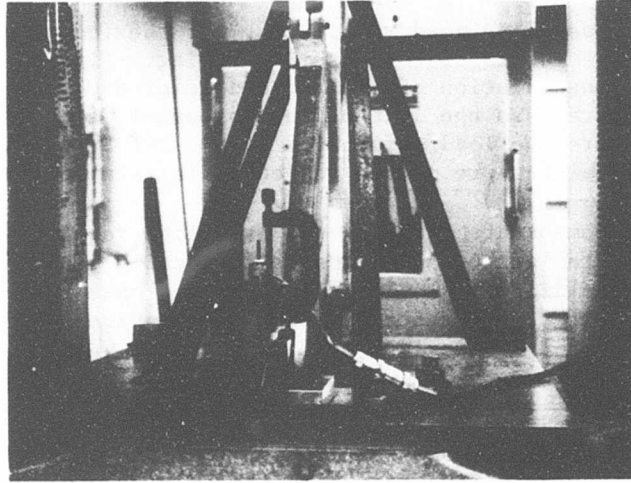
Figure 41. Test Setup for Forward Bell Crank.

The base line requirement for the forward bell crank assembly is a compressive load of -2,070 lb. Figure 41 shows the typical installation of the forward bell crank in the test fixture. In the front left portion of the picture is the extensometer which is mounted directly at the pivot fitting for measuring load/deflection during the test. Figure 42 shows a typical failure of the connecting link assembly. All components tested met or exceeded the base line ultimate load requirements. Set no. 2, which had been ballistically impacted, failed at 2,080 lb, just slightly above the base line requirement. All other components failed in excess of 200% of the base line load. The spread for the remaining components was between 4,000 and 4,900 lb.

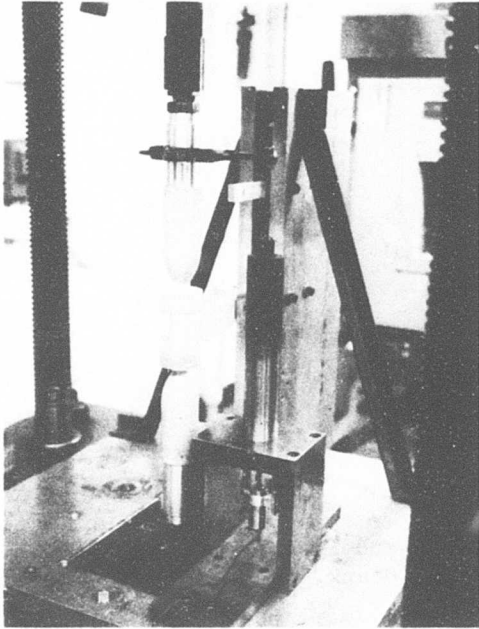
Figure 43. Test Setup for Idler Assembly.

The base line load requirement for the rod end idler arm assembly is -4,013 lb compressive loading. Figure 43 shows a typical installation of the rod end idler arm assembly in the test fixture. To the left of the component is the apparatus used to measure the load/deflection during the test. Figure 44 is a typical failure of the rod end idler arm assembly.

All components exceeded the base line requirement at failure. With the exception of the ballistically impacted component, which failed just slightly above the base line requirement, all other components exceeded the requirement by at least 150% of the base line load.

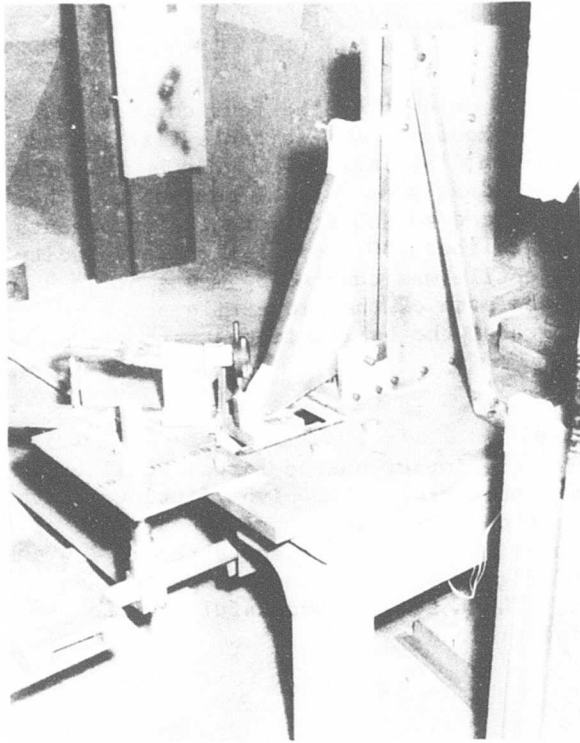
Figure 47. Forward Bell Crank  
Before Impact.

The target area for the ballistic impact on the forward bell crank assembly was the rectangular tube between the pivot fitting and the outboard clevis fitting. The objective was to sever one-half of the rectangular tube cross section. Figure 47 shows the bell crank installed in the fixture, and Figure 48 shows the damage to this area after ballistic impact. The test was successful and the component maintained the initial preload.

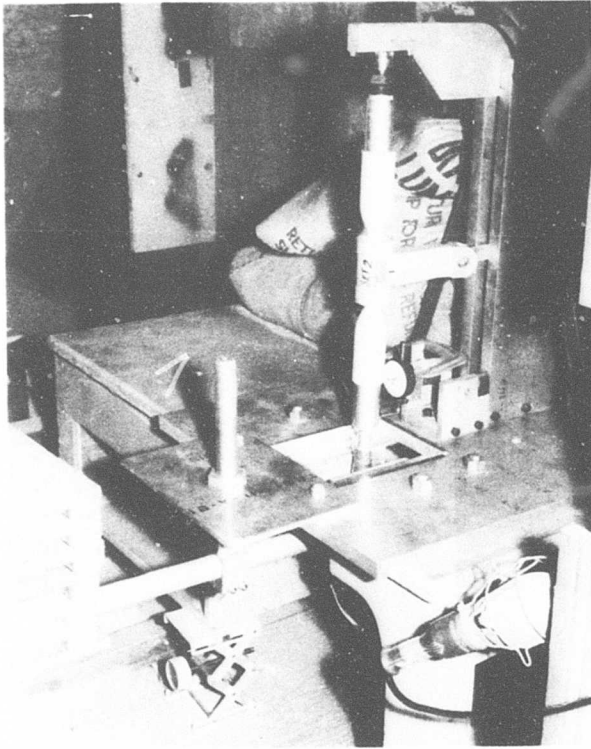
Figure 49. Rod End Idler Arm  
Before Impact.

The rod end idler arm assembly was positioned in a fixture and loaded as shown in Figure 49. The target for the ballistic impact was the very center of the ball and socket joint on the lower side. The test was successful in that the tumbled projectile hit nearly dead center, as shown in Figure 50. However, the projectile ricocheted off the ball, severing a portion of the molded idler arm assembly. The component withstood the impact and was still operational.

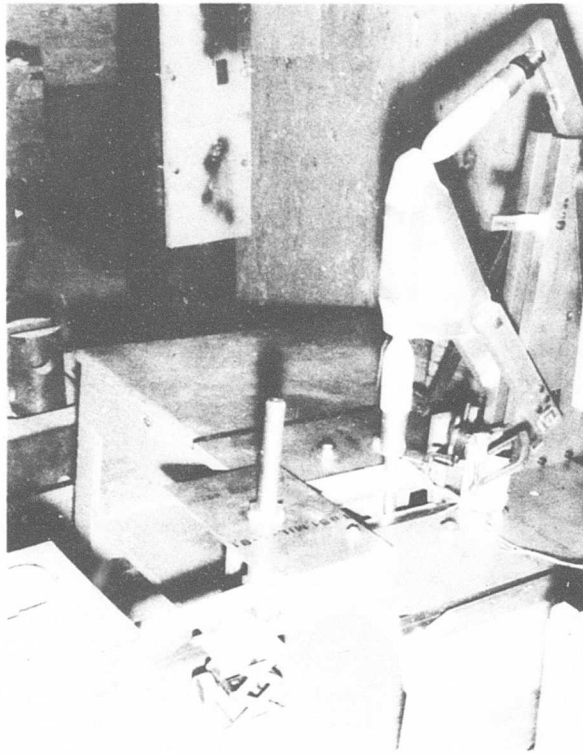
The aft bell crank assembly was positioned in the fixture and loaded as shown in Figure 51. The target for the ballistic impact was the center of the ball and socket joint at the input fitting. In the first test, the projectile hit approximately 0.4 inch below in a tumbled fashion. In this area it impacted the retainer ring and completely severed it from the rest of the assembly. No further damage was incurred; however, the ball was completely loose from the socket and would not permit further testing. Observation of the failure indicated that the projectile, when penetrating the retainer ring, had made contact with the unidirectional glass wrapped reinforcement around the retainer and appeared to have unwrapped this reinforcement on its path through the part. A second test was performed

Figure 51. Aft Bell Crank  
Before Impact.

Figure 52. Aft Bell  
Crank  
After  
Impact.

in an attempt to achieve a hit more centered on the ball and socket joint. The component for this test was the aft bellcrank assembly that had been exposed to the ultraviolet radiation condition. During the second test, the tumbled projectile hit directly on the center of the ball and socket joint and ricocheted inward. While there was minimal damage to the ball itself, it did stop the projectile, leaving the jacket and lead fragments inside the bell crank cavity. While absorbing this impact, considerable damage was incurred in the molded fitting. However, the bell crank was still operational. Figure 52 is a picture of the damage incurred on the second ballistic test.
